<h2 style="text-align: center;">STORMWATER COMPLIANCE INSPECTION REPORT</h2> <p style="text-align: center;">State of Washington Department of Ecology 15700 Dayton Avenue N, Shoreline, WA 98133</p>			WADOE Stormwater Phone: (206) 594-0000										
Section A: General Data															
Inspection Date 6/15/2023	NPDES Permit # WAR003231	County King	Receiving Waters Duwamish	Inspector Jessica Kasmari	Facility Type Industrial										
Discharges to: Surface Water <input checked="" type="checkbox"/> Ground Water <input type="checkbox"/>				ANNOUNCED Inspection											
Section B: Facility Data															
Name and Location of Site Inspected Jorgensen Forge 8531 E MARGINAL WAY S, TUKWILA, 98108				Entry Time 2:00 pm	Permit Effective Date 01/01/2020										
				Exit Time 3:30 pm	Permit Expiration Date 12/31/2024										
On-Site Representative(s): Name(s)/Title(s)/Contact number(s) or E-mail Stacy Fox, Senior Consultant of DH Environmental stacyfox@dhenviro.com 206.777-5159 David Hill, President of DH Environmental davehill@dhenviro.com 206-293-3126				Additional Participants:											
Responsible Official(s): James Robertson, President jrobertson@jorgensenforge.com (206) 676-

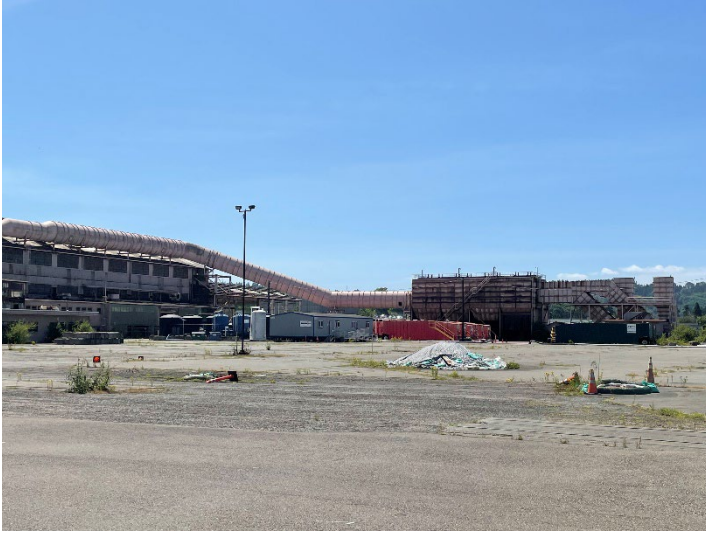
**PHOTO 1**

DIRECTION: Looking West towards the Duwamish River
DESCRIPTION: Back half of the facility where the treatment system is located

- Bag House Tunnel (photo 1 and photo 2)
 - KO61 waste was cleaned and inspected prior to DH Environmental involvement.
 - DH Environmental will demolish the tunnel in pieces and place it in a containment zone.

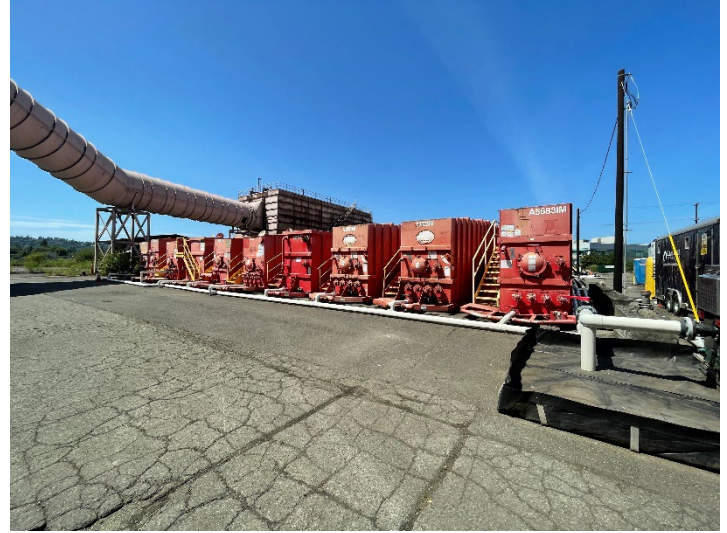
**PHOTO 2**

- Treatment
 - 19 baker tanks in the summer and 49 tanks in the winter, during the wet season (photo 2).
 - 3 types of filters, sand, chitosan, and one for metals.

DIRECTION: Looking Northwest
DESCRIPTION: Baker Tanks and Bag House

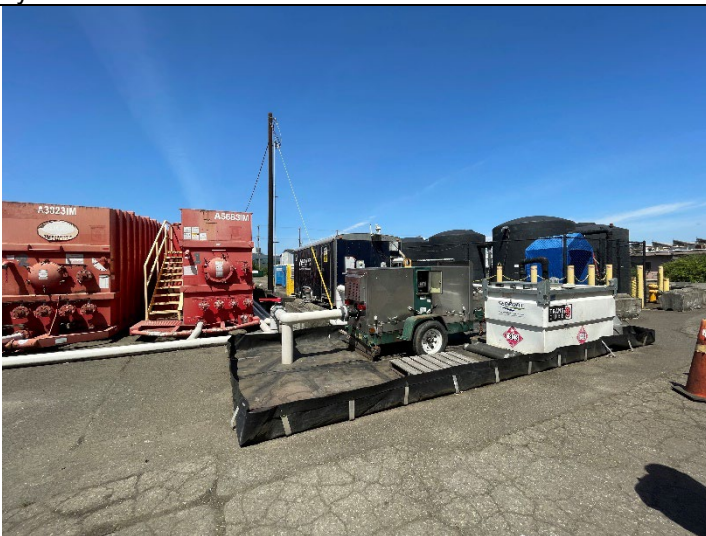
**PHOTO 3**

- The sand filter has been changed out twice in this permit cycle.
 - The other two have been changed once since 2020.
 - There is a double-walled diesel tank and generator within secondary containment (photo 3).

DIRECTION: Looking North
DESCRIPTION: Secondary containment and double-wall diesel tank for the generator

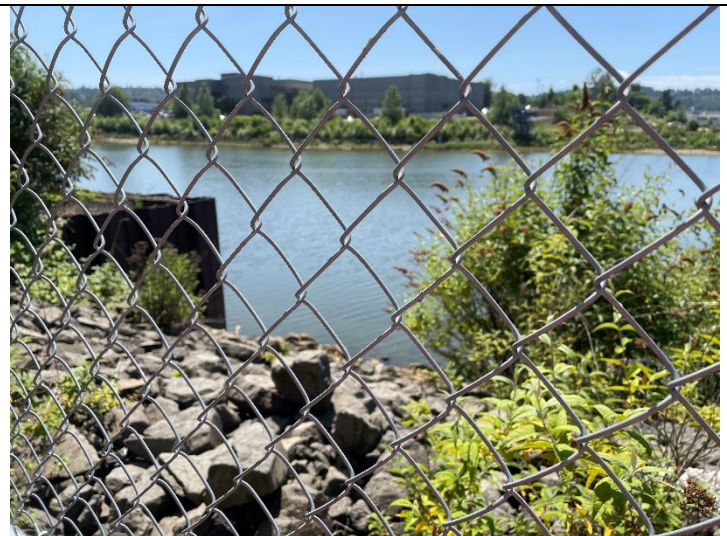
**PHOTO 4**

- During demolition they will monitor the treatment system more frequently than the current once a week.
 - After treatment water is stored in tanks then discharged to the Duwamish (photo 4).

DIRECTION: Looking West
DESCRIPTION: Approximate location of the discharge pipe

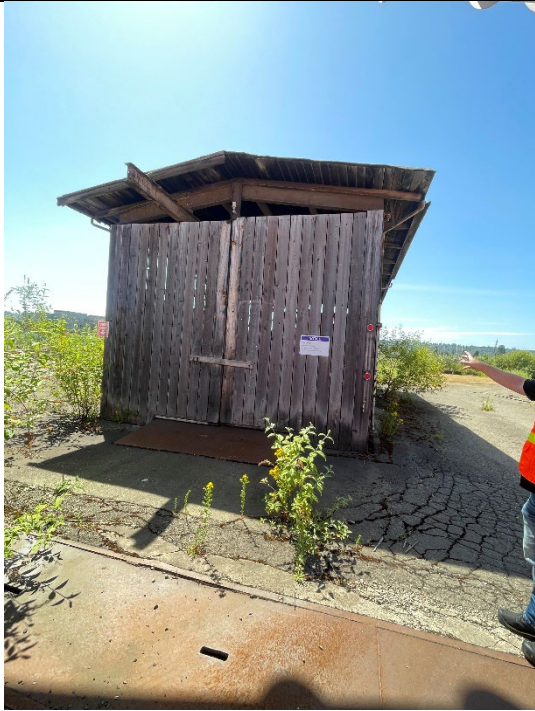
- Using wet rags (wet wipes) any remaining dust will be removed and disposed of.
- Tote Building
 - This is a shed and the building materials contain PCB. (photo 5)

**PHOTO 5****DIRECTION:** Looking West towards the Duwamish River**DESCRIPTION:** PCB containing materials

- As part of the demolition, they will remove building and up to 18 inches of soil below the building will be removed and disposed of off-site.
- BMPs along the Duwamish

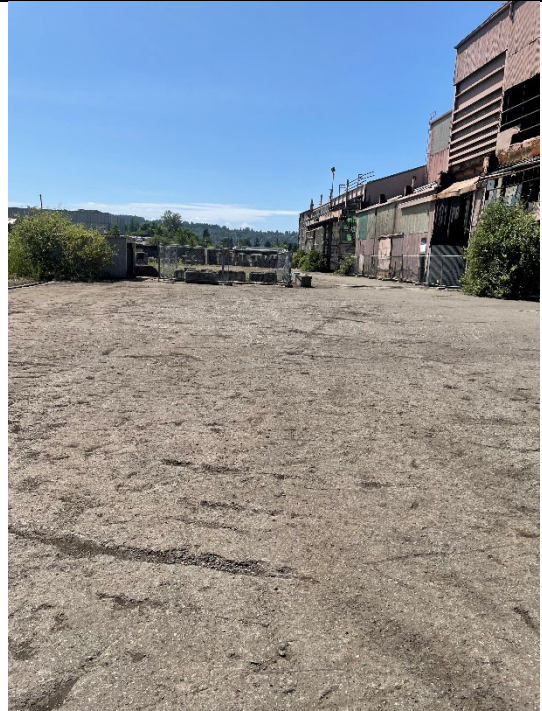
- Ecology recommends ecology blocks with filter fence.
- CAA or diesel storage
 - Former oil storage, currently empty of any oils
- Ponding area
 - Within the demolition report, there was an area described as ponding. This is a low-lying area on the southern side of the property adjacent to the Boeing facility.

- There are no catch basins in this area the water just infiltrates through the pavement or evaporates. (photo 6).
- They do not have a grading permit therefore major grading will not occur.

**PHOTO 6****DIRECTION:** Looking West towards the Duwamish River**DESCRIPTION:** The area where stormwater ponds. There are no catch basins in this area

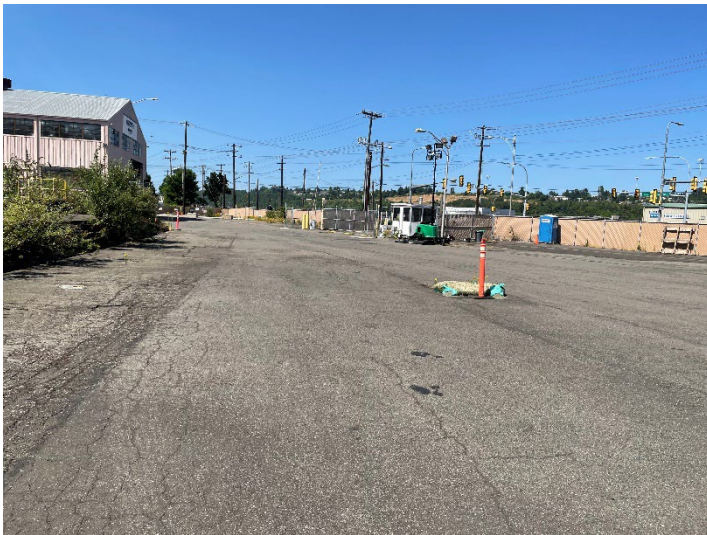
- They have a permit to discharge to sanitary.
- All water inside buildings have been and will continue to be treated as wastewater.
- Two outfalls are plugged, one is open.
- Some catch basins are sealed.
- Every catch basin has a boom and filter (photo 7).
- Sweeping occurs weekly.
- Jorgensen's goal to be able to submit a notice of termination for the ISGP permit after demolition and before the new property owner takes ownership.

**PHOTO 7****DIRECTION:** Looking North**DESCRIPTION:** Example of catch basin with filter sock

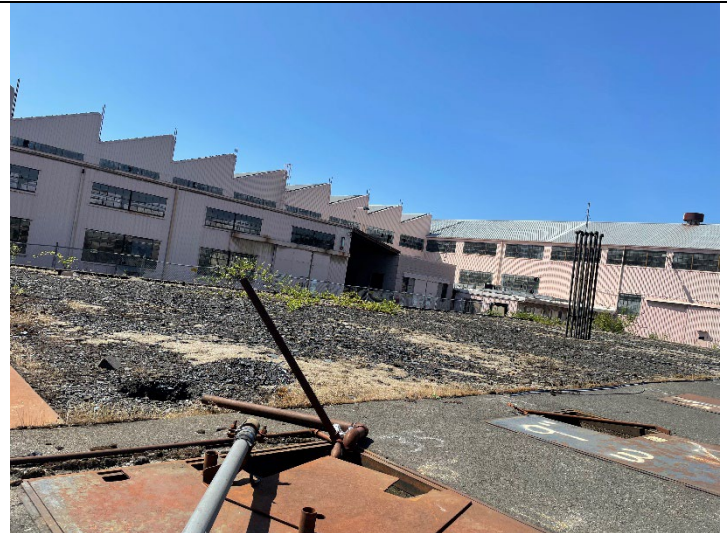
- Abatement is approximately 90-95% complete.
- Underground Storage Tanks (USTs)
 - Slag material containing metals was used as fill material between the USTs. During removal the slag will be loaded directly onto trucks for disposal. If there is a need to create piles, the slag material will be covered to prevent stormwater pollution. (photo 8)

**PHOTO 8****DIRECTION:** Looking Northwest**DESCRIPTION:** SLAG MATERIAL SURROUND THE UNDERGROUND STORAGE TANKS
