State of Washington Department of Ecology <b>WASTEWATER TREATMENT PLANT COMPLIANCE INSPECTION REPORT</b>	Northwest Region Office 15700 Dayton Ave N Shoreline, WA 98133 206-594-0000 ph 206-366-7810 fax (last update 7-6-2021)
	Section A: General Information

Name, Location, and Phone of Facility Inspected King County – Carnation Wastewater Treatment Plant 4405 Larson Ave, Carnation WA 98014	Entry Time 9:30 AM	Permit Effective Date 09/24/2021
	Exit Time 12:30 PM	Permit Expiration Date 10/31/2026

Section D: Summary of Findings/Comments	
---	--

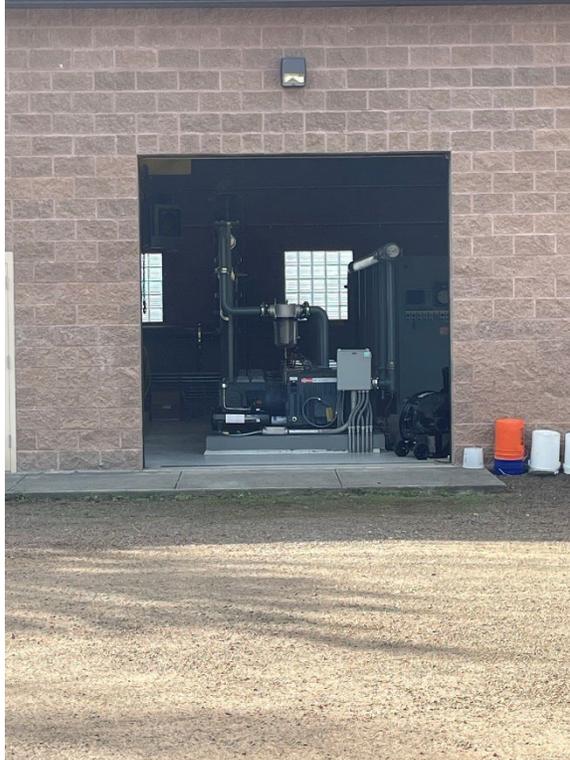
### PHOTO NO. 1

Vacuum transfer station owned and operated by City of Carnation located adjacent to the treatment plant.

Collection System: The City of Carnation owns and operates a vacuum collection system for sewage collection in the City and surrounding areas. All drain lines from the City collect at receiving facility located adjacent to the County-operated treatment plant. The receiving facility sends sewage to the treatment plant at a rate of approximately 1000 Gallons per Minute (GPM) in 10–20 minute pulses making the flow into the plant intermittent. The vacuum collection system was installed around the same time as the treatment plant's construction and is a fairly new system. County operators stated that they have started to notice a small amount of flow increase during wet weather which could indicate that there is some infiltration and inflow, but it is still minor.

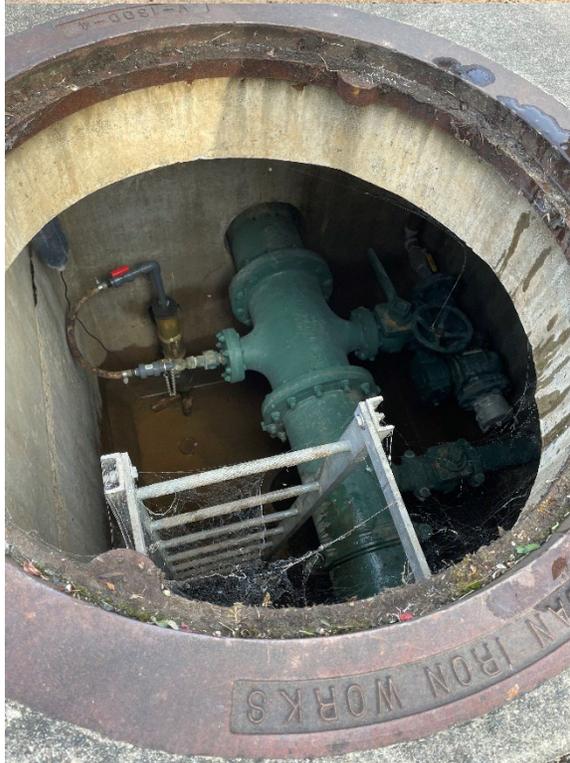
### PHOTO NO. 2

Chemical addition location prior to screening.

Liquid Stream: All flows received by the treatment plant enter the facility via underground piping. The facility has the capability (although it does not typically use it) to chemically dose influent flows to enhance treatment. The chemical addition system was originally designed to dose sodium hypochlorite, but theoretically can be used to dose a wide range of chemicals. After the chemical dosing vault, flows proceed to two fine rotary screens. The automated influent sampler was recently relocated to a location after the rotary screens to reduce the likelihood of clogging the sample lines.

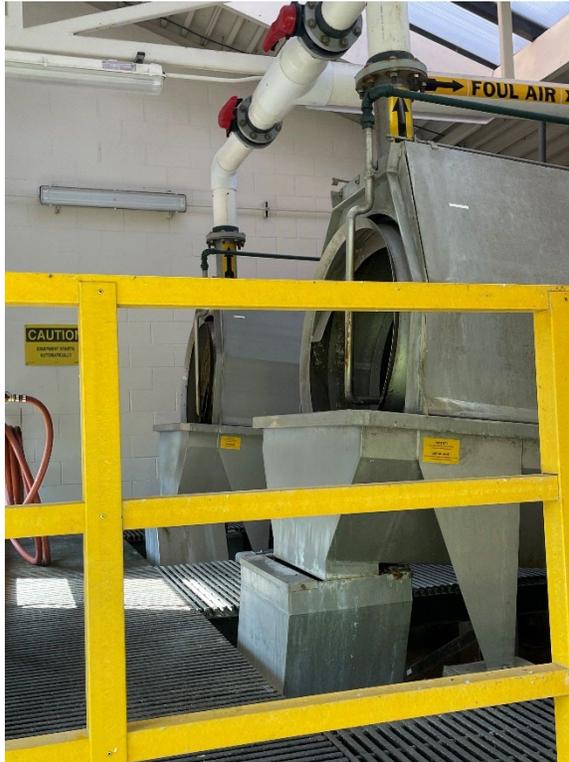
**PHOTO NO. 3**

**Description:**  
Rotary screens used to remove debris from influent.

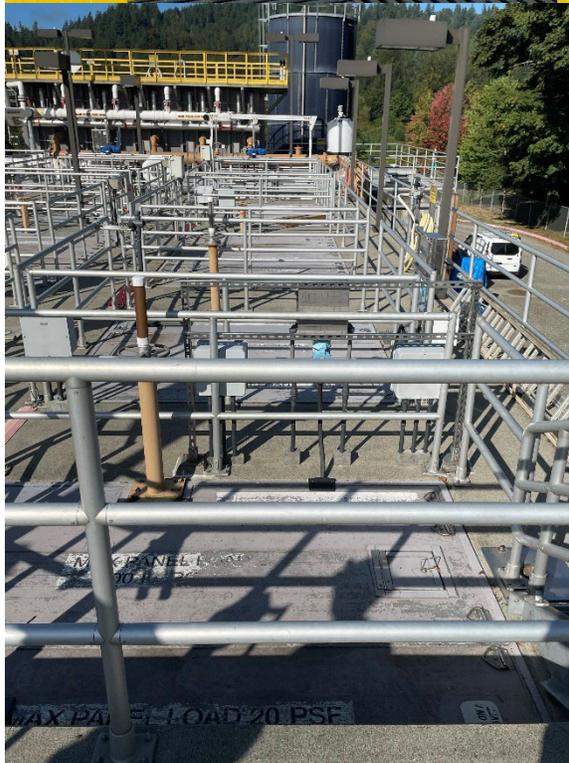
**PHOTO NO. 4**

**Description:**  
Aeration basins (closest basin is 1).

Once screened, influent then passes through one of two identical aeration basin trains. Typically, the facility uses only one train and keeps the other empty. The empty aeration basin train is used for emergency storage or to store flows that facility does not want to immediately discharge. Most frequently, this is treated wastewater that contains residual chlorine from biannual membrane cleaning activities. Return Activated Sludge (RAS) is reintroduced immediately before the first aeration basin. The first two aeration basins in the train are not agitated and have no oxygen addition. The third and fourth basins do have oxygen injection and are currently targeting approximately 0.9-1.1 mg/L Dissolved Oxygen (DO). This set point was lowered when new nutrient limits were introduced in the permit in 2018.

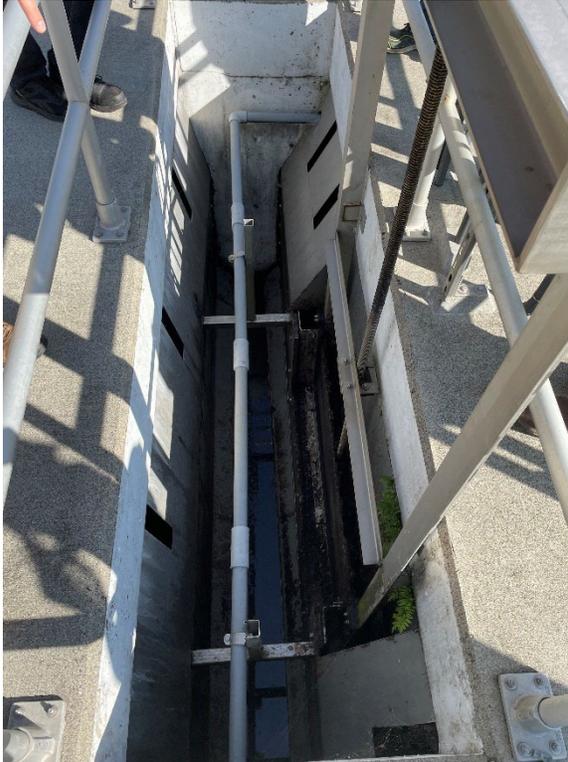
**PHOTO NO. 5**

There is a scum trough after the aeration basins and before the membrane trains. Operators stated that, in general, they have had issues with foaming in the aeration basins.

**Description:**  
Scum trough.

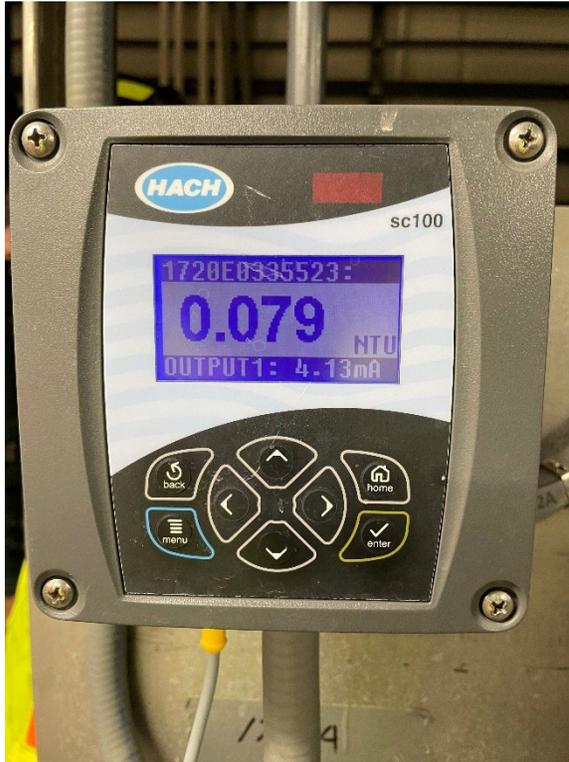
**PHOTO NO. 7**

**Description:**  
Turbidity meter located in membrane effluent.

Membrane effluent, then moves into a series of pipes equipped with flow, pH, and turbidity meters. The flow meters are used to determine the require ultraviolet (UV) dosage to be applied in the subsequent UV disinfection system. The turbidity meters are used to determine if the current membrane train is working effectively while the pH reading is used to determine if effluent meets permit requirements for discharge. The whole treatment train will shut down if the pH reading is below 6.3 standard units (SU). UV disinfection itself is done with medium pressure UV bulbs that are set perpendicular to the flow. This UV bulb arrangement can be restrictive of low flow scenarios and there is a potentially a plan to replace the system in the end of 2023.

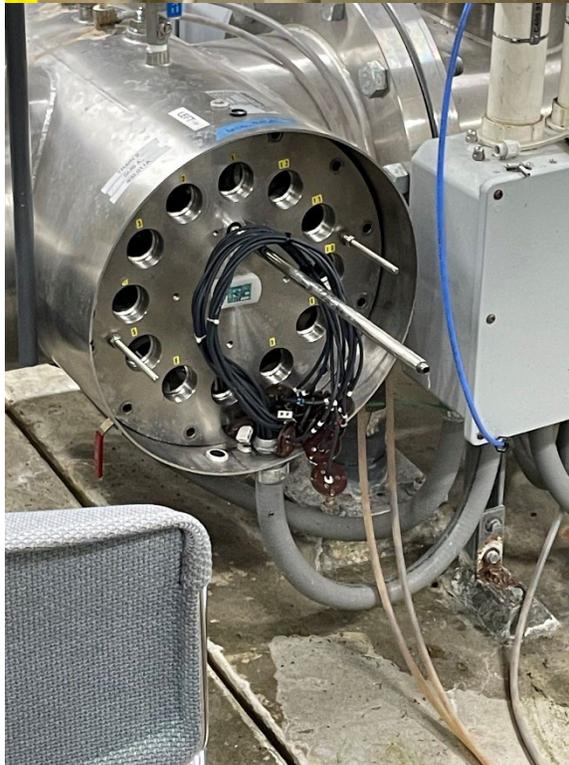
**PHOTO NO. 8**

**Description:**  
Open UV contact chamber undergoing bulb replacement.

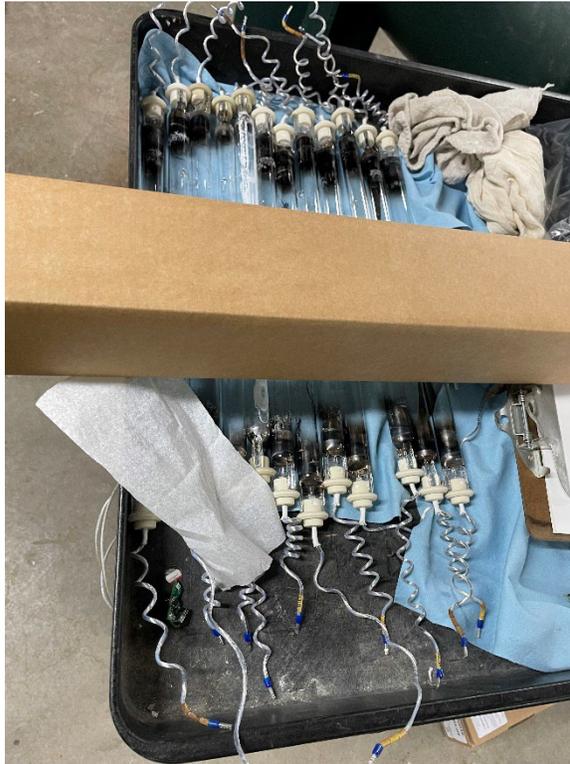
**PHOTO NO. 9**

**Description:**  
Removed UV bulbs.

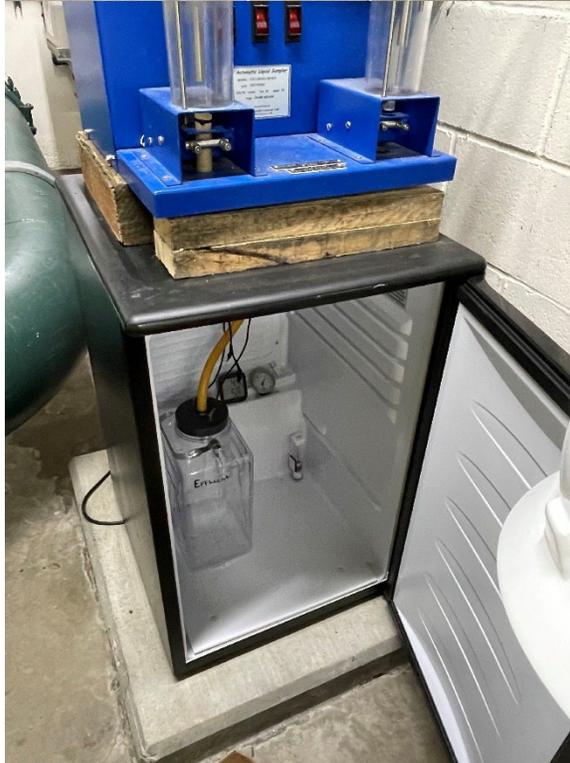
**PHOTO NO. 10**

**Description:**  
Effluent sampling location and refrigerator.
