CONSTRUCTION STORMWATER GENERAL PERMIT INSPECTION REPORT

State of Washington Department of Ecology

The Aberdeen Dollar General project is covered under the State of Washington's Construction Stormwater General Permit (CSWGP). The CSWGP is a National Pollutant Discharge Elimination System (NPDES) and a State Waste Discharge permit for discharge of construction-related stormwater. The purpose of this inspection is to conduct a compliance inspection and to provide technical assistance as appropriate.

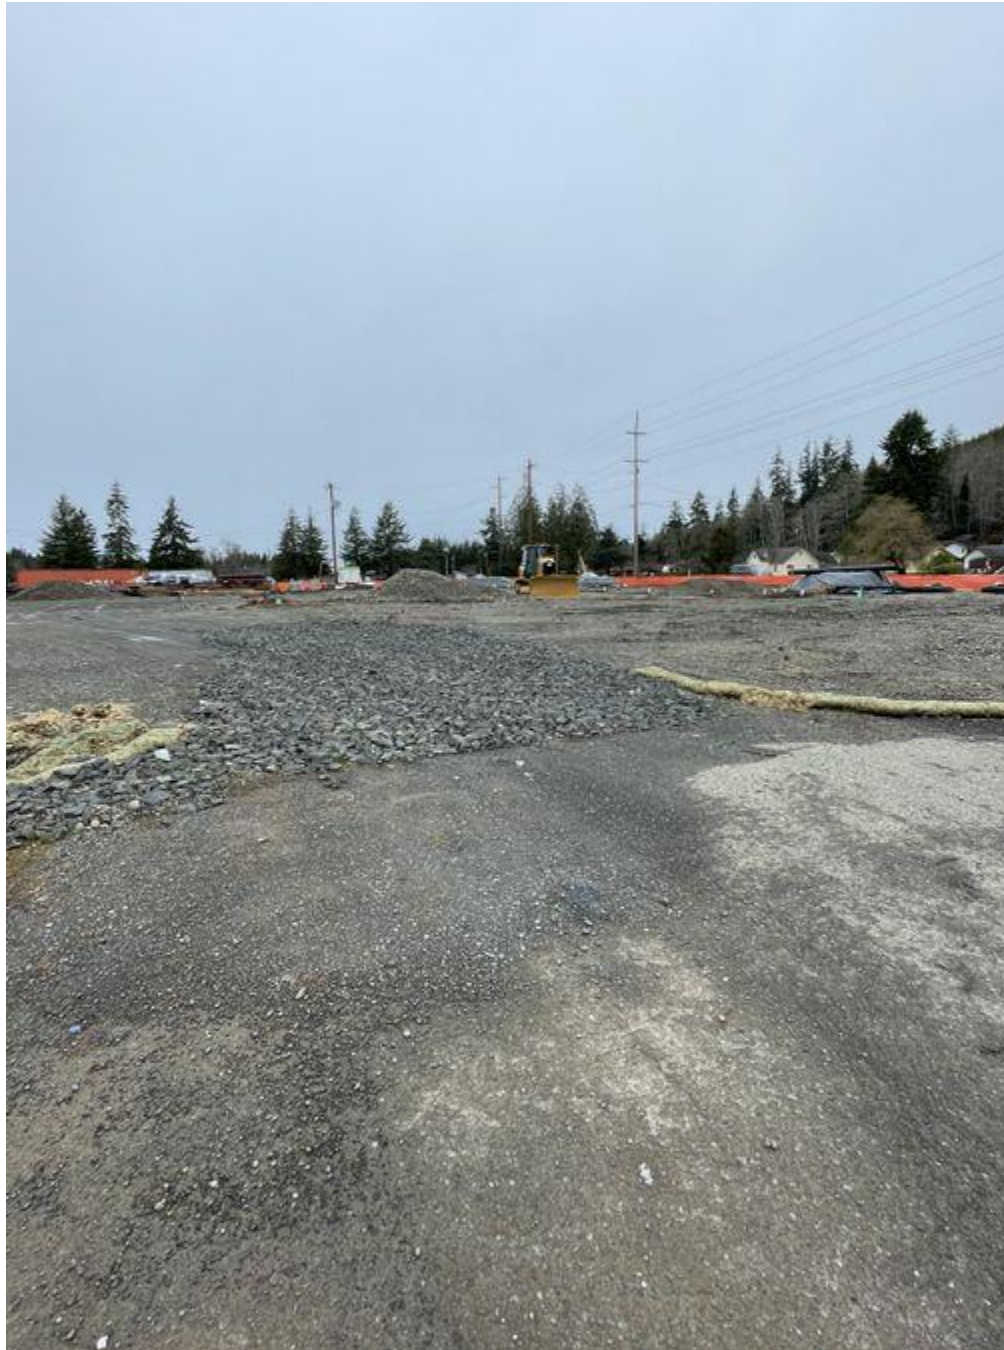
Photo 1

| <u>Violations and action required to achieve compliance</u> | <u>Complete or submit date</u> | <u>Guidance</u> |
|--|---|---|
| <p><u>S9.C.1 Stormwater Best Management Practices (BMPs)</u></p> <p>Construction entrance is not sufficient to provide sediment reduction (Photo 1).</p> <p><i>Failure to meet S9.C1: BMPs must be consistent with the Stormwater Management Manual for Western Washington.</i></p> | <p>Immediately begin. Address the problems no later than 10 days from the date of this inspection.</p> | <p>C105</p> |

Photo Description: Facing west, construction entrance is not adequate to prevent trackout

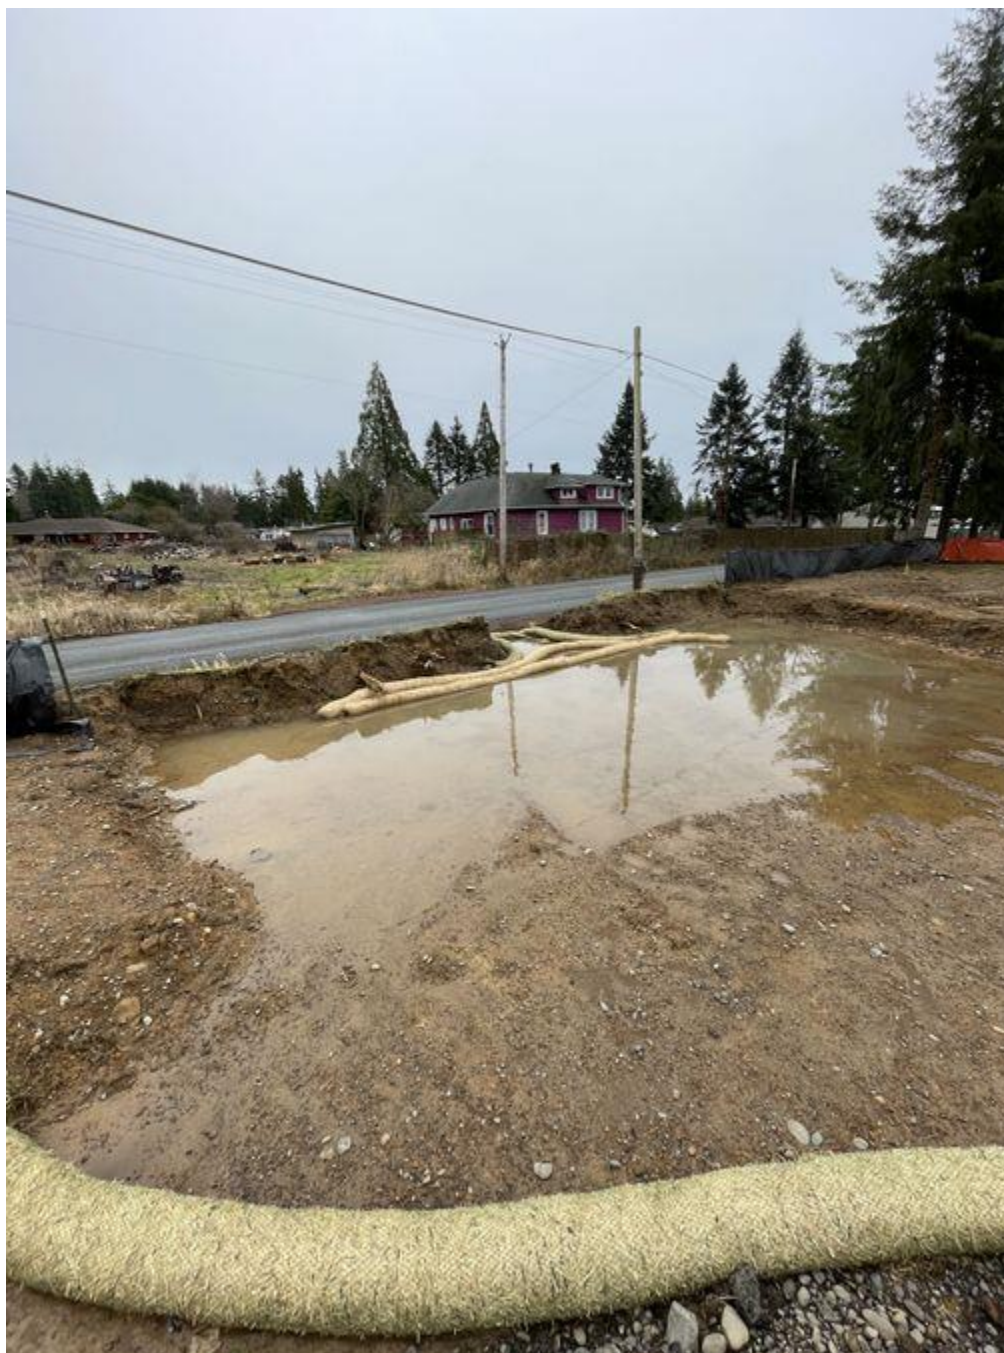
Photo 2

| <p><u>S9.D.3 Control Flow Rates</u> Retained water on site is being detained by straw wattle (Photos 2, 3). Additional evidence of water ponding beyond permit boundaries (Photo 5).</p> <p><i>Failure to meet S9.D.3.a:</i> Protect properties and waterways downstream of construction sites from erosion and the associated discharge of turbid waters due to increases in the velocity and peak volumetric flow rate of stormwater runoff from the project site, as required by local plan approval authority. Control flow rates, as set forth in permit condition S9.D.3.a.</p> | <p>Immediately begin. Address the problems no later than 10 days from the date of this inspection.</p> | <p>C203, C207, C209, C235, C240, C241</p> |

Photo Description: Facing southeast, water retained on site in puddle instead of designed stormwater pond

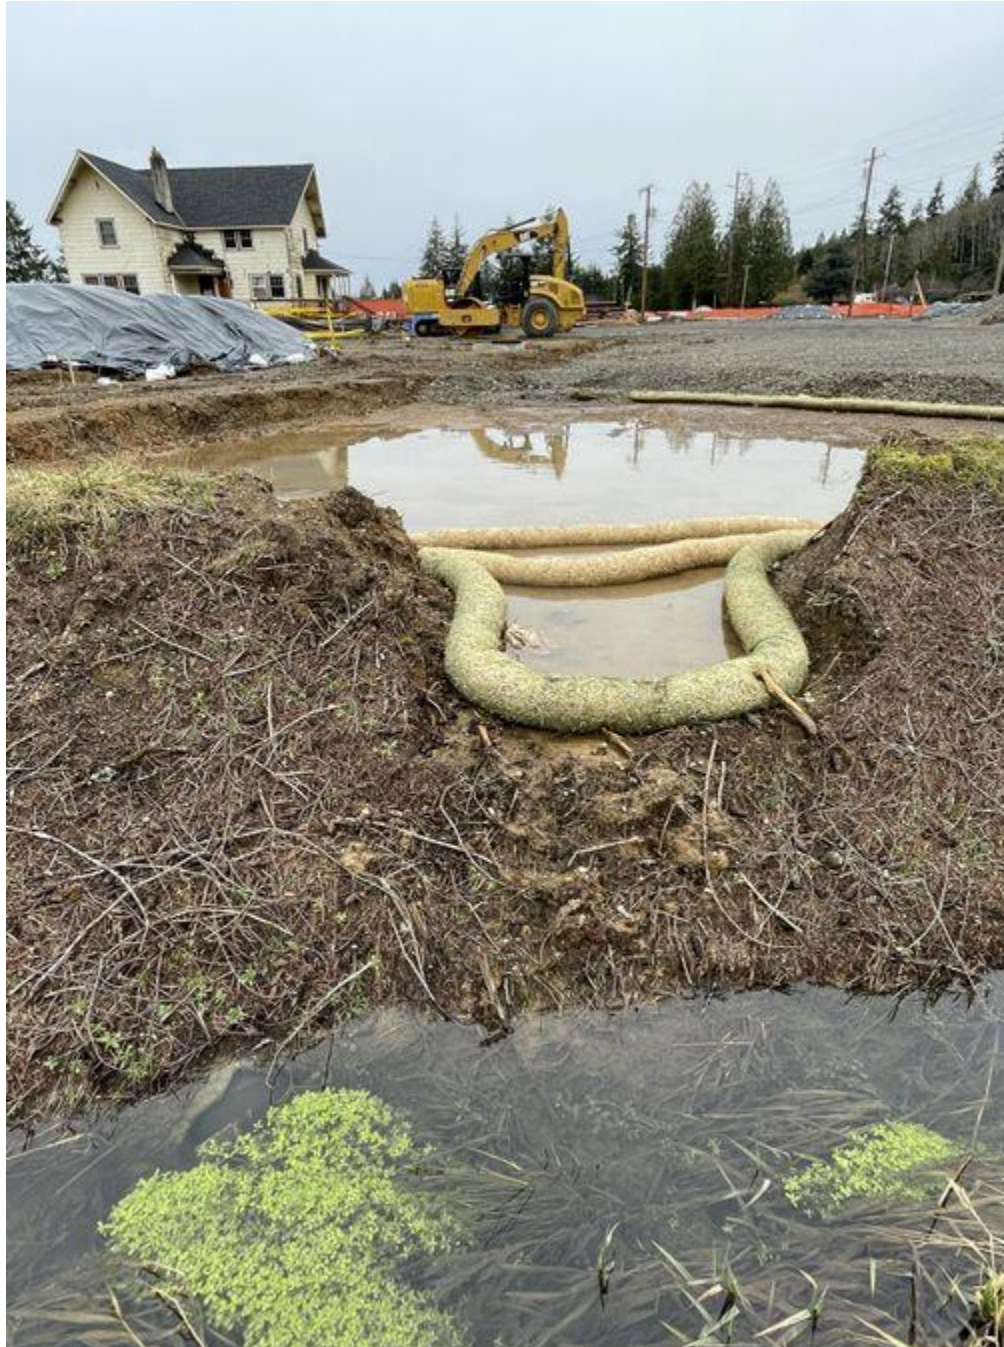
Photo 3

| <p><u>S9.D.8 Stabilize Channels and Outlets</u> Point of outflow for retained water is not stabilized to prevent erosion (Photo 3).</p> <p><i>Failure to meet S9.D.8.b:</i> Provide stabilization, including armoring material, adequate to prevent erosion of outlets, adjacent stream banks, slopes, and downstream reaches at the outlets of all conveyance systems. Stabilize channels and outlets, as set forth in permit condition S9.D.8.</p> | <p>Immediately begin. Address the problems no later than 10 days from the date of this inspection.</p> | <p>C202, C207, C209</p> |

Photo Description: Facing west, discharge point of retained water held by straw wattles above drainage ditch

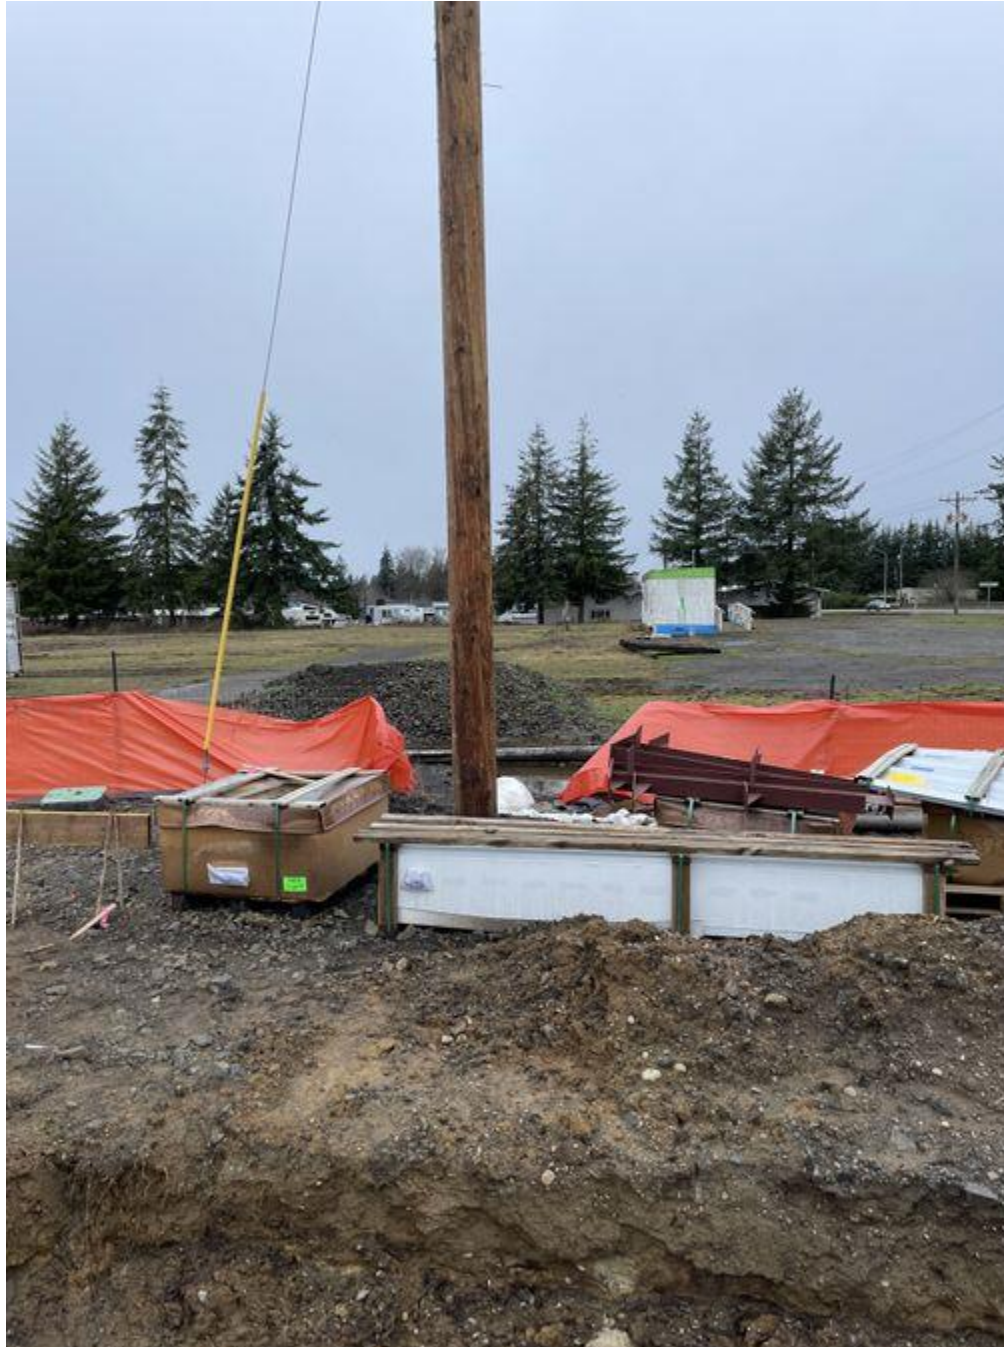
Photo 4

| <p><u>S9.D.12 Manage the Project</u> Silt fence along western boundary in need of maintenance (Photo 4).</p> <p><i>Failure to meet S9.D.12.b:</i> Inspect, maintain and repair all BMPs as needed to assure continued performance of their intended function. Conduct site inspections and monitoring in accordance with Special Condition S4.,</p> | <p>Immediately begin. Address the problems no later than 10 days from the date of this inspection.</p> | <p>C233</p> |

Photo Description: Facing west, downed silt fence

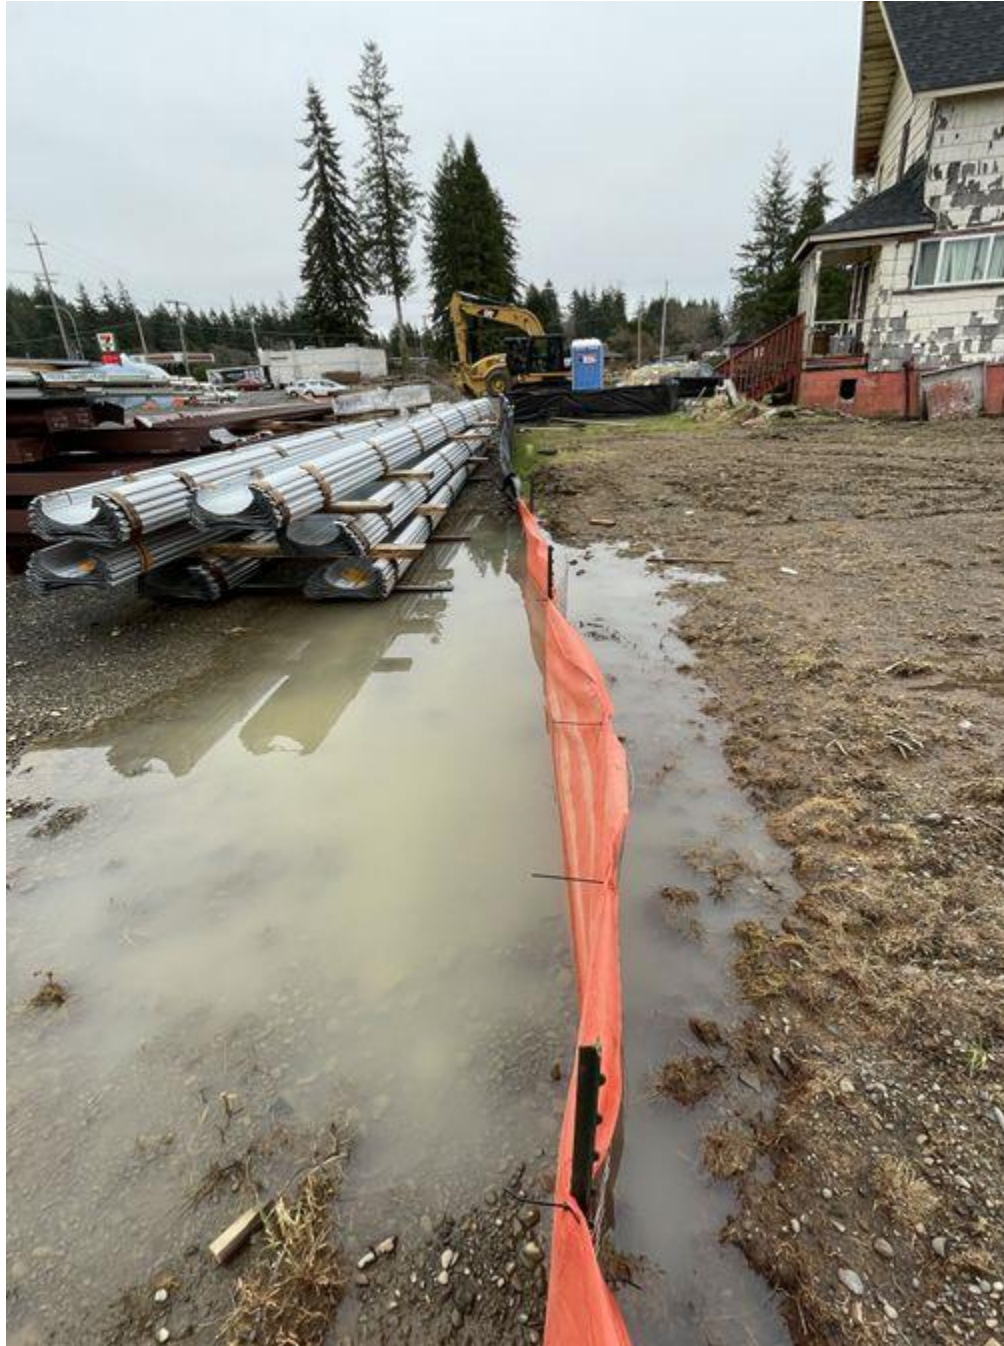
Photo 5

Photo Description: Facing east, turbid water ponding through silt fence and beyond permitted area
