DEPARTMENT OF <b>ECOLOGY</b> State of Washington	<h2 style="text-align: center;">CONSTRUCTION STORMWATER GENERAL PERMIT</h2> <h3 style="text-align: center;">INSPECTION REPORT</h3> <p style="text-align: center;">State of Washington Department of Ecology</p>		
<b>Section A: General Data</b>			
Ecology Inspector(s):  Joe McCord	On-Site Representative Name: n/a Title: Phone: Email:	Inspection Date and Entry/Exit Time: February 22, 2024, 11:01/11:24	Inspection Type: Unannounced
		Receiving waters: Puyallup River	Permit webpage: <a href="https://www.ecy.wa.gov/programs/water/construction/permits/permitwebpage.htm">WAR309147</a>
<b>Section B: Background</b>			
<p>The East Town Crossing project is covered under the State of Washington's Construction Stormwater General Permit (CSWGP). The CSWGP is a National Pollutant Discharge Elimination System (NPDES) and a State Waste Discharge permit for discharge of construction-related stormwater. The purpose of this inspection is to conduct a compliance inspection and to provide technical assistance as appropriate.</p> <p>Ecology arrived on site to conduct a routine CSWGP compliance inspection. Responsible party or their representative were not pres

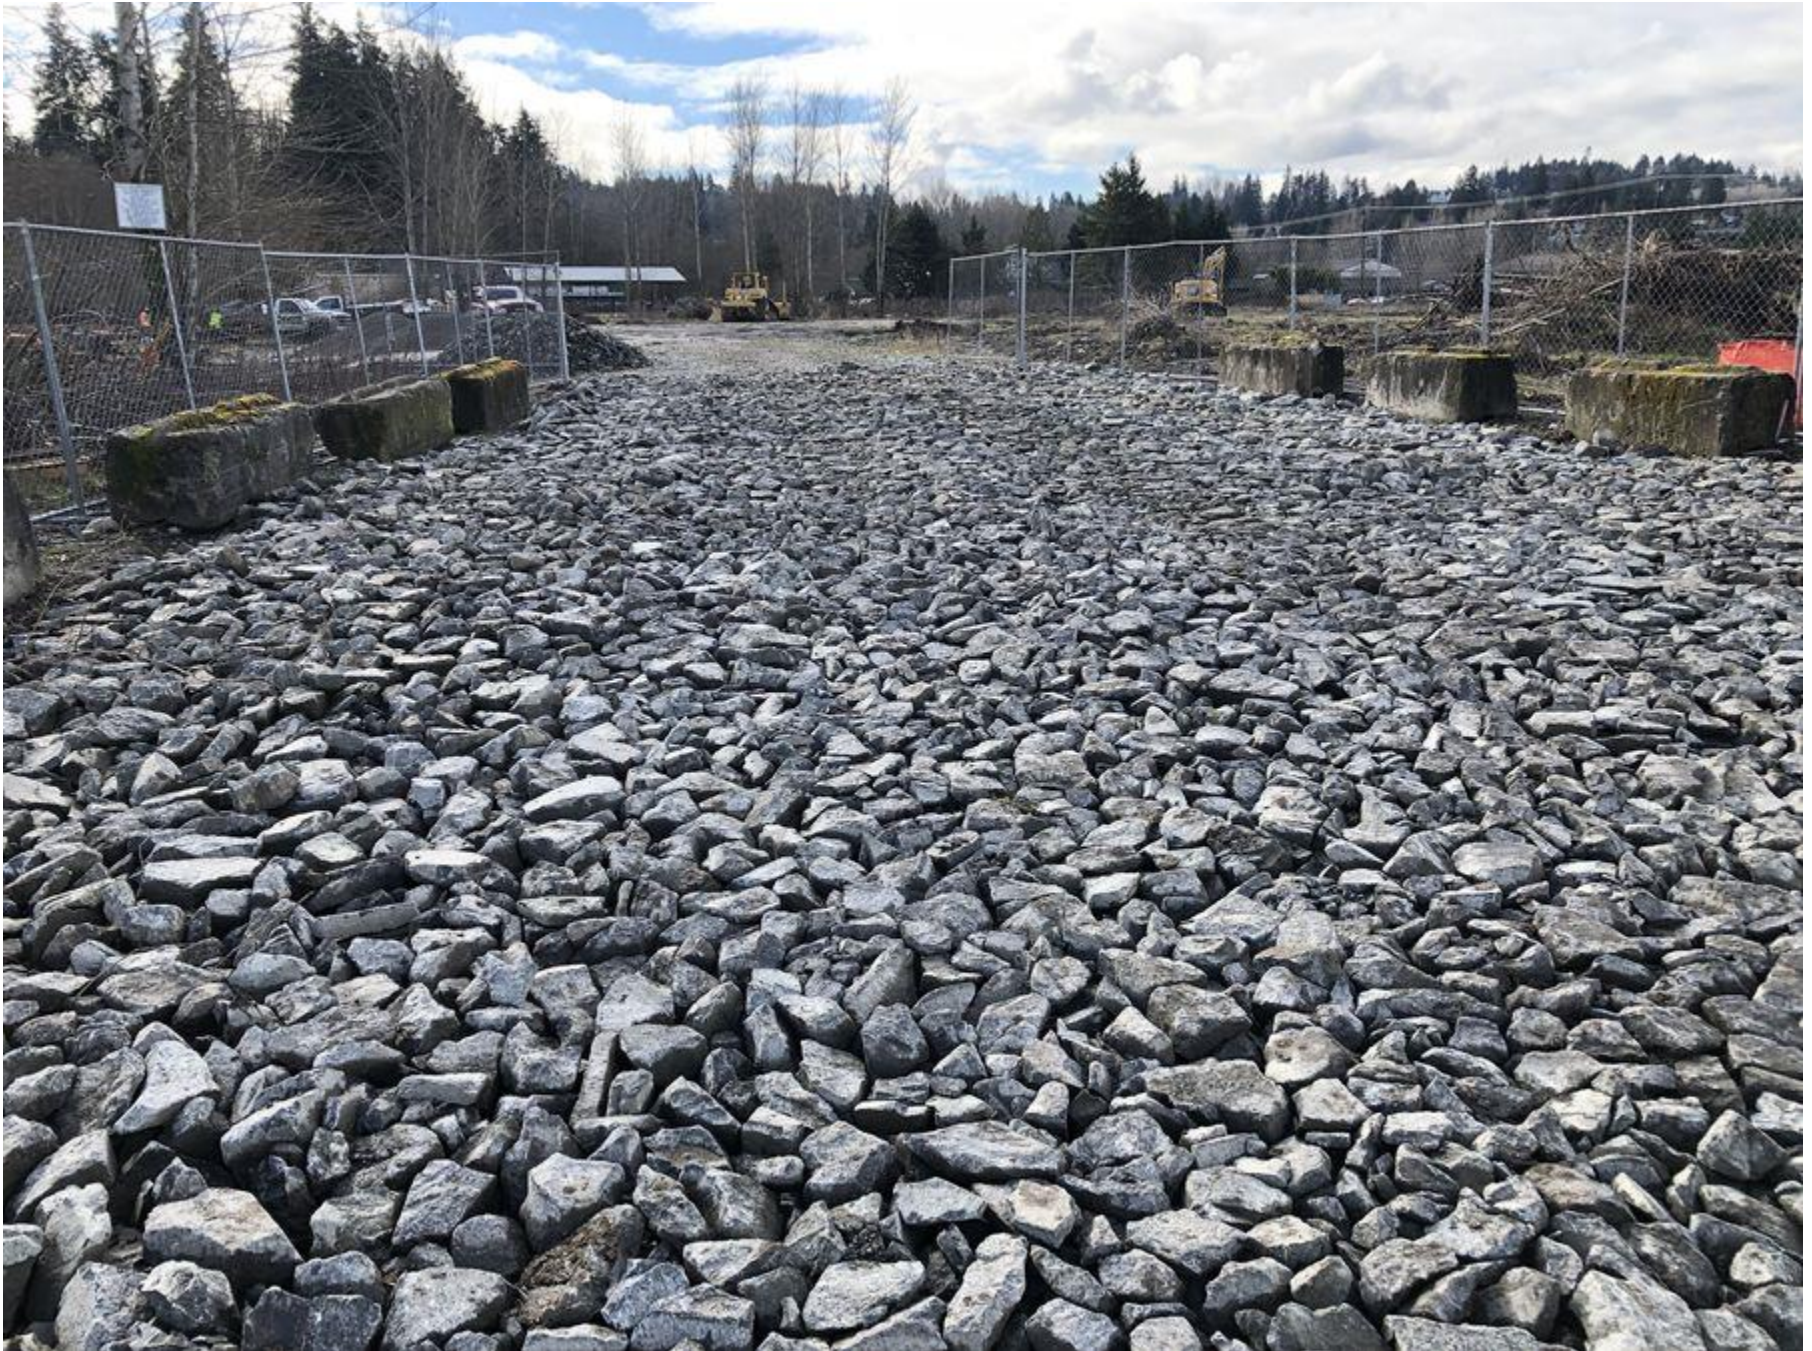
**Photo 1**

Photo Description: BMP C105: Stabilized Construction Access is well maintained and without sediment accumulation.

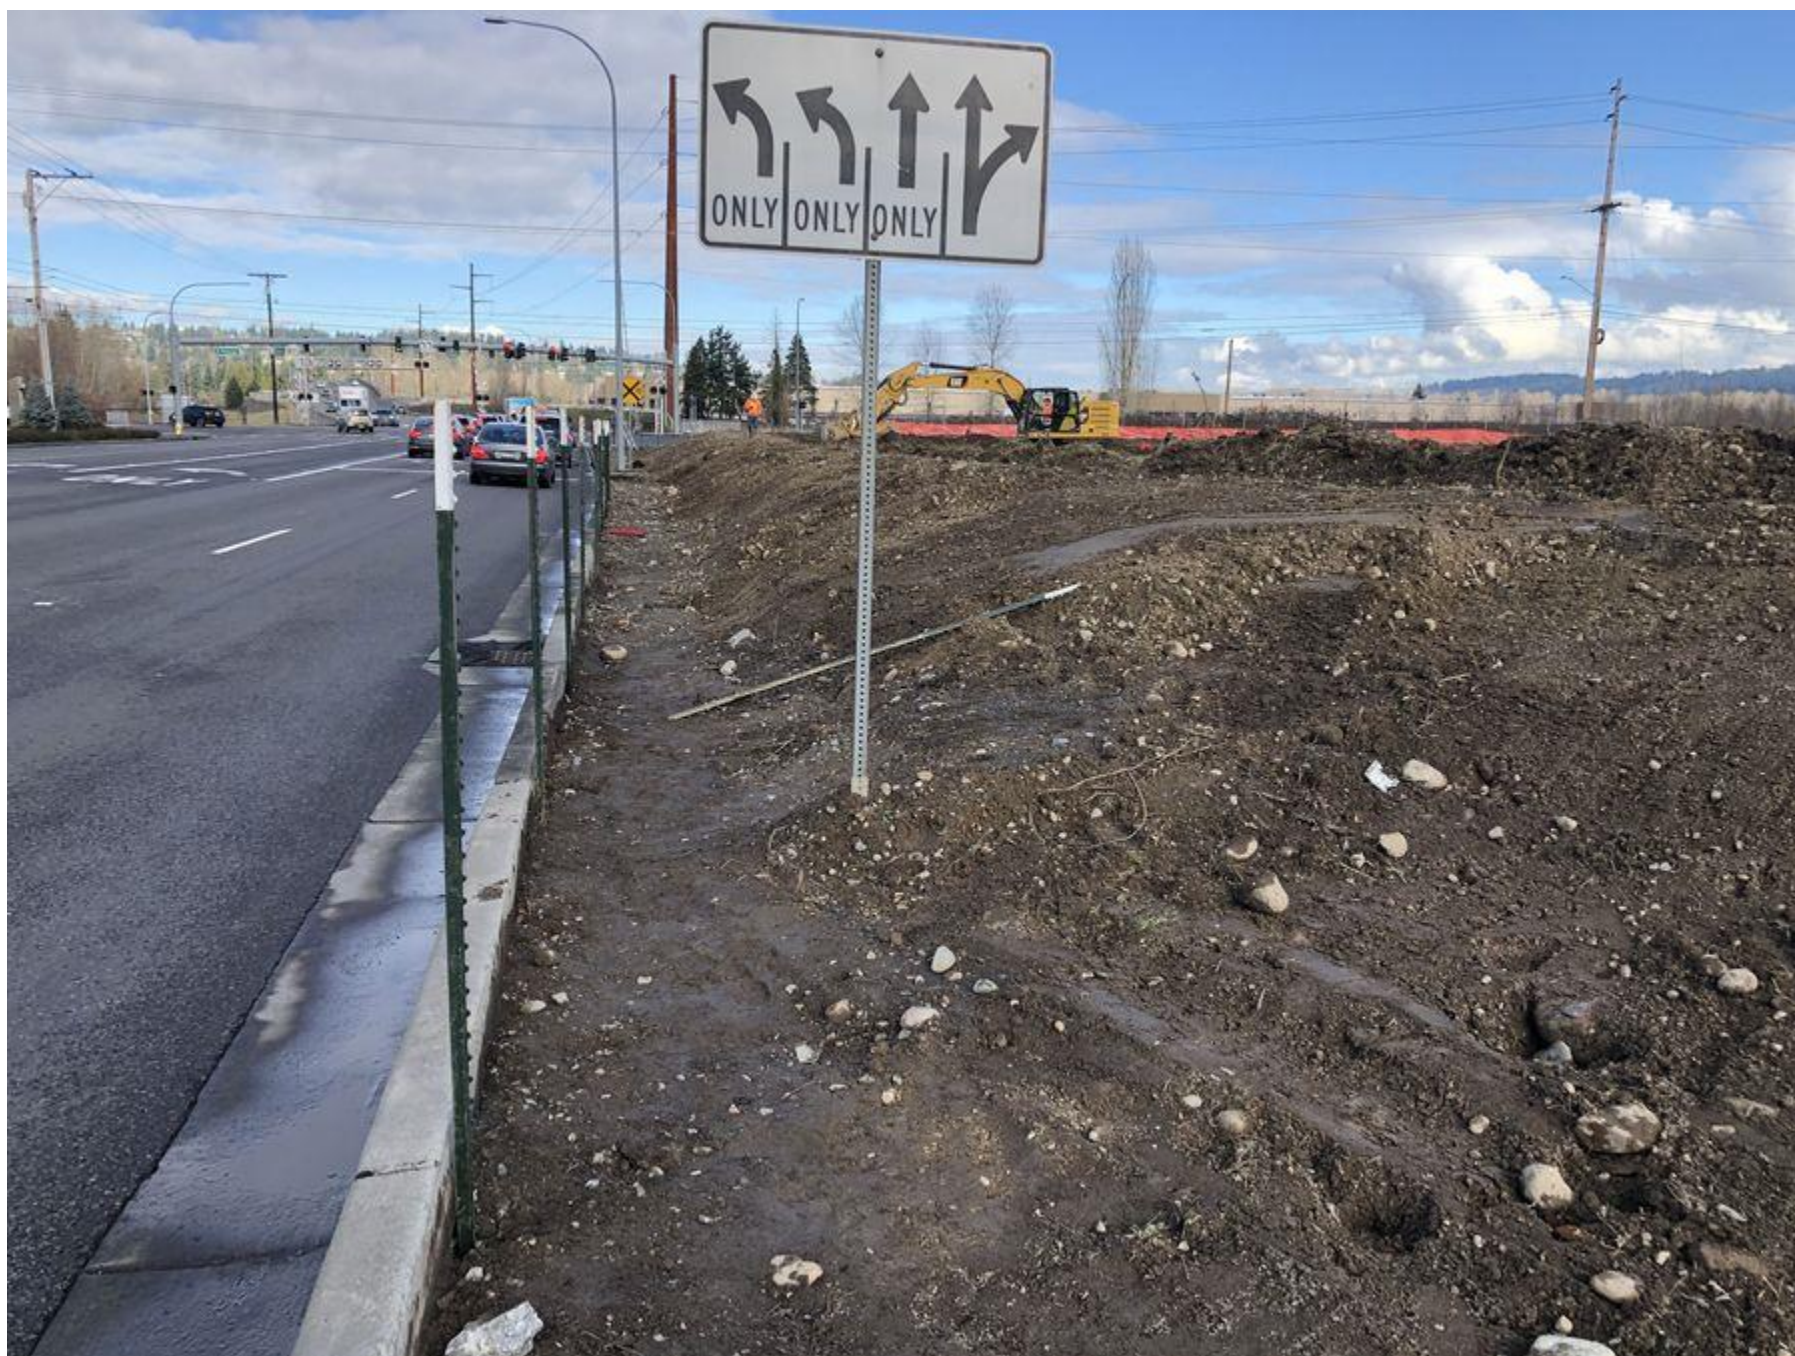
**Photo 2**

Photo Description: Crews were on site moving soil and installing BMP C233: Silt Fence.
