**Permit Compliance Inspection Report**  
**Water Quality Program**  
 Central Region Office

Facility Name & Address: Desert Wind Holdings LLC dba Desert Wind Winery  
 2258 Wine County Rd  
 Prosser, WA 99350

Permit Type: State Waste Discharge IP Only      Permit Number: ST0009272

Type of Inspection: Announced  
 Compliance Inspection - Without Sampling

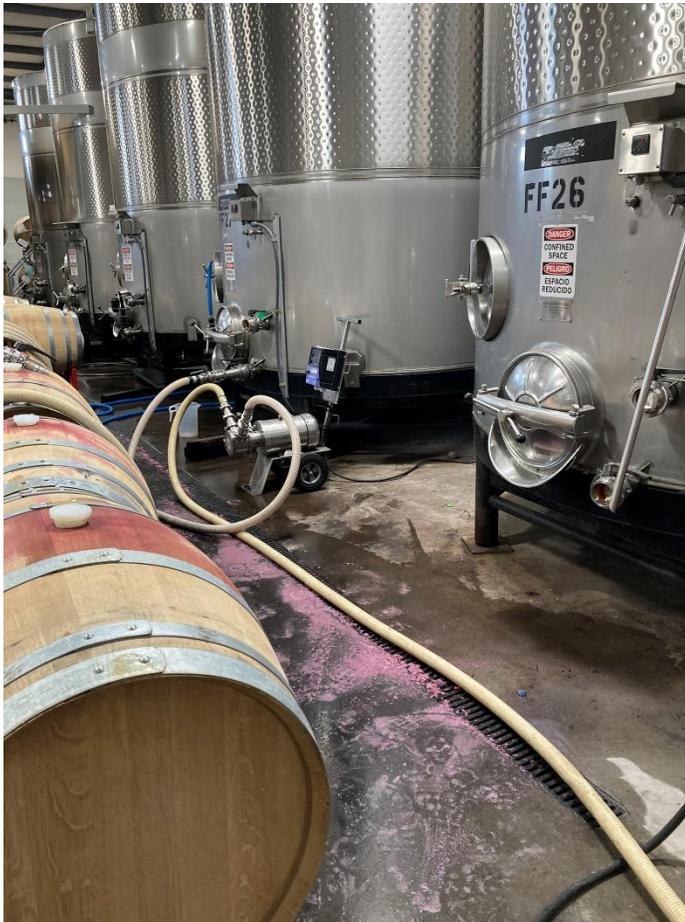
**Photo 1 [IMG\_0357]**  
**Description: wine transferred from barrel to tank then back to barrel**

Ben took us inside to the barrel room. We saw hoses connecting winery tank to barrels and Ben said they were transferring wine from the barrels into the tanks and back into the barrels. Andrea asked how they filter their wine before it is bottled. Ben said they have ATP, a mobile filtration system, come in to filter their wine before bottling.

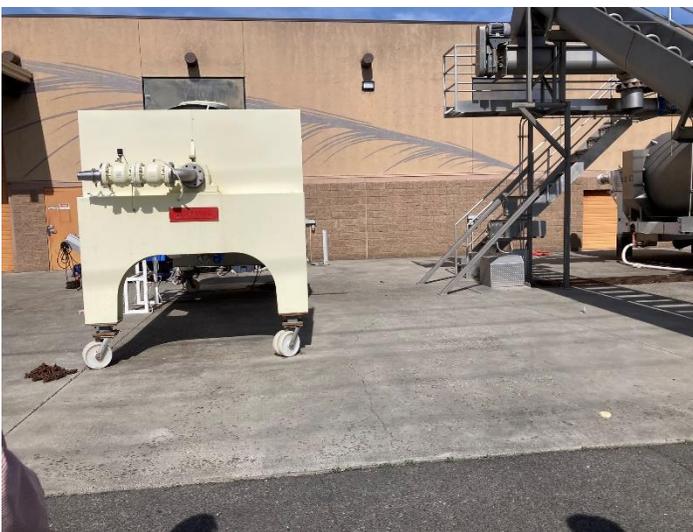
**Photo 3 [IMG\_0359]**  
**Description: *8-ton wine press next to crush pad***

Ben then took us outside to the crush pad and explained they have two wine presses, 8 ton and 25 ton, to press and process wine. Solid waste is disposed of offsite at a landfill. Must pumps wine from the presses outside into the tanks inside the building for further processing and barreling.

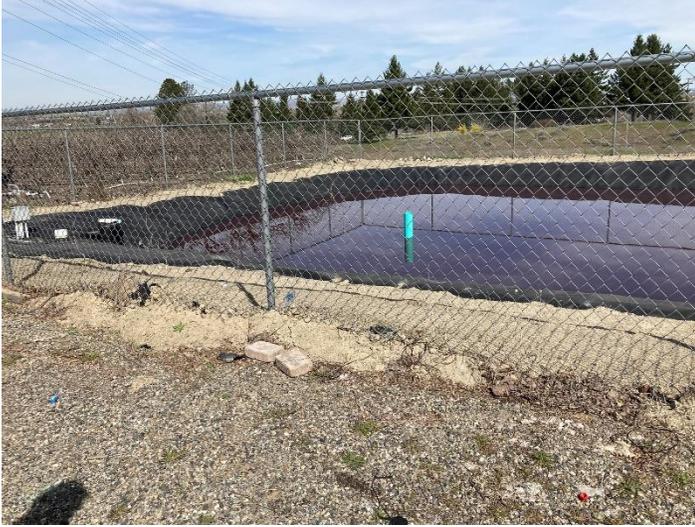
**Photo 5 [IMG\_0361]**  
**Description: *wastewater lagoon***

From the crush pad, we walked over to the lagoon. I asked Ben when they first started discharging to the lagoon. He said they started discharging to the lagoon a few months ago. They installed a new liner and a few pipes before they discharged to the lagoon. I said I would need to review the permit file to see if we had engineering documents on the lagoon because we would need engineering document that describe the lagoon's design capacity. The lagoon was abandoned and has not been used by the facility for processing wastewater since the permit was transferred from the previous owner in 2021. The current permit allows the facility to discharge the Prosser Publicly Owned Treatment Works (POTW) only. The winery is not permitted for a ground water discharge (discharging to the lagoon). I asked if the wastewater from the lagoon was discharged to the POTW. Ben said he was not sure.

The facility is only permitted to discharge their wastewater to the POTW. We will need to review an engineering report for their lagoon. After the inspection, I sent Ben an email that included their previous completed application, digital PDF version of the industrial discharge to POTW application and digital PDF of the industrial to groundwater application for their wastewater discharge to the lagoon. Several submittals are still required that include O&M manual, Solid Waste Control Plan, Spill Plan, and Slug Discharge Control Plan that were due January 1, 2022.

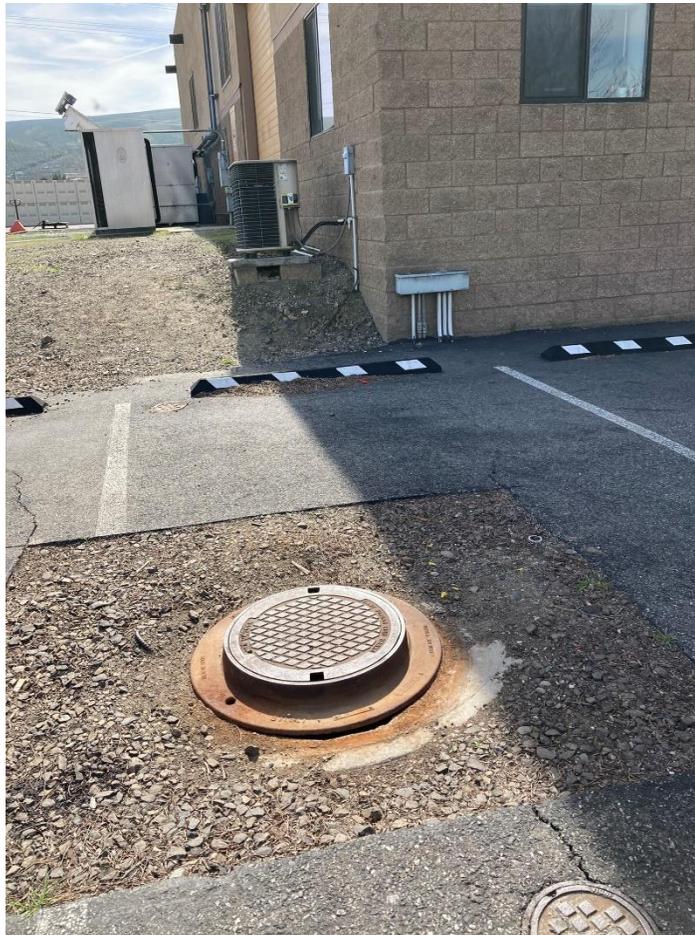
**Photo 7 [IMG\_0363]**  
**Description: *facility sampling location***

Before we went inside to discuss the renewal application, Ben showed us where the facility gets samples from. The City obtains samples from their effluent sampler that we did not observe during the inspection.
