# Permit Compliance Inspection Report

## Water Quality Program

Facility Name & Address: Cowiche City Road Plant  
200 Cowiche City Road, Cowiche, WA 98923

Permit Type: Fruit Packer General Permit Permit Number: WAG435106

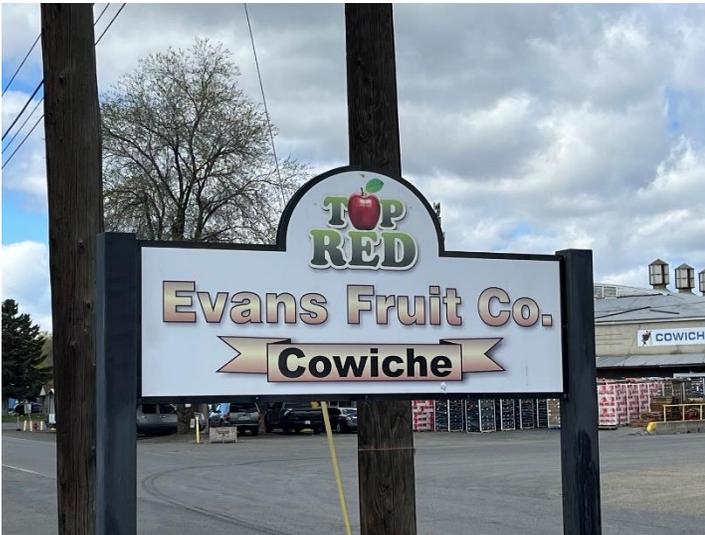
**Photo 1**

**Description:** *Evans Fruit*

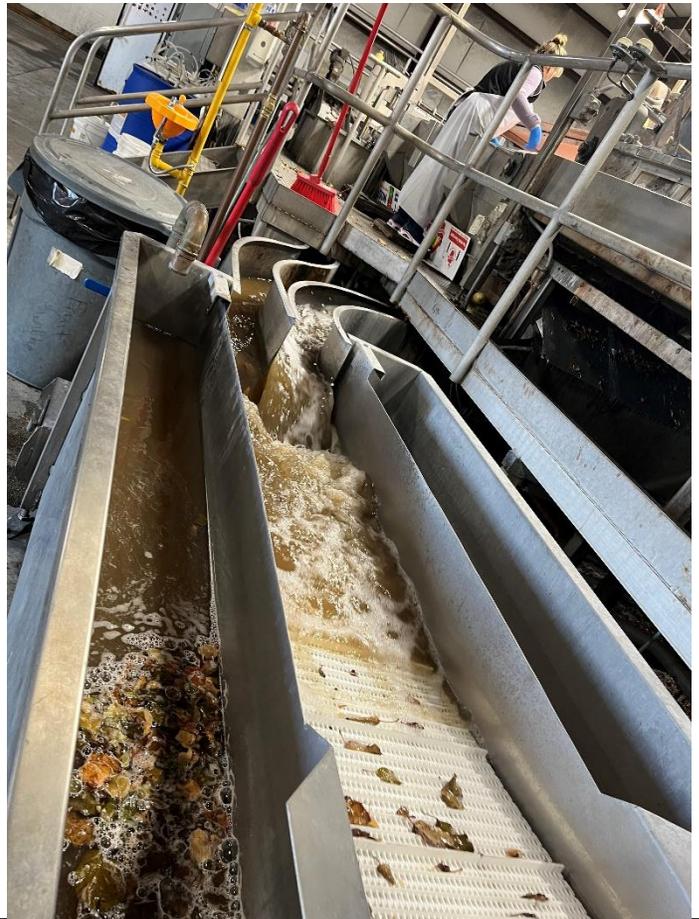
**Photo 2**

**Description:** Float water being filtered from leaves and debris that comes in with the fruit. Debris is collected and disposed of as solid waste.

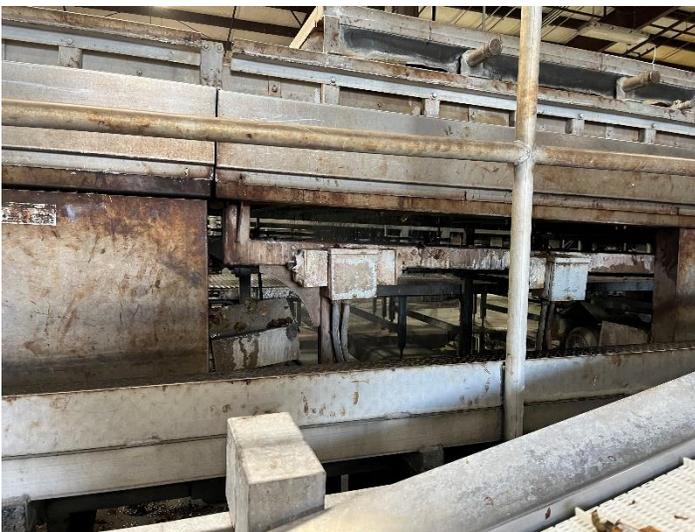
**Photo 3**

**Description:** *pack line is kept very clean underneath*

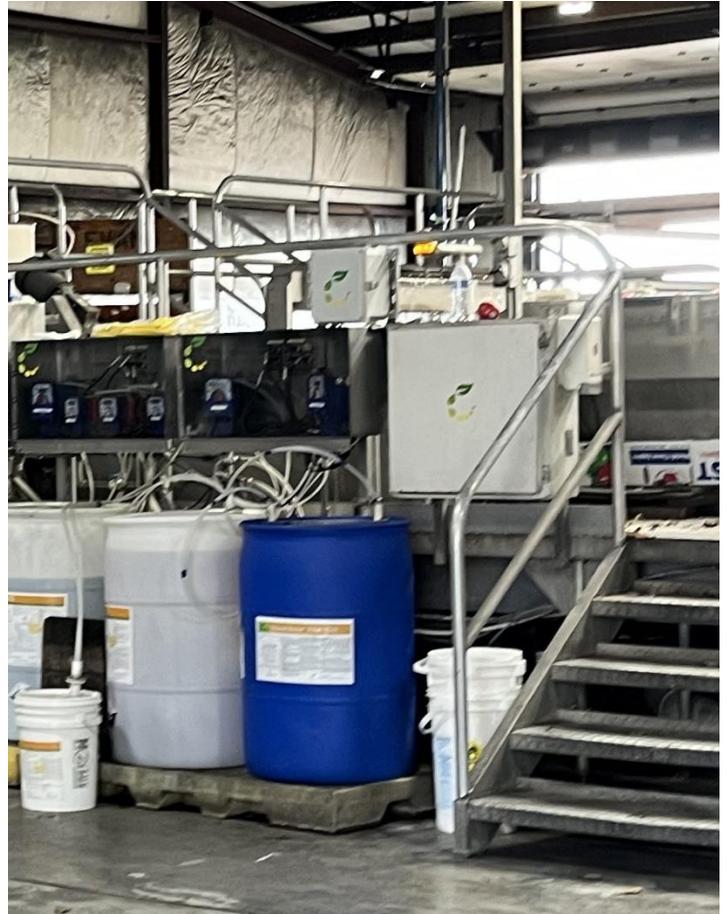
**Photo 4**

**Description:** *chemical usage on the line for fruit cleaning, disinfection, and polishing (aesthetics)*

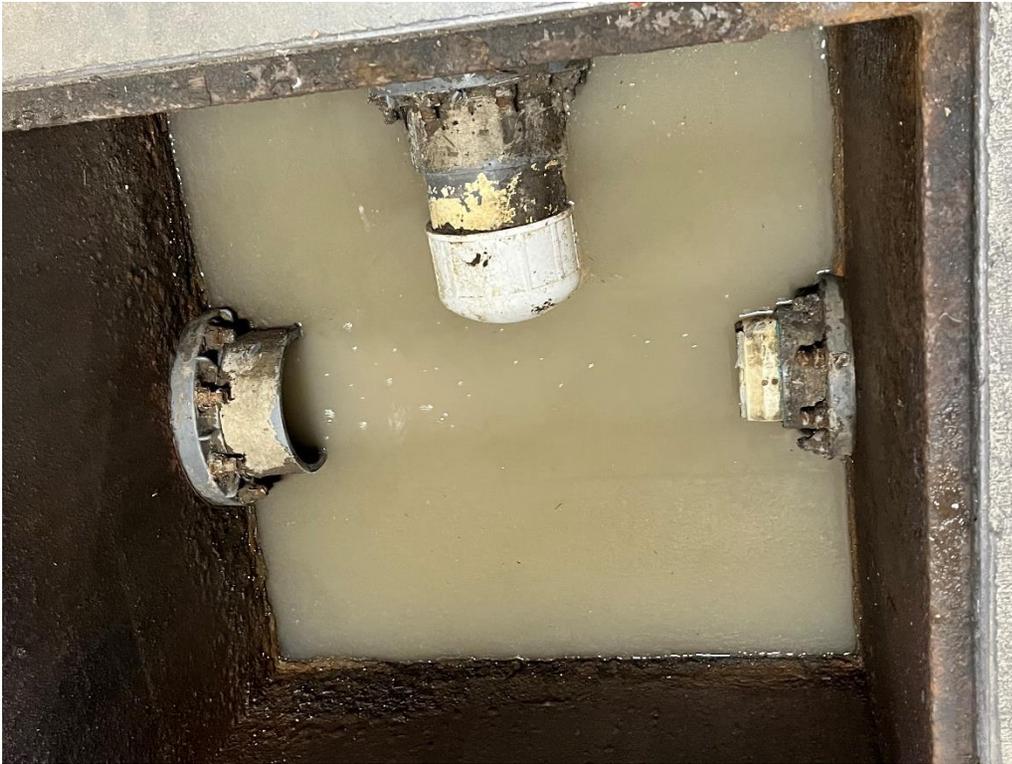
**Photo 5**

**Description:** *Discharge to POTW (open line) and the plugged line to the evaporative lagoon. With a modification to cover the POTW line will be plugged and the line to the evaporative lagoon will be unplugged.*

At the time of the inspection, none for this facility. This facility would like to land apply wastewater discharges from the lined evaporative lagoon in a substantial sized field directly behind the lagoon. I sent them a modification of permit coverage form via email. Upon viewing at the time of the inspection, I did not see an issue with this proposed modification to their coverage.

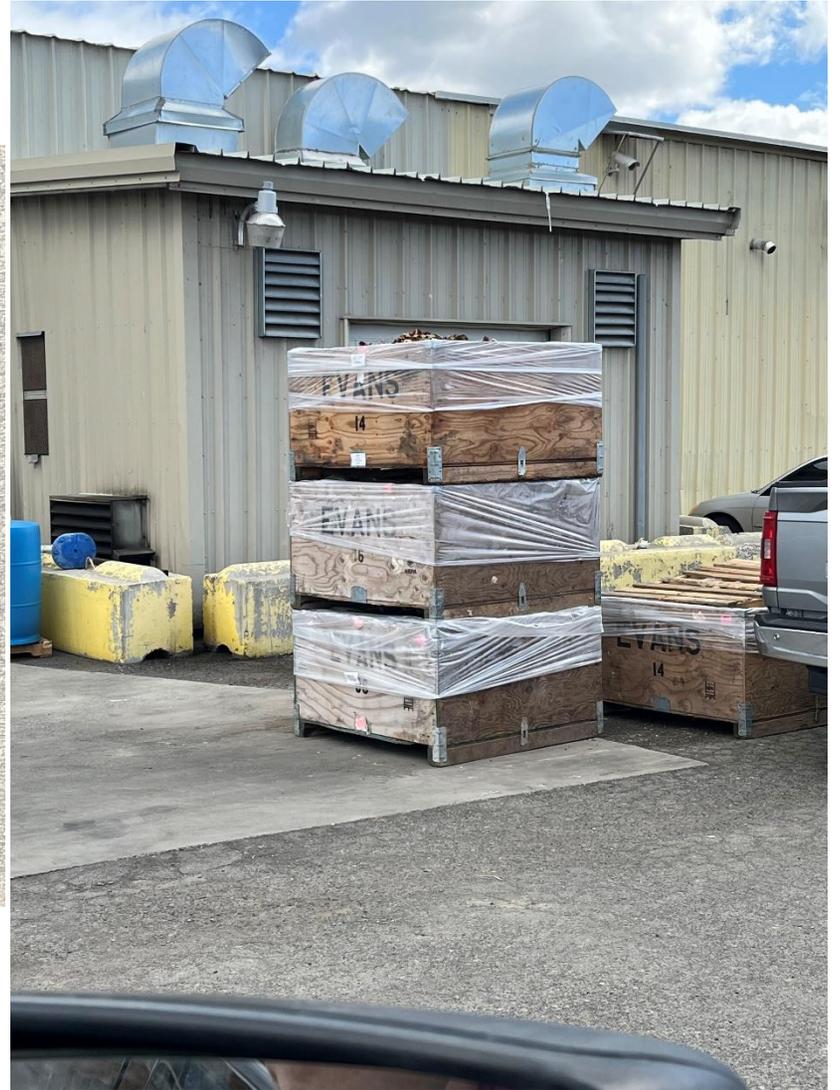
**Photo 6**

**Description:** proper storage of cull and/or rot product for pickup. Lined bins that contain all product and liquid

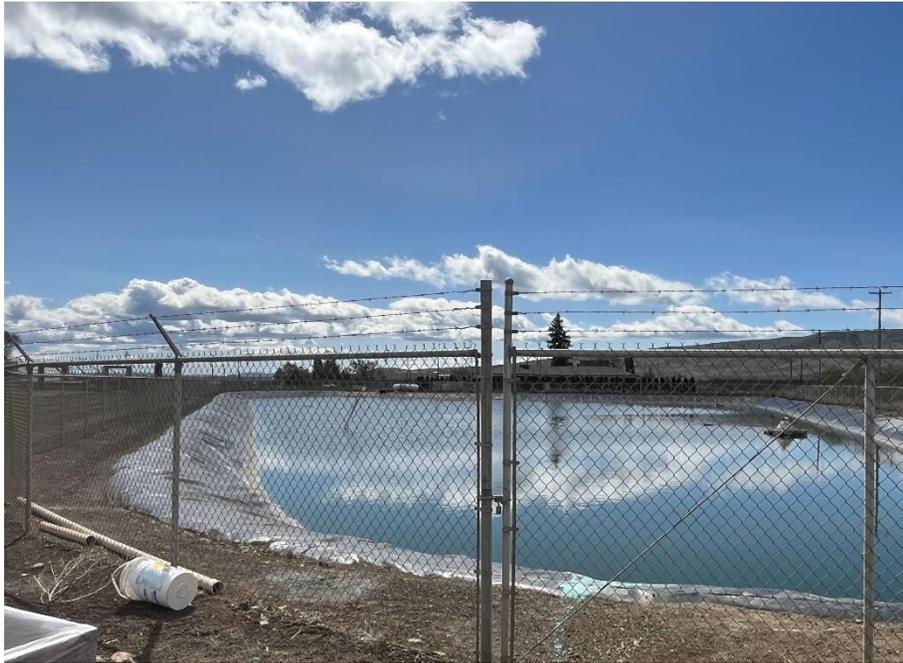
**Photo 7**

**Description: Lined evaporative lagoon. Facility will get aerators going before using for when the modification of coverage is completed.**

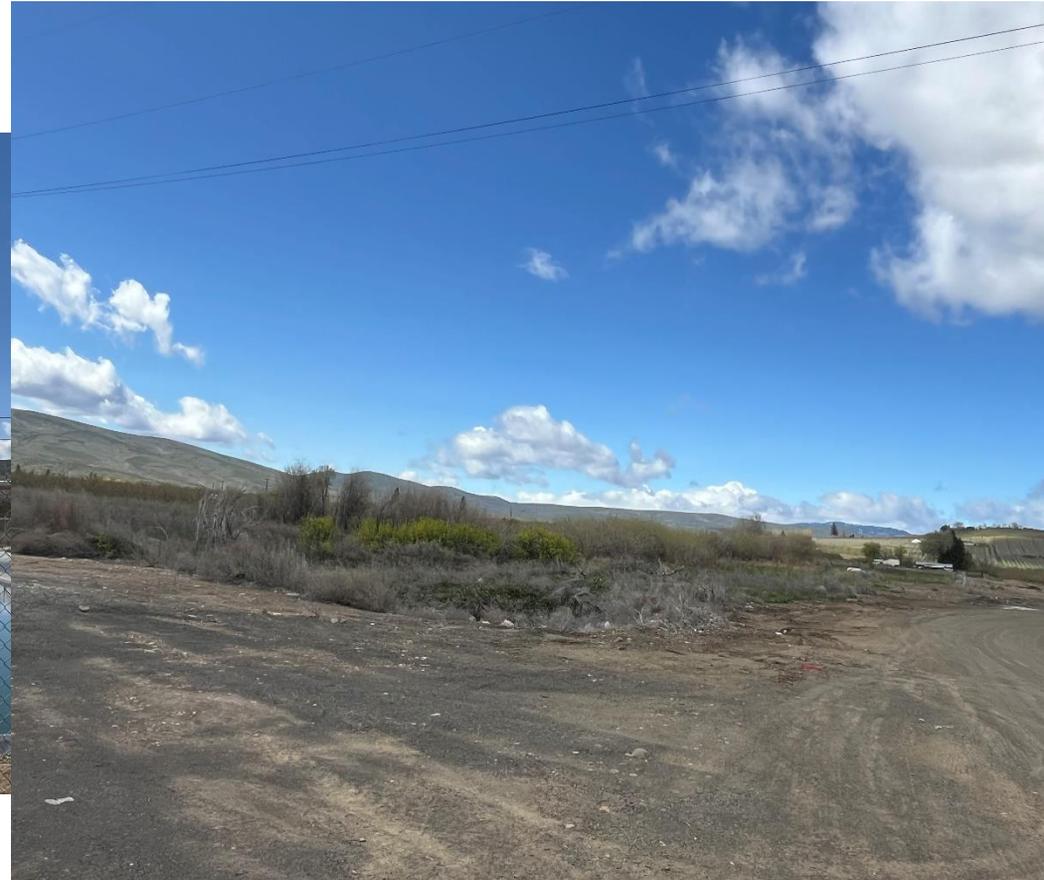
**Photo 8**

**Description: property for land application with sprinklers. Runs from back of lined lagoon to the house in the distance. Acreage available will be listed on the change of operations modification form.**
