Permit Compliance Inspection Report

Water Quality Program

Facility Name & Address: Bakerview Everett
4308 108th Street SE
Everett, WA 98208

Permit Type: Construction Stormwater General Permit Permit Number: WAR306901

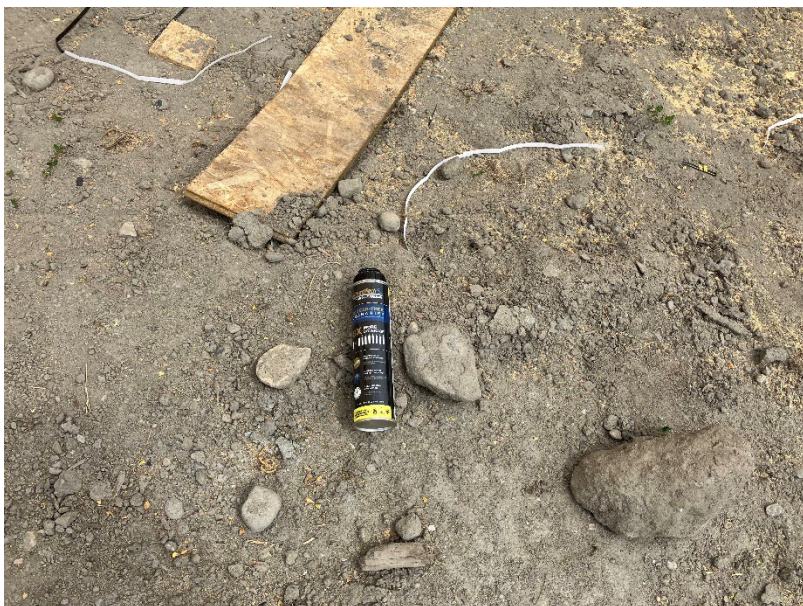
Photo 1 [IMG_1311]

In several areas onsite, there were empty containers/cans, labeled Weathermaster sealant and AdvanTech subfloor adhesive, and a fuel container placed on the ground (**Photos 1-3**). The empty containers needed to be properly disposed of and secondary containment is needed for the fuel container to minimize the discharge of pollutants. There was a spill of concrete washout onto the ground (**Photos 4-6**). This spill needed to be cleaned and follow proper concrete handling BMPs. There were no sediment controls in two catch basins onsite (**Photos 7-8**). Install sediment controls, such as filter inserts, to minimize sediment discharges from the site.

Description: Empty cans labeled AdvanTech subfloor adhesive were disposed onto the ground.

Control Pollutants: Failure to meet S9.D.9.a: In several areas onsite, there were empty containers/cans, labeled Weathermaster sealant and AdvanTech subfloor adhesive, placed on the ground. Handle and dispose of all pollutants, including waste materials and demolition debris that occur on site in a manner that does not cause contamination of stormwater. Design, install, implement and maintain effective pollution prevention measures to minimize the discharge of pollutants, as set forth in permit conditions S1.D.1, S9.D.9. **Proof of correction of empty containers labeled Weathermaster sealant removed was emailed on 6/21/2024. Immediately begin. Address the problems no later than 10 days.**

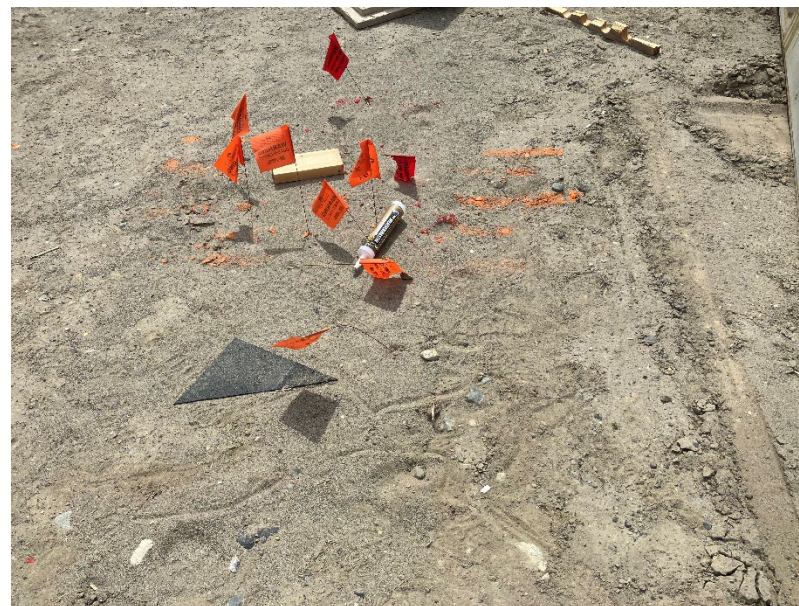
Photo 2 [IMG_1329]

Description: Empty containers labeled Weathermaster sealant were disposed onto the ground.

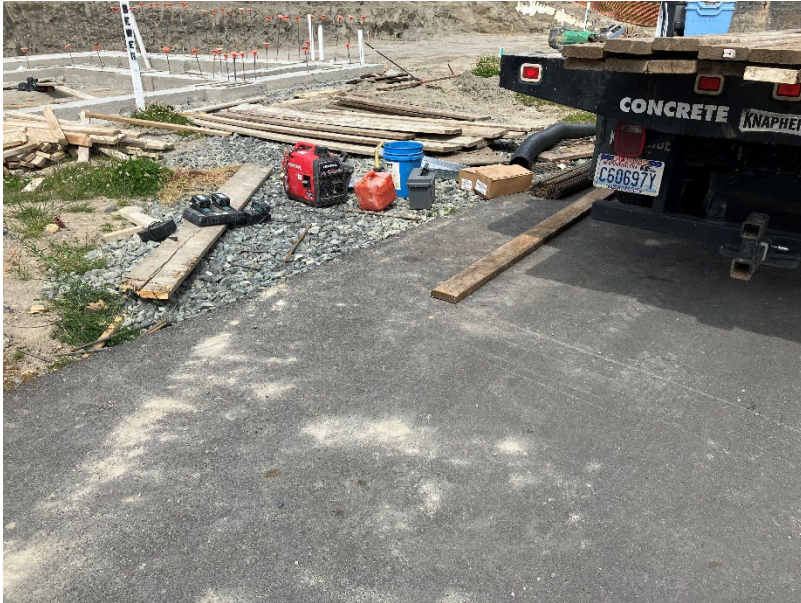
Photo 3 [IMG_1334]

Description: A fuel container placed on the ground.

Control Pollutants: Failure to meet S9.D.9.b: A fuel container was placed on the ground. Provide cover, containment, and protection from vandalism for all chemicals, liquid products, petroleum products, and other materials that have the potential to pose a threat to human health or the environment. Minimize storage of hazardous materials on-site. Safety Data Sheets (SDS) should be supplied for all materials stored. Chemicals should be kept in their original labeled containers. On-site fueling tanks must include secondary containment. Secondary containment means placing tanks or containers within an impervious structure capable of containing 110% of the volume of the largest tank within the containment structure. Doublewalled tanks do

not require additional secondary containment. Design, install, implement and maintain effective pollution prevention measures to minimize the discharge of pollutants, as set forth in permit conditions S1.D.1, S9.D.9. **Immediately begin. Address the problems no later than 10 days.**

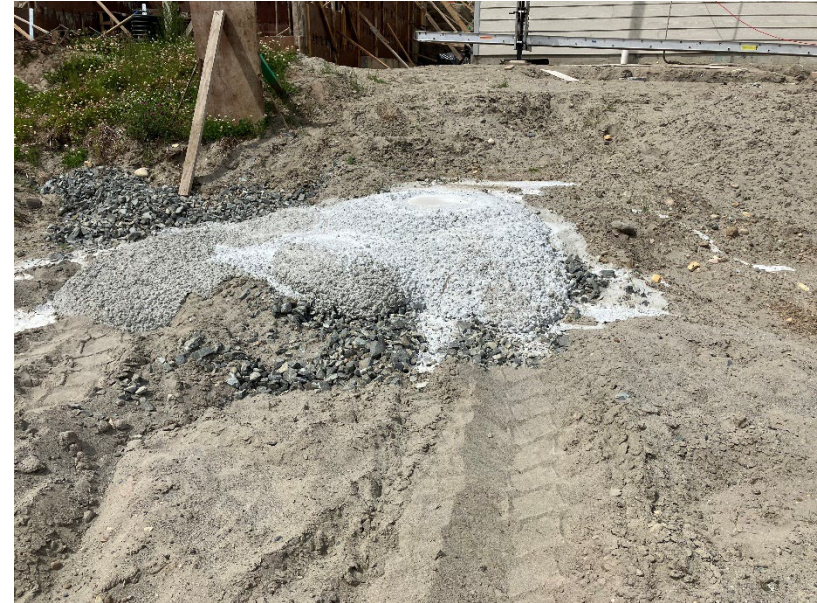
Photo 4 [IMG_1326]

Description: Spill of concrete washout on the ground.

Control Pollutants: Failure to meet S9.D.9.h: There was a spill of concrete washout onto the ground. Assure that washout of concrete trucks is performed off-site or in designated **concrete washout areas** only. Do not wash out concrete truck drums onto the ground, or into storm drains, open ditches, streets, or streams. Washout of small concrete handling equipment may be disposed of in a formed area awaiting concrete where it will not contaminate surface or groundwater. **Do not dump excess concrete on site**, except in designated concrete washout areas. Concrete spillage or concrete discharge directly to groundwater or surface waters of the State is prohibited. At no time shall concrete be washed off into the footprint of an area where an infiltration BMP will be installed. **Proof correction emailed on 6/21/2024.**

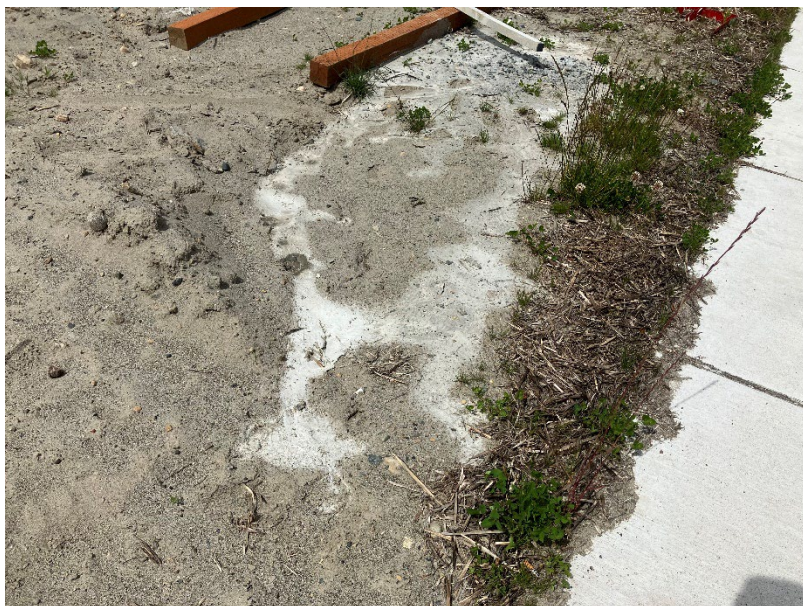
Photo 5 [IMG_1325]

Description: Spill of concrete washout on the ground.

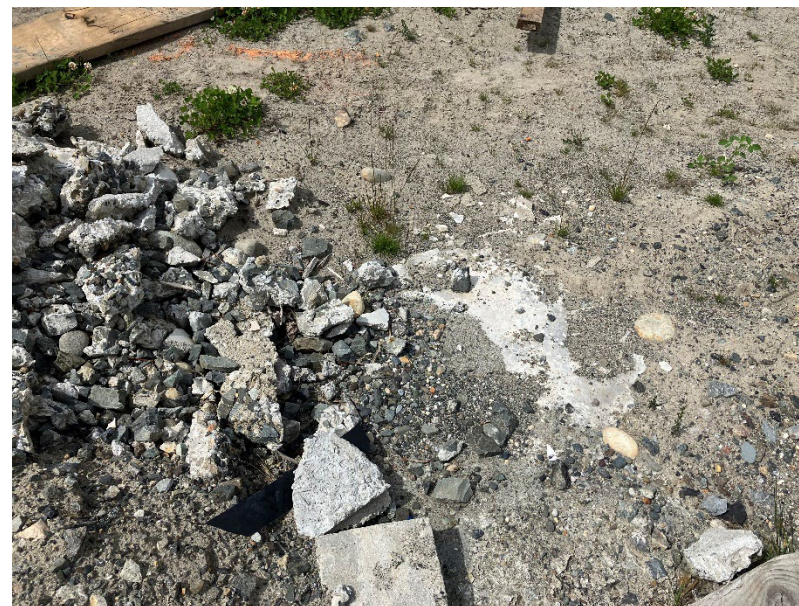
Photo 6 [IMG_1331]

Description: Spill of concrete washout on the ground.

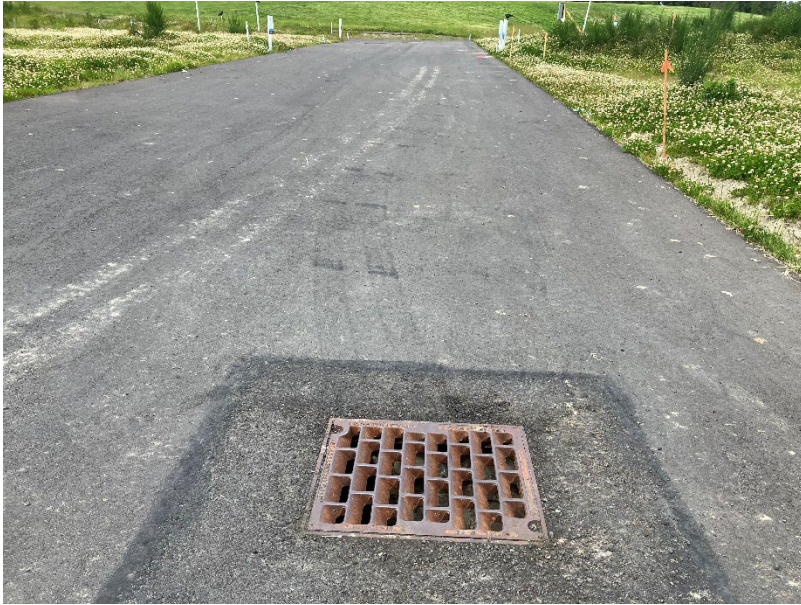
Photo 7 [IMG_1314]

Description: No sediment control in catch basin.

Protect Drain Inlets : Failure to meet S9.D.7.a: There were no sediment controls in two catch basins onsite. Protect all storm drain inlets made operable during construction so that stormwater runoff does not enter the conveyance system without first being filtered or treated to remove sediment. **Proof of correction emailed on 6/21/2024.**

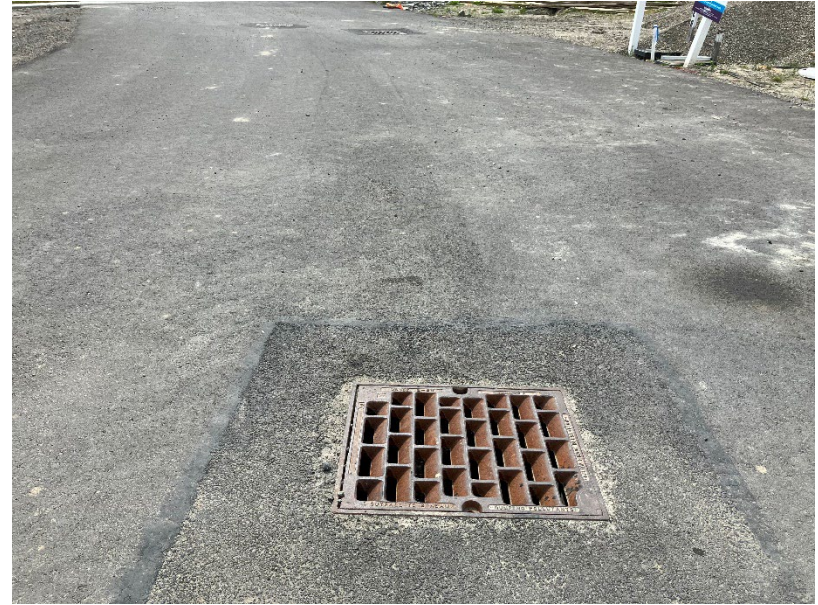
Photo 8 [IMG_1333]

Description: No sediment control in catch basin.
