CONSTRUCTION STORMWATER GENERAL PERMIT INSPECTION REPORT

State of Washington Department of Ecology

Notice of Termination – Denied

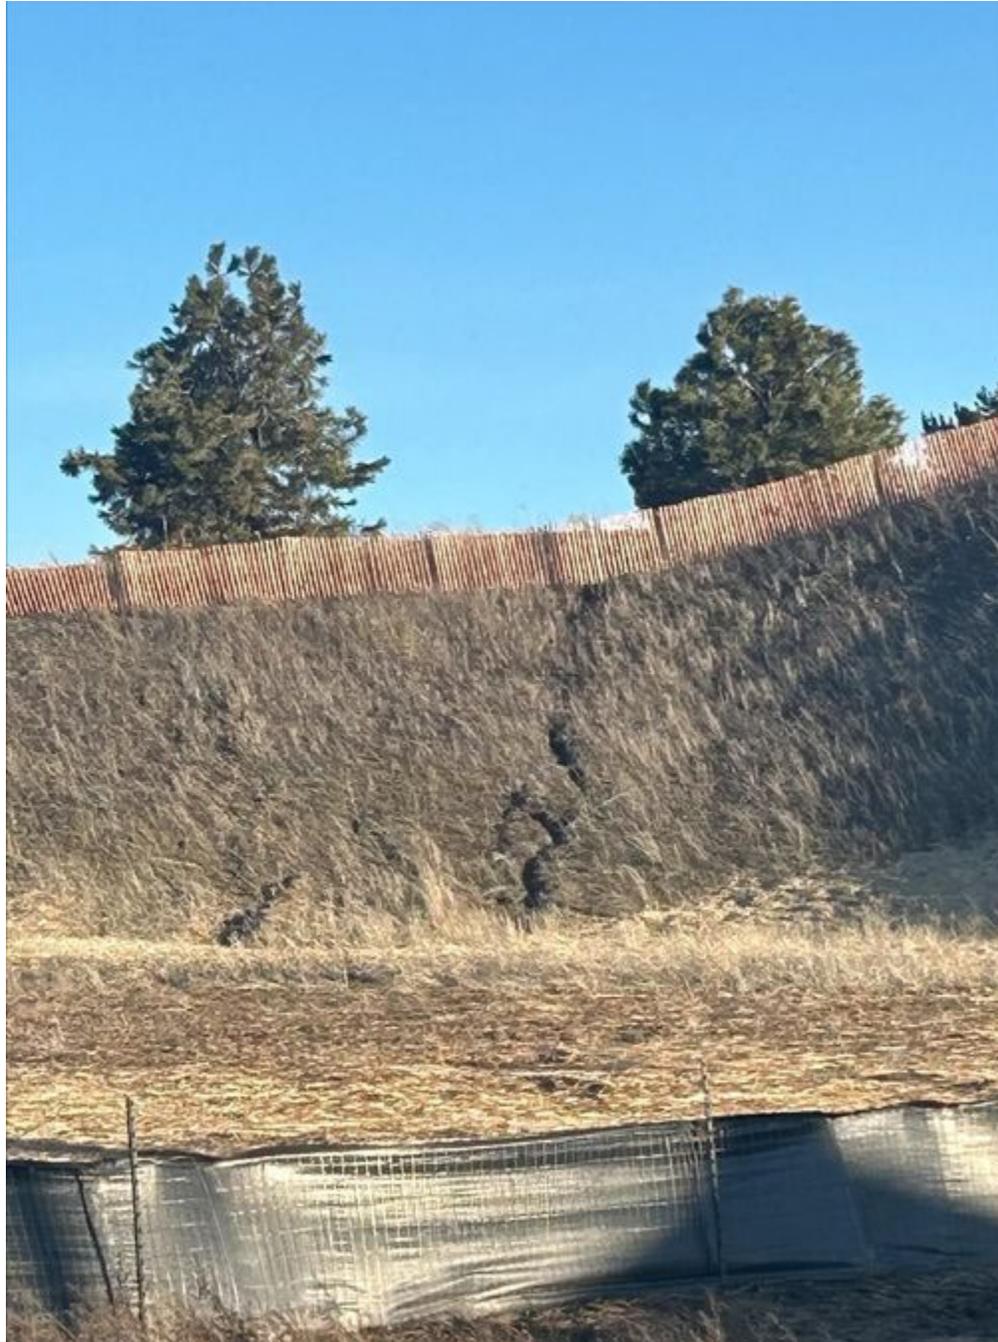
Photo 1

Photo Description: Looking South - BMP's/ Silt Fencing have not been removed from site, erosion on slopes throughout site

| <u>Violations and action required to achieve compliance</u> | Complete or submit date | Guidance |
|--|---|--|
| <p><u>S9.D.11 Maintain BMPs</u> Failure to meet S9.D.11.b: Permittee must remove all temporary erosion and sediment control BMPs within 30 days after achieving final site stabilization or after the temporary BMPs are no longer needed. Maintain and repair all temporary and permanent BMPs, as set forth in permit condition S9.D.11.a.</p> | <p>Immediately begin. Address the problems no later than 10 days from the date of this inspection.</p> | <p>https://fortress.wa.gov/ecy/ezshare/wq/SWMMs/2024 SWMMEW/2024 SWMMEW.htm</p> |

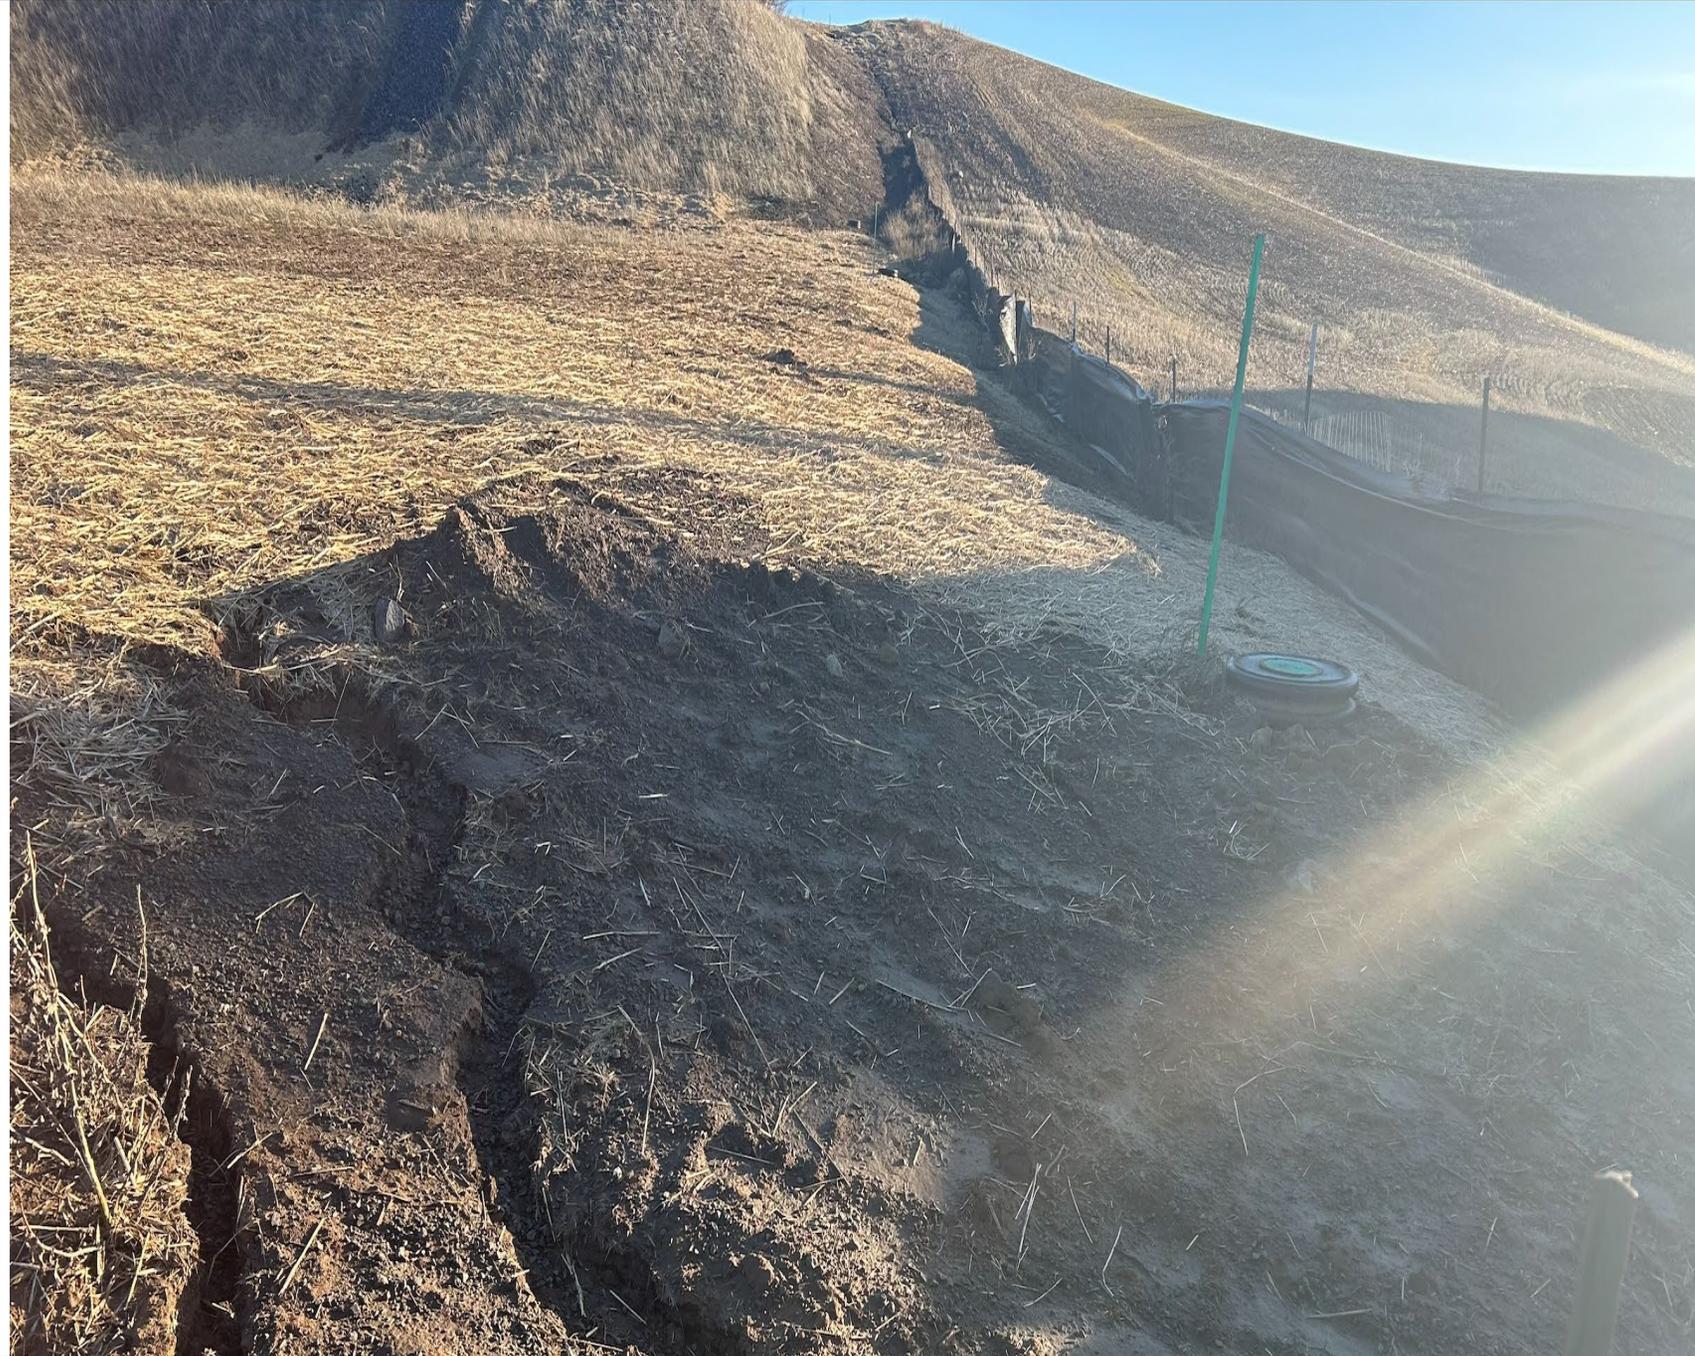
Photo 2

Photo Description: View facing South from roadway - silt fencing still installed. Erosion and sediment runoff

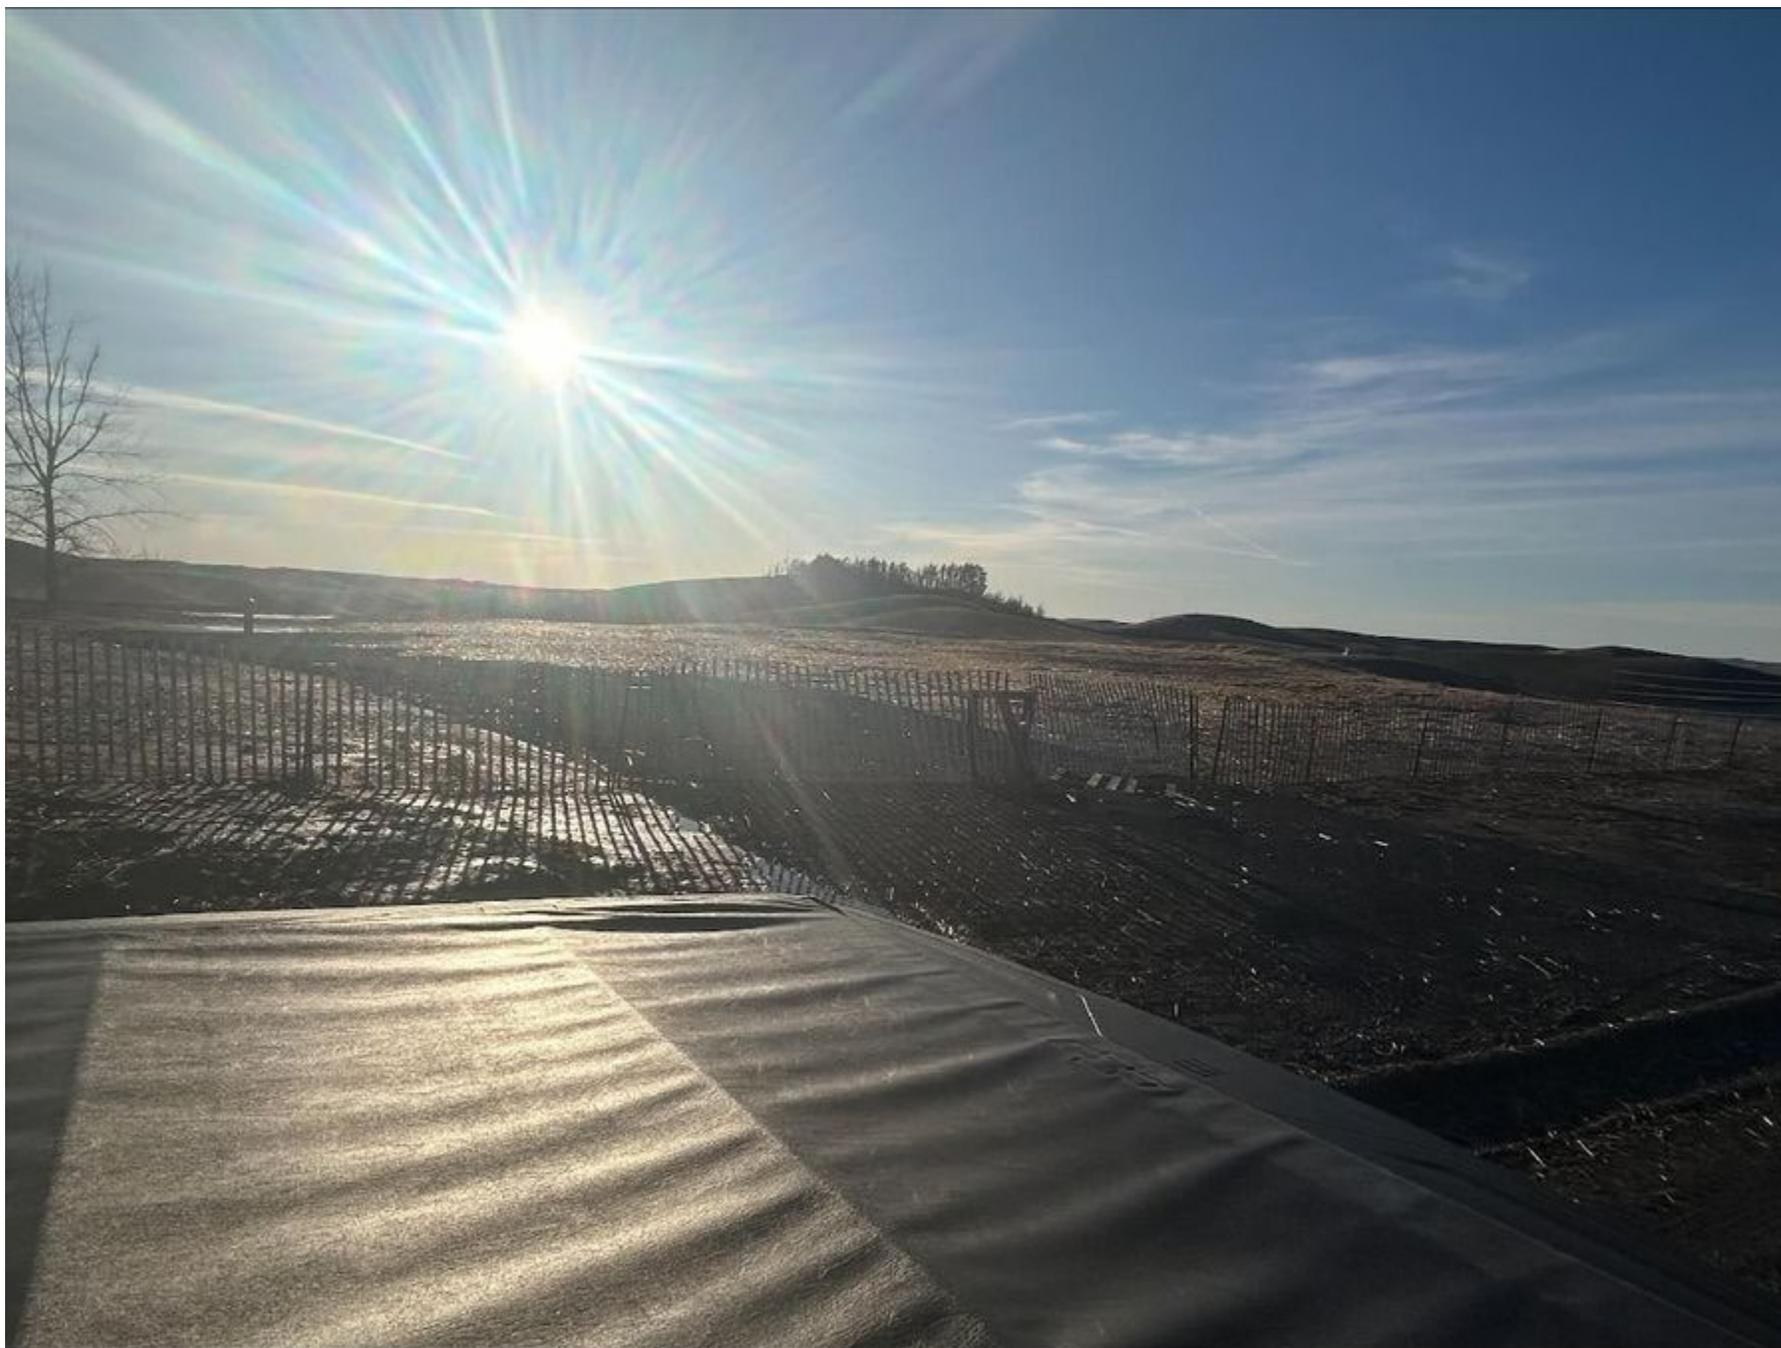
Photo 3

Photo Description: View facing West - minimal stabilization and vegetation for ground coverage

| <u>Violations and action required to achieve compliance</u> | Complete or submit date | Guidance |
|--|---|--|
| <p><u>S9.D.5 Stabilize Soils</u> Failure to meet S9.D.5.a: The Permittee must stabilize exposed and unworked soils by application of effective BMPs that prevent erosion. Applicable BMPs include, but are not limited to: temporary and permanent seeding, sodding, mulching, plastic covering, erosion control fabrics and matting, soil application of polyacrylamide (PAM), the early application of gravel base on areas to be paved, and dust control., Failure to meet S9.D.5.b: The Permittee must control stormwater volume and velocity within the site to minimize soil erosion., Failure to meet S9.D.5.c: The Permittee must control stormwater discharges, including both peak flow rates and total stormwater volume, to minimize erosion at outlets and to minimize downstream channel and stream bank erosion. Stabilize exposed and unworked soils, including stockpiles, by application of effective BMPs to prevent erosion, as set forth in permit condition S9.D.5.a and timeline in S9.D.5.d.</p> | <p>Permittee must not allow soils to remain exposed and unworked for more than the time periods set forth below to prevent erosion: During the wet season (October 1 - April 30): 2 days from the date of this inspection.</p> | <p>https://fortress.wa.gov/ecy/ezshare/wq/SWMMs/2024 SWMMEW/2024 SWMMEW.htm</p> |

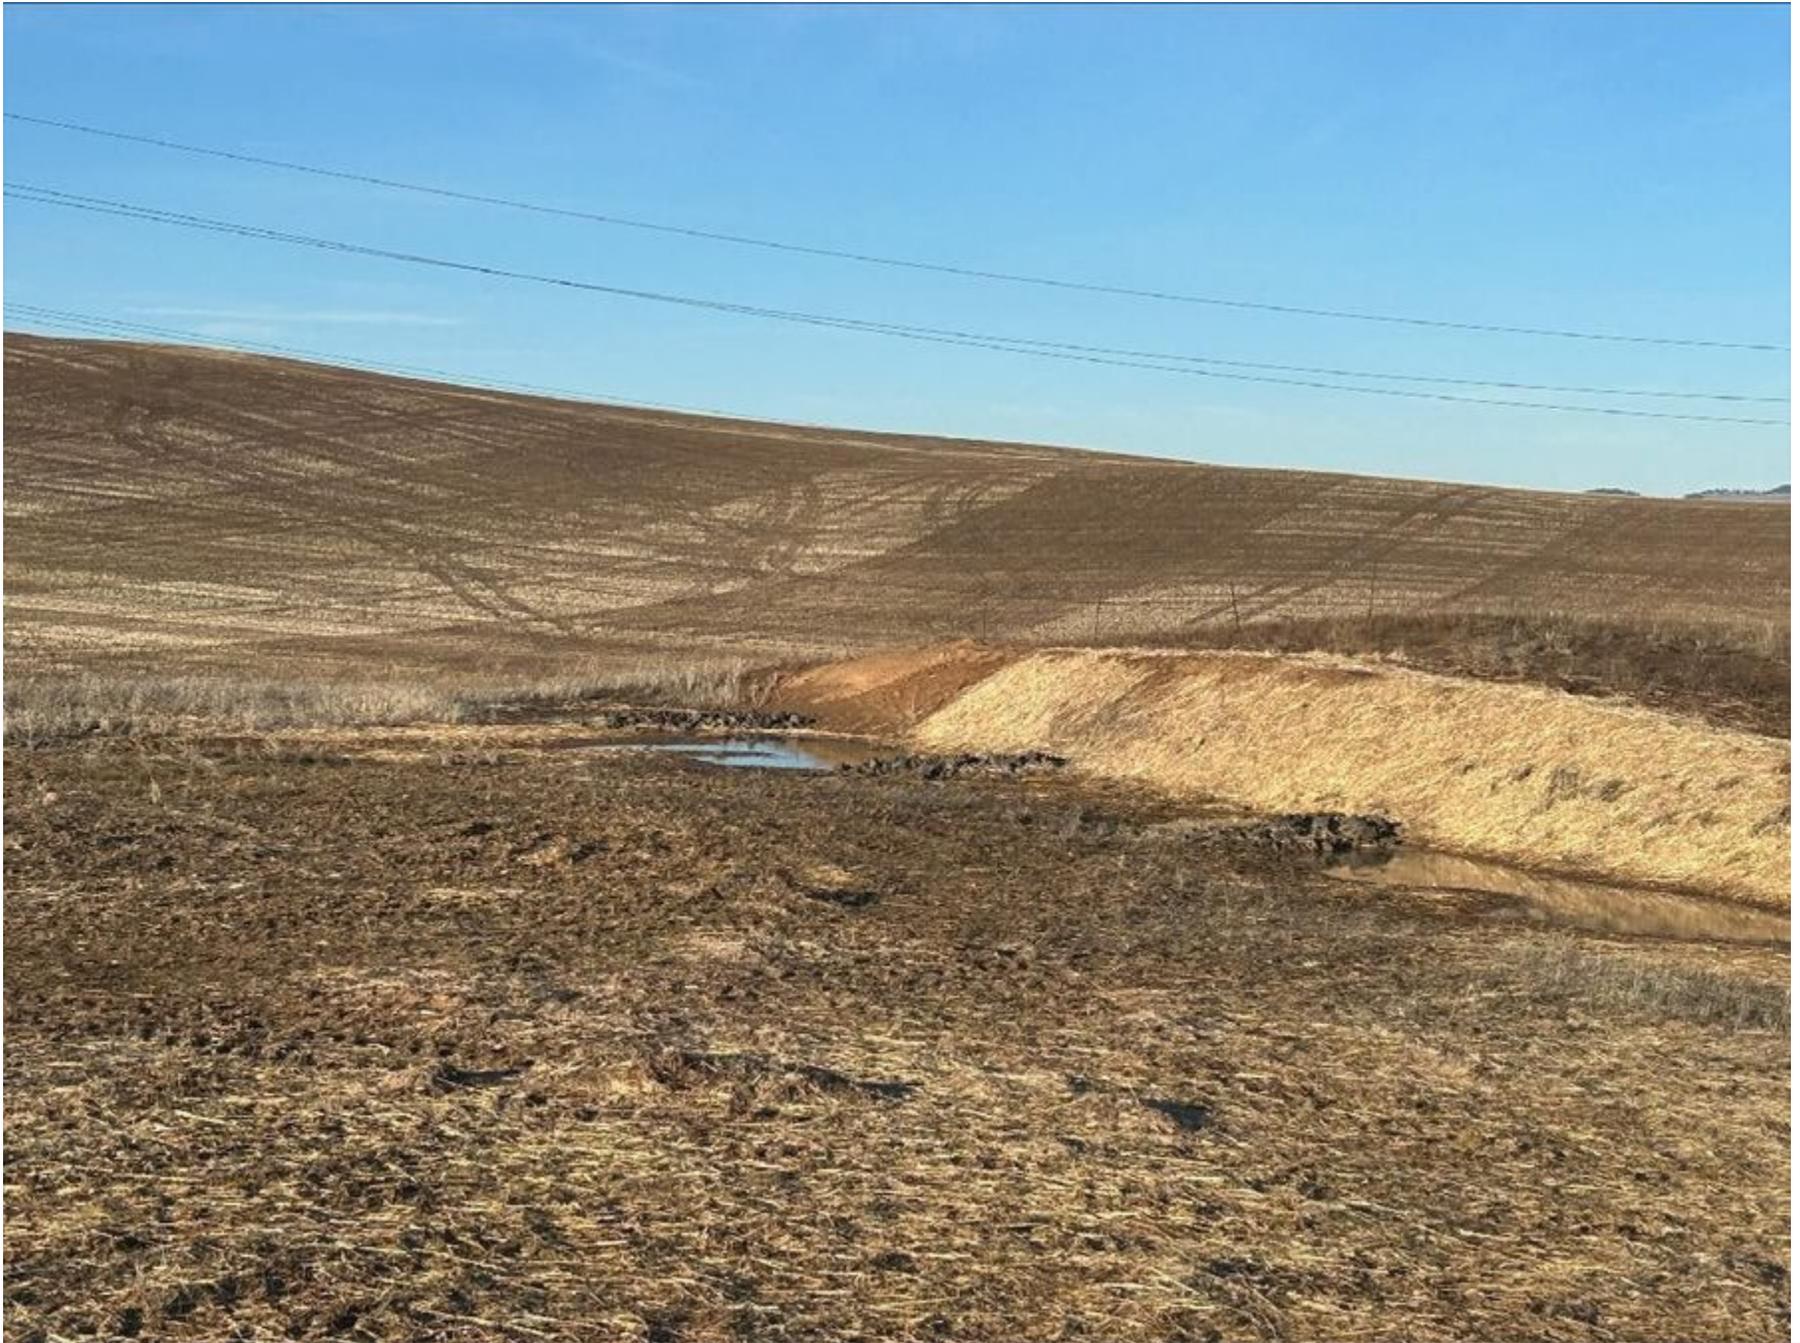
Photo 4

Photo Description: Looking north from mid project - minimal ground cover / vegetation to protect from sediment infiltration

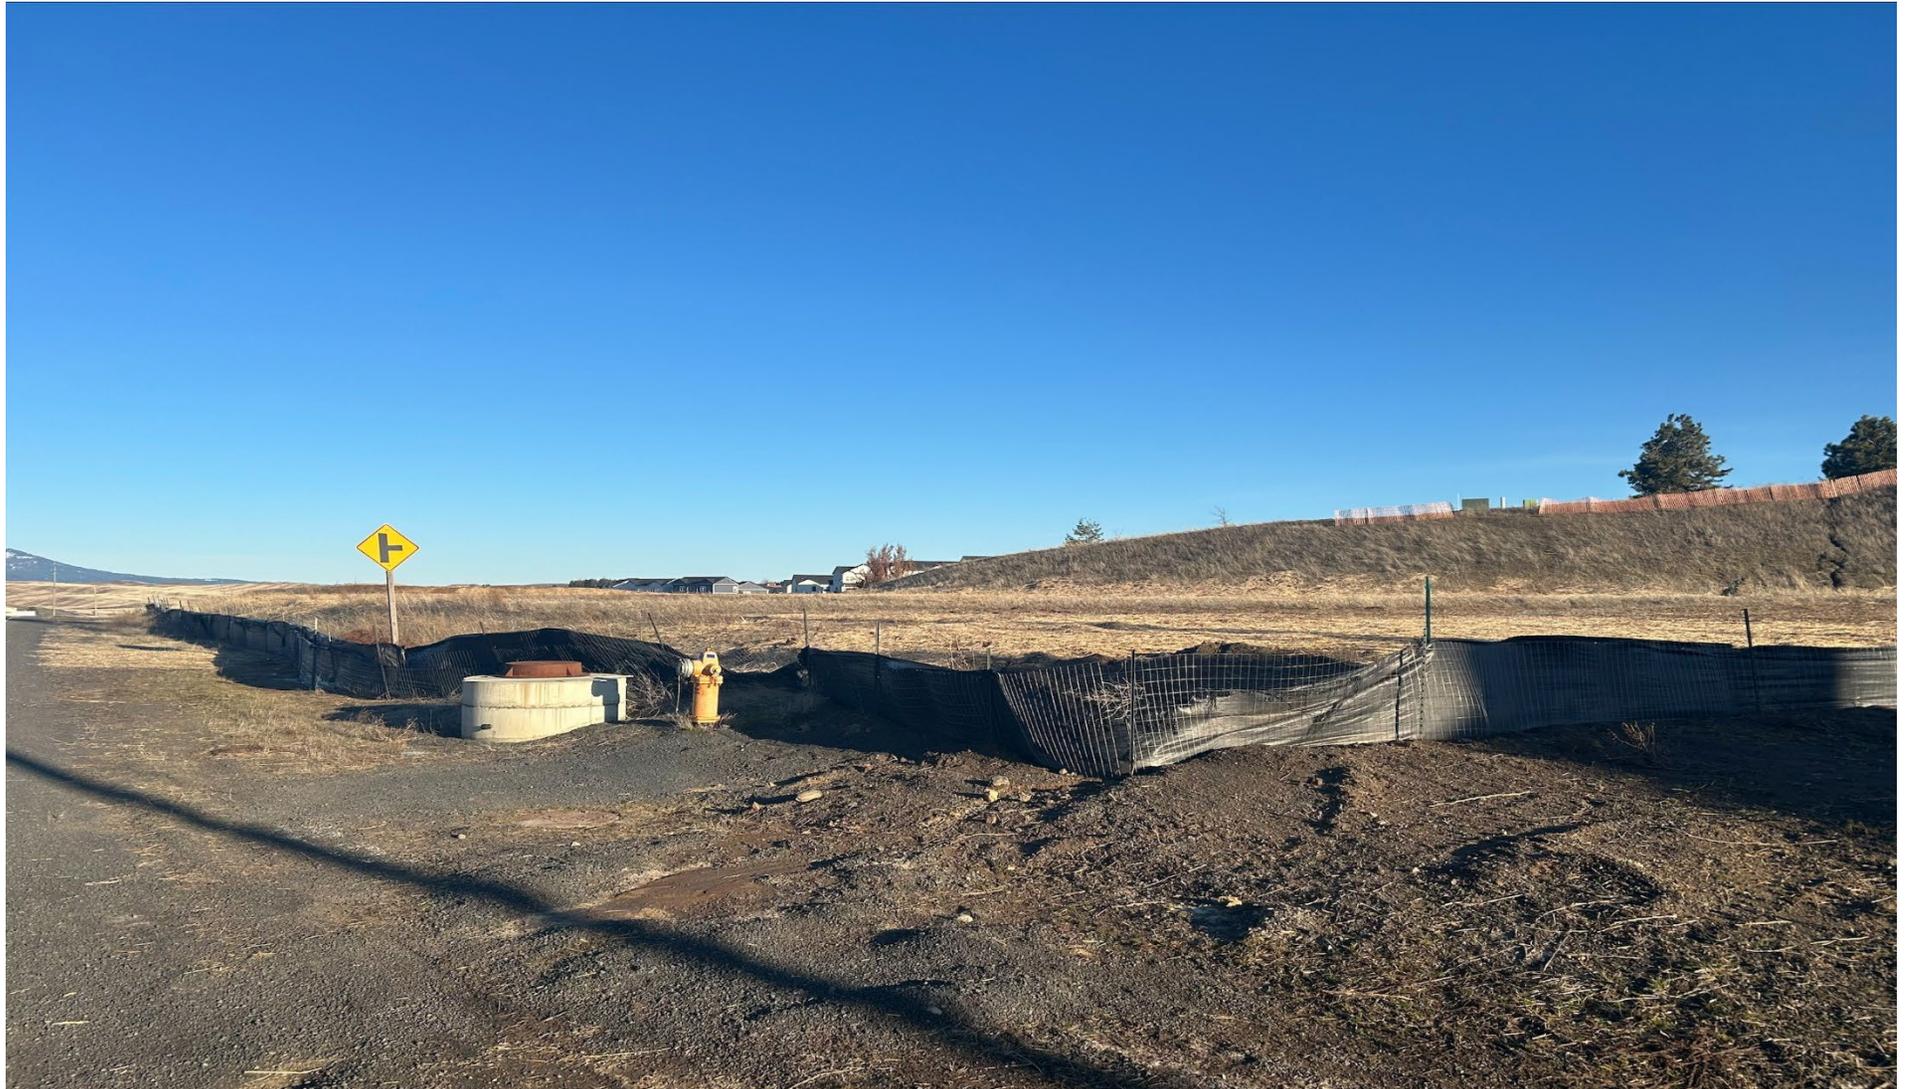
Photo 5

Photo Description: Looking northeast from roadway - minimal ground cover / sediment infiltration outside work area / BMP's not removed
