Re: Industrial Stormwater General Permit NPDES inspection (WAR000507)

Enclosures: Industrial Stormwater General Permit NPDES Inspection Report (WAR000507)  
Photolog

Facility Name and Address: Ocean Spray Markham Facility  
1480 State Route 105  
Aberdeen, WA 98520

Ocean Spray Markham Facility  
Permit #WAR000507  
4/22/25  
Photo Log

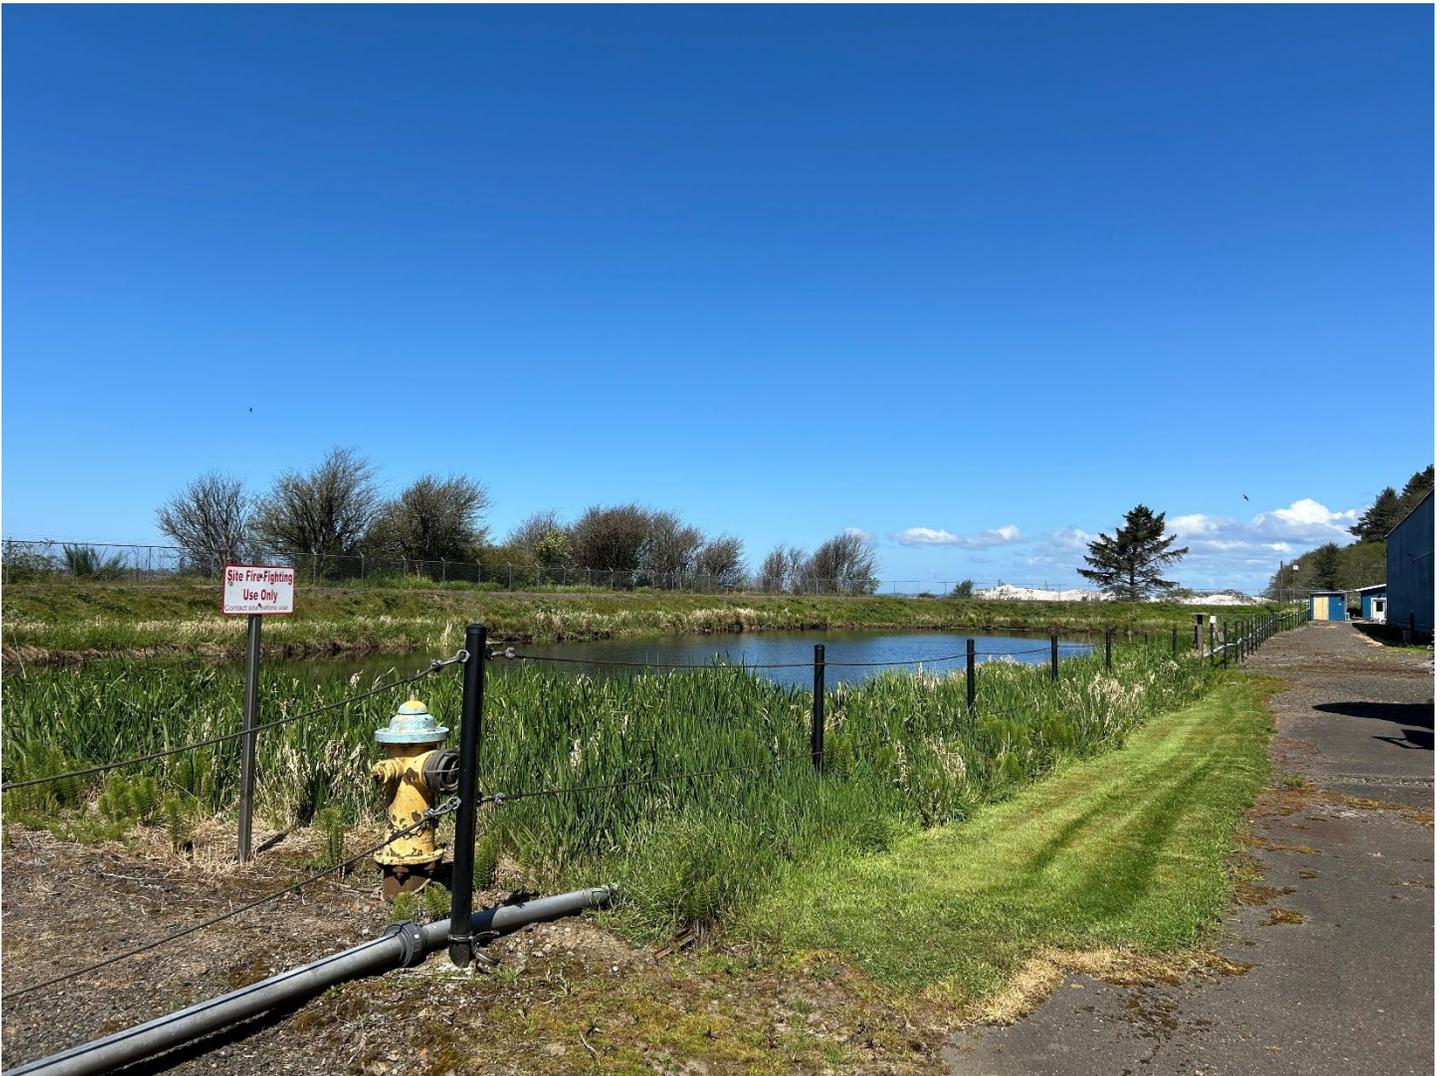
Photo 1: Stormwater pond facing north. Pipe in foreground directs stormwater to the treatment lagoon in Photo 2.

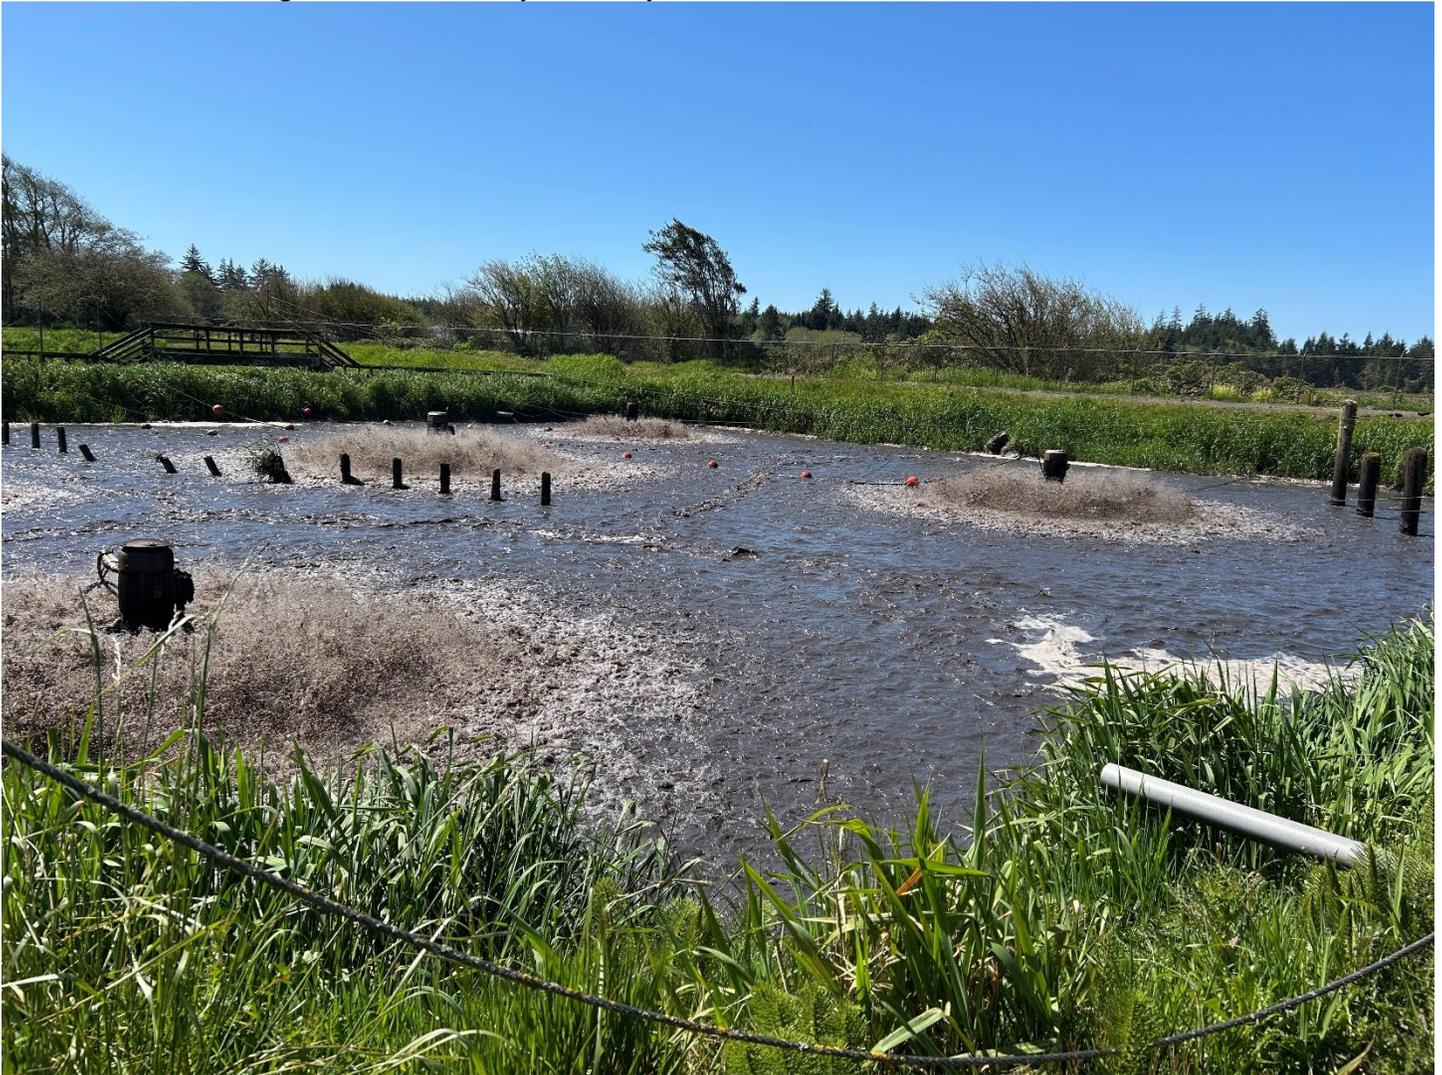
Ocean Spray personnel Glen Piehl and Kristi Melinkovich led Adonia McKinzi to Outfall C along the highway and around the facility to the stormwater pond and wastewater aeration lagoon. The facility appeared clean. The treatment lagoon smelled earthy, indicating a healthy microbial consortium.

Photo 2: Treatment lagoon smelled earthy – healthy microbial consortium.
