State of Washington Department of Ecology
**WASTEWATER TREATMENT PLANT
 COMPLIANCE INSPECTION REPORT**

Name and Location of Facility Inspected and Phone City of Oak Harbor Wastewater Treatment Plants RBC Plant: 1501 SE City Beach Dr. Lagoon: 60 E. Pioneer Ave. Oak Harbor, WA 98277	Entry Time 9:50 AM	Permit Effective Date June 1, 2005
	Exit Time 3:15 PM	Permit Expiration Date May 25, 2010

PHOTO ADDENDUM – OAK HARBOR WASTEWATER TREATMENT PLANT, WA-002056-7

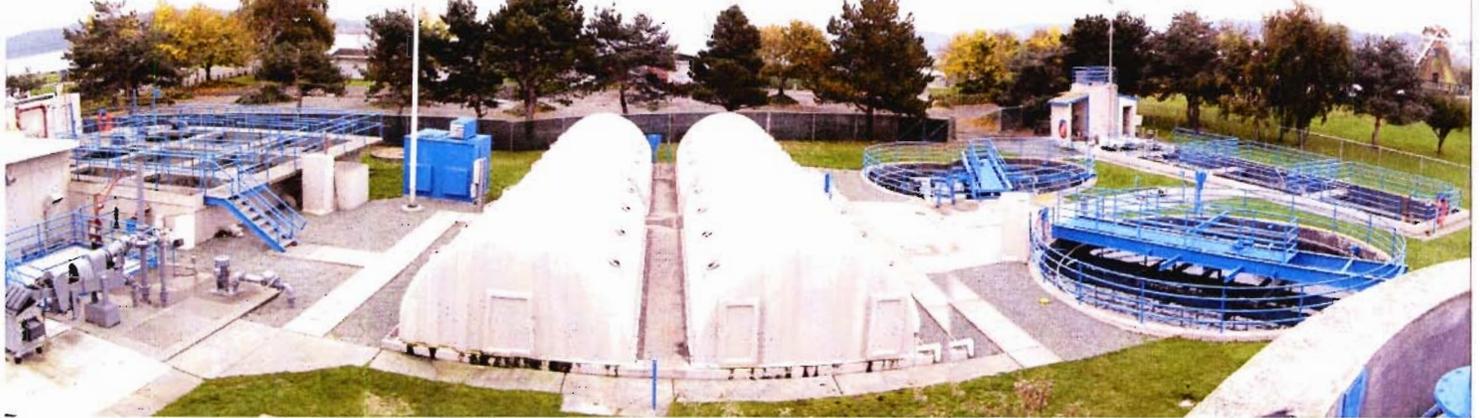
PHOTO #01 DATE: 10/18/05, 12:05 PM
FILE: SMITH/PANORAMA31.JPG

RBC facility: The RBC plant (photo #01) was built in 1978 as an upgrade to a pre-existing primary plant. Parts of the primary plant, including the primary clarifiers, were incorporated into the secondary design. In late 1985, BOD loadings to the RBC plant suddenly increased, impacting performance. A plant evaluation revealed that influent greases were unusually high and were causing problems. In 1994 the City passed a grease trap ordinance and began a rigorous inspection and enforcement program (Scott Hubbard responsible for inspection and enforcement). As a result treatment plant performance improved significantly. In 1995 and 1996, the City received approval of an engineering report addendum, which recommended an increase to the approved design loading criteria for BOD for the RBC plant, from 1200 pounds per day (ppd) to 1500 ppd. These ratings were reassessed in 2004 in an addendum engineering report which recommended increasing the approved loading rate to 2000 ppd.

TAKEN BY: JARON SMITH
DESCRIPTION: OVERVIEW OF RBC PLANT

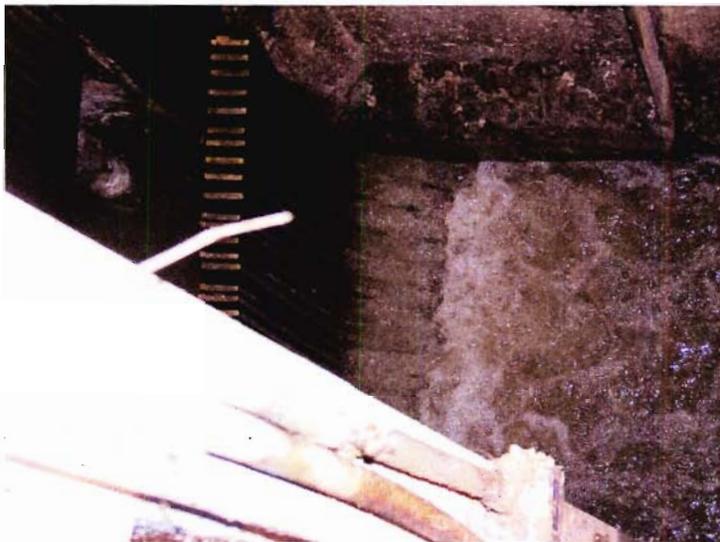
The RBC facility consists of bar screens (photo #02; at the diversion pump station), a grit chamber, influent pump station, primary clarification, rotating biological contactors (RBC's), secondary clarification, disinfection with chlorine, dechlorination with Captor (calcium sulfate) and an effluent pump station used for certain tide stages.

PHOTO #02 DATE: 10/18/05, 10:33 AM
FILE: MCKONE/PA180007.JPG
TAKEN BY: SHAWN MCKONE
DESCRIPTION: INFLUENT BAR SCREENS AT INFLUENT DIVERSION PUMP STATION

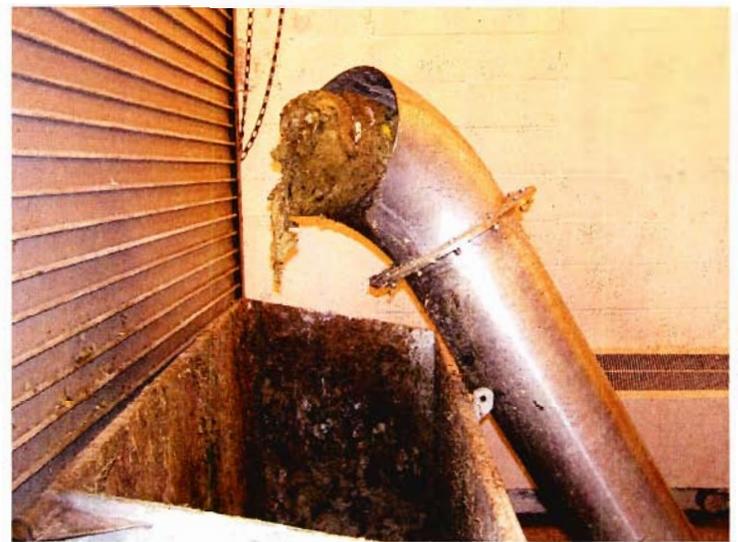
Screenings (photo #03) and grit are collected and sent to the landfill about once a week. Scum is collected and sent to the digester, decant goes to the grit chamber. In August of 1997 a new sludge thickener was added to the RBC plant, resolving an old problem associated with the handling of sludge removed from the primary and secondary clarifiers. Thickened sludge goes to the primary digester then to the old digester is mixed and tested before being transported to the lagoon facility through the diversion force main for further digestion in the anaerobic treatment cell.

PHOTO #03 DATE: 10/18/05, 10:36 AM
FILE: SMITH/PA180020.JPG
TAKEN BY: JARON SMITH
DESCRIPTION: INFLUENT SCREENINGS DISPOSAL.

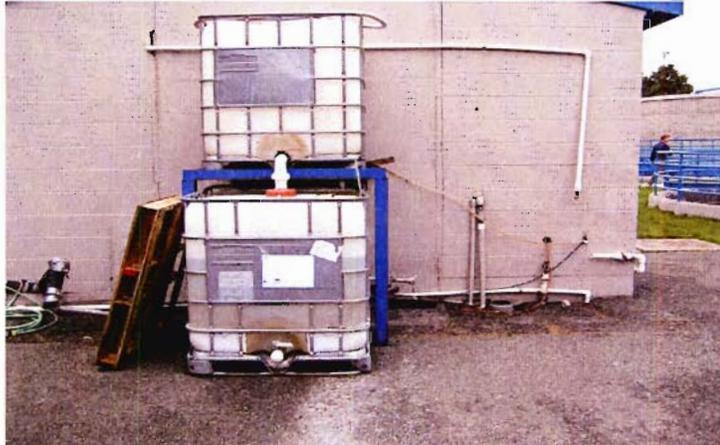
PHOTO #04 DATE: 10/18/05, 10:24 AM
FILE: SMITH/PA180018.JPG
TAKEN BY: JARON SMITH
DESCRIPTION: CHEMICAL (COAGULANT) STORAGE NEAR SECONDARY CLARIFIERS.

The storage of chemicals and empty chemical containers at both the RBC facility and the Lagoon facility should be evaluated. Chemicals should be stored in secondary containment and covered if possible. The coagulant stored outside does not have proper secondary containment (photo #04). There were empty or near empty drums near the headworks of the lagoon and next to wetlands (photos #025 and #026). Empty drums should be properly sealed and removed (to a proper disposal/recycling site) in a timely manner. There was also used coagulant/chemical storage barrels stored outside near the lagoon tertiary treatment area on bare ground (photo #032). These chemicals, if not used, should be removed (to a proper disposal/recycling site) in a timely manner, or if used, should be stored in secondary containment.

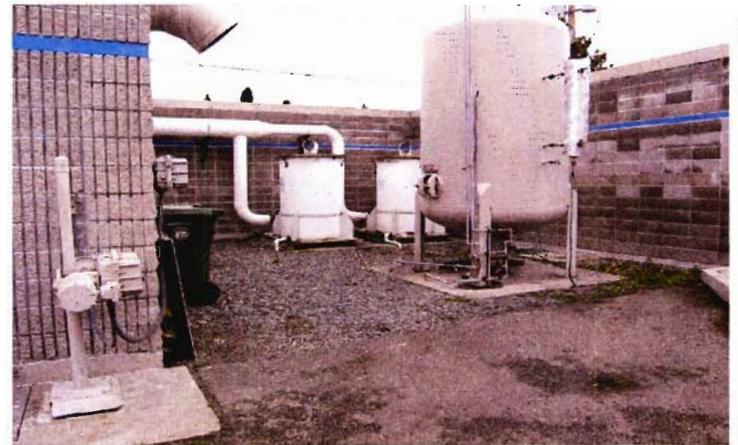
PHOTO #05 DATE: 10/18/05, 10:45 AM
FILE: MCKONE/PA180011.JPG
TAKEN BY: SHAWN MCKONE
DESCRIPTION: SURGE TANK AND CARBON ODOR SCRUBBERS OUTSIDE OF DIVERSION PUMP STATION

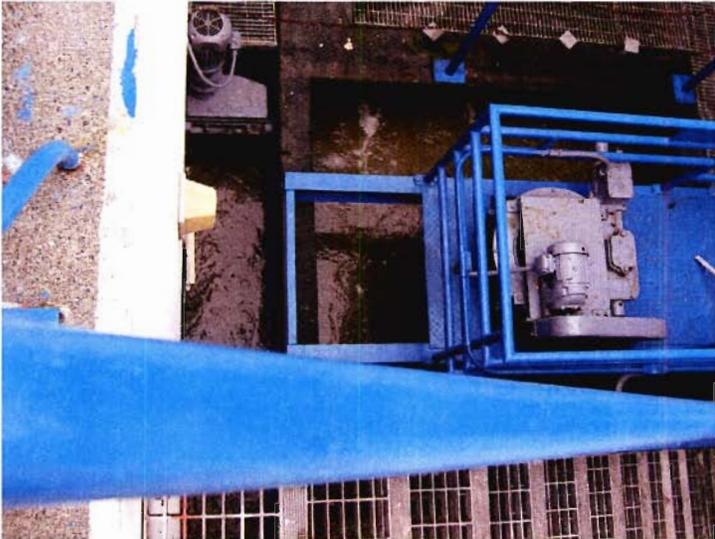
PHOTO #06 DATE: 10/18/05, 10:56 AM
FILE: MCKONE/PA180013.JPG
TAKEN BY: SHAWN MCKONE
DESCRIPTION: RBC PLANT GRIT CHAMBER.

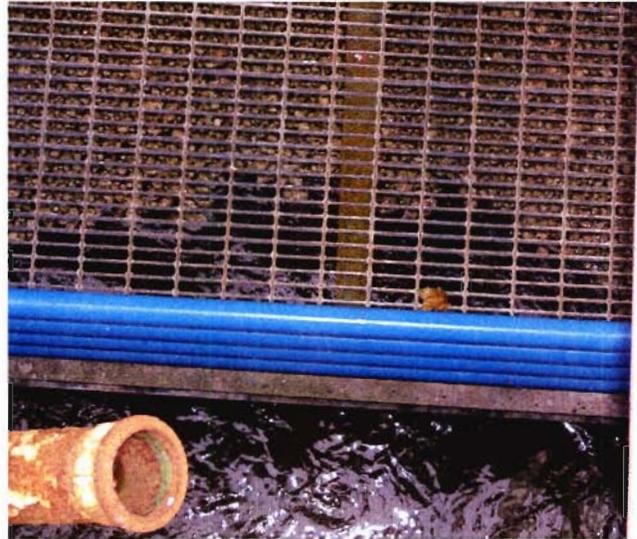
PHOTO #07 DATE: 10/18/05, 10:59 AM
FILE: MCKONE/PA180017.JPG
TAKEN BY: SHAWN MCKONE
DESCRIPTION: GREASE FLOATING IN COMMUNUTOR AREA.

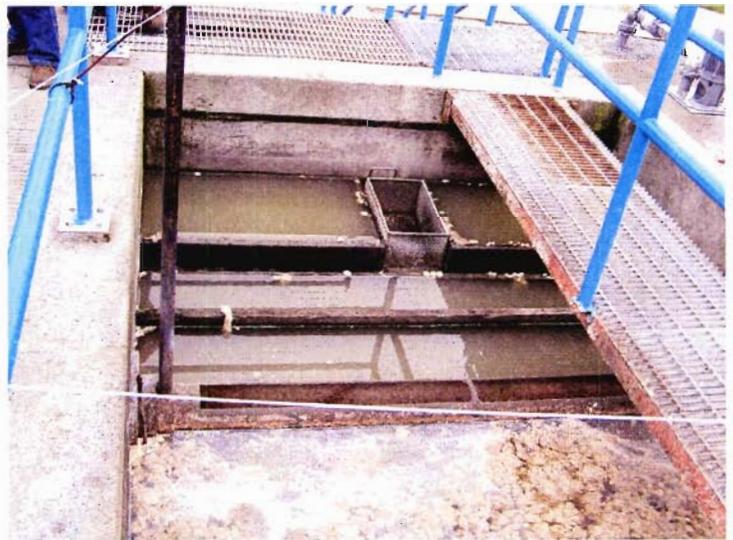
PHOTO #09 DATE: 10/18/05, 11:11 AM
FILE: SMITH/PA180035.JPG
TAKEN BY: JARON SMITH
DESCRIPTION: PRIMARY SEDIMENTATION BASIN, EFFLUENT END.

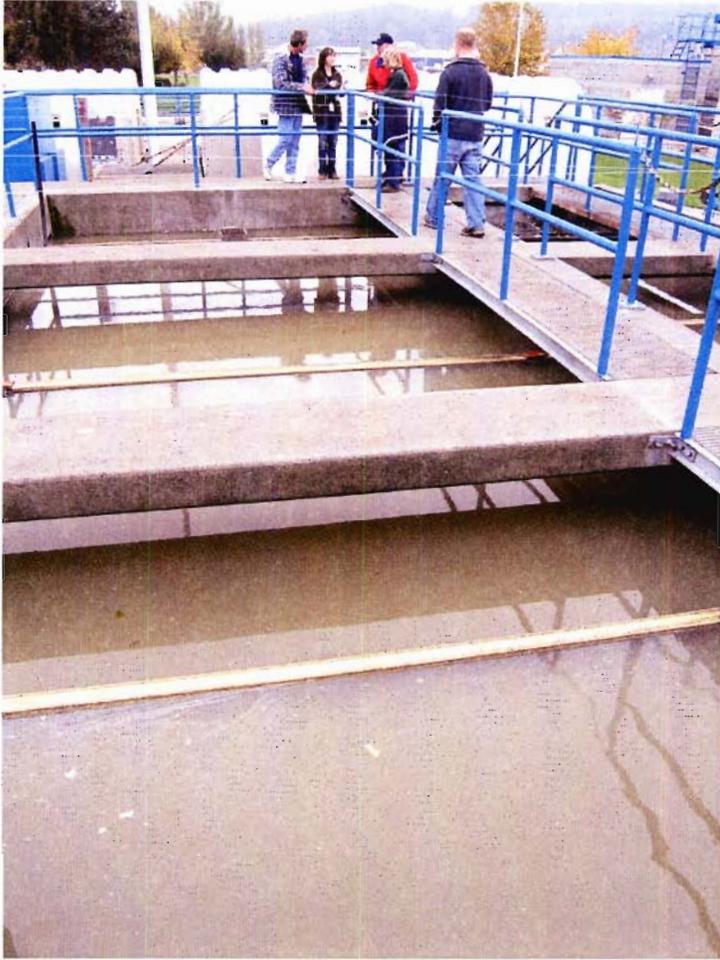
PHOTO #:010 DATE: 10/18/05, 11:06 AM
FILE: MCKONE/PA180021.JPG
TAKEN BY: SHAWN MCKONE
DESCRIPTION: PRIMARY SEDIMENTATION BASINS.

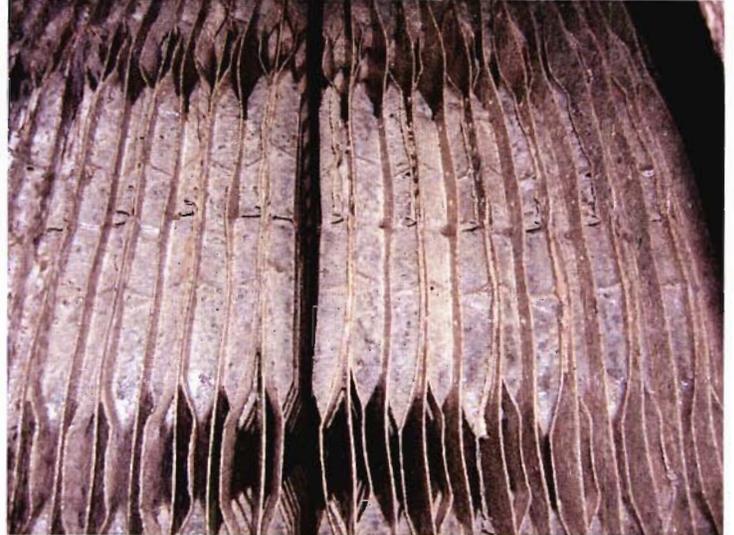
The flow from the primary clarifiers is combined at the splitter box and then split evenly between the two RBC trains. There are two shafts in each train (photos #011, #012, and #013). Two large blowers feed all 4 RBC's. RBC's are cleaned about 2-3 times per year and sluffings are drained to the grit chamber. The RBC's are cleaned with caustic soda to achieve a complete biological kill about once a year. The flows from the RBC's stay separated as they enter the secondary clarifiers (two). The secondary clarifiers (photo #014) are lateral feed. The weirs are hosed down about once a week which includes dropping the level 2-3 feet. About once every 3 months the clarifiers are emptied and cleaned. The clarifiers are also steam cleaned about twice a year.

PHOTO #:011 DATE: 10/18/05, 11:15 AM
FILE: MCKONE/PA180023.JPG
TAKEN BY: SHAWN MCKONE
DESCRIPTION: INFLUENT END RBC DISCS.

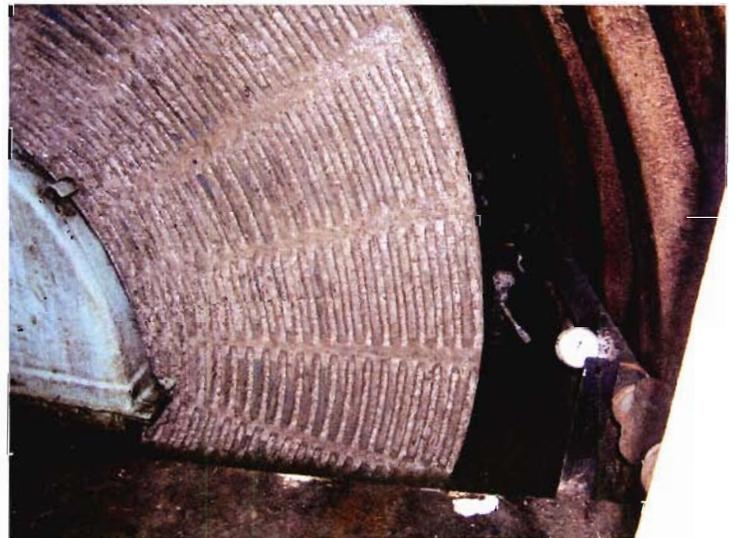
PHOTO #:012 DATE: 10/18/05, 11:15 AM
FILE: MCKONE/PA180024.JPG
TAKEN BY: SHAWN MCKONE
DESCRIPTION: INFLUENT END RBC DISCS, END VIEW. AIR HEADER FOR AERATION ON RIGHT SIDE.

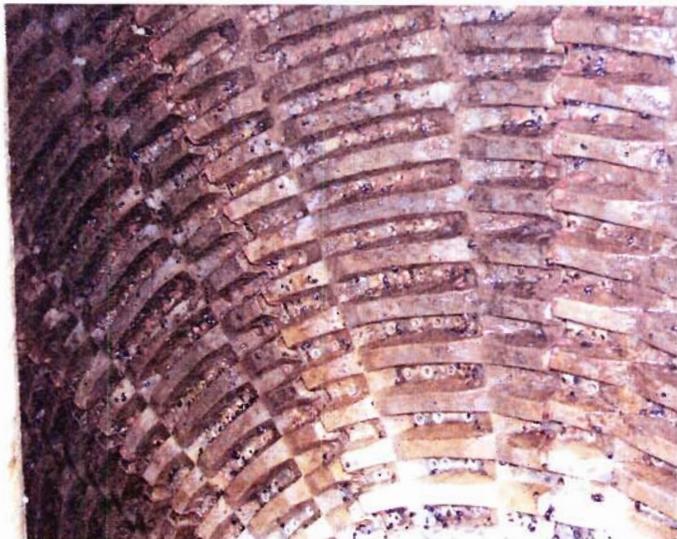
PHOTO #:013 DATE: 10/18/05, 11:18 AM
FILE: MCKONE/PA180027.JPG
TAKEN BY: SHAWN MCKONE
DESCRIPTION: EFFLUENT END RBC DISCS, END VIEW.

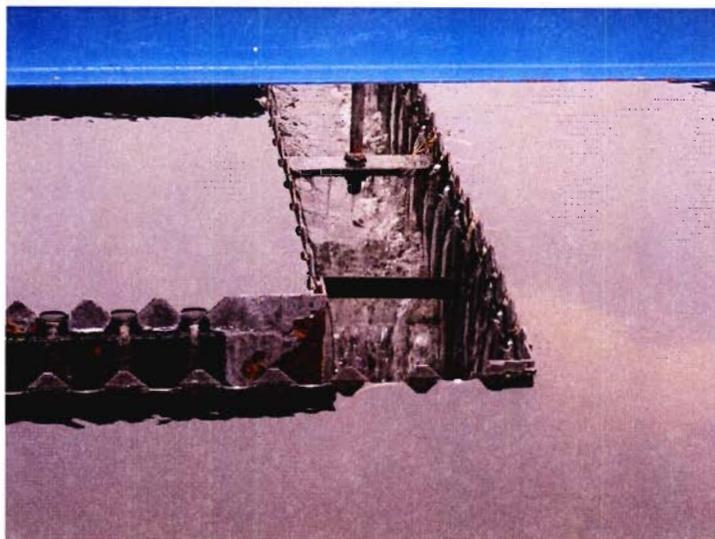
PHOTO #:014 DATE: 10/18/05, 11:21 AM
FILE: MCKONE/PA180030.JPG
TAKEN BY: SHAWN MCKONE
DESCRIPTION: SECONDARY CLARIFIER OVERFLOW WEIR.

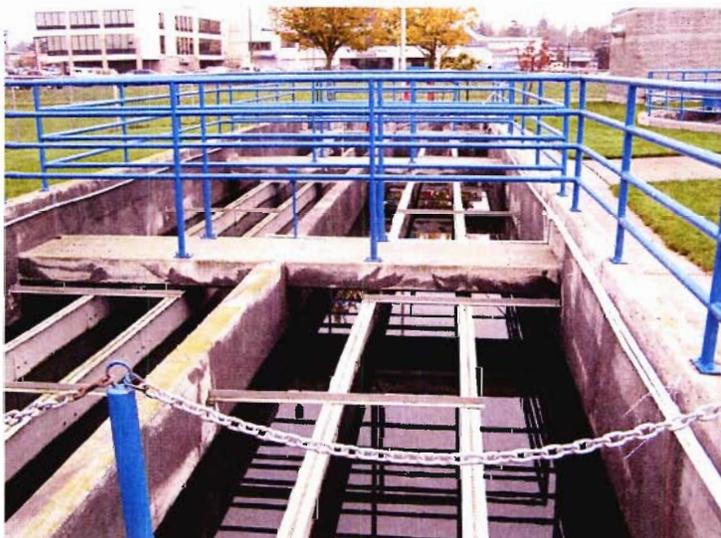
Clarified effluent is then sent to a flash mixer where chlorine is added and then onto a contact chamber. The contact chamber has two trains with about a 30 minute contact time (photo #015). Liquid chlorine is generated on-site. Captor (calcium thiosulfate) is used for dechlorination at the end of the contact chamber. The chamber is cleaned in the same manner as the secondary clarifiers. Effluent sampling is conducted at the end of the chlorine contact chamber. Effluent flow is sent through the outfall and is pumped (photo #016) as needed when high tides do not allow for sufficient gravity flow.

PHOTO #:015 DATE: 10/18/05, 10:22 AM
FILE: SMITH/PA180016.JPG
TAKEN BY: JARON SMITH
DESCRIPTION: CHLORINE CONTACT CHAMBERS.

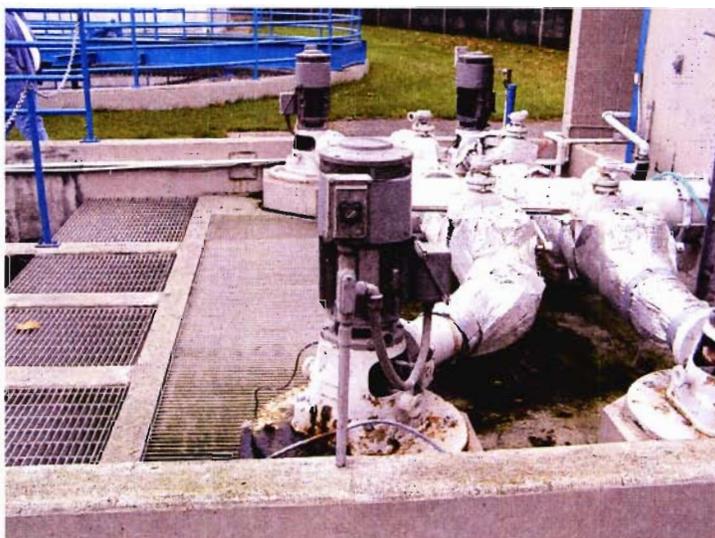
PHOTO #:016 DATE: 10/18/05, 11:32 AM
FILE: SMITH/PA180053.JPG
TAKEN BY: JARON SMITH
DESCRIPTION: FINAL EFFLUENT DISCHARGE PUMPS. USED ONLY AT HIGH TIDES WHEN EFFLUENT IS NOT ABLE TO PROPERLY FLOW UNDER GRAVITY.

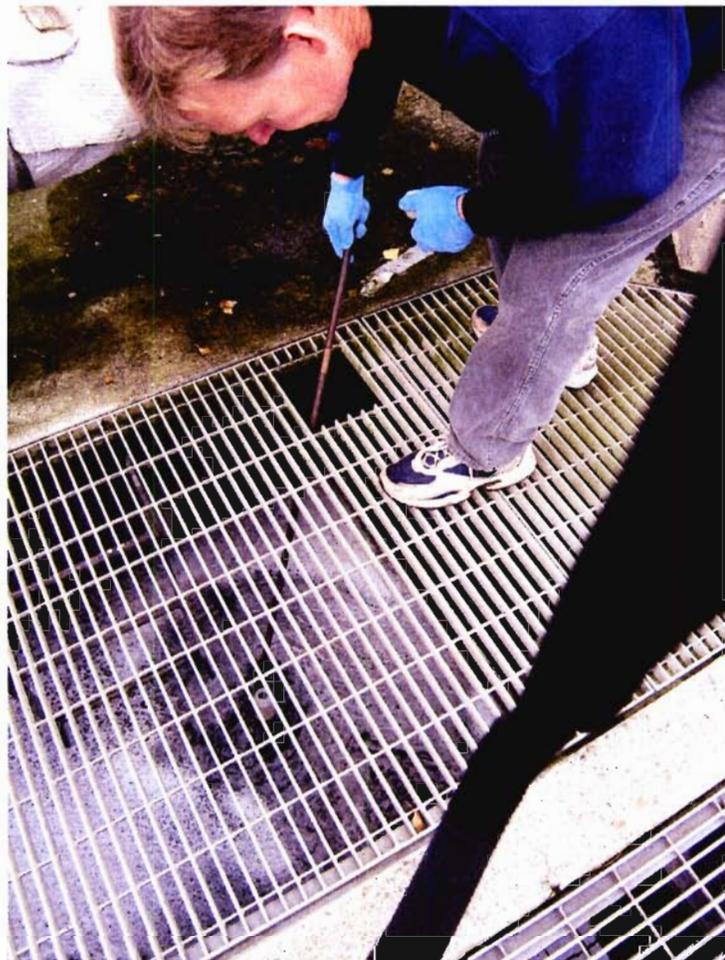
Composite and grab samples were taken and split (photos #017, #020, and #030) on October 18, 2005 after Ecology arrived.

PHOTO #:017 DATE: 10/18/05, 10:18 AM
FILE: MCKONE/PA180004.JPG
TAKEN BY: SHAWN MCKONE
DESCRIPTION: GRAB SAMPLING OF FINAL EFFLUENT AT DISCHARGE END OF CHLORINE CONTACT CHAMBER, RBC PLANT.

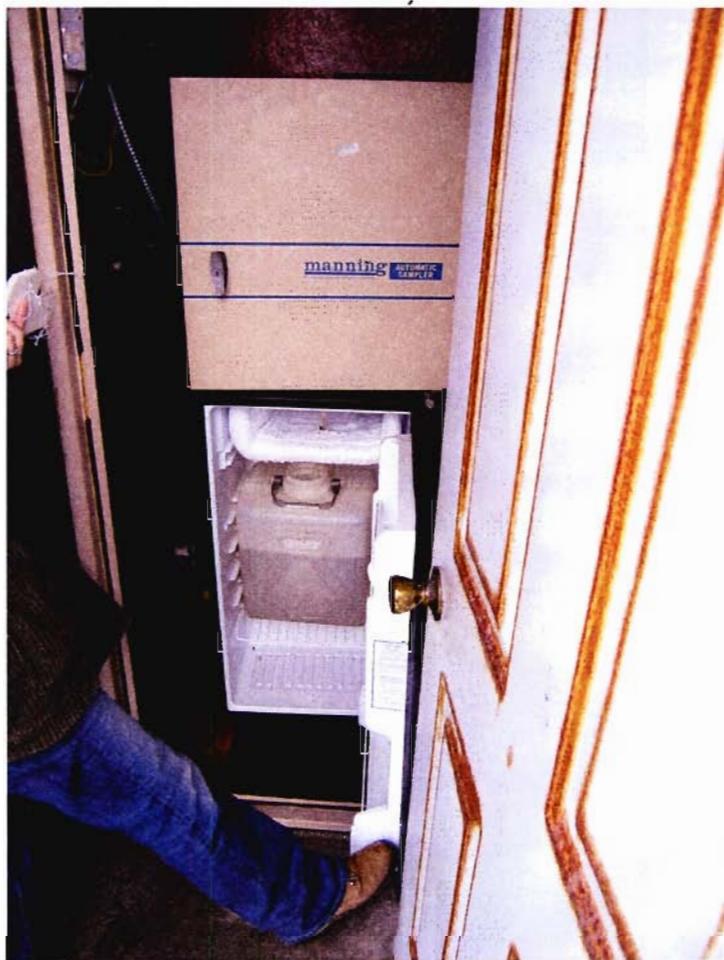
PHOTO #:018 DATE: 10/18/05, 10:09 AM
FILE: MCKONE/PA180001.JPG
TAKEN BY: SHAWN MCKONE
DESCRIPTION: RBC PLANT FINAL EFFLUENT COMPOSITE SAMPLER, PRIOR TO REMOVAL OF SAMPLE FOR SPLITTING.

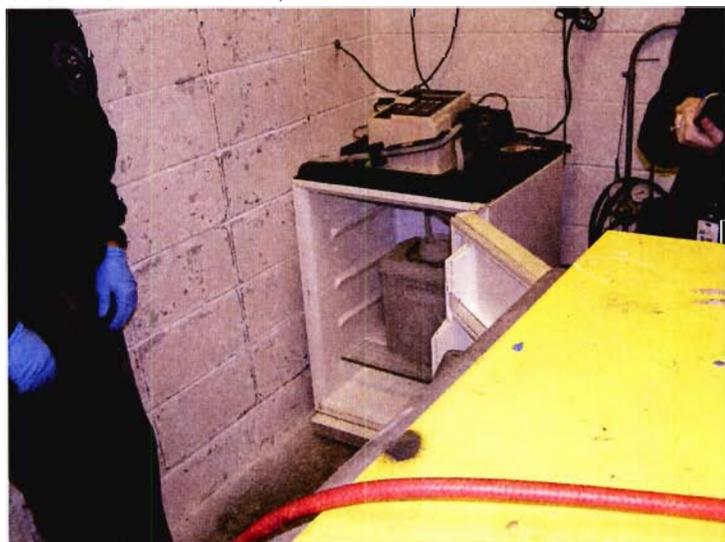
Influent sampling is conducted after screening and prior to recycle flows with a refrigerated composite sampler (photo #019). The composite sampler is flow proportional. Effluent composite sampling is conducted at the end of the chlorine contact chamber after dechlorination with a flow proportional refrigerated composite sampler (photo #018). Effluent grab samples are taken in the same location (photo #017). Both composite sampler temperatures were within the required range of 2°C and 4°

PHOTO #:019 DATE: 10/18/05, 10:11 AM
FILE: SMITH/PA180009.JPG
TAKEN BY: JARON SMITH
DESCRIPTION: RBC INFLUENT COMPOSITE SAMPLER.

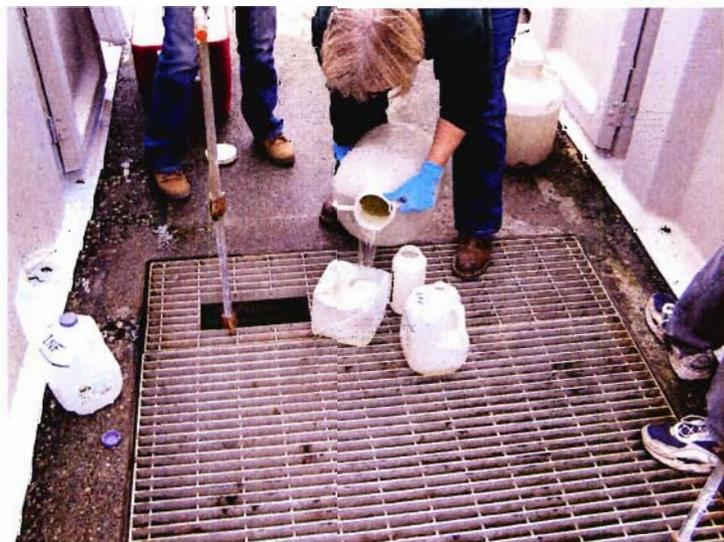
PHOTO #:020 DATE: 10/18/05, 10:02 AM
FILE: SMITH/PA180006.JPG
TAKEN BY: JARON SMITH
DESCRIPTION: SAMPLE SPLITTING, LAGOON COMPOSITE SAMPLES.

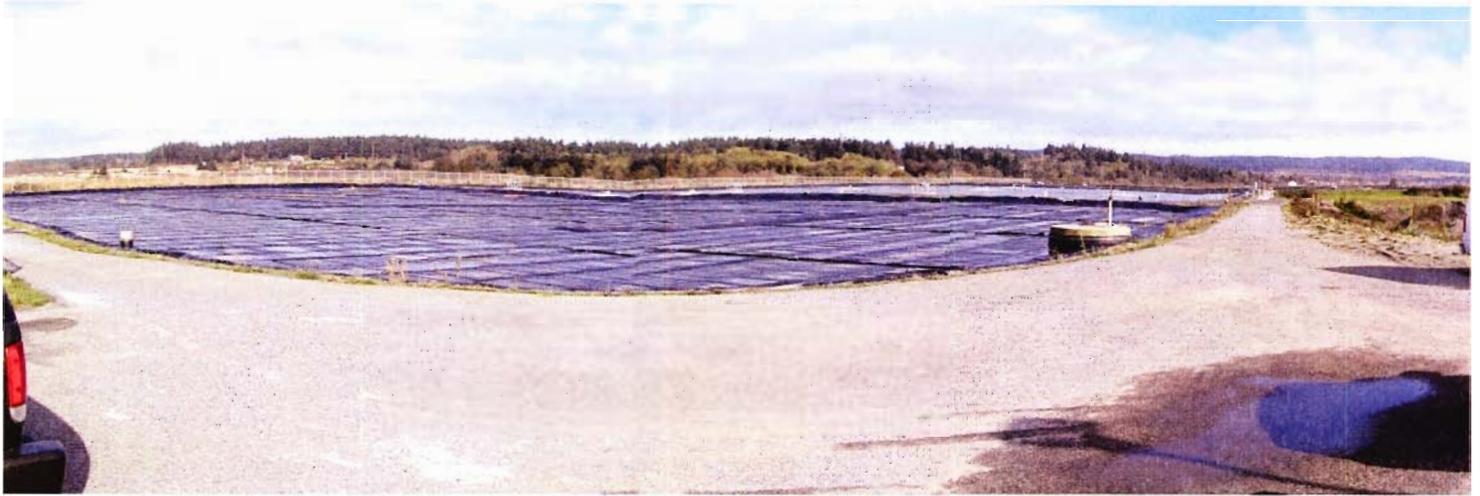
PHOTO #:021 DATE: 10/18/05, 2:08 PM
FILE: SMITH/PANORAMA41.JPG

The lagoon treatment facility (photos #021 and #022) consists of coarse bar screens at the diversion pump station, influent flow measurement with a Parshall flume, macerators, an anaerobic pretreatment lagoon, three aerated lagoons, disinfection with chlorine, and an effluent pump station for discharge at high tides. This facility also includes a diversion structure to allow effluent polishing in a physical-chemical treatment system. The physical chemical system includes two flash mix basins, two flocculation basins and two rectangular clarifiers. The system is capable of feeding both ferric sulfate and polymer. The tertiary plant is capable of handling 0.885 mgd average flow, while the lagoons have a maximum month average design flow of 2.5 mgd. Space is available to construct a fourth lagoon cell as needed for expansion.

TAKEN BY: JARON SMITH
DESCRIPTION: OVERVIEW OF LAGOON FACILITY ANAEROBIC CELL.

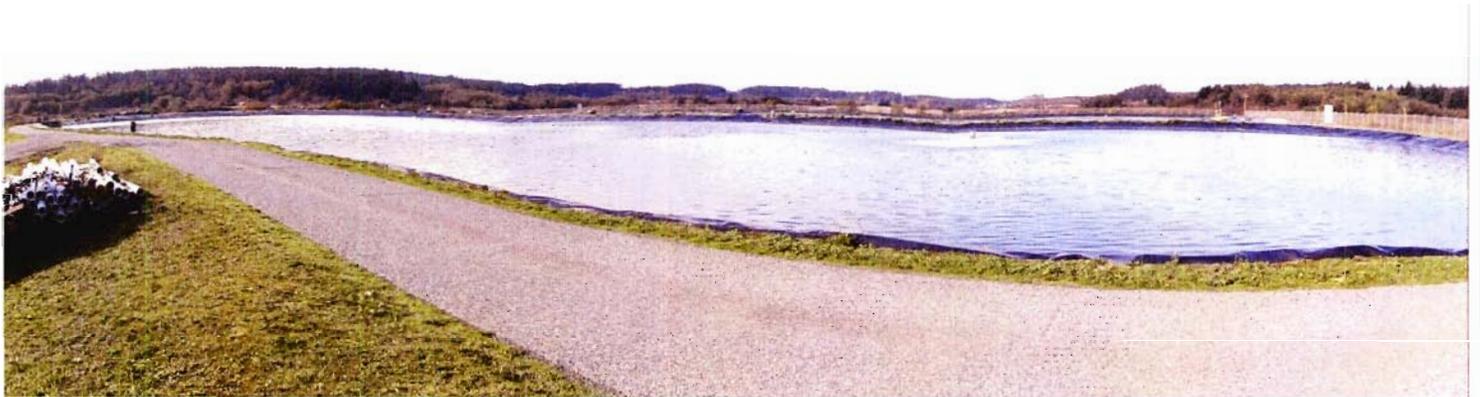
PHOTO #:022 DATE: 10/18/05, 3:04 PM
FILE: SMITH/PANORAMA61.JPG

TAKEN BY: JARON SMITH
DESCRIPTION: OVERVIEW OF AERATED MAIN NW LAGOON CELL.

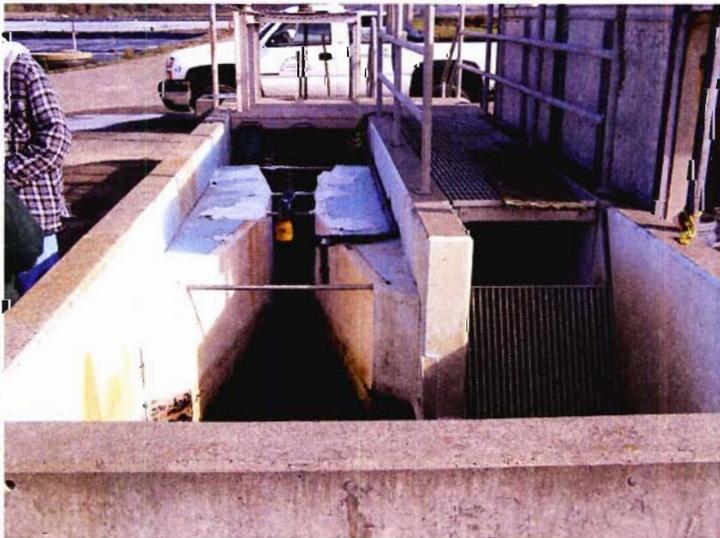
Flow is measured at the influent via a Parshall flume/ultrasonic meter (photo #023). Effluent flow is measured with a propeller type meter at the tertiary treatment area (photo #031).

PHOTO #:023 DATE: 10/18/05, 2:00 PM
FILE: SMITH/PA180061.JPG
TAKEN BY: JARON SMITH
DESCRIPTION: LAGOON FACILITY HEADWORKS, PARSHALL FLUME FOR MAIN INFLOW MEASUREMENT (LEFT) AND SCREENED DIVERSION CHANNEL (RIGHT).

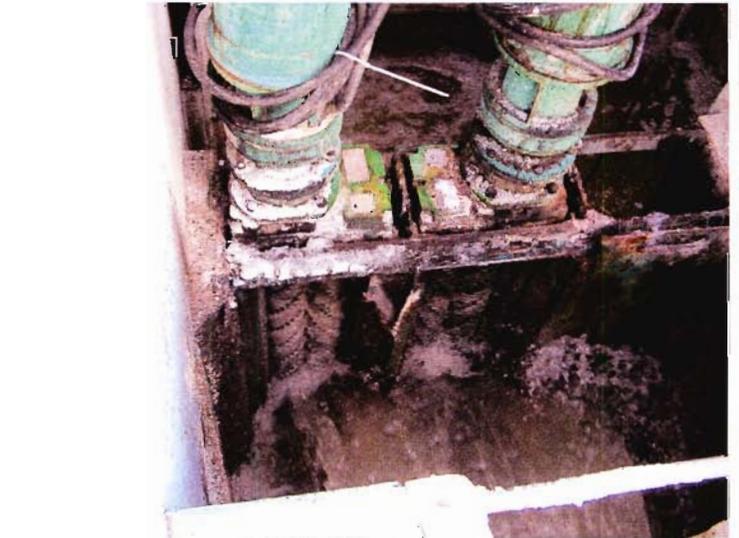
PHOTO #:024 DATE: 10/18/05, 2:04 PM
FILE: SMITH/PA180063.JPG
TAKEN BY: JARON SMITH
DESCRIPTION: MACERATORS AT LAGOON HEADWORKS.

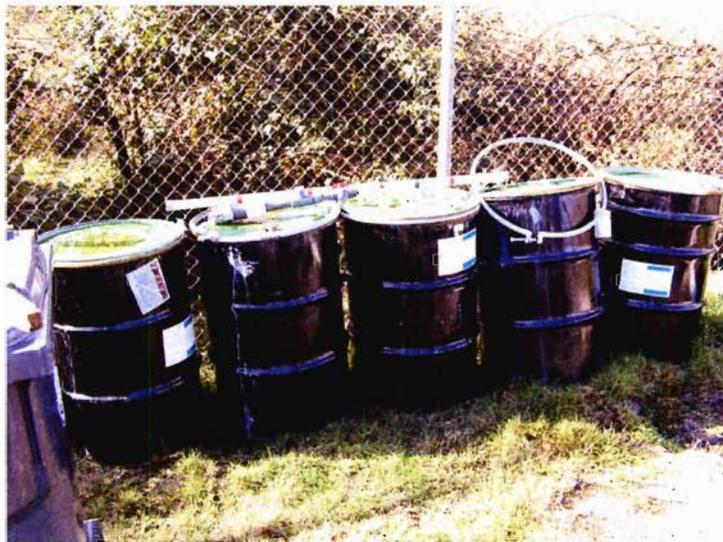
PHOTO #025 DATE: 10/18/05, 1:58 PM
FILE: SMITH/PA180060.JPG
TAKEN BY: JARON SMITH
DESCRIPTION: EMPTY CHEMICAL BARRELS STORED NEAR LAGOON HEADWORKS. NAVY MITIGATION WETLAND IN BACKGROUND.

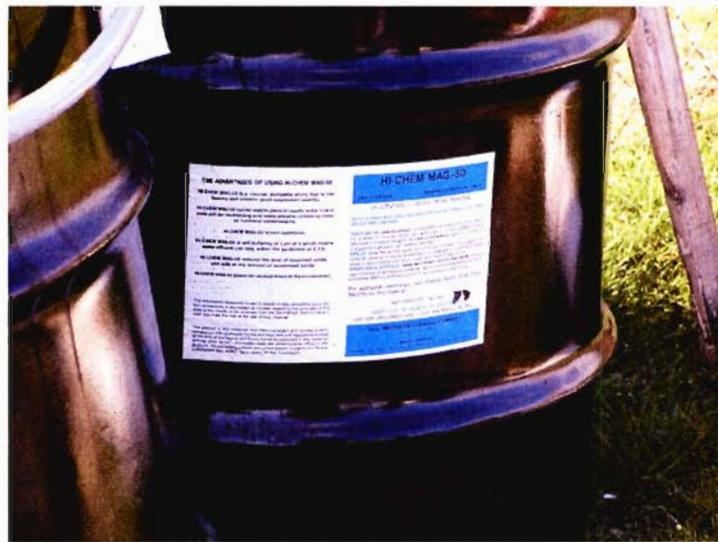
PHOTO #026 DATE: 10/18/05, 1:57 PM
FILE: SMITH/PA180059.JPG
TAKEN BY: JARON SMITH
DESCRIPTION: LABEL ON CHEMICAL BARREL STORED NEAR LAGOON HEADWORKS.

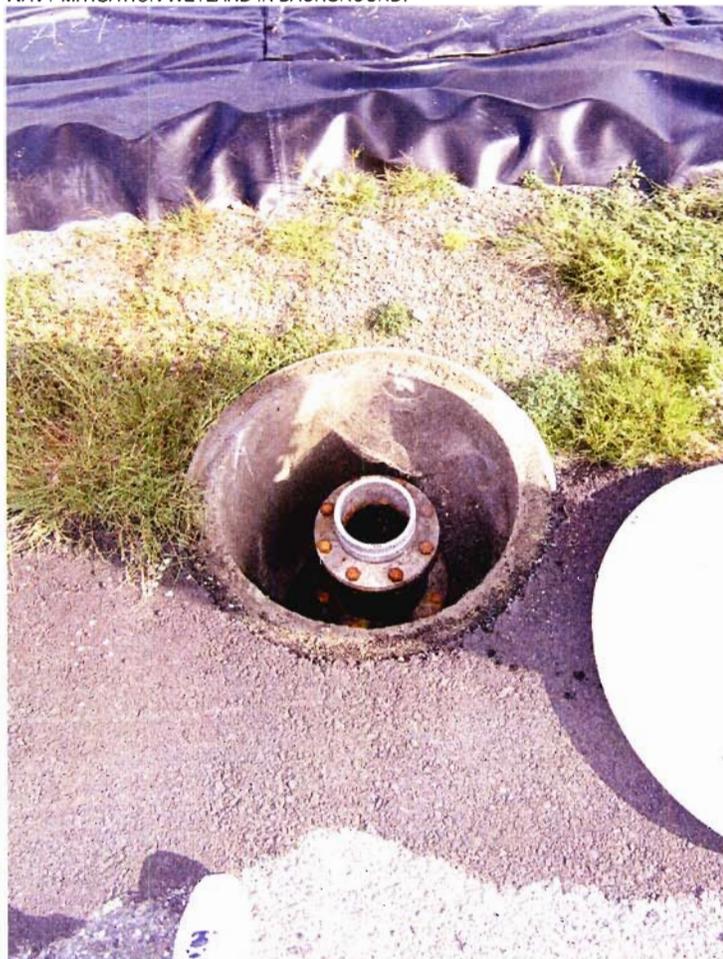
PHOTO #027 DATE: 10/18/05, 2:17 PM
FILE: MCKONE/PA180039.JPG
TAKEN BY: SHAWN MCKONE
DESCRIPTION: EXTRACTION PORT FOR ANAEROBIC LAGOON SOLIDS REMOVAL..

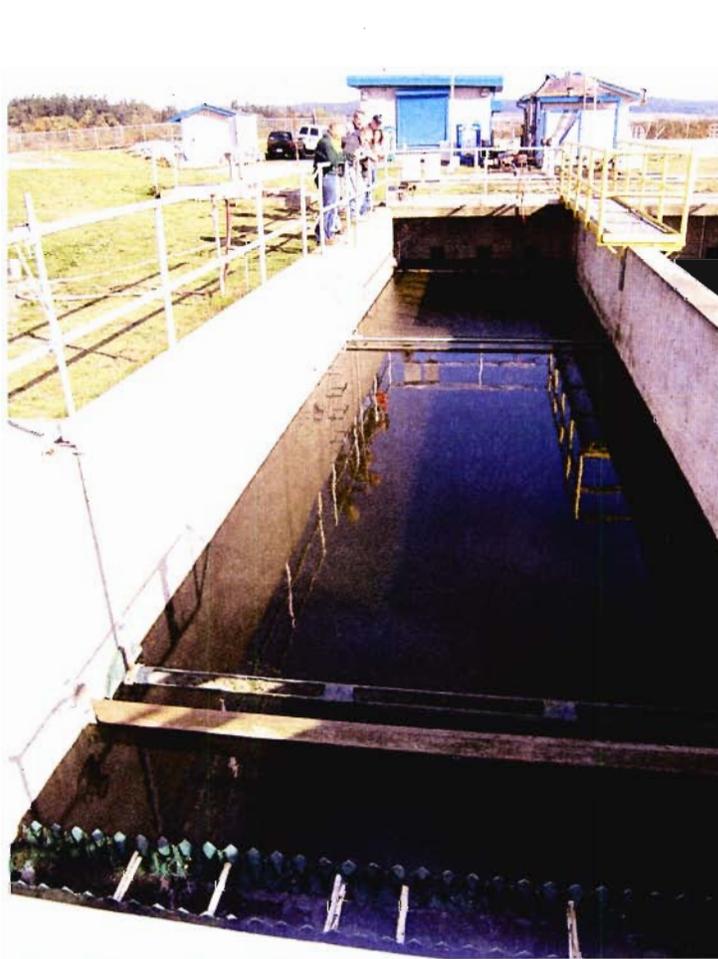
PHOTO #028 DATE: 10/18/05, 2:36 PM
FILE: MCKONE/PA180046.JPG
TAKEN BY: SHAWN MCKONE
DESCRIPTION: LAGOON TERTIARY TREATMENT BASIN FOR ALGAE REMOVAL.

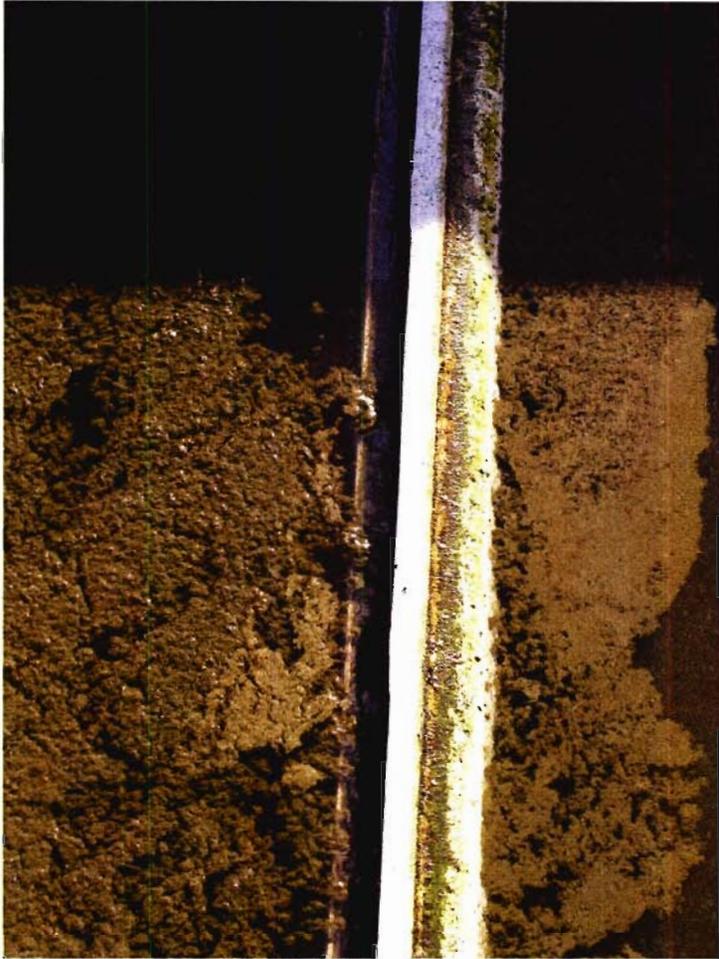
PHOTO #:029 DATE: 10/18/05, 2:37 PM
FILE: MCKONE/PA180047.JPG
TAKEN BY: SHAWN MCKONE
DESCRIPTION: COAGULATED ALGAE BEING SKIMMED FROM THE SURFACE OF THE LAGOON TERTIARY TREATMENT BASIN.

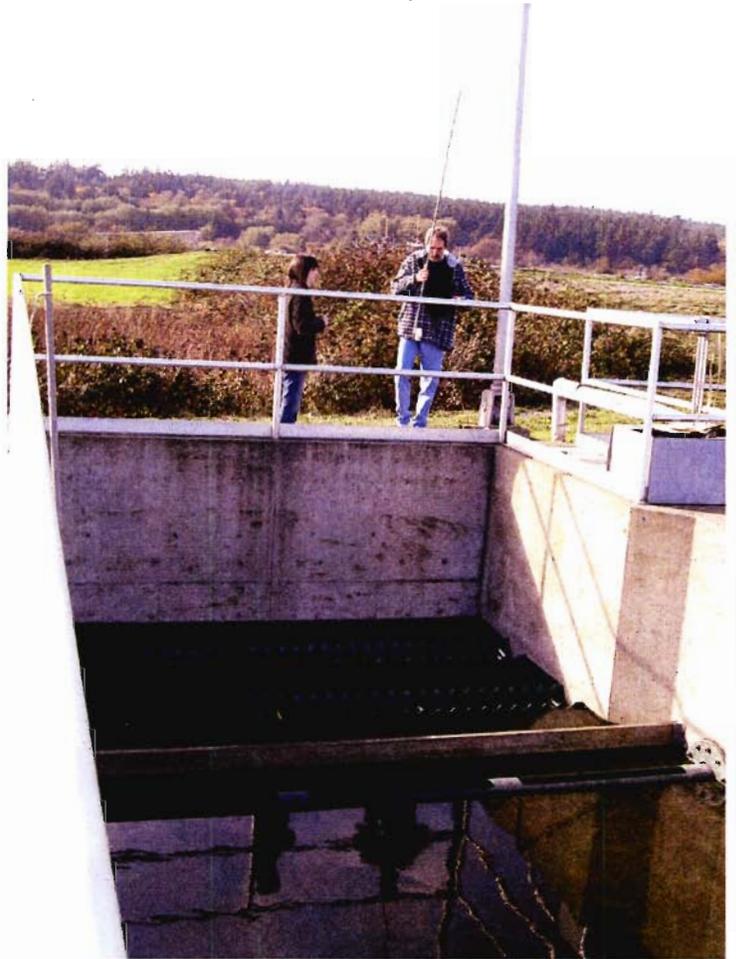
PHOTO #:030 DATE: 10/18/05, 2:56 PM
FILE: MCKONE/PA180050.JPG
TAKEN BY: SHAWN MCKONE
DESCRIPTION: GRAB SAMPLING FOR CHLORINE RESIDUAL AT THE DISCHARGE END OF THE LAGOON TERTIARY TREATMENT BASIN.

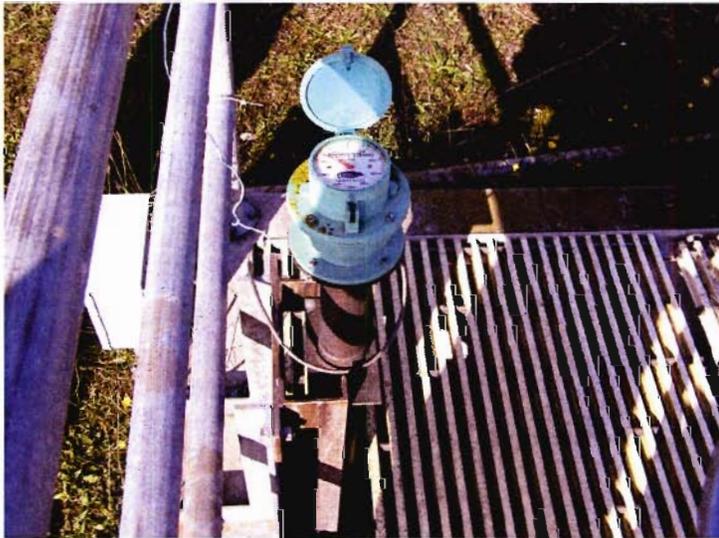
PHOTO #:031 DATE: 10/18/05, 2:36 PM
FILE: SMITH/PA180074.JPG
TAKEN BY: JARON SMITH
DESCRIPTION: EFFLUENT FLOW METER, PROPELLER TYPE, AT LAGOON TERTIARY TREATMENT AREA.

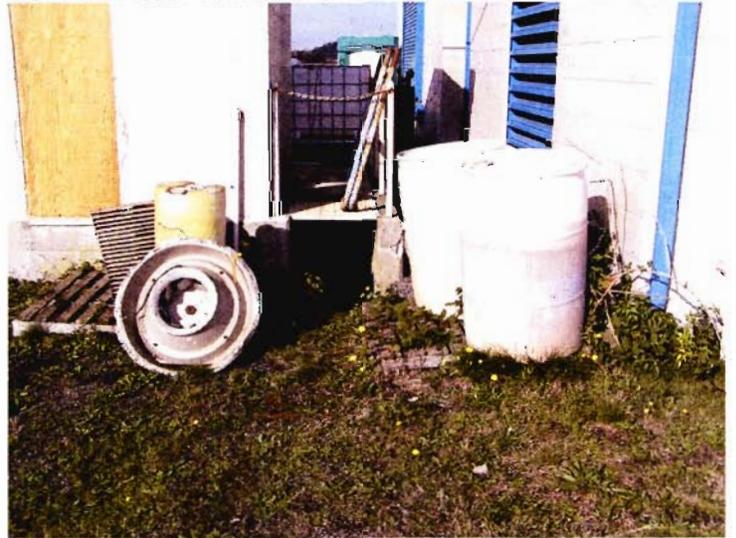
PHOTO #:032 DATE: 10/18/05, 2:51 PM
FILE: SMITH/PA180079.JPG
TAKEN BY: JARON SMITH
DESCRIPTION: USED COAGULANT STORAGE CHEMICAL BARRELS STORED AT LAGOON TERTIARY TREATMENT AREA.
