State of Washington Department of Ecology Northwest Regional Office WATER COMPLIANCE INSPECTION REPORT	substitute for OMB No. 2040-0057 and EPA form 3560-3 (Rev. 9-94) (last file update 12-95.)
---	---	---

The City of Bremerton (City) owns and operates two wastewater treatment plants (WWTPs) - West Plant and East Plant. The West Plant on Oyster Bay Road provides secondary treatment and disinfection to the wastewater prior to discharging it to Sinclair Inlet. The East Plant on Stephenson Avenue provides advanced primary treatment and disinfection to the combined sewage from East Bremerton, prior to discharging it to Port Washington Narrows.

A regional Class II inspection was conducted at the West Plant on December 5, 2006. A Class I inspection of the East Plant was also conducted at this time. Amy Jankowiak, Mike Dawda, and Greg Stegman, Northwest Regional Office, Water Quality Program (NWRO-WQ) conducted the inspections with assistance from John Bykonen, Operations Supervisor at the plant. Prior notification of the inspection was given to the WWTP staff.

PHOTO ADDENDUM –BREMERTON WWTP, WA002928-9 WEST PLANT

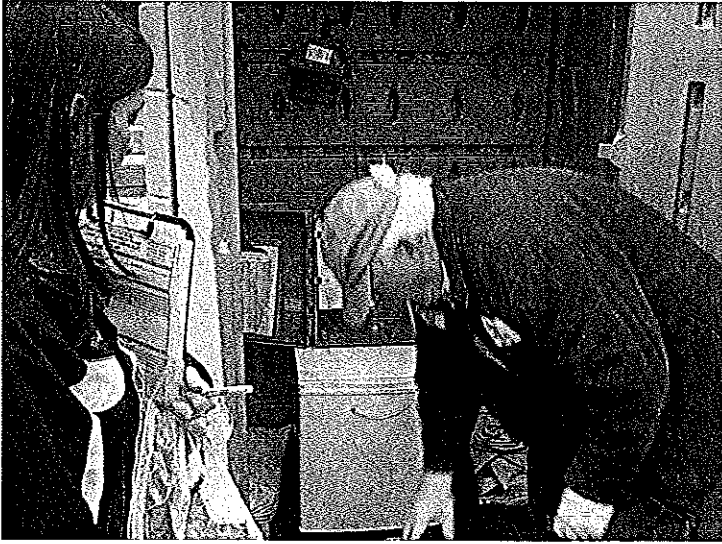
PHOTO #:01 DATE: 12/05/06 TAKEN BY: GREG STEGMAN
FILE No.:PC050001.JPG
DESCRIPTION: PROCESS CONTROL SAMPLER

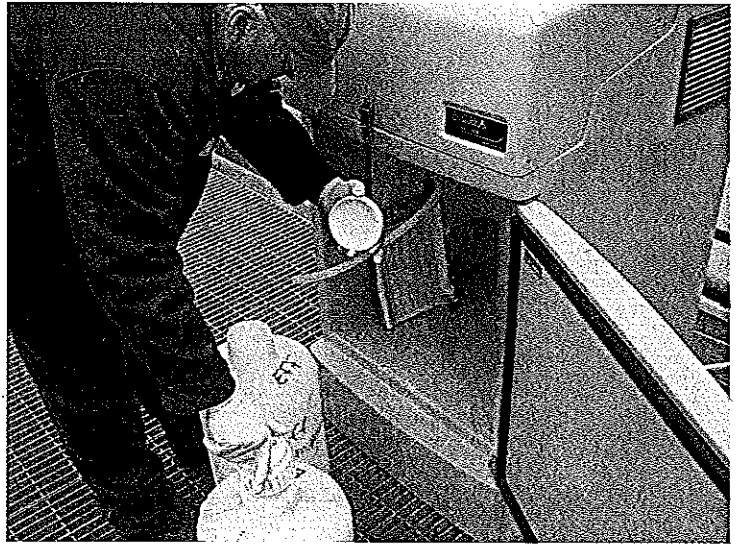
Influent sampling does not include any in-plant recycle flows, with the exception of tank drainings. If this recycle flow is occurring during sampling, it is recorded. Effluent samples are collected at the end of the chlorine contact chamber, after dechlorination. Both samplers collect time proportional refrigerated composite samples. The samplers are cleaned, and the sample collection hoses are replaced or cleaned about once a month. The influent composite sampler (photo #05) thermometer reading was about 2.5° - 3° C at the time of inspection. The thermometer on the composite sampler (photo #01) used to collect process control samples showed temperature of 3.5° C. The effluent composite sampler (photo #02) thermometer reading was 3° C.

PHOTO #:02 DATE: 12/05/06 TAKEN BY: GREG STEGMAN
FILE No.:PC050002.JPG
DESCRIPTION: EFFLUENT SAMPLER (SPLITTING SAMPLES)

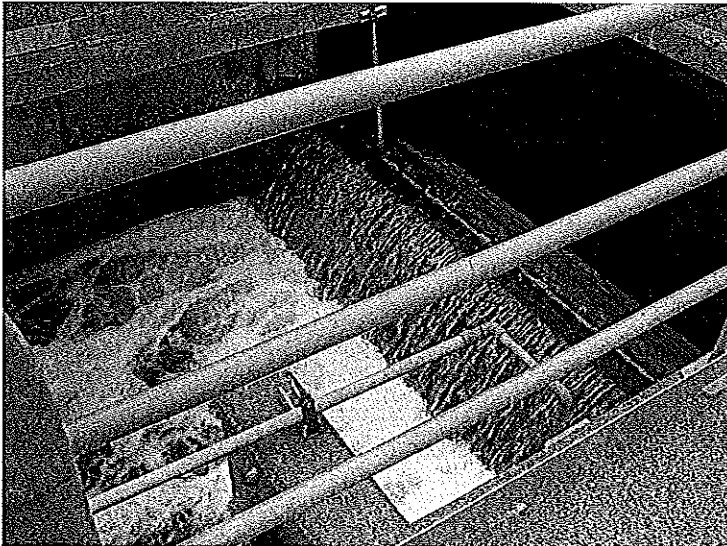
Secondary treated and disinfected effluent (photo #03) from the plant is discharged 568 feet offshore into Sinclair Inlet, Puget Sound, at a location west of PSNS, via a 36-inch diameter outfall equipped with a diffuser.

PHOTO #:03 DATE: 12/05/06 TAKEN BY: GREG STEGMAN
FILE No.:PC050003.JPG
DESCRIPTION: EFFLUENT (END OF CHLORINE CONTACT CHAMBER)

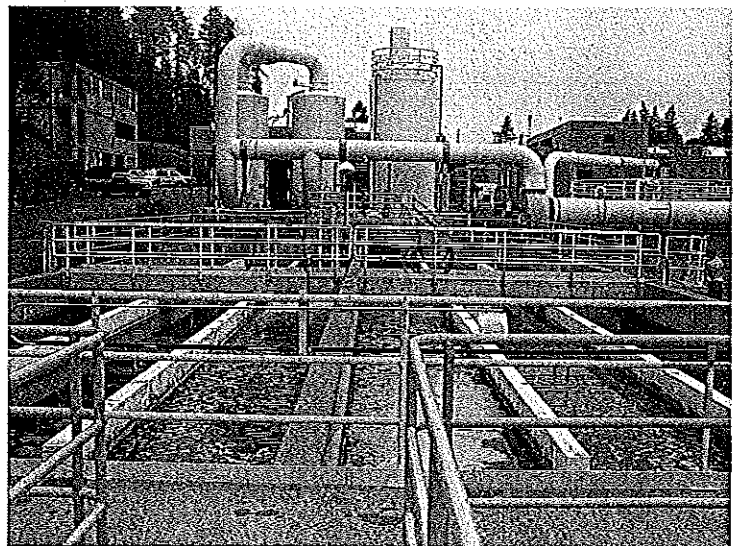
PHOTO #:04 DATE: 12/05/06 TAKEN BY: GREG STEGMAN
FILE No.:PC050004.JPG
DESCRIPTION: CHLORINE CONTACT CHAMBERS

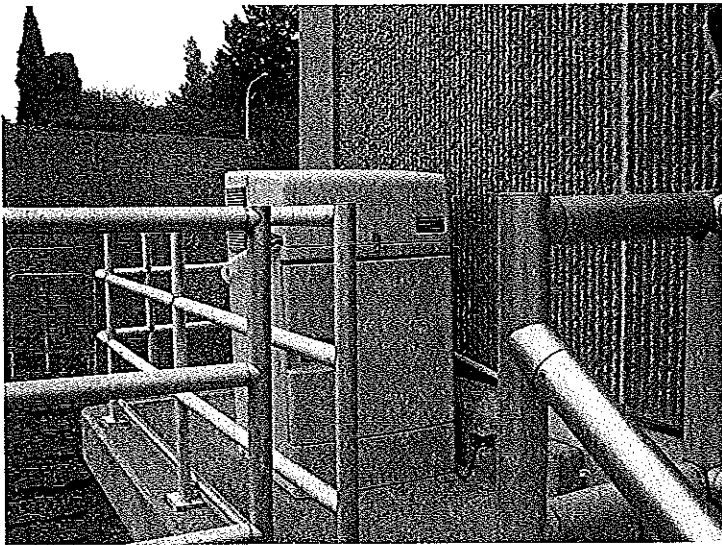
PHOTO #:05 DATE: 12/05/06 TAKEN BY: GREG STEGMAN
FILE No.:PC050005.JPG
DESCRIPTION: INFLUENT SAMPLER

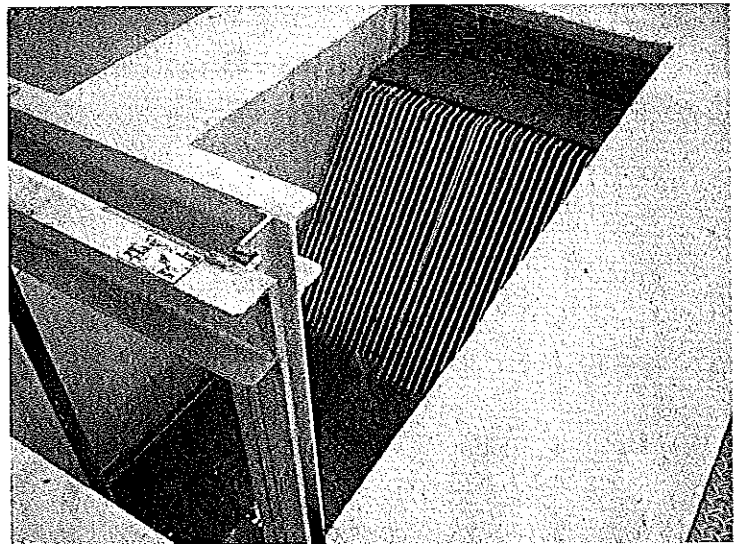
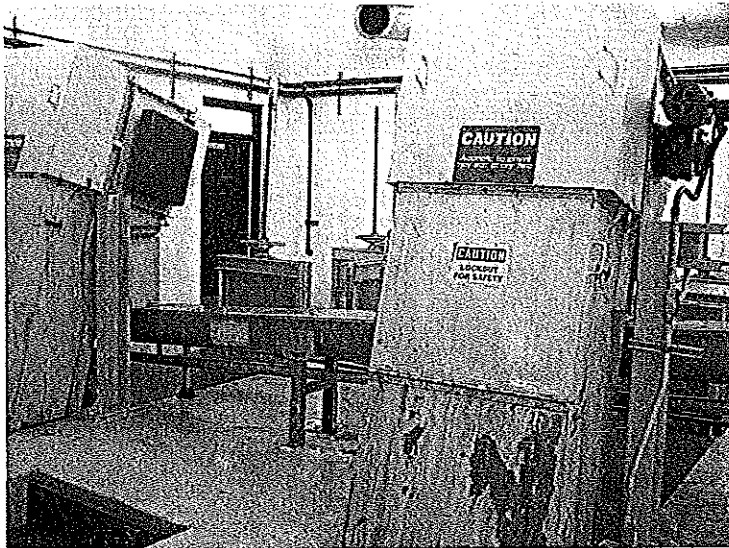
The incoming wastewater first flows to headworks consisting of two mechanical bar screens (photos #06 and #07) and one manual bar screen, followed by two aerated grit chambers (photo #09). The wastewater then flows to the primary clarifiers (photo #11) for settling of heavier solids. The plant flow is measured at the influent end of the primary clarifiers (photo #10).

PHOTO #:06 DATE: 12/05/06 TAKEN BY: GREG STEGMAN
FILE No.:PC050006.JPG
DESCRIPTION: CENTER BAR SCREEN

PHOTO #:07 DATE: 12/05/06 TAKEN BY: GREG STEGMAN
FILE No.:PC050007.JPG
DESCRIPTION: BAR SCREENS

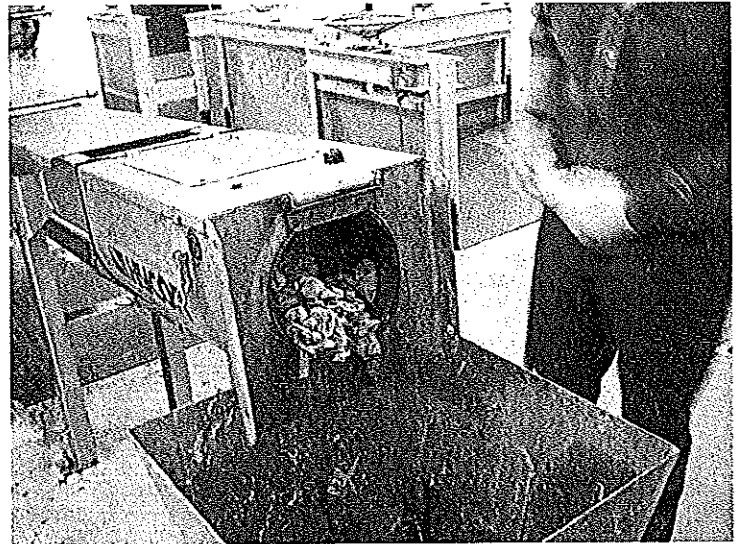
The City's grease ordinance is enforced by a full time city staff. The City's collections system staff conducts periodic vacuuming of sewer lines (as preventative maintenance) and also responds to alarms for emergencies, such as, high wet wells and overflows at pump stations. One of the concerns at the plant is the presence of rubber gloves, debris and rags in the collection system. The plant staff believes the gloves are coming from a local hospital. During the inspection, a large number of rubber gloves were observed in the influent screens (photo #08).

The screenings from the influent screens are collected in a dumpster by an auger (photo #08). Settled grit from the aerated grit chambers is also collected in the dumpster. Screenings and grit are disposed of at the Olympic View Sanitary Landfill.

PHOTO #:08 DATE: 12/05/06 TAKEN BY: GREG STEGMAN
FILE No.:PC050008.JPG
DESCRIPTION: BAR SCREEN SOLIDS (NUMEROUS GLOVES)

The comprehensive grease program is a great way to prevent problems within the collection system pipes, pump stations and at the treatment plant. It is recommended that the collection system staff work with entities responsible for flushing of gloves into the collection system, to prevent gloves from entering the system.

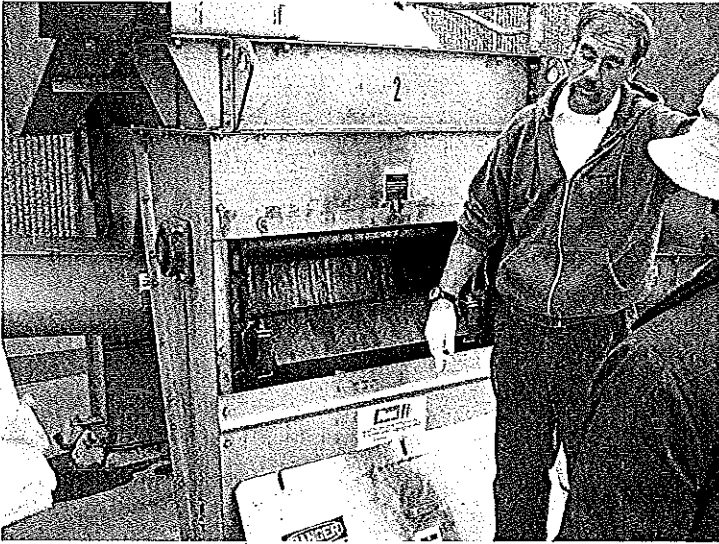
PHOTO #:09 DATE: 12/05/06 TAKEN BY: GREG STEGMAN
FILE No.:PC050011.JPG
DESCRIPTION: GRIT REMOVAL

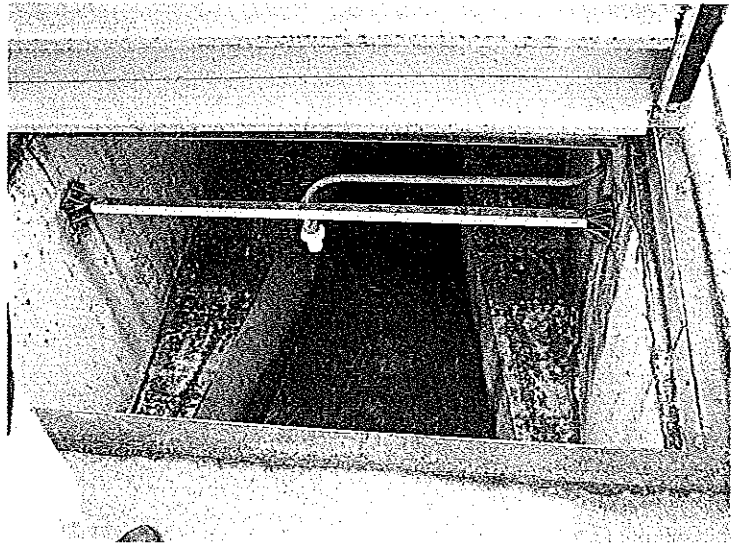
PHOTO #:10 DATE: 12/05/06 TAKEN BY: GREG STEGMAN
FILE NO.:PC050015.JPG
DESCRIPTION: PRIMARY FLOW METER/FLUME

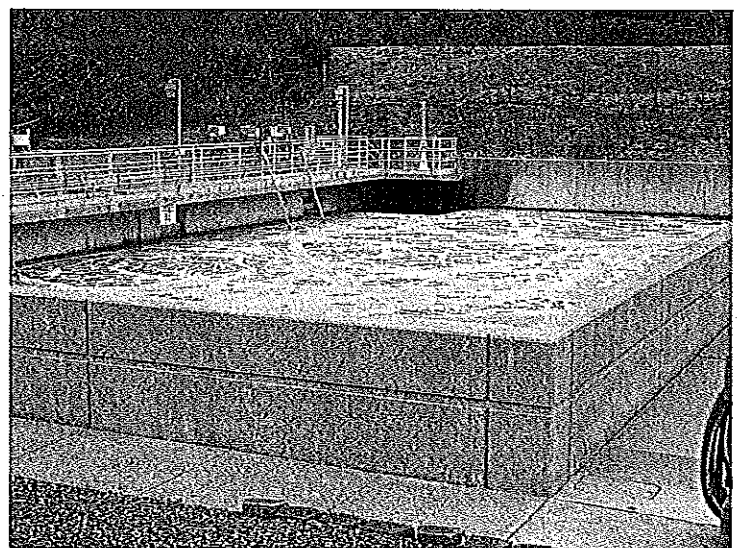
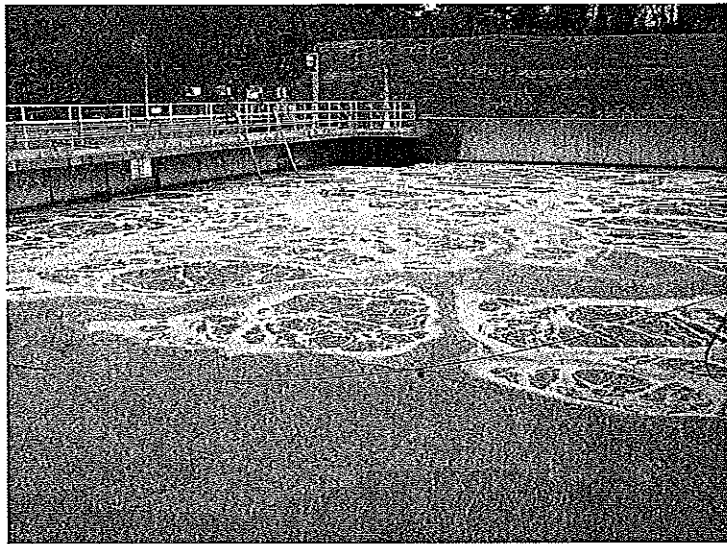
Primary clarifier effluent then flows to the aeration basins. The aeration basins (photos #12 and #13) are equipped with fine bubble diffusers. The selectors at the head end of the aeration basins help control filamentous bacteria in the mixed liquor. The diffusers in the aeration basins are cleaned about once every three months. The sludge age is currently maintained at approximately four days.

PHOTO #:12 DATE: 12/05/06 TAKEN BY: GREG STEGMAN
FILE No.:PC050019.JPG
DESCRIPTION: AERATION BASIN

PHOTO #:13 DATE: 12/05/06 TAKEN BY: GREG STEGMAN
FILE No.:PC050021.JPG
DESCRIPTION: AERATION BASIN

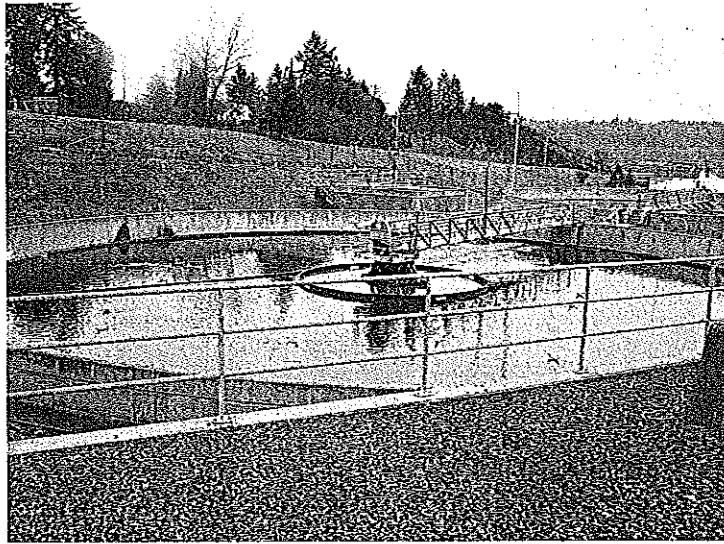
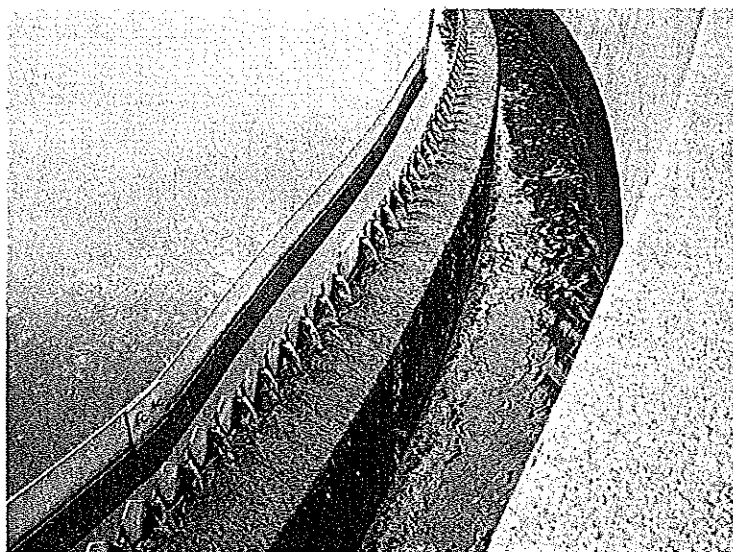
From the aeration basins, the wastewater flows to the secondary clarifiers (photos #14 and #15) for settling of biological solids (activated sludge). The secondary clarifier effluent flows to the chlorine contact chambers (photo #04) for disinfection with sodium hypochlorite. Dechlorination of the wastewater at the end of the chlorine contact chambers is accomplished with sodium bisulfite. The chlorine contact chambers are cleaned about once every three months. Effluent samples are collected at the end of the chlorine contact chamber, after dechlorination.

PHOTO #:14 DATE: 12/05/06 TAKEN BY: GREG STEGMAN
FILE No.:PC050020.JPG
DESCRIPTION: ONE OF THE SECONDARY CLARIFIERS

PHOTO #:15 DATE: 12/05/06 TAKEN BY: GREG STEGMAN
FILE No.:PC050022.JPG
DESCRIPTION: CLOSE UP OF ONE OF THE SECONDARY CLARIFIERS

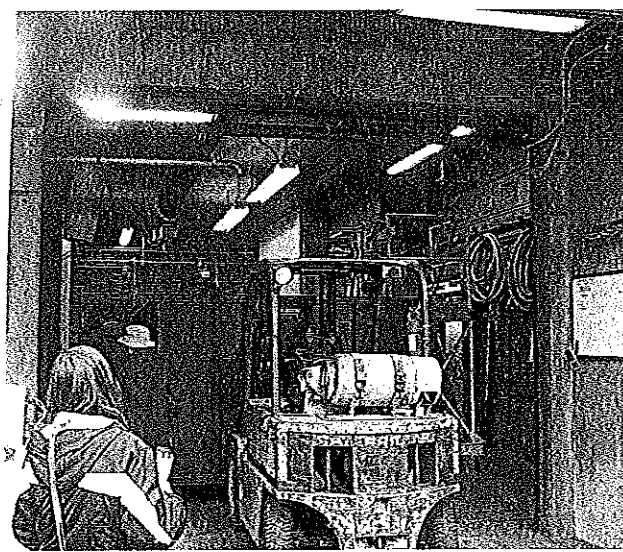
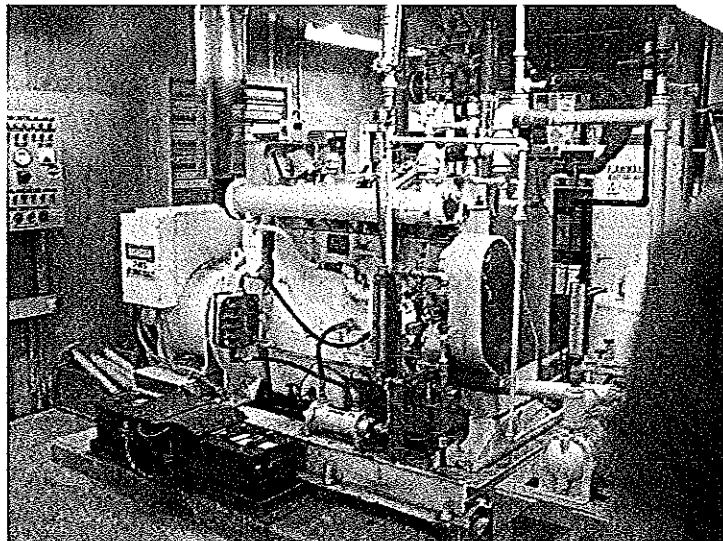
The solids treatment and stabilization system (photos #16 and #18) consists of a dissolved air flotation thickener (DAFT), two anaerobic digesters, and a centrifuge. The primary sludge (solids settled in the primary clarifiers) is pumped to the anaerobic digesters. The secondary sludge (waste activated sludge from the secondary clarifiers) is thickened in the DAFT prior to anaerobic digestion. Digested sludge is dewatered in the centrifuge. The dewatered sludge (biosolids) (photo #17) with approximately 18% solids content is spread on permitted forest land owned by the City. The separated wastewater (from DAFT, digesters and centrifuge) is returned to the headworks for treatment.

PHOTO #:16 DATE: 12/05/06 TAKEN BY: GREG STEGMAN
FILE No.:PC050023.JPG
DESCRIPTION: SOLIDS HANDLING BUILDING

PHOTO #:18 DATE: 12/05/06 TAKEN BY: GREG STEGMAN
FILE No.:PC050028.JPG
DESCRIPTION: SOLIDS HANDLING

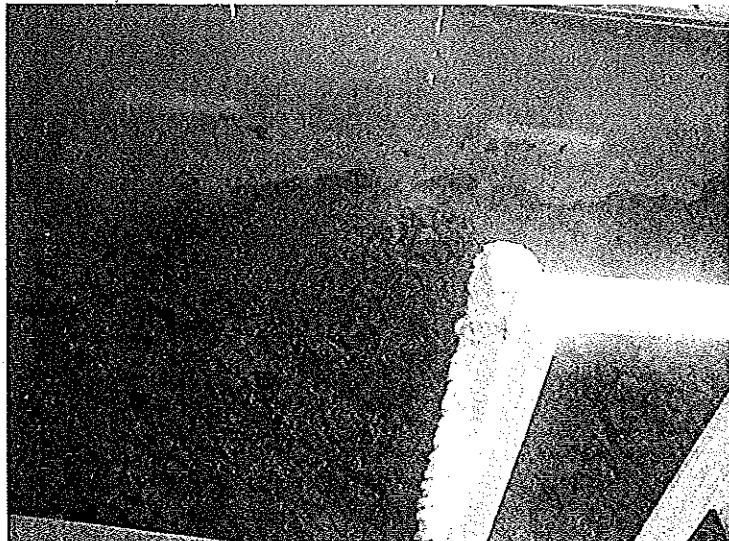
PHOTO #:17 DATE: 12/05/06 TAKEN BY: GREG STEGMAN
FILE No.:PC050026.JPG
DESCRIPTION: BIOSOLIDS INSIDE OF TRUCK

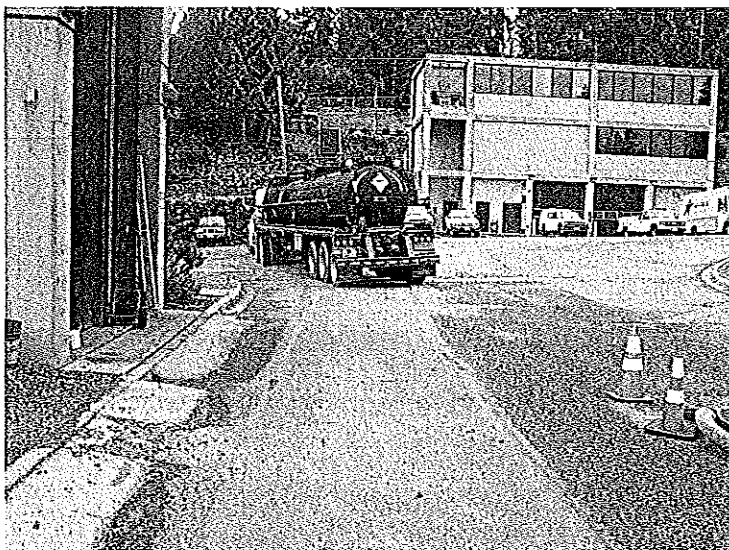
PHOTO #:19 DATE: 12/05/06 TAKEN BY: GREG STEGMAN
FILE No.:PC050029.JPG
DESCRIPTION: LEACHATE DELIVERY

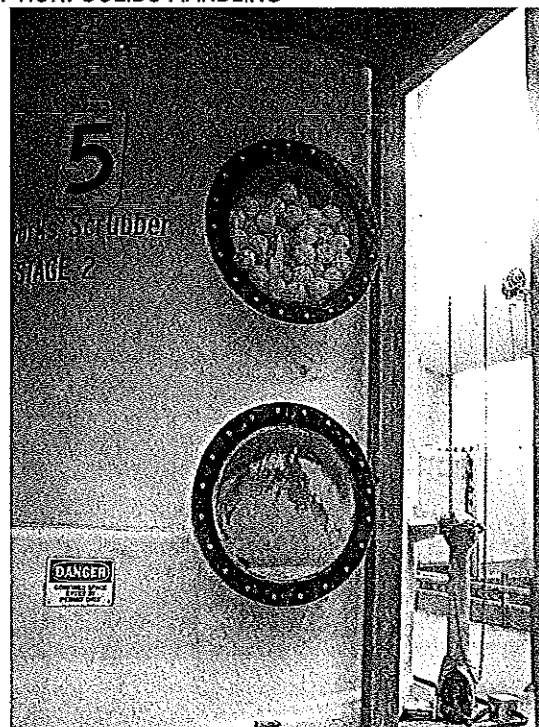
An odor control system (photo #20) consisting of three packed tower chemical odor scrubbers is used at the plant to process odorous air generated from various treatment units - headworks, primary clarifiers, gravity thickener, DAFT, digester complex, centrifuge area, aeration basin headworks, return activated sludge (RAS) wet well, and primary and secondary scum boxes.

PHOTO #:20 DATE: 12/05/06 TAKEN BY: GREG STEGMAN
FILE No.:PC050030.JPG
DESCRIPTION: ODOR CONTROL SCRUBBER/MEDIA

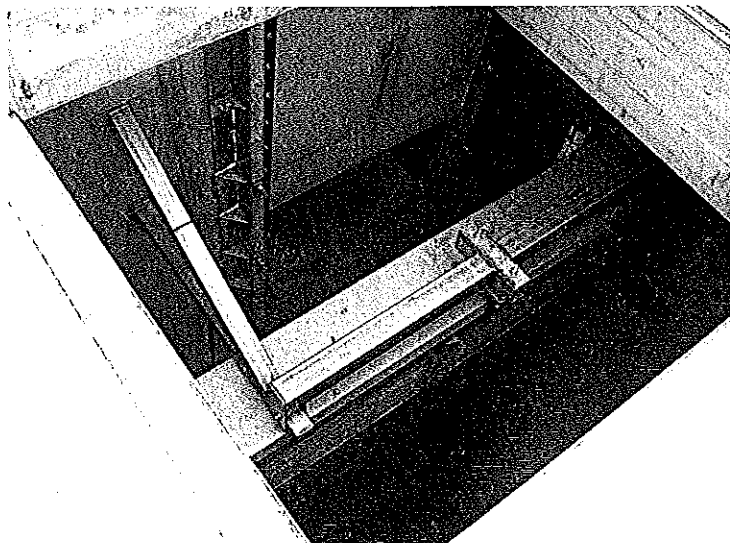
The attached photographs of the East Plant show the bar screen (photo #21) inside the storage tank, Parshall flume (photo #23) for flow measurement, coagulant injection point (photo #24), polymer injection area (photo #25), the sedimentation tank (photo #27) of the HRC system, and UV disinfection system (photo #26).

PHOTO #:21 DATE: 12/05/06 TAKEN BY: GREG STEGMAN
 FILE No.:PC050032.JPG
 DESCRIPTION: SCREEN INSIDE HOLDING TANK

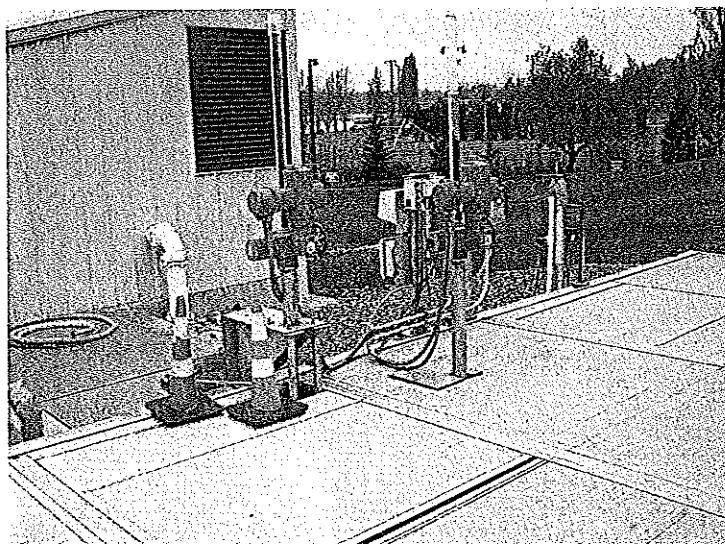
The East Plant starts automatically when the in-line storage capacity has been exhausted and the 100,000 gallon capacity storage tank (photo #22) is nearing full. If the capacity in the inverted siphons (across Port Washington Narrows) starts to free up before the in-line storage capacity is exhausted and the storage tank becomes full, the combined sewage drains back to the siphons and to the West Plant without the East Plant operating.

PHOTO #:22 DATE: 12/05/06 TAKEN BY: GREG STEGMAN
 FILE No.:PC050034.JPG
 DESCRIPTION: TOP OF HOLDING TANK

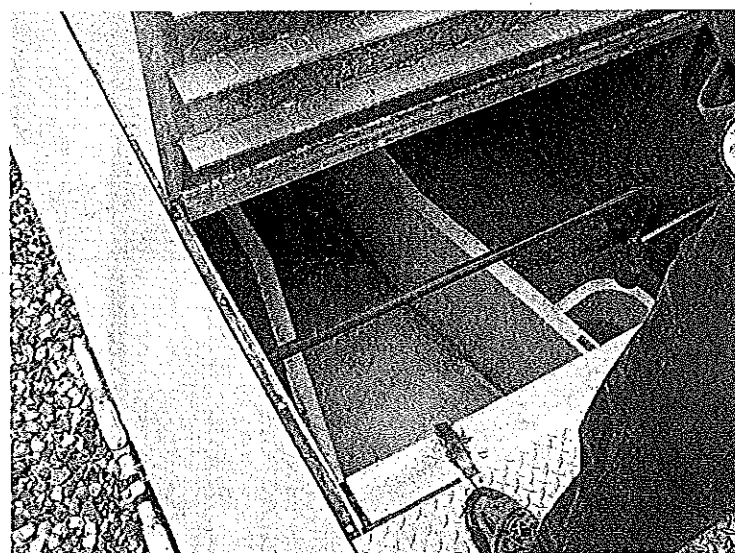
Flow is measured by a Parshall flume equipped with an ultrasonic meter.

PHOTO #:23 DATE: 12/05/06 TAKEN BY: GREG STEGMAN
 FILE No.:PC050036.JPG
 DESCRIPTION: PARSHALL FLUME/ENTRY TO PLANT FROM HOLDING TANK/SCREEN

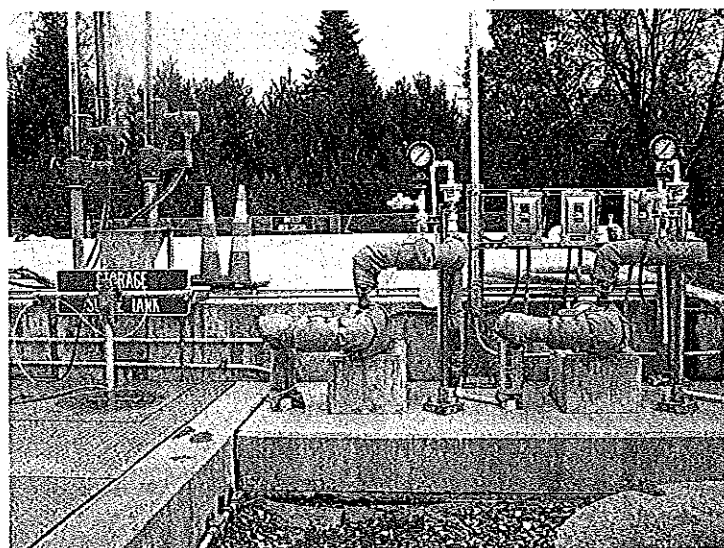
PHOTO #:24 DATE: 12/05/06 TAKEN BY: GREG STEGMAN
 FILE No.:PC050038.JPG
 DESCRIPTION: VIEW BACK AT HOLDING TANK/COAGULANT INJECTION

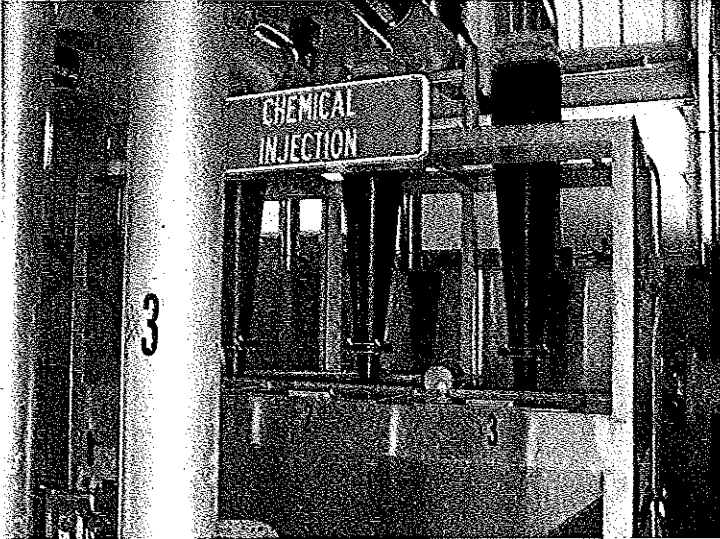
PHOTO #:25 DATE: 12/05/06 TAKEN BY: GREG STEGMAN
FILE No.:PC050040.JPG
DESCRIPTION: POLYMER INJECTION

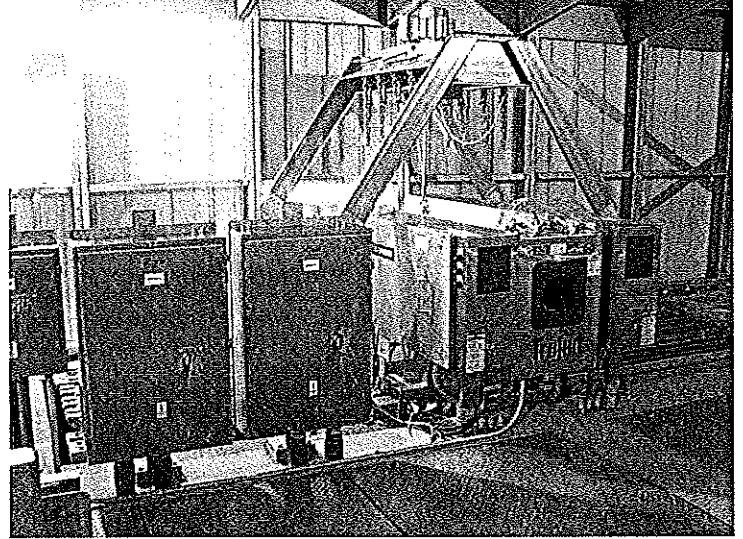
PHOTO #:26 DATE: 12/05/06 TAKEN BY: GREG STEGMAN
FILE No.:PC050042.JPG
DESCRIPTION: UV DISINFECTION SYSTEM

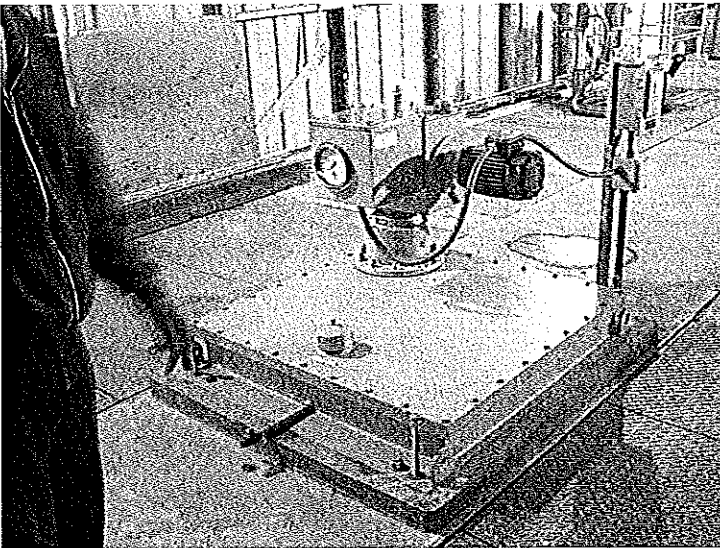
PHOTO #:27 DATE: 12/05/06 TAKEN BY: GREG STEGMAN
FILE No.:PC050043.JPG
DESCRIPTION: SAND/SEDIMENT TANK

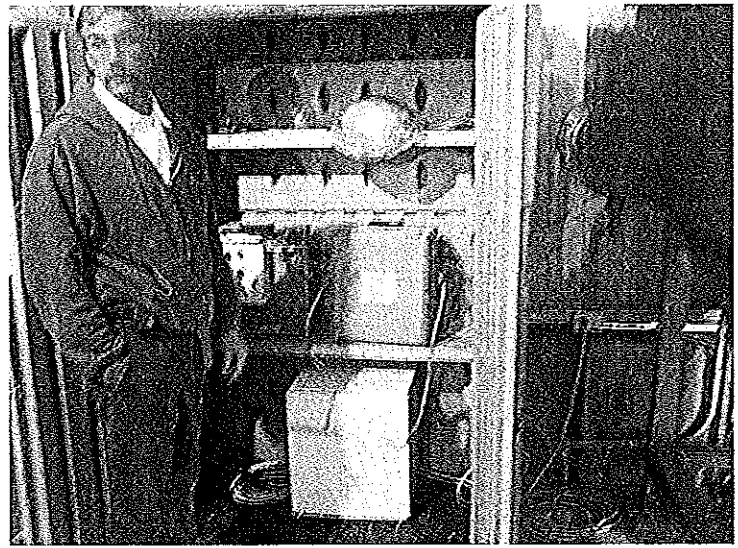
The influent samples are collected at the head end of the plant and the effluent samples are collected after UV disinfection (photo #28).

PHOTO #:28 DATE: 12/05/06 TAKEN BY: GREG STEGMAN
FILE No.:PC050044.JPG
DESCRIPTION: SAMPLERS (MR. BYKONEN)

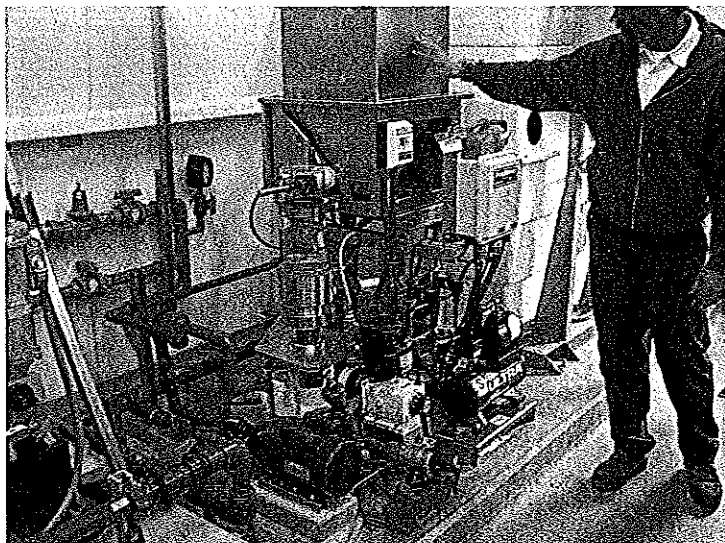
PHOTO #:29 DATE: 12/05/06 TAKEN BY: GREG STEGMAN
 FILE No.:PC050046.JPG
 DESCRIPTION: CHEMICAL STORAGE ROOM

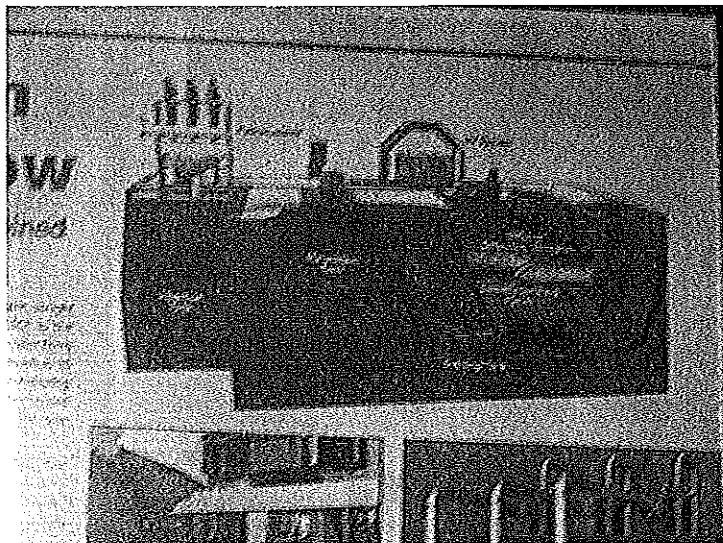
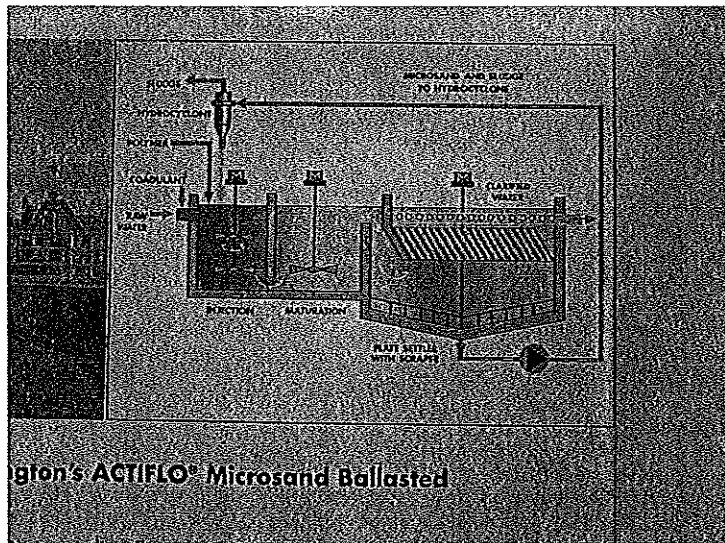
PHOTO #:30 DATE: 12/05/06 TAKEN BY: GREG STEGMAN
 FILE No.:PC050049.JPG
 DESCRIPTION: SCHEMATIC OF EAST PLANT

PHOTO #:31 DATE: 12/05/06 TAKEN BY: GREG STEGMAN
 FILE No.:PC050052.JPG
 DESCRIPTION: SCHEMATIC OF EAST PLANT
