State of Washington Department of Ecology
Northwest Regional Office
WATER COMPLIANCE INSPECTION REPORT

Name and Location of Facility Inspected (For industrial users discharging to POTW, also include POTW name and NPDES permit number) Hughes Farms 1325 Farm to Market Road Mount Vernon, WA 98273	Entry Time/Date 1 pm 12/06/10	Permit Effective Date
	Exit Time / Date 1:45 pm 12/06/10	Permit Expiration Date

This was an announced inspection. Cheryl Thompson and I arrived on site at approximately 1:00 pm. We met with Dave Hughes, owner of the plant. The facility submitted a state waste discharge permit application and supplement to Ecology in 2009. The application package has not yet been completed, and I am still waiting for application Form 2D to be submitted for stormwater discharge. Since the last inspection on February 4, 2009, the facility has routed part of their wastewater from the settling pond to a nearby agricultural application site. Mr. Hughes accompanied us on a walk-through inspection of the plant. The following details our discussion and my findings during the inspection.

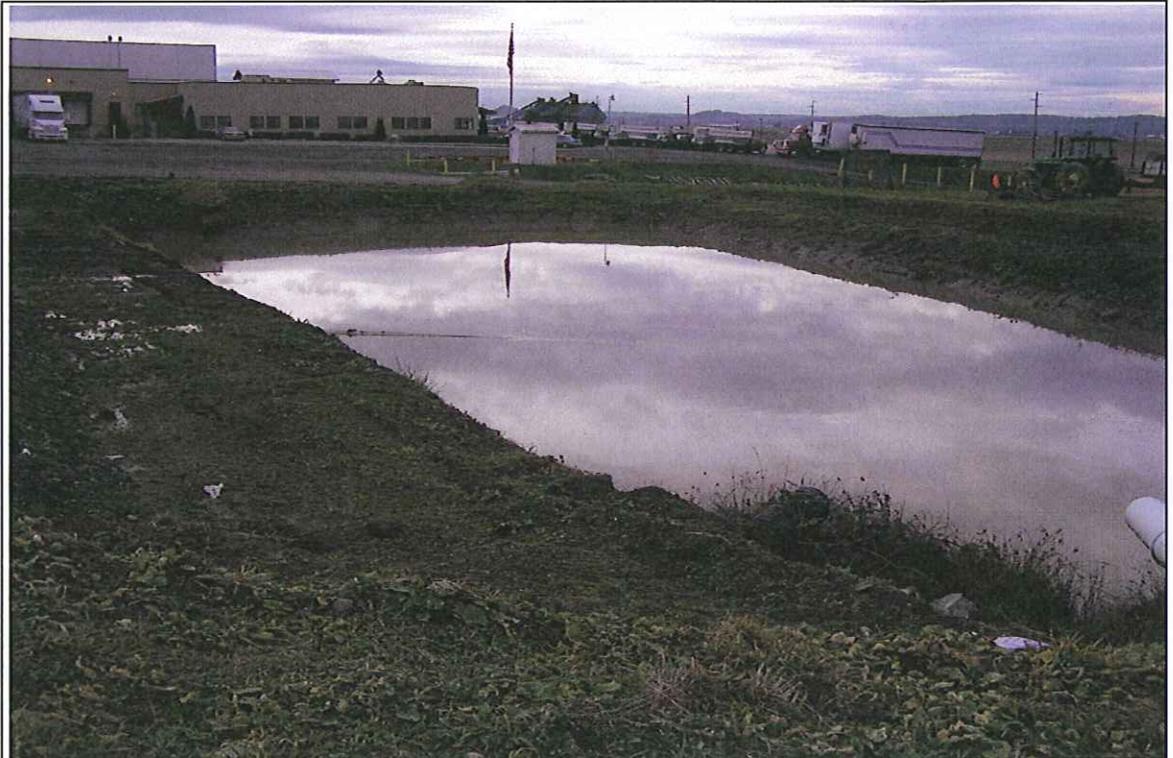
PHOTO NO. 1

DESCRIPTION:
The facility
discharges potato
washwater to the
settling pond,
located northwest
of the facility. This
pond is shared with the neighboring facility, Sulex.

We did not observe any water quality violations during our inspection. However, Ecology is concerned that the settling pond is being made larger and larger each year. Dave Hughes indicated that he will inform his staff not to dredge the pond too much when they are cleaning out the sludge build-up in the pond.

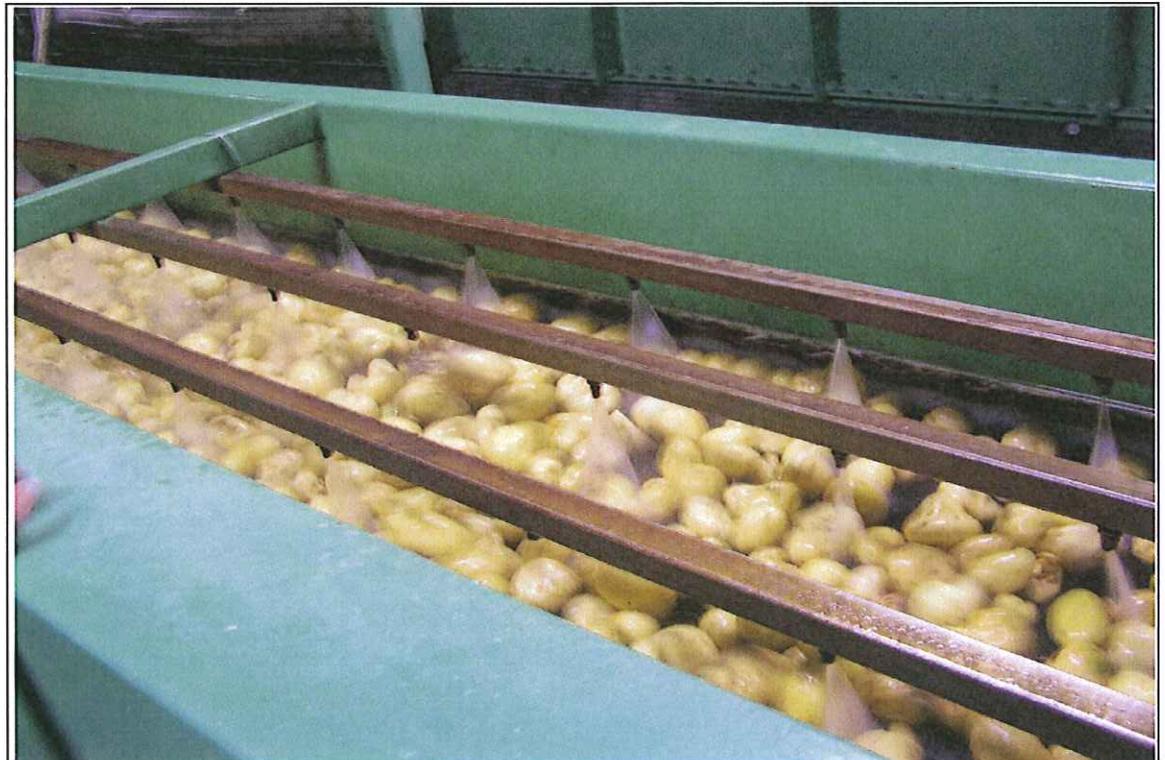
PHOTO NO. 2

DESCRIPTION:
Potatoes are being
routed through the
wash table for
washing.

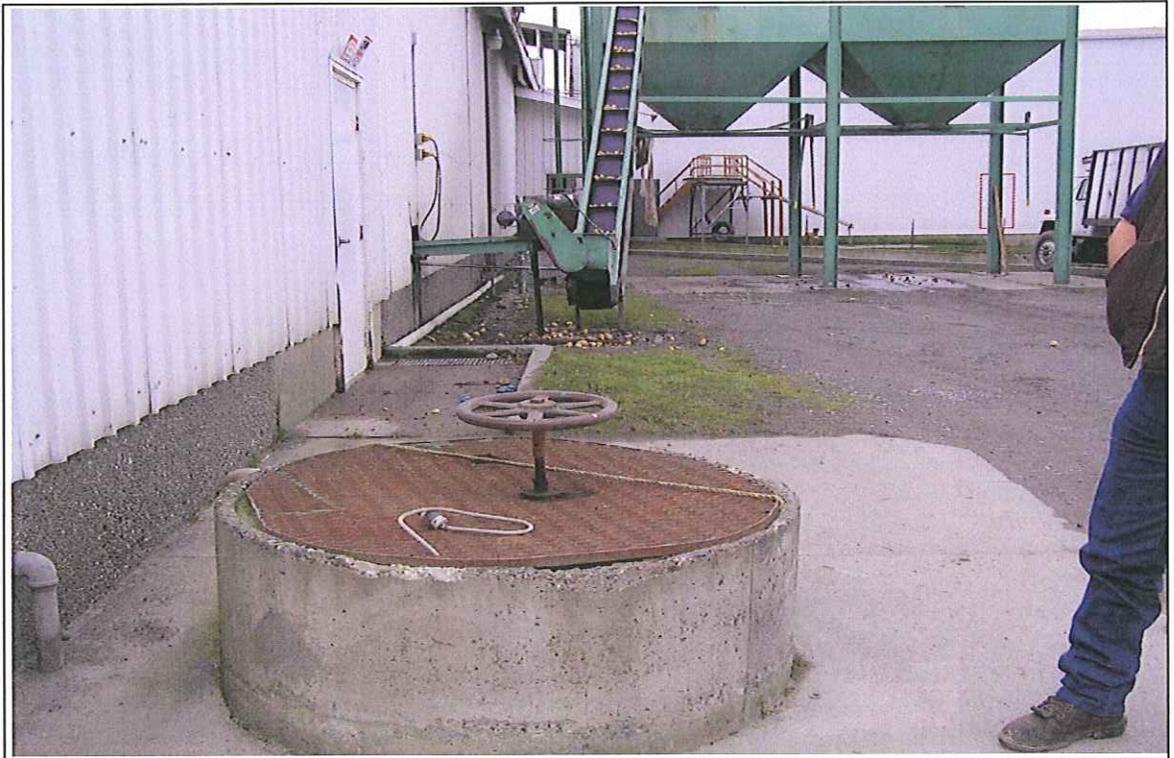
PHOTO NO. 3

DESCRIPTION:
All process wash
water and
stormwater are
collected in this
wastewater
collection vault.

The water in the vault can be manually controlled to be released to the settling pond. However, the valve is typically left open unless the pond is full.

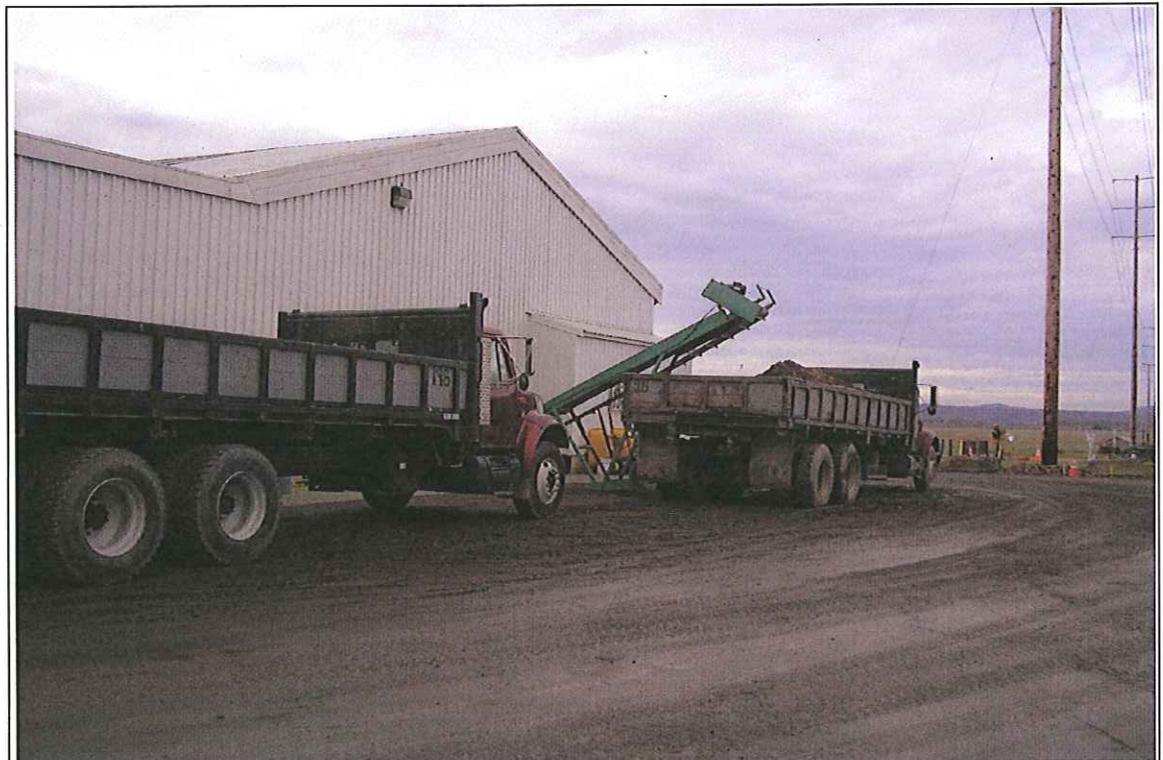
PHOTO NO. 4

DESCRIPTION: A
view of the
removed mud/soil
from the potatoes
being moved by
means of a

conveyor belt to the truck. The soil is to be trucked back to the field.

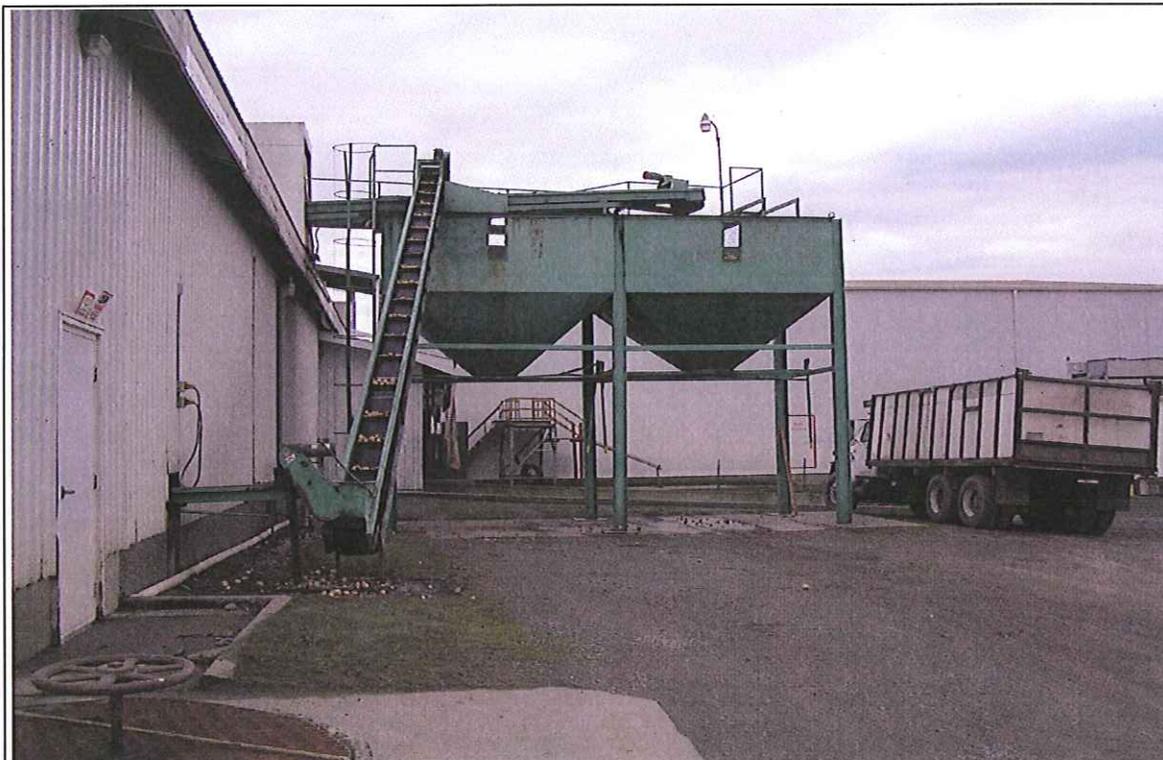
PHOTO NO. 5

DESCRIPTION:
The off-spec
potatoes are being
taken by elevator
up into the hopper,
where they are
ground up and
trucked out for livestock feed.

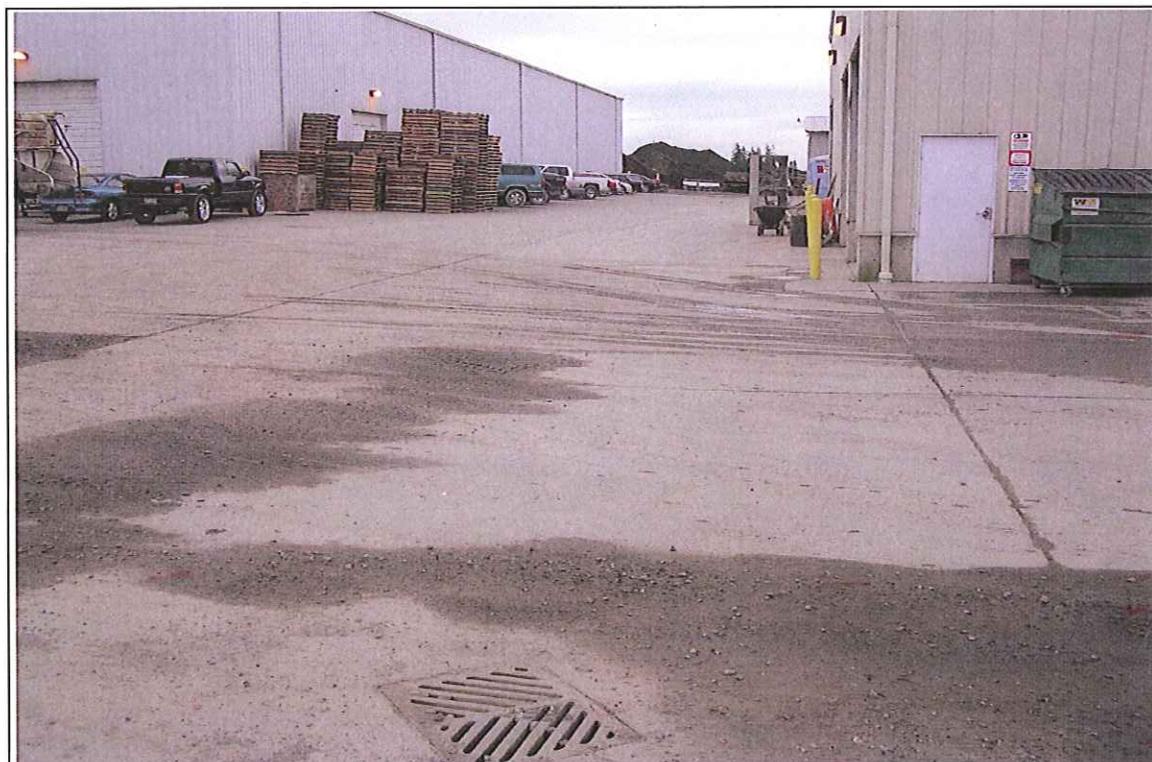
PHOTO NO. 6

3) Stormwater from the site is drained to the collection system which ultimately drains to the settling pond. The area around the buildings is paved, but the access road to the plant is not paved (See photo 6 and 7). Those unpaved areas

appeared to be muddy from truck traffic. There are underground graded catch basins throughout the site. We did not observe a filter in these catch basins.

DESCRIPTION:
Stormwater runoff
from the paved area
is drained to the
underground catch
basin, which drains
to the settling pond.

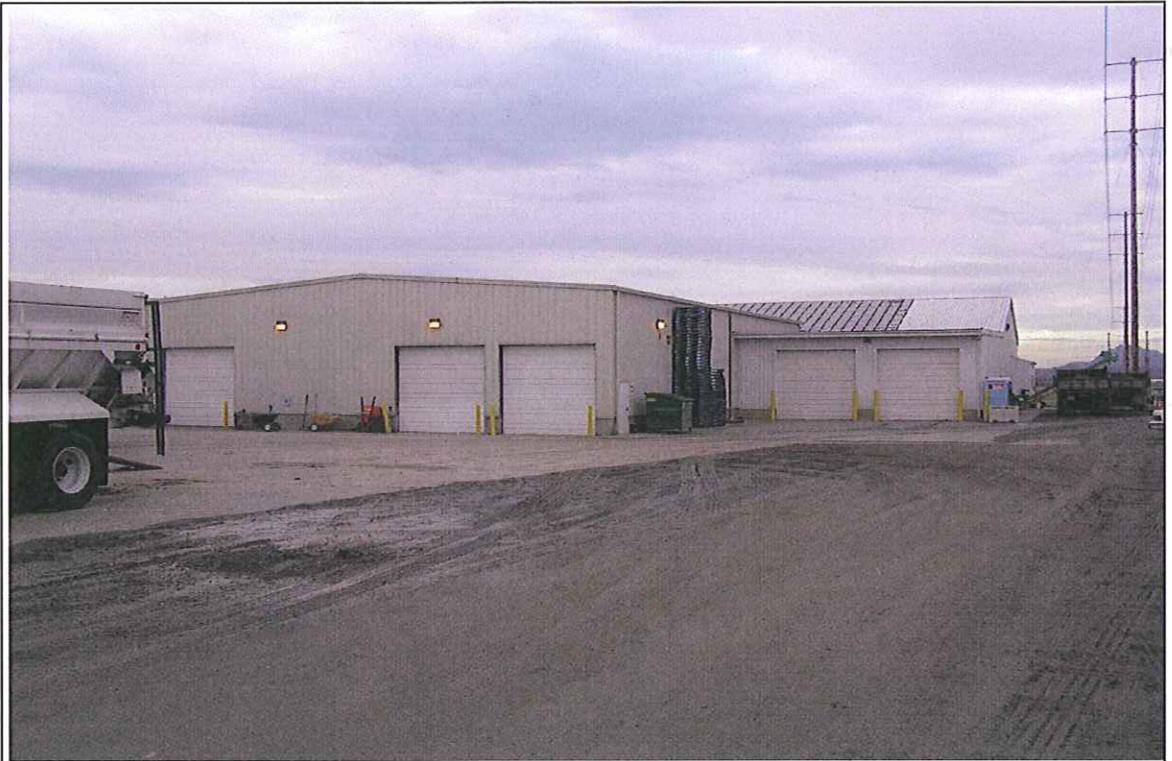
PHOTO NO. 7

DESCRIPTION:
The access road to the plant is not paved. Stormwater runoff either infiltrates to the ground or drains to the nearest catch basin, which drains to the settling pond.

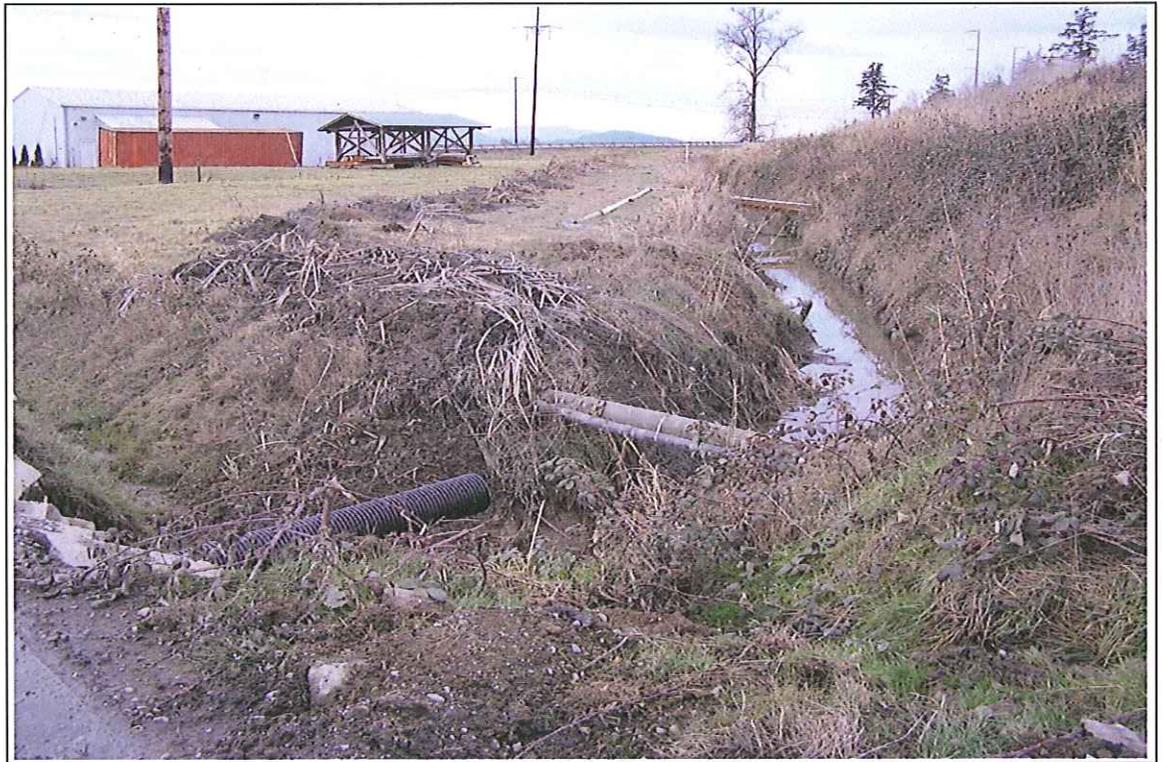
PHOTO NO. 8

1) We briefly inspected the wash room where we observed potatoes were being moved through the spray washers for cleaning. Washwater is reused three times before it is discharged to the settling pond. Floor washing is conducted at the end of the day. Wastewater including stormwater is collected in an underground collection vault and drained to the settling pond. The vault has a manual control valve (see photo 3). Mr. Hughes informed us that the valve is usually kept in the open position, and it would only be closed if the settling pond is really full. The facility was not discharging at the time of the inspection. Mr. Hughes informed us that since our last visit in February 2009, they have installed a 4-inch underground pipe to route the water from the settling pond to the land application site. This pipe can be viewed crossing over Little Indian slough to the field (see photo 8).

DESCRIPTION: A view of Little Indian Slough. The 8-inch white pipe gravity drains water from the settling pond to the land application site.
