Livestock and Water Quality Site Visit

Site Information	
County: Whatcom	Watershed: Squaw Creek, tributary of Johnson Creek which flows into the Sumas River
<p>General site description (include information about nearby waterbodies and description of farm conditions): In response to a citizens water pollution complaint (ERTS # 634355) water quality inspectors Jessica Kirkpatrick and Chris Luerkens and I conducted a complainece inspection of Mr. Tom Crabtree's property to evaluate complainece with Washington State's Water Pollution Control Law (RCW 90.48). Mr. Crabtree's property is approximately a 10 acre parcel that is bisected from northwest to southeast by Squaw Creek. When we arrived to investigate this livestock/manure-related complaint, we observed Mr. Crabtree on his excavator clearing and grubbing in a wetland associated with Squaw Creek with no Best Management Practices (BMPs) installed to protect water quality. Mr. Crabtree had also excavated a low-lying area on the northeast portion of the property in an attempt to create a decoratve pond on the property. There was engine oil on the ground from a recent spill as well.</p> <p>We contacted Mr. Crabtree and properly identif

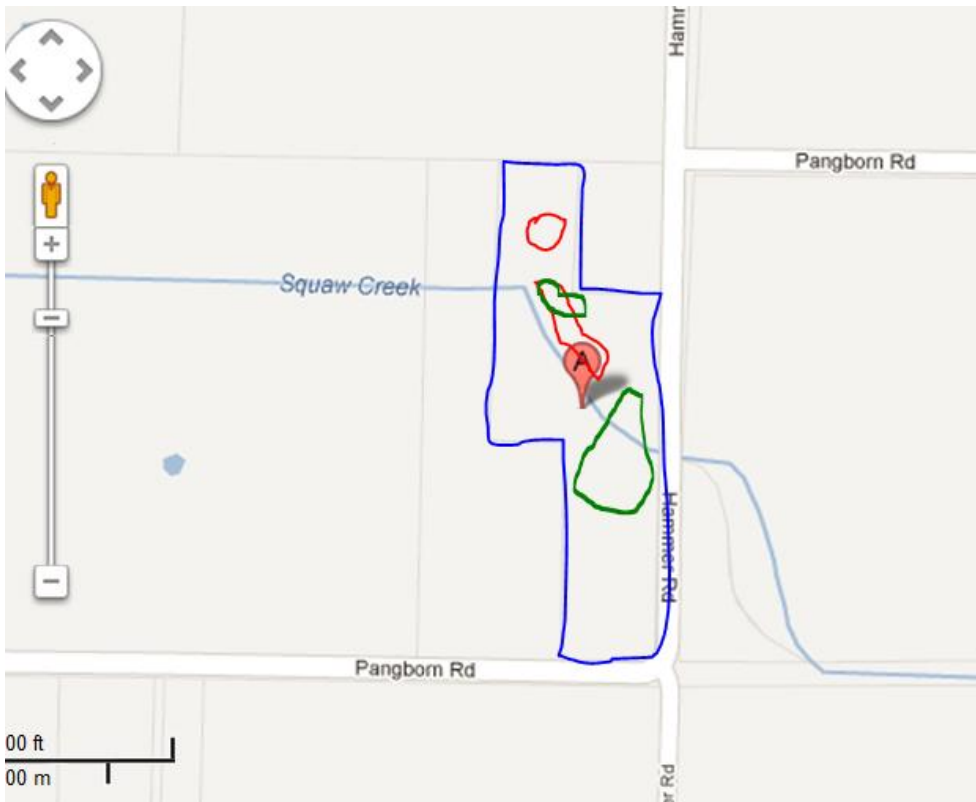
Photo 1: Google map showing Tom Crabtree's property at 9331 Hammer Road in relation to Squaw Creek. The blue line shows approximate property boundaries. Red line shows approximate area that has been excavated. Green lines show area of manure contaminated soils.

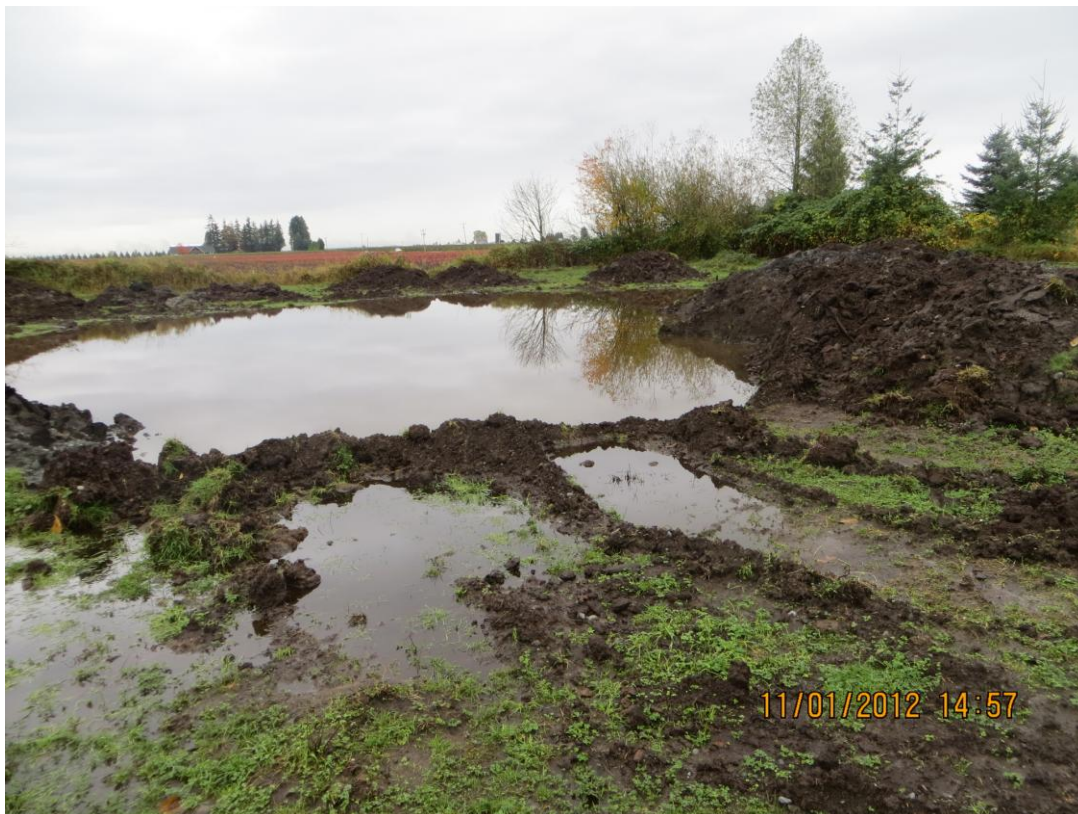
Photo 2: Low lying area east side of Squaw Creek at the north portion of Mr. Crabtree's property that he had excavated further in an attempt to create a decorative pond on the property. Constitutes violation of RCW 90.48. Mr. Crabtree has agreed to halt excavation until a wetland delineation is completed and he has the proper permits from Whatcom County Planning and Development Services.

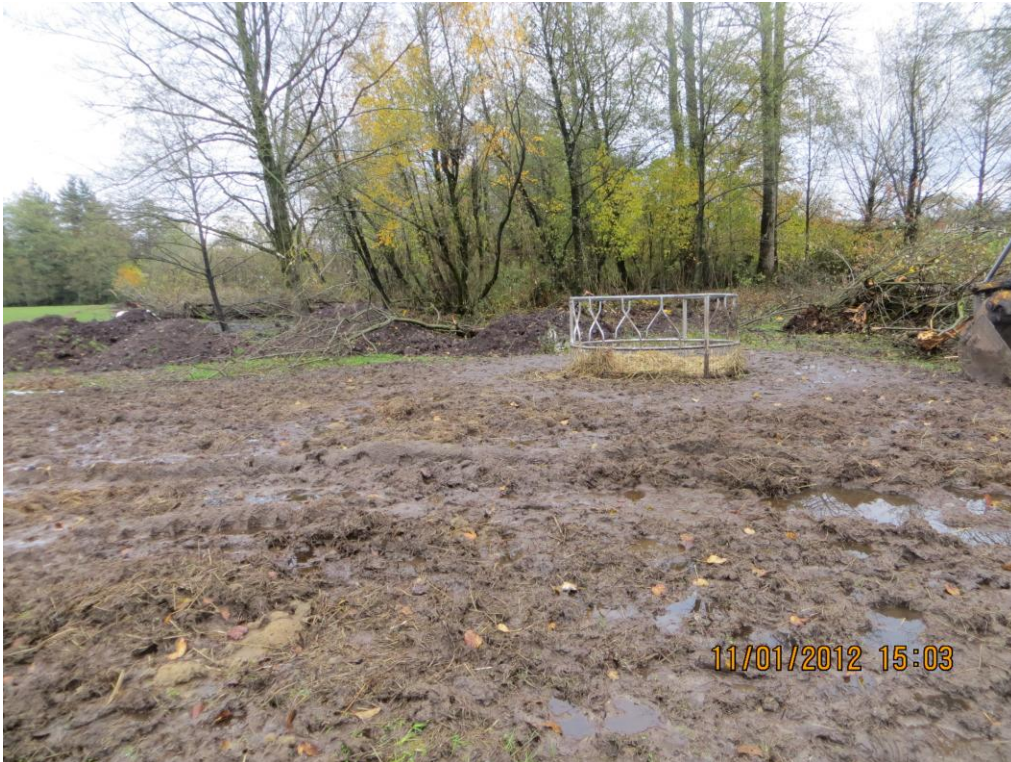
Photo 3: Manure contaminated muddy area directly adjacent to excavated area in wetland soils on east side of Squaw Creek on Tom Crabtree's property. Constitutes violation of RCW 90.48. Mr. Crabtree has agreed to excavate these manure-contaminated soils and store them on an upland area on the west side of Squaw Creek on his property.

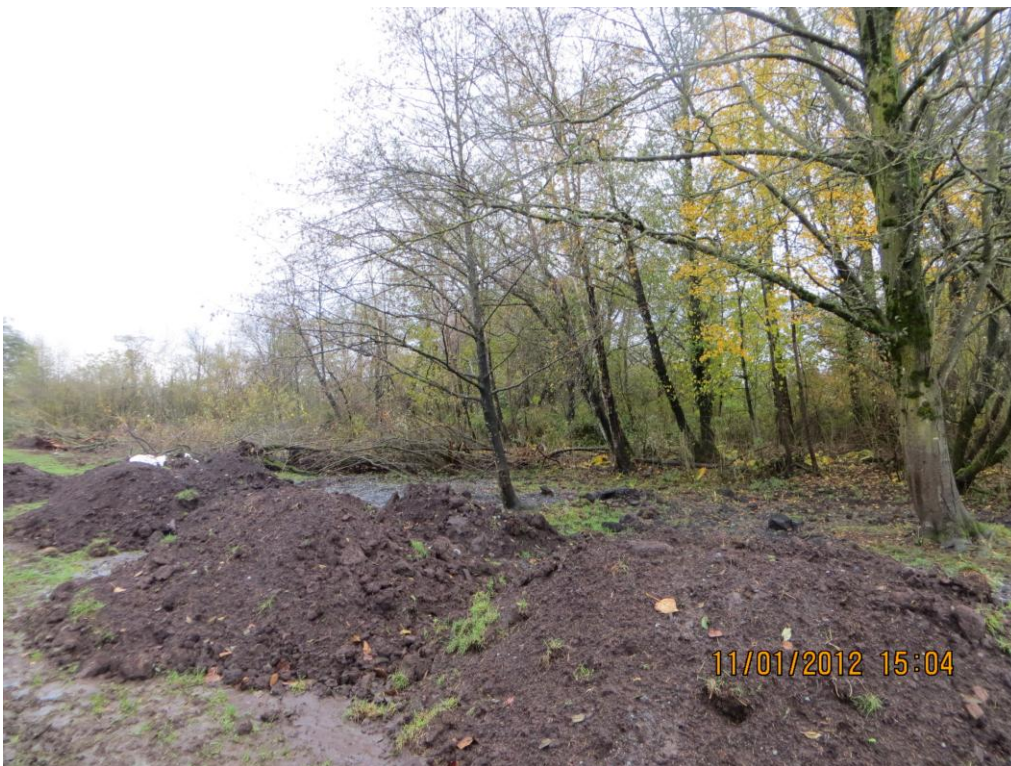
Photo 4: Piles of excavated soils placed in wetlands on east side of Squaw Creek. Constitutes violation of RCW 90.48. Mr. Crabtree has agreed to halt all excavation work and install a silt fence between these soil piles and the wetlands to reduce the risk of sediment entering the wetlands and Squaw Creek.

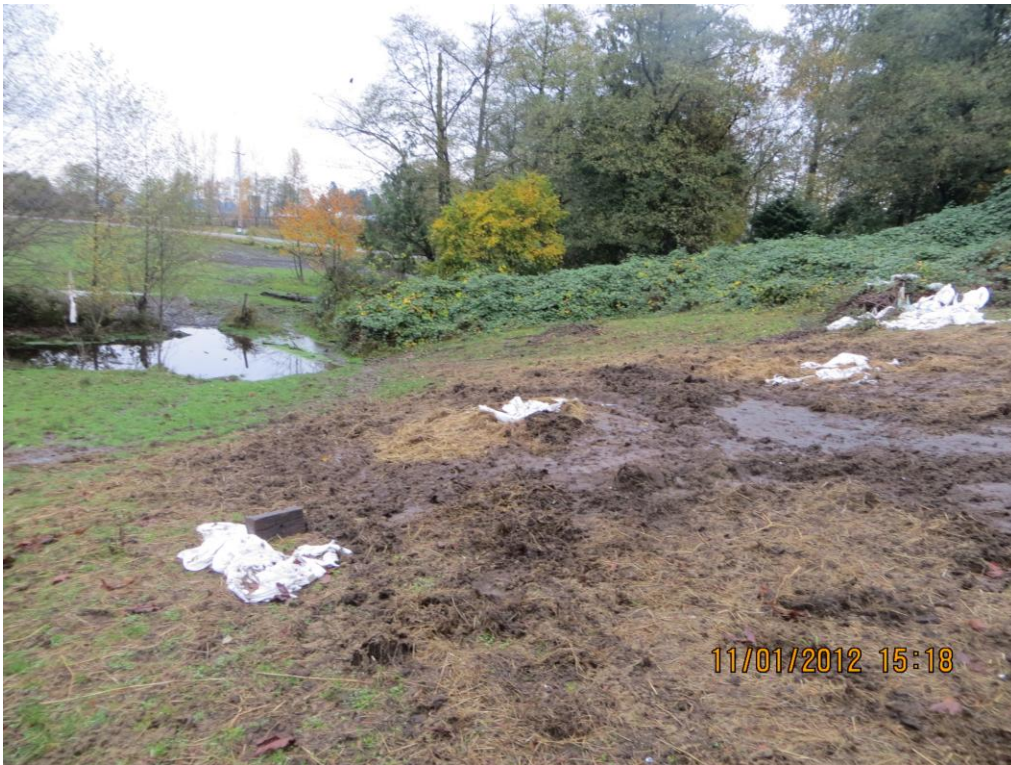
Photo 5: Photo shows manure contaminated soils on both sides of Squaw Creek. Constitutes violation of RCW 90.48. Mr. Crabtree has agreed to excavate these manure contaminated soils and store them in an upland area that does not have the potential to cause runoff during rain events.

Corrective Actions
<input checked="" type="checkbox"/> Install livestock exclusion fencing to keep animals at least 35 feet from wetland on east side of creek and more than 100 feet on west-side of creek past crest of hill shown in Photo 5 ft from surface waters (35ft minimum) Permanent buffers function most effectively to protect water quality and prevent invasion by weeds when planted and maintained with native shrubs and trees suited to the soils and hydrology of the site.
<input checked="" type="checkbox"/> Install off-stream stock water watering facilities and locate them at least 75 ft from surface to prevent risk of water quality impacts (minimum of 75ft)
<input checked="" type="checkbox"/> Collect manure frequently and store it in a dry, covered area with an impervious floor or deck
<input checked="" type="checkbox"/> Apply manure during the growing season at proper rates and times (minimum of 100ft setback from surface water, or the use of a 35ft vegetative buffer)

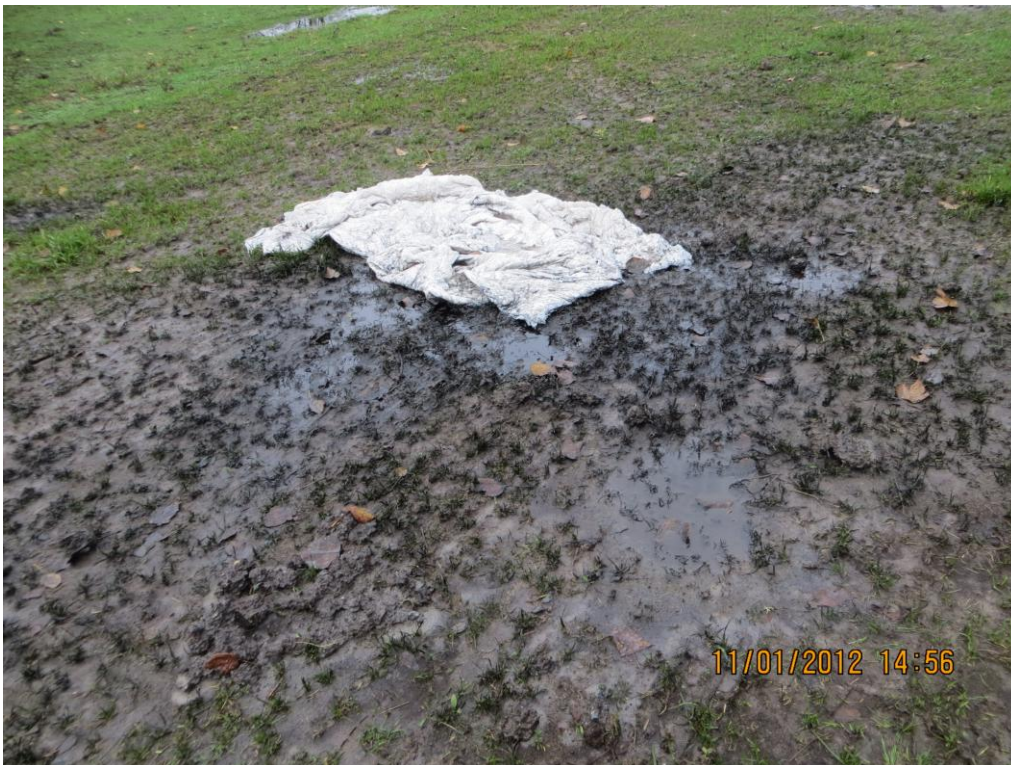
Photo 6: Oil contaminated soils located on east side of Squaw Creek on Tom Crabtree's property. Constitutes violation of RCW 90.48. Mr. Crabtree has agreed to excavate these soils and properly dispose of them.
