Photo Log of Site Conditions of Marr Mink Farm's Cornell  
Creek Road mink-rearing facility and Mt. Baker Highway  
mink-rearing facility.

Photos taken during Ecology water quality compliance  
inspections conducted on December 10, 2012; December  
14, 2012 and January 7, 2013

## Marr Mink Farm

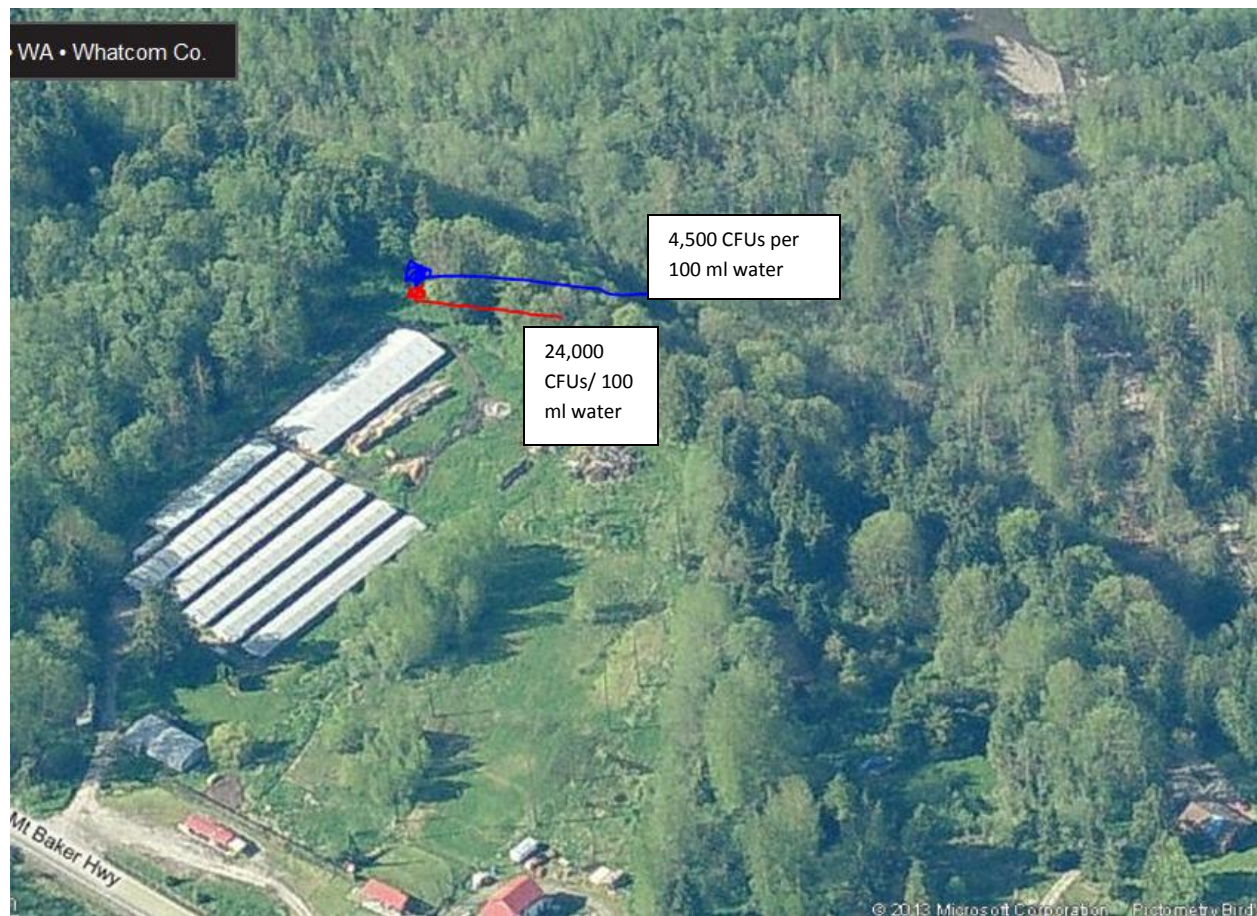
Photo 2: MS “Bing” aerial photograph of Marr Mink Farm’s Mt. Baker Road facility looking Northwest and showing location of water samples collected on December 10, 2012 (in red) and January 4, 2013 (in blue).

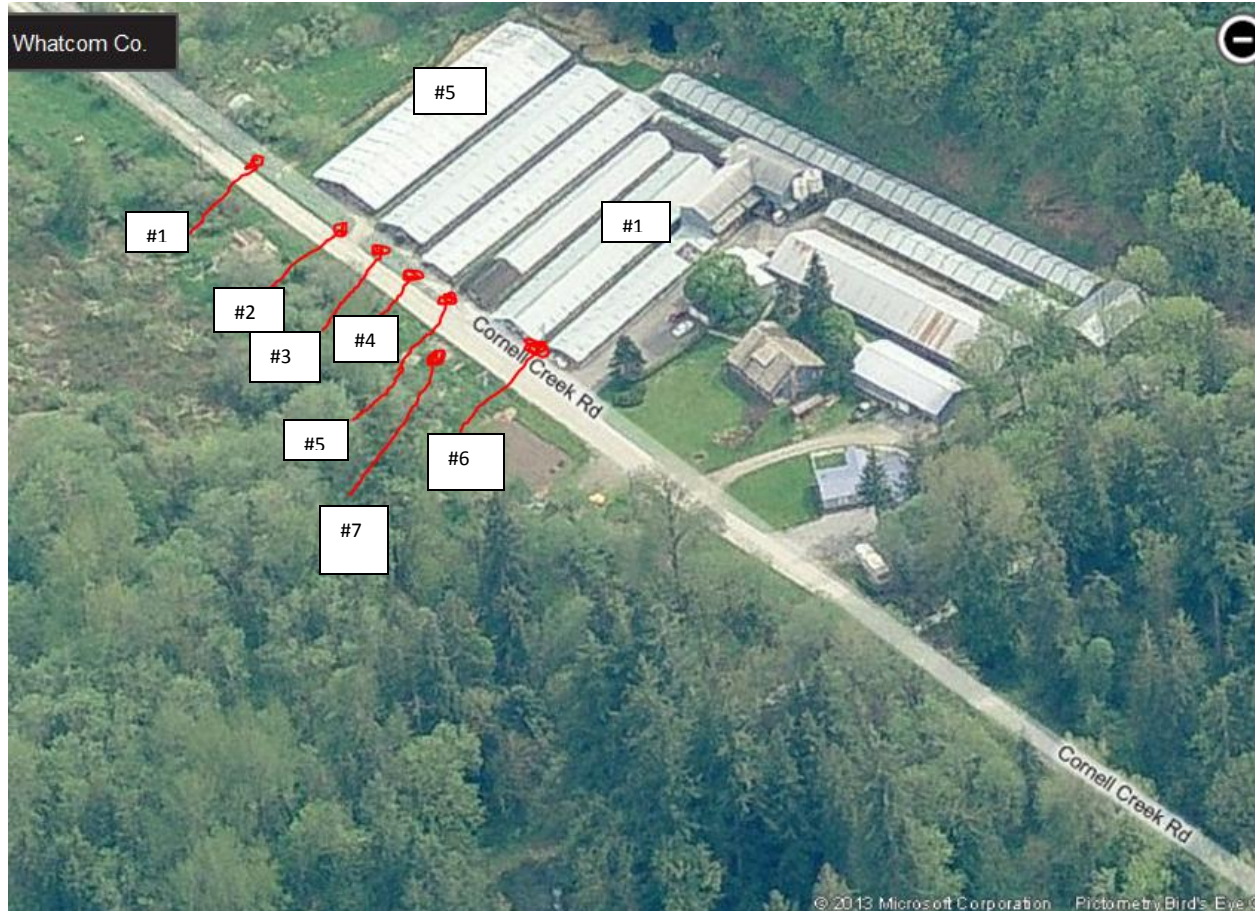
Photo 3: MS “Bing” aerial photograph of Marr Mink Farm’s Cornell Creek Road facility looking Southwest and showing locations of water samples collected on December 10, 2012. For orientation, note that mink barn# 1 is labeled as the second long building in the row of long buildings. Building # 5 is in the far southwest portion of this photograph. The first long building located northwest of #1 is for storage of sawdust and equipment.

Sample #1 upstream of the facility= 920 Colony Forming units (CFUs) /100 ml water.

Sample #2 Upstream of culvert = 820 CFUs /100 ml water

Sample #3 From contaminated area = 920 CFUs /100 ml water

Sample #4 Confluence of culverts = 760 CFUs /100 ml water

Sample #5 Between barns 3-4 = 1,800 CFUs /100 ml water

Sample #6 From sump in front of Barn #1 = 120,000 CFUs /100 ml water

Sample #7 From Creek downstream of farm = 900 CFUs /100 ml water

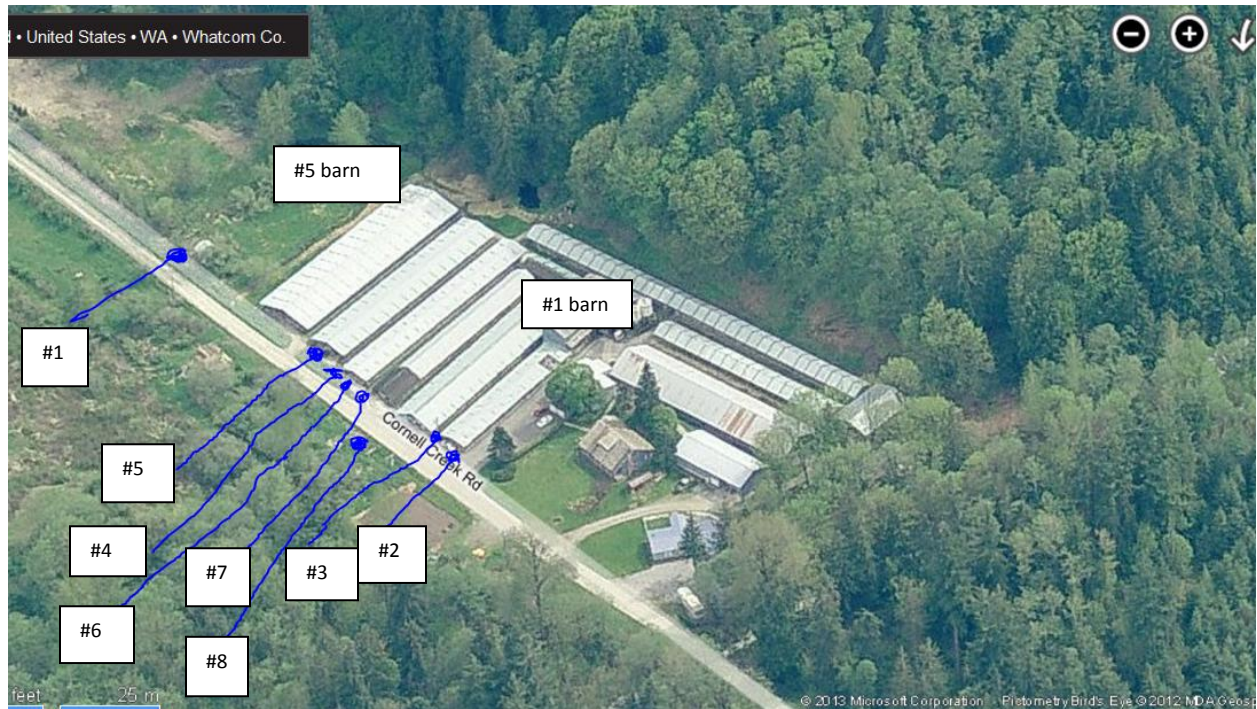
Photo 4: MS “Bing” aerial photograph of Marr Mink Farm’s Cornell Creek Road facility looking Southwest and showing locations of water samples collected on January 7, 2013. For orientation, note that mink barn# 1 is labeled as the second long building in the row of long buildings. Building # 5 is in the far southwest portion of this photograph. The first long building located northwest of #1 is for storage of sawdust and equipment. It was raining extremely hard on January 7, 2013.

Sample #1 upstream of the facility= 5,000 CFUs/100 ml water.

Sample #2 Stormwater flowing from the parking lot = 4,200 CFUs /100 ml water

Sample #3 From sump at barn 1 = 2,400 CFUs /100 ml water

Sample #4 Sump between #4 and #4 barns = 6,000 CFUs /100 ml water

Sample #5 Contaminated area near Barn #4 = 2,100 CFUs /100 ml water

Sample #6 Confluence of east and west culverts = 1,900 CFUs /100 ml water

Sample #7 From Creek downstream of farm = 2,600 CFUs /100 ml water

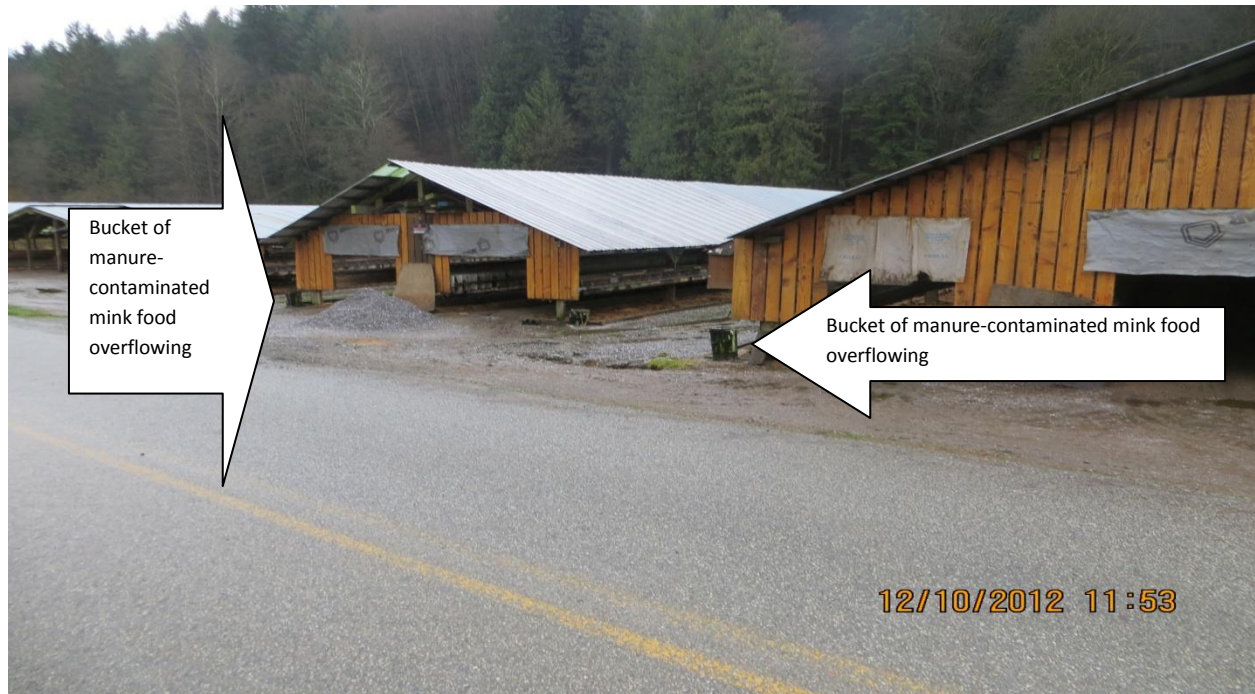
Photo 5: Marr Mink Farm facility on Cornell Creek Road. View looking southwest from Cornell Creek Road. Note: overflowing bucket of manure contaminated mink food at end of stainless steel trough.

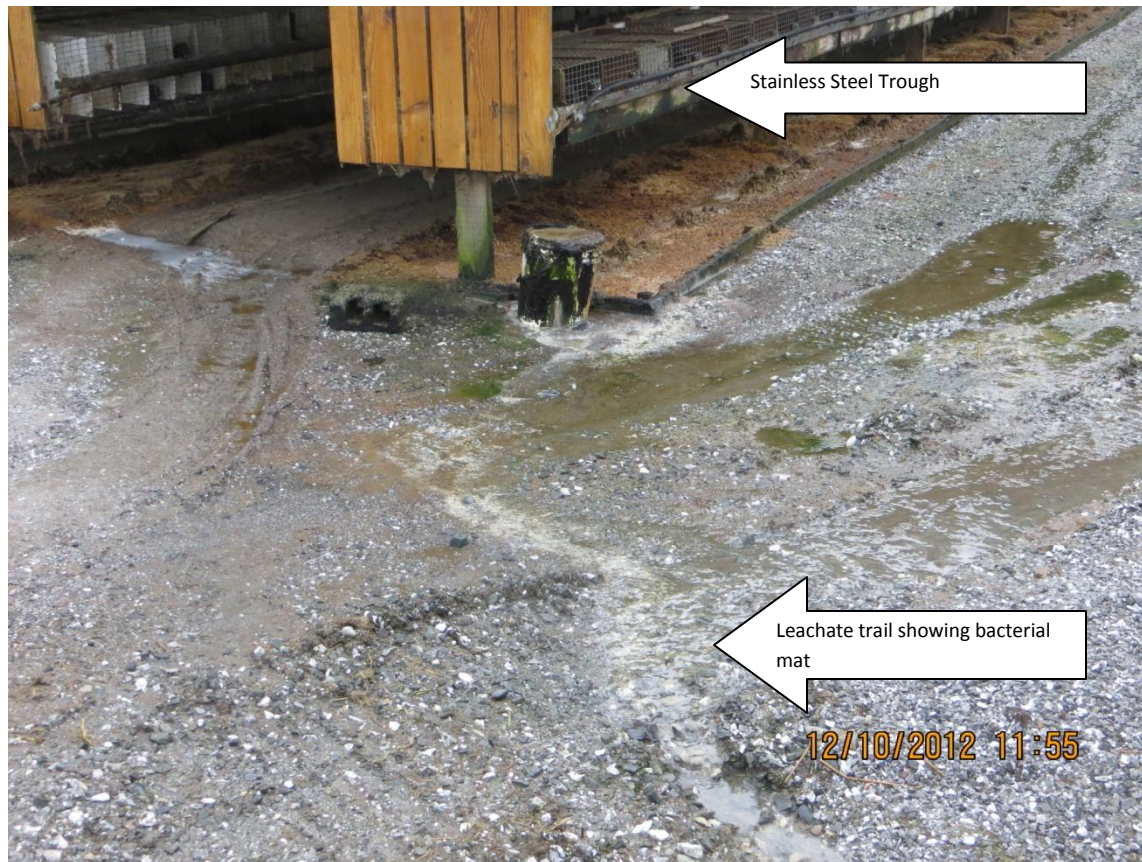
Photo 6: Same bucket depicted in photo 2 showing stainless steel watering trough and bucket overflowing with mink food waste contaminated with manure. Additionally, note the leachate trail flowing toward piping that conveys the contamination to the south Cornell Creek Road ditch.

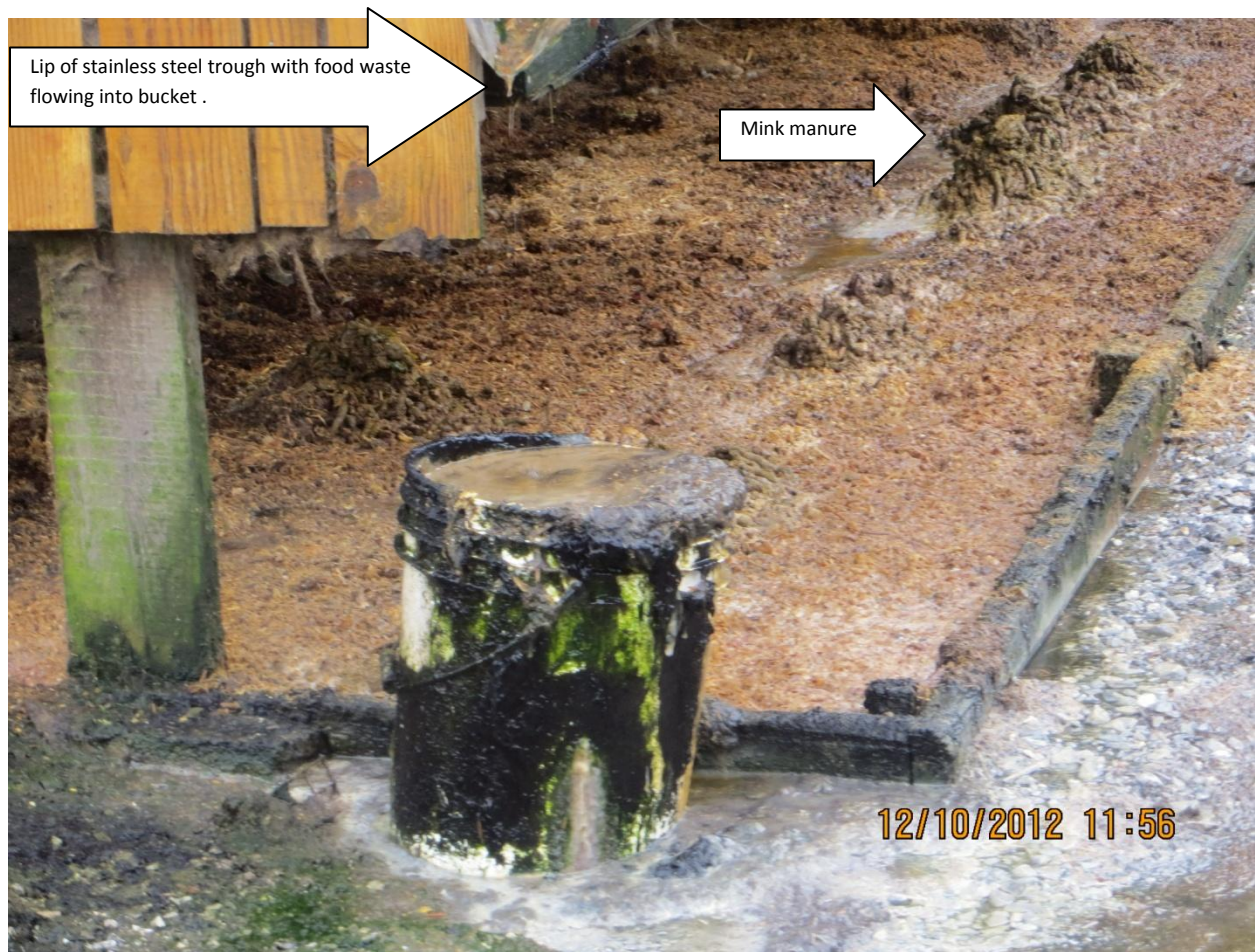
Photo 7: Further magnified photo depicting contaminated wastes overflowing with mink manure in background and lip of stainless steel trough. This lack of maintenance in one of the sources of contamination and allowing this waste to flow into state waters constitutes violation of RCW 90.48.080 for not preventing discharges and violation of RCW 90.48.010 for not implementing AKART to prevent and control pollution of state waters.

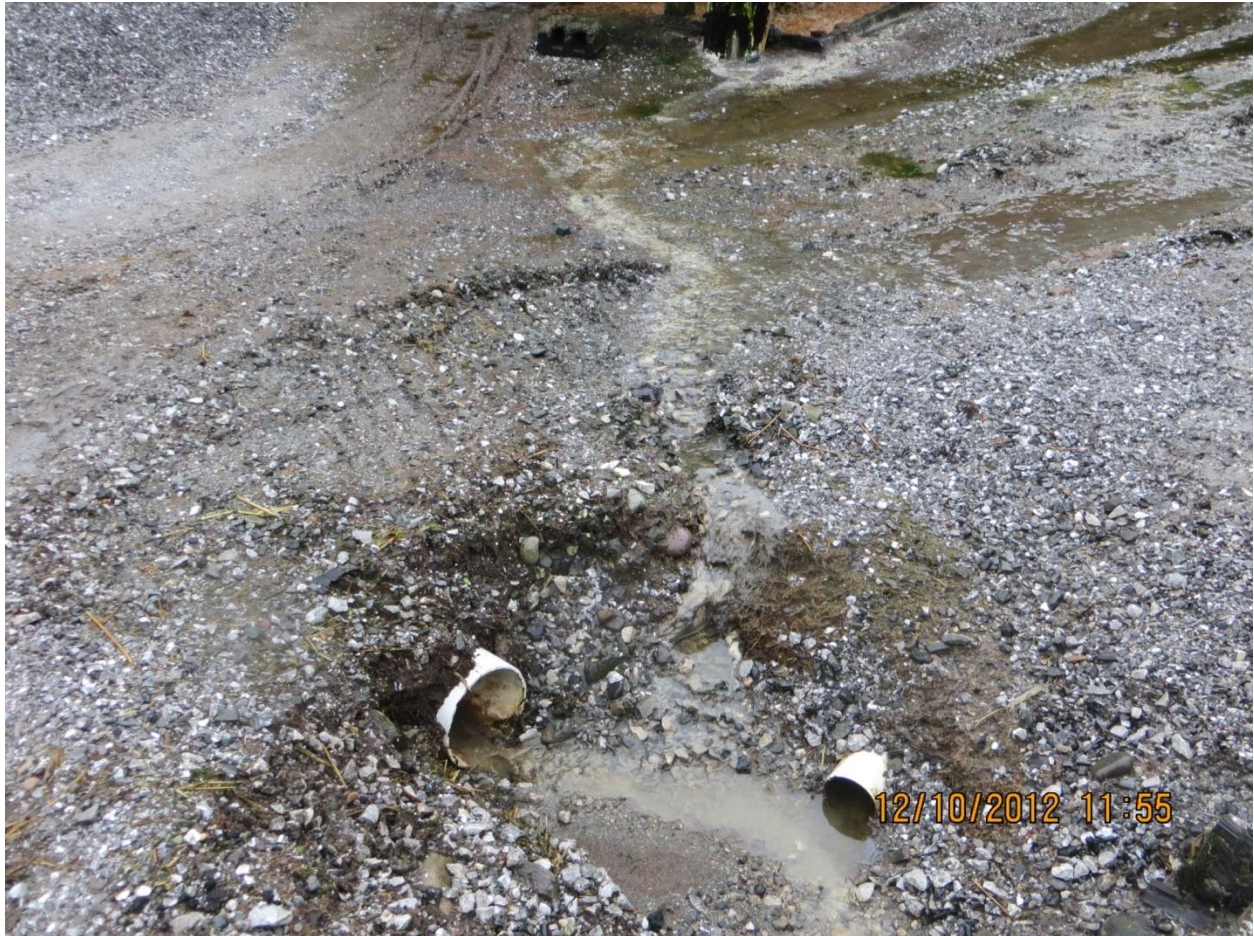
Photo 8: Depicts contaminated leachate trail flowing into pipes that flow convey flow to the South Cornell Creek Road ditch (state waters). Smaller pipe in right field of photo is of unknown origin and needs to be tested.

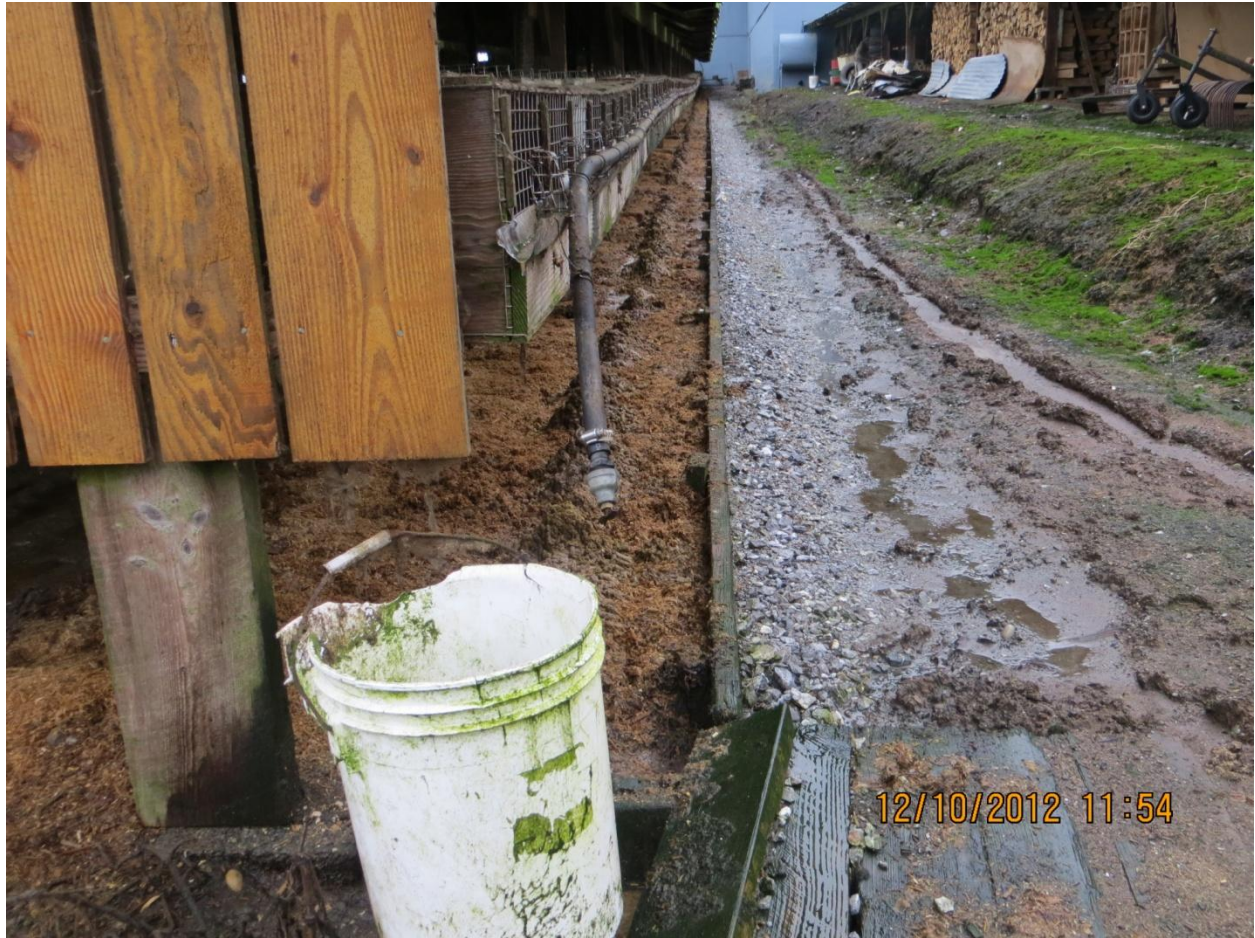
Photo 9: Photo stainless steel trough and black “poly-pipe” sued for nipple watering system. Boards in foreground are covering a sump that had “milk-colored” water. Sample from this sump that was analyzed for fecal coliform bacteria came back from the laboratory at 120,000 CFUs per 100 ml water. The state standard is 200 CFUs per 100ml water. Mr. Marr admitted later that his kitchen sink was plumbed into this sump. When we returned on January 7, 2013, Mr. Marr stated that the sink had been disconnected from this sump and was no longer contributing to the contaminated discharges.

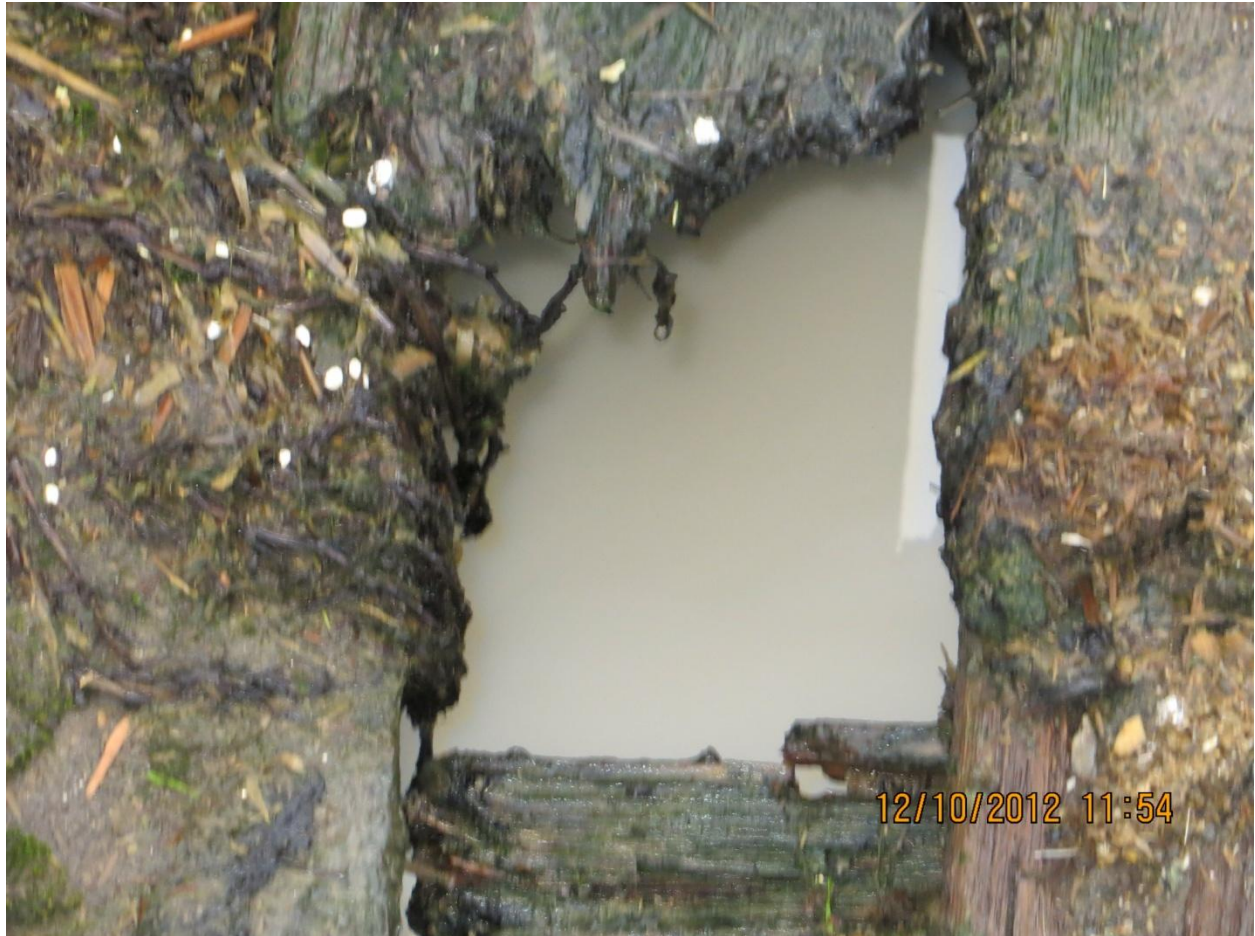
Photo 10: Photo showing “milk colored” water depicted in Photo 10. Sample collected from this sump which was analyzed for fecal coliform bacteria came back from the laboratory at 120,000 CFUs per 100 ml water. The state standard is 200 CFUs per 100ml water. Mr. Marr admitted later that his kitchen sink was plumbed into this sump. When we returned on January 7, 2013, Mr. Marr stated that the sink had been disconnected from this sump and was no longer contributing to the contaminated discharges. The sample collected on January 7, 2013 came back from the lab at 2,400CFUs per 100 ml water showing a vast reduction.

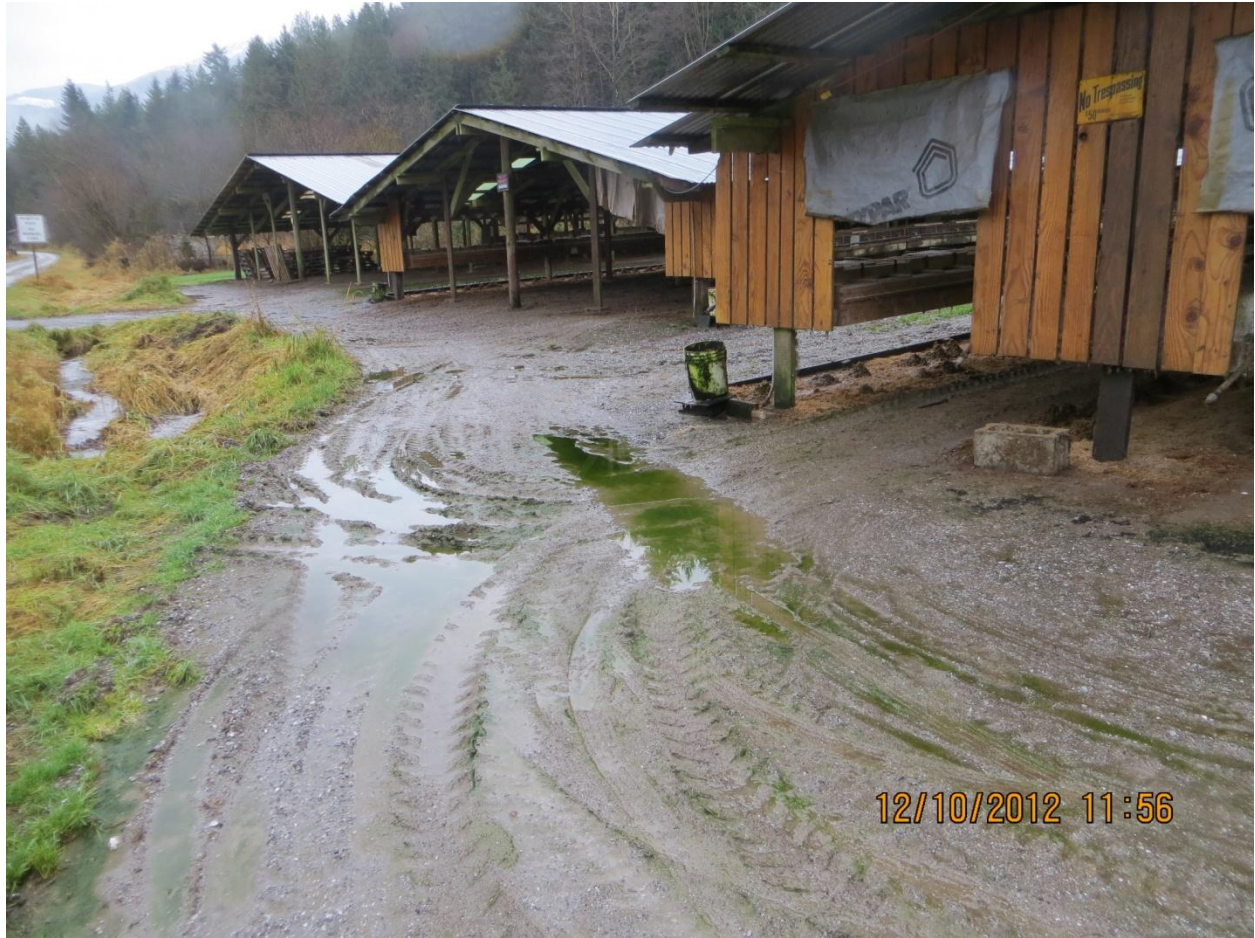
Photo 11: Photo showing water with blue-green algae bloom in the middle of December. This is another indication of long-term contamination with high nutrient loading. Photo also shows how close to the stream these barns have been sited.

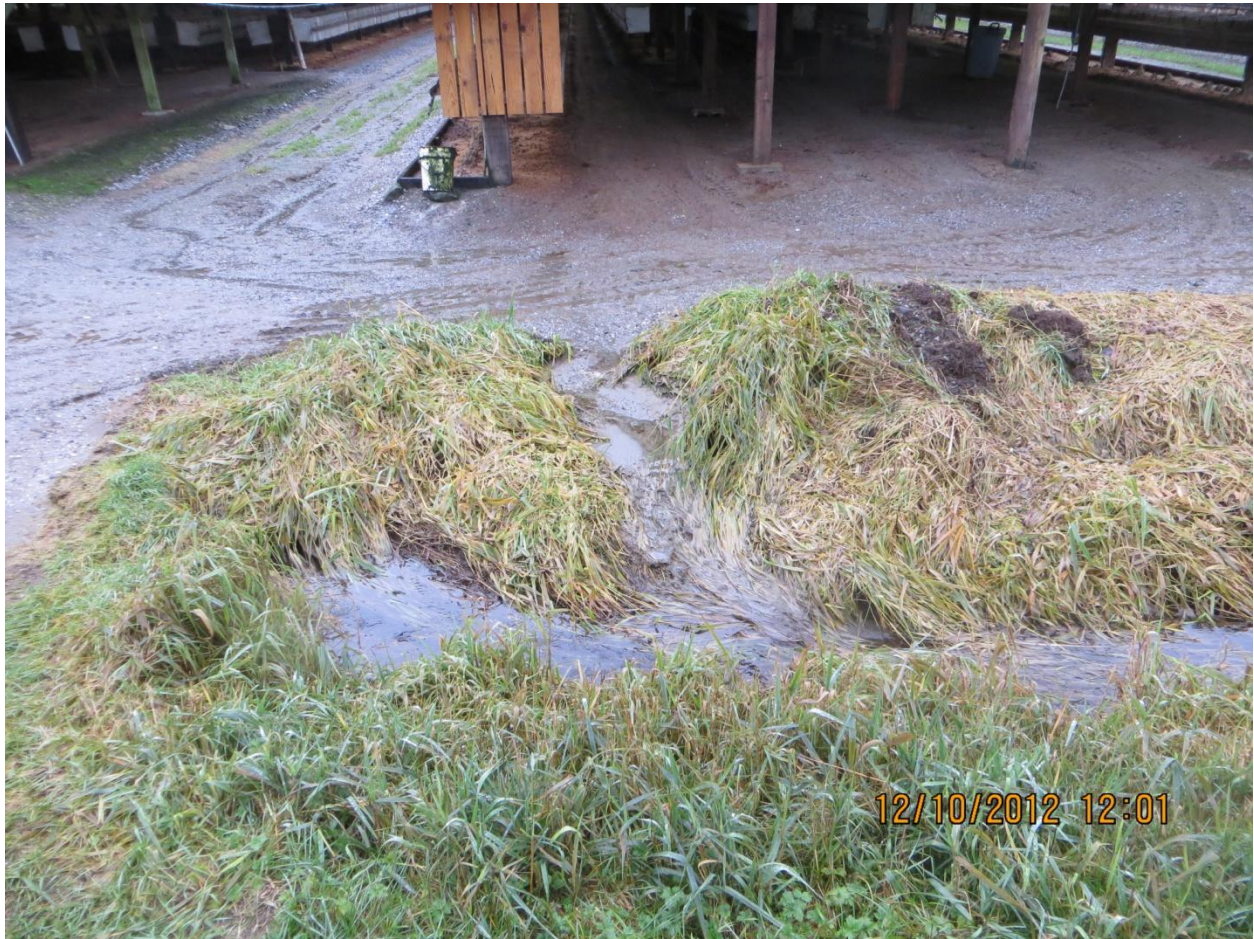
Photo 12: Photo showing leachate path with an active discharge that was occurring at the time of the compliance inspection. Contaminated discharge is from overflowing bucket directly into the South Cornell Creek Road ditch (aka West Creek)

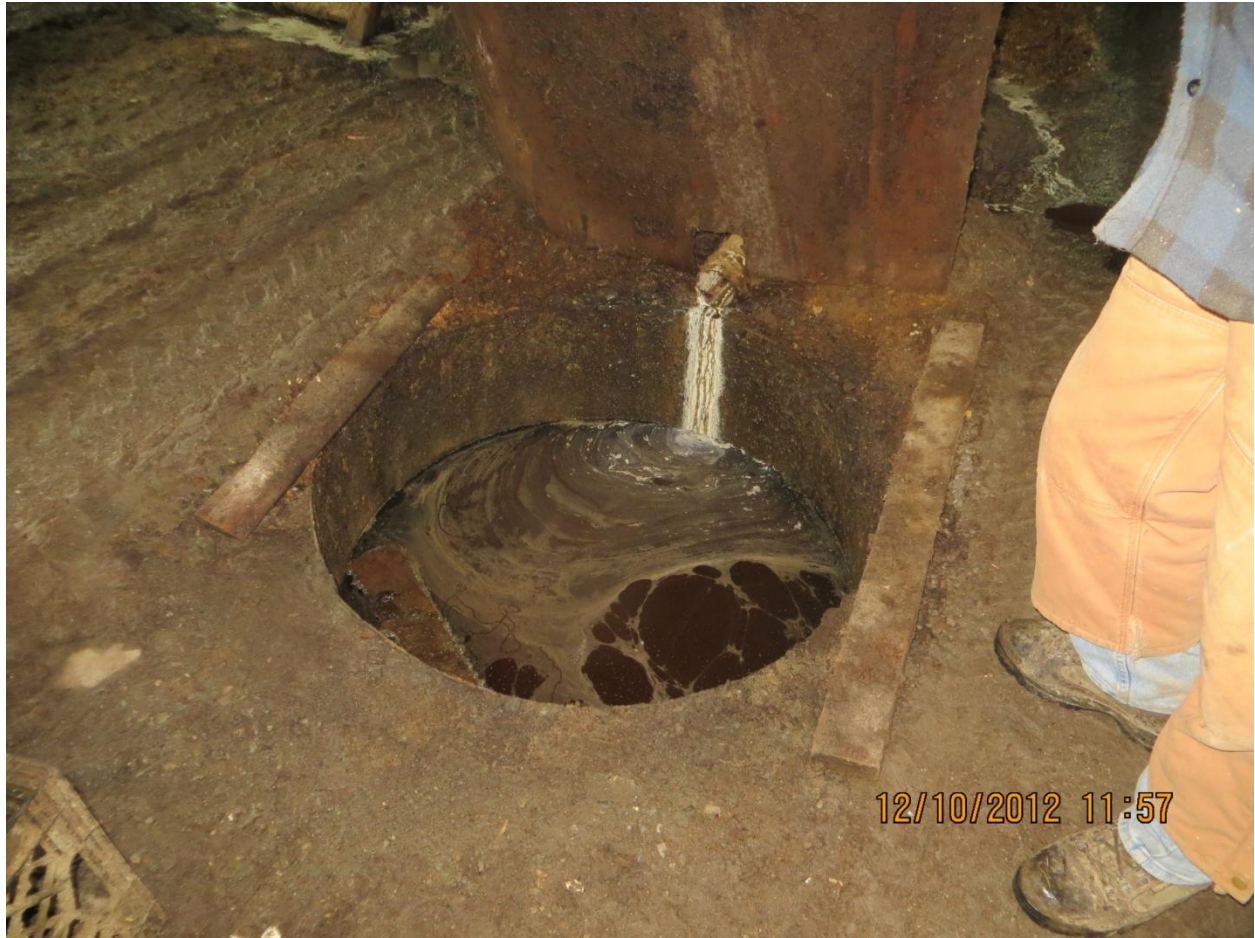
Photo 14: Shows leachate collection system Mr. Marr had installed in two of his barns. This was marginally functional, but Mr. Marr stated that he could not afford to install this in all of his mink barns.

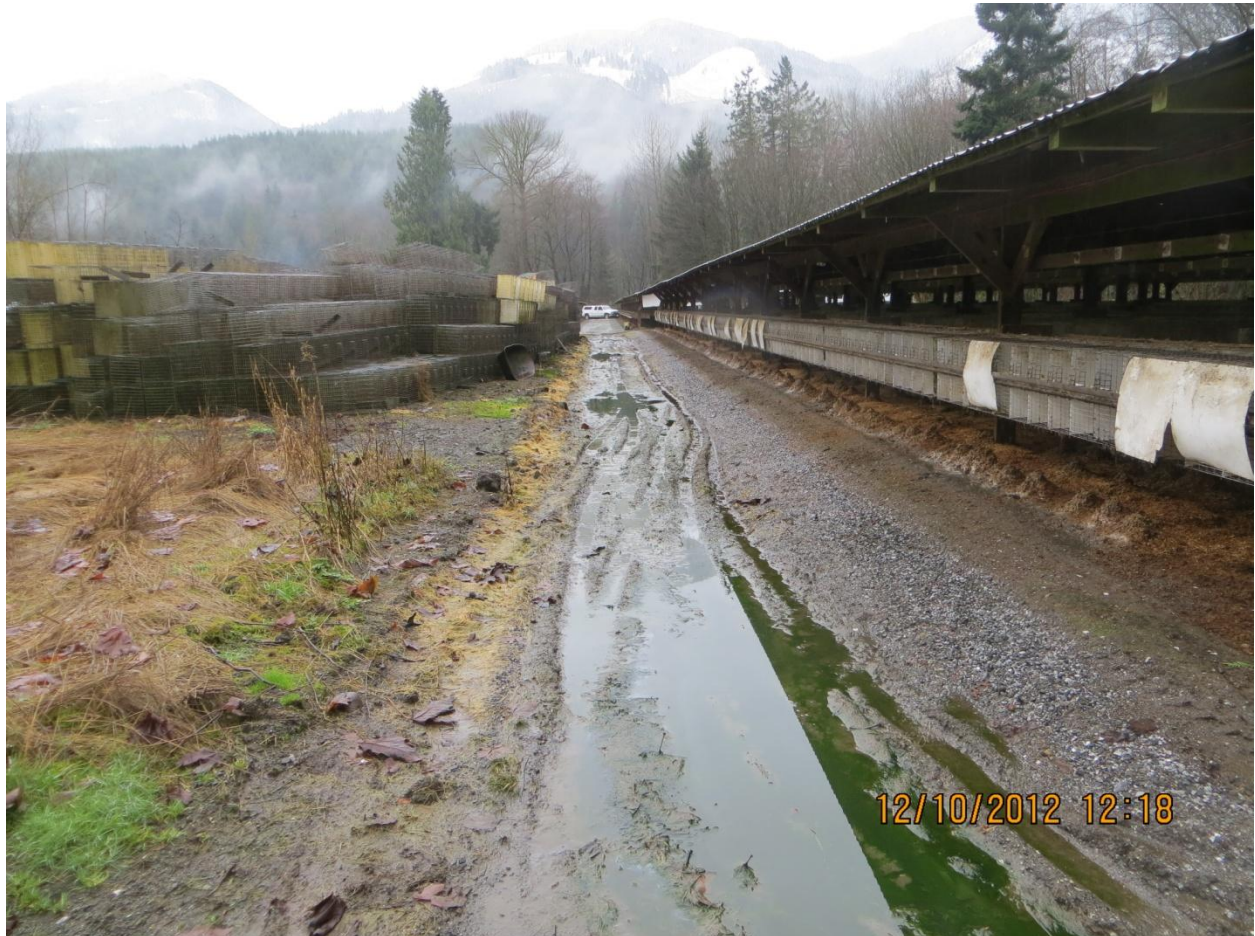
Photo15: Photo shows water puddles with blue-green algae bloom in middle of December at Marr Mink Farm's Mt. Baker Road facility. This water flows around this barn and through a vastly undersized "de-facto" swale before flowing off of Mr. Marr's property and onto the property he deeded to Whatcom Land Trust in lieu of paying the \$24,000 Notice of Penalty Ecology issued for almost identical discharges into state waters. This property exchange was accepted as an "innovative settlement" for the previous discharges and was supposed to be protected into perpetuity.

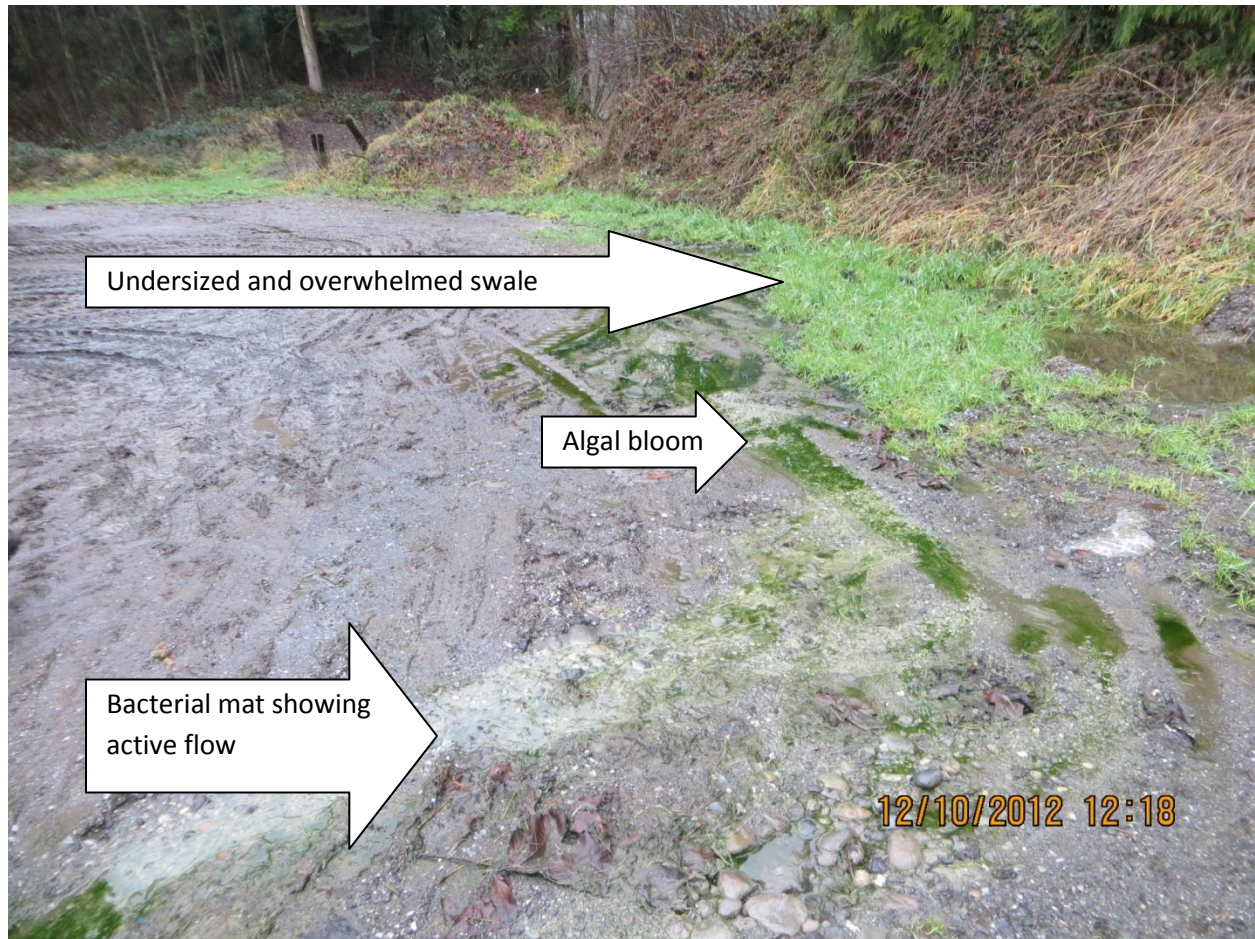
Photo 16: Photo shows bacterial mat flowing with active flow from the area depicted in Photo 16. Note the vastly undersized an overwhelmed vegetated swale and more of the blue-green algal bloom.

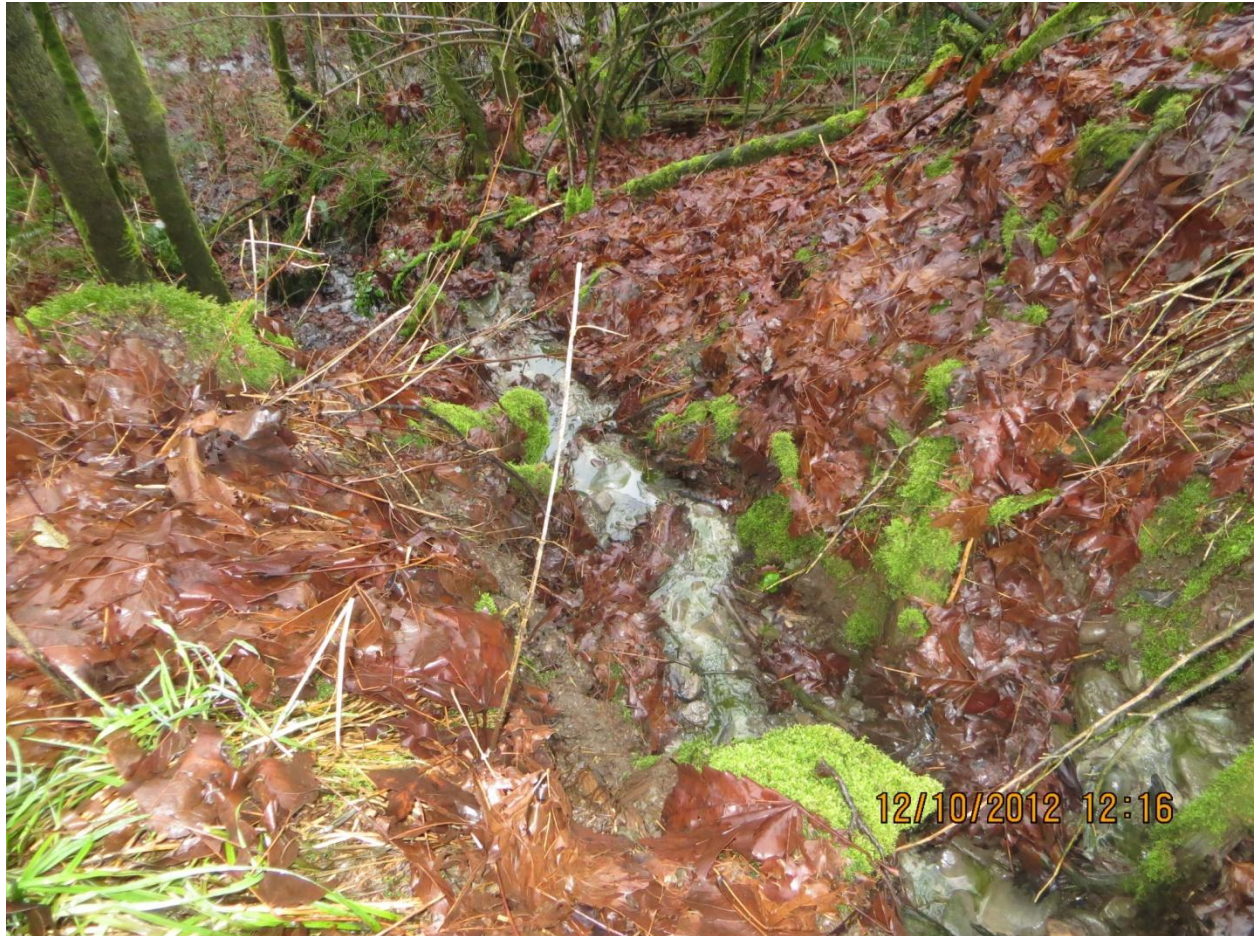
Photo 17: Photo showing active contaminated flow at time of inspection. Note bacterial mat in bottom of channel. A water sample collected on December 10, 2012 from this flow was analyzed for fecal coliform bacterial concentration and came back from the laboratory at 24,000 CFUs per 100 ml water. A second sample was collected during the compliance inspection conducted on January 7, 2013 came back from the laboratory at 4,500 CFUs/100 ml water. Both samples exceed state water quality standards and constitute violation of RCW 90.48.080.
