State of Washington Department of Ecology
Northwest Regional Office
WATER COMPLIANCE INSPECTION REPORT

Name and Location of Facility Inspected (For industrial users discharging to POTW, also include POTW name and NPDES permit number) Nucor Steel Seattle, Inc. 2424 SW Andover Street Seattle, WA 98106	Entry Time/Date 11:23 am 09/05/13	Permit Effective Date 03/24/11
	Exit Time / Date 1:15 pm 09/05/13	Permit Expiration Date 03/24/16

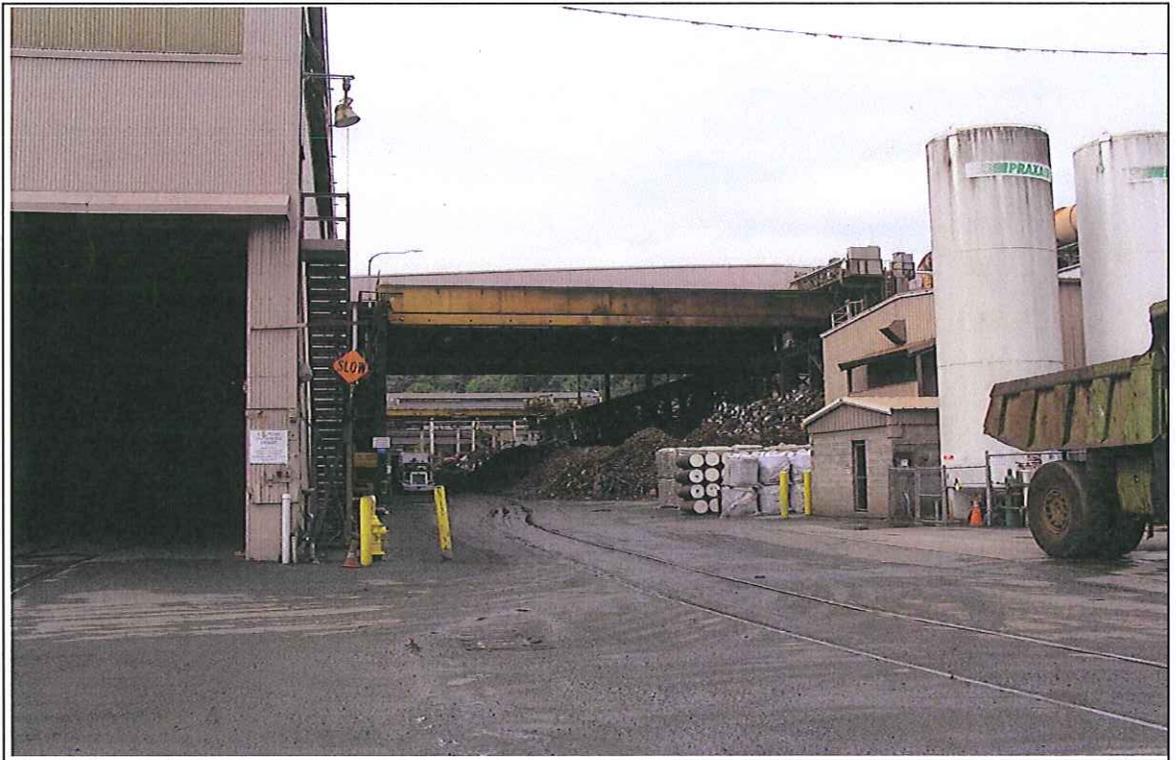
PHOTO NO. 1

DESCRIPTION:
Approximately
70% of the scrap
yard is now
covered.

3) In 2006, the roof over the scrap yard was extended. Approximately 70% of the scrap yard is now covered (See photo taken on September 23, 2013). Currently, the facility has no immediate plans to extend the roof over the rest of the scrap yard.

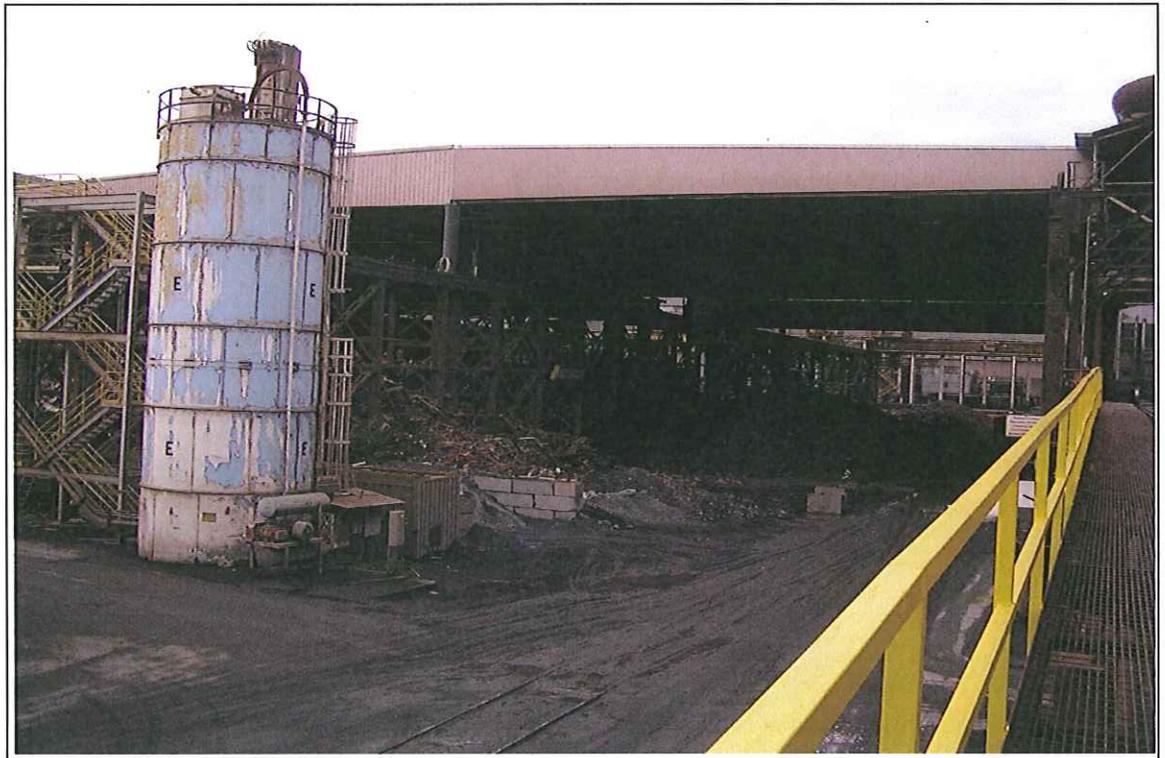
PHOTO NO. 2

DESCRIPTION:
Another view of
the scrap yard.
