State of Washington Department of Ecology
Northwest Regional Office
WATER COMPLIANCE INSPECTION REPORT

Name and Location of Facility Inspected (For industrial users discharging to POTW, also include POTW name and NPDES permit number) Hughes Farms 1325 Farm to Market Road Mount Vernon, WA 98273	Entry Time/Date 11:35 am 10/24/13	Permit Effective Date
	Exit Time / Date 1:12 pm 10/24/13	Permit Expiration Date

PHOTO ADDENDUM – HUGHES FARMS, INC., WA0501489

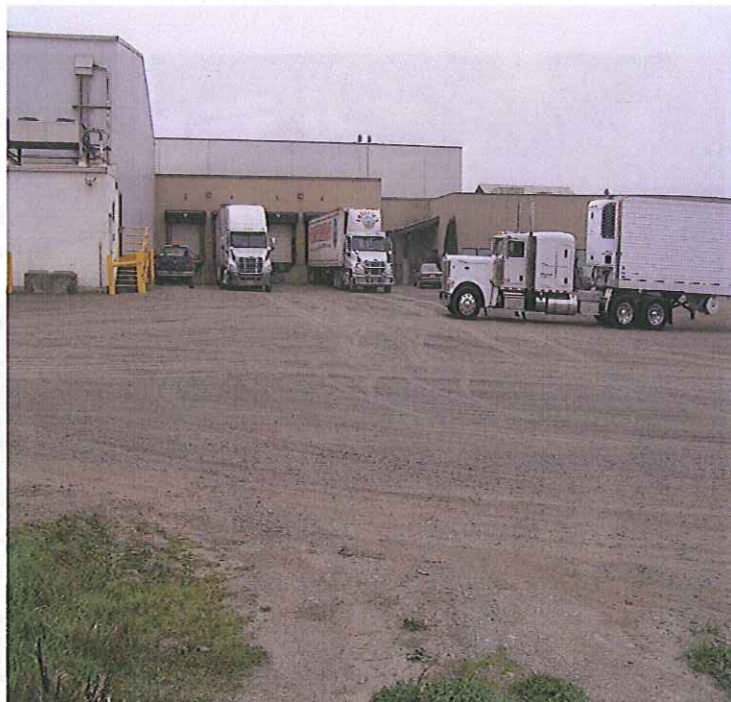
PHOTO #:02 DATE: 10/24/13 TAKEN BY: JEANNE TRAN
DESCRIPTION: TRUCK LOADING AREA, LOCATED EAST OF THE OFFICE, WEST OF THE COOLER, AND NORTH OF THE WAREHOUSE.

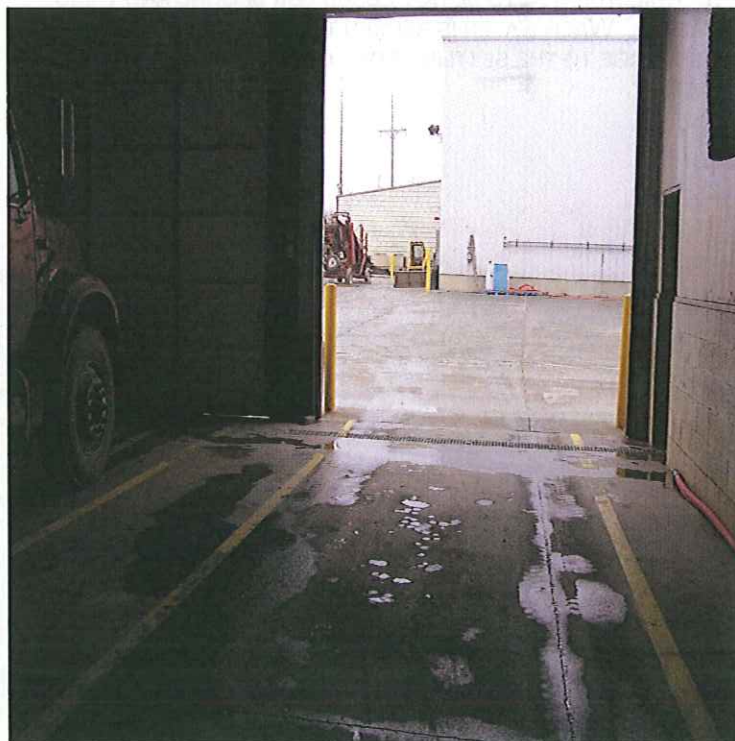
PHOTO #:03 DATE: 10/24/13 TAKEN BY: JEANNE TRAN
DESCRIPTION: POTATO TRUCK OFF-LOADING AREA.

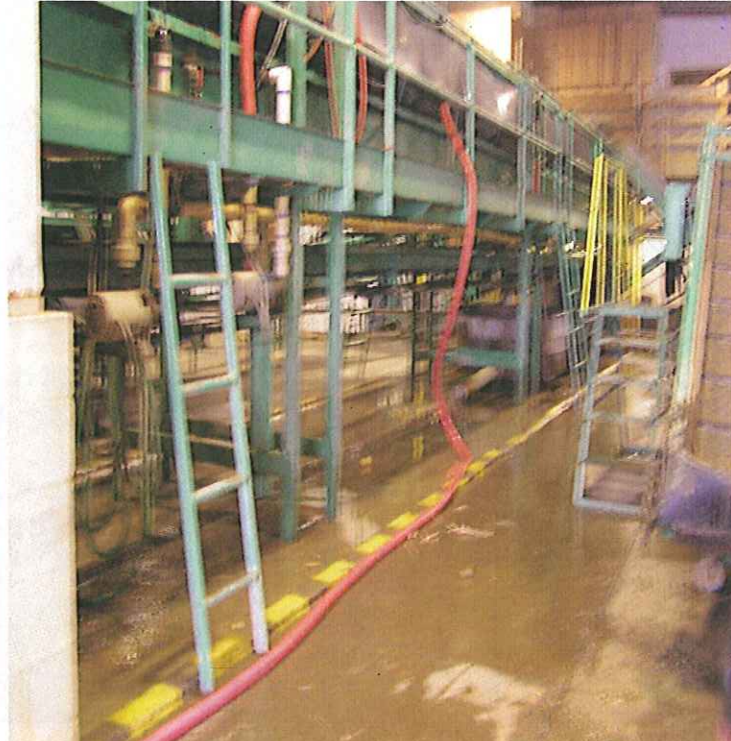
PHOTO #:04 DATE: 10/24/13 TAKEN BY: JEANNE TRAN
DESCRIPTION: A VIEW OF THE POTATO WASHER ASSEMBLY LINE.

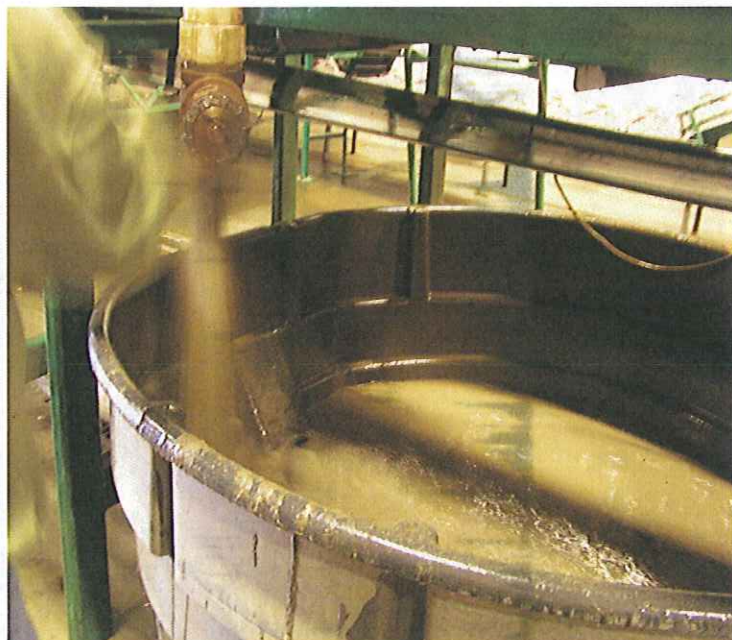
PHOTO #:05 DATE: 10/24/13 TAKEN BY: JEANNE TRAN:
DESCRIPTION: WASH WATER BEING COLLECTED IN A LARGE TUB
TO SCREEN OUT ROCKS AND LARGE DEBRIS.

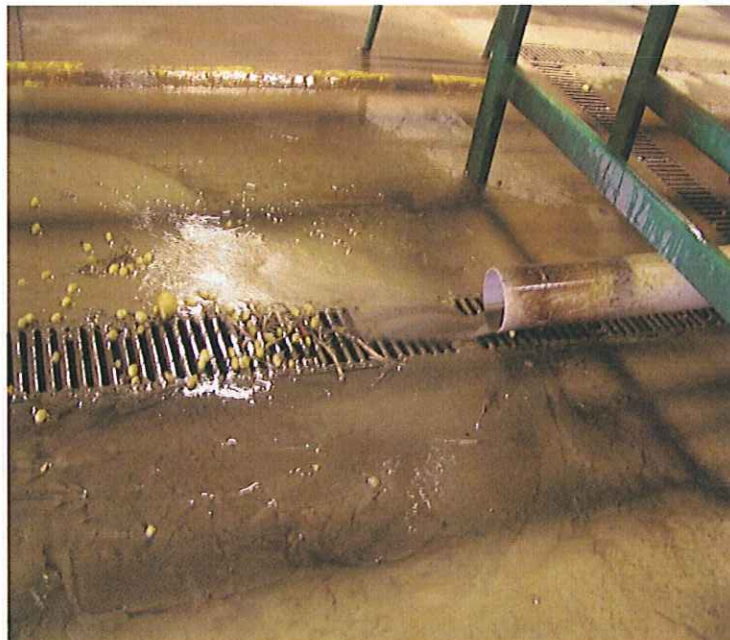
PHOTO #:06 DATE: 10/24/13 TAKEN BY: JEANNE TRAN
DESCRIPTION: SCREENED WASH WATER IS THEN DISCHARGED
INTO FLOOR SUMPS FOR COLLECTION AND SEDIMENTATION
TREATMENT PRIOR TO BEING REUSED FOR SECOND AND THIRD
WASHES. WASH WATER IS REUSED THREE TIMES PRIOR TO
DISCHARGE TO THE SETTLING POND LOCATED NORTH OF THE
FACILITY.

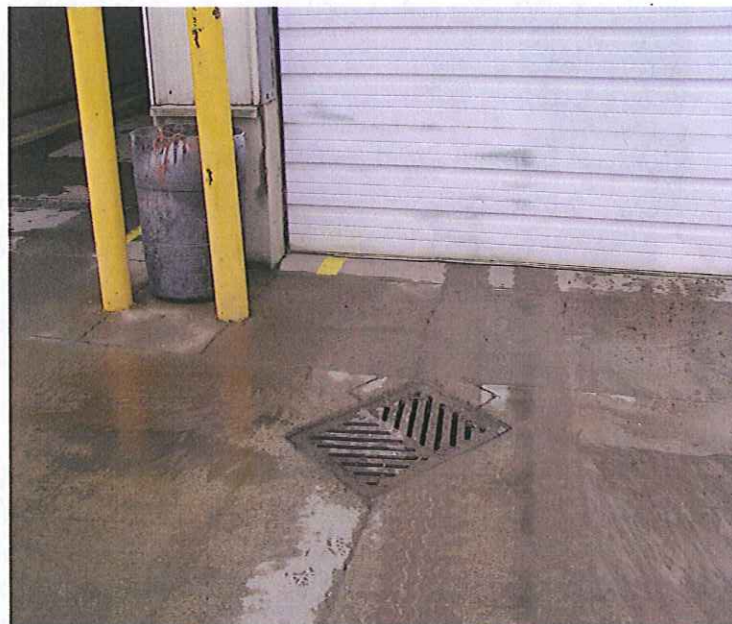
PHOTO #:07 DATE: 10/24/13 TAKEN BY: JEANNE TRAN
DESCRIPTION: THIS STORMWATER DRAIN IS LOCATED OUTSIDE OF
THE INCOMING TRUCK OFF-LOADING BUILDING.

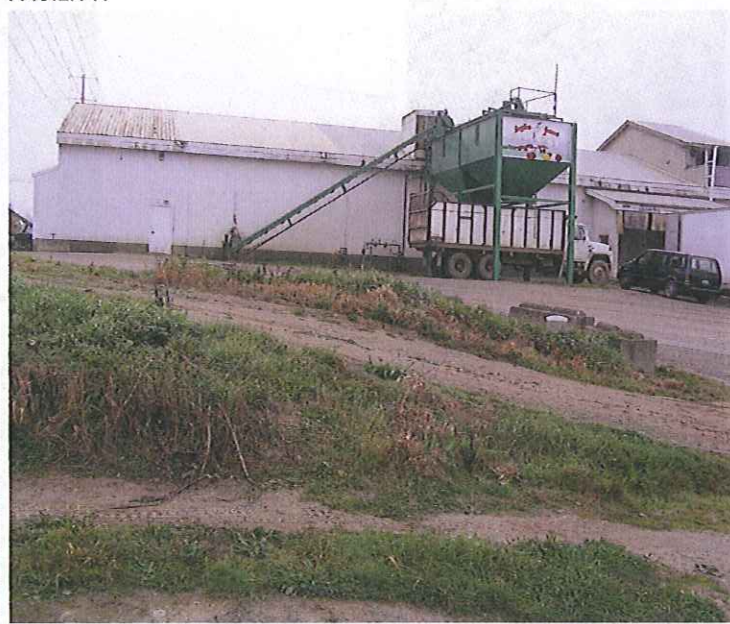
PHOTO #:08 DATE: 10/24/13 TAKEN BY: JEANNE TRAN
DESCRIPTION: SCREENED SOLIDS ARE CONVEYED OUT OF THE
PLANT AND INTO TRUCKS TO BE TAKEN BACK TO THE FIELD.

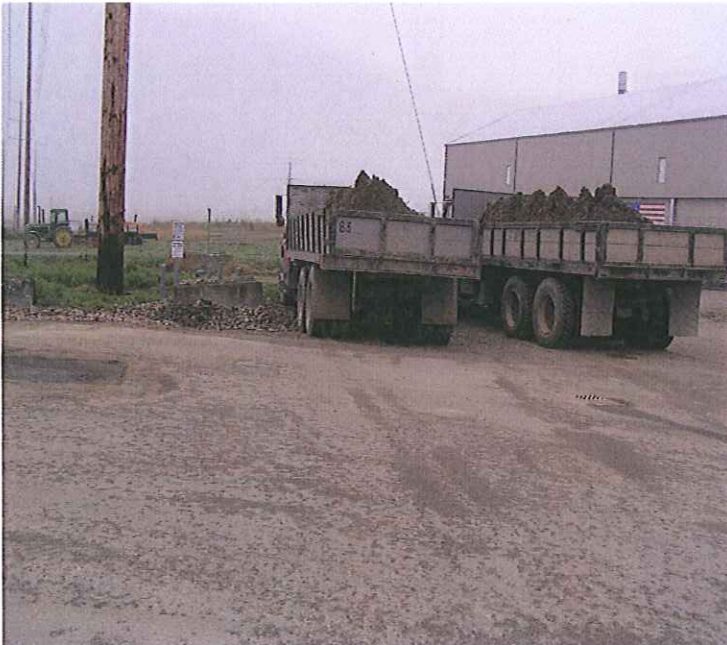
PHOTO #:09 DATE: 10/24/13 TAKEN BY: JEANNE TRAN
DESCRIPTION: SOIL LOADED ON TRUCK, WAITING TO BE TAKEN BACK TO THE FIELD FOR RE-APPLICATION.

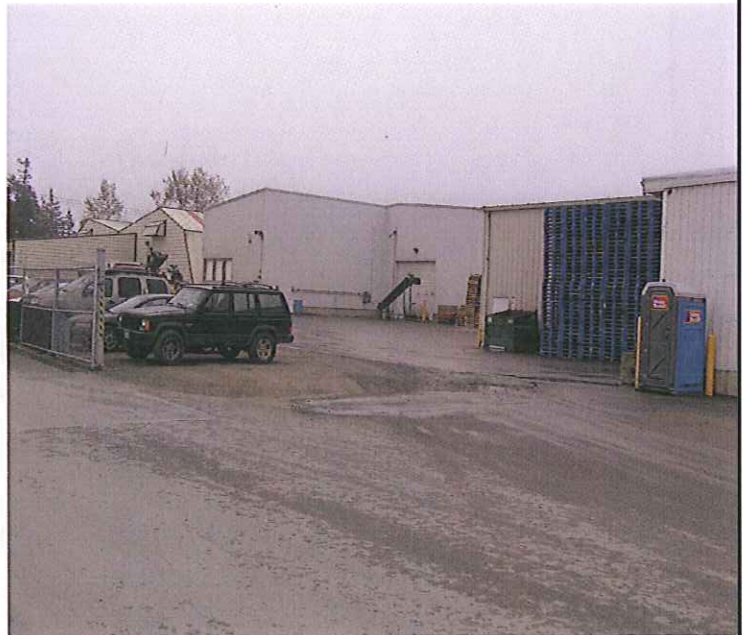
PHOTO #:010 DATE: 10/24/13 TAKEN BY: JEANNE TRAN
DESCRIPTION: SOME AREAS OF THE PLANT ARE NOT PAVED, AND STORMWATER RUNOFF DRAINS INTO UNDERGROUND SUMPS, WHICH DRAIN INTO AN UNDERGROUND COLLECTION SUMP BEFORE IT IS GRAVITY DRAINED TO THE SETTLING POND.

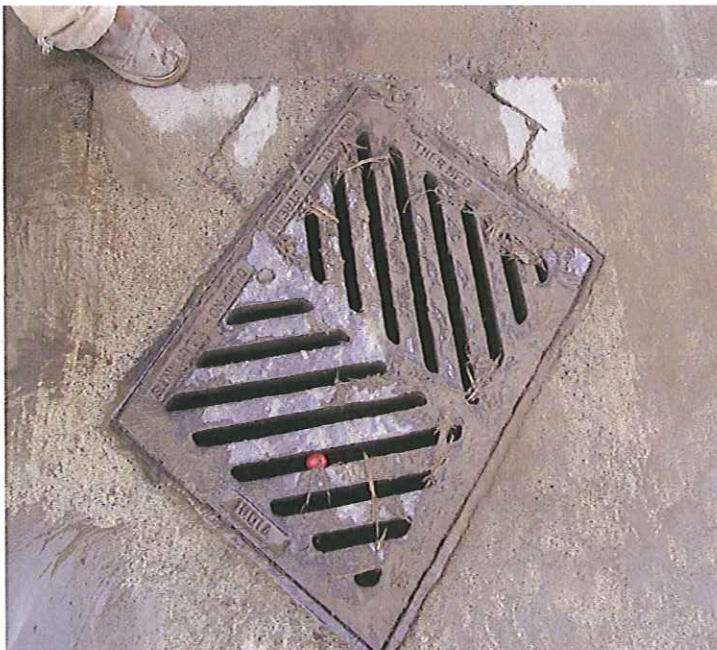
1) Jose informed us that all wash water and stormwater runoff (see photos # 3 to 13) from the yard are collected in a large underground vault (see photo #12), which is gravity drained to the settling pond. This pond is not lined, and the outlet of the pond is piped to the land application site. It appears that all water collected is routed to the farmland for land application and that there is no discharge to surface water. The wash water from the plant is reused two times, prior to discharge to the settling pond. There are approximately 5 underground stormwater vaults located around the processing buildings, and they all drain to the large underground vault. We observed no absorbent pad or stormwater filters installed in the on-site stormwater vaults.

PHOTO #:11 DATE: 10/24/13 TAKEN BY: JEANNE TRAN
DESCRIPTION: A VIEW OF THE STORMWATER SUMP. NO ABSORBENT PADS OR STORMWATER FILTER WERE OBSERVED IN STORMWATER DRAINS.

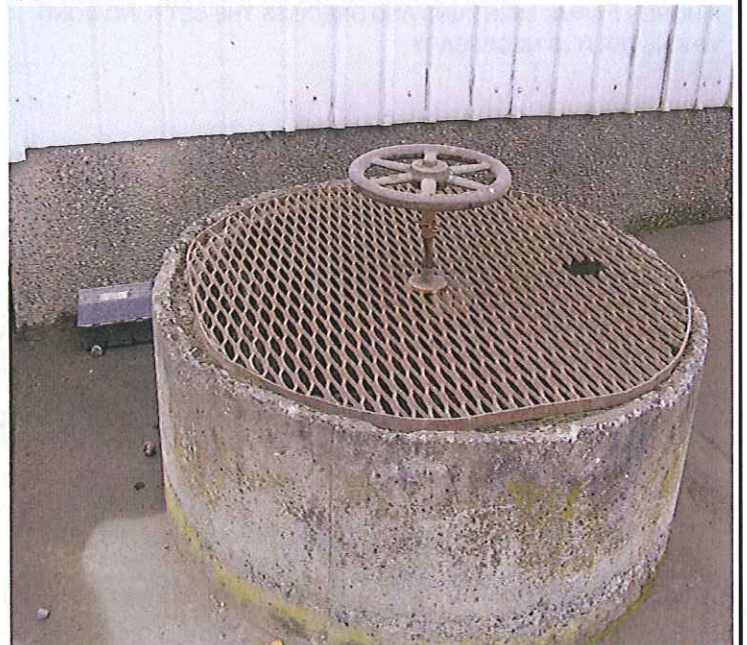
PHOTO #:12 DATE: 10/24/13 TAKEN BY: JEANNE TRAN
DESCRIPTION: AN UNDERGROUND COLLECTION SUMP LOCATED WEST OF THE PROCESSING PLANT AND SETTLING POND. THIS SUMP COLLECTS WASH WATER AND STORMWATER AND GRAVITY DRAINS IT TO THE SETTLING POND.

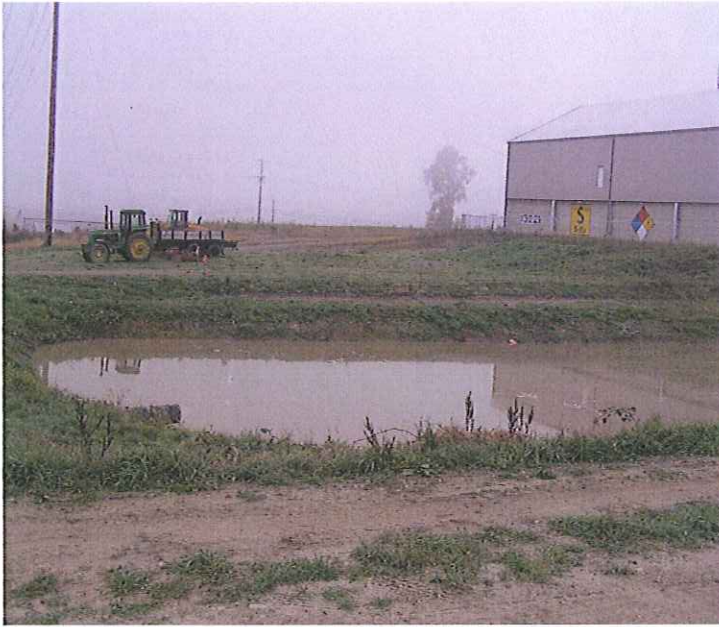
2) Since Hughes Farms discharges to the settling pond on a regular basis (more often than the neighboring facility, Chemtrade Sulex), Hughes Farms has assumed the responsibility of maintaining the settling pond. This includes dredging the settling pond every other year or as often as necessary(See photo #13). The water in the settling pond had a muddy appearance.

PHOTO #13 DATE: 10/24/13 TAKEN BY: JEANNE TRAN
DESCRIPTION: THE SETTLING POND THAT HUGHES FARMS SHARES WITH NEIGHBORING FACILITY, CHEMTRADE SULEX. SINCE HUGHES FARMS DISCHARGES INTO THIS SETTLING POND ON A REGULAR BASIS IN COMPARISON TO CHEMTRADE SULEX, HUGHES FARMS MAINTAINS AND DREDGES THE SETTLING POND WHENEVER IT IS NECESSARY.

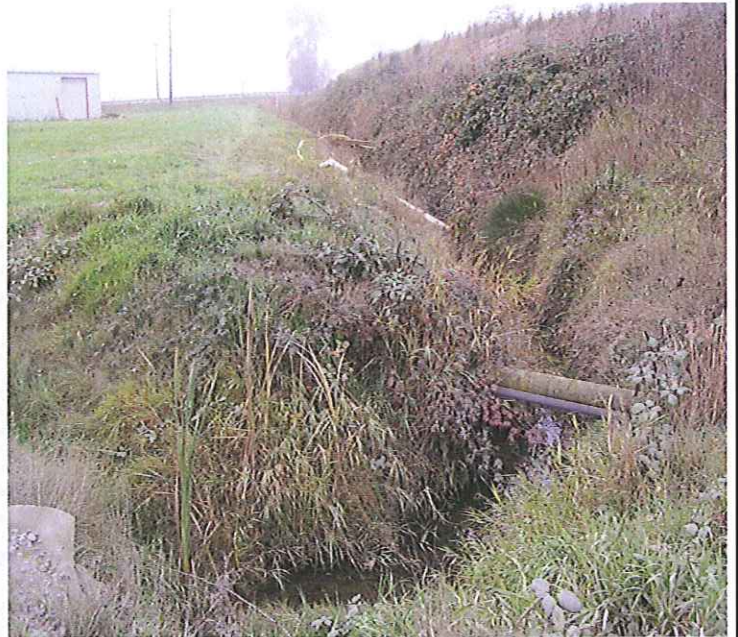
PHOTO #14 DATE: 10/24/13 TAKEN BY: JEANNE TRAN
DESCRIPTION: CURRENTLY, THE SETTLING POND'S OUTLET IS PIPED UNDER THE ROADS TO THE LAND APPLICATION FIELD FOR IRRIGATION.

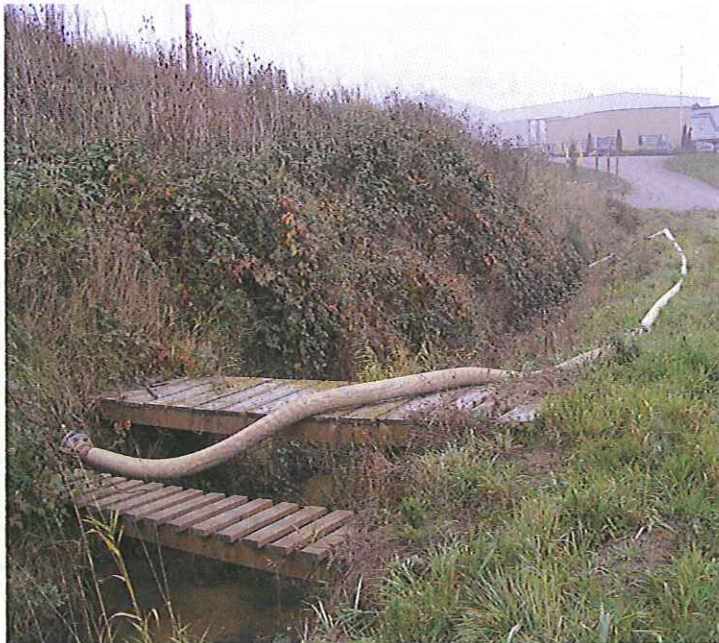
PHOTO #15 DATE: 10/24/13 TAKEN BY: JEANNE TRAN
DESCRIPTION: A CLOSE UP VIEW OF THE POND'S OUTLET BEING PIPED ACROSS AND UNDER THE FACILITY ACCESS ROAD, THEN TRAVELS WEST ACROSS AND UNDERNEATH FARM TO MARKET ROAD TO THE LAND APPLICATION SITE.

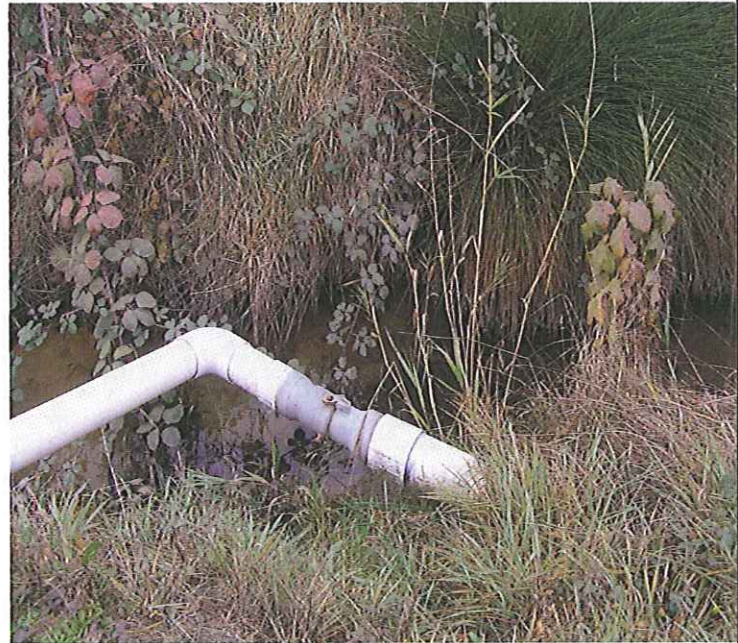
PHOTO #16 DATE: 10/24/13 TAKEN BY: JEANNE TRAN
DESCRIPTION: AFTER CROSSING THE FACILITY'S ACCESS ROAD, THE PIPE IS ELBOWED AND CONTINUES UNDERGROUND AND ACROSS THE FARM TO MARKET ROAD TO THE LAND APPLICATION SITE.

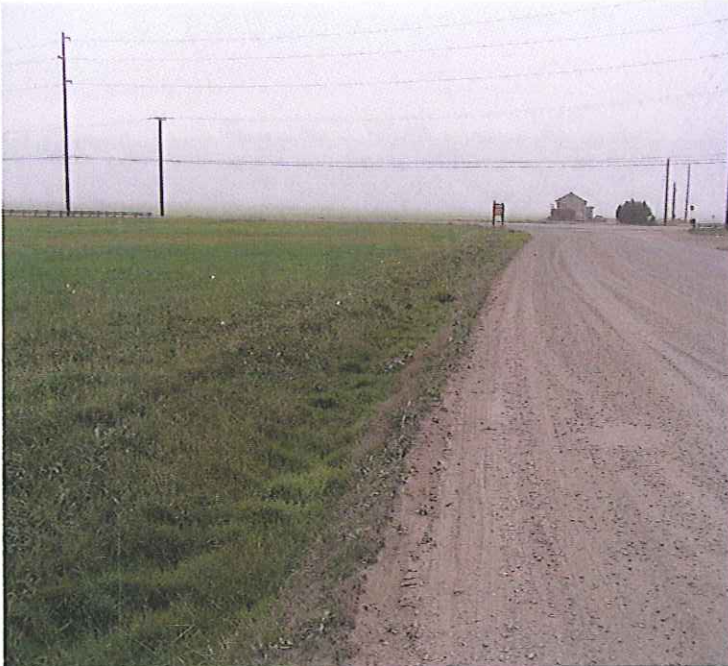
PHOTO #:17 DATE: 10/24/13 TAKEN BY: JEANNE TRAN
DESCRIPTION: A VIEW OF THE FACILITY'S ACCESS ROAD, WHERE THE TRANSFER PIPE TRAVELS ALONG UNDERGROUND AND ACROSS THE FARM TO MARKET ROAD.

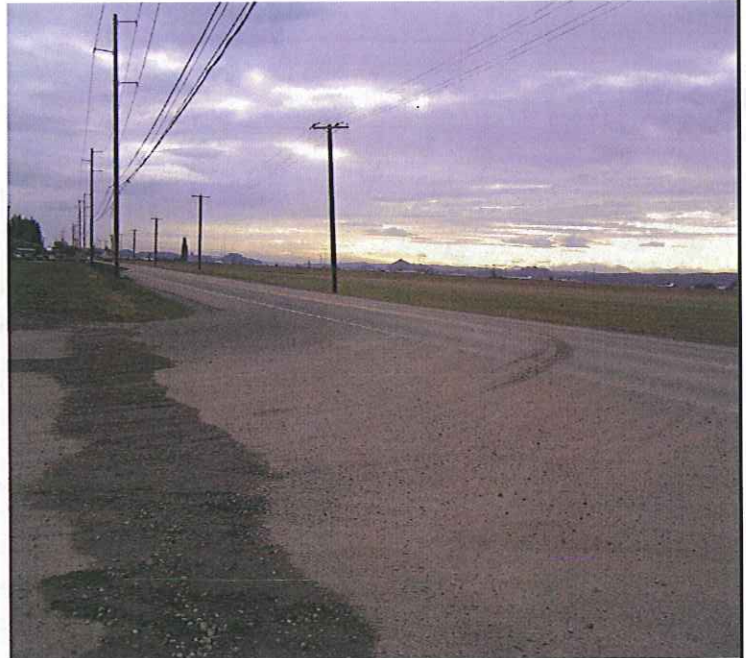
PHOTO #:18 DATE: 10/24/13 TAKEN BY: JEANNE TRAN
DESCRIPTION: FARM TO MARKET ROAD, THE TRANSFER PIPE TRAVELED UNDERNEATH THIS ROAD AND ACROSS TO THE LAND APPLICATION SITE.

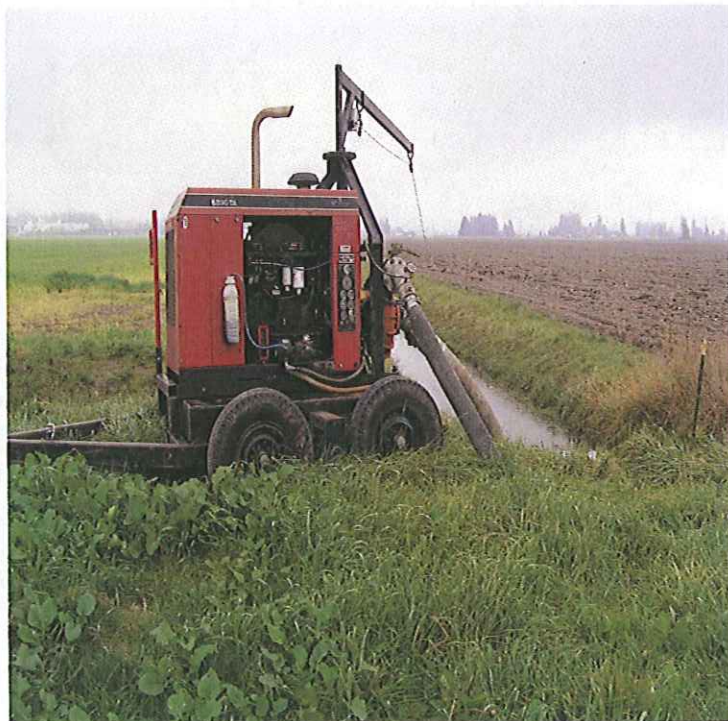
PHOTO #:19 DATE: 10/24/13 TAKEN BY: JEANNE TRAN
DESCRIPTION: WATER FROM THE TRANSFER PIPE DISCHARGES INTO THE FIELD DITCH PRIOR TO BEING LAND APPLIED TO THE FIELD.

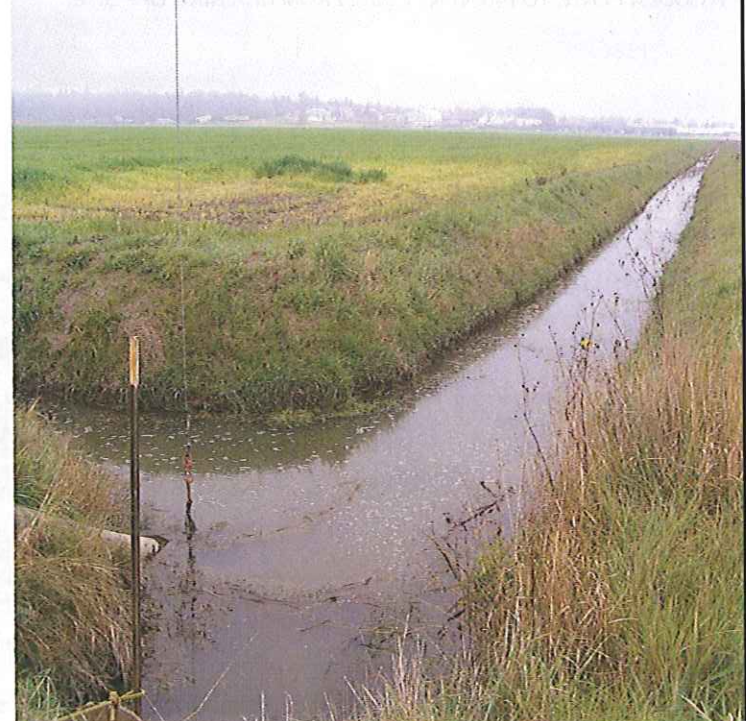
PHOTO #:20 DATE: 10/24/13 TAKEN BY: JEANNE TRAN
DESCRIPTION: A CLOSE-UP VIEW OF THE FIELD DITCH IN THE FARMLAND APPLICATION SITE.

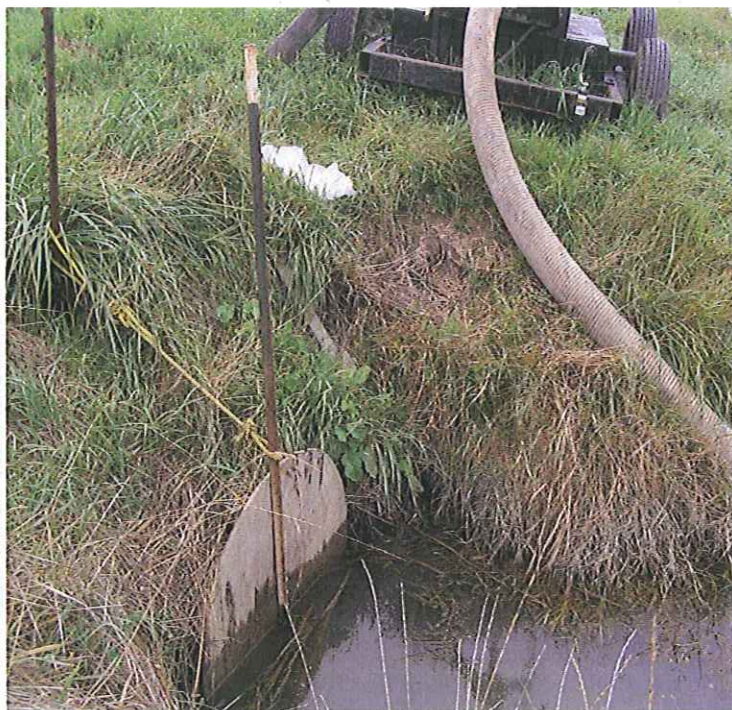
3) The outlet of the settling pond is piped underneath and across the facility's access road and across the public access road (Farm to Market Road), to the farmland (see photos #14-18). The water is emptied into the field ditch (see photos #19 - 24), where it is then drawn and irrigated on the field. Each end of the field ditch is blocked off with a wooden barrier/plate to prevent water from draining off-site (see photos #21 and 24). The entire farmland is approximately 140 acres in area.

PHOTO #:21 DATE: 10/24/13 TAKEN BY: JEANNE TRAN
DESCRIPTION: EACH END OF THE DITCH IS BLOCKED OFF WITH A WOODEN PLATE TO PREVENT FLOW FROM DRAINING OFF SITE.

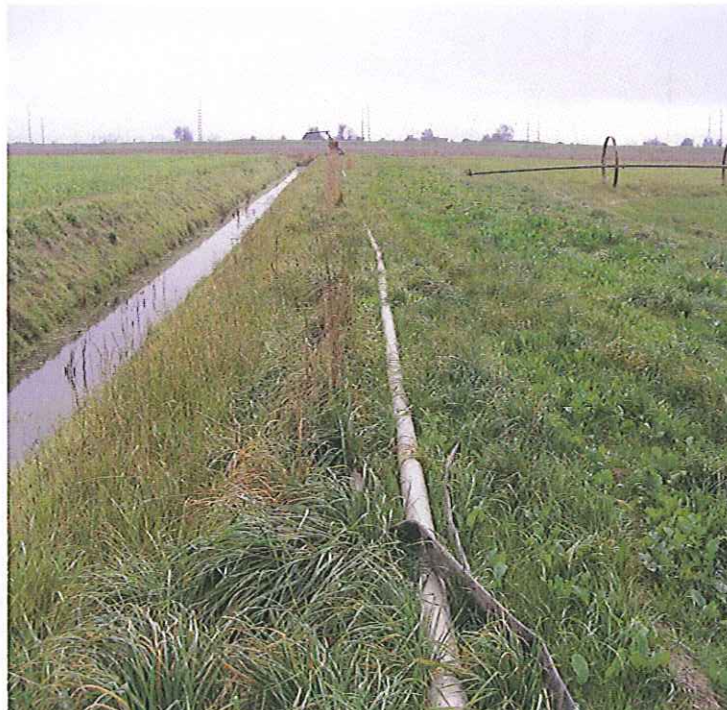
PHOTO #:22 DATE: 10/24/13 TAKEN BY: JEANNE TRAN
DESCRIPTION: WATER IN THE DITCH IS THEN WITHDRAWN AND LAND APPLIED THROUGH AN IRRIGATION SYSTEM.

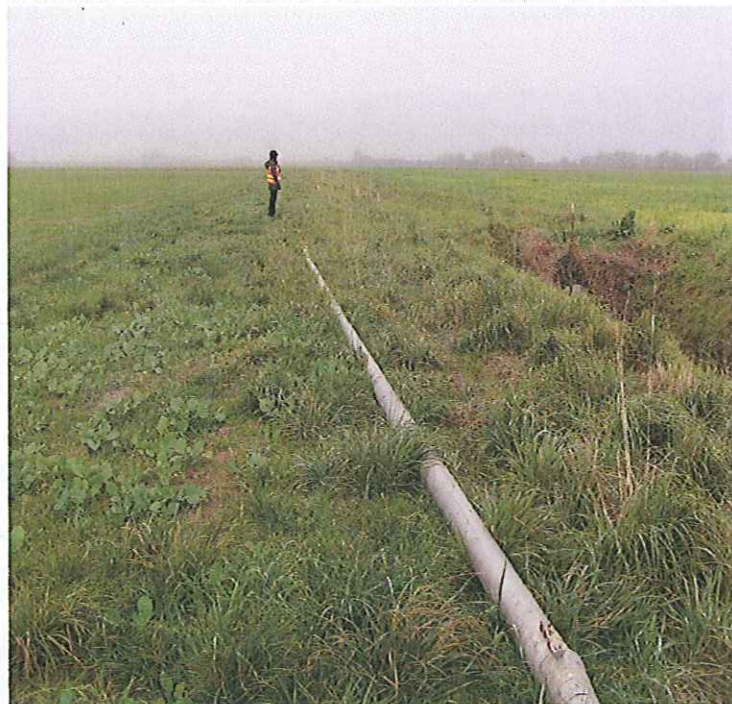
PHOTO #:23 DATE: 10/24/13 TAKEN BY: JEANNE TRAN
DESCRIPTION: ANOTHER VIEW OF THE END OF THE FIELD DITCH.

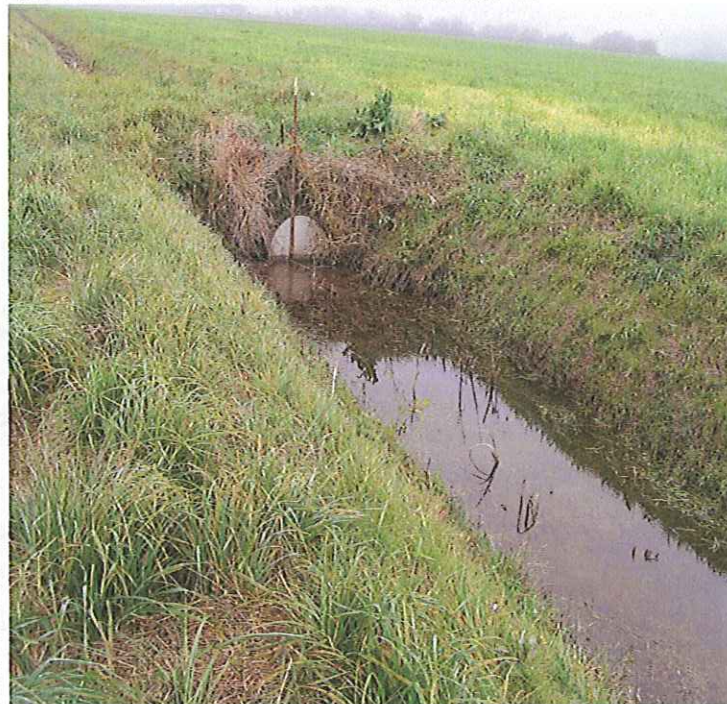
PHOTO #:24 DATE: 10/24/13 TAKEN BY: JEANNE TRAN
DESCRIPTION: ANOTHER VIEW OF THE END OF THE FIELD DITCH WHICH IS BLOCKED OFF TO PREVENT FLOW FROM DRAINING OFF-SITE.
