STUDY WELL LOCATIONS, IN-STREAM PIEZOMETER THERMOGRAPHS, AND STREAM SEEPAGE RESULTS FOR THE DESCHUTES RIVER AND PERCIVAL CREEK WATERSHEDS, THURSTON COUNTY, WASHINGTON

By
K.A. Sinclair and D.B. Bihmer
2007

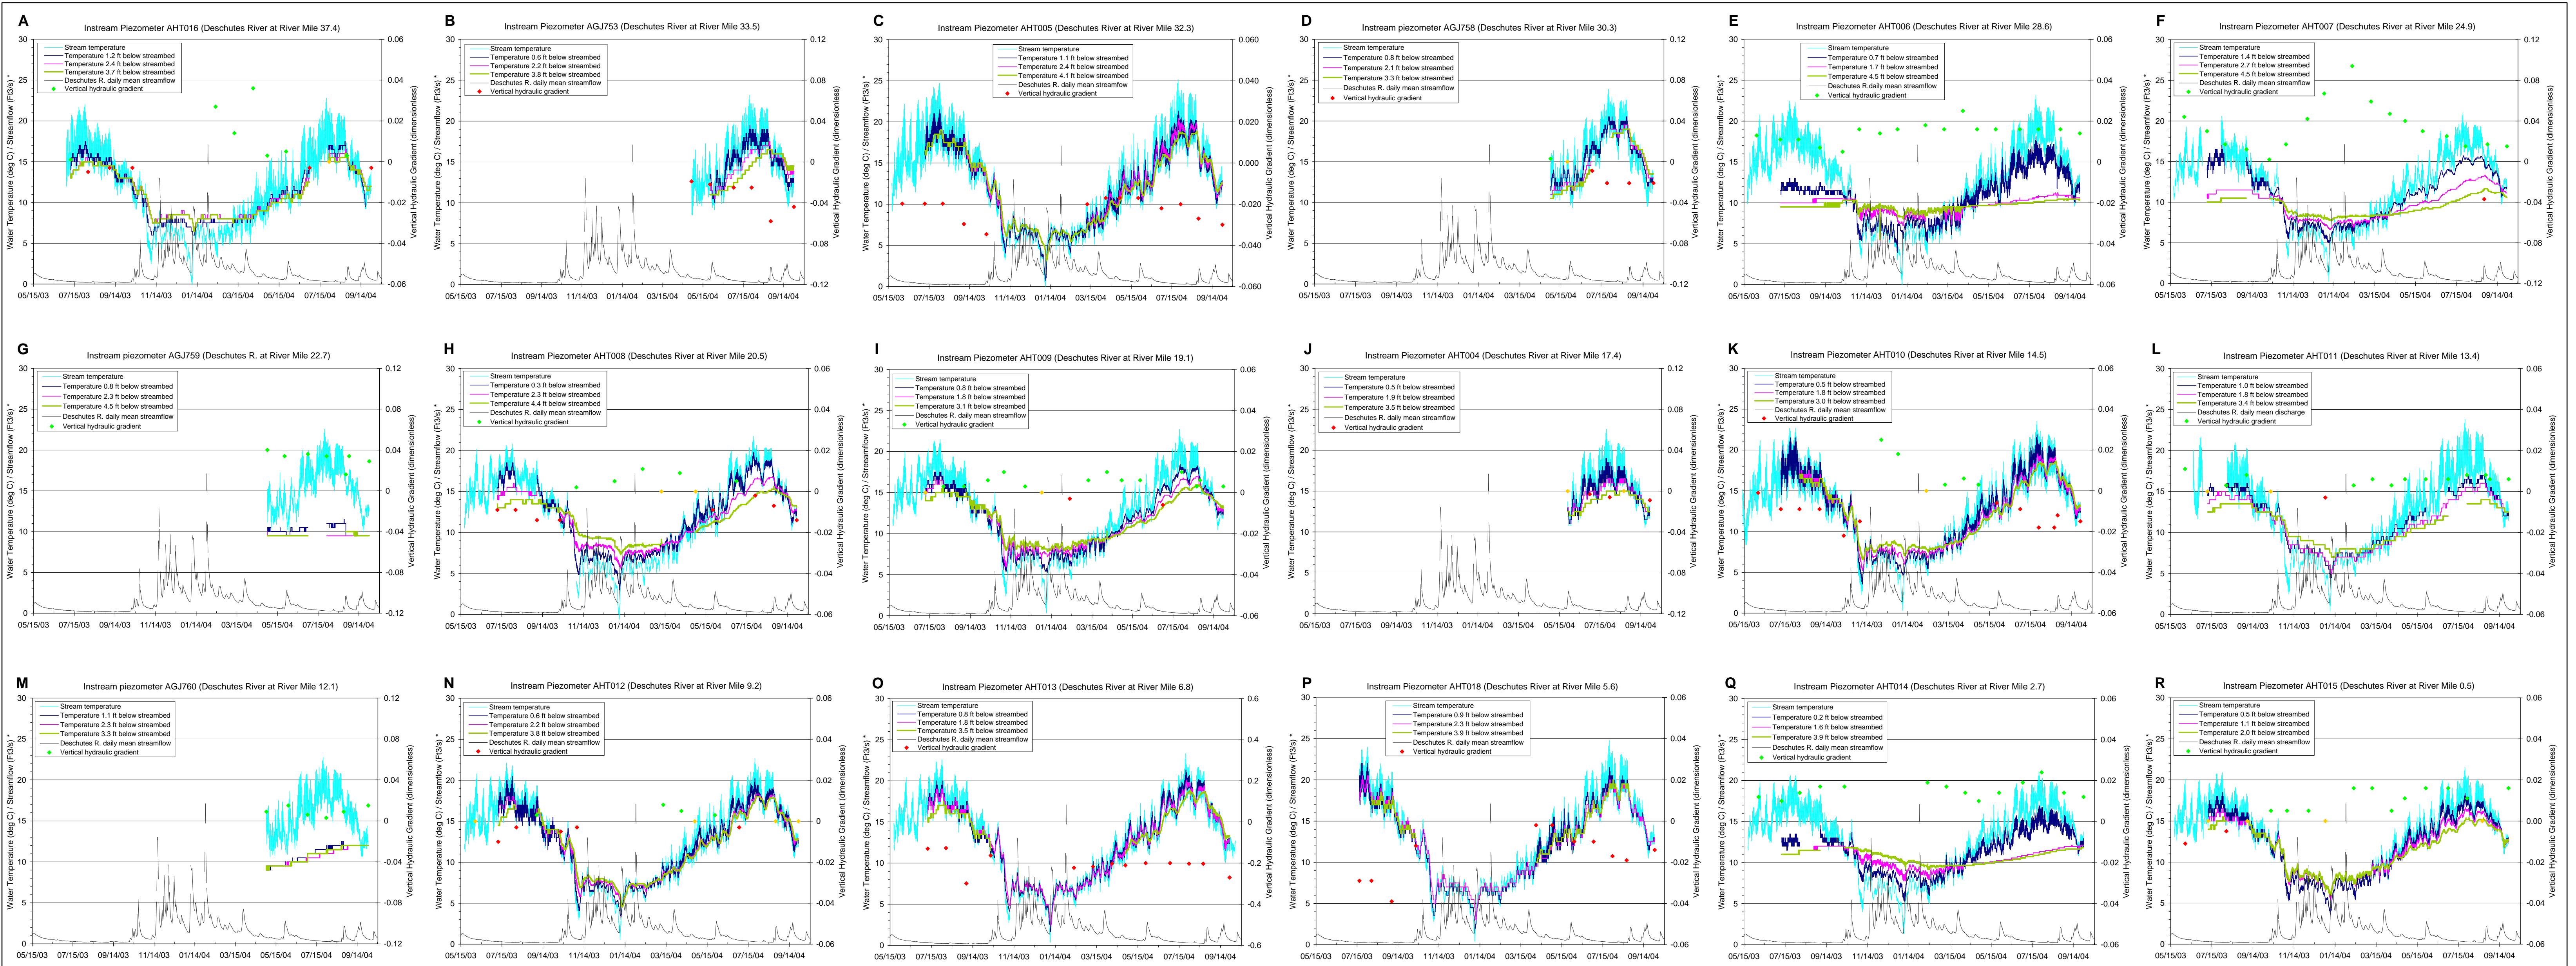
FIGURE 2 EXPLANATION

Positive hydraulic gradient
 No measurable gradient
 Negative hydraulic gradient

* To accommodate graph scale limitations, the streamflow values shown in graphs A-R, and W, depict only one percent of the actual daily mean streamflow measured at the Deschutes River gaging station near Rainier (USGS 1207900).

FIGURE 2 - Instream piezometer and off-stream well thermographs, by map ID

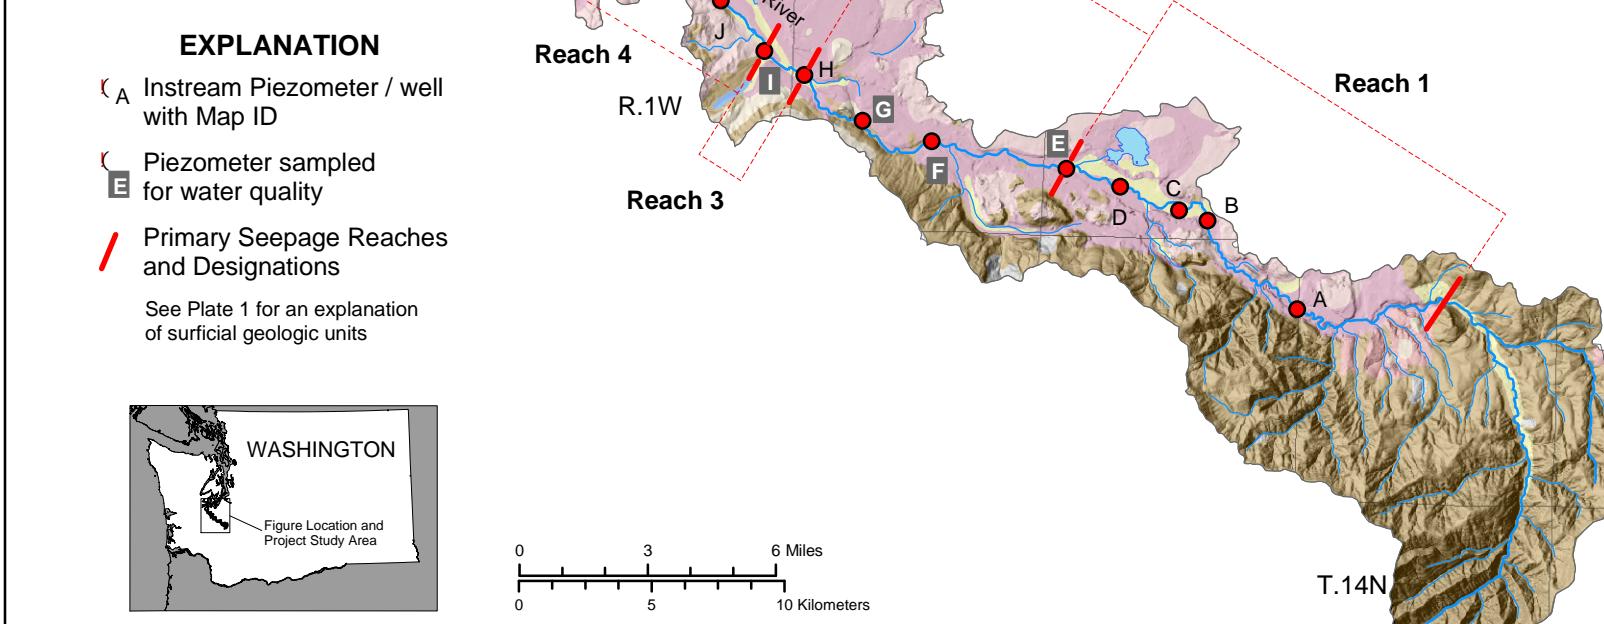
FIGURE 1 - Wells, instream piezometers, seepage reaches, and generalized surficial geology

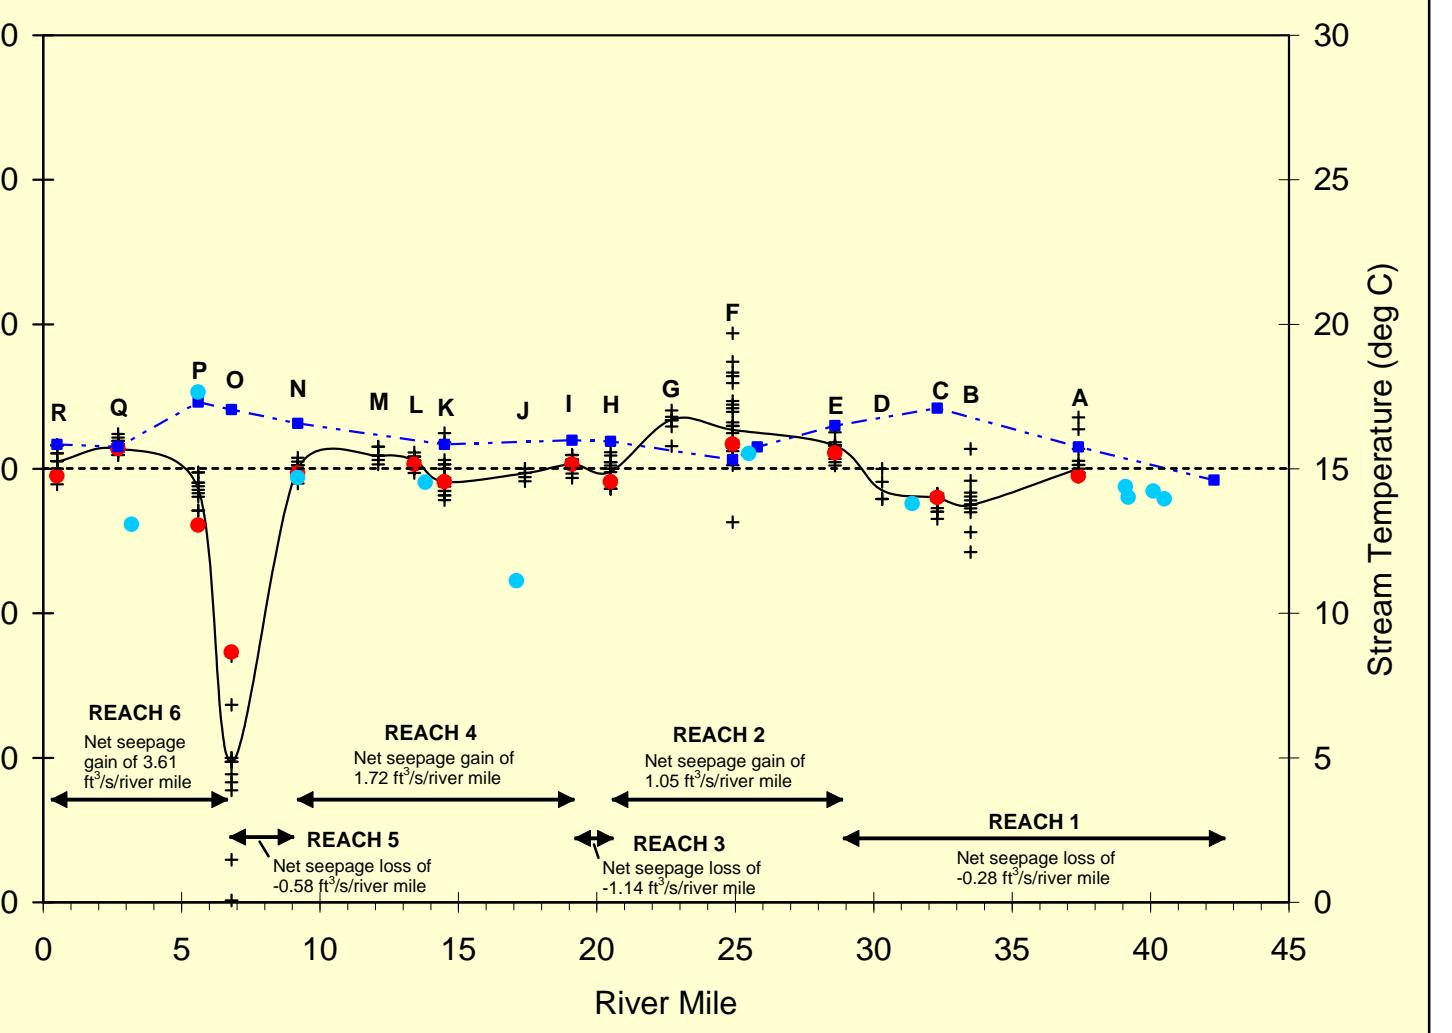
FIGURE 3
Net seepage values by reach,
vertical hydraulic gradients in
instream piezometers, and daily
mean stream temperatures
measured during the August 5, 2003
seepage evaluation of the
mainstem Deschutes River.

- A** Instream piezometer with map ID (see Figure 1 at left)
- Hydraulic gradient measured during seepage evaluation
- August 5, 2003 daily mean temperature for the mainstem Deschutes River
- August 5, 2003 daily mean temperature measured at major tributaries to the mainstem Deschutes River
- Median hydraulic gradient value for the 2003-2004 study period
- E Individual hydraulic gradients measured during the 2003-2004 study period
