**Lake Ballinger
Total Phosphorus
Total Maximum Daily Load**

**Water Quality
Attainment Monitoring Report**

April 2008

Publication No. 08-03-007

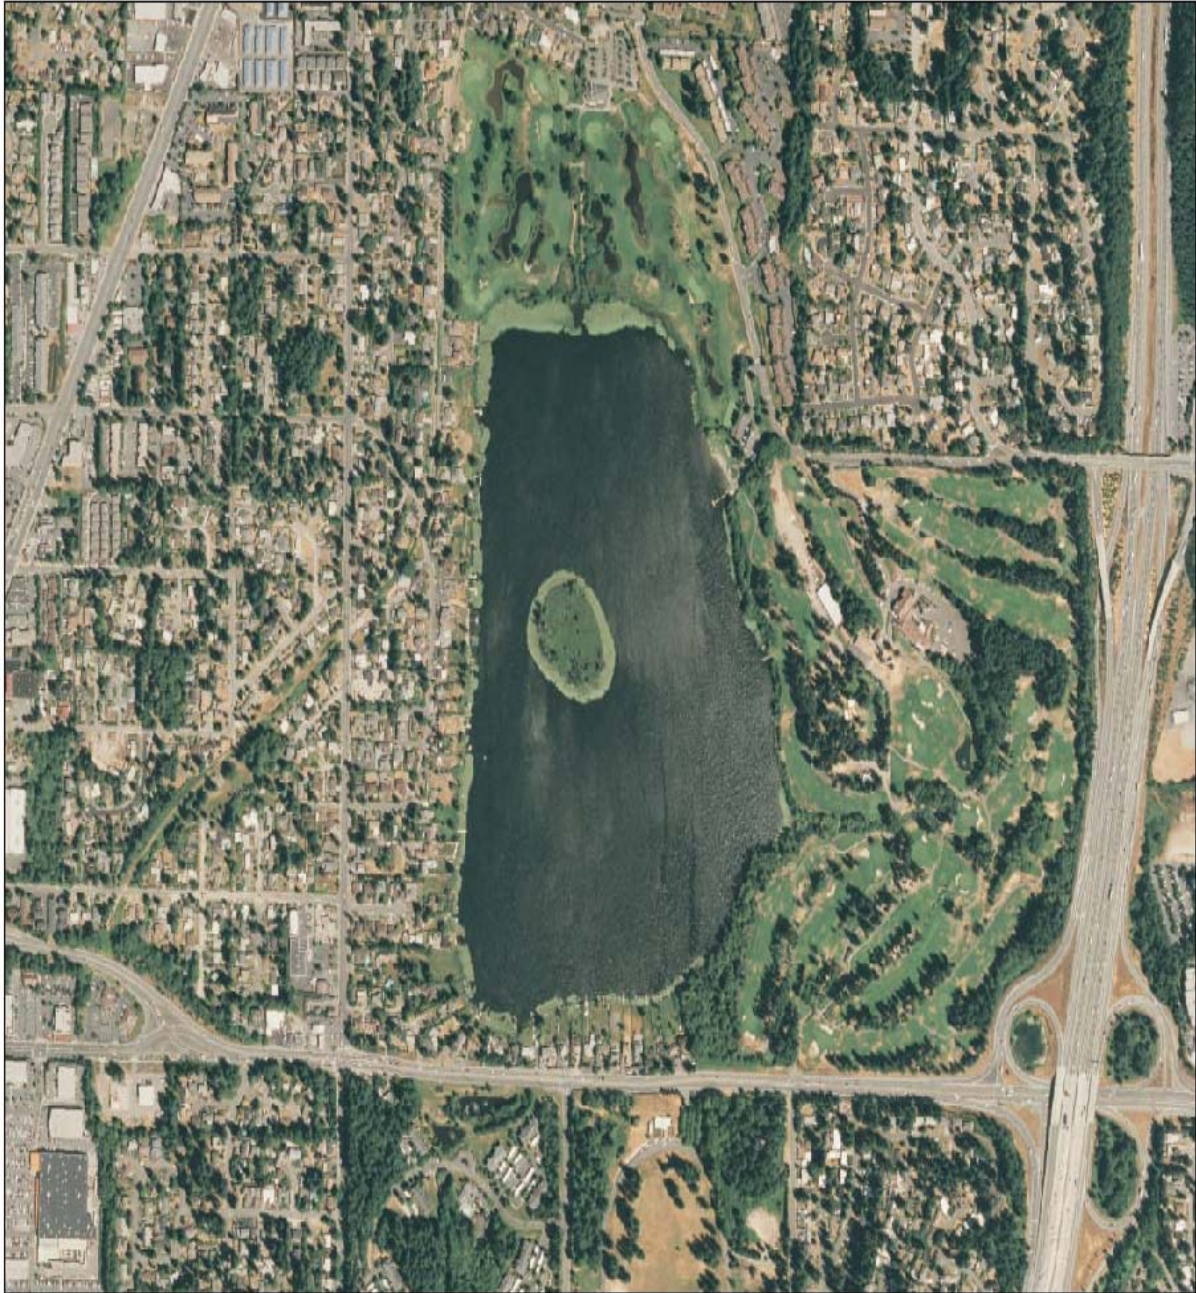
Figure 1. Aerial photo of Lake Ballinger.

Lake Ballinger is in Snohomish County and within the cities of Mountlake Terrace and Edmonds between Interstate 5 and Highway 99 (Figure 1). The lake has a surface area of approximately 40.5 hectares (100 acres), a maximum depth of 11 meters (35 feet), and an average depth of 5 meters (15 feet).

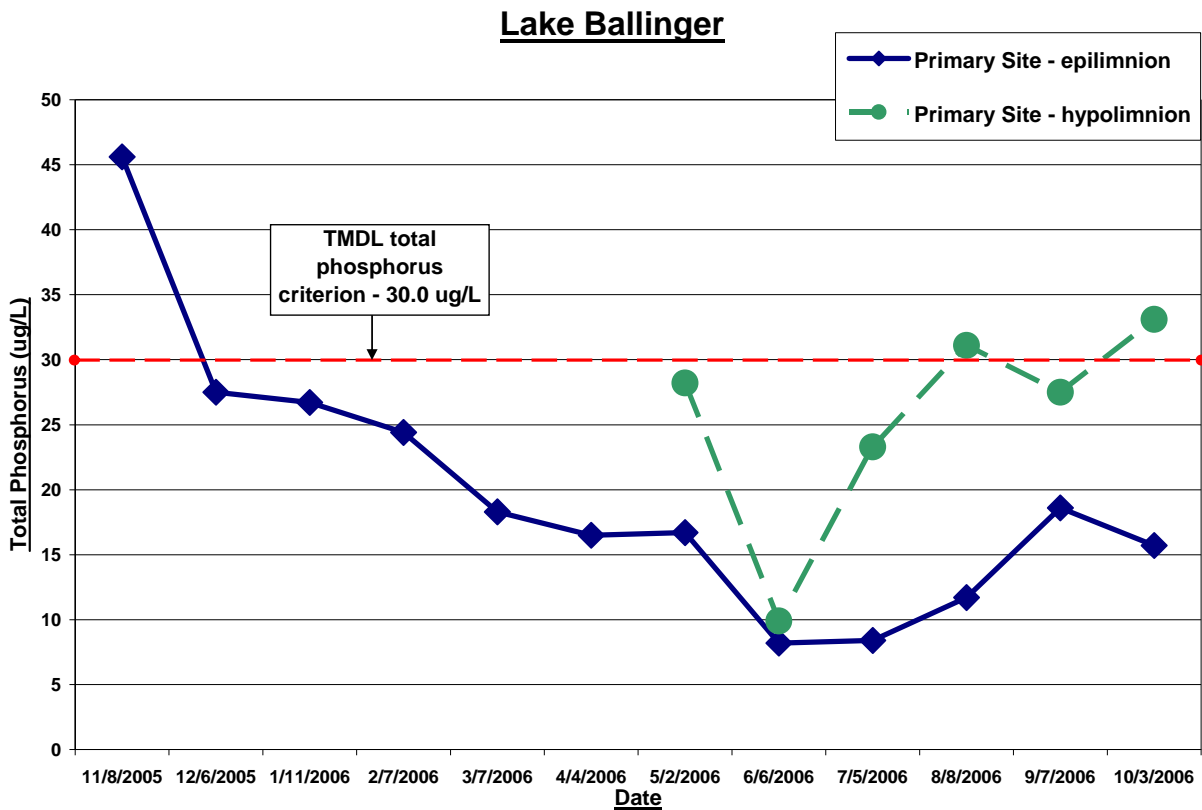
Figure 3. Monthly total phosphorus concentrations at the primary sampling location for Lake Ballinger.

These criteria were established in 1997, after the Lake Ballinger TMDL was approved. However, the mean summer epilimnetic total phosphorus result from this 2005-06 current study (11.7 µg/L) shows Lake Ballinger below the criteria for a mesoeutrophic lake as well as below the TMDL criteria of 30.0 µg/L.

Figure 3 shows the monthly total phosphorus concentrations for Lake Ballinger.

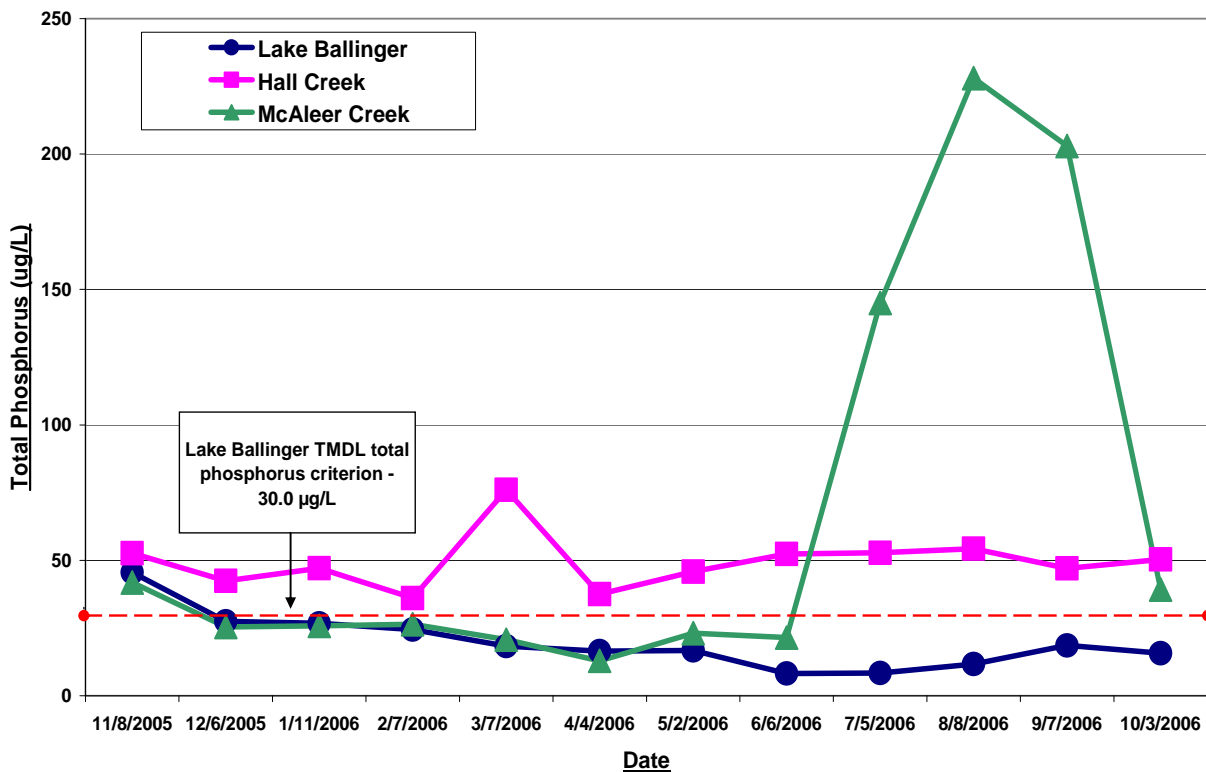
Figure 4. Total phosphorus levels for Hall Creek and McAleer Creek as compared to Lake Ballinger.

In McAleer Creek, total phosphorus concentrations got much higher. They ranged from 12.9 µg/L on 4/4/2006 to 228.0 µg/L on 8/8/2006. The minimum and maximum orthophosphate concentrations also occurred on these same dates and were 4.7 µg/L and 30.0 µg/L, respectively.

Comparisons of monthly total phosphorus concentrations in Hall Creek, Lake Ballinger, and McAleer Creek are shown in Figure 4.

Monthly total phosphorus concentrations in Hall Creek were consistently higher than those measured in Lake Ballinger. Total phosphorus concentrations in McAleer Creek correlated closely to Lake Ballinger concentrations until July 2006. Increased total phosphorus levels in McAleer Creek appeared to coincide with the release of hypolimnetic water from Lake Ballinger into McAleer Creek. At this same time, anoxic conditions existed in Lake Ballinger allowing for the release of phosphorus from the lake sediments.
