## **Appendix E. Acoustic Doppler Current Profiler (ADCP) Results**

Table E-1. Transects conducted July 10, 2007 across multiple inlets in South Sound on a flooding tide (page 2)

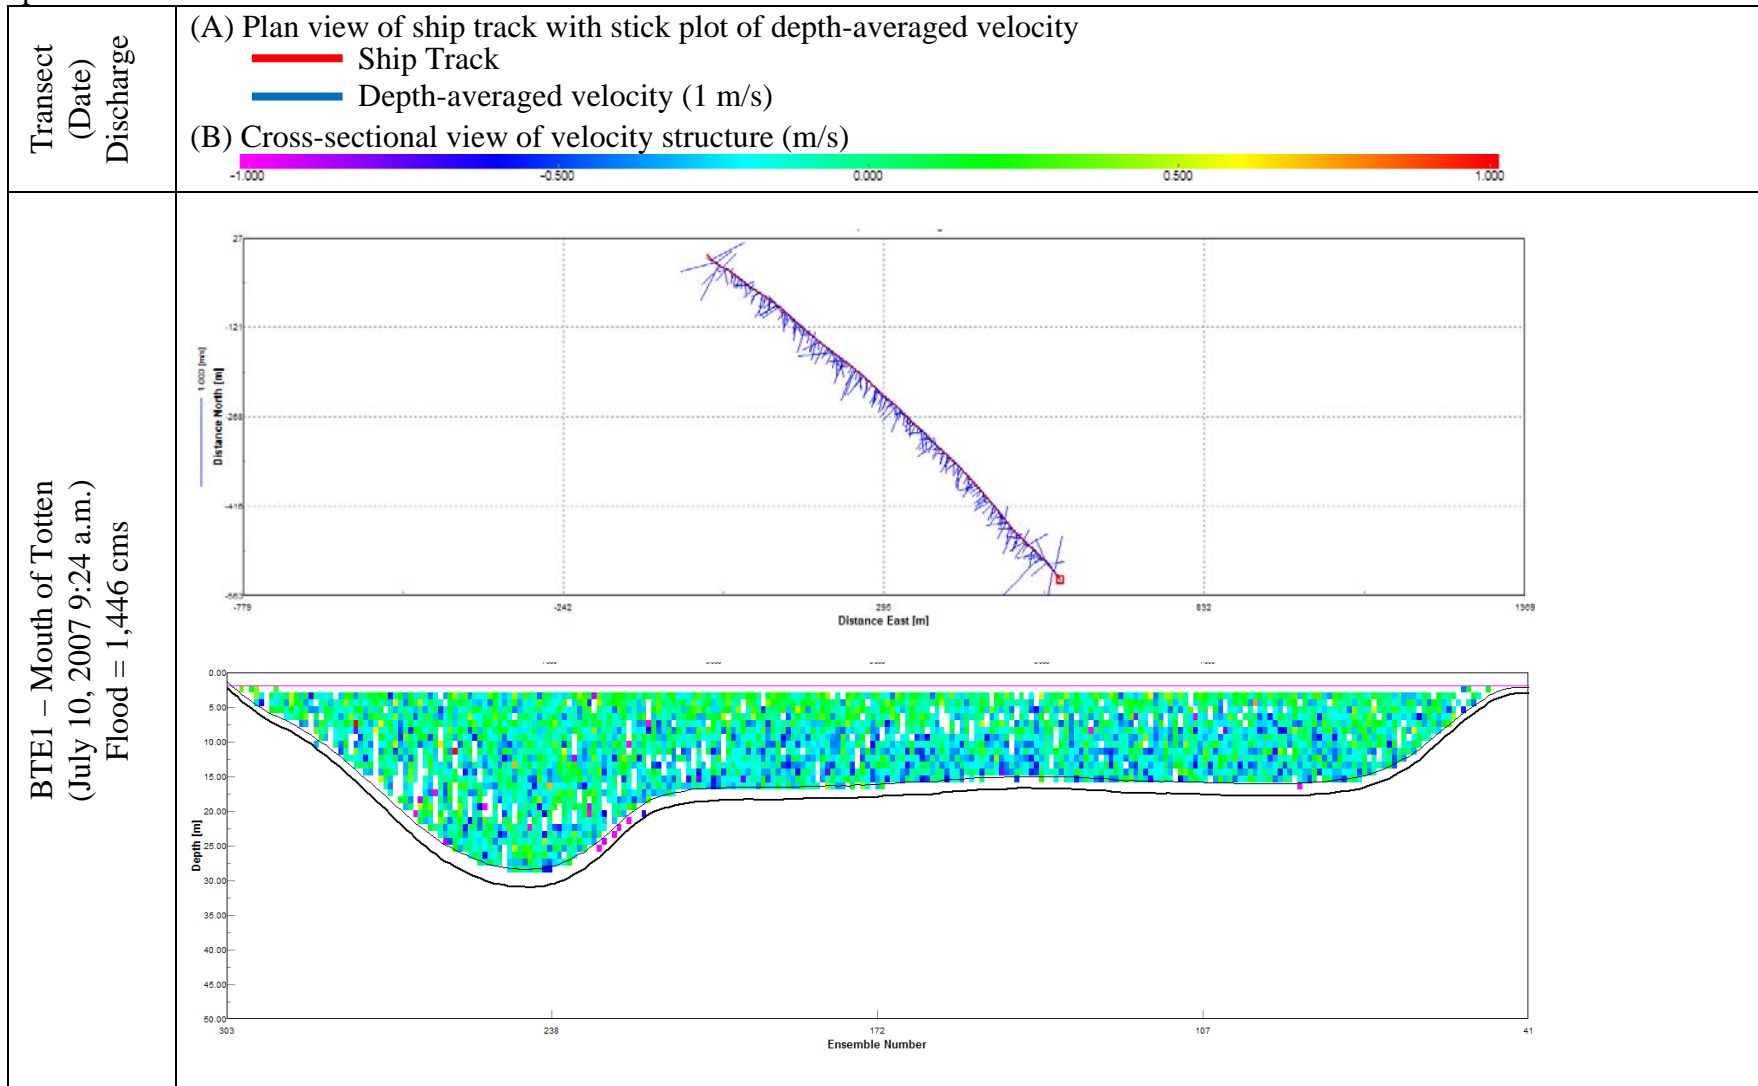
Table E-1. Transects conducted July 10, 2007 across multiple inlets in South Sound on a flooding tide. Colors indicate the flow direction, with red and blue in opposite directions. Magnitude is expressed as color intensity, with the darkest colors indicating the highest velocities. The transects indicate that while flow patterns are fairly uniform even where bottom topography is complex, flow patterns around Hope Island are particularly complicated. The northern ends of Case and Carr also exhibit lateral variability in flow patterns.

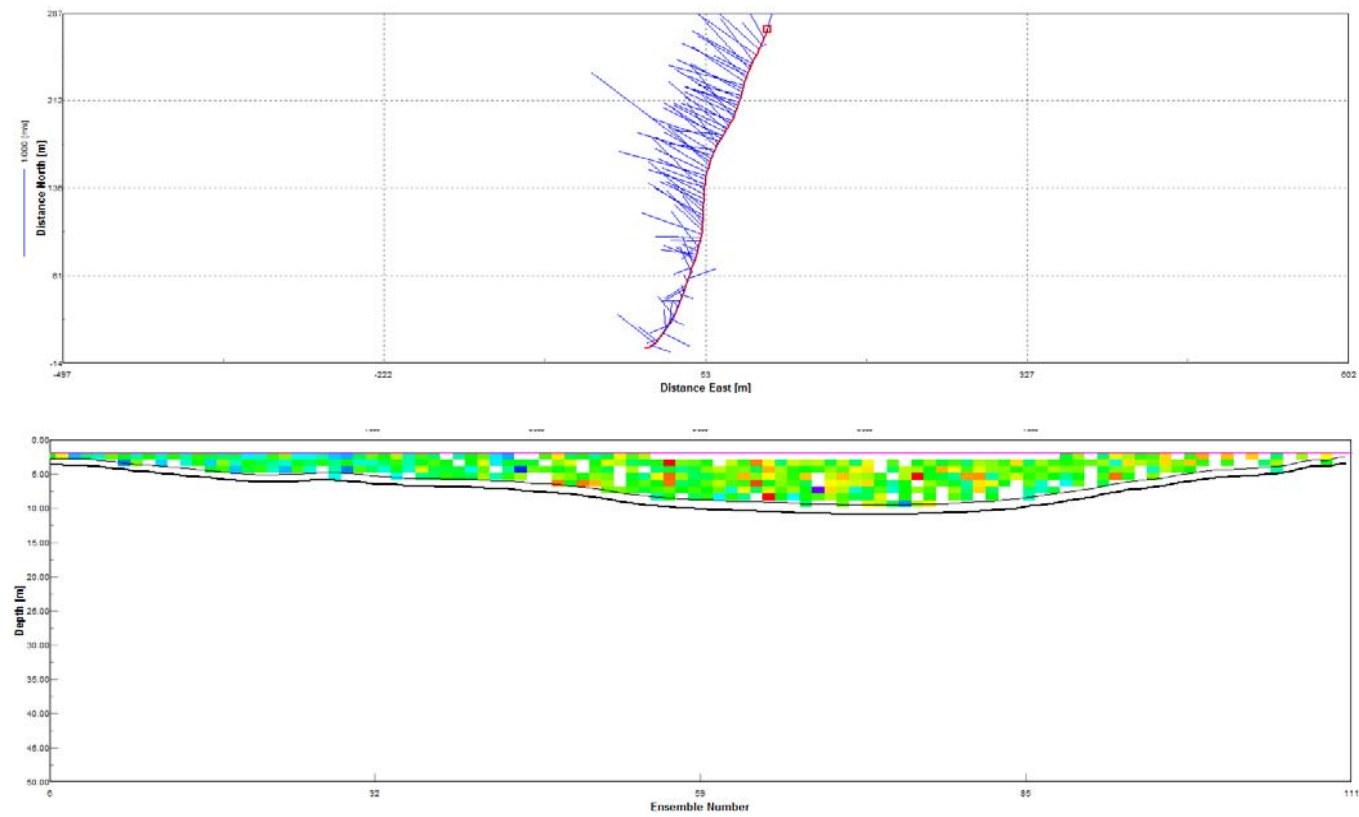
BTE2a – N. of Hope Island  
(July 10, 2007 11:22 a.m.)  
Total = 1,104 cms (Flood = 1,111 cms and Ebb = 7 cms)

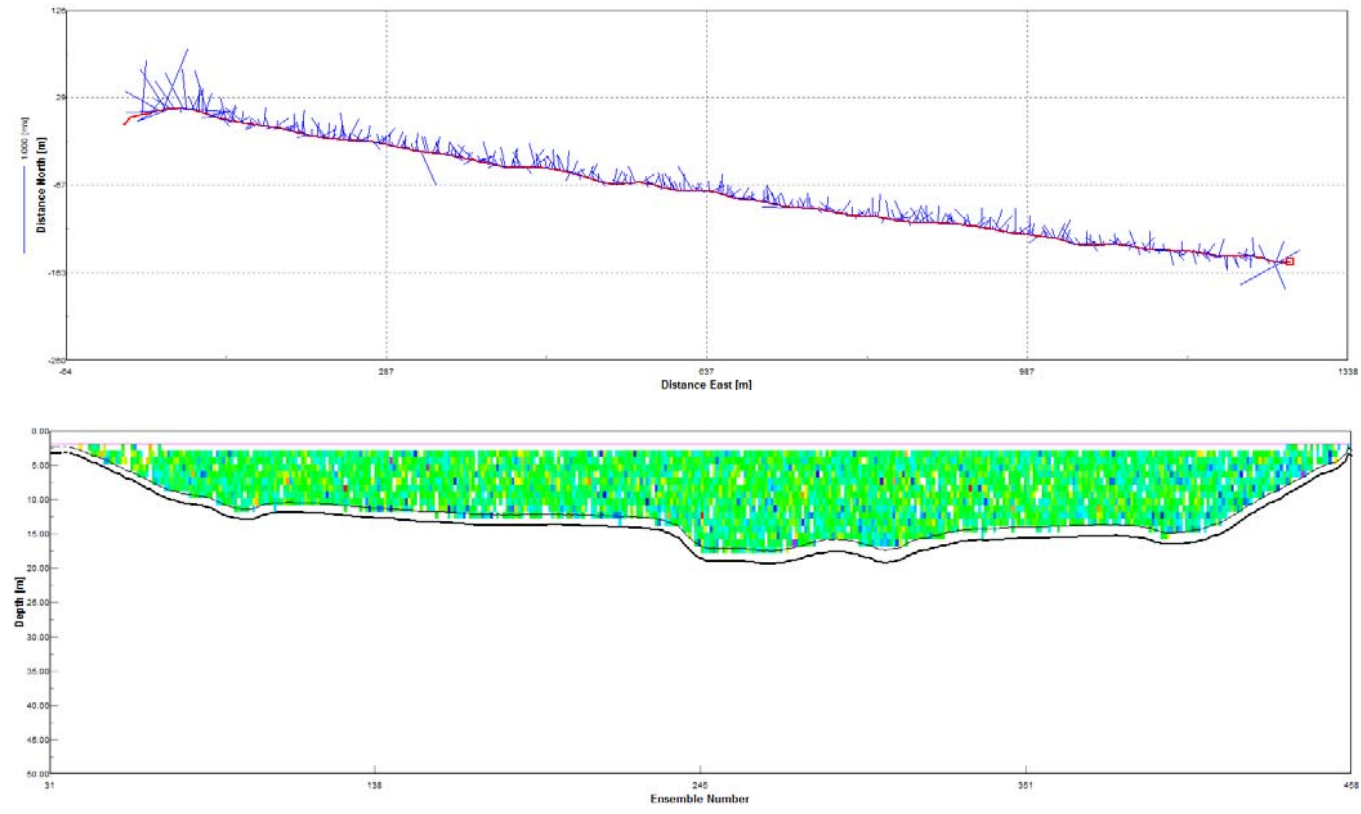
Case5 – Rocky Pt.  
(July 12, 2007 2:25 p.m.)  
Flood = 1,562 cms

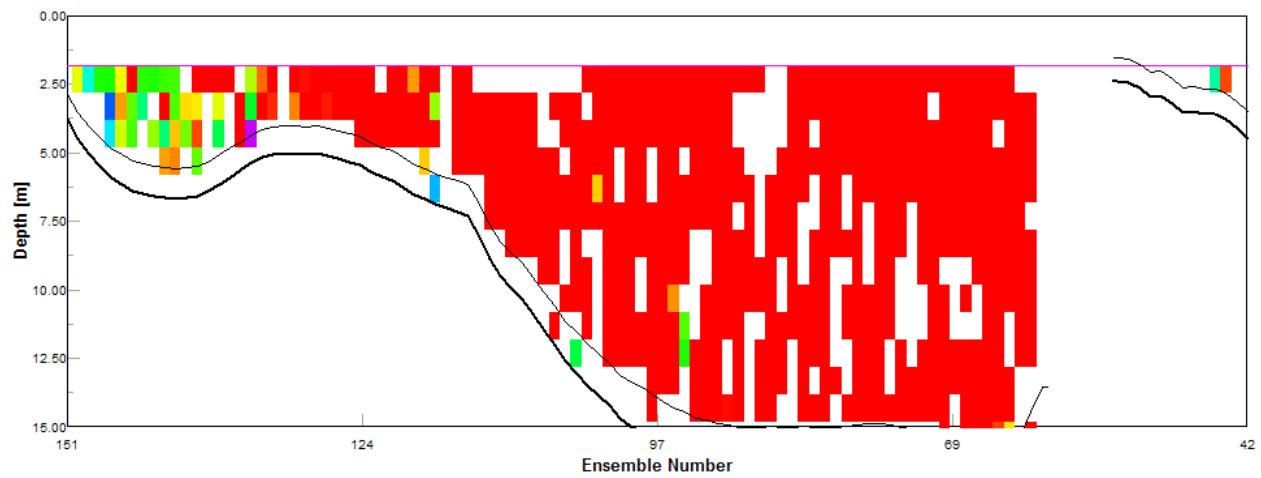
T5 – Hammersley Inlet  
(September 26, 2007 9:26 a.m.)  
Ebb = 3,162 cms

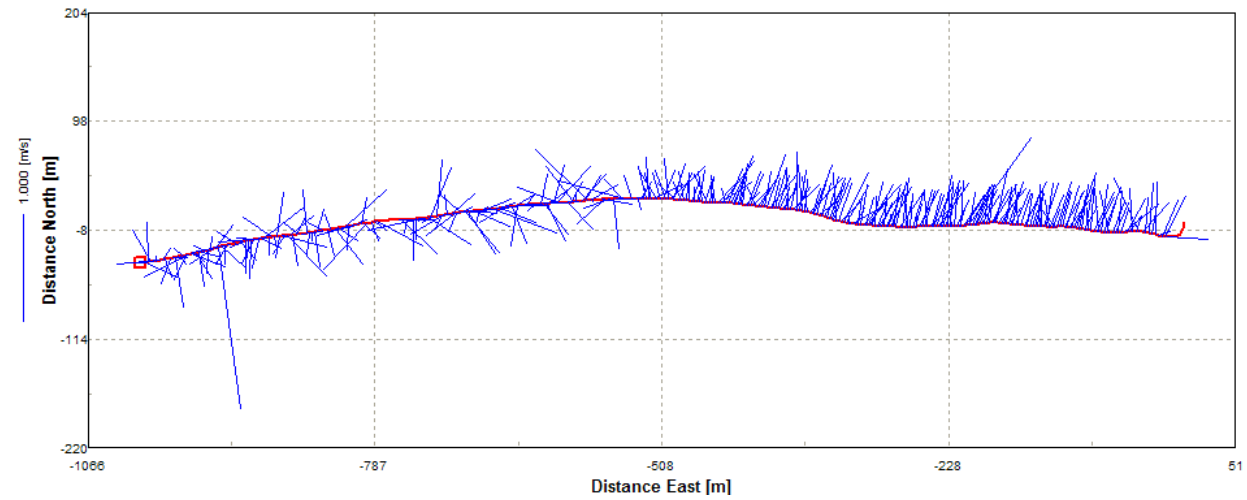
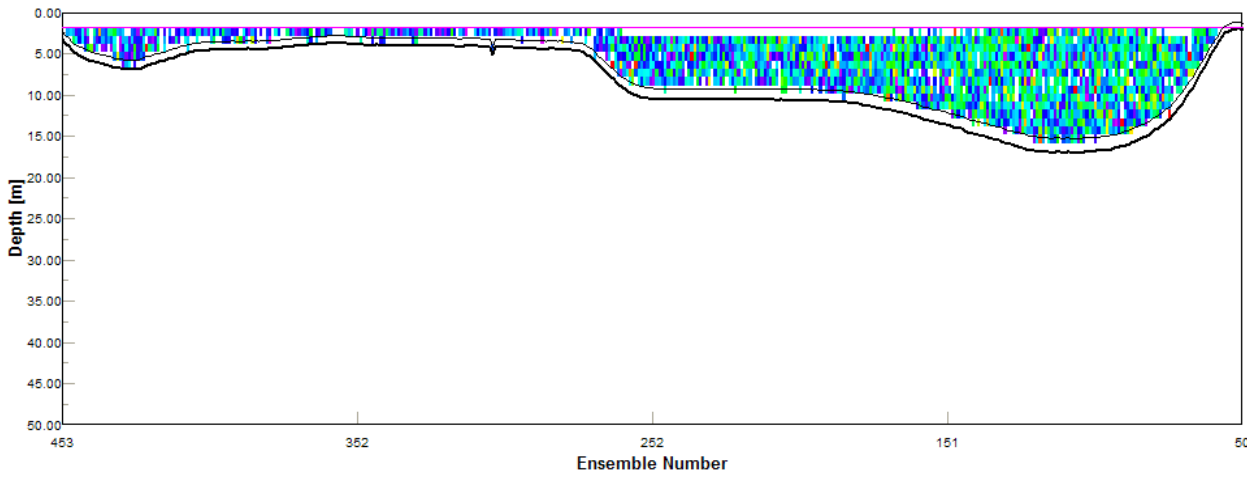
T6 – Potlatch Pt. (S. of Hope Island)  
(September 26, 2007 9:41 a.m.)  
Ebb = 1,828 cms

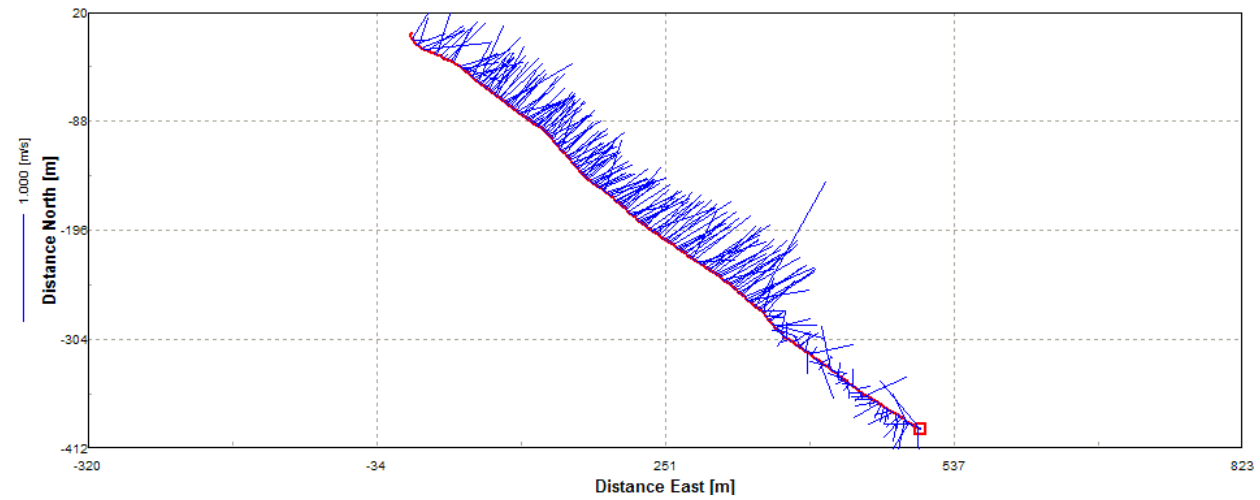
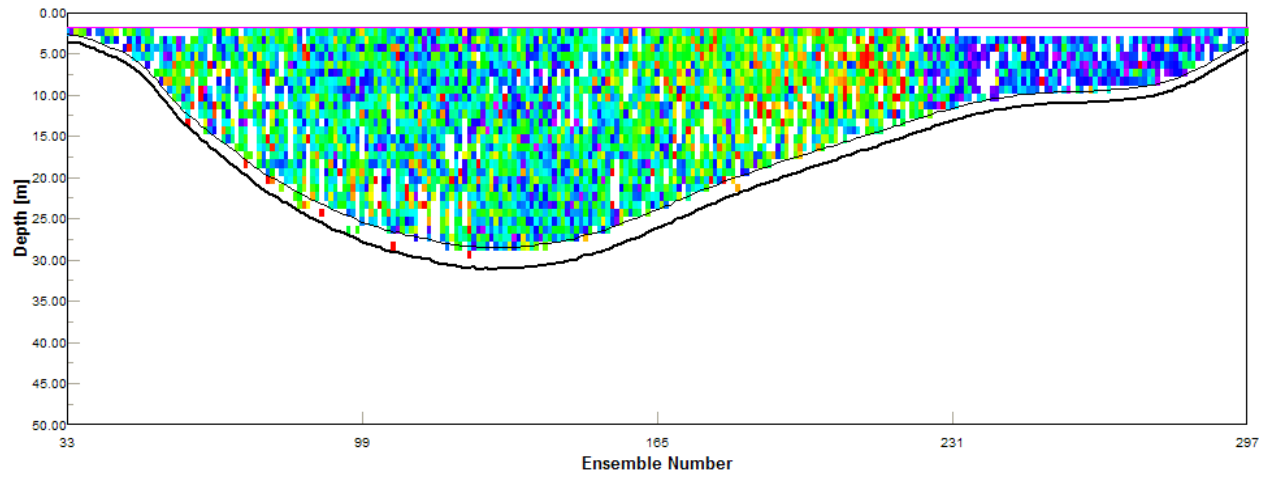
T7 – Totten  
(September 26, 2007 10:06 a.m.)  
Ebb = 3,953 cms

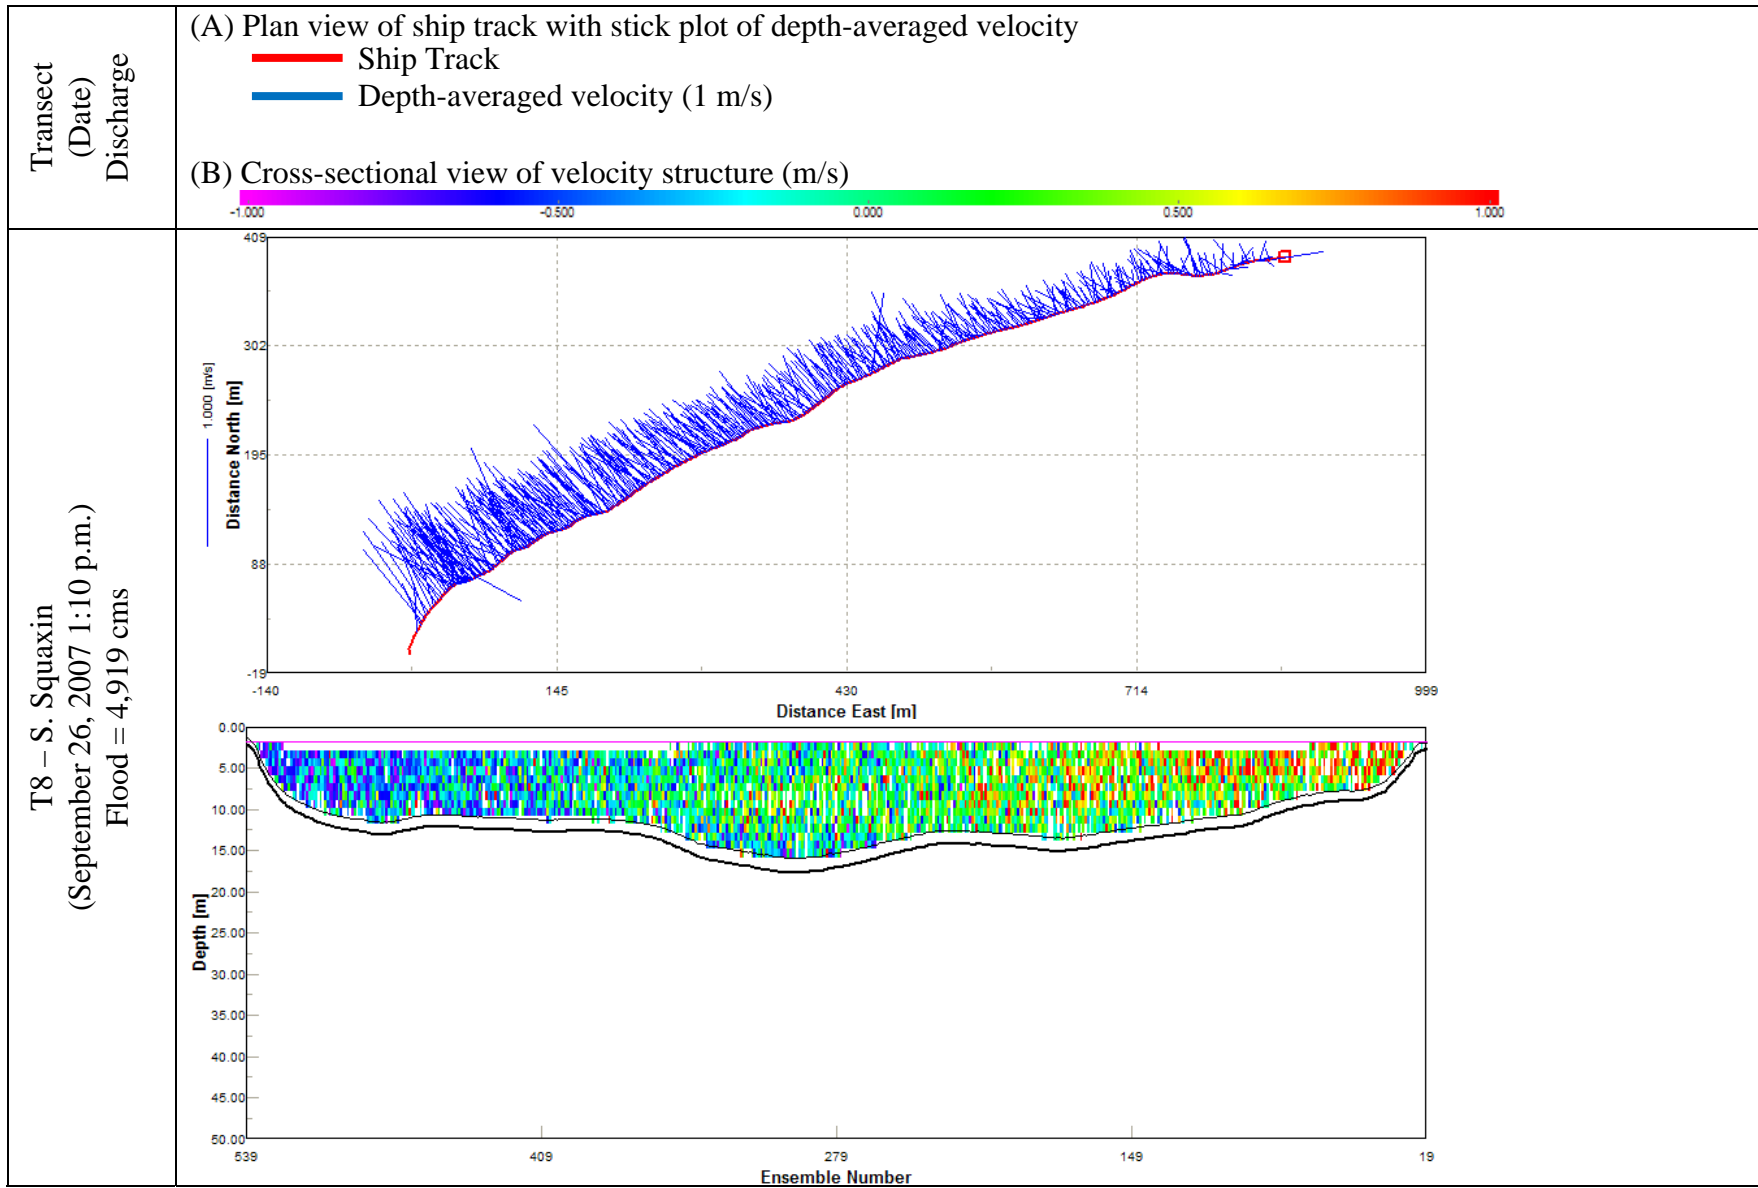
Table E-3. Flood-tide transects conducted the afternoon of September 26, 2007. See Table E-1 for legend.

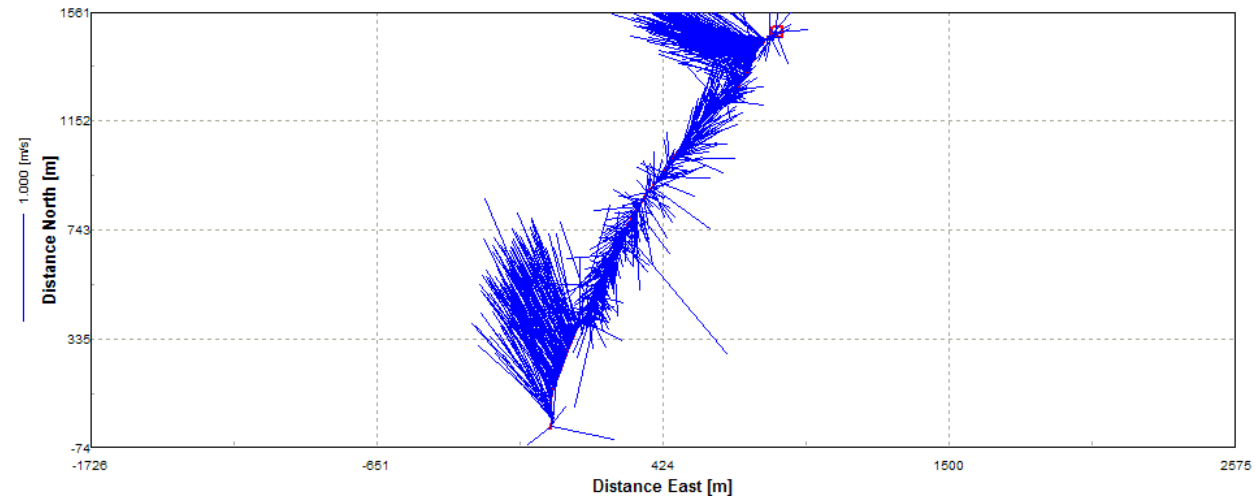
T12 – Hope Island Inner  
(September 27, 2007 1:40 p.m.)  
Flood = 4,957 cms

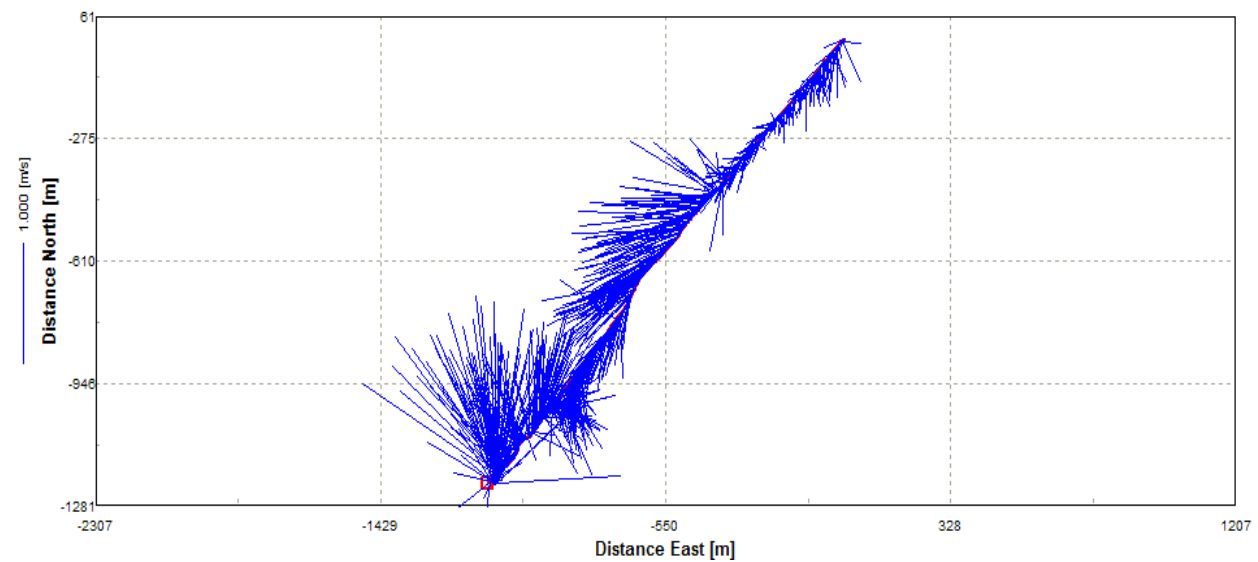
T14 – Hope Island Outer  
(September 26, 2007 2:16 p.m.)  
Flood = 4,080 cms

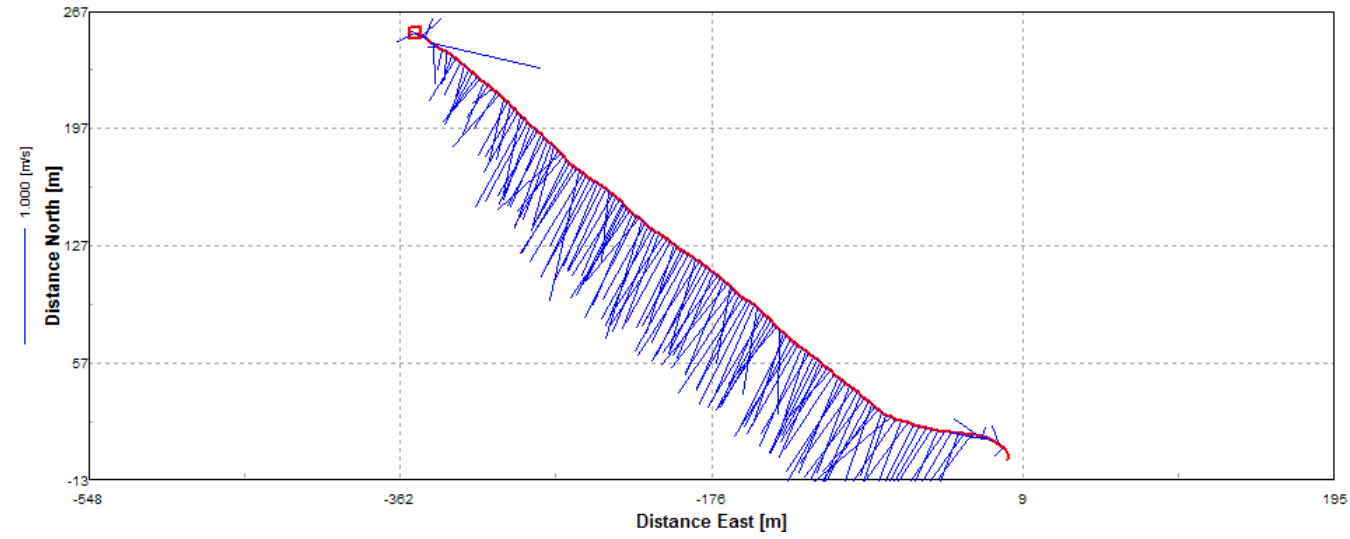
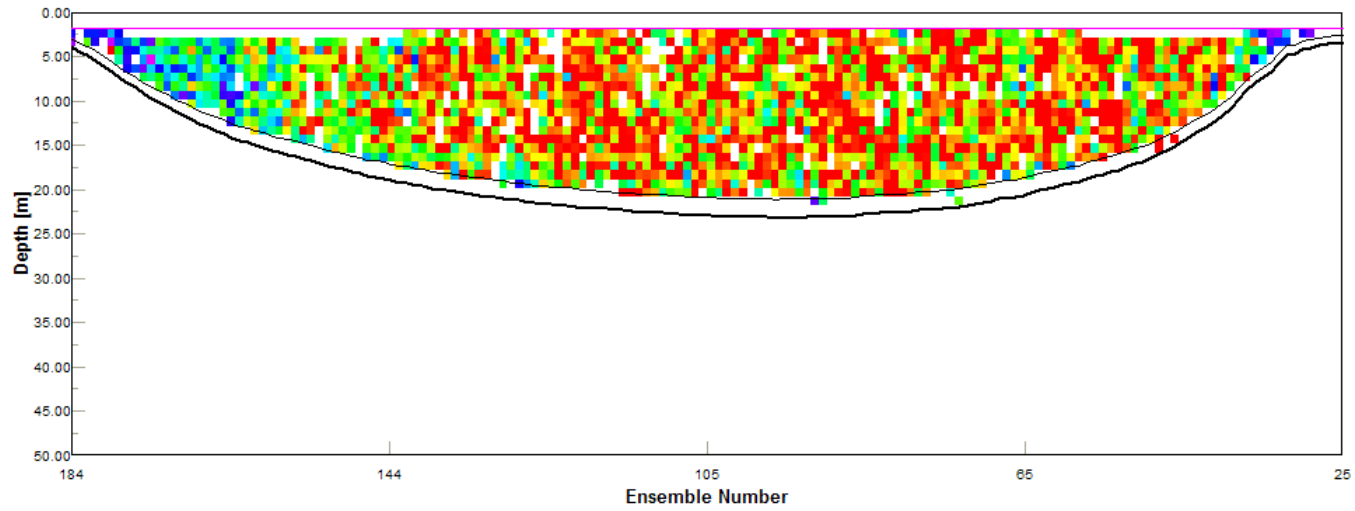
T1 – Harstine bridge  
(September 26, 2007 4:34 p.m.)  
Flood = 5,514 cms
