## The CATHERINE QUIGG

On Monday morning, September 4, 2006, the tug CATHERINE QUIGG was conducting an internal transfer. The Engineer transferred diesel fuel oil from the tug's storage tanks to a day tank. A day tank is typically a smaller fuel oil tank in or near the engine room. They store purified oil from which a vessel's engines draw their fuel 'for the day'. The tug was moored at the tug company facility in Seattle, Washington. The transfer began after 1045. At about 1110, the CATHERINE QUIGG was informed by another company tug that diesel was spilling off their deck into the water. The Engineer shut down the internal transfer. Approximately 43 gallons of diesel was spilled to waters of Washington State.

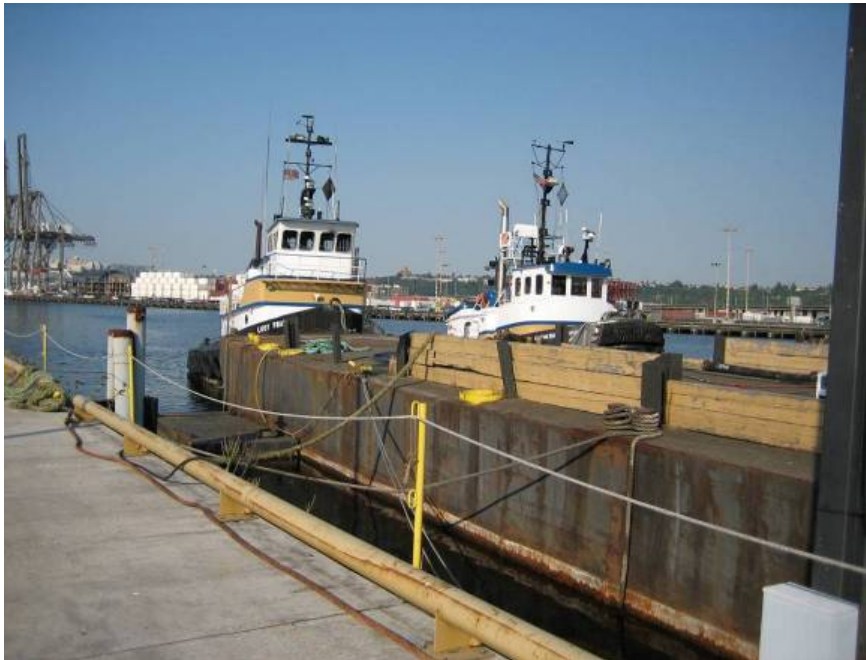
Figure 1 - CATHERINE QUIGG (tug on right) moored at Seattle on September 4, 2006.

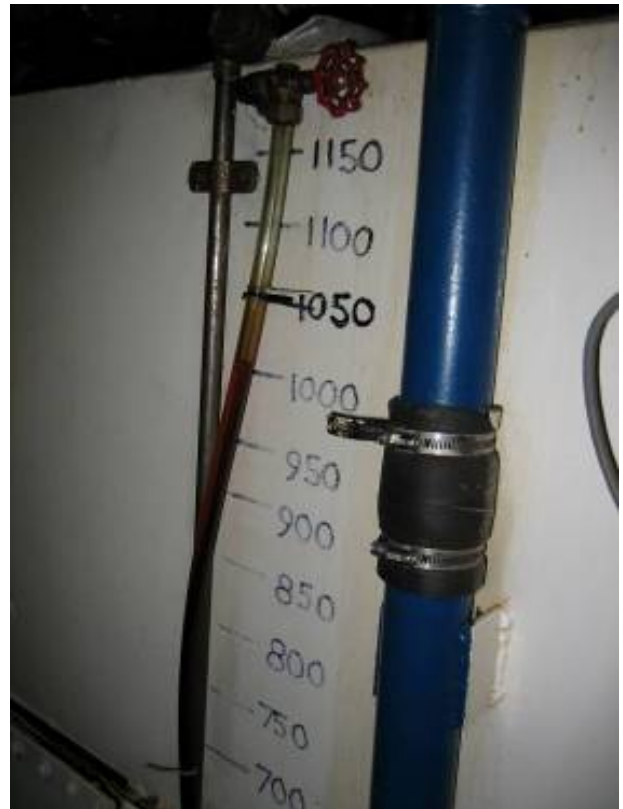
The tug's fuel tanks were all fitted with visual sight gauges (see Figure 2). The fuel tanks were not fitted with high level alarms. Staining on the interior of the plastic tube used as the port day tank sight gauge indicated the typical level in the tank was 1,050 gallons or less. It was common for the day tanks to be filled to between 750 and 1,050 gallons during internal transfers (about 65 to 91 percent of capacity).

Figure 2 – Port day tank sight glass.

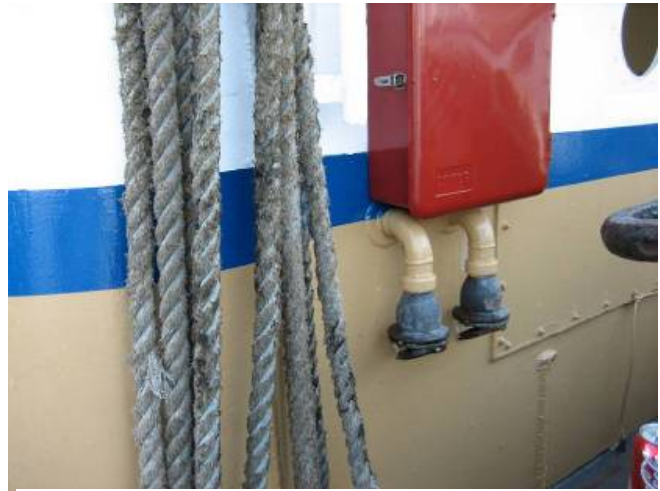
The Engineer believed that the “exaggerated trim” (trim describes the height of a vessel’s stern versus its bow as measured by relative depth of immersion at the waterline) of the tug put “the port tank vent at level with maximum fill mark.” He went on to say “During this transfer the vent being susceptible to air lock or overflow, evacuated fuel onto the aft deck of the tug before maximum operational fill mark of the port day tank was reached.”

*Figure 3 - Day tank vents located on the port side main deck of the CATHERINE QUIGG.*

The company's operations manual required that all vents (Figure 3) have bags or buckets under them and that all scuppers (Figure 4) be plugged for the transfer. Neither action was accomplished prior to the start of the transfer.

- Maximum fill levels for oil tanks should be approached at a reduced transfer rate, and only with adequate planning, monitoring and personnel.
- Containment devices constitute an important safety net for oil transfers.
- Clear, consistent, communication between the deck and engine departments and between those involved in oil transfers is important to maintaining their safety.
- Oil transfers should be approached as a team effort to support the situational awareness of the PIC.
- Company procedures for oil transfers should be understood and consistently used.

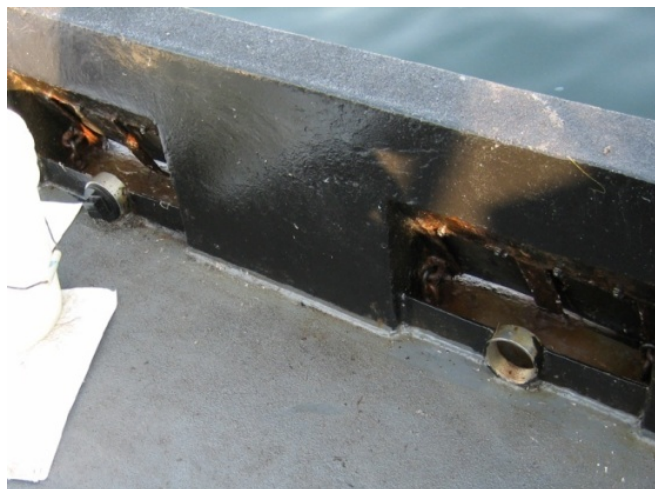
Based on the information gathered, the immediate cause of the spill was the lack of containment due to the absence of vent bags, vent buckets and scupper plugs in violation of written company procedures. This allowed the tank overfill to become a spill of oil to water. Factors contributing to the spill included:

Figure 4 – Port side scuppers.
