Bellingham Bay Wood Waste Survey, 2015-2016

October 2017

Publication No. 17-03-025

Toxics Studies Unit
Environmental Assessment Program
Washington State Department of Ecology
Olympia, Washington 98504-7710

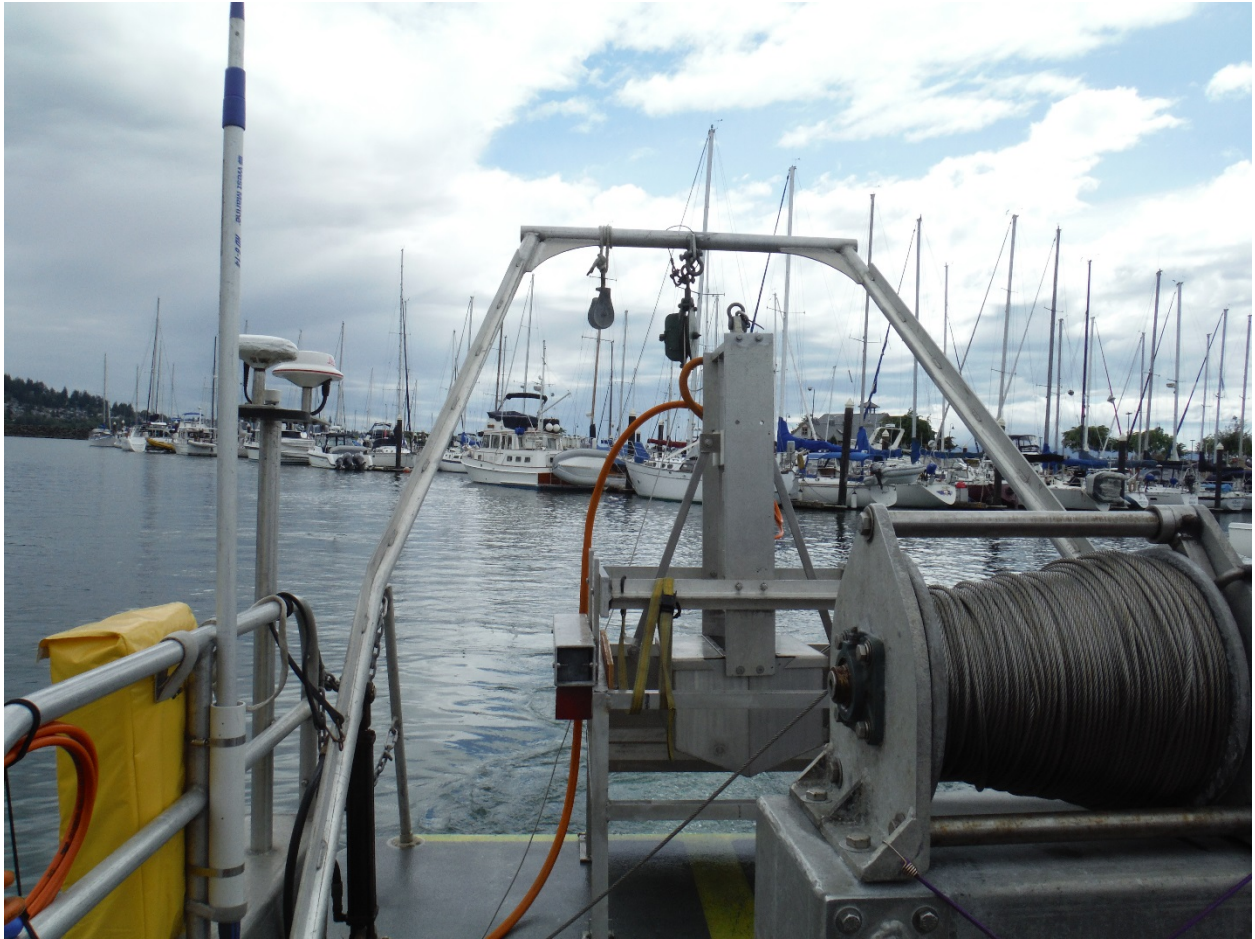
Figure 5. Power grab.

Each grab sample was visually checked for wood fibers. Large wood debris, biota, and/or shells were removed before collecting the sediment out of the grab. Approximately 12-cm of surface sediment was collected into a clean stainless-steel bowl to composite for grain size, total organic carbon (TOC), total volatile solids (TVS), and percent solids analyses. Replicate samples were taken from five sediment grab samples.

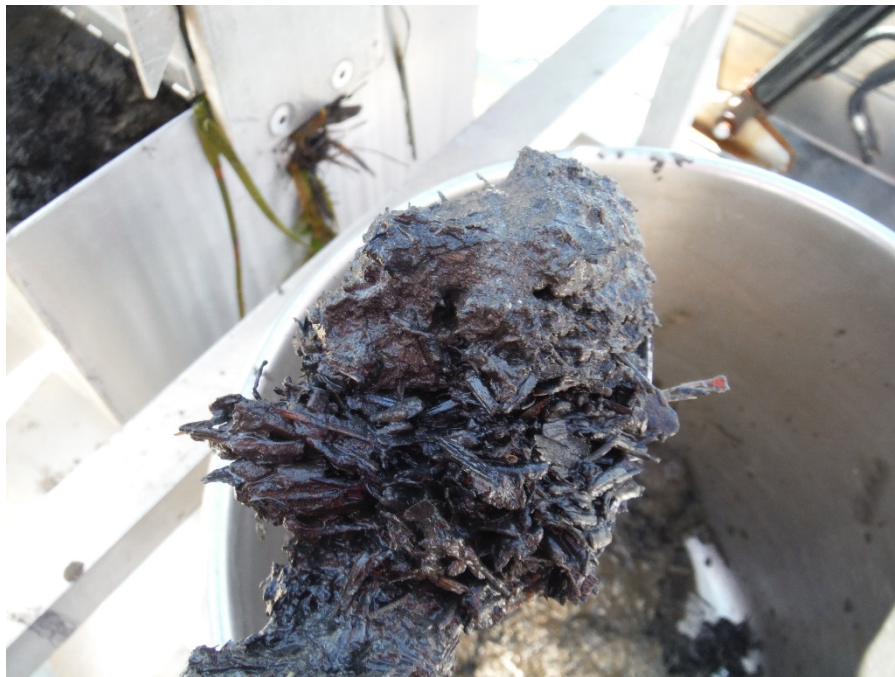
The highest TOC level was found in a sample from the northwest area of Flats09 (Location ID F09-27), which did not follow the observed pattern. Woody and other organic debris was observed in this sample as well as several other samples nearby. Woody and organic debris were observed also in the northwest portion of Flats10. Examples are shown in Figures 12-14.

Figure 12. Woody and organic debris found in sediment sample, Location ID F09-27.

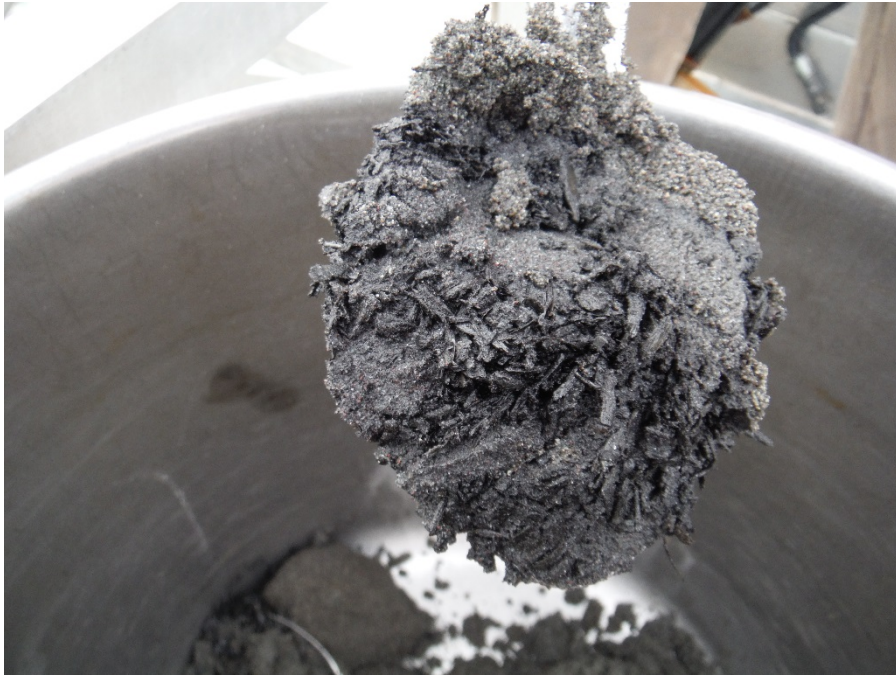
Figure 13. Woody and organic debris found in sediment sample, Location ID F10-14.

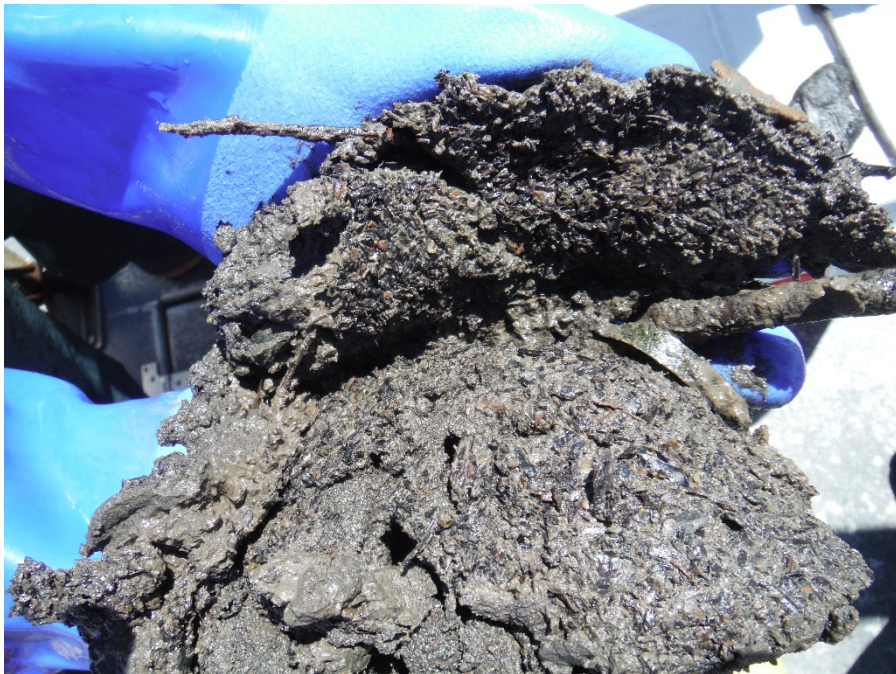
Figure 14. Woody and organic debris found in sediment sample, Location ID F10-30.

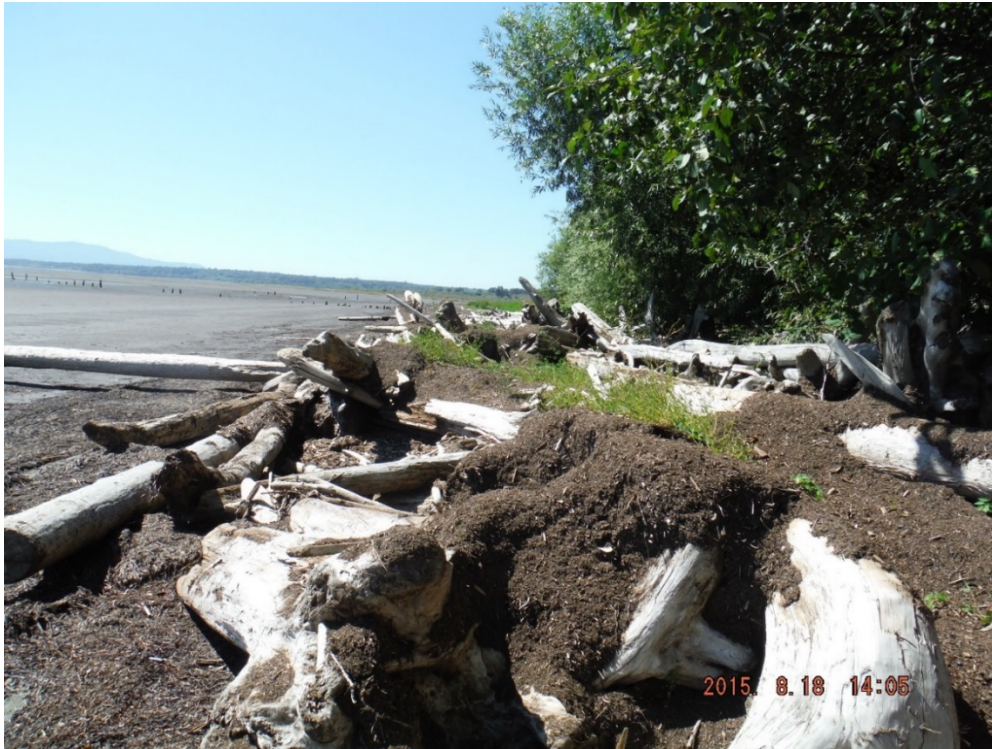
Historical woody debris found in this area could be considered mobile and able to move and redeposit in different marine, as well as on shore, areas due to the river and intertidal dynamic energies where currents, wind, and waves can affect the bottom of the bay (Figure 25 and 26). This likely explains, in part, the patchy pattern of the woody debris observed.

Figure 25. Woody and organic debris on shore at Fort Bellingham beach area, 2015.

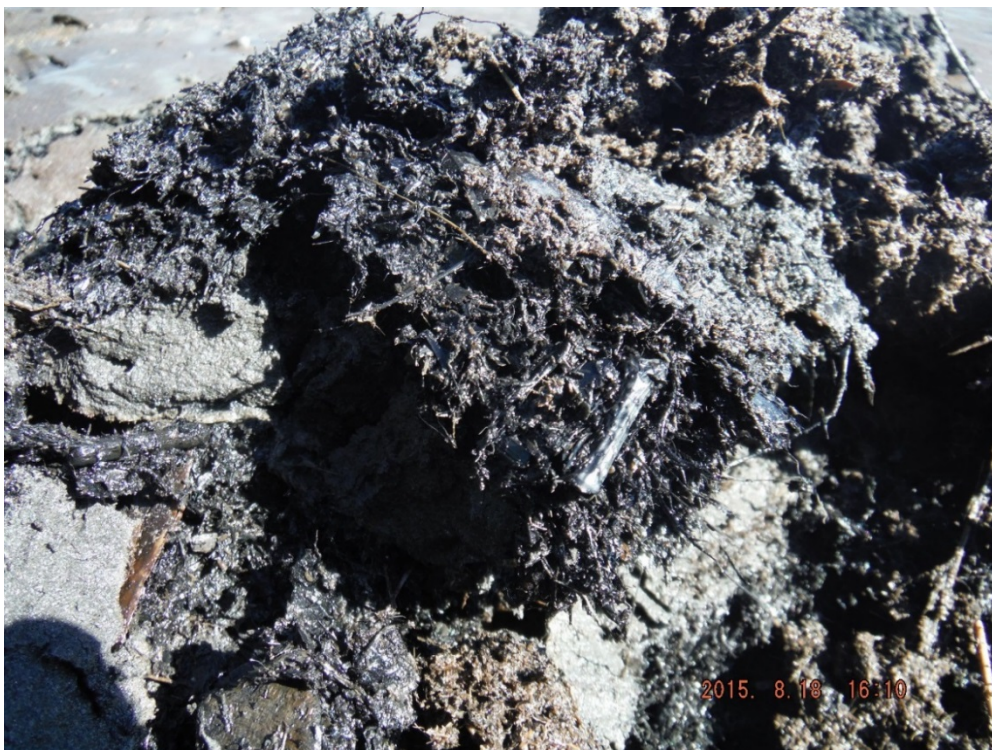
Figure 26. Buried woody and organic debris in the upper intertidal area of Fort Bellingham beach, 2015.

The beach area from northwest of downtown Bellingham extending to the Nooksack River is naturally positioned to receive material due to the northwest net shore-drift, predominant winds from the south, and surface currents in a general clockwise rotating gyre in northern Bellingham Bay (Sandvik and Wong, 2015). When these factors are considered in total, this beach area is positioned to receive sediment and flotsam input from both marine and river systems.

- Conduct tests to assess the depth, extent, and percent volume of buried woody debris found in the flats09 and flat10 areas.
- Determine the toxicity impact of the buried woody debris.
- Conduct tests to assess and compare composition of wood waste found in sediments versus wood waste deposited on shore east of the Nooksack River.
