Eyes Over Puget Sound

Surface Conditions Report: Feb 25, 2022

Up-to-date observations of water quality conditions in Puget Sound and coastal bays

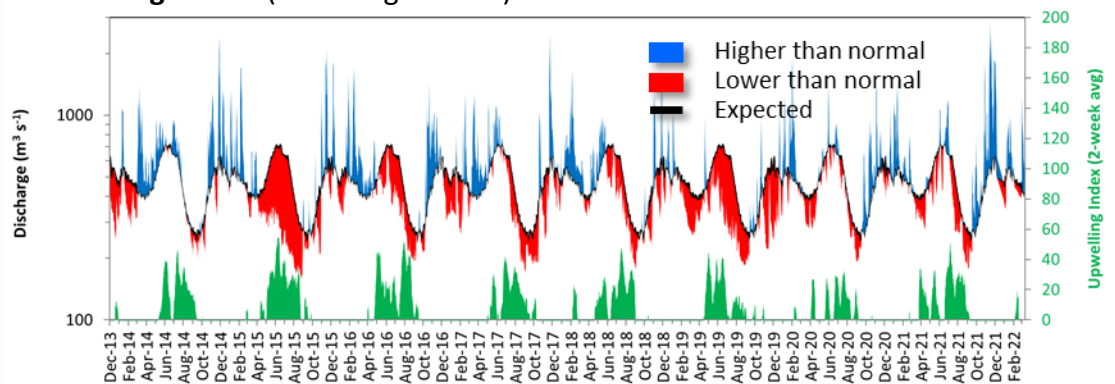
Skagit River (at midnight USGS)

The Skagit River freshet is no longer clearly pronounced, because the river is a regulated system for hydroelectric power generation. However, drought years and low flows can be seen in the river's discharge data. In 2021, flows were higher than normal.

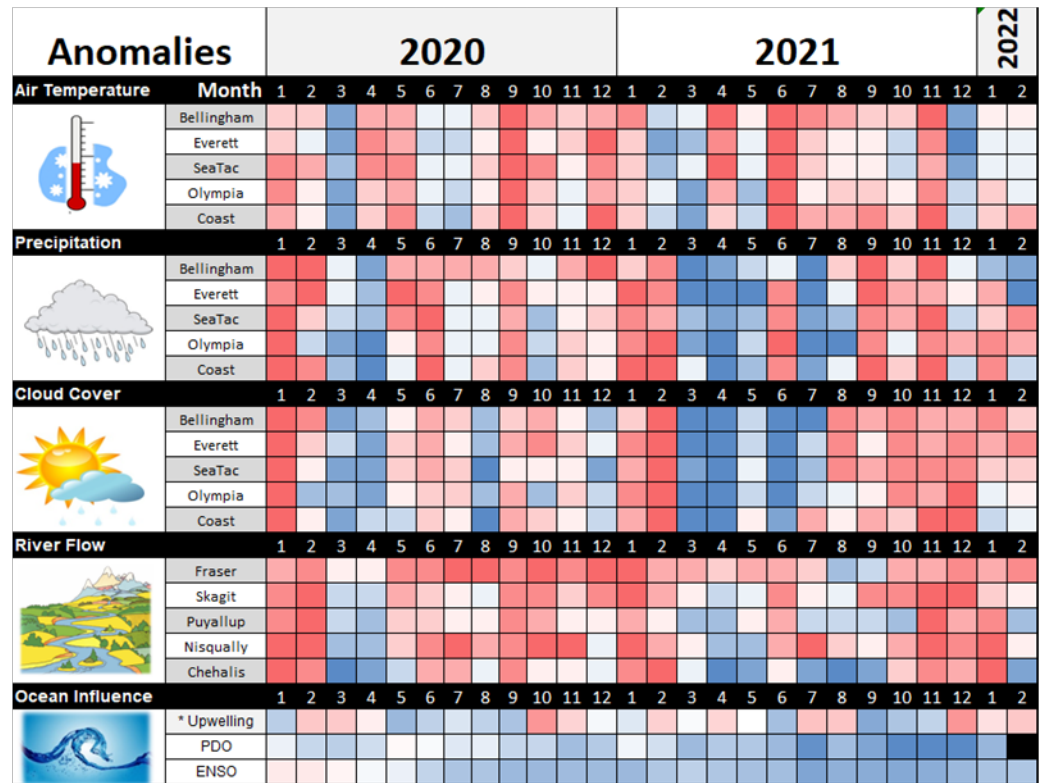
In the anomaly plot, we want to connect different factors influencing water quality in the context of space and time. We do this with a heat map and anomalies by month for selected regions from north to south. All data are from public sources: UW GRAYSKIES; river flows from USGS and Environment Canada; indices from NOAA & UW (PDO).

Air temperatures have been variable after a cold December.

Precipitation has been above normal except recently to the extreme north.

Cloud cover has mostly been higher since August.

River flows have been higher except recently in the Puyallup and Chehalis.

Downwelling has been weaker since December. PDO & ENSO are in cold phase (La Niña).

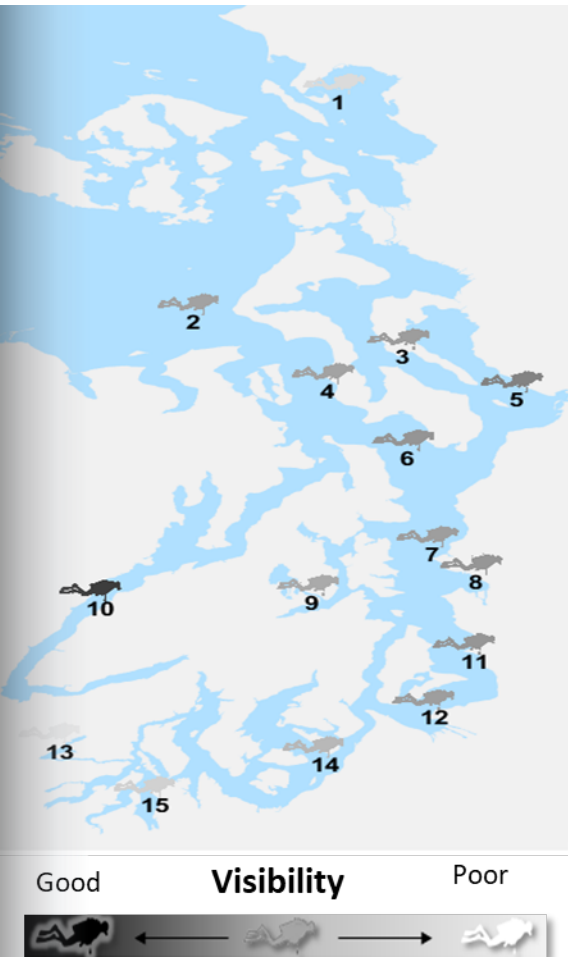
Diver visibility, January 2022

- **Best visibility** (45 ft) occurred near Octopus Hole in Hood Canal, at a depth of 64 ft (Location 10).
- **Poor visibility** (no diver icon) of 1 ft occurred in Mukilteo at a depth of around 5 ft (Location 5).

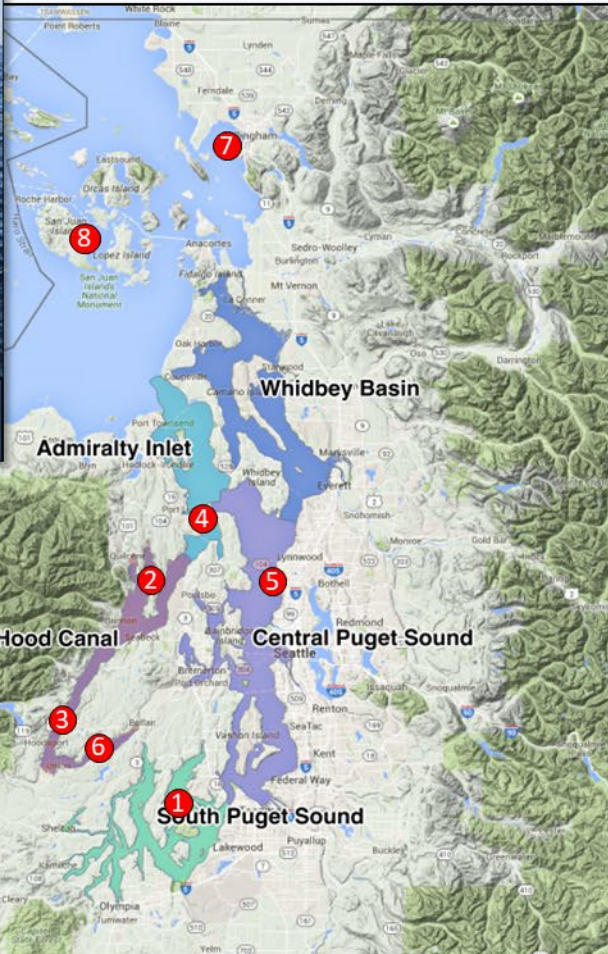
Connecting aerial observation with data from ORCA moorings

Nick Michel-Hart,
John Mickett, UW/APL.

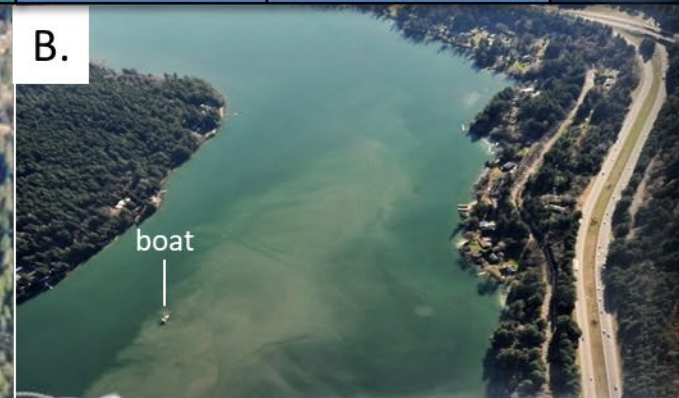
Marine vessel associated with large sediment plume. A. looking north, B. looking south.
Location: Southern Eld Inlet (South Sound), 11:32 AM

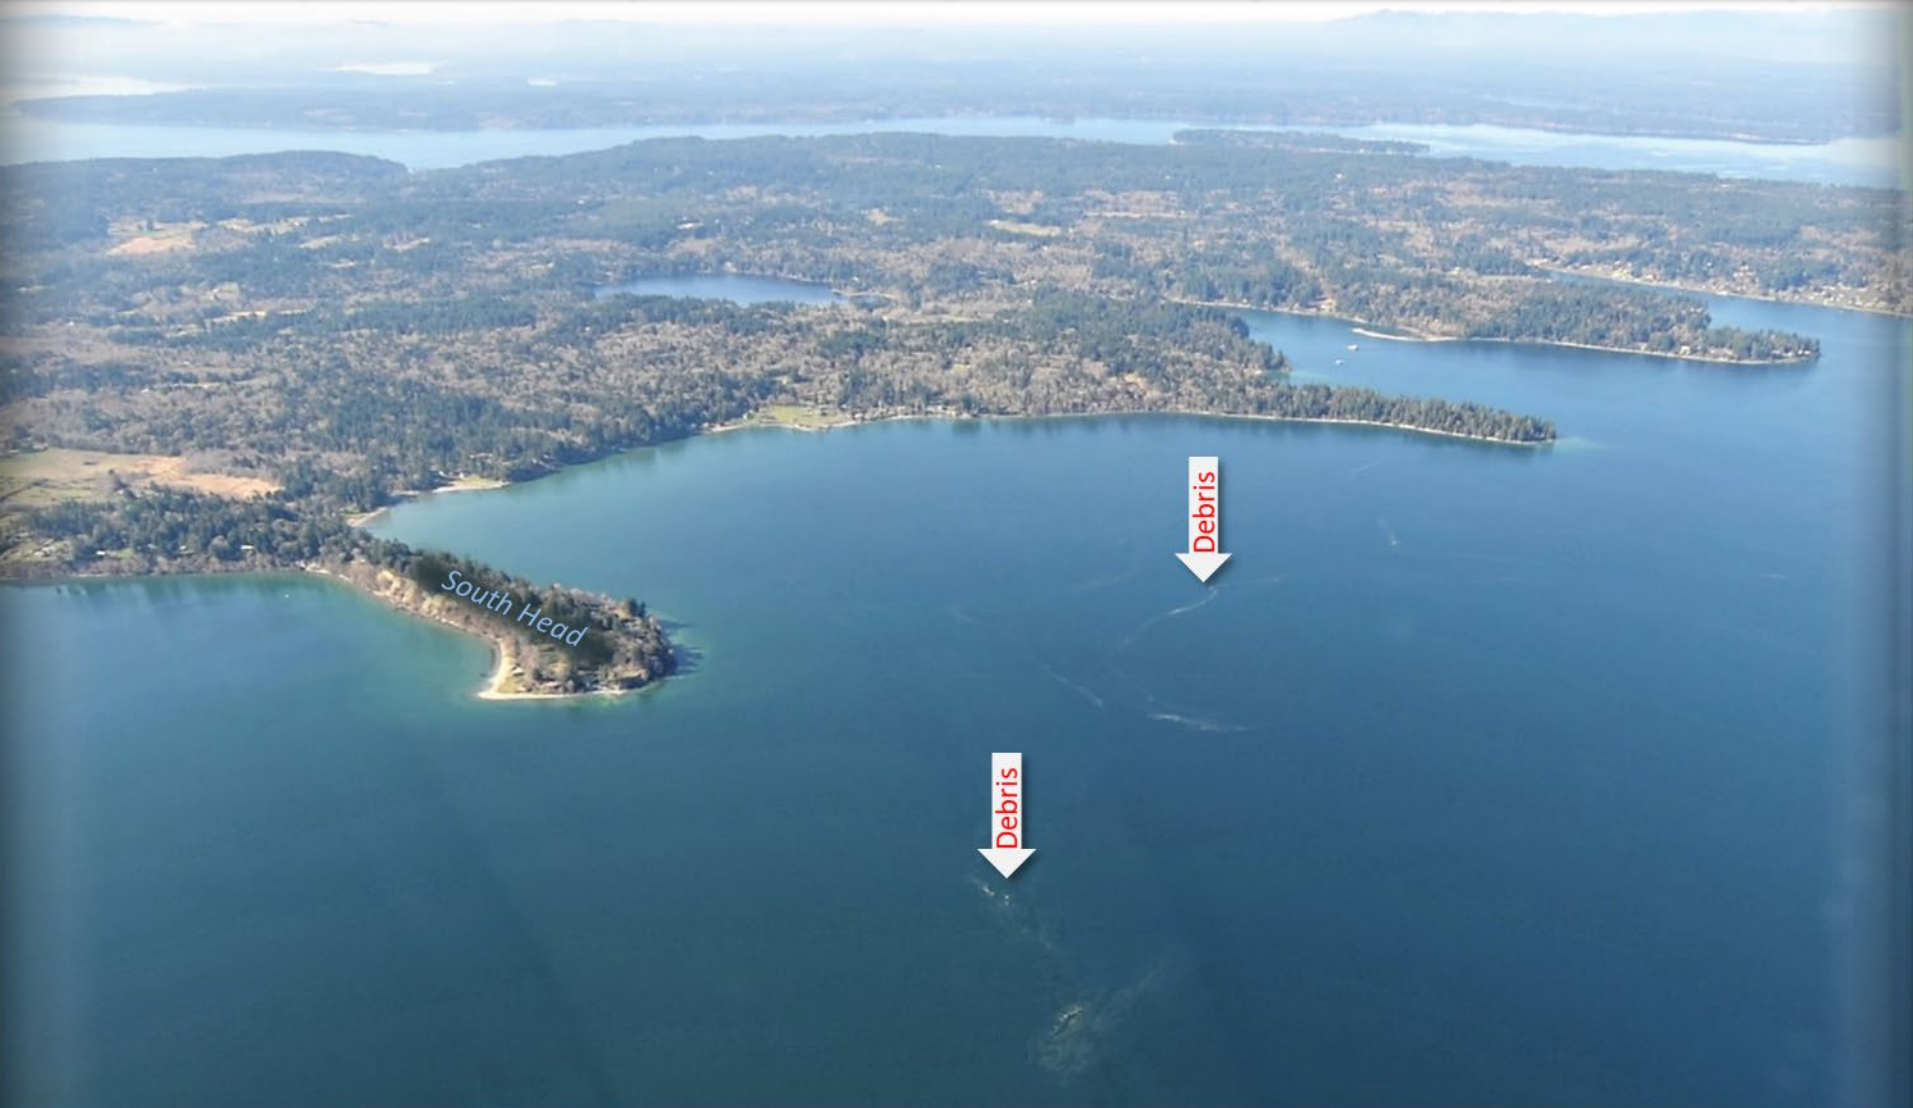
Organic material floating at surface. Location: Carr Inlet (South Sound), 11:45 AM

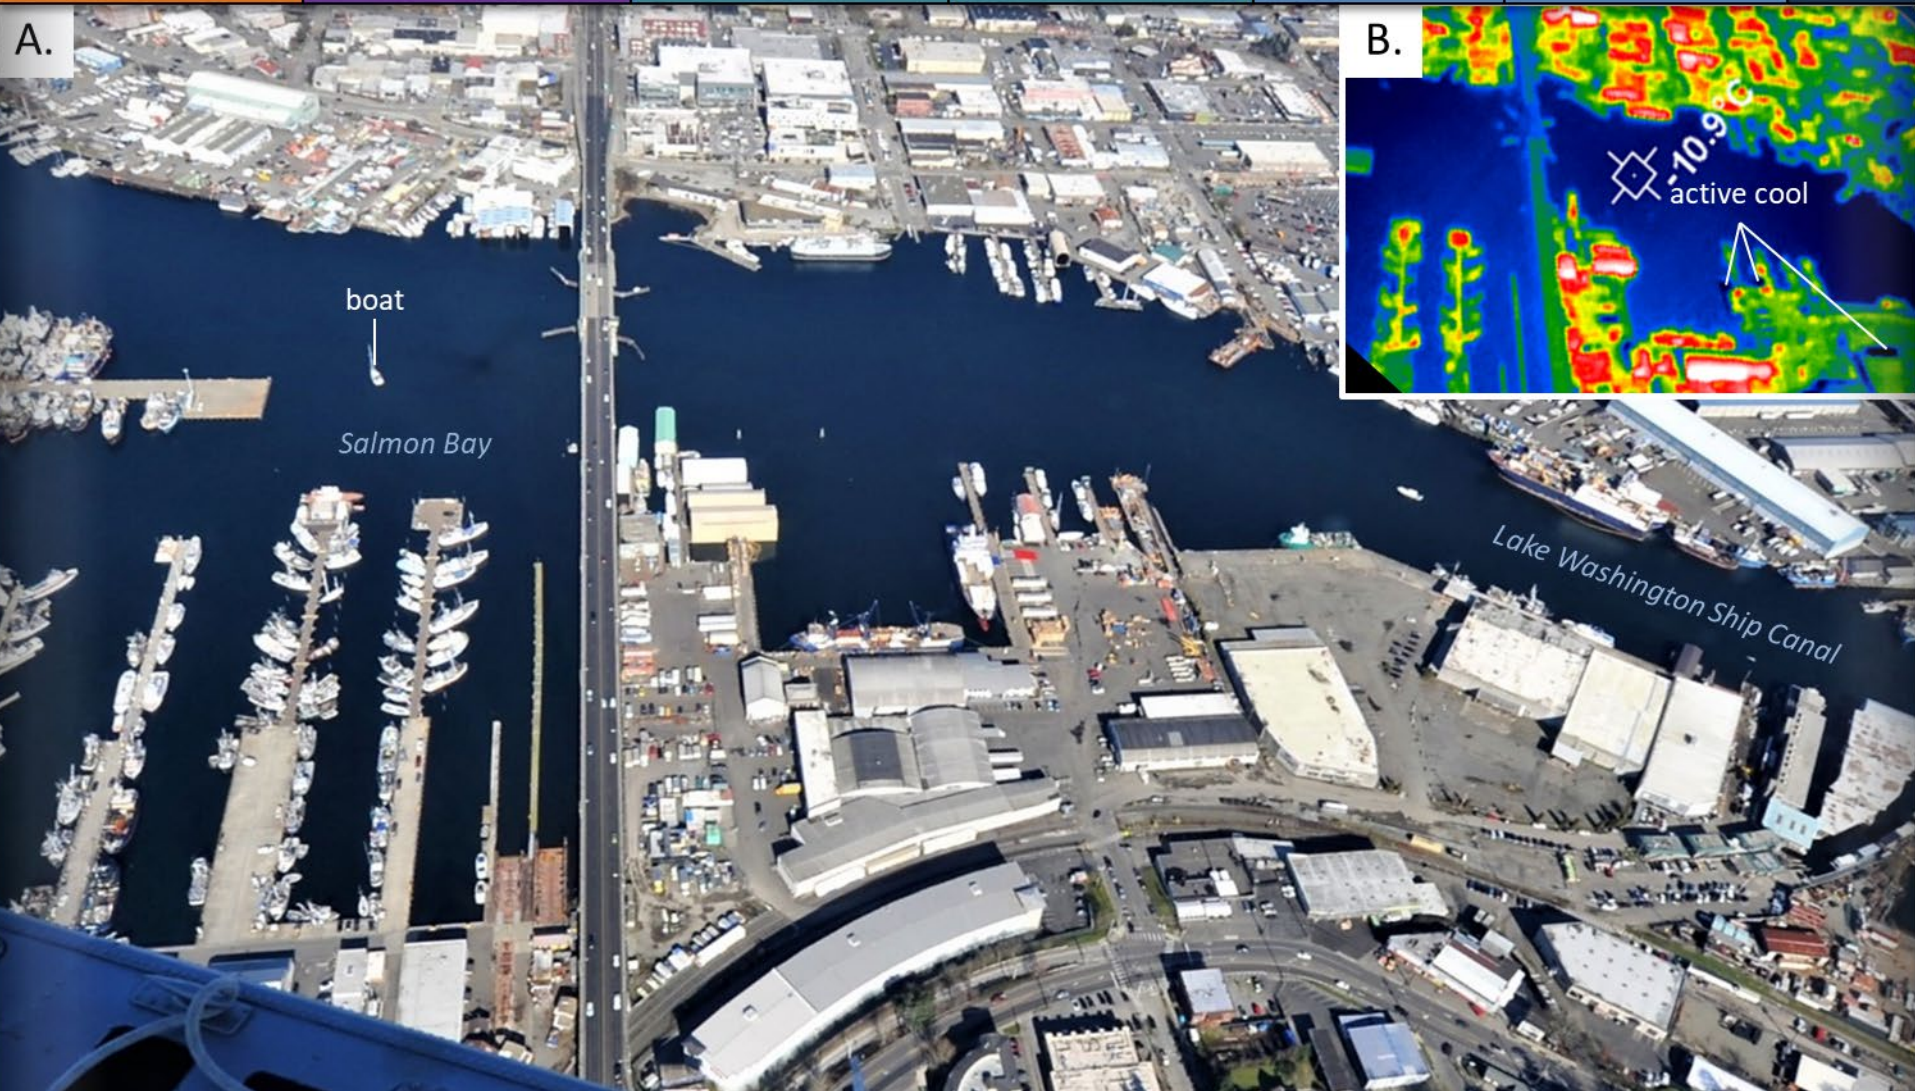
A. Busy urban waterway in Ballard. B. IR camera showing industrial areas with sites of active heating and cooling. Location: Seattle (Central Sound), 12:07 PM

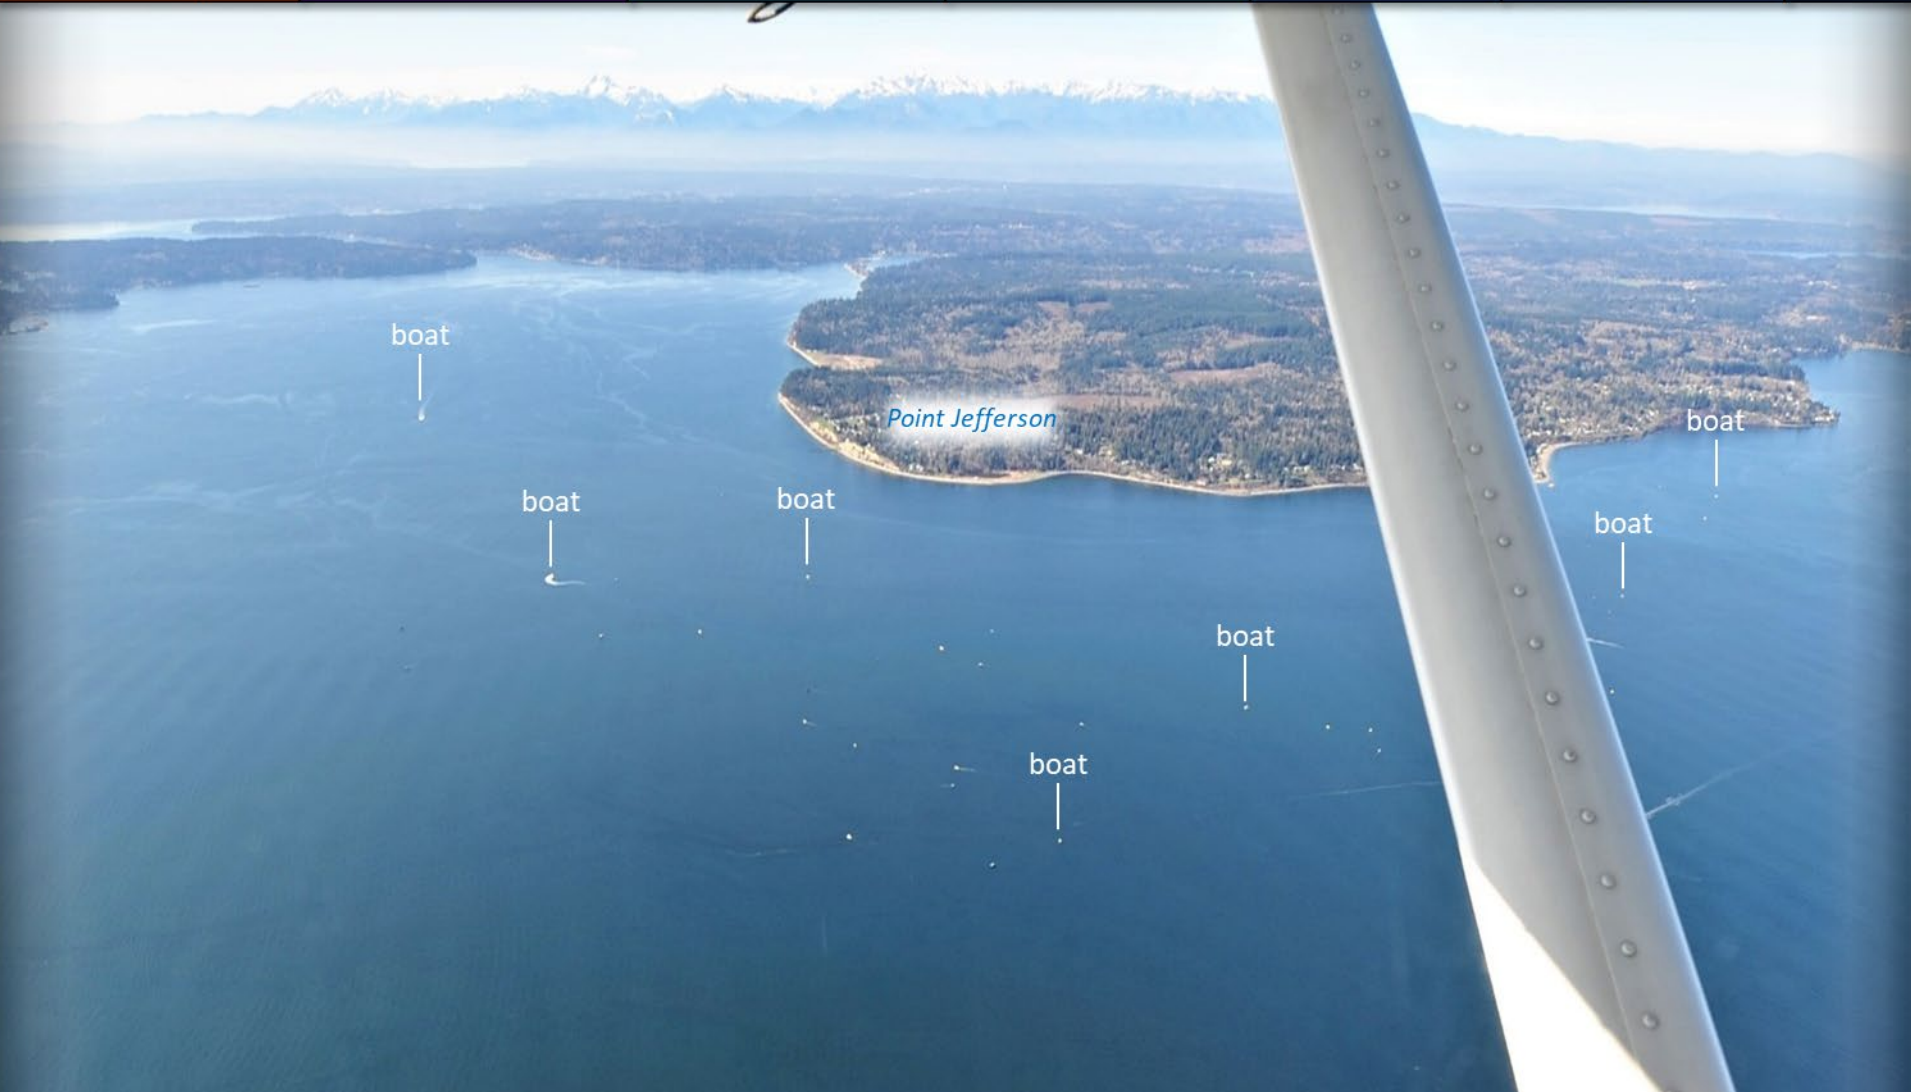
*More than 25 boats fishing on western shores from Point Jefferson all the way to Kingston.
Location: East of Port Madison (Central Sound) 12:19 PM*

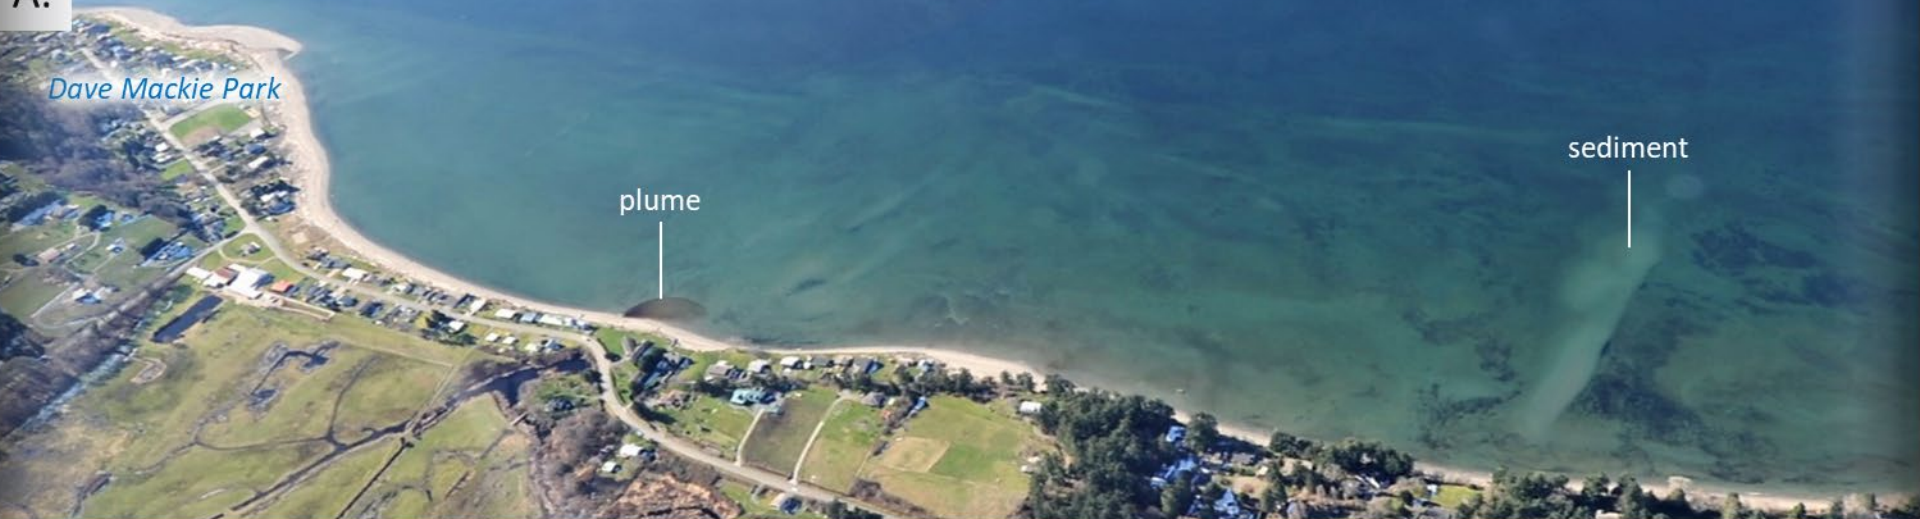
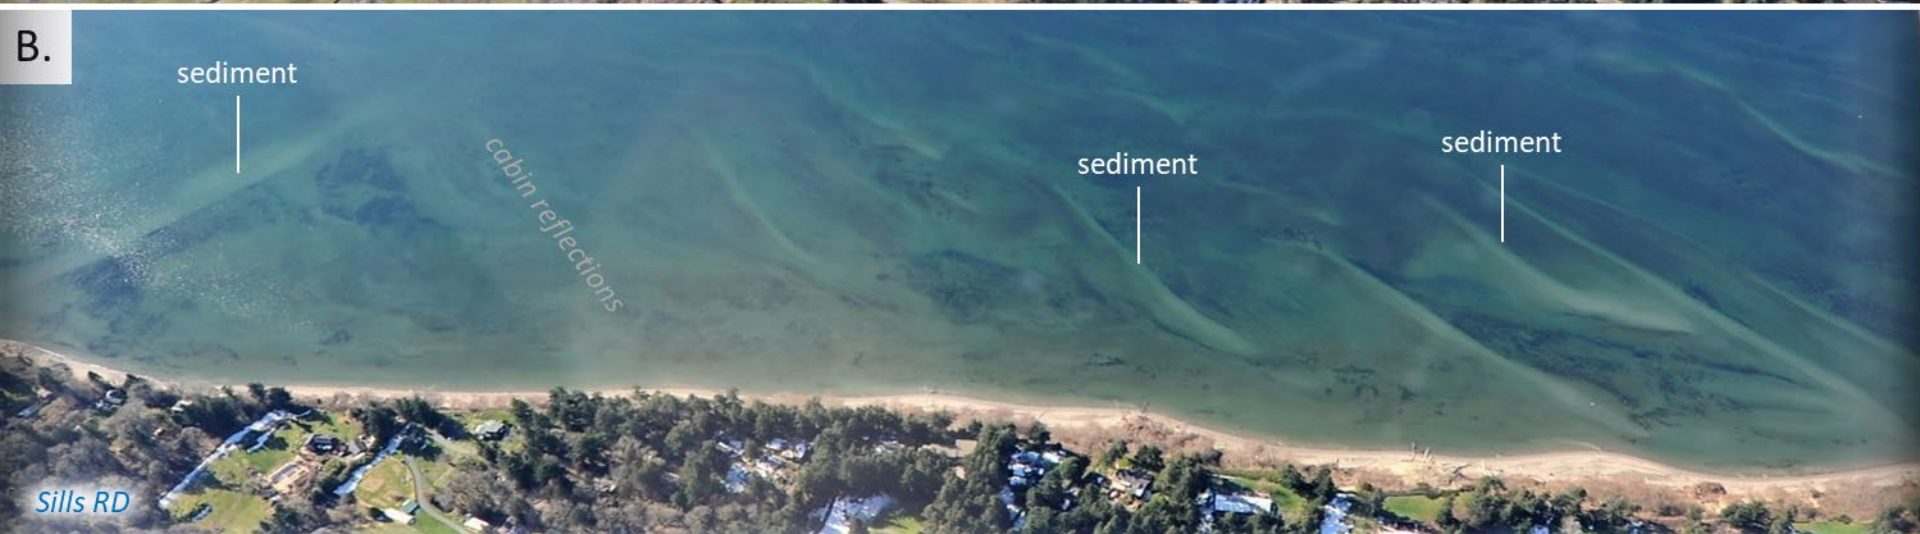
A. Freshwater plume of boggy water B. Recurring lines of exposed sediment, devoid of vegetation.
 Location: Western shore of Whidbey Island (Central Sound), 12:28 PM

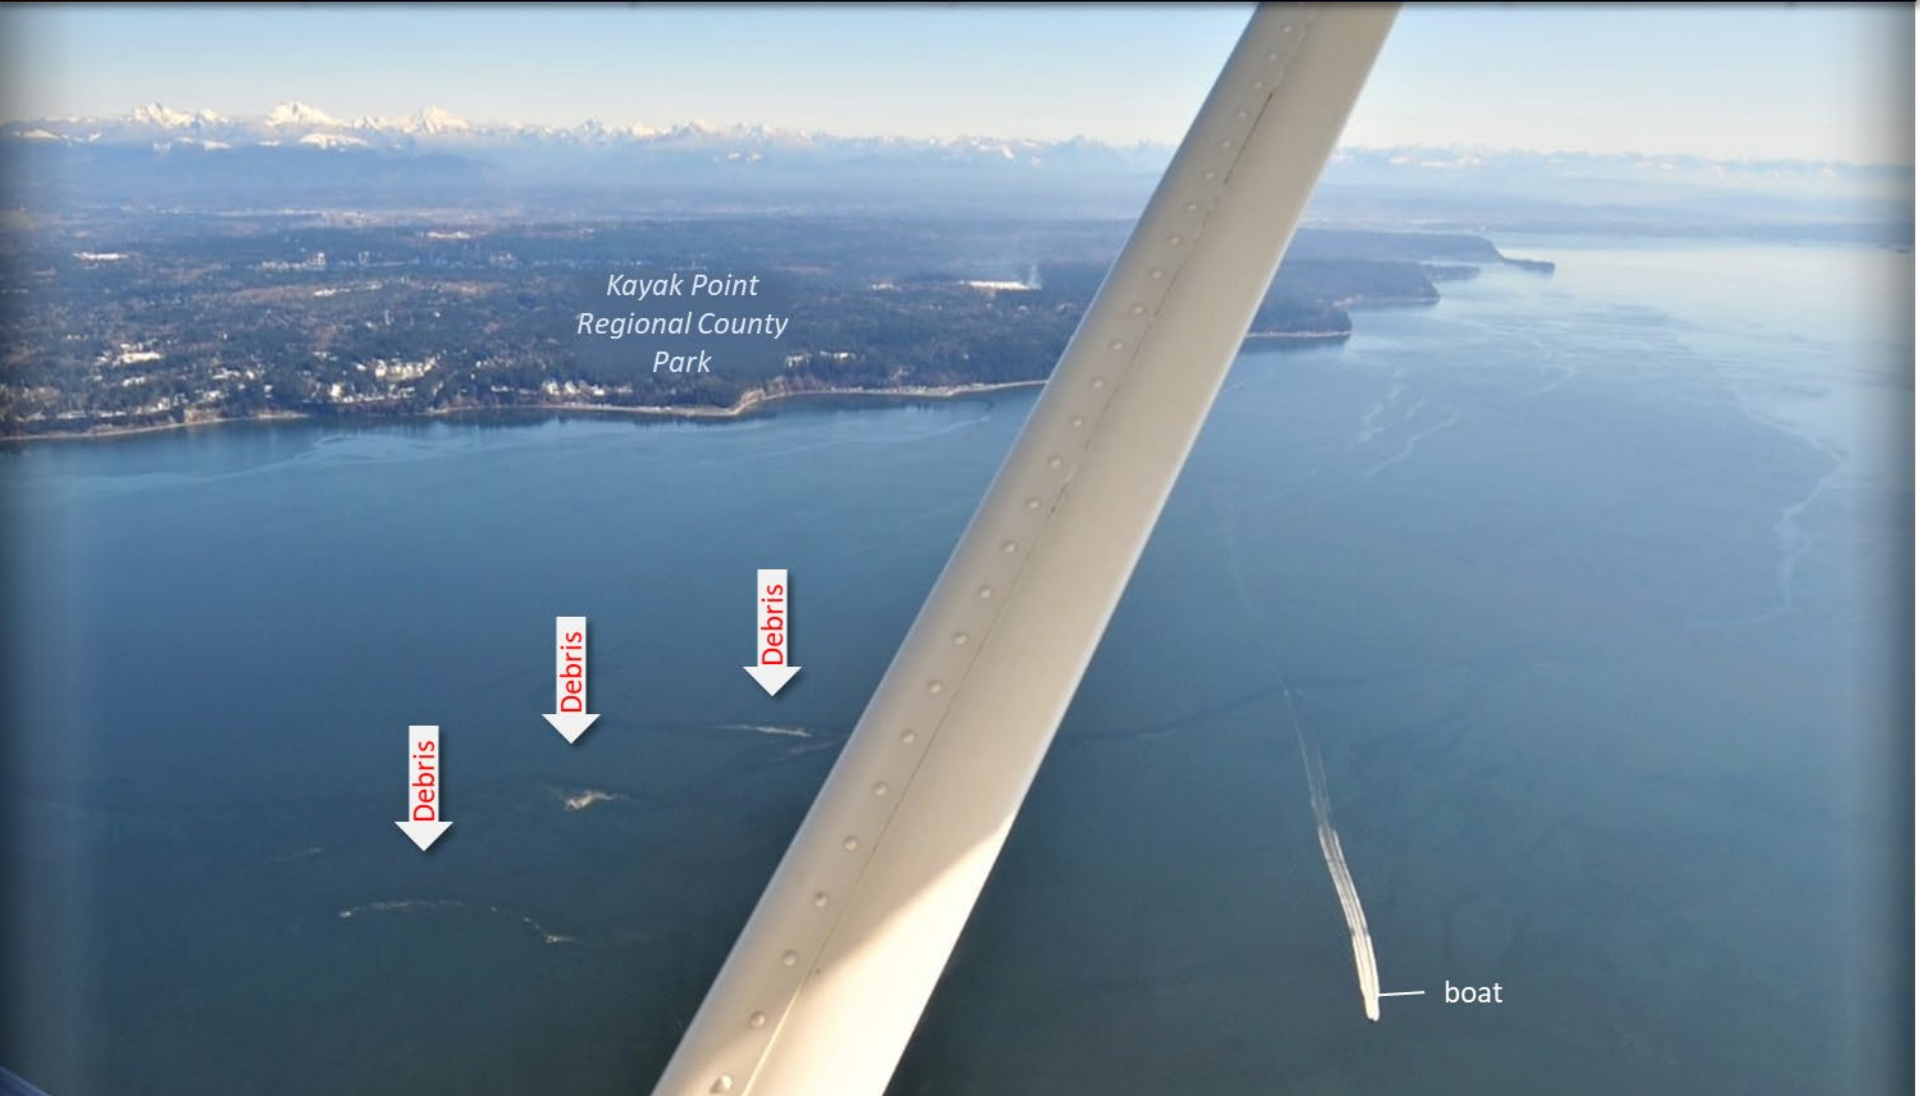
Organic material floating at surface in Port Susan. Location: Port Susan (Whidbey Basin), 12:37 PM

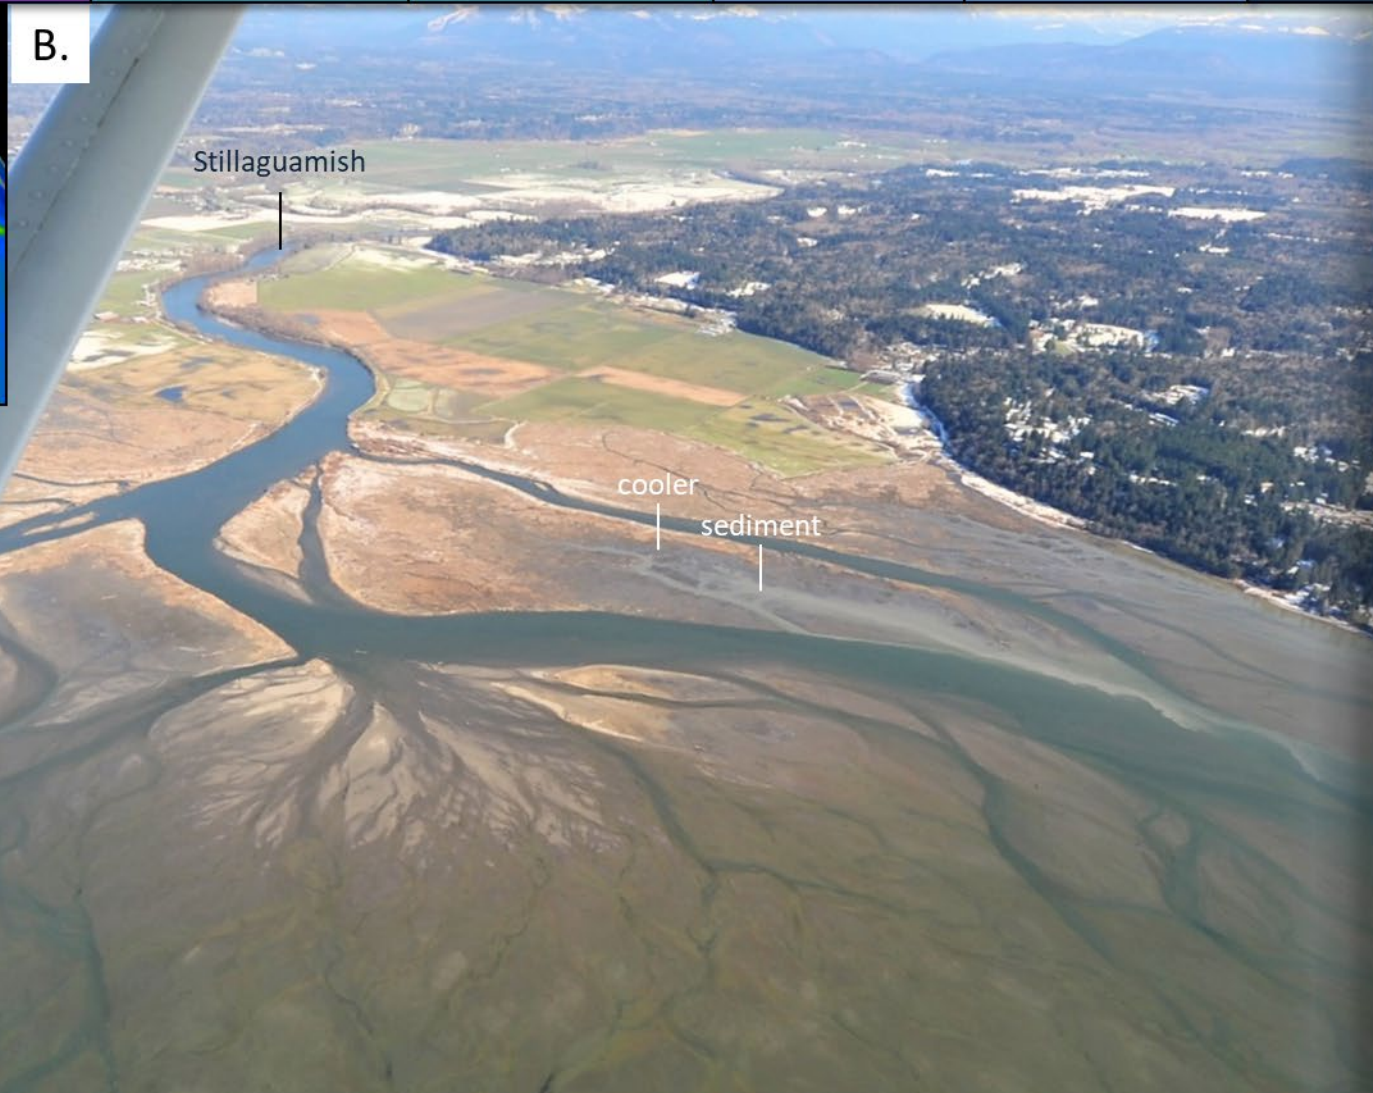
A. Stillaguamish estuary with warmer, sun-exposed mud flats. B. Suspended sediment in a region that is also cooler.
Location: Stillaguamish estuary (Whidbey Basin), 12:40 PM

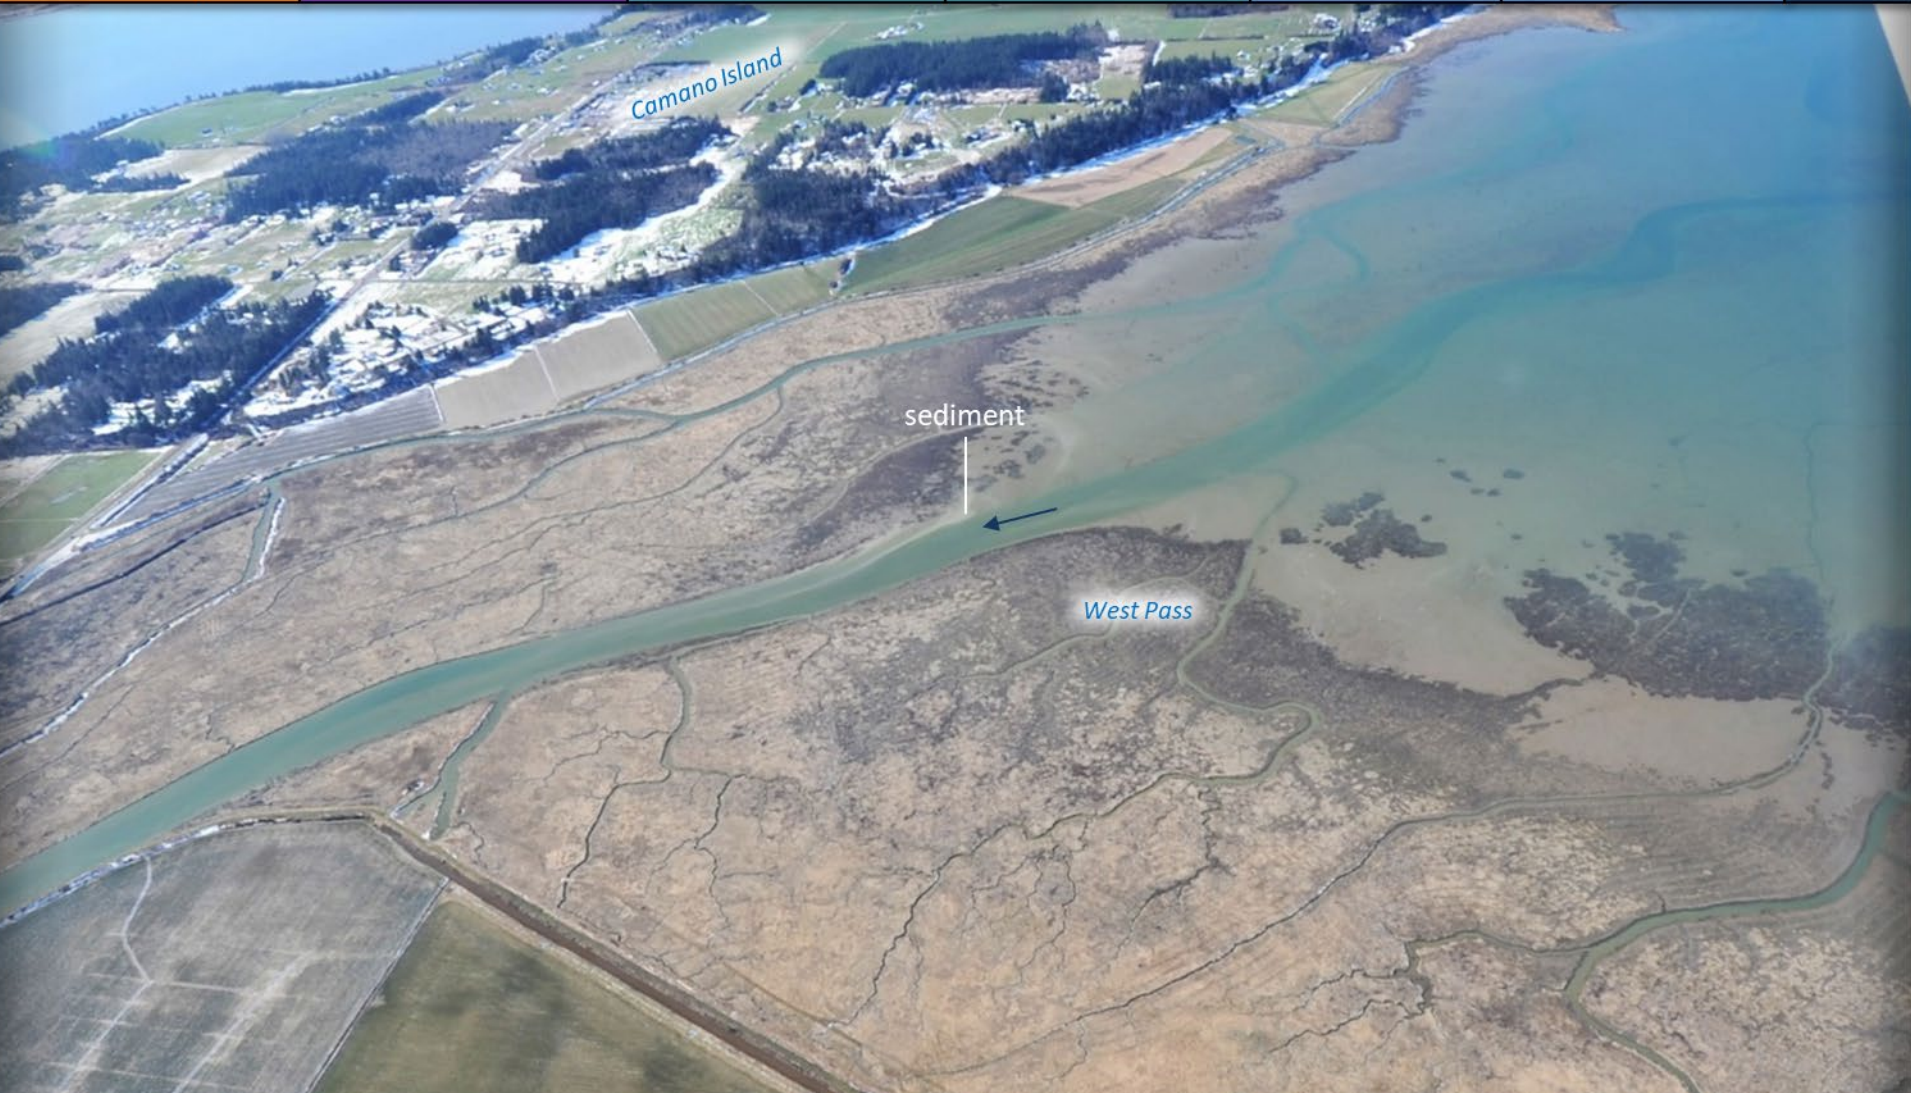
Suspended sediment flows into West Pass (Stillaguamish water) during incoming tide.
Location: Skagit Bay (Whidbey Basin), 12:42 PM

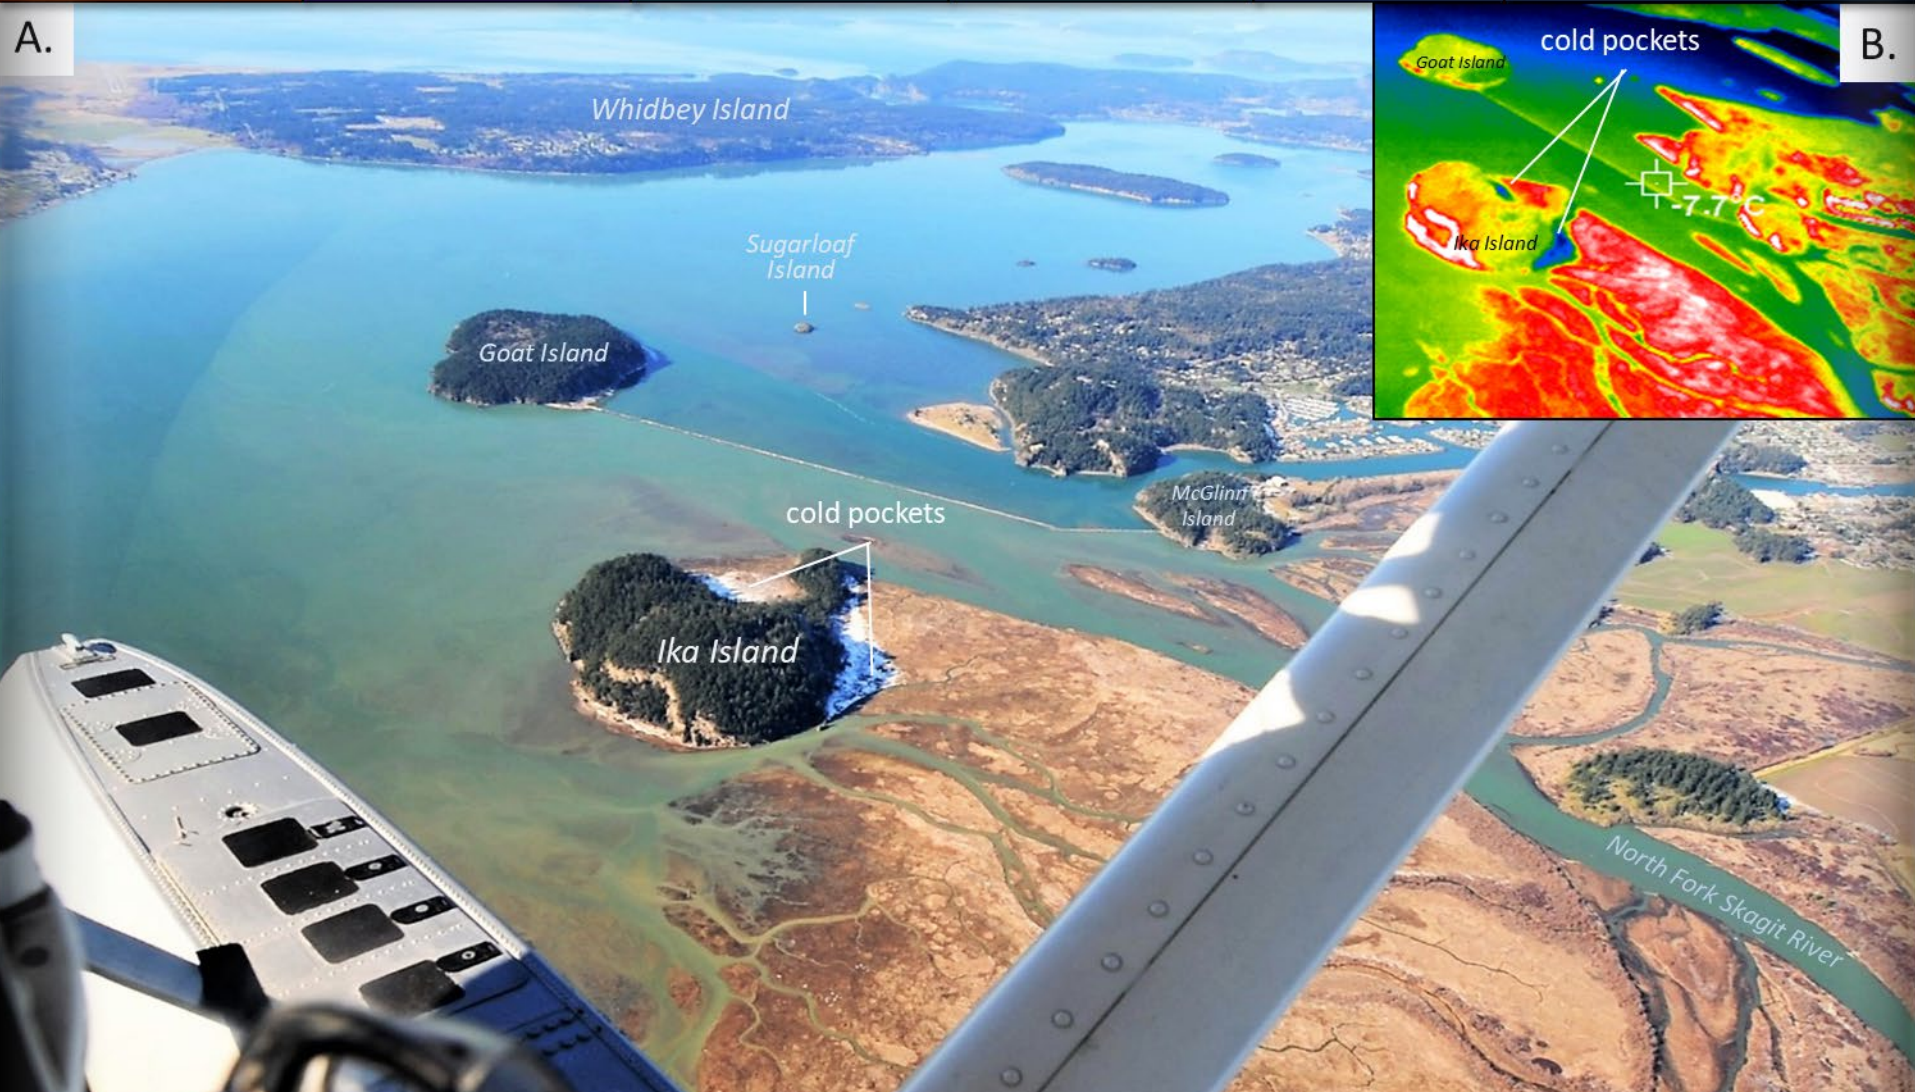
Shady regions remain cooler and still carry snow.
 Location: Skagit Bay (North Sound), 12:49 PM

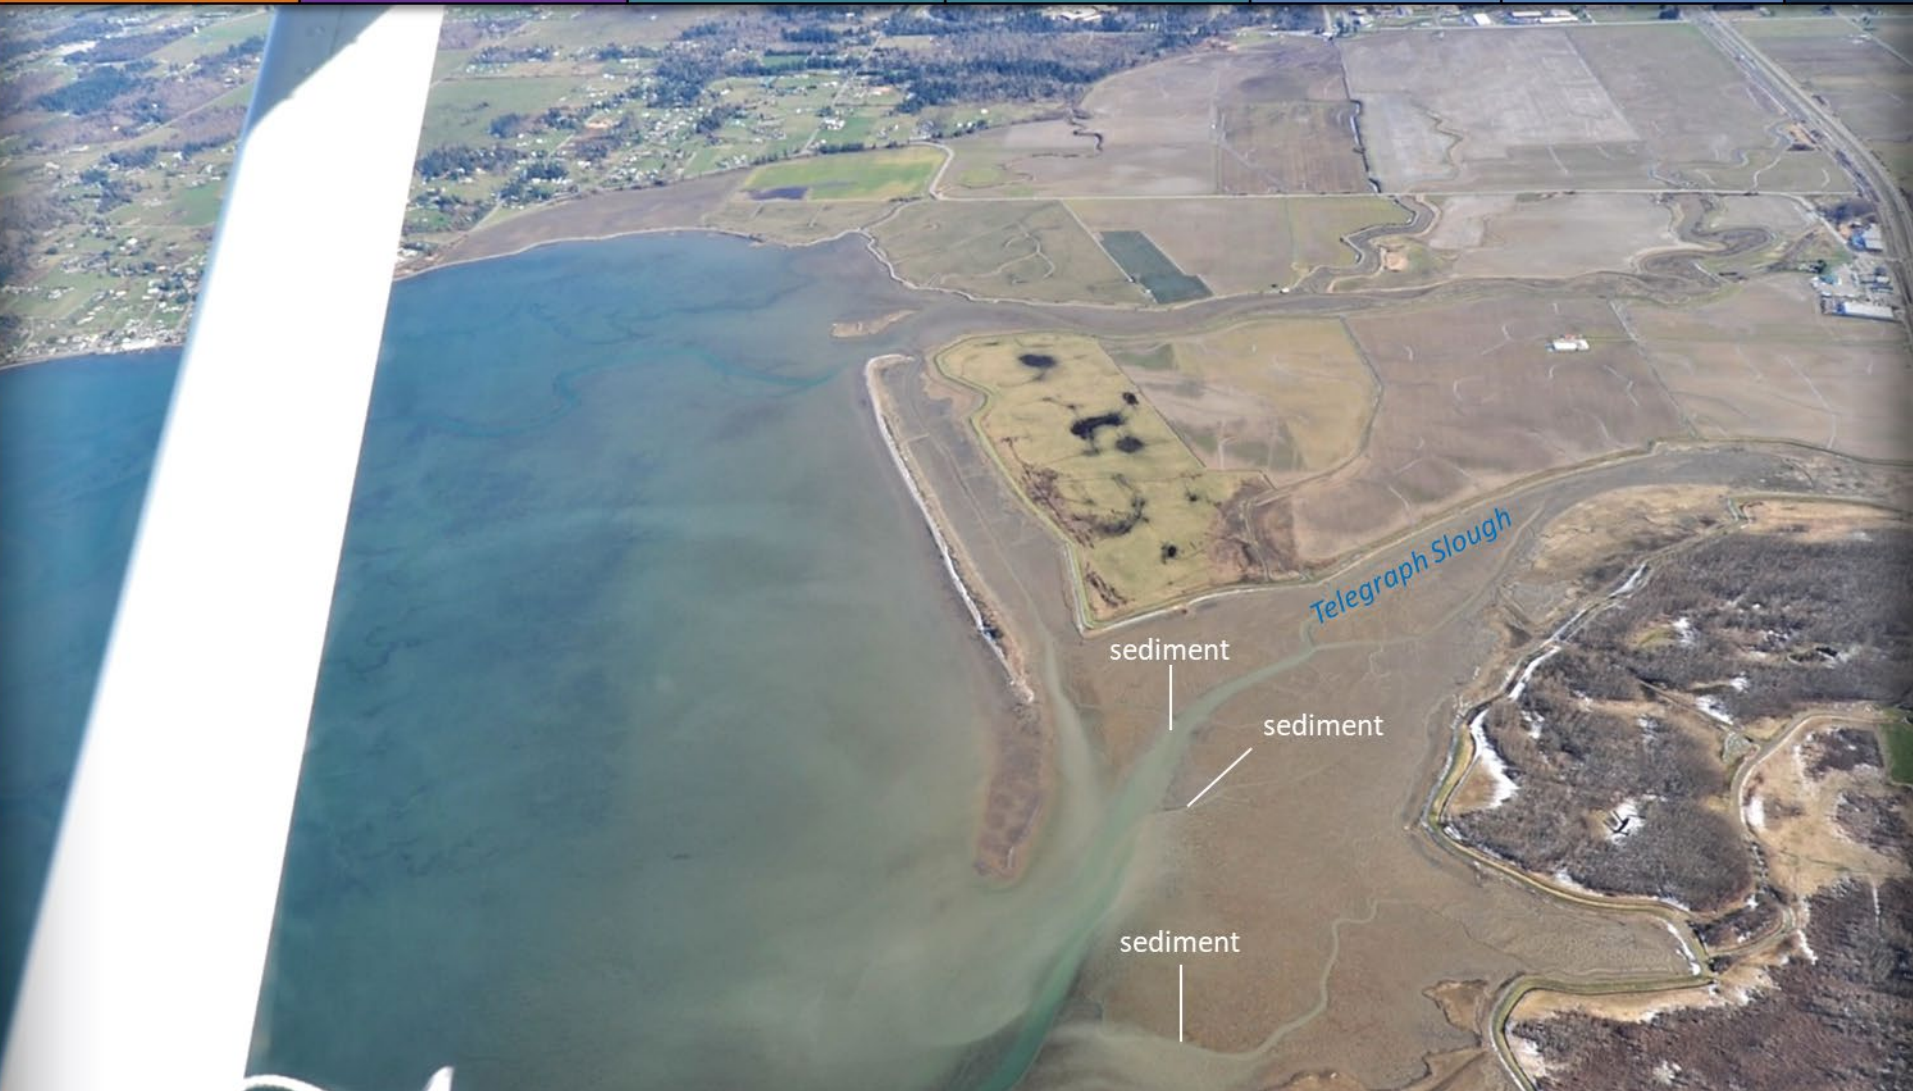
Location: Padilla Bay (North Sound), 12:54 PM

Locally-suspended sediment during high tide, suggesting some biological activity.
