Eyes Over Puget Sound

Surface Conditions Report: Feb 25, 2022

Up-to-date observations of water quality conditions in Puget Sound and coastal bays

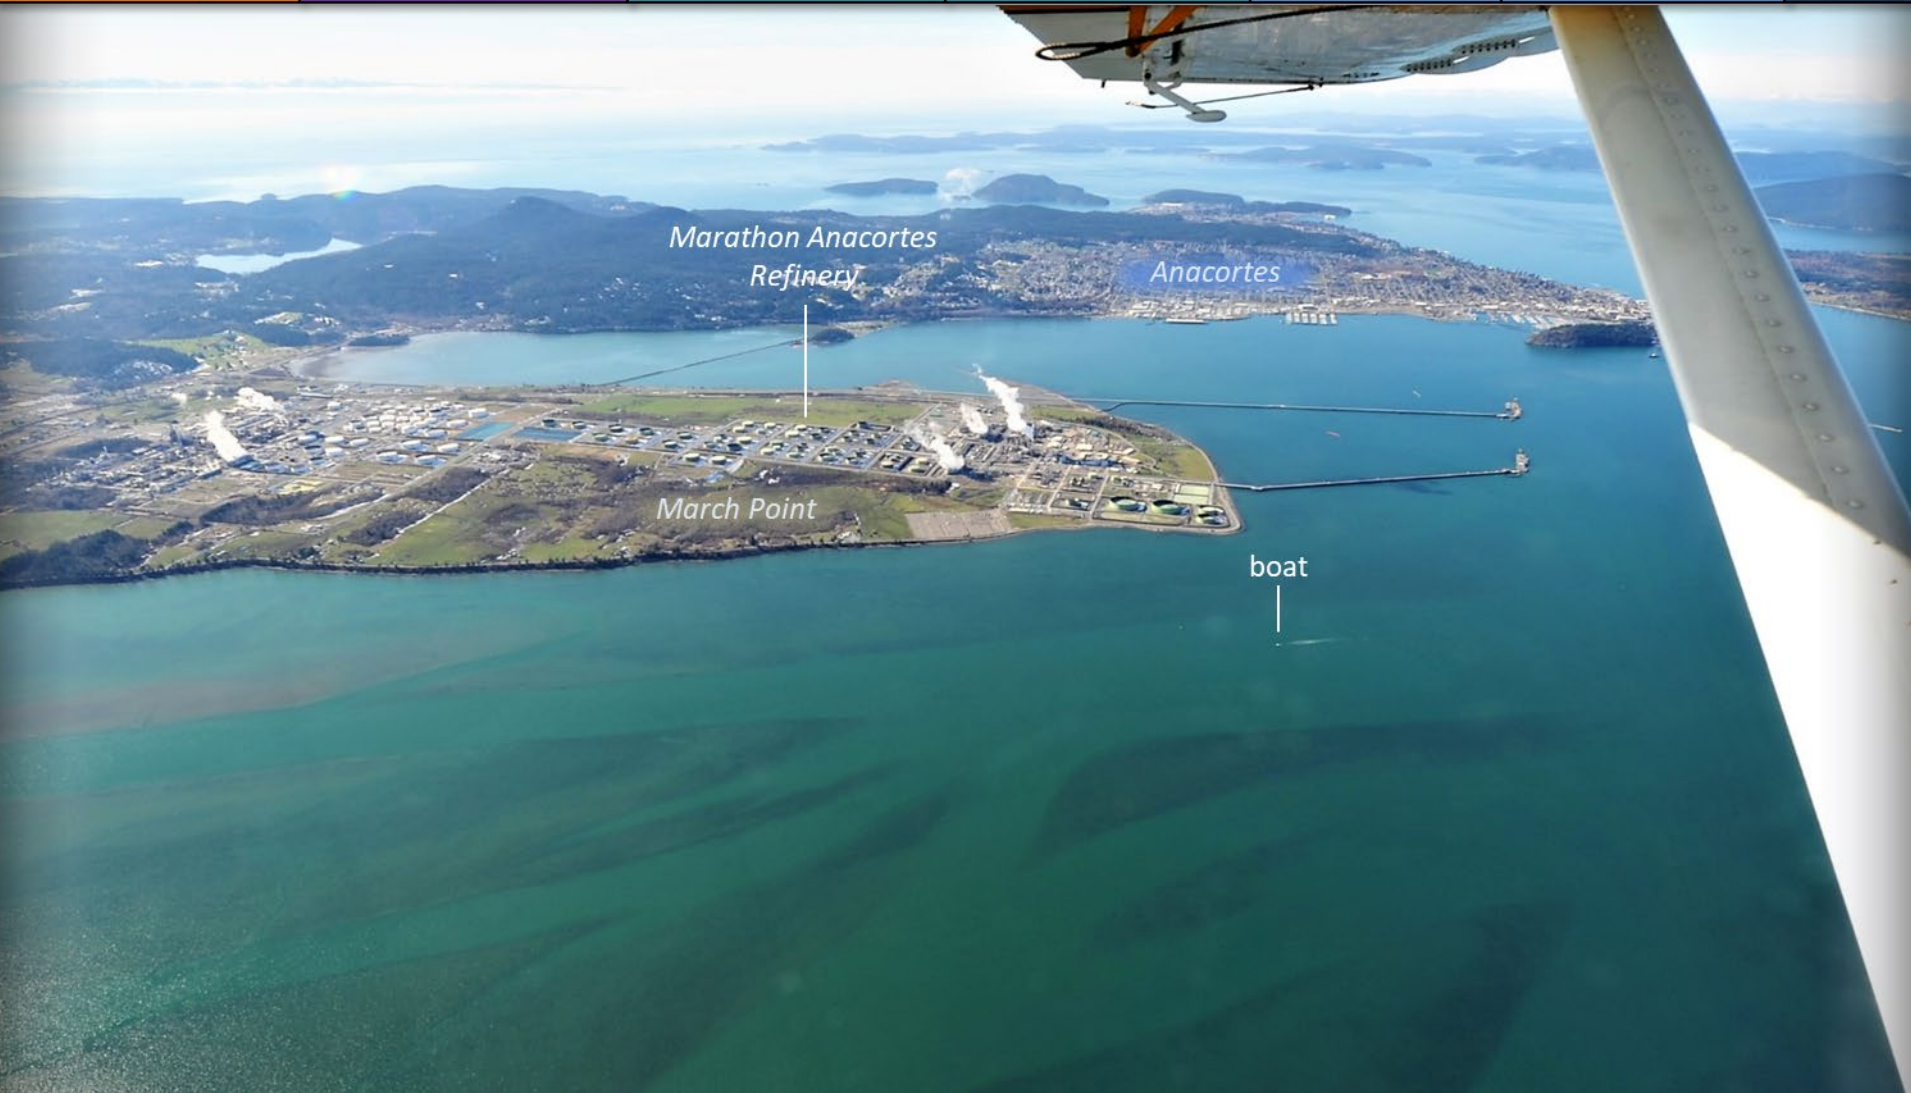
Quiet conditions near Anacortes. Location: Padilla Bay (North Sound), 12:55 PM

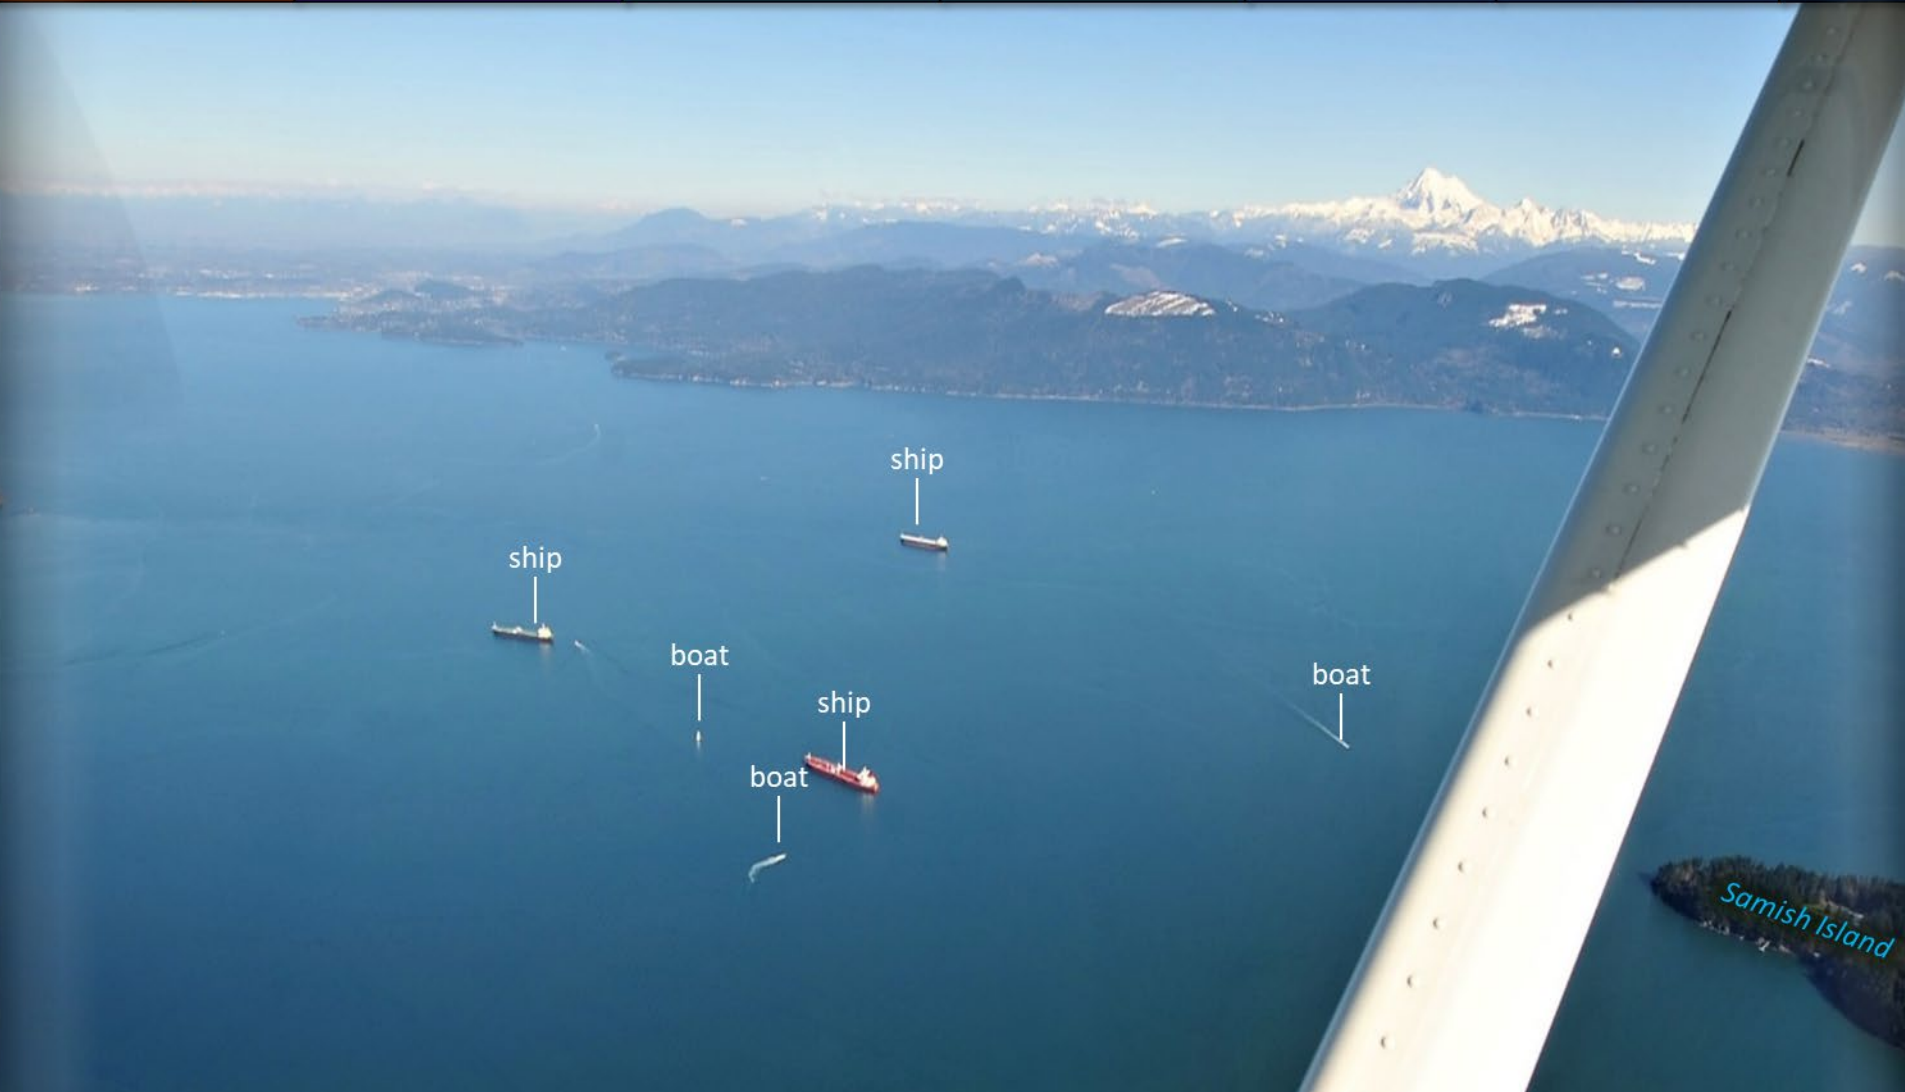
*Bellingham Bay, a busy waterway. Oil tankers waiting to be filled at the Marathon Anacortes Refinery.
Location: Bellingham Bay (North Sound), 12:58 PM*

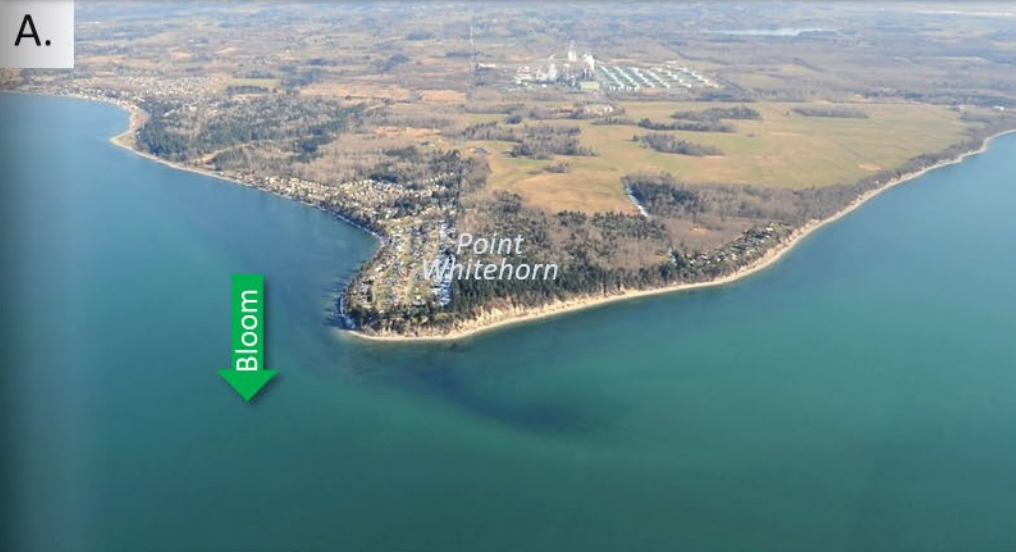
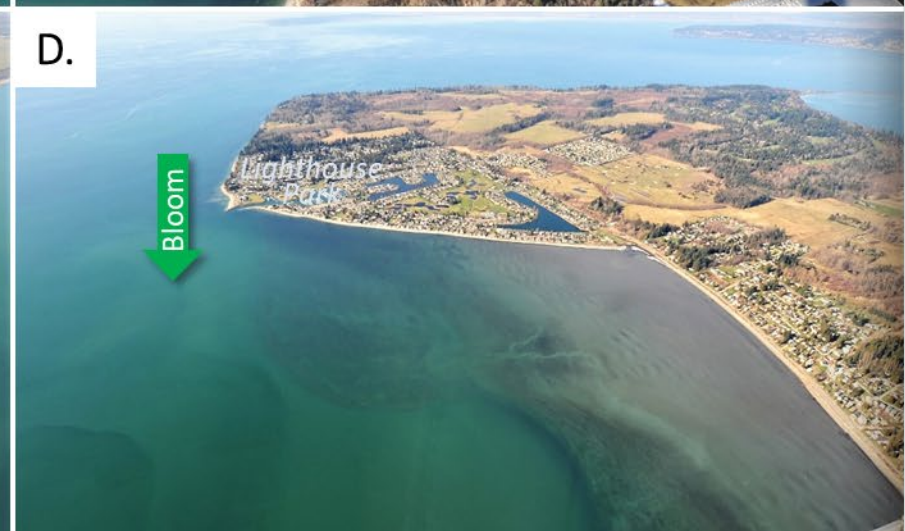
Location: Birch Bay (North Sound), 1:10 PM

A-D. Local differences in the color of surface water, with bloom in Birch Bay.

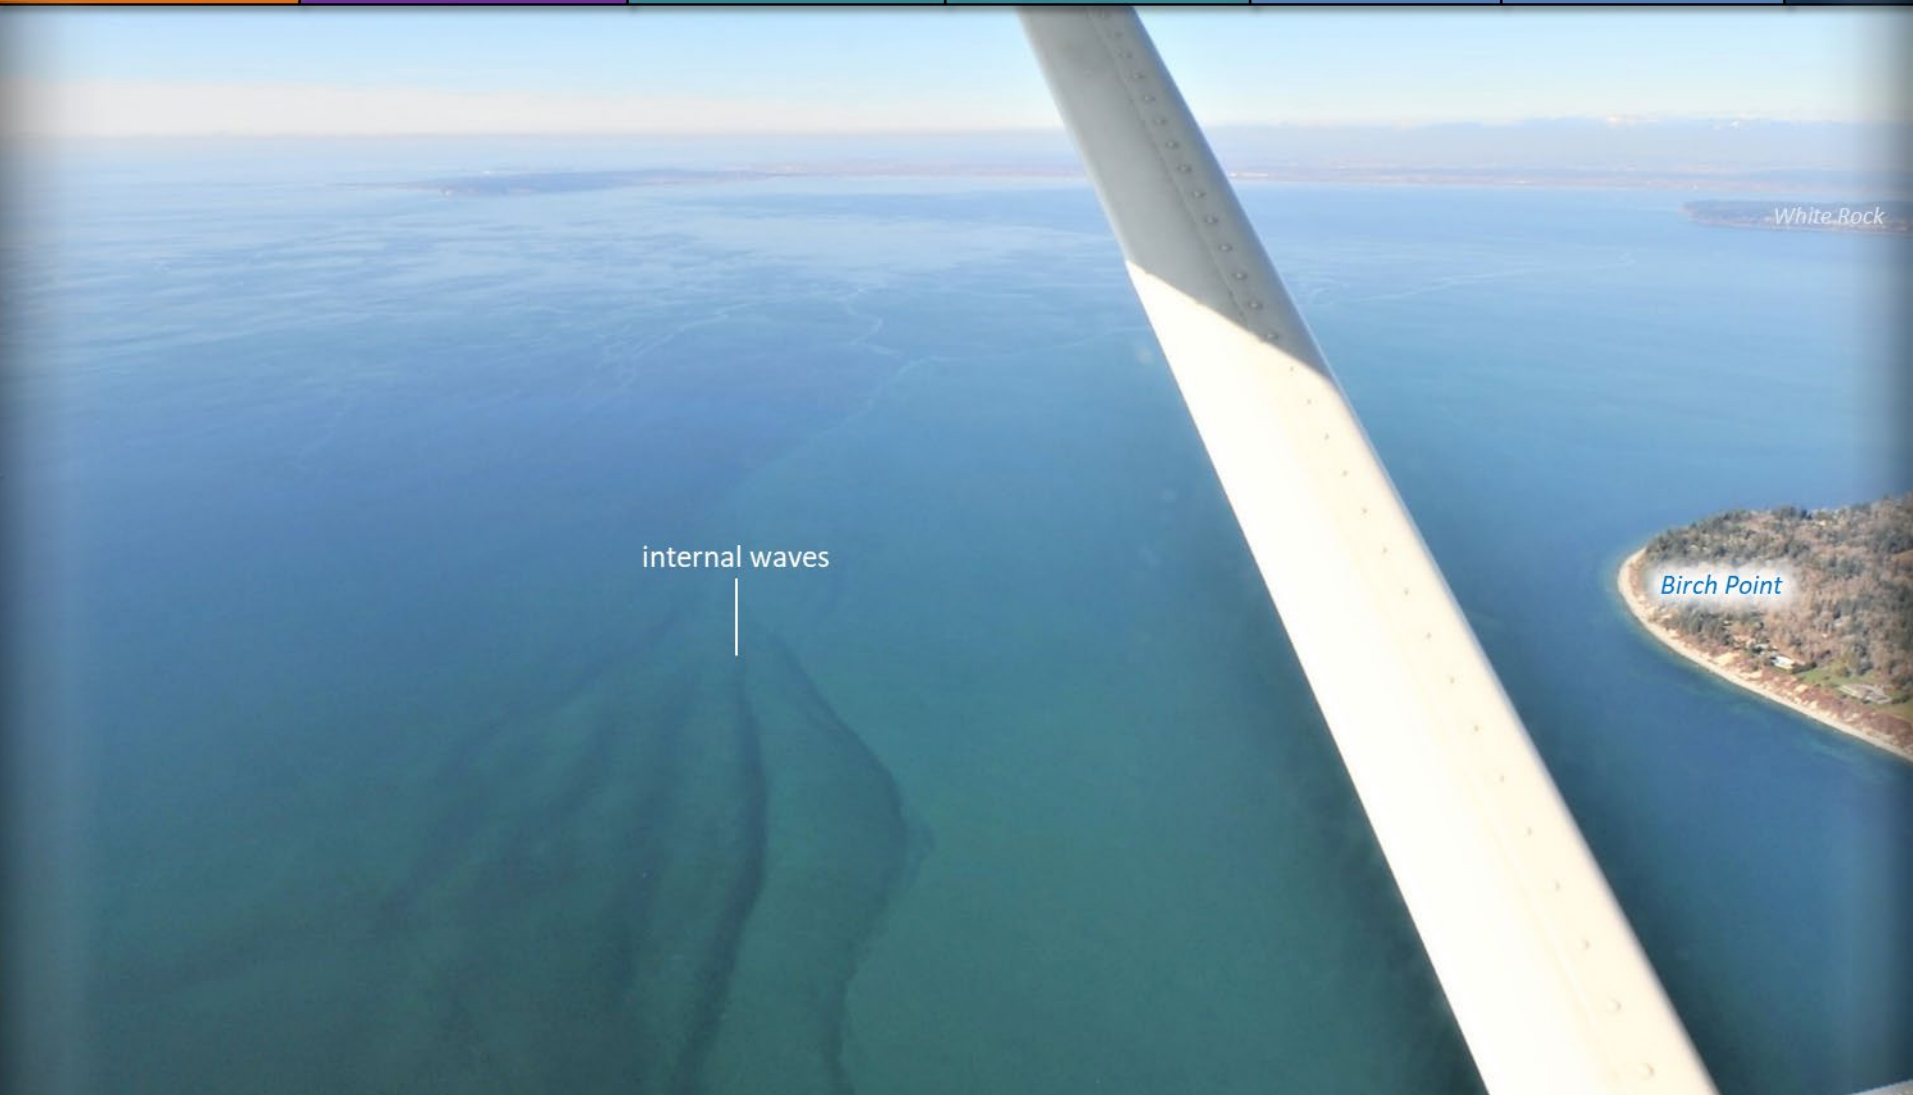
Location: Birch Bay (North Sound), 1:11 PM

Internal waves traveling onshore off Birch Point.

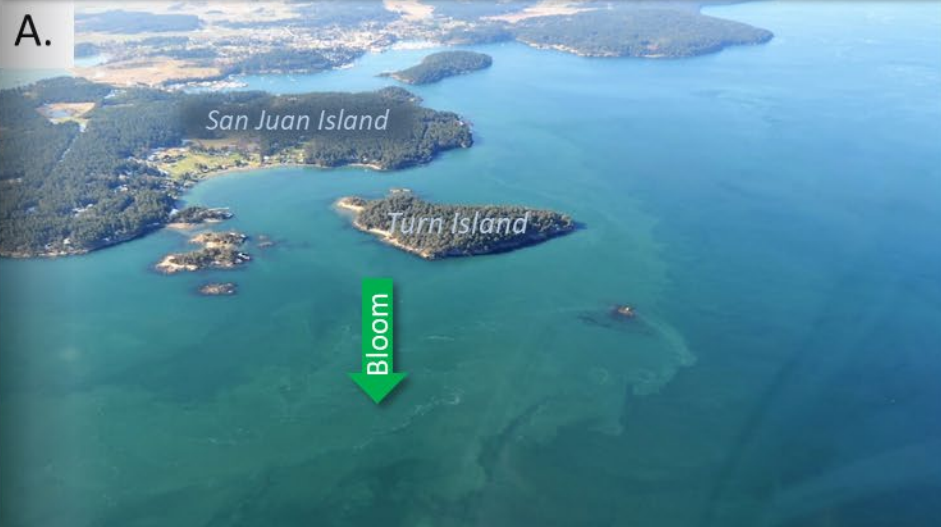
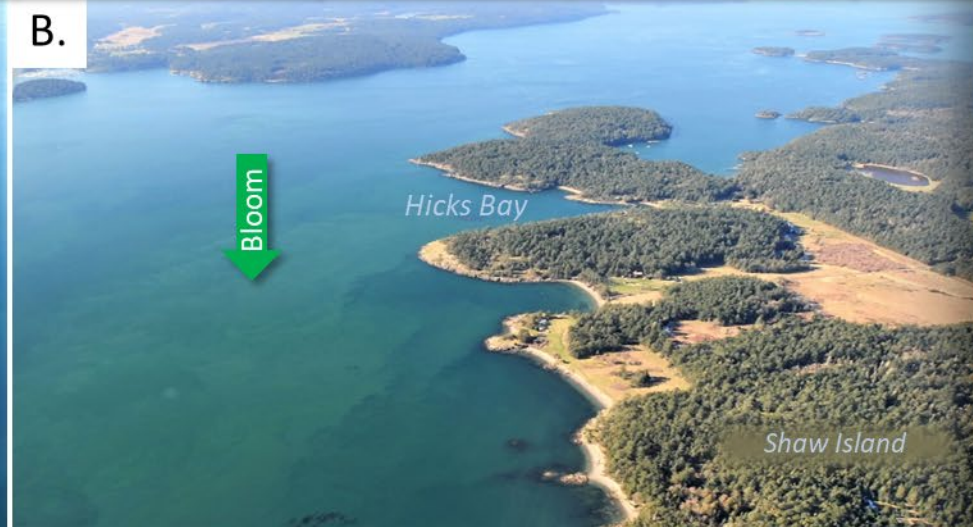
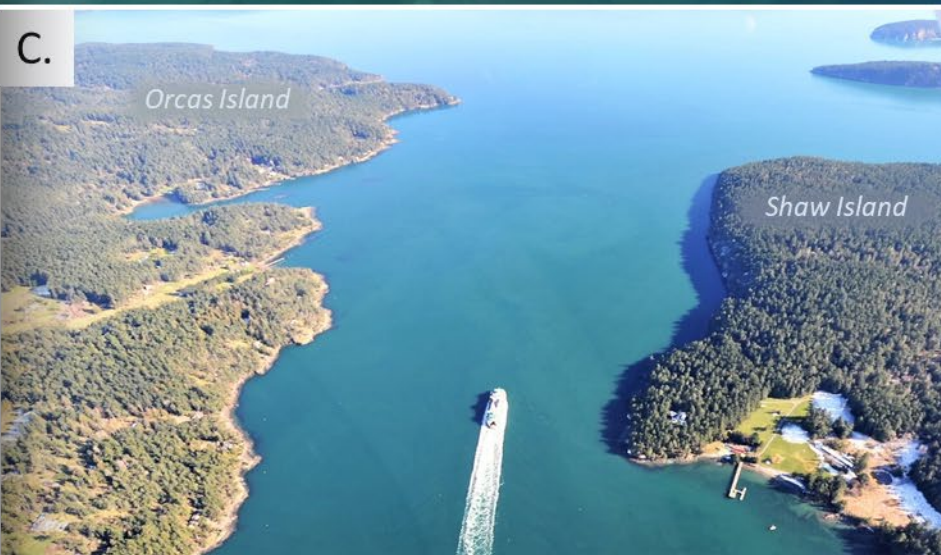
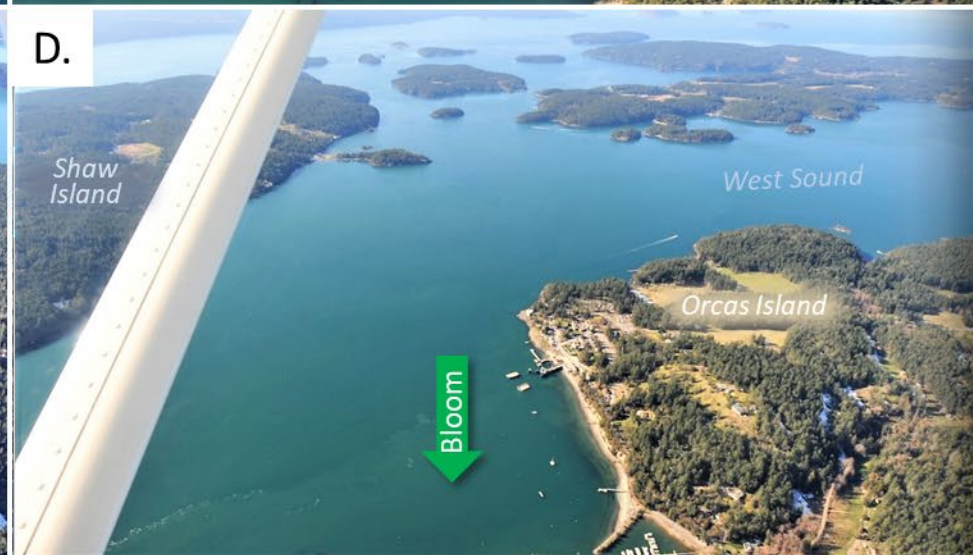
A-B. Strong tidal mixing of surface water containing a bloom. C-D. Beginning of a bloom. Location: A-B. south and C-D. north of Shaw Island (North Sound), 1:29 PM

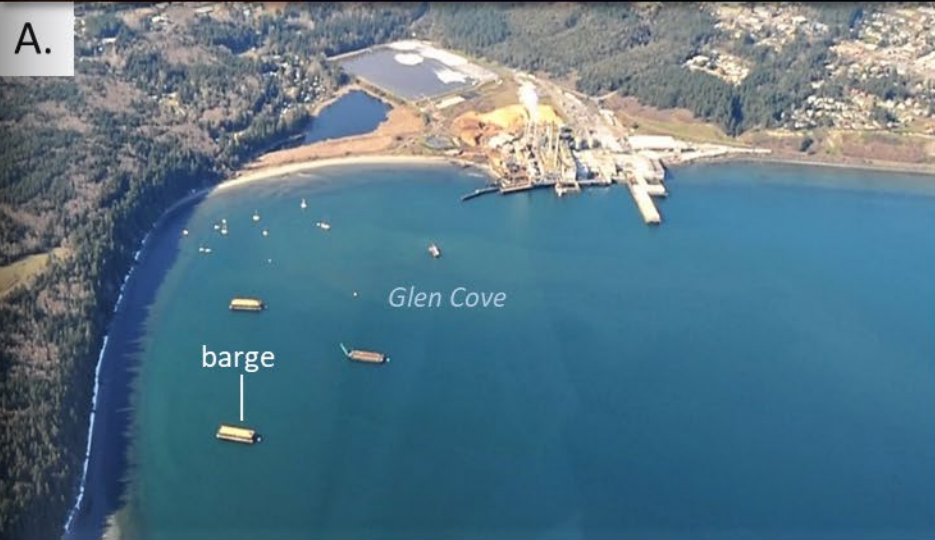
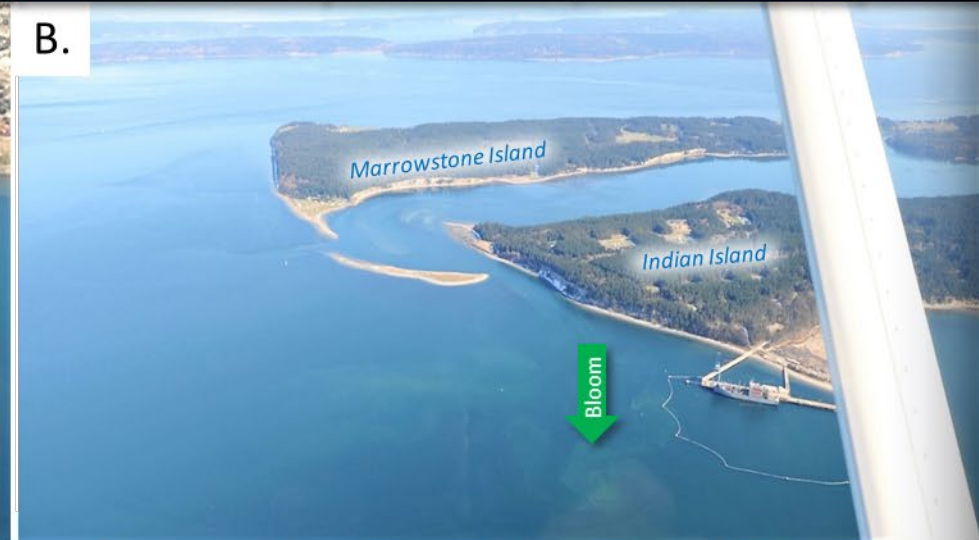
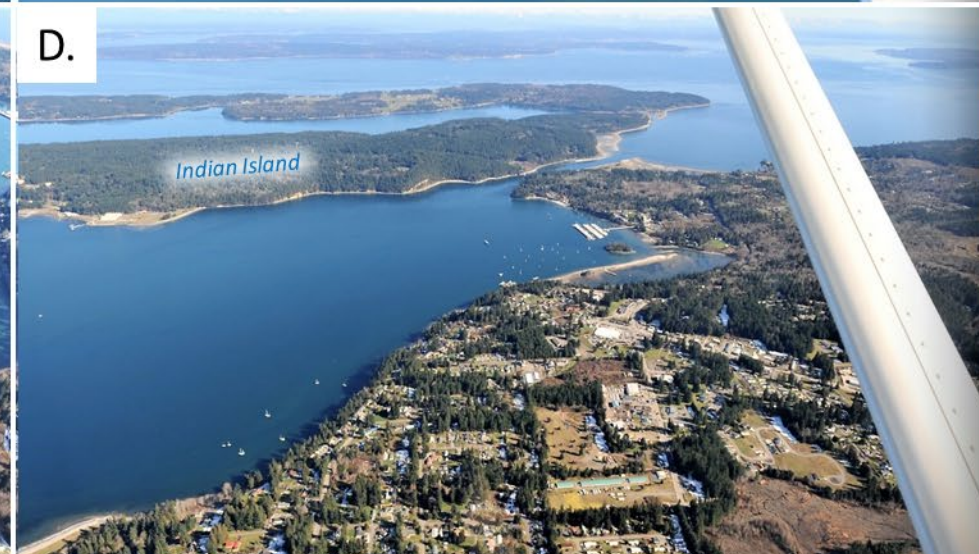
A. Barge and many boats in Glen Cove. B. Beginning bloom. C. Plume of boggy water from Chimacum Creek. D. Southern tip of Port Townsend Bay. Location: Port Townsend Bay (North Sound), 1:54 PM

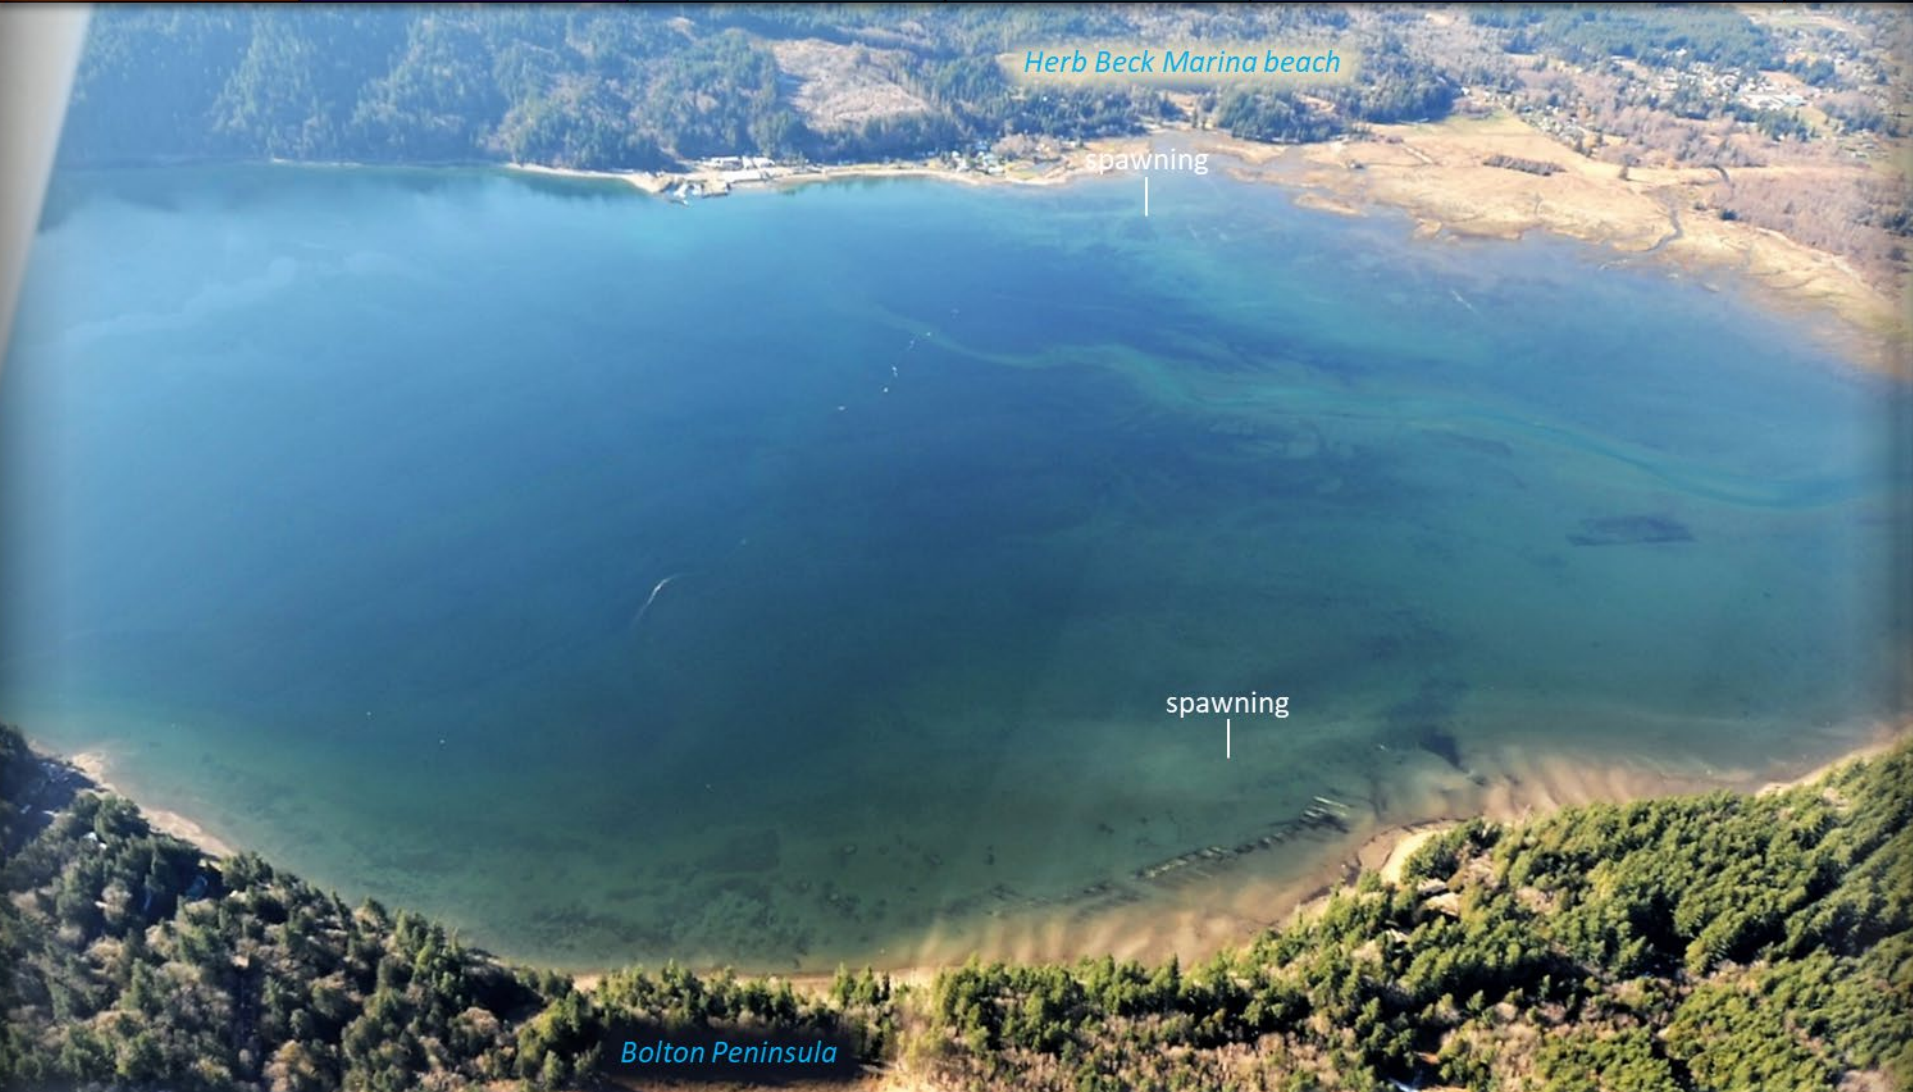
Location: Quilcene Bay (Hood Canal), 2:04 PM

Faint indication of herring, potentially spawning.

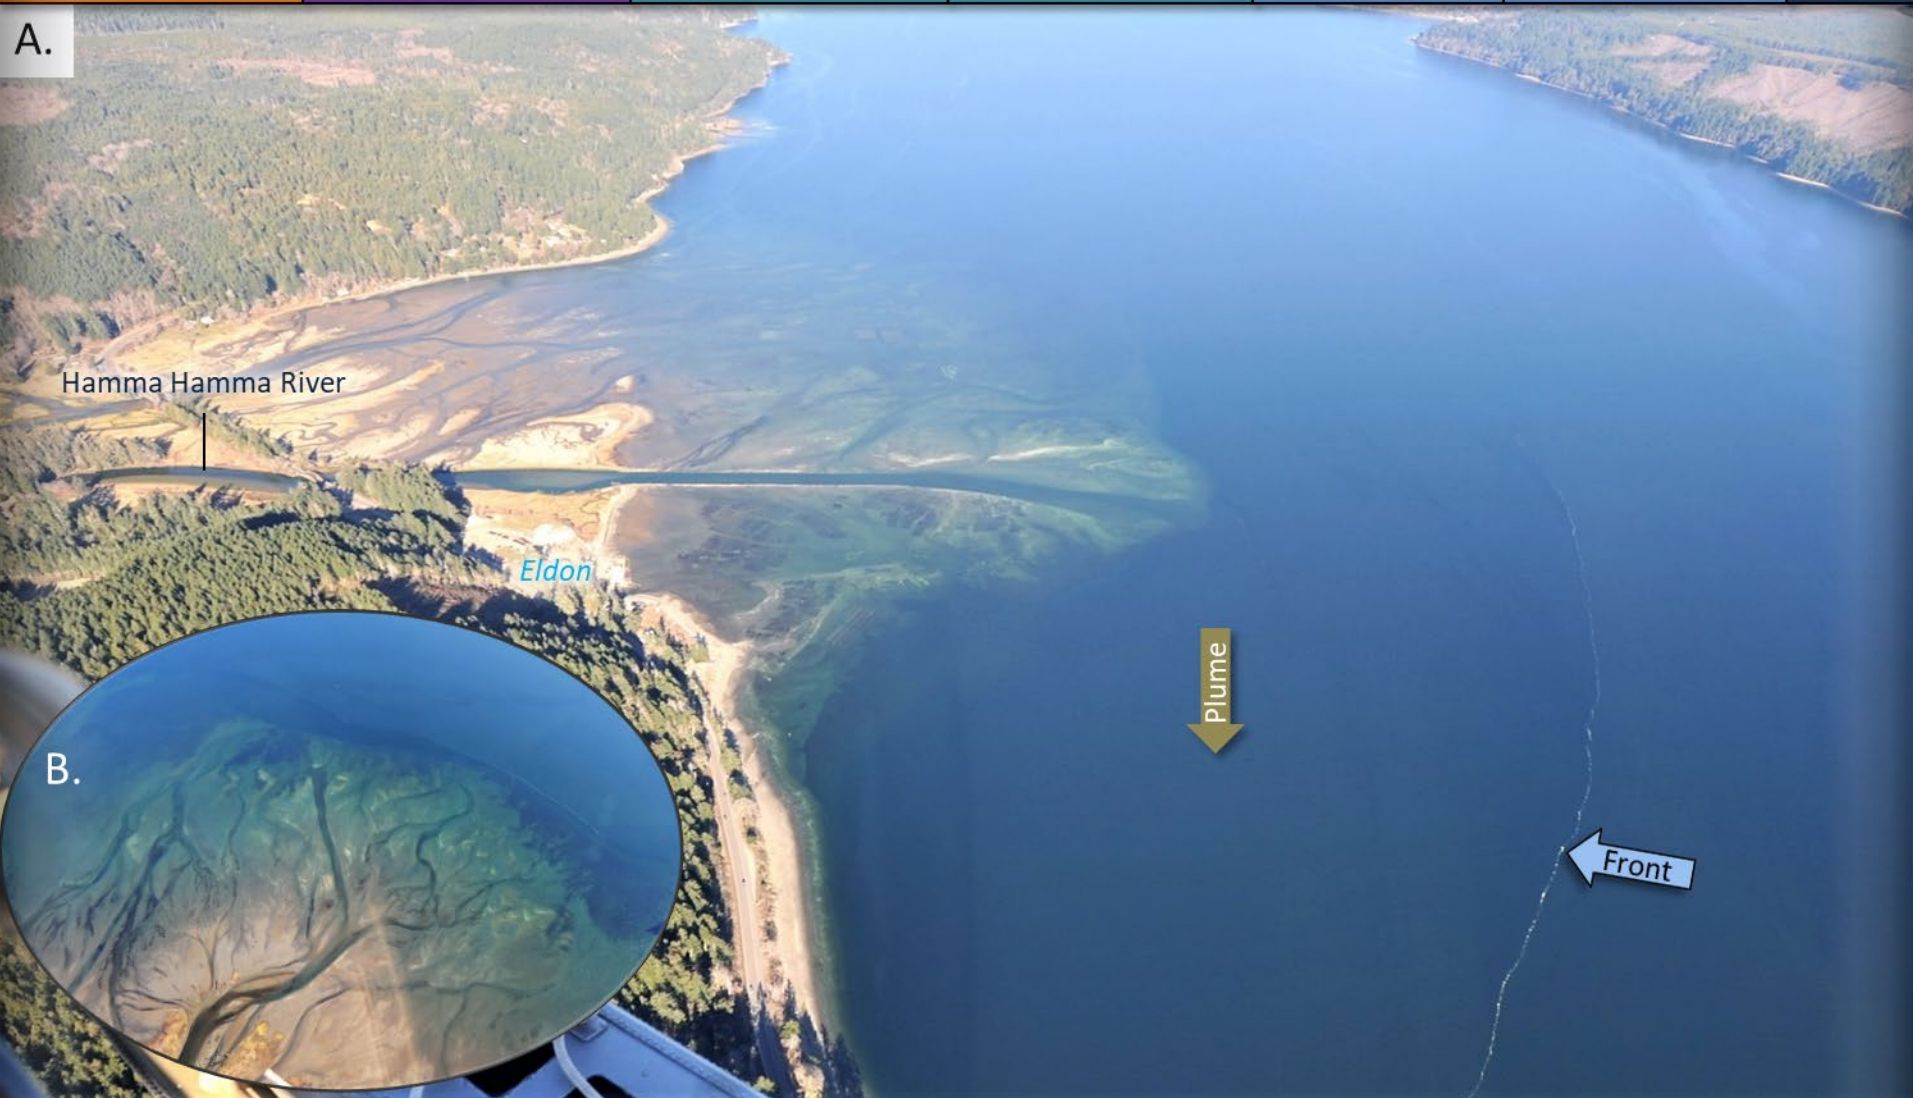
Location: Eldon (Hood Canal), 2:11 PM

Hamma Hamma River delta and freshwater plume extending into Hood Canal.

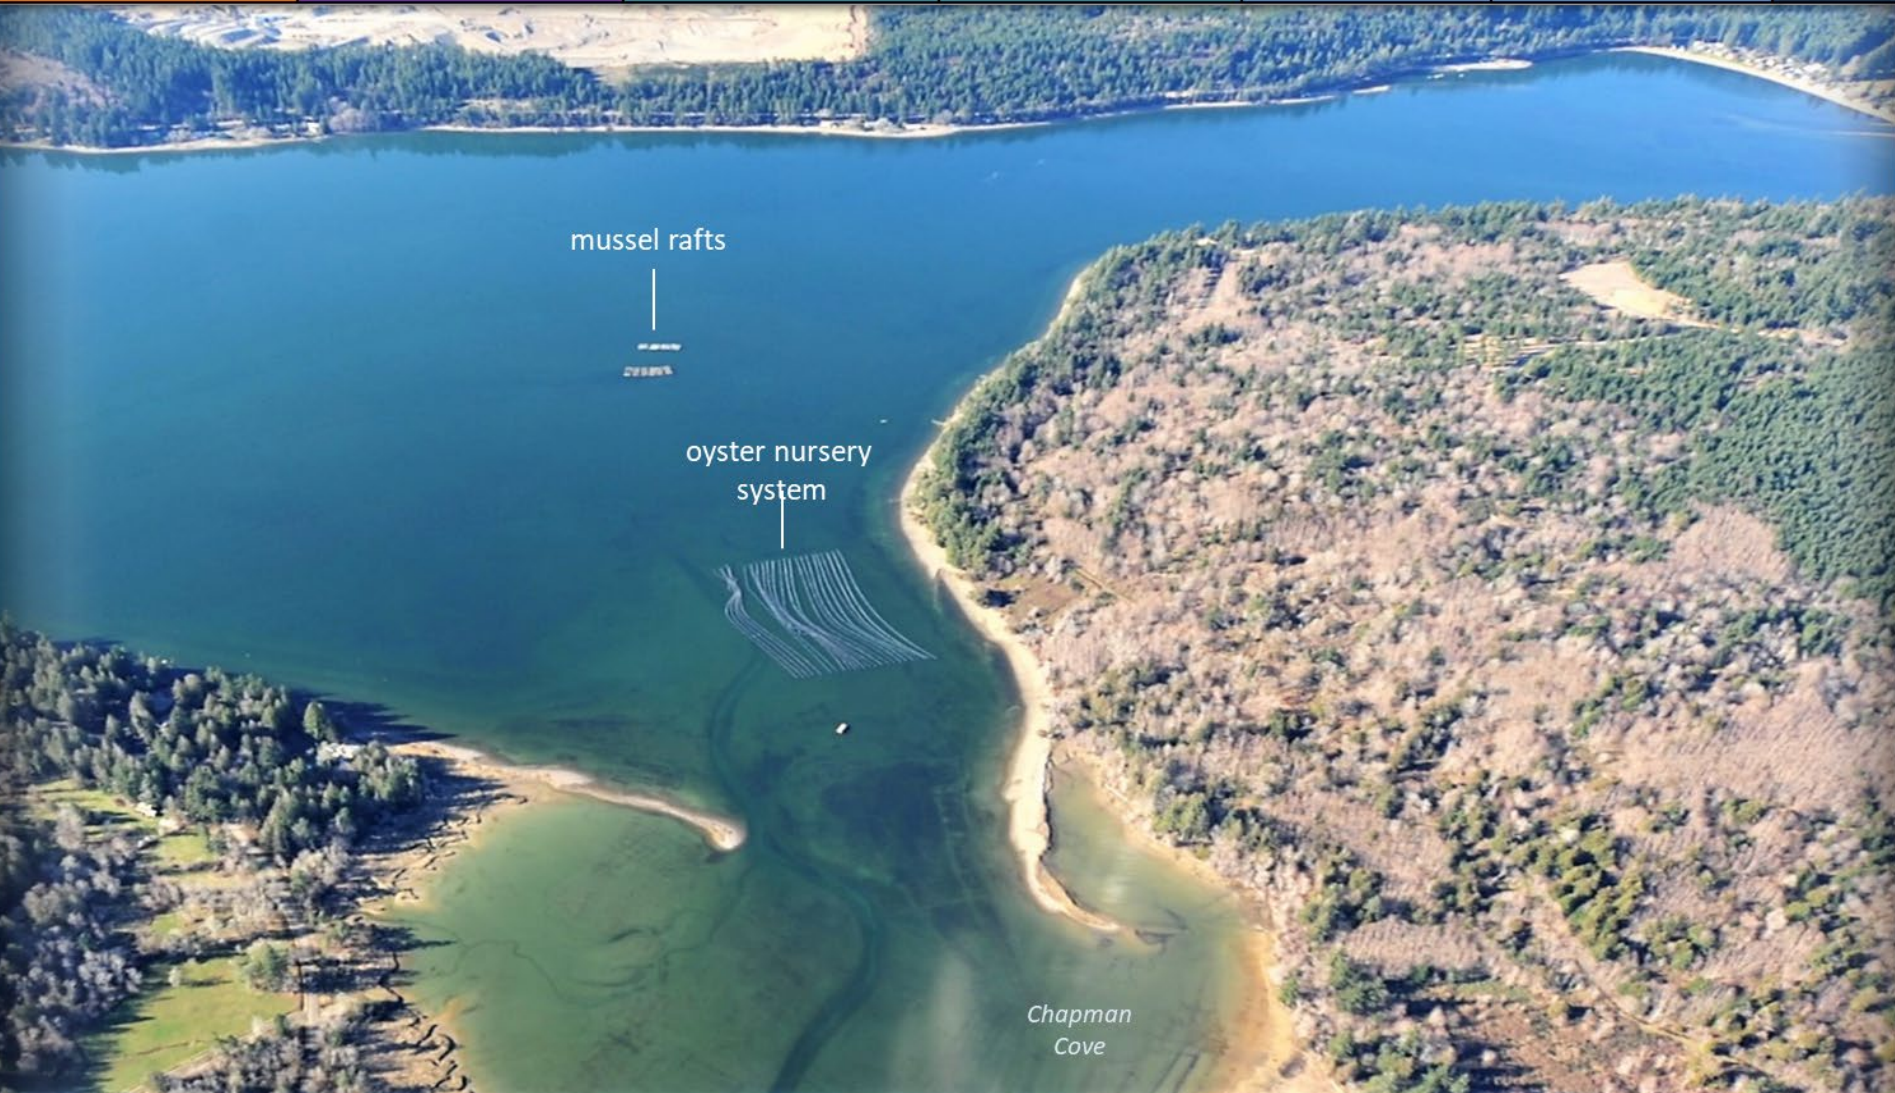
Location: Oakland Bay (South Sound), 2:33 PM

A newer oyster nursery system used to grow seed in Chapman Cove.

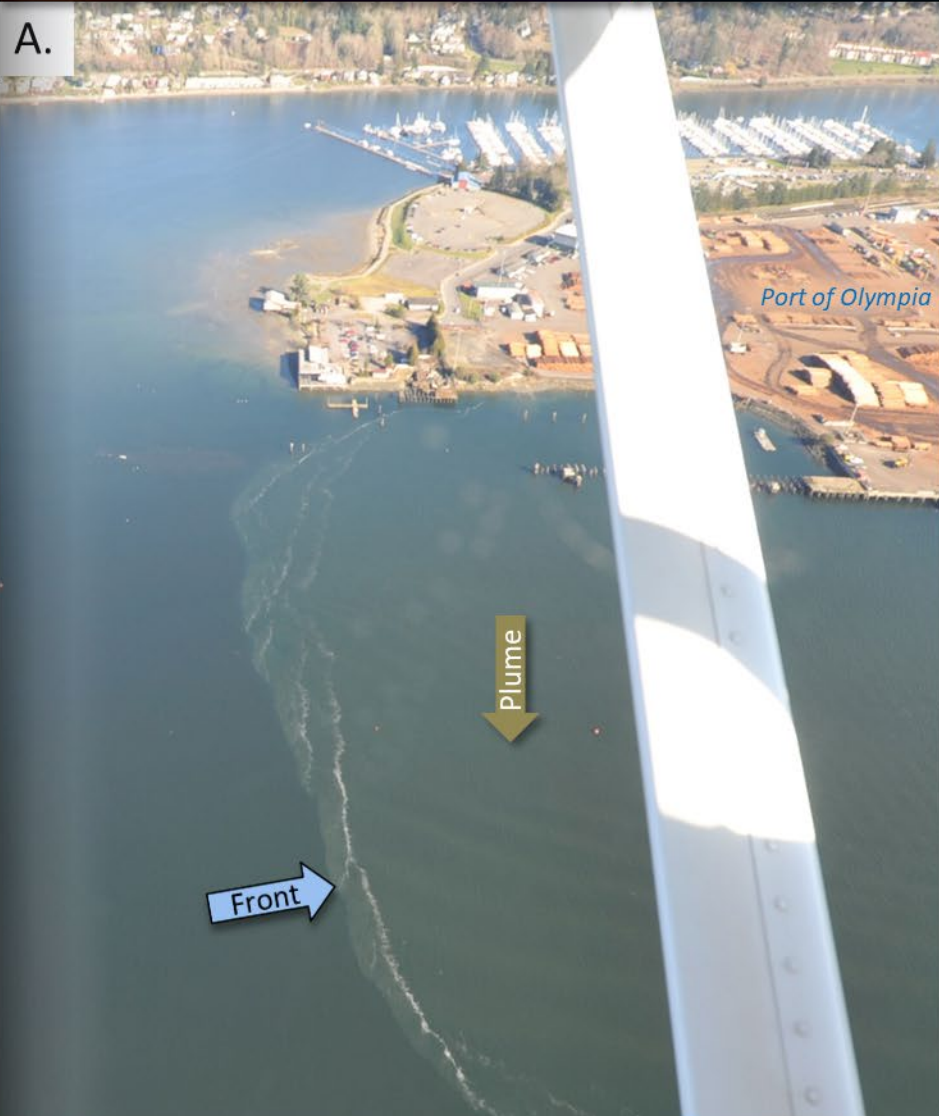
Location: Budd Inlet (South Sound), 2:41 PM

A. Front at edge of Deschutes River plume, B. Port of Olympia.

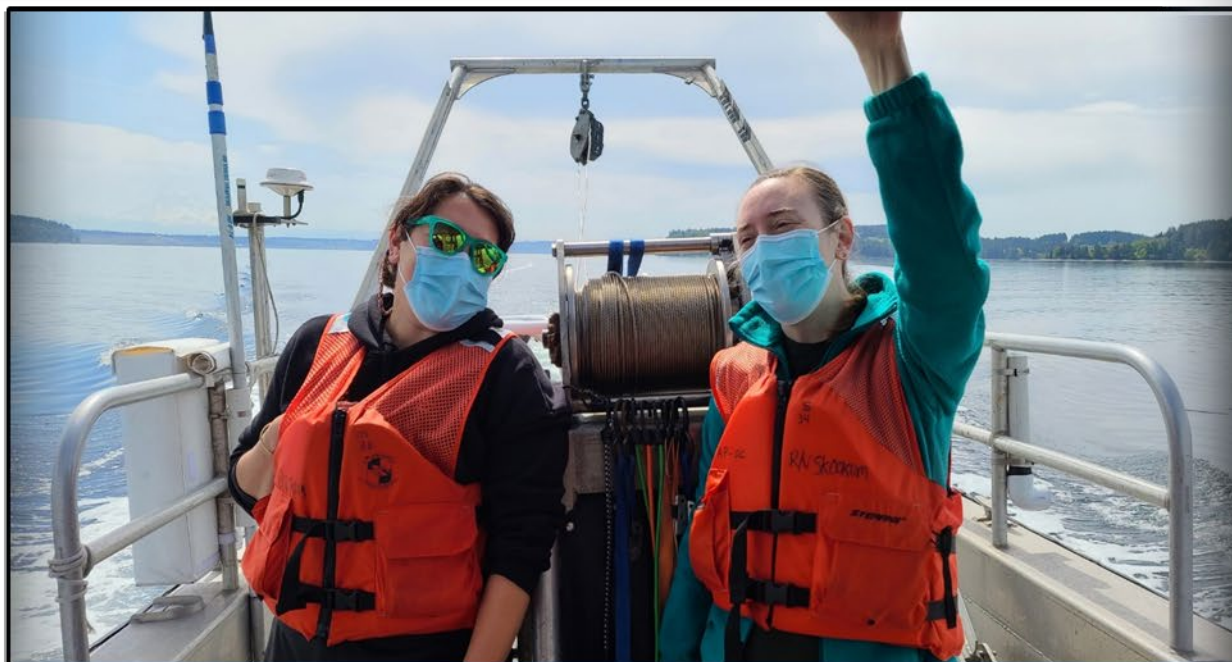
Long-term monitoring data from Puget Sound and coastal bays

- 39 stations sampled monthly
- 16 physical, chemical, biogeochemical parameters
- data from 1999-present
