Eyes Over Puget Sound

Surface Conditions Report: March-June 2022

Up-to-date observations of water quality conditions in Puget Sound and coastal bays

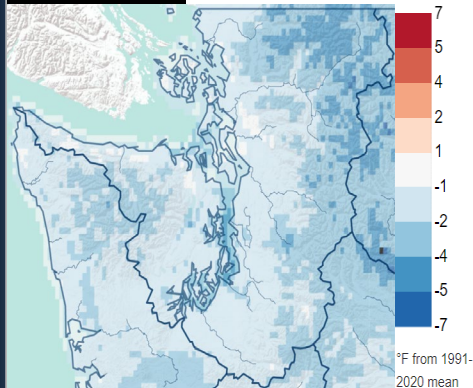
In late spring, Puget Sound air temperatures were below normal, while precipitation was above normal (A). Snowpack has begun to melt, but due to continued cool conditions and late season accumulation, more snow than normal currently remains (B) to feed rivers this summer. Despite current robust values, not all locations reached their median peak volumes, so air temperature and precipitation trends should still be monitored closely.

from historical mean daily ranged from 0 to -7 °F in the Puget Sound region during the past 30 days.

from historical mean ranged from 0 to +15 inches in the Puget Sound region during the past 30 days.

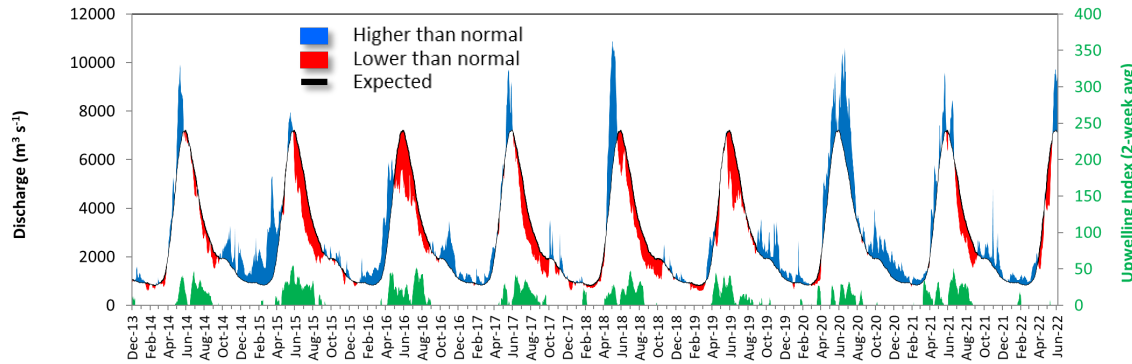
Fraser River (at midnight)

The Fraser River is the major driver of [estuarine circulation](#) and water exchange between the Salish Sea and the ocean. Fraser River flows are currently higher than normal. Upwelling off the coast, however, is yet not coinciding with the freshet.

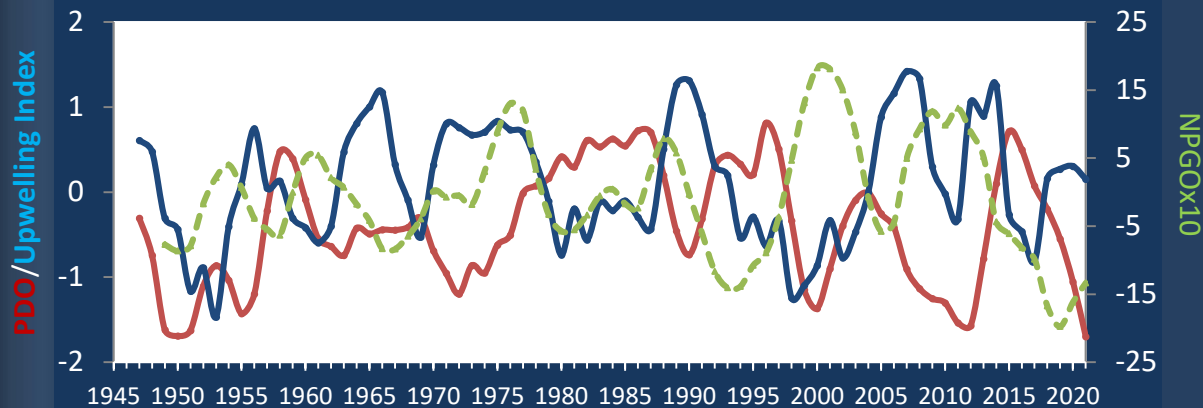
Three-year running average of PDO, Upwelling, and NPGO Indices

How do ocean boundary conditions affect the quality of water the Salish Sea exchanges with the ocean? Water has cooled (PDO). Upwelling (Upwelling Index [anomaly](#)) is at expected level. Productivity in the eastern Pacific is lower (NPGO; last updated Jan 2022).

Pacific Decadal Oscillation Index (PDO, [temperature](#), [explanation](#)). Upwelling Index (anomalies) ([Upwelling](#), [low oxygen](#), [explanation](#)). North Pacific Gyre Oscillation Index (NPGO, [productivity](#), [explanation](#)).

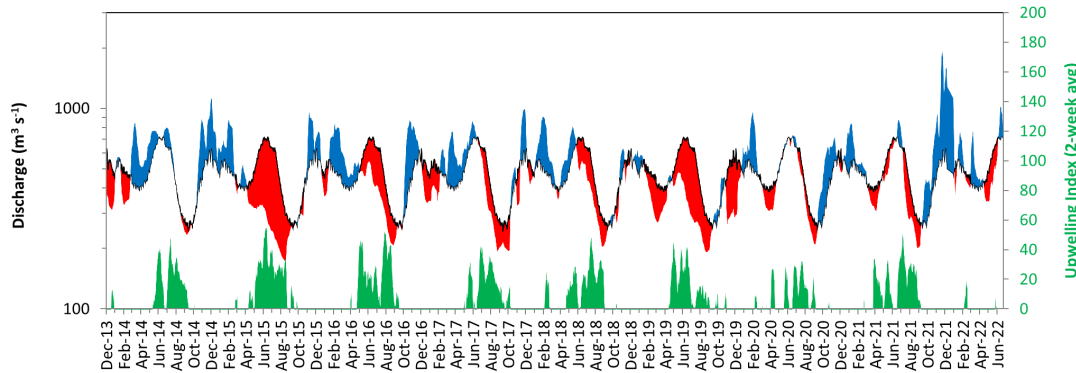
Skagit River (at midnight USGS)

The Skagit River freshet is no longer clearly pronounced because the river is a regulated system for hydroelectric power generation. However, drought years and low flows can be seen in the river's discharge data. In 2022, flows were near normal. Upwelling, to date, is weak.

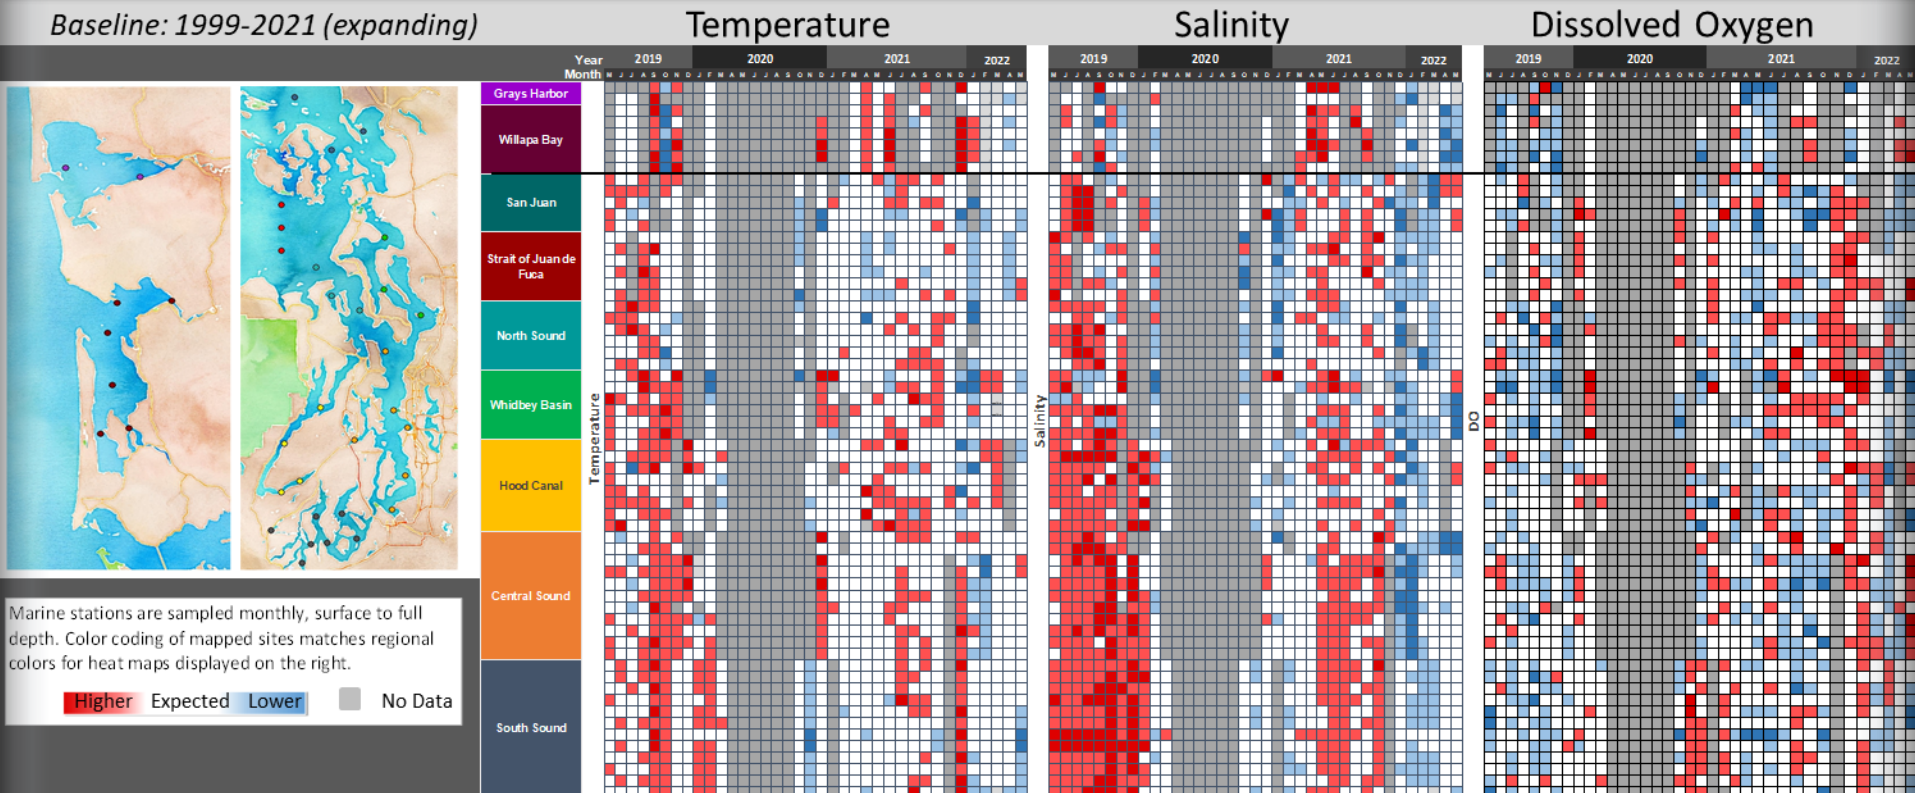
The year 2022 is shaping up to be relatively normal for temperature, lower in salinity reflecting a lot of rain, and normal to slightly lower in oxygen concentration. In contrast 2019 and 21 were saltier.

Marine stations are sampled monthly, surface to full depth. Color coding of mapped sites matches regional colors for heat maps displayed on the right.

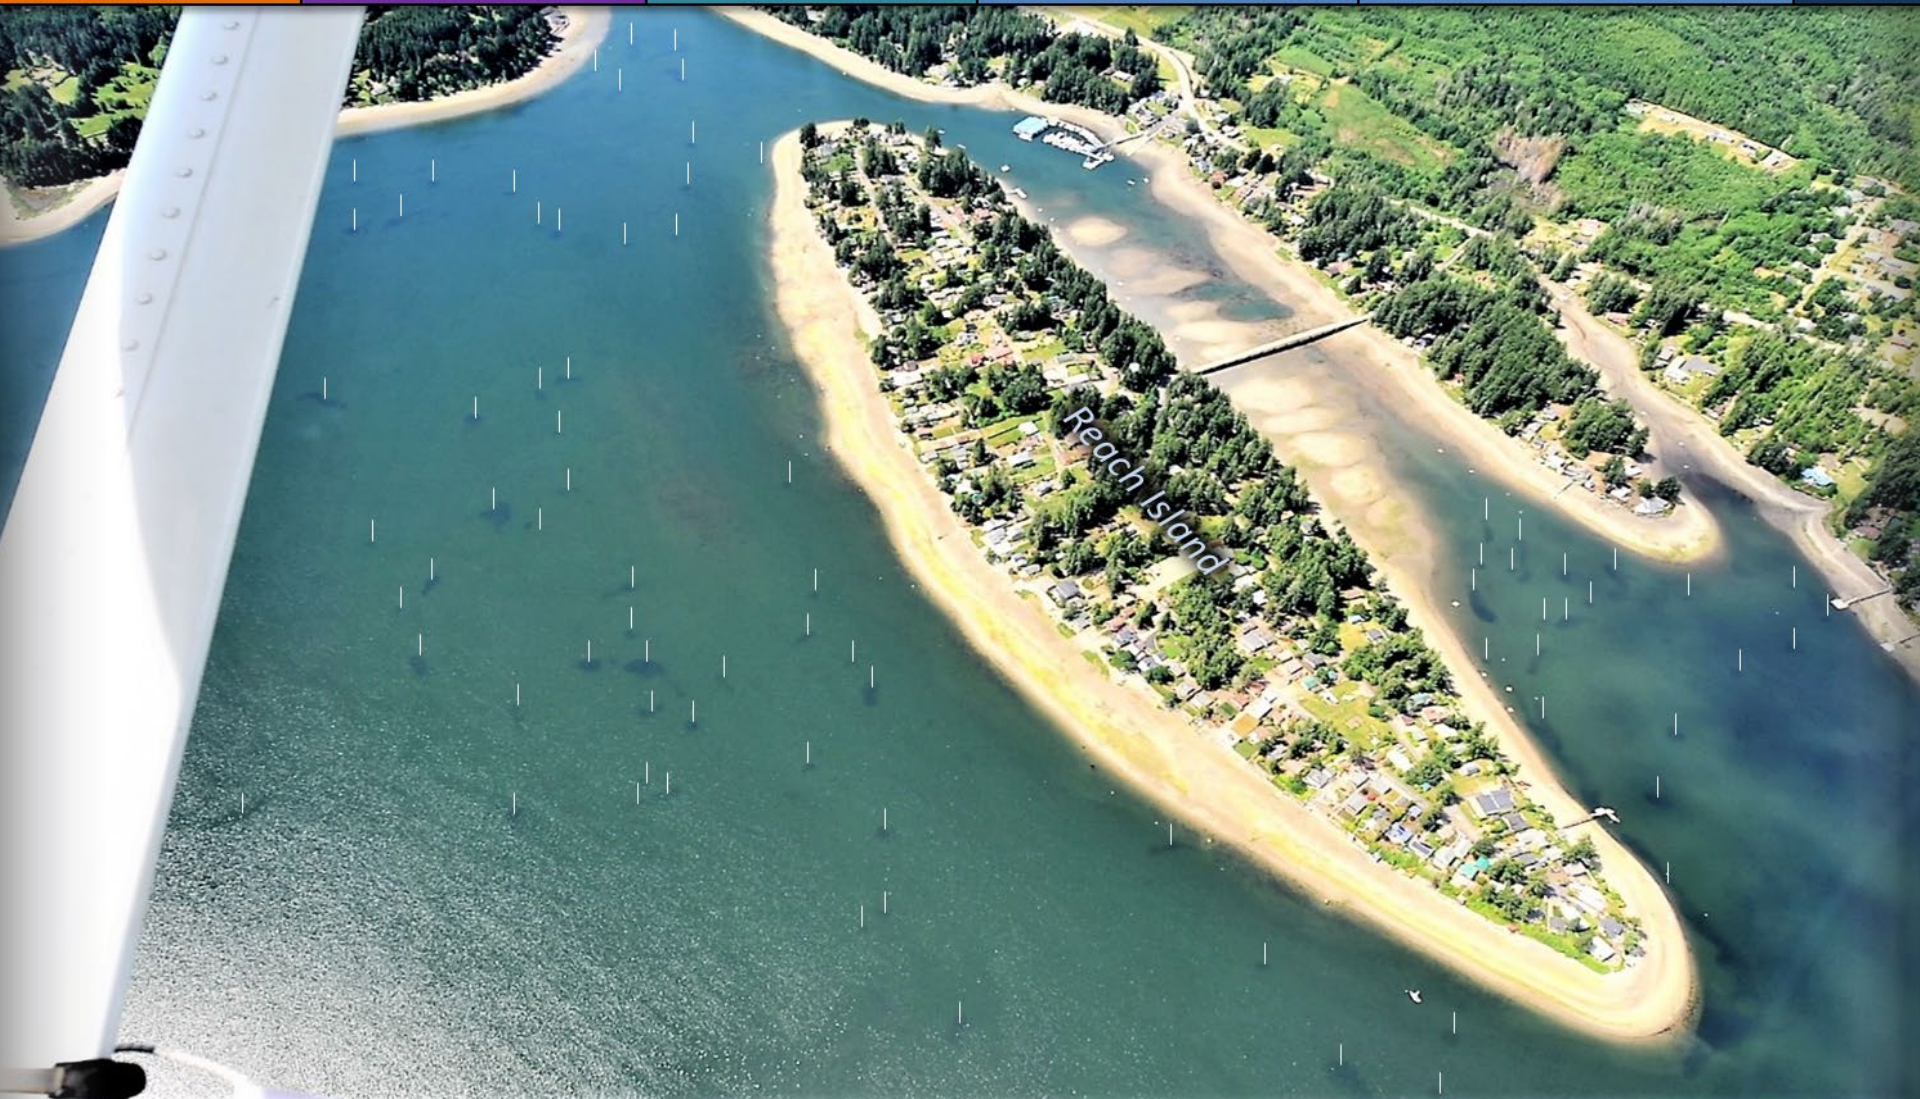
High number of schooling fish. On the image, we count more than 85 schools (marked with white vertical lines).

Location: Case Inlet (South Sound), 12:05 PM

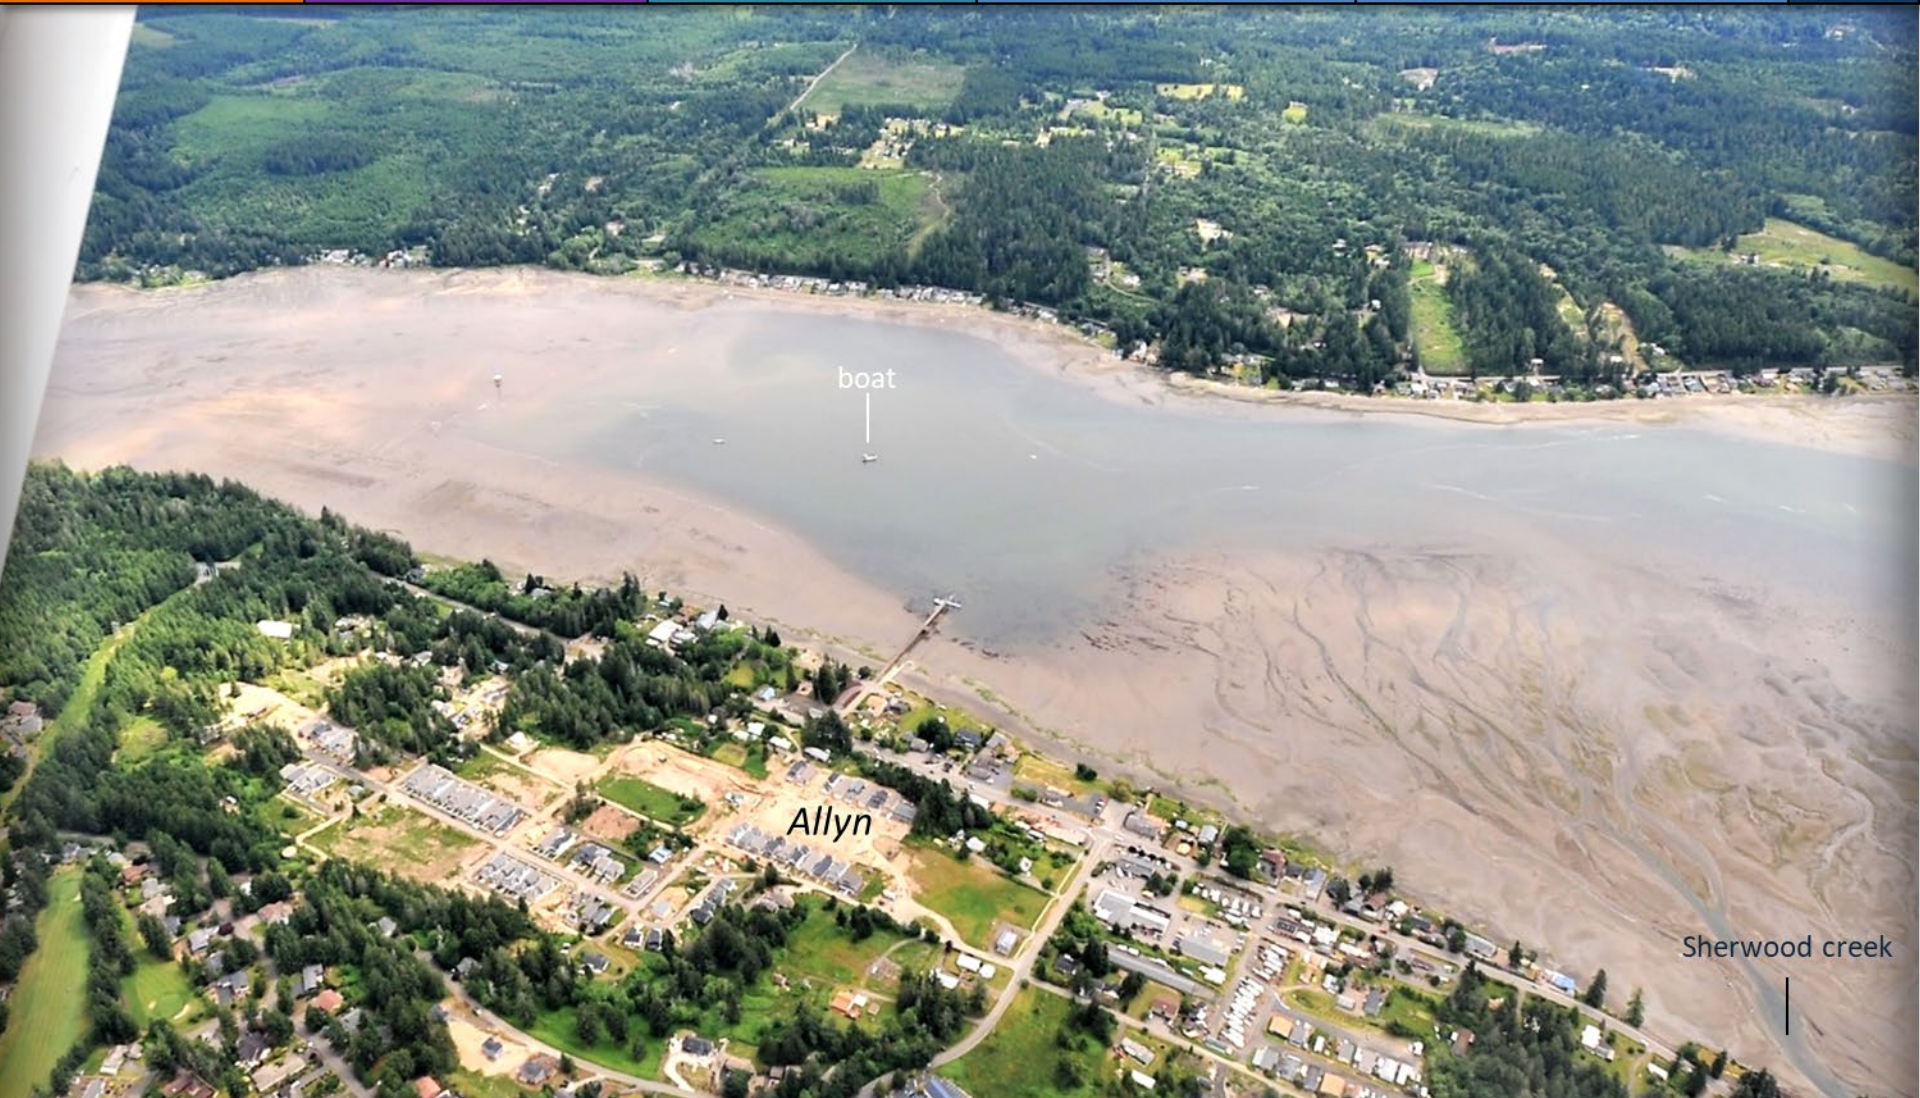
Extremely low tide exposes much of the sediment in North Bay.

Location: Case Inlet (South Sound Basin), 12:06 PM

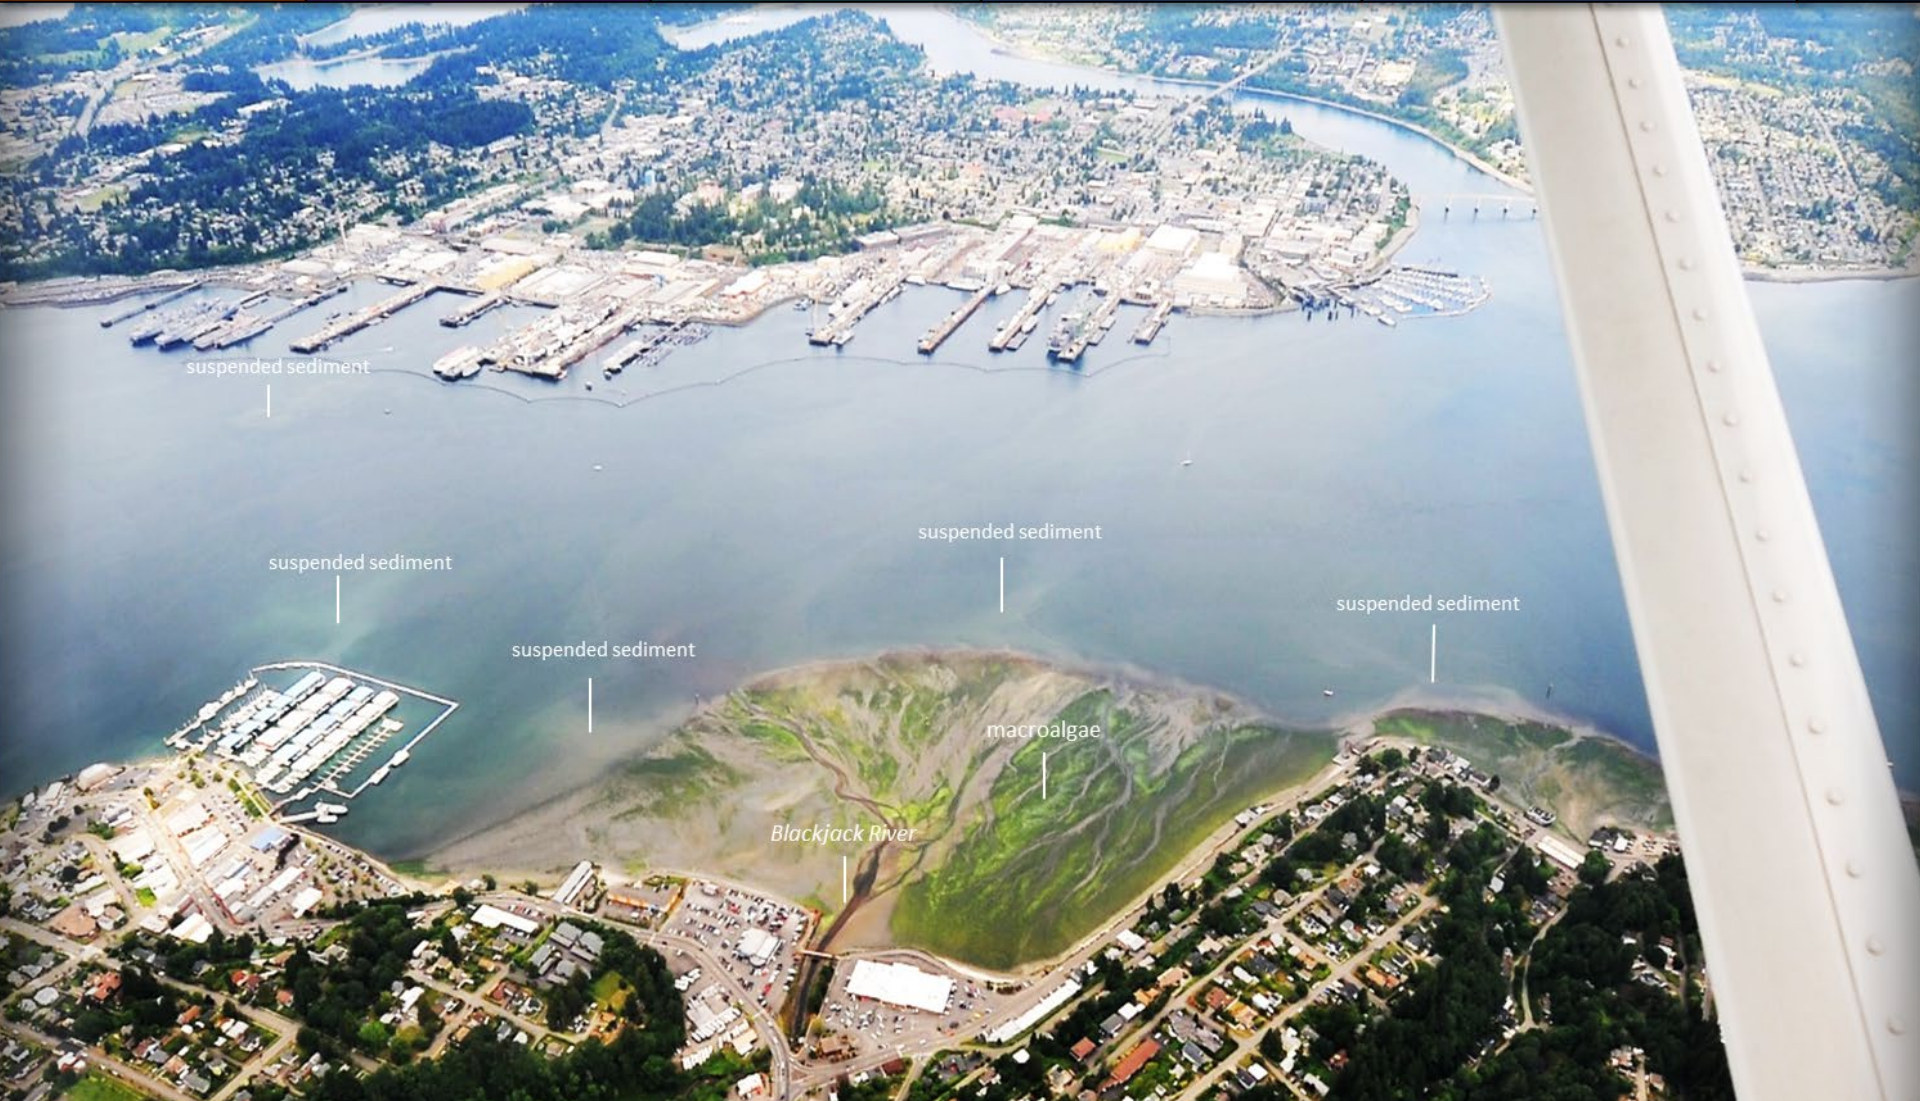
Suspended sediment in Sinclair Inlet at a very low tide. Many macroalgae growing in Blackjack River estuary.
Location: Sinclair Inlet (Central Sound), 12:18 PM

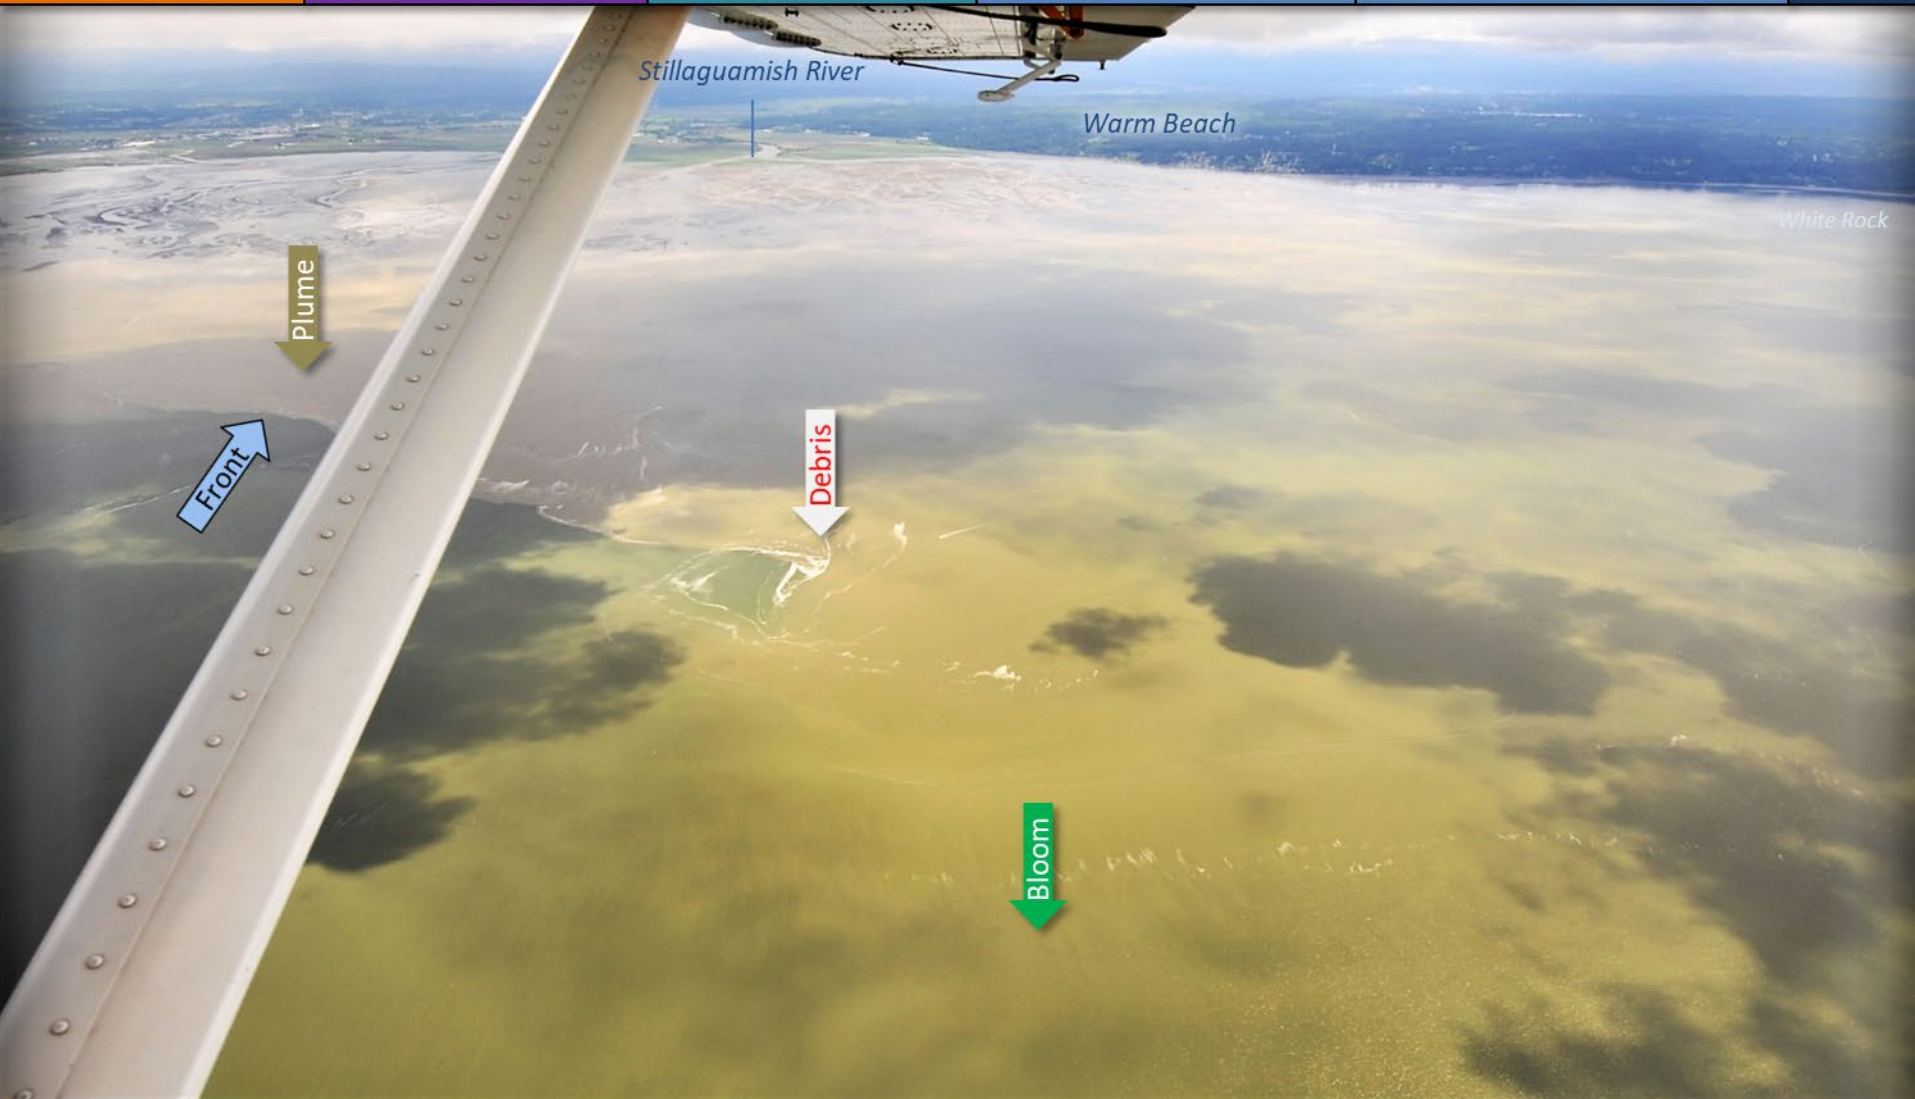
Strong discoloration of water in Port Susan by bloom and sediment. Fronts surrounding the Stillaguamish River plume. Location: Port Susan (Whidbey Basin), 12:46 PM

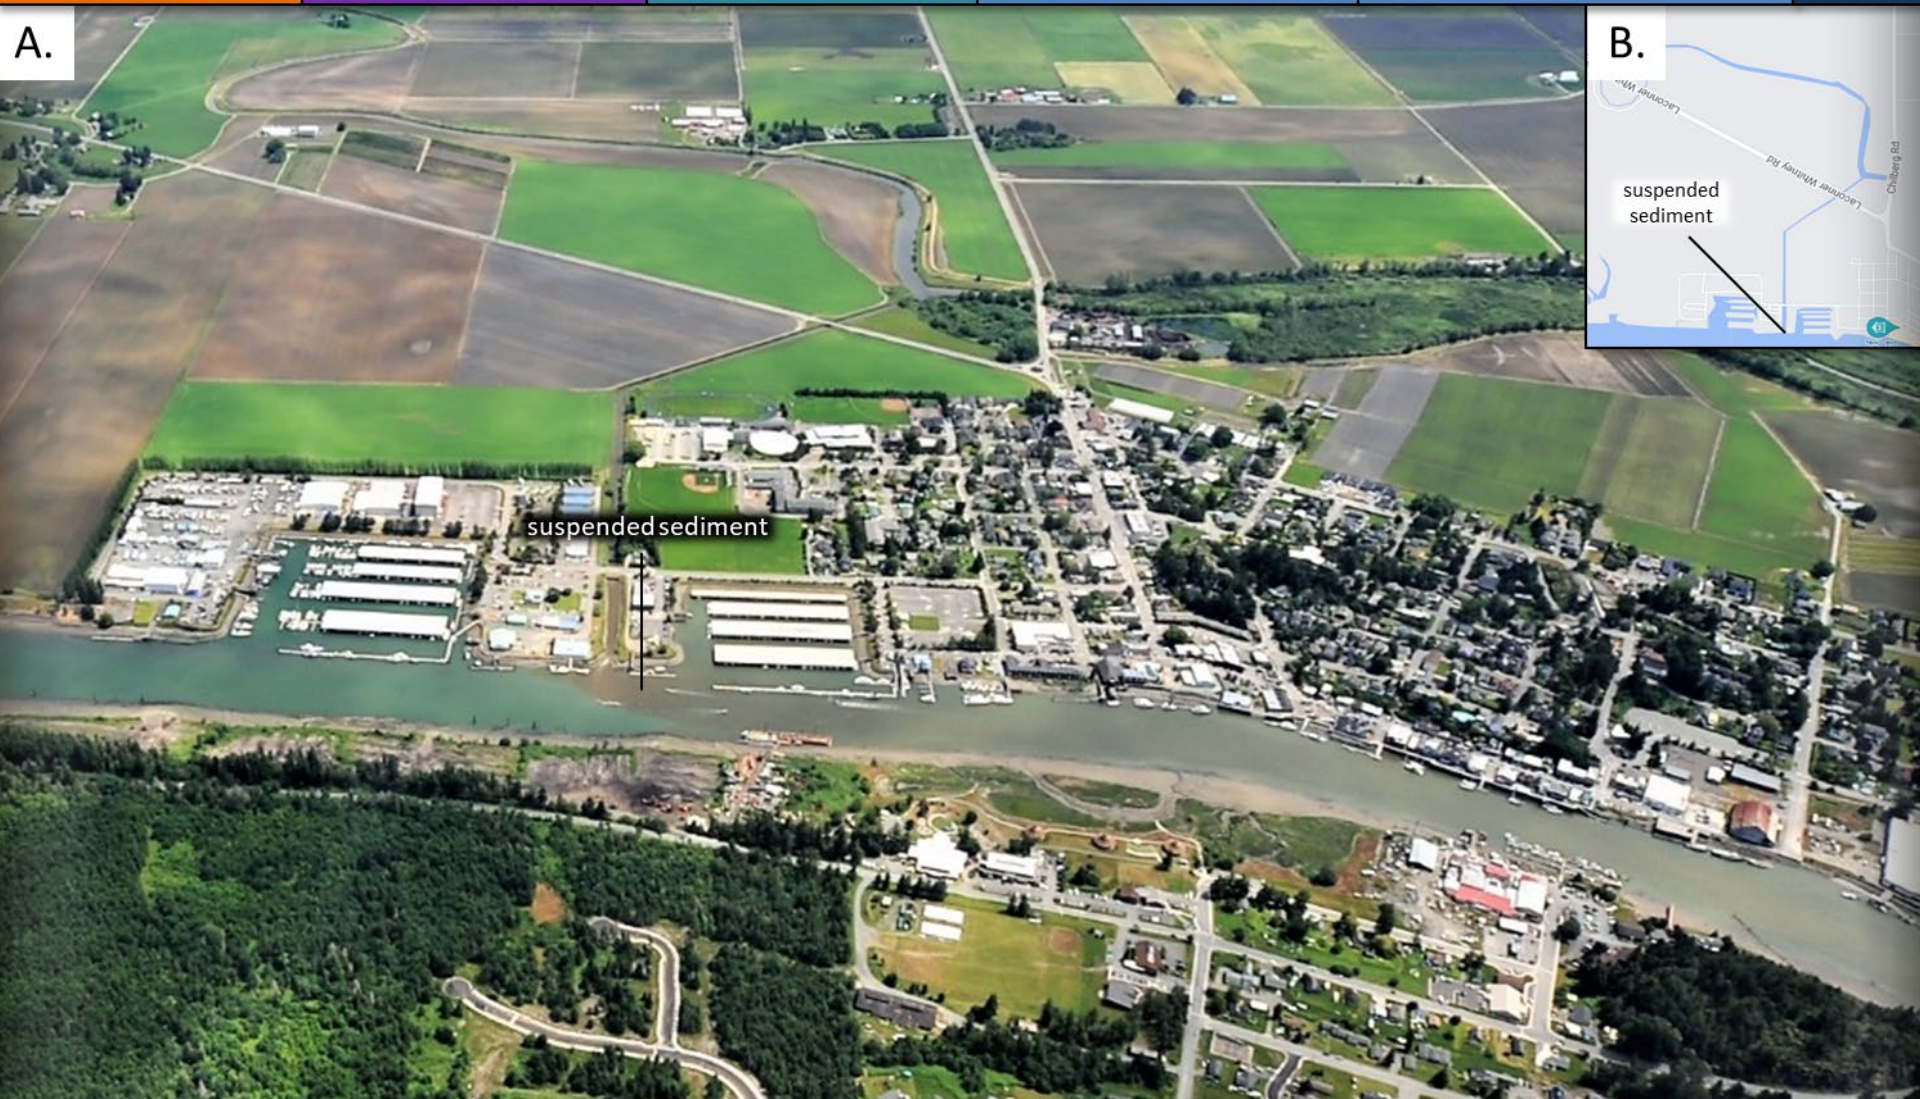
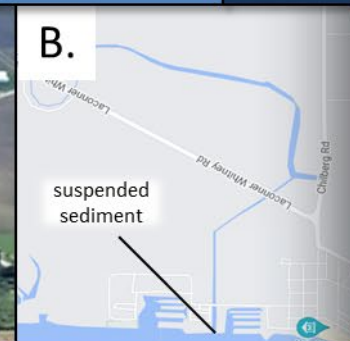
*A. Very brown water entering the Swinomish Channel from a B. drainage channel next to La Conner Marina.
Location: Whidbey Basin (North Sound), 12:55 PM*

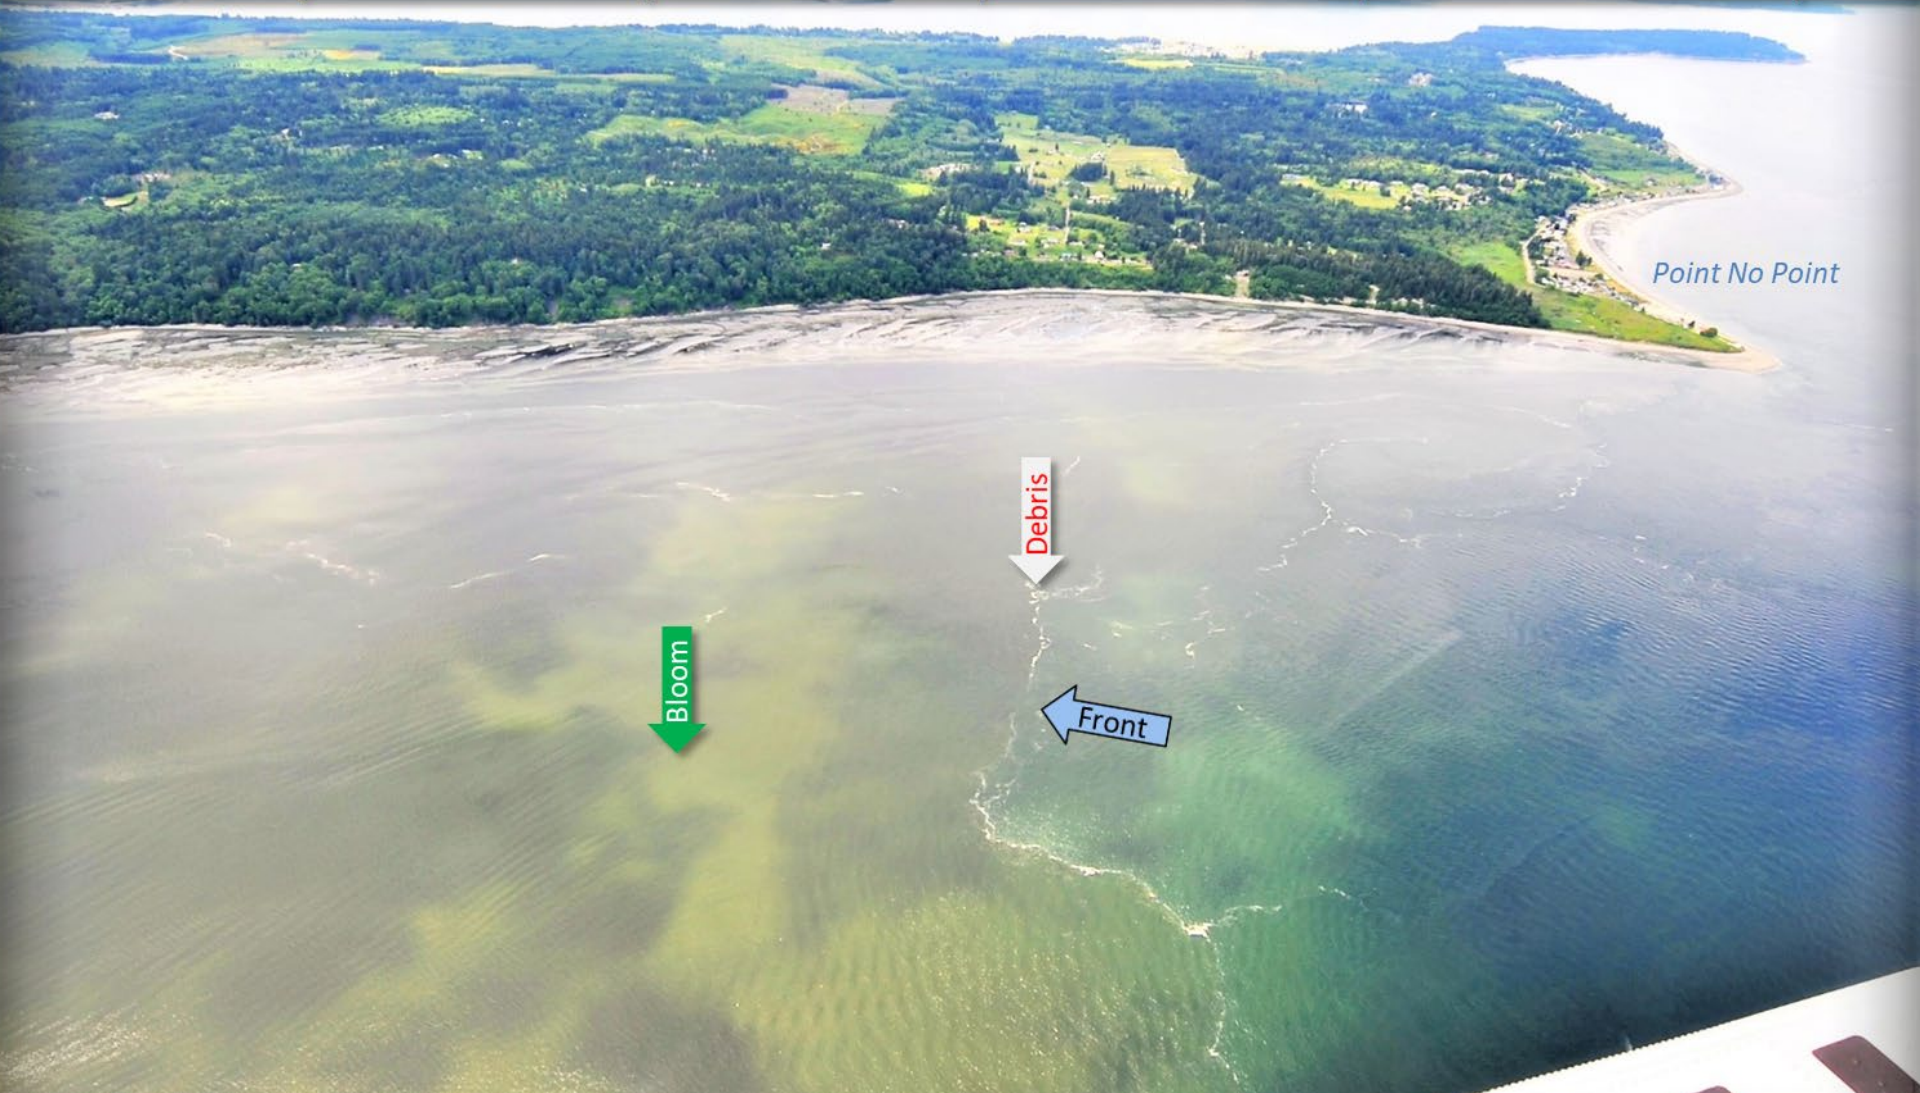
*Front separating water discolored by a strong bloom in Central Basin from clearer water to the north.
Location: Point No Point (Central Sound), 1:35 PM*

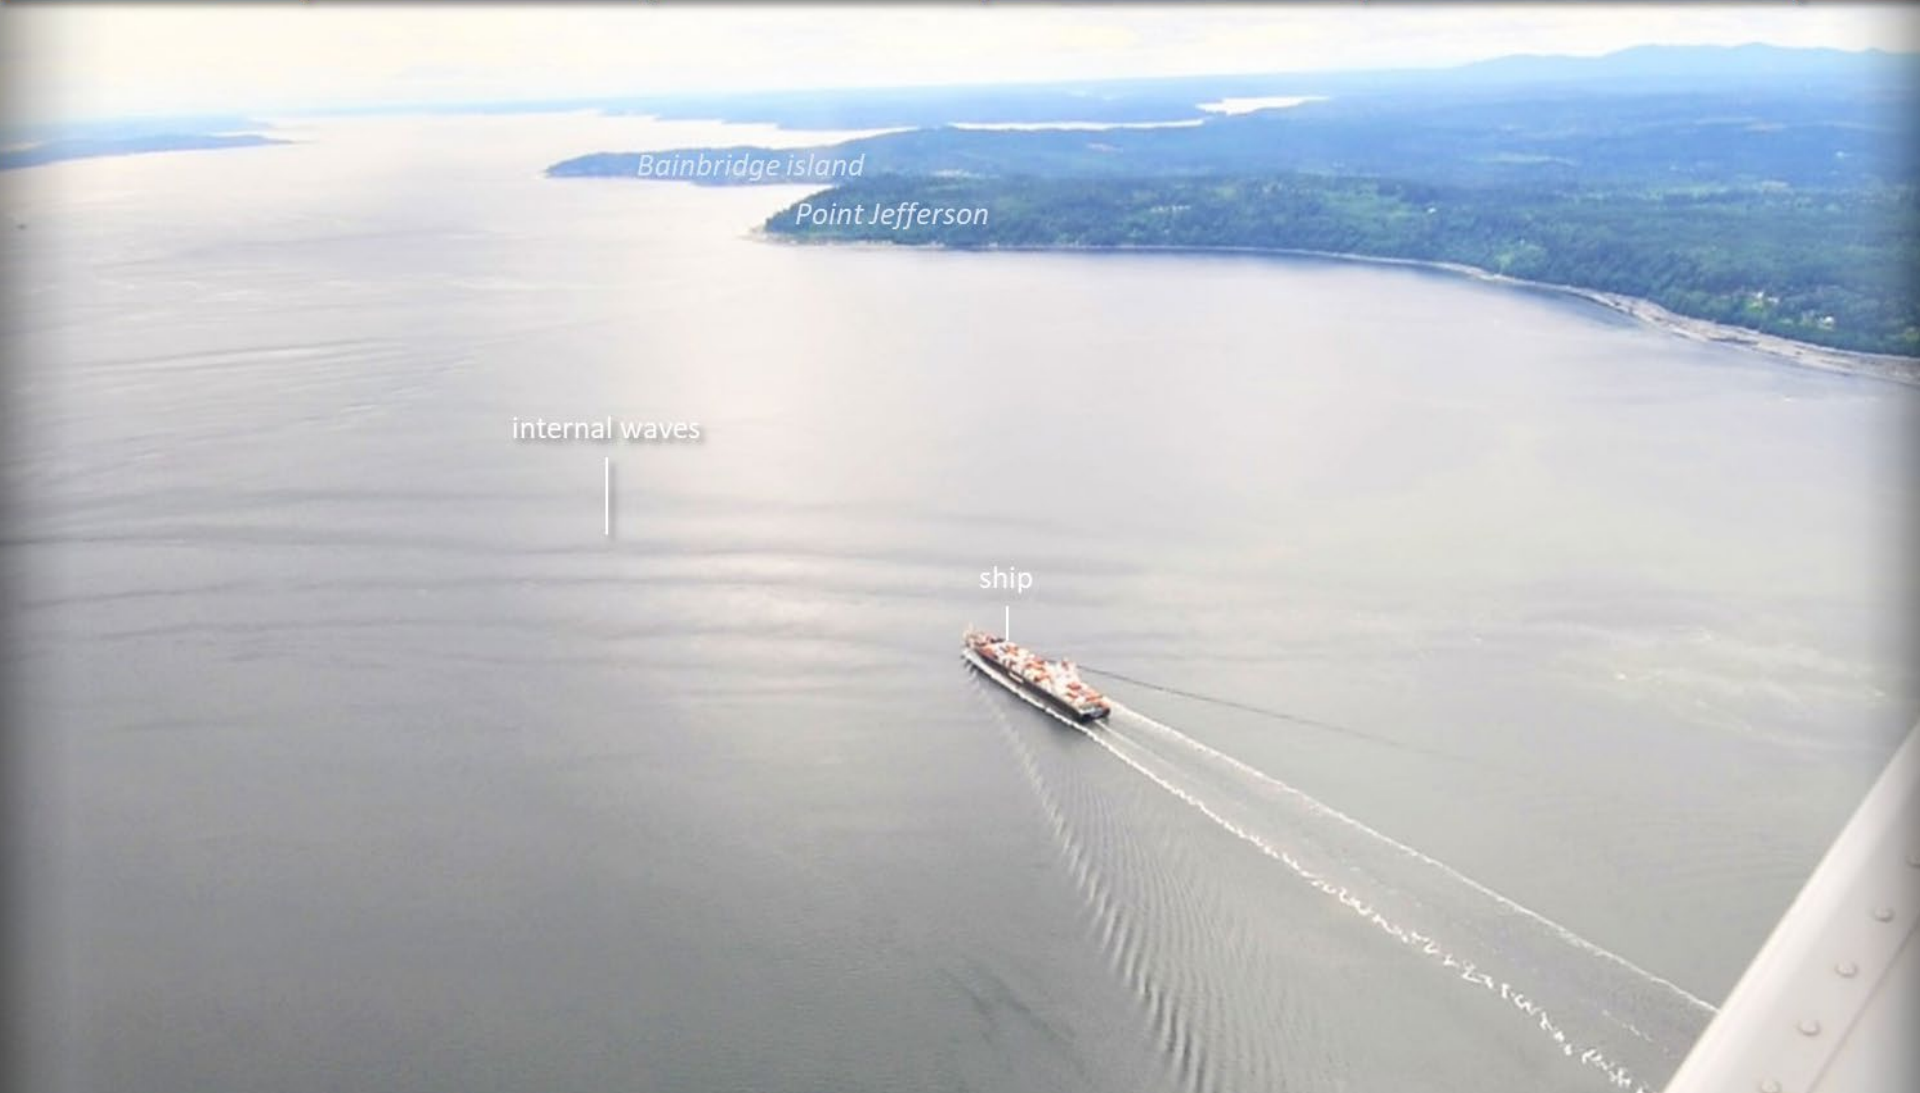
Large internal waves interacting with the water surface. The container ship surface waves appear small in comparison. Location: Kingston (Central Sound), 1:37 PM
