Coastal Landsliding on Puget Sound:

A review of landslides occurring between 1996 and 1999

Report #01-06-019

**Hugh Shipman
Washington Department of Ecology
Shorelands and Environmental Assistance Program
Olympia, Washington**

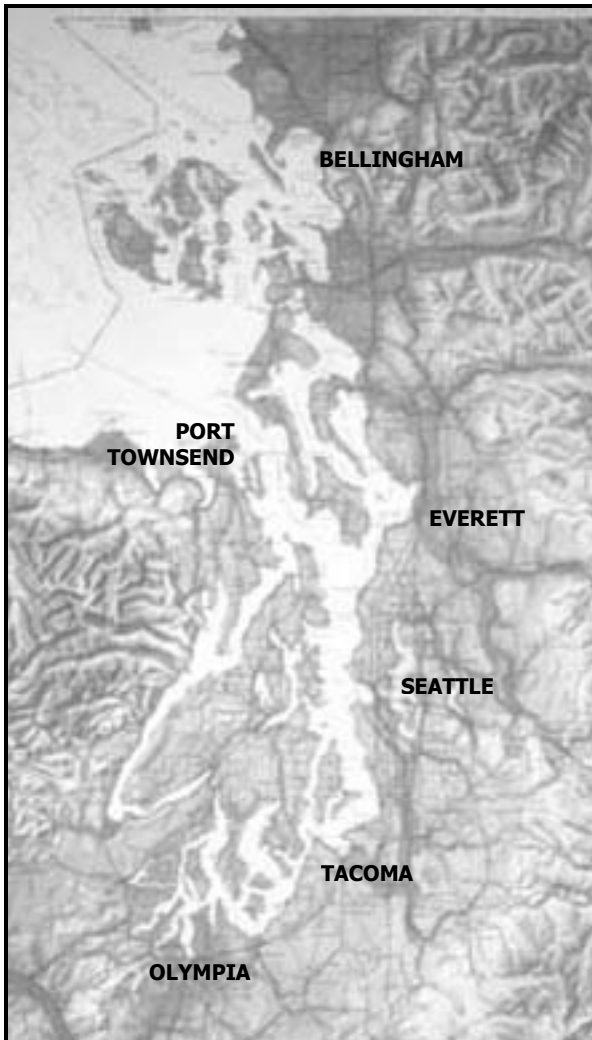
Figure 1. Map of the Puget Lowland.

The Puget Lowland contains considerable geologic variation, from extensive bedrock terrain to large Holocene river deltas (Figure 1). Most of the shoreline, however, is developed in late Pleistocene glacial and interglacial sedimentary deposits. Much of the Puget basin is blanketed with sediments deposited in association with the last advance of glaciers into the basin. At the peak of the Vashon glaciation, the Puget Lobe of the Cordilleran ice sheet extended south of

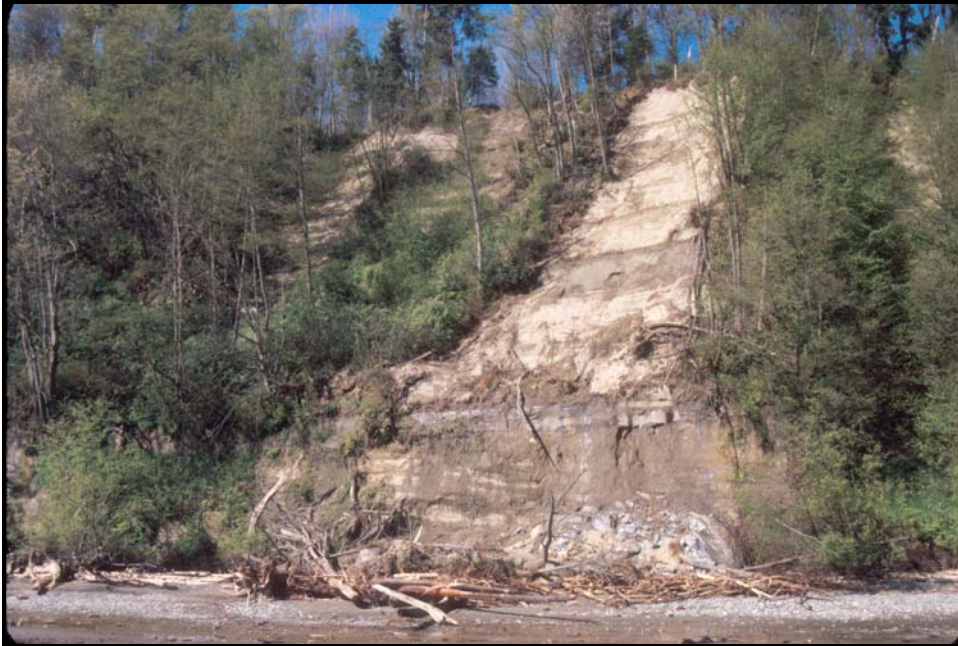
Figure 3. Shallow landslide exposing characteristic sequence of Puget Sound region geological units. The darker units in the lower part of the bluff consist of Lawton Clay and underlying Whidbey formation. Much of light-colored upper bluff consists of sandy advance outwash sediments (Esperance Sand). Vashon till caps the bluff. Note seepage along contact between outwash and Lawton Clay - this zone is likely where the landslide began. [Photo: Eglon area, Kitsap County, 1995, #95-17-7]

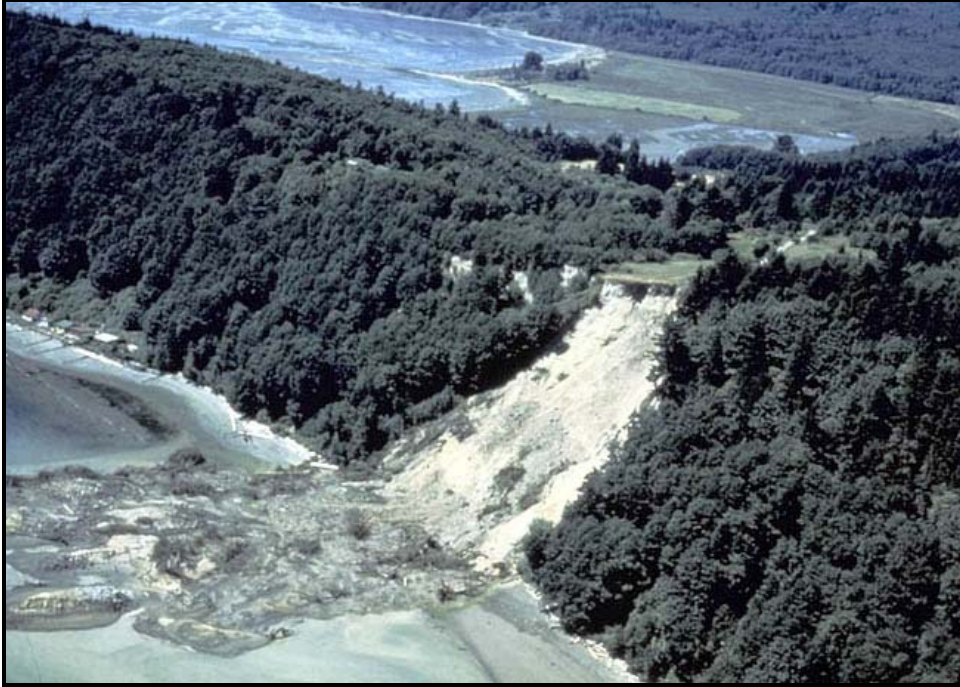
Figure 6. Large landslide that occurred in 1979 between Possession Beach and Glendale on southeastern Whidbey Island. Note beach houses on the left for scale. [Photo: Dave Frank, USGS, #0128_59].

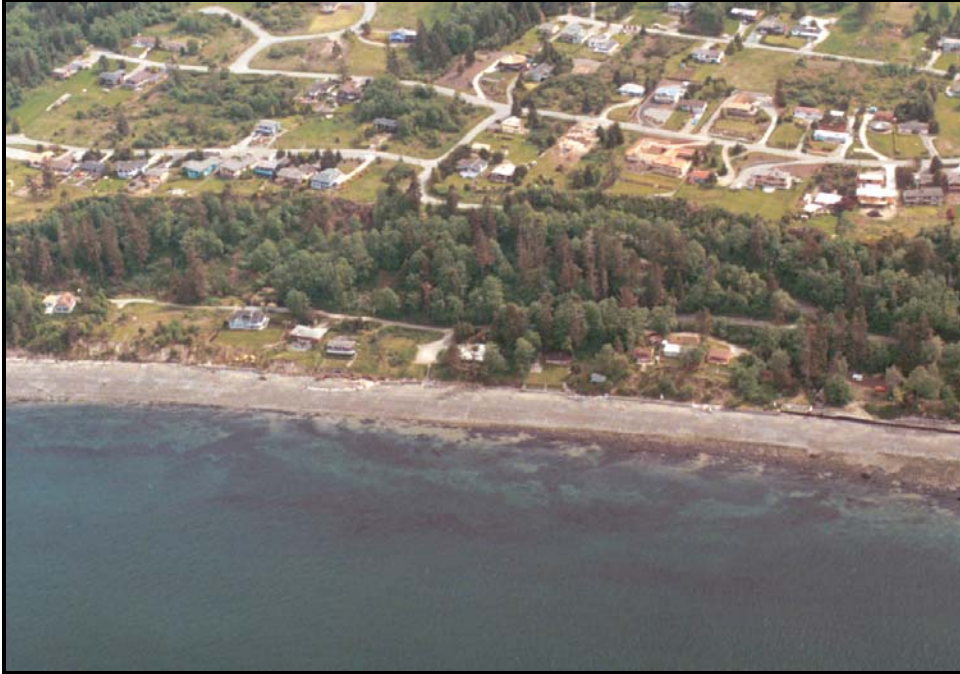
Figure 8. Aerial photograph of Ledgewood Beach landslide on Whidbey Island. Homes lower on slope are built on a deep-seated landslide, portions of which periodically reactivate resulting in damages to homes and roads. The toe of the landslide is located near sea level [Ecology, 5-5-199, ISL#0415]

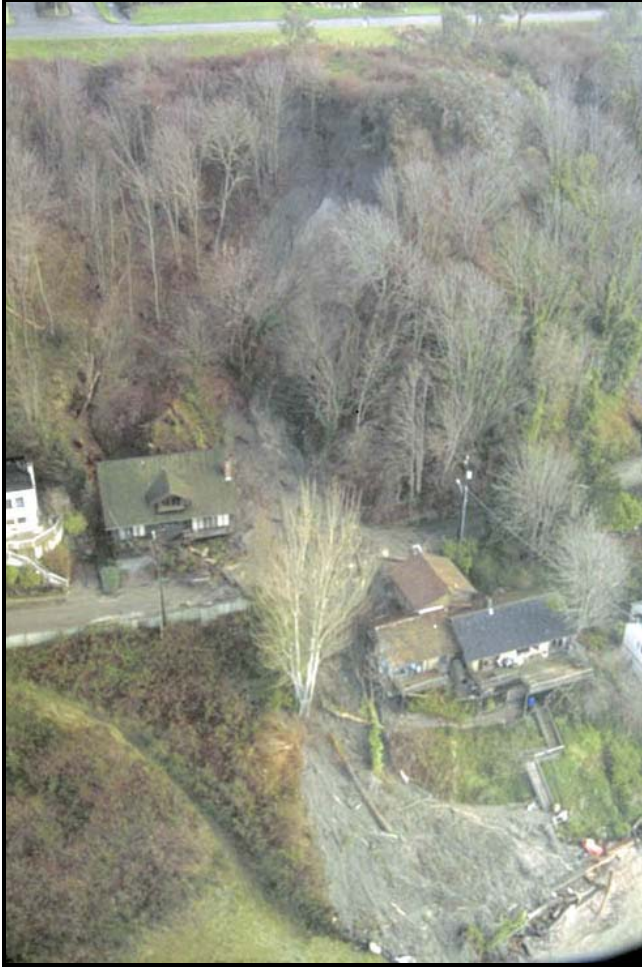
Figure 9. Debris flow downslope from a shallow landslide that occurred along Magnolia Bluff in Seattle during the 1996-97 Holiday Storm.

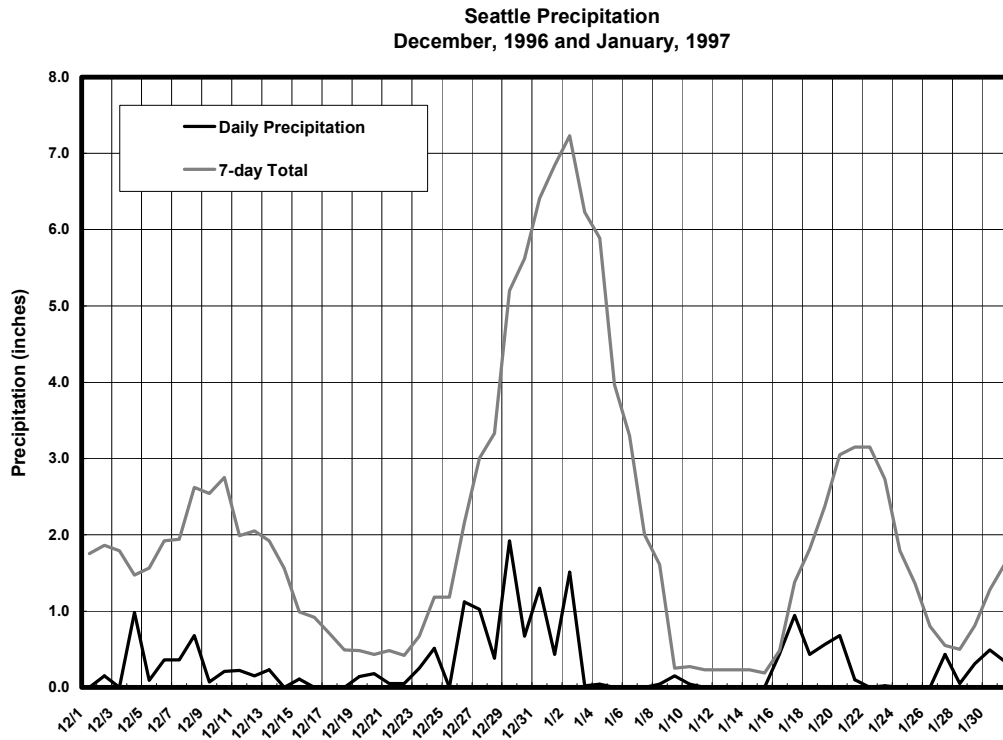
Figure 10. Precipitation records for SeaTac airport south of Seattle for December, 1996 and January, 1997. Lower curve indicates daily precipitation while upper curve shows a 7-day running total that may better predict soil saturation and landsliding.

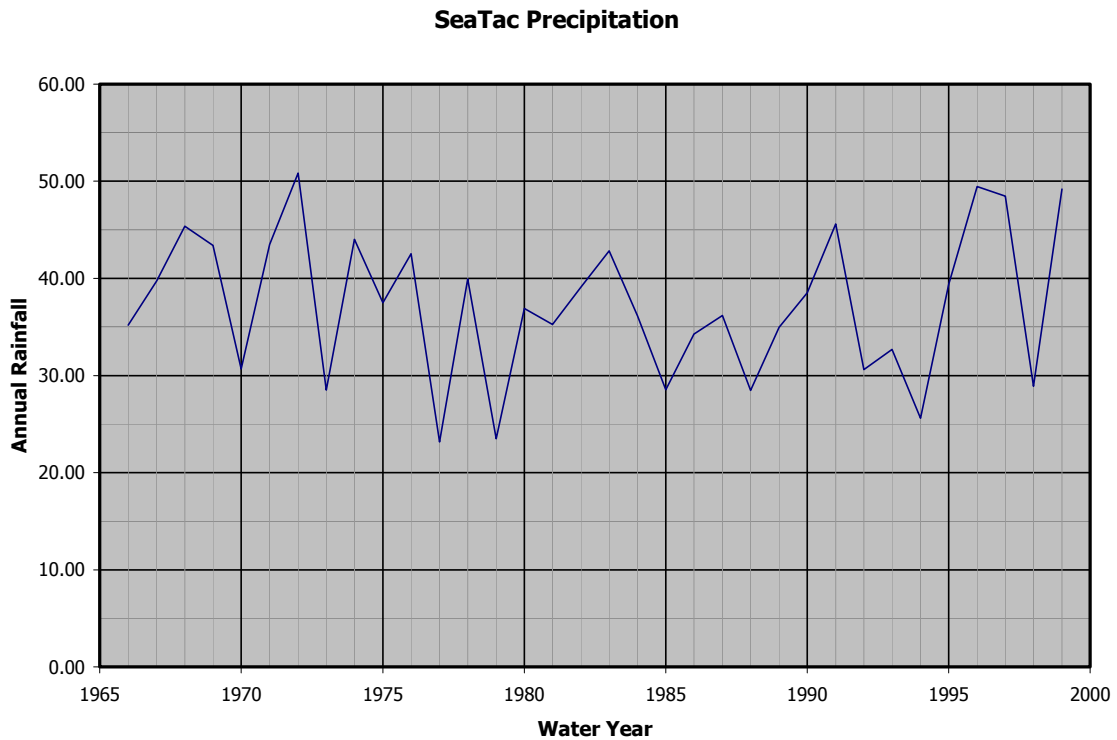
Figure 11. Plot of annual rainfall at SeaTac airport, showing above normal rainfall in water years 1996, 1997, and 1999. Water years describe precipitation between October and September (e.g. the 1997 water year extended from October 1, 1996, through September 30, 1997).

A series of La Nina episodes during the late 1990s brought almost 50 inches of rain to Seattle in three of the four water years (October through September) between 1995-96 and 1998-1999 (Figure 11). The only dryer year occurred during the El Nino of 1997-1998. As a result, the cumulative multi-year rainfall was at record levels in 1998 and 1999.

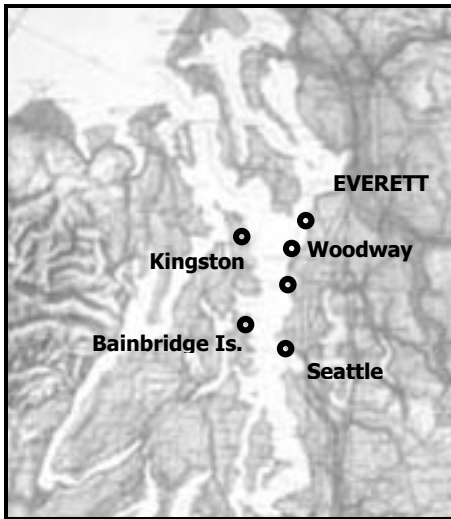
Figure 13. Location of 1996-97 landslides described in this report. Note that all are in central Puget Sound region.

The remainder of this chapter describes a number of coastal landslides that occurred during the winter of 1996-97 in the region for which information was available and that I believe illustrate the range of landslide types and associated hazards. The examples are by no means a complete inventory. Rather, their purpose is to educate about the character of sliding and to provide some historical information for evaluating future sliding in the same general areas. The information was obtained from field visits, interviews, geotechnical reports, and press accounts.

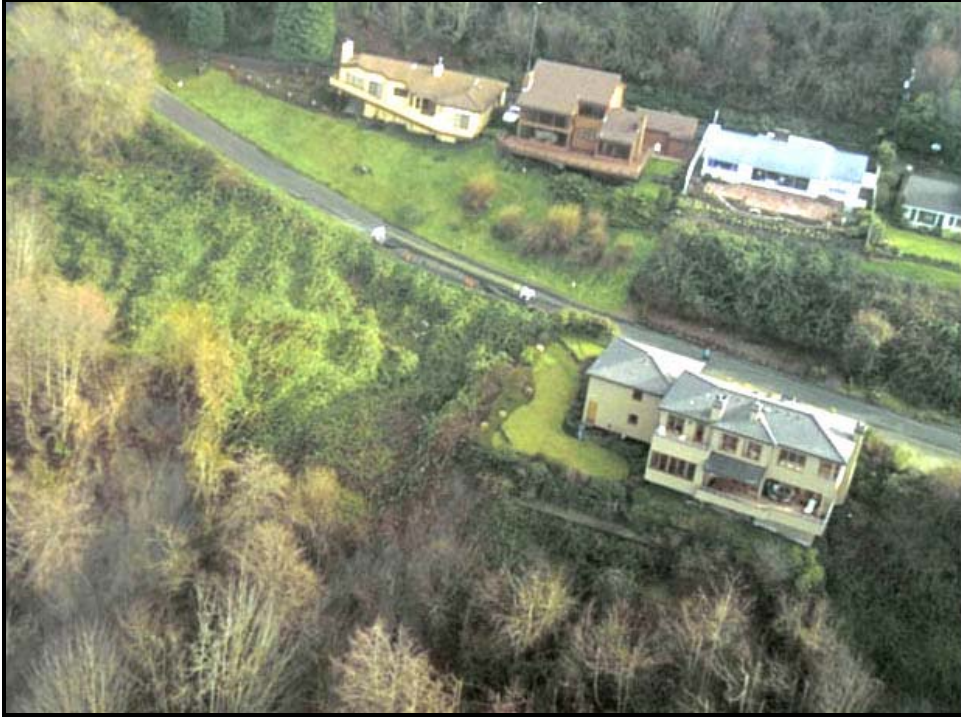
Figure 14. Landslide along Bonair Drive SW, above Alki Beach in West Seattle. Note scarp cutting downslope edge of road and through the lot in the foreground. [Photo: #4108_18, 1/2/1997]

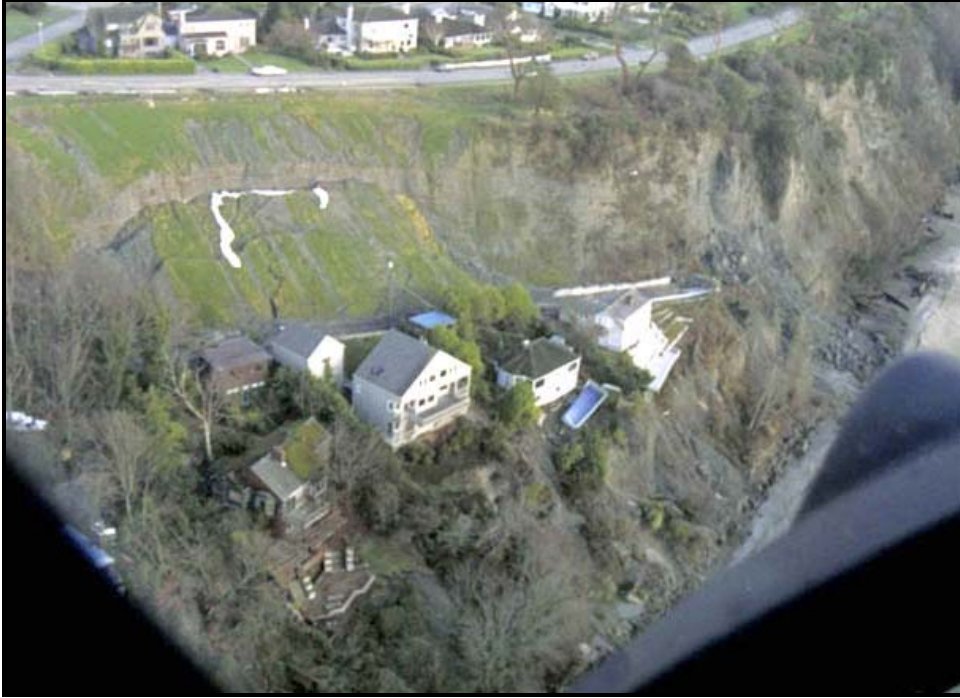
Figure 15. Aerial view of southeast end of Perkins Lane taken after the 96-97 Holiday Storm. Homes are located along a mid-slope bench. Note large failure in glacial till behind homes. [Photo: 1/2/1997, #4108_17]

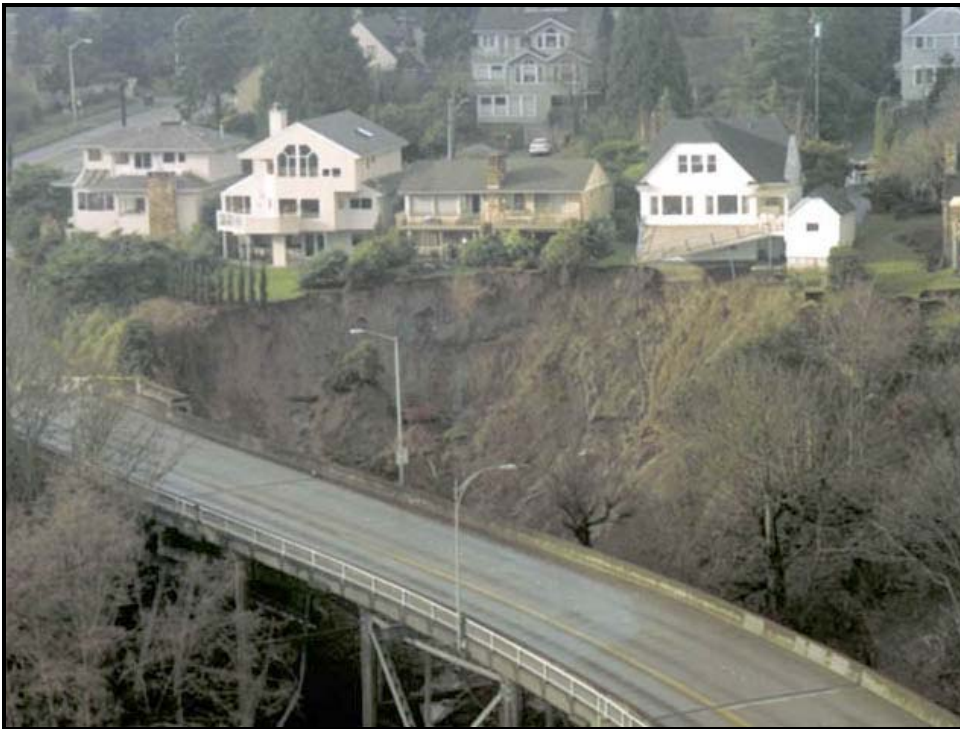
Figure 17. Landslide above Magnolia Bridge. In addition to threatening homes at top of slope, slide debris damaged bridge supports and a home located at the base of the slope. [Photo: 1/2/1997, #4108_14]

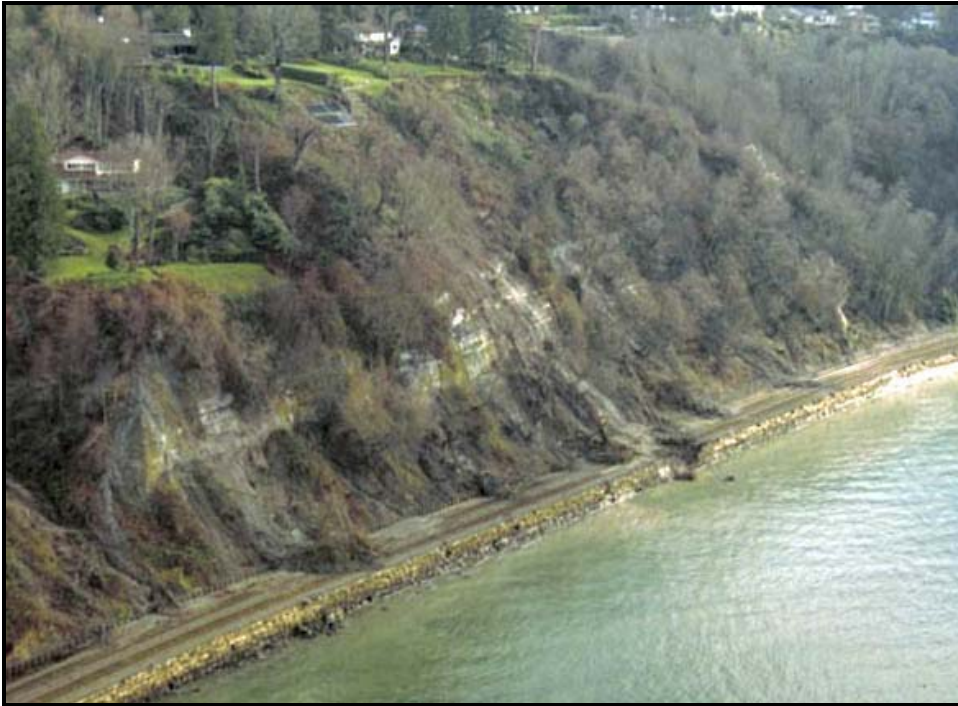
Figure 19. Aerial view of landslides over railroad tracks north of Seattle.
[Photo: 1/2/1997, #4108_19]

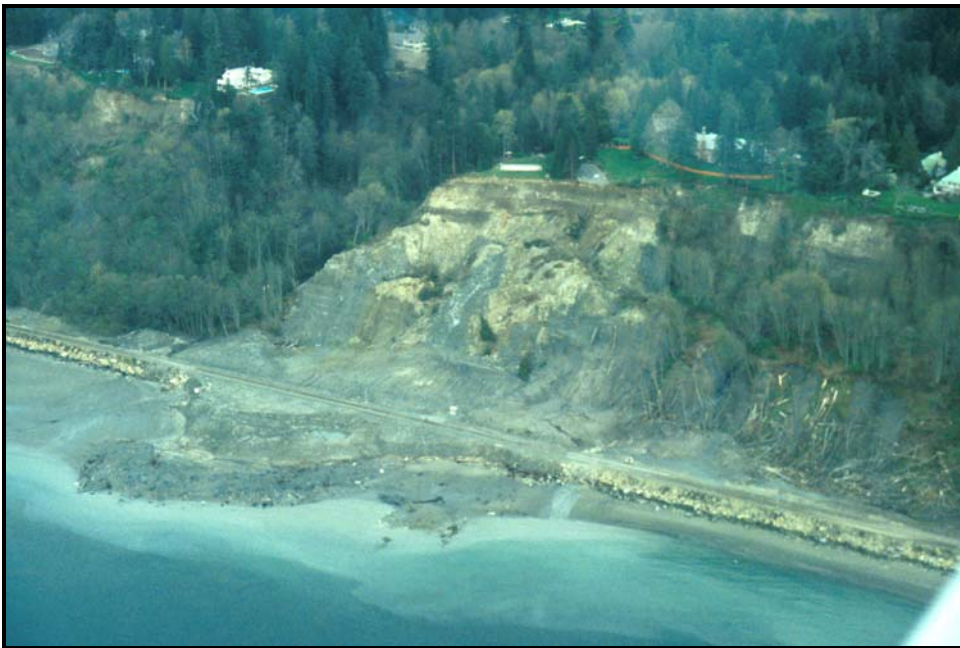
Figure 21. Woodway landslide from the air. Photo taken in late March, 1997. Prior relocation of the tracks waterward had left a broad trough at the base of the slope. The landslide filled this low trough, crossed the tracks, and formed a large point of land on the shoreline. [Photo: 3/30/1997, #97-22-17]

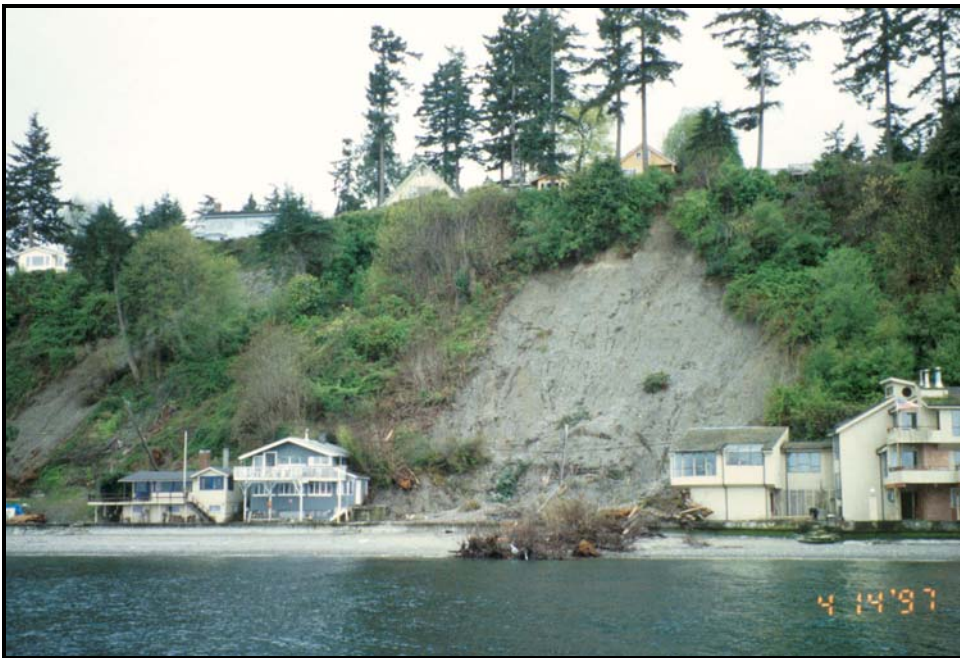
Figure 22. Site of destroyed Herron family home at Rolling Bay from the water. Vacant lot at left edge of photo is site of house destroyed by a landslide the previous winter. [Photo: 4/14/1997]

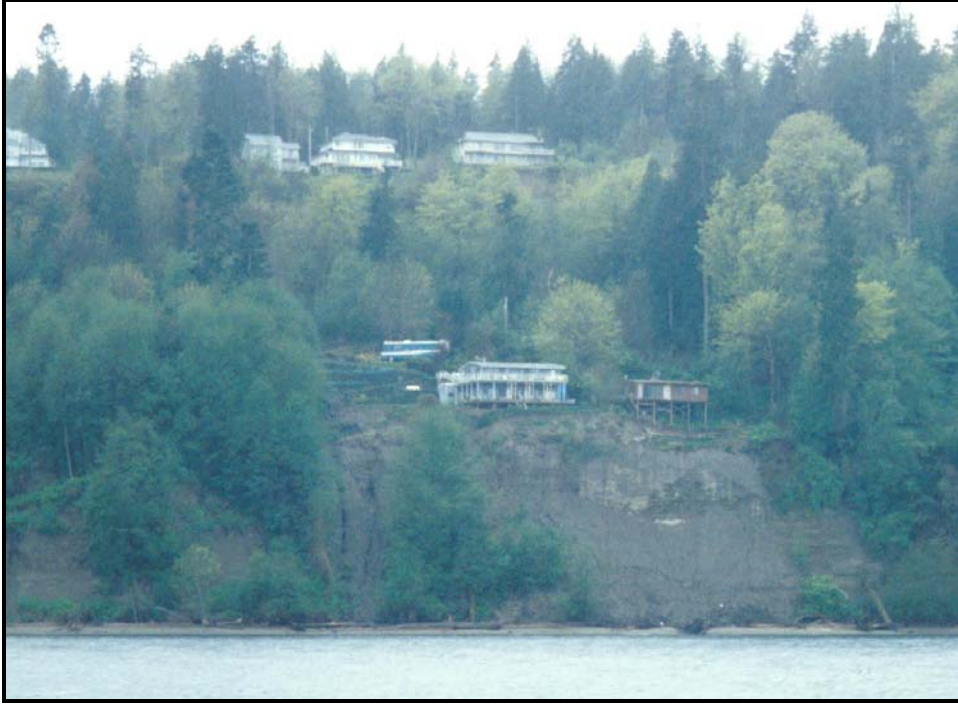
Figure 23. Mid-slope bench located along high bluffs north of Kingston and Apple Cove Point. Home in foreground was impacted by 1996-97 landslides. [Photo: 4/14/1997, 97-30-18]

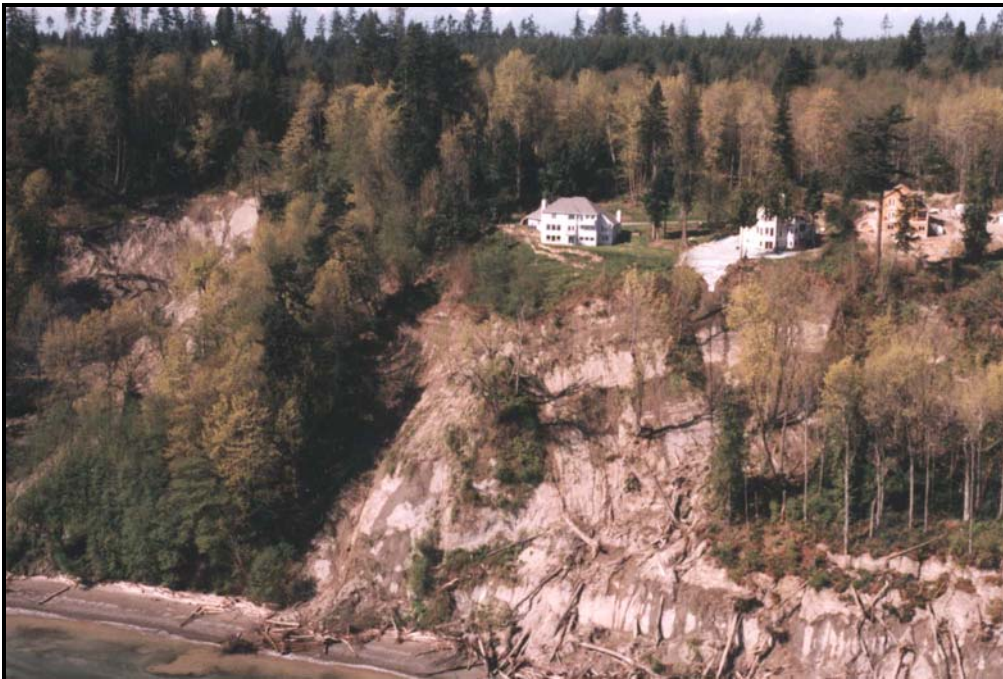
Figure 24. Aerial photo of bluff near north end of map in Figure 25. Note active landsliding, distinct mid-slope bench, distorted stratigraphy, and relatively new homes located along top edge of the bluff. The site described in the text is located at the left margin of the photograph. [Photo: Len Palmer, 4/1997]

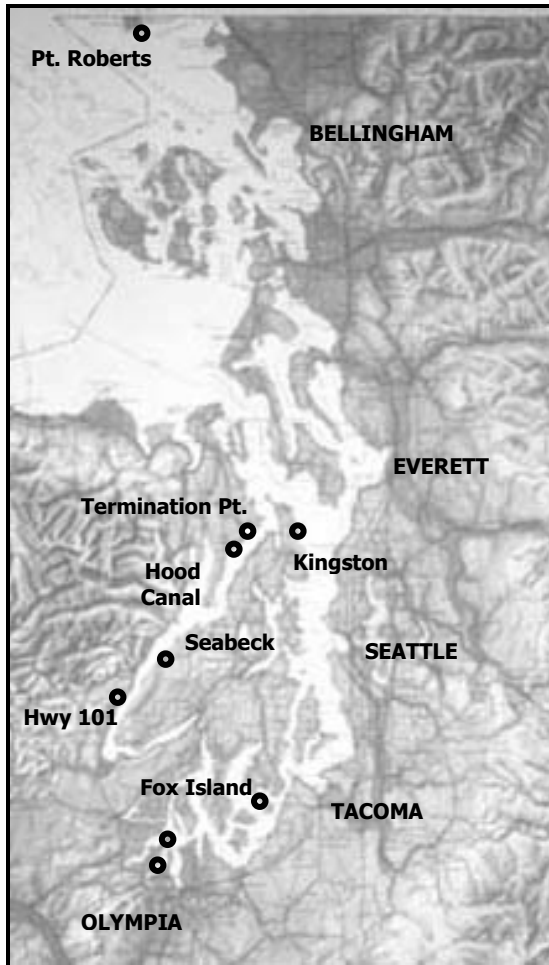
Figure 26. Locations of 1998-99 landslides described in this report.

Although detailed geotechnical studies were carried out for many of these slides, there was no regional inventory of landsliding associated with this period. This chapter describes several of the landslides that occurred during 1998-99 [Figure 26]. Our purpose is not necessarily to present in detail the timing and mechanisms of each of these slides, but to document a number of slides that affected the Puget Sound shoreline and provide historical information that may be useful when future sliding happens - which in most of these locations is highly likely.

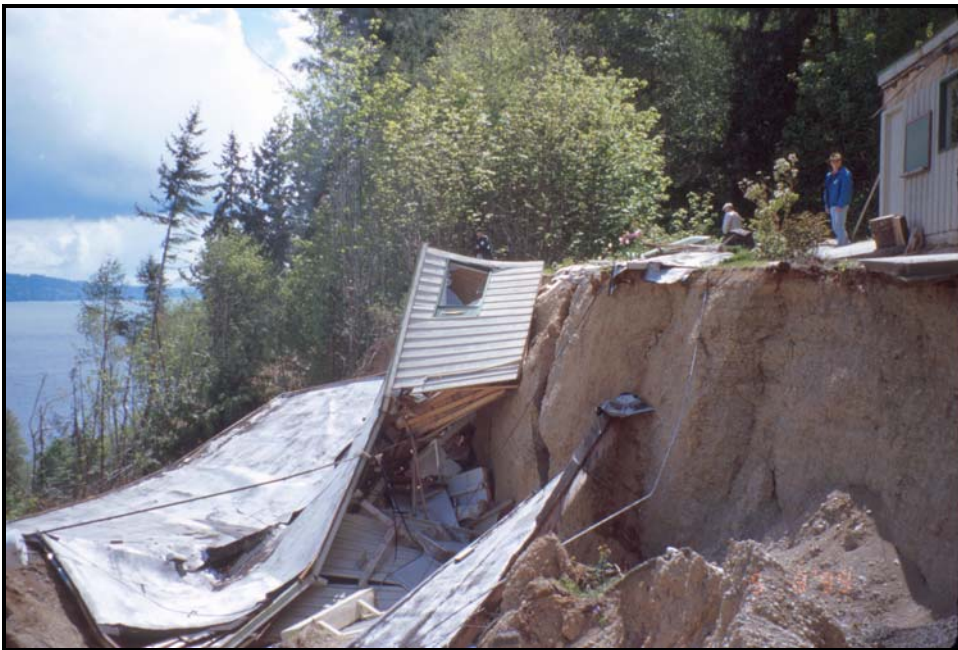
Figure 27. House destroyed at the headscarp of the Milepost 326 landslide.
[Photo: 5/8/1999, #99-25-2]

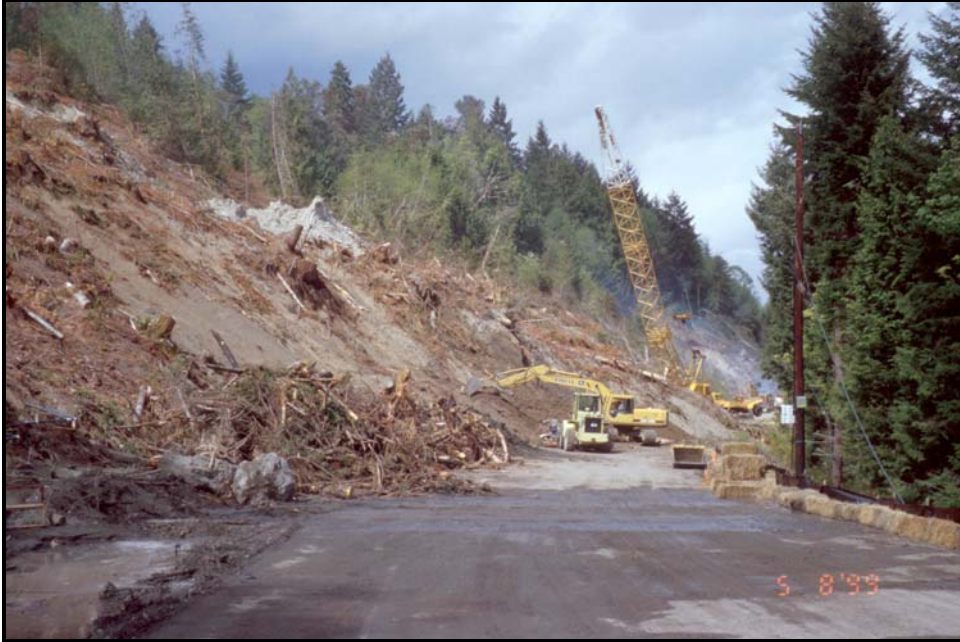
Figure 28. Highway crews attempting to clear highway and stabilize toe of Milepost 322 landslide.
[Photo: 5/8/1999, #99-25-7]

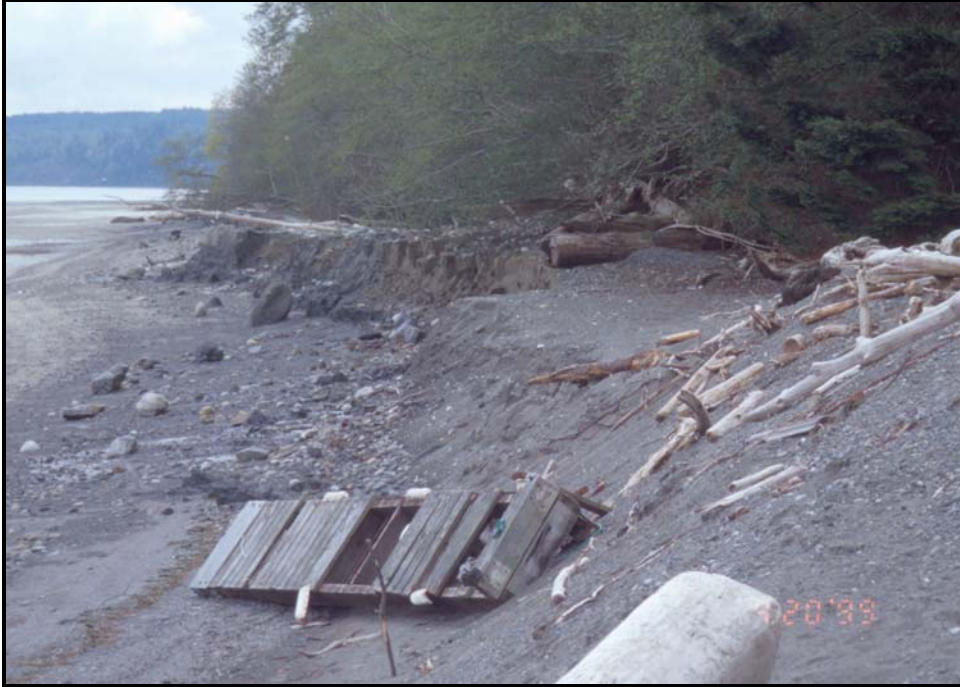
Figure 30. Toe of Thorndyke Road landslide, showing steep scarp has developed in the upper beach.
[Photo: 4/20/1999, #99-21-22]

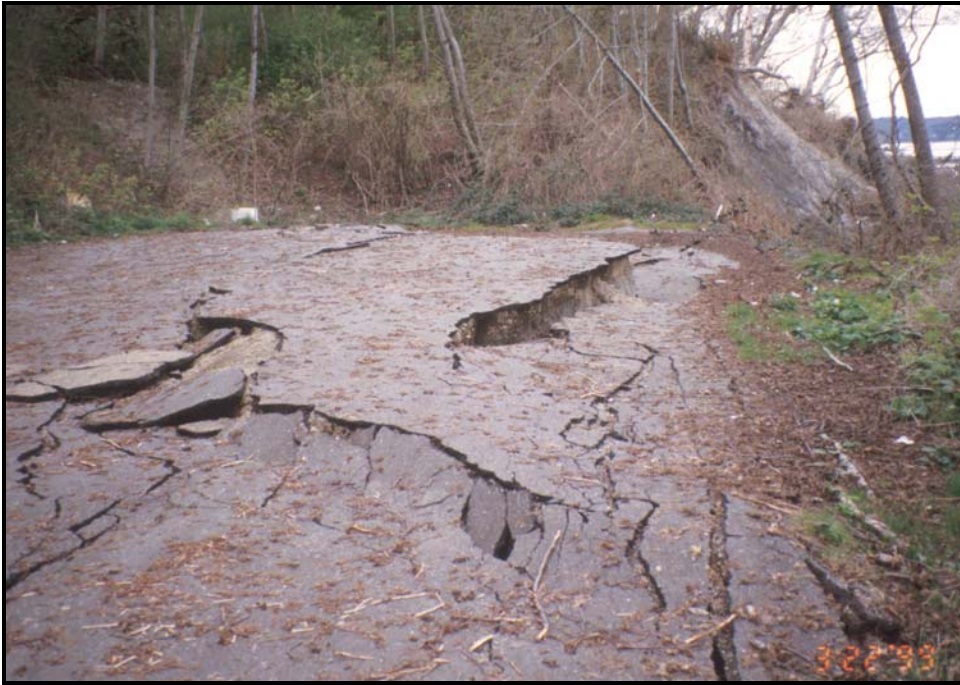
Figure 32. Disturbed asphalt at lower end of Killapie Beach Road. Shoreline is located to the right.
[Photo: 3/22/1999, #99-11-25]

Killapie Beach road, so damages have been limited to the road itself and to undeveloped lots (Figure 32).

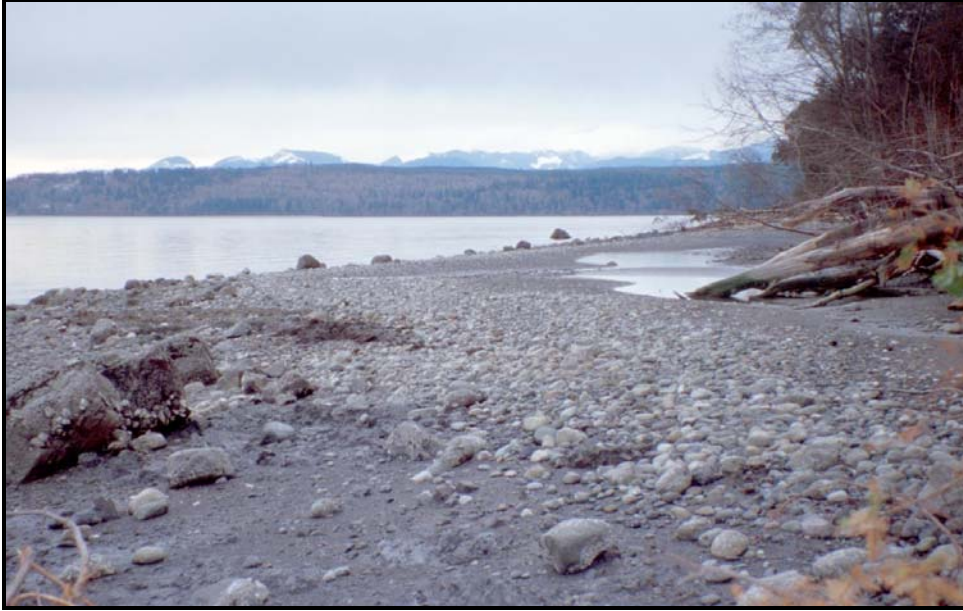
Figure 33. Raised beach at the toe of Termination Point landslide. The waterward portion of the uplifted area is marked by arcuate band of disturbed clays. Note ponded water on the upper portion of beach. [Photo: 3/22/1999, #99-12-13]

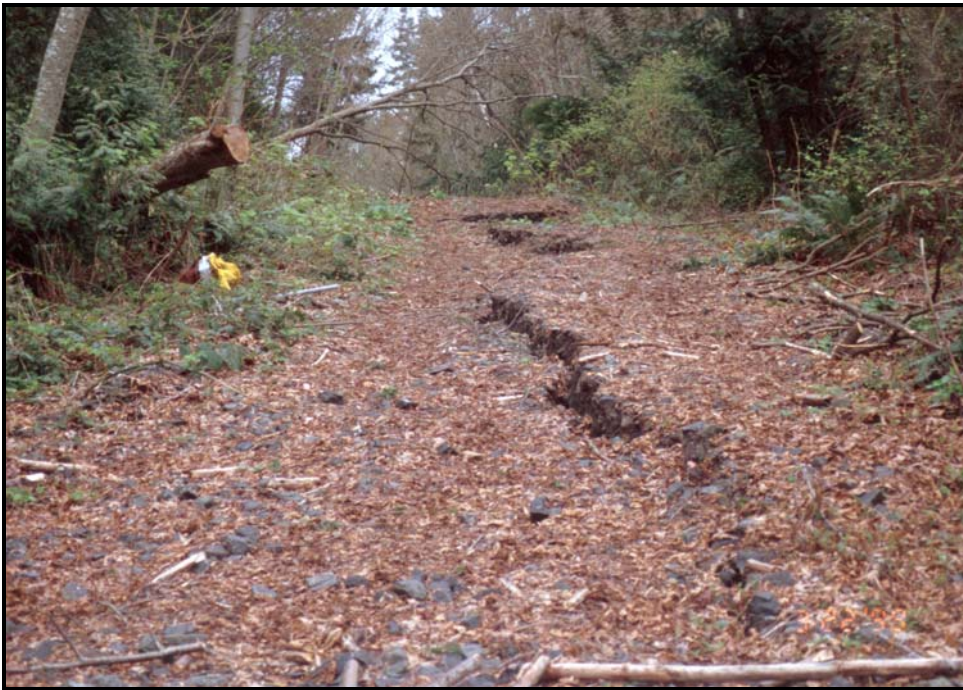
Figure 34. Fissure running down the center of the western portion of Ricky Beach Road. The shoreline is located over 100 feet to the right of this photo. [Photo: 3/22/1999, #99-12-8]

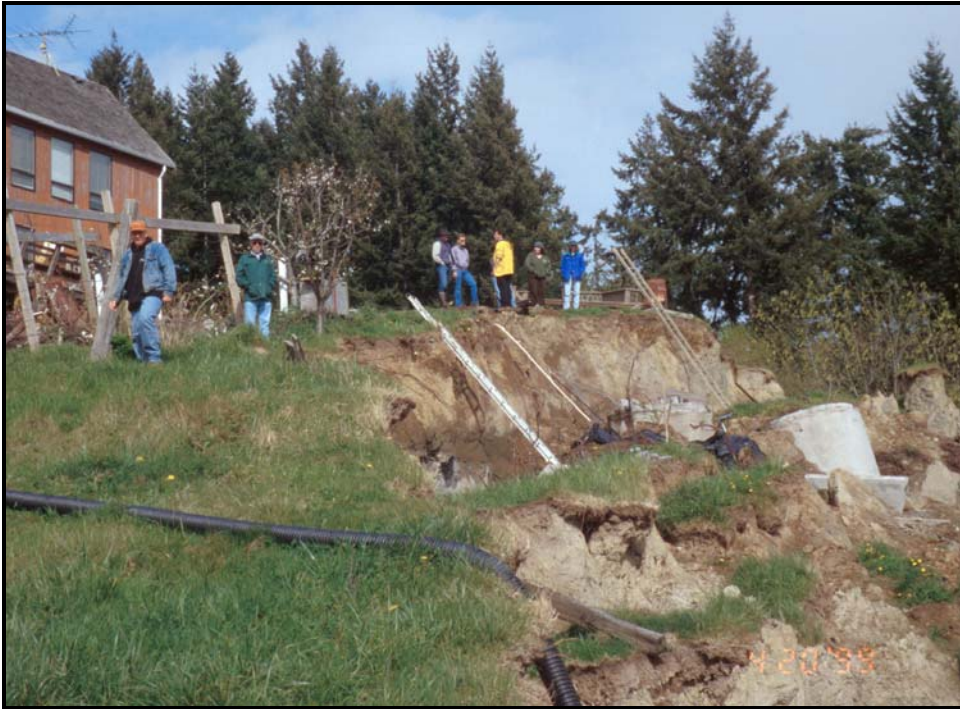
Figure 35. Headscarp of a large upper bluff slump overlooking Hood Canal, west of Termination Point. Original bluff edge was more than fifty feet farther to the right of the most recent scarp. Note septic tank and landscaping on the upper portion of the landslide mass. [Photo: 4-20-1999, #99-21-17]

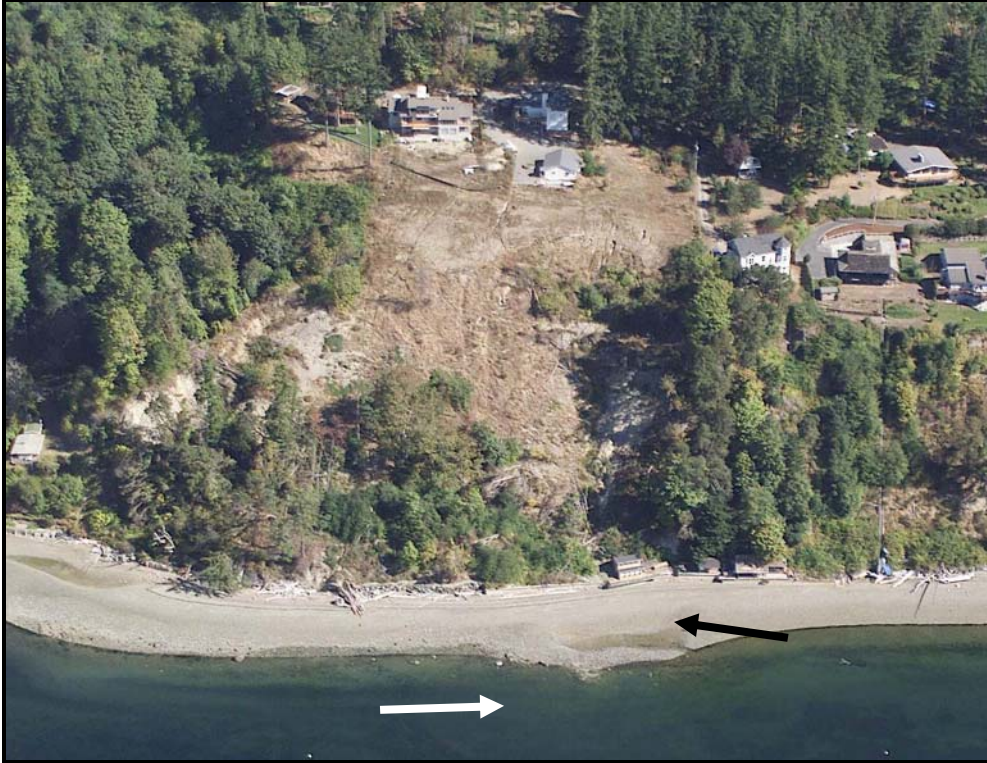
Figure 36. Aerial view of landslide south of Kamus Road on Fox Island. Photo was taken in summer, 2000, about a year and a half after the slide. Note how toe of slide affects shape of the beach. Arrows indicate locations of Figure 37 and Figure 38. [*Ecology, Kamus_2000*]

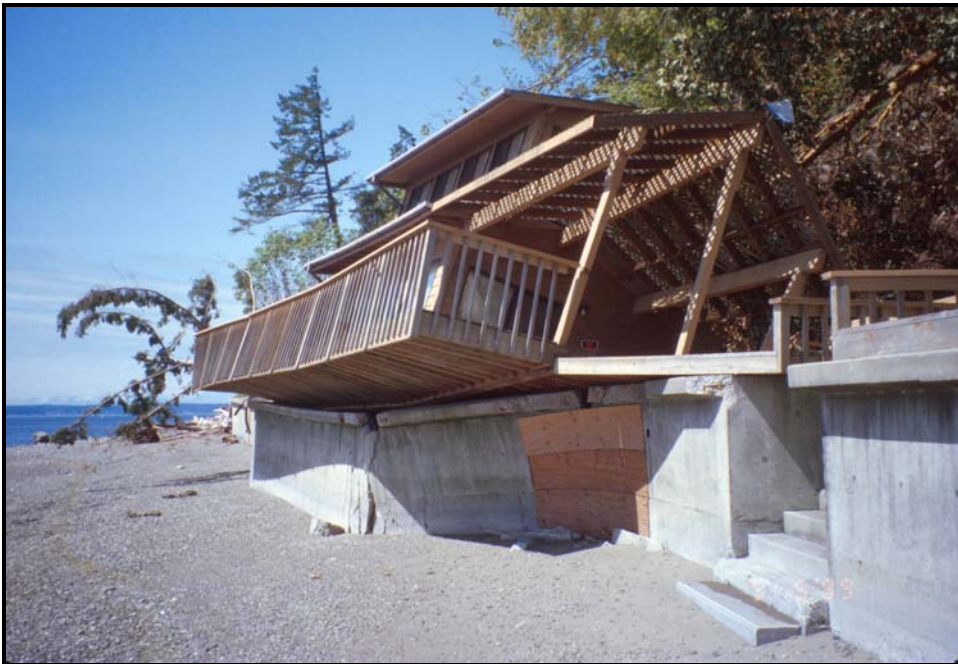
Figure 37. Beach cabin destroyed by landslide. Cabin was involved both in deeper movement of landslide and by debris avalanches from above. [*Photo: 5/5/1999, #99-24-1*]

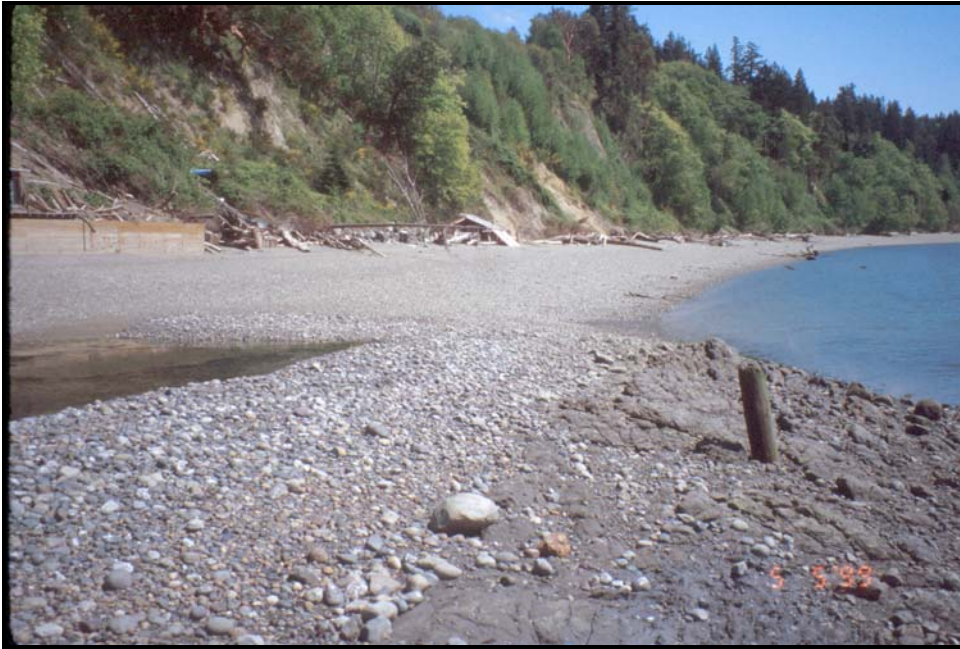
Figure 38. Toe of eastern portion of landslide, showing uplifted beach.
Note ponded water in mid intertidal and distorted clays in uplifted portion. [Photo: 5/5/1999, #99-23-16]

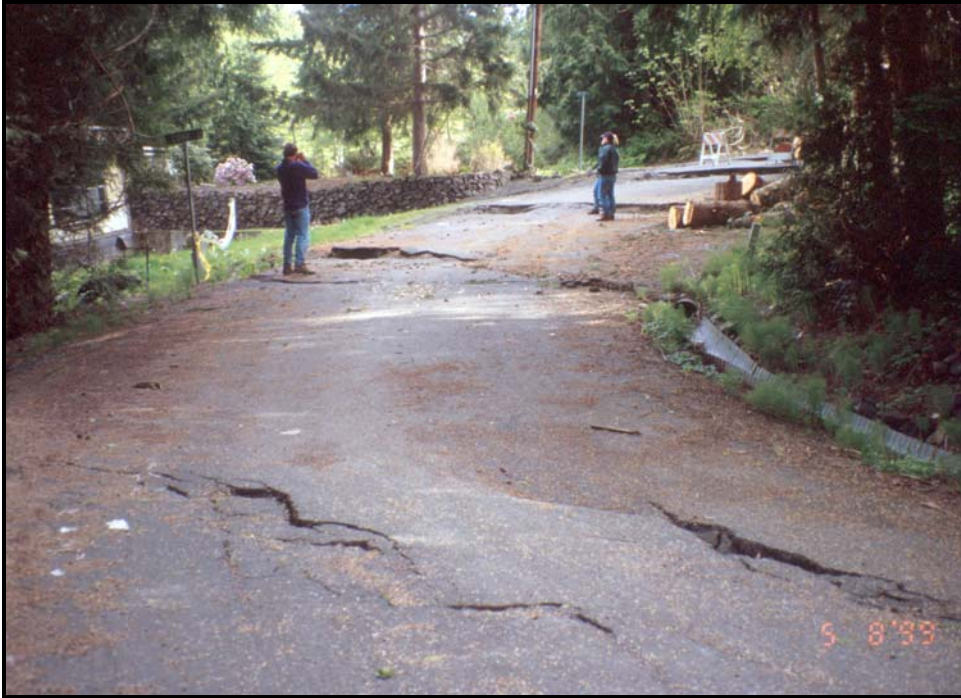
Figure 39. Fractures along Mariner Drive in eastern portion of Carlyon Beach neighborhood.
[Photo: 5/8/1999, #99-25-14]

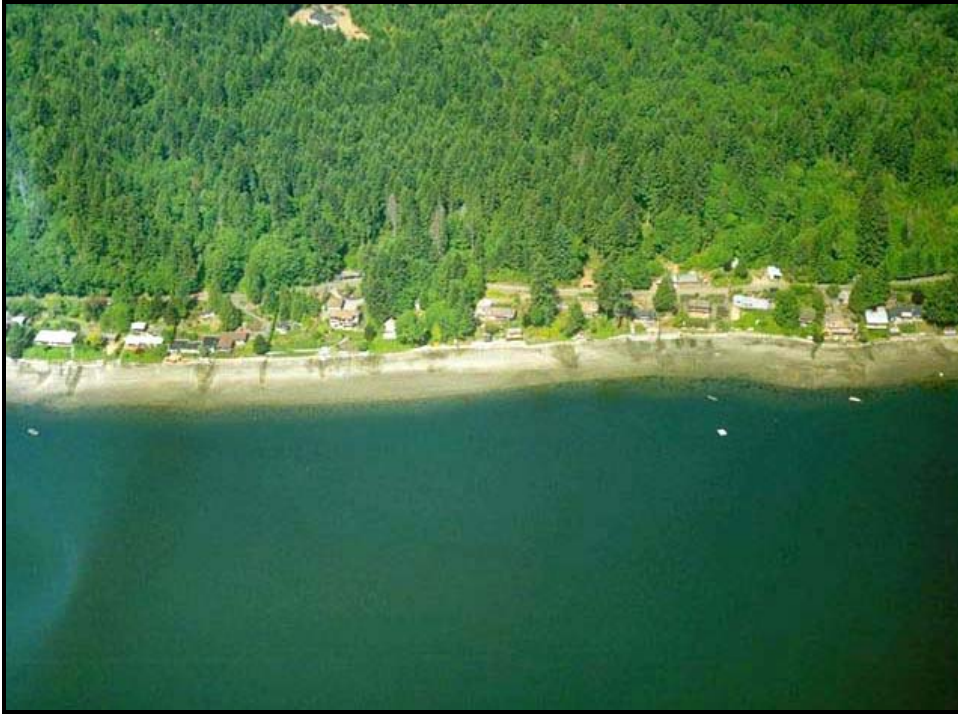
Figure 40. Aerial photograph of Sunrise Beach area affected by 1999 landslide.
[Ecology, 5/14/1992, THU#0241]

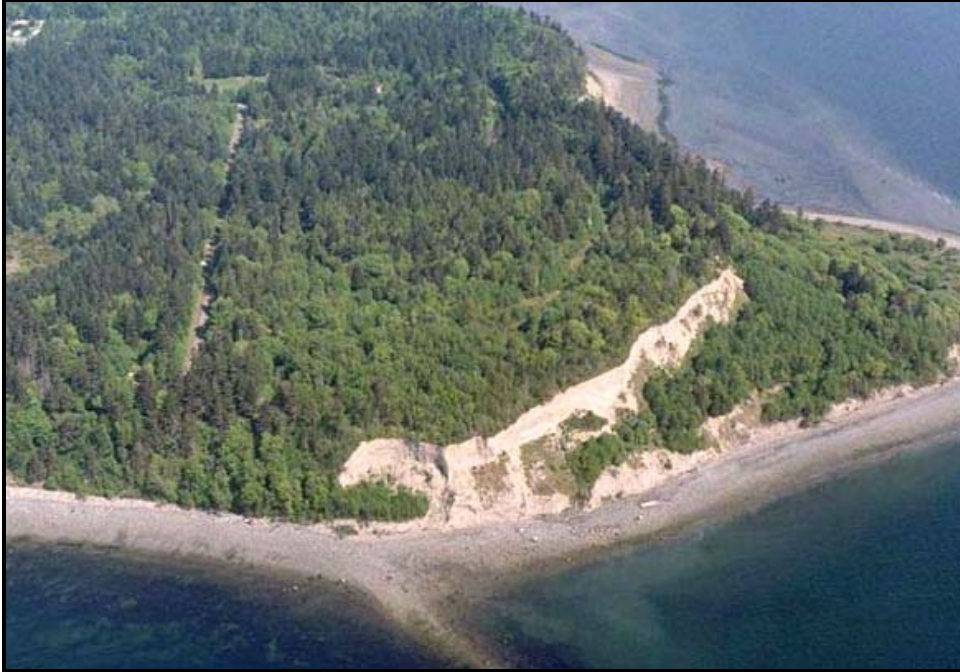
Figure 41. 1994 photograph of large landslide complex at southeastern end of Point Roberts, prior to 1999 failure. Lilly Point is at right edge of photo.
[Ecology, 4/28/1994, WHA#022]

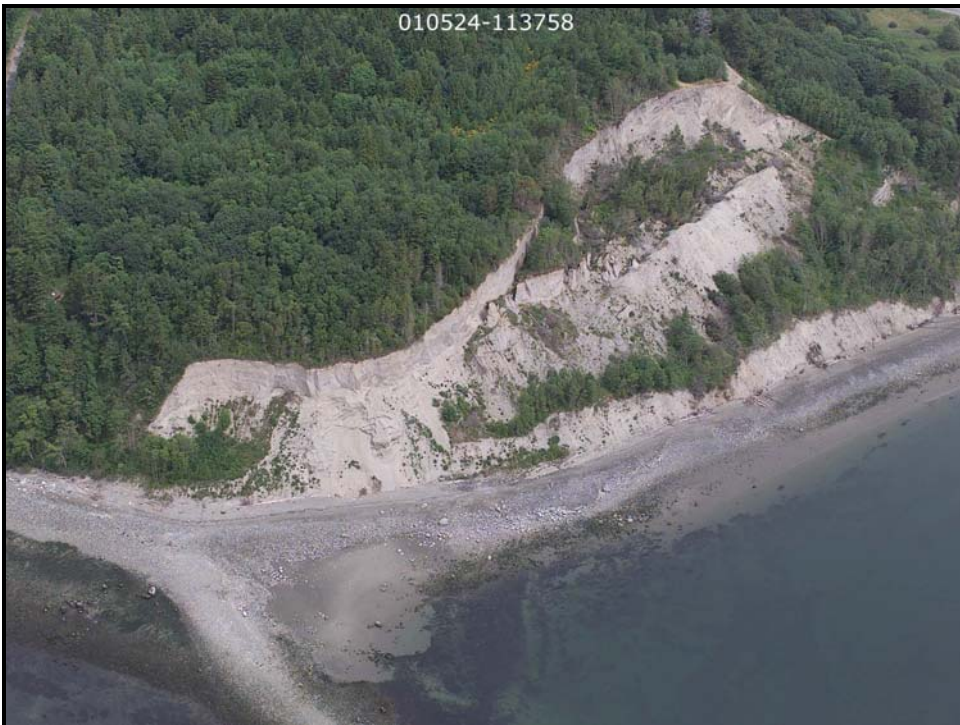
Figure 42. 2001 photograph of Point Roberts landslide. Area of 1999 failure can be seen on right half of image by comparing to 1994 photo (previous figure).
[Ecology, 5/24/2001]

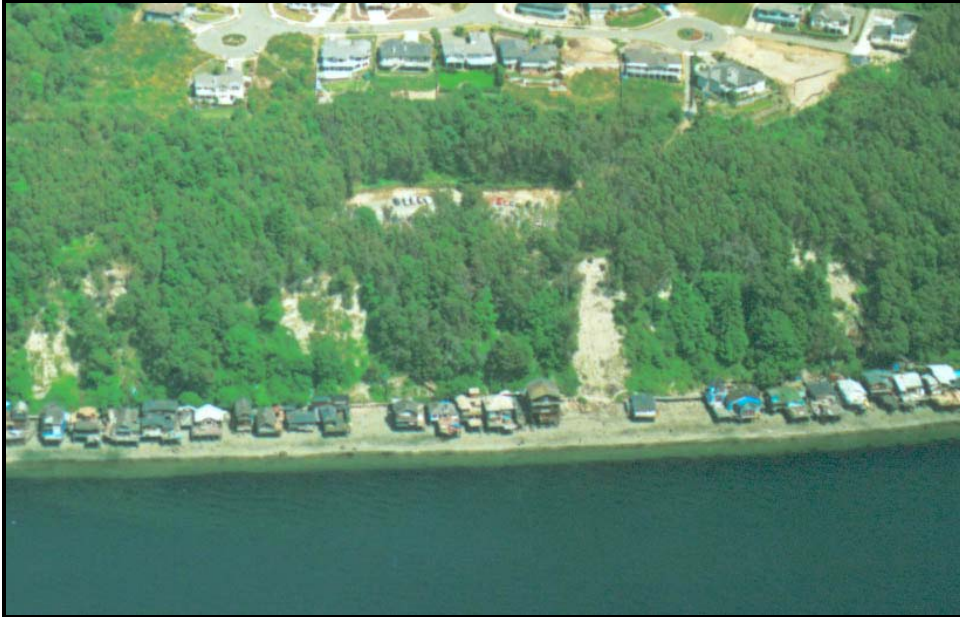
Figure 43. The Salmon Beach community in Tacoma is built on piles at the base of a steep, unstable bluff. A large landslide developed on the slope above this community following the February, 2001, Nisqually Earthquake - see Appendix. [*Ecology*, 5/16/1992, PIE#0116]
