Coastal Landsliding on Puget Sound:

A review of landslides occurring between 1996 and 1999

Report #01-06-019

**Hugh Shipman
Washington Department of Ecology
Shorelands and Environmental Assistance Program
Olympia, Washington**

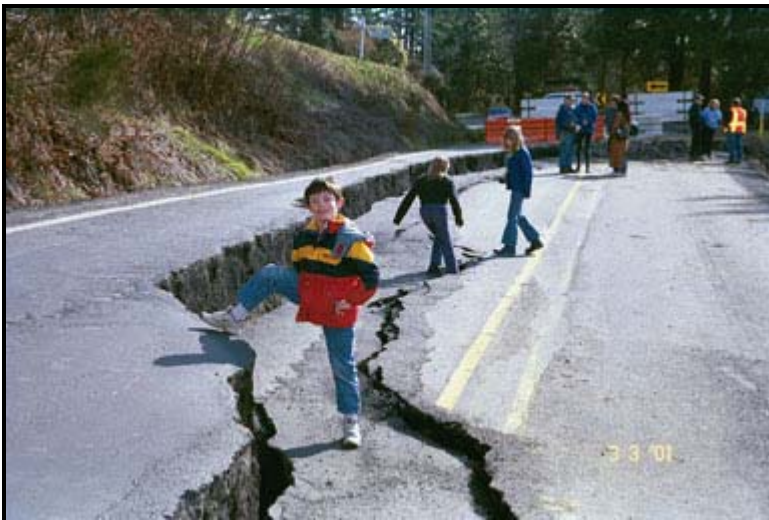
Figure 45. Reactivation of landslide along Highway 302 near Victor in Mason County. Field assistant is approximately 4.2 feet high [Photo: 3/3/2001].
