**Interim Report:**  
**Stormwater Quality Survey of**  
**Western Washington Construction Sites**

September 2004

Publication No. 04-03-036

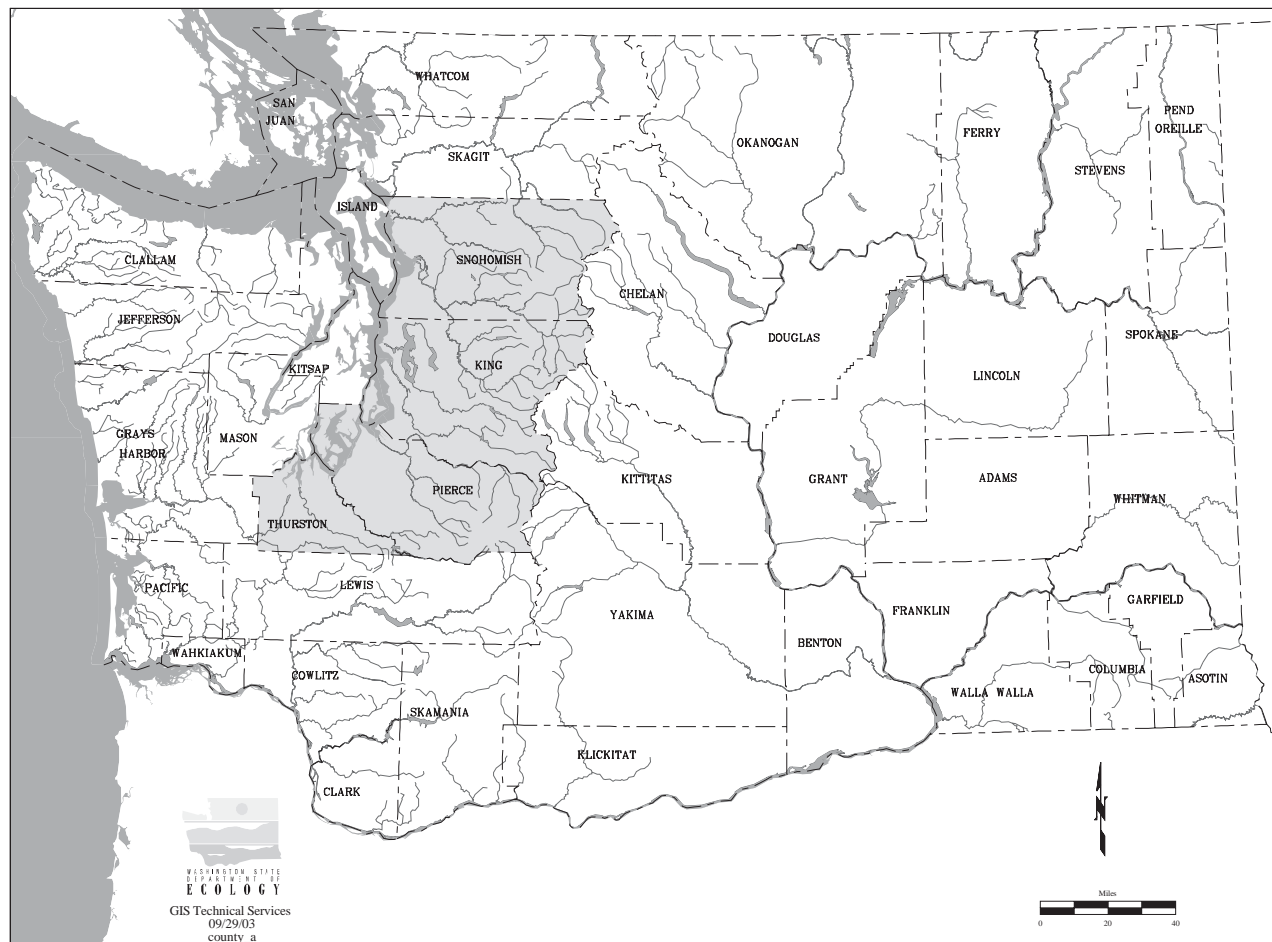
Figure 1. Study Area. Shaded areas are counties to be included in the study.

Figure 1 shows the study area. This study was limited to western Washington because it has a distinctly different climate and soil characteristic than the eastern portion of the state. Western Washington has wet winters with saturated soils and a high potential for erosion problems. Most of the state's construction activity is taking place in western Washington. Also, logistical limitations favored limiting this study to the western portion of the state.

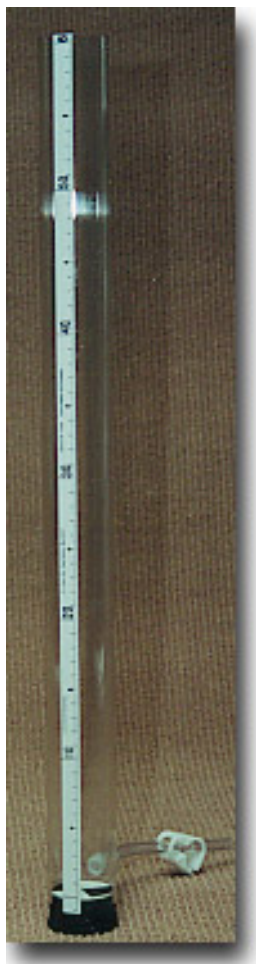
Figure 2. A Transparency Tube.

A transparency tube was also used to make a quantified estimate of transparency from each discharge, by simple, visual means. A transparency tube is a simple field device used to estimate the transparency of a water column by noting the depth at which a black and white secchi disk affixed to the bottom of the clear tube is no longer visible. The transparency tube measurements were paired with turbidity measurements so that a comparison could be made between transparency tube results and conventional turbidity readings, and a correlation between the two could be developed.

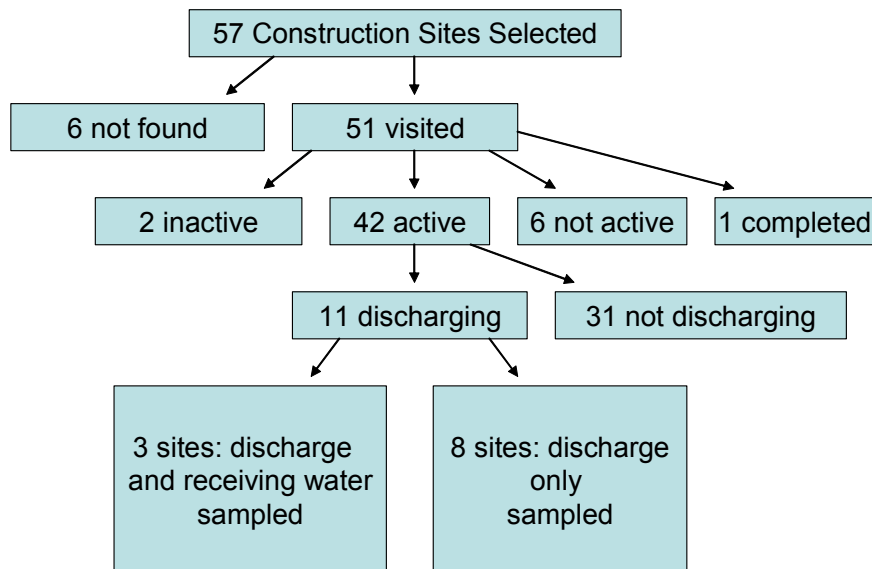
Figure 3. Outcomes of 57 Construction Sites Selected for the 2003-2004 Sampling Season.

Of the 57 sites selected, 51 were visited. Forty-two of these were active. Eleven of the active sites were discharging while 31 were not. The large number of sites not discharging was unexpected and is, in part, responsible for the continuation of the study into a second year. The active sites are summarized in Table 2 and shown in Figures 4a and 4b. Only two of the 11 discharging sites were located in Thurston County, reflecting the small number of construction stormwater permits issued there.

The Quality Assurance Project Plan for this survey study called for the sampling of 44 sites (Golding, 2003). A total of 57 sites were selected at random for visits during the 2003-2004 wet season. Figure 3 summarizes the outcome of the site visits.

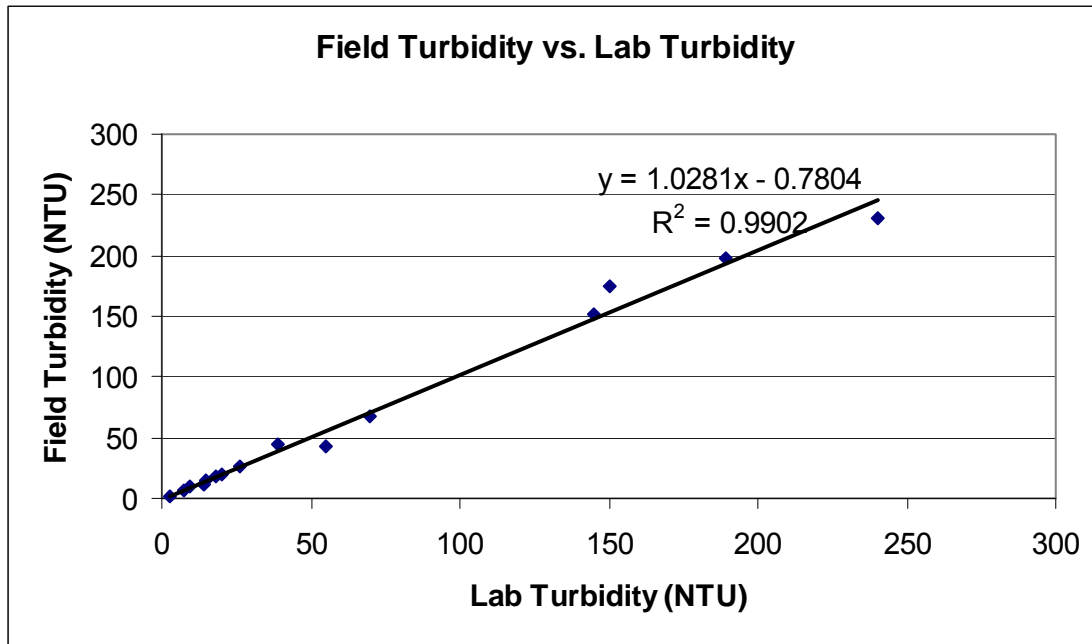
Figure 6. Field Turbidity versus Laboratory Turbidity Results.

The turbidity of discharges and receiving waters measured in the field was compared with that determined in the laboratory (Figure 6). It was anticipated that the results would correlate well because both instruments were ratio-type and of the same manufacturer. A correlation coefficient of 0.995 ( $r^2 = 0.9902$ ) shows that the correlation between field and laboratory measurements was excellent.

Field turbidity determinations with a ratio-type nephelometer were found to be as precise and accurate as laboratory turbidity.

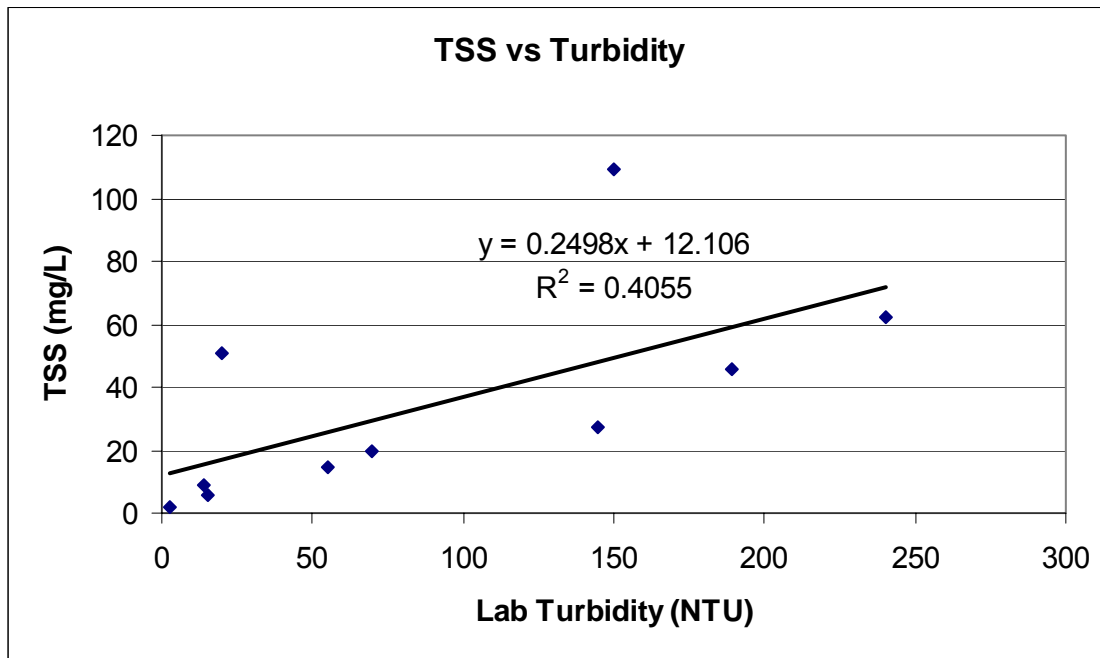
Figure 8. Total Suspended Solids Results versus Laboratory Turbidity Results.

The possibility of a correlation between TSS and turbidity was also explored, although a good correlation was not anticipated. TSS, a measure of total suspended solids concentrations, may be expected to relate somewhat to turbidity, though particle size, while having a potentially large effect on turbidity measurements, does not enter into TSS determinations. Figure 8 shows the relationship between the TSS concentrations obtained and turbidity.

The correlation coefficient between TSS and turbidity was 0.637 ( $r^2 = 0.4055$ ), indicating the lack of a correlation between TSS and turbidity. The presence of two of ten points far from the best-fit line in Figure 8 shows that TSS cannot be used as a surrogate for turbidity.
