Helping Urban Streams

North Creek Watershed—Fighting Flashy Flow

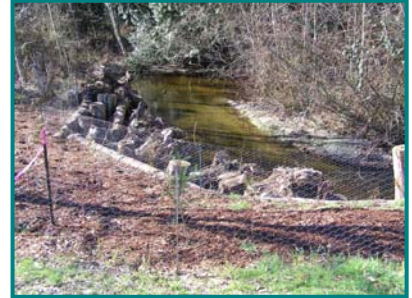
After receiving all the necessary approvals, Mill Creek started working with contractors, city staff, and the Adopt-A-Stream Foundation. Adopt-A-Stream coordinated local volunteers and started by removing invasive plant species. Biologists then relocated the fish from the area. Team members temporarily rerouted North Creek around the construction area. Finally, sediment and erosion control was put in place so construction could begin.

The coordinated effort to help North Creek occurred during the summer of 2005, before salmon returned to spawn in the fall. Near-stream areas were excavated to install logs with root wads that were at least 16 feet long. This kept them well anchored when high flows returned. Placing these pieces of large woody debris (LWD) in the creek created better fish habitat that would also absorb the force of the rising winter waters. After the proper placement of the wood, soil and gravel were added to finish the in-stream habitat. The Adopt-A-Stream Foundation volunteers completed improvements to the near-stream area by planting 400 trees and shrubs.

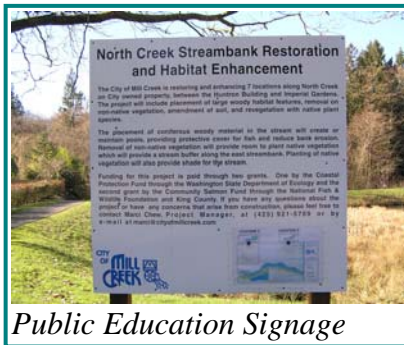
Public Education Signage

This first step in Mill Creek's North Creek restoration project restored 150 feet of degraded streambank. The success of this project allowed urban residents to see and learn about riparian restoration. The city also installed educational signage and a pet waste station to help protect North Creek from bacteria and nutrient pollution.
