Washington Conservation Corps Ecological Restoration Evaluation

December 2008
Publication no. 08-06-026

Ecological Restoration Evaluation

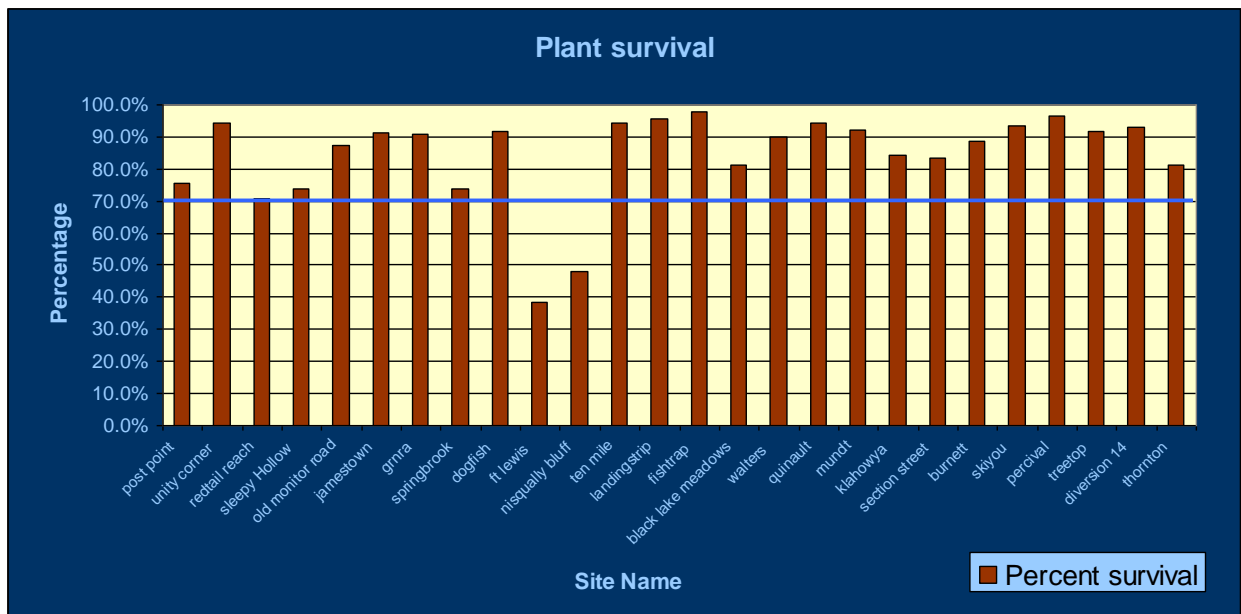
Overall plant survival is a common indicator used to gauge restoration project success. Figure 2 represents the 26 project sites that included a re-vegetation component. The average plant survival rate for all 26 re-vegetation projects is 83.4%. Twenty four out of 26 planted sites meet or exceed the 70% plant survival goal for project sites, with 20 sites above 80%.

Figure 2: The overall average plant survival for all project sites.

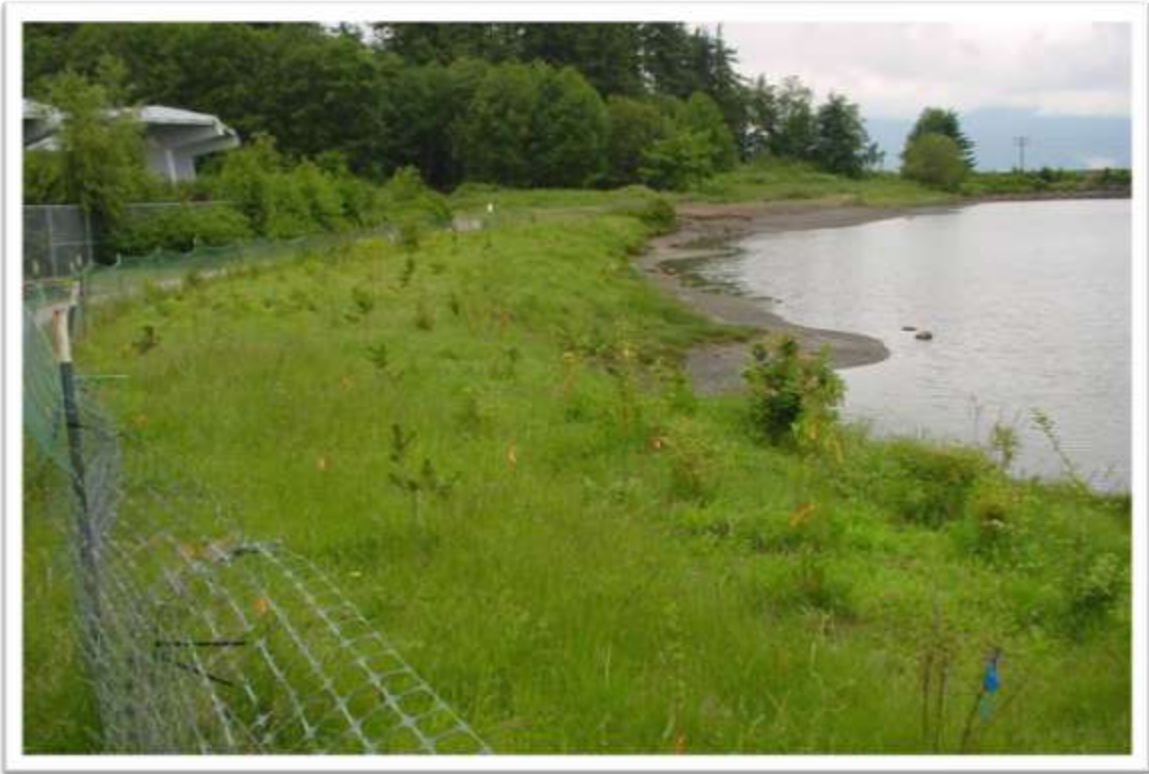
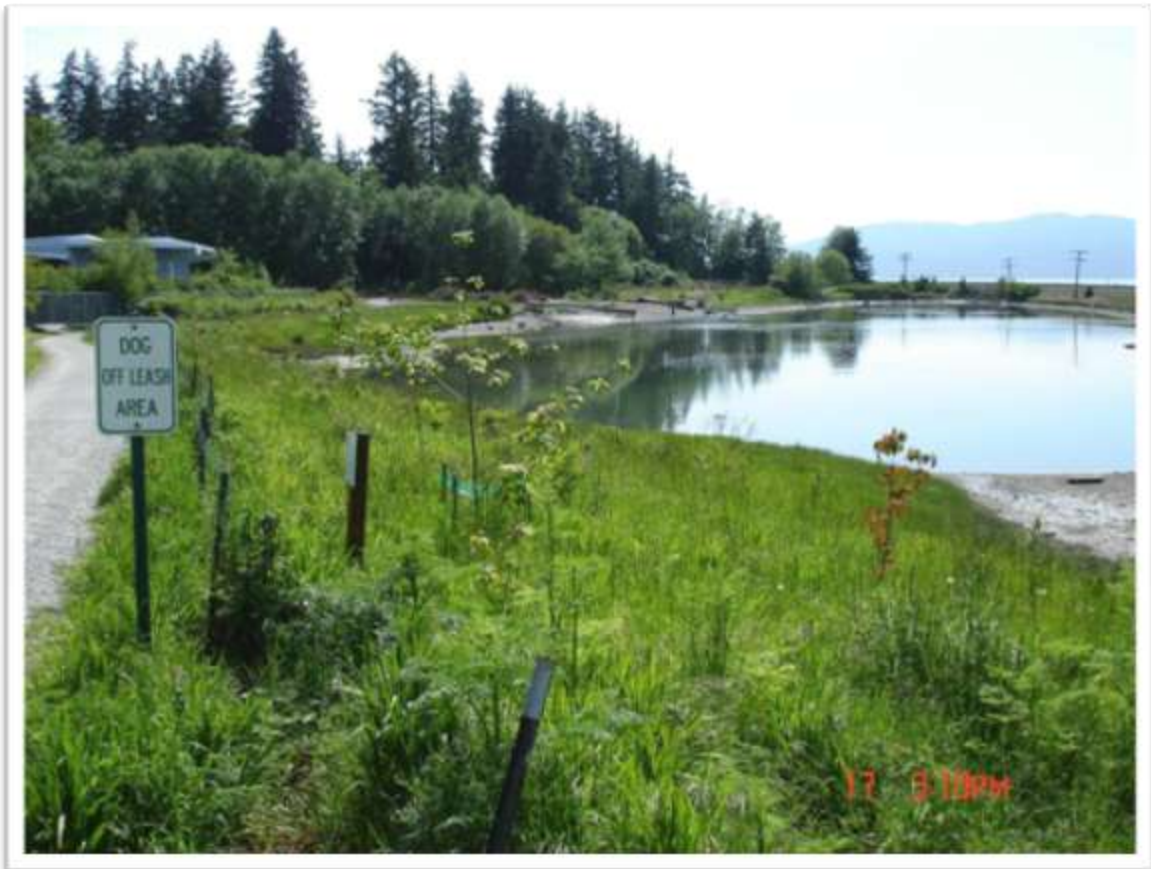
Bellingham Post Point Photos

The City of Bellingham's Post Point project is enhancement of a degraded estuarine public park. Challenges this project is facing include significant sun exposure, difficult freshwater hydrological conditions resulting from its proximity to saltwater, a well-established invasive Himalayan blackberry population, impacts of a neighboring waste treatment construction project, and over use as a popular dog exercise area.

The Post Point estuary is located within the city of Bellingham port district and is a multi-use recreation area. Located on this property is a great blue heron rookery and important salmonid habitat. The site receives a lot of pedestrian and dog use, which has contributed to the degradation of this site. This project aims to educate the public, improve the ability of the site to sustain the existing heron population and create near-shore riparian habitat for salmon by installing fencing around areas most susceptible to the impacts of dog use. The project consisted of planting native vegetation, installing informational signs, and installing LWD habitat features for salmonids. This project was planted in winter 2005 and consisted of approximately 800 linear feet of shoreline and 30,000 square feet total restored area.

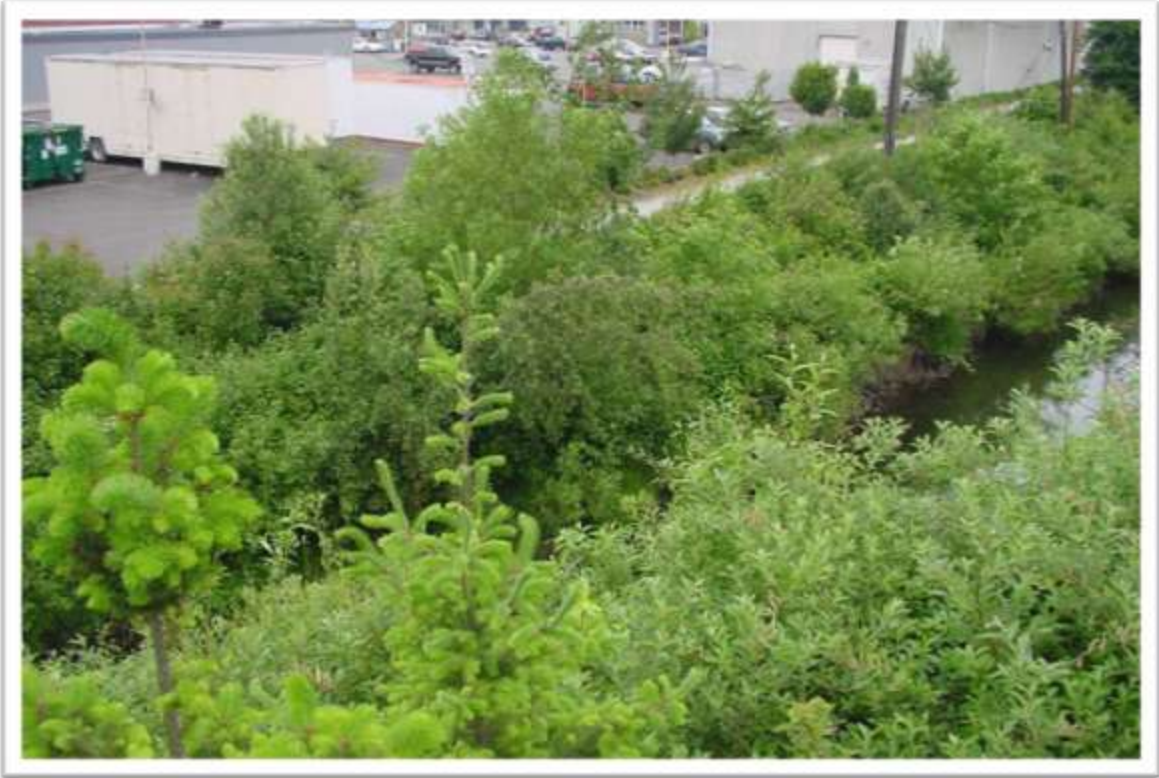
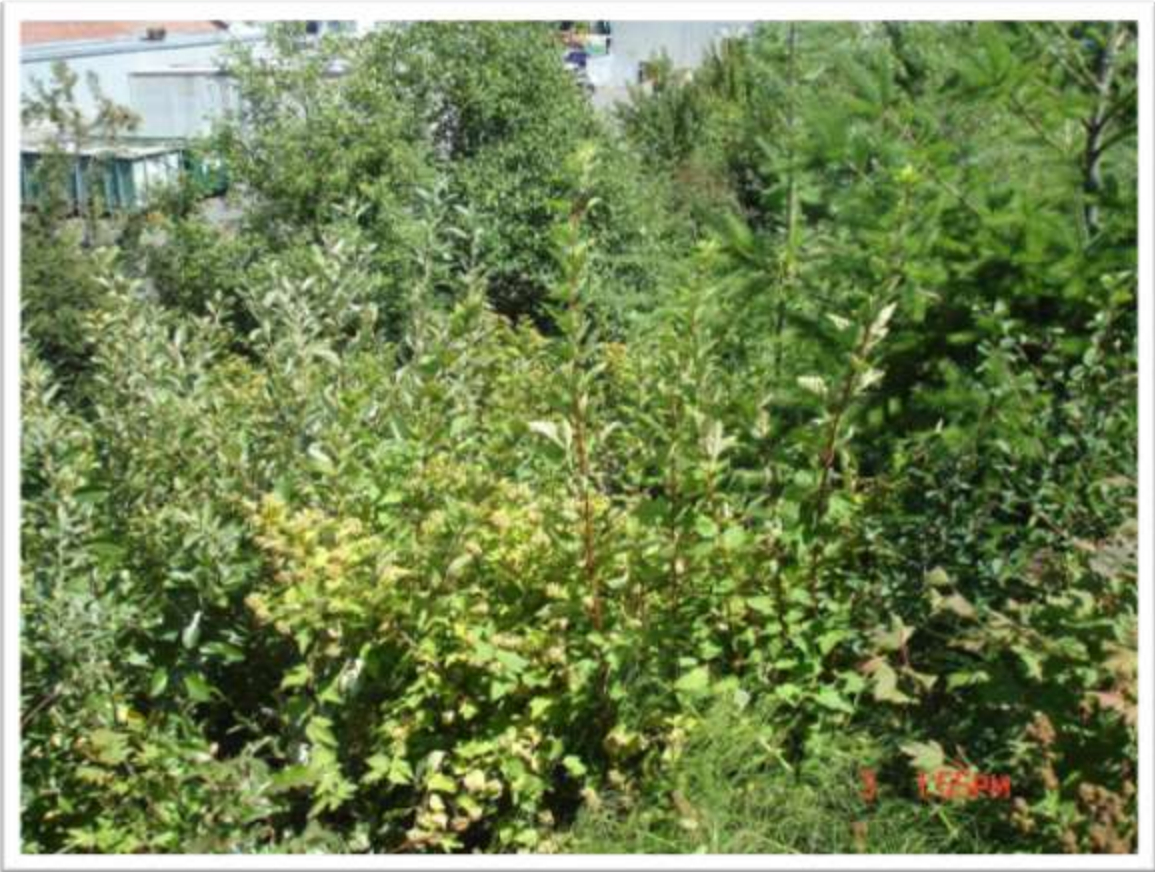
The site is making great progress toward full habitat restoration and is currently ranked successful by this evaluation. The buffer extends more than 75feet from the channel and the plantings are providing adequate shade to the stream. The high-density planting and the use of multiple tree and shrub species has immensely helped in stabilizing this steep slope. This site was maintained on a regular basis but now seems to be self-sufficient. The LWD is still in place and in use (several cutthroat were observed utilizing the placed woody debris). Although this site is about as “back to natural” as it could possibly be, it is in an urban setting, and there will always be a need for trimming for power lines/signs and litter patrol.

- no irrigation
- extremely steep slope (which presents maintenance problems)

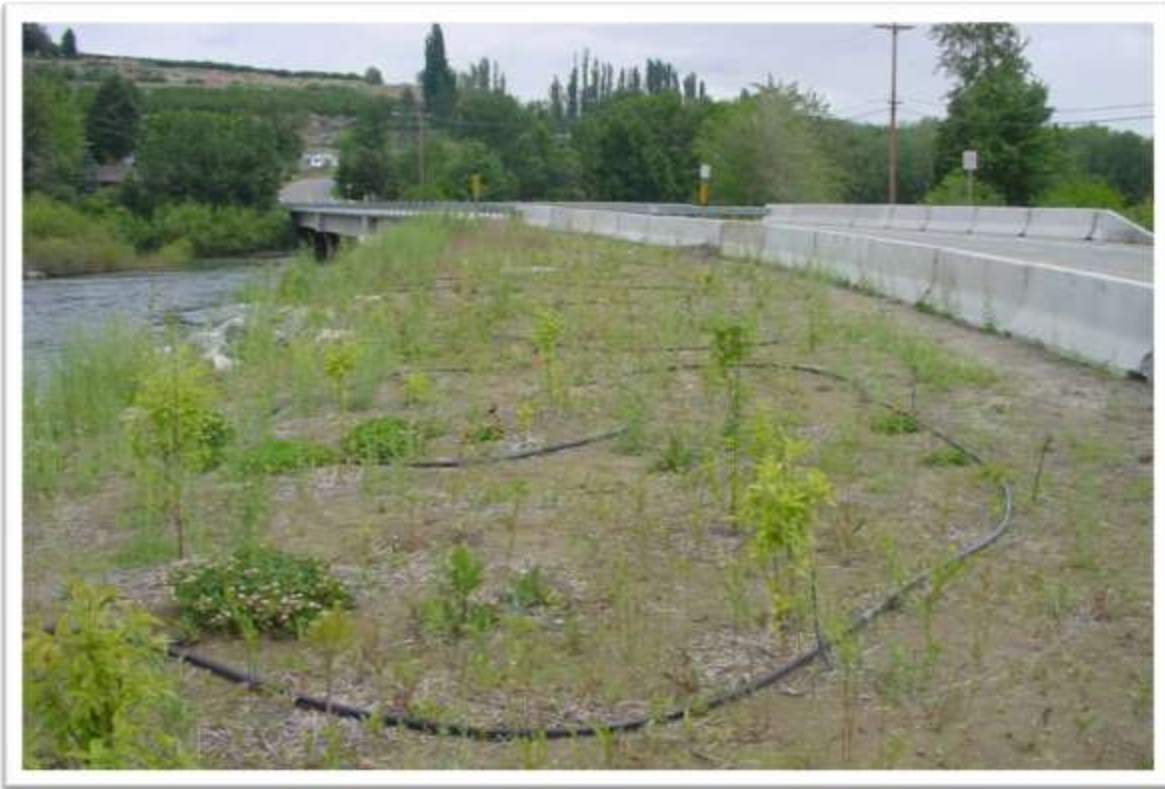
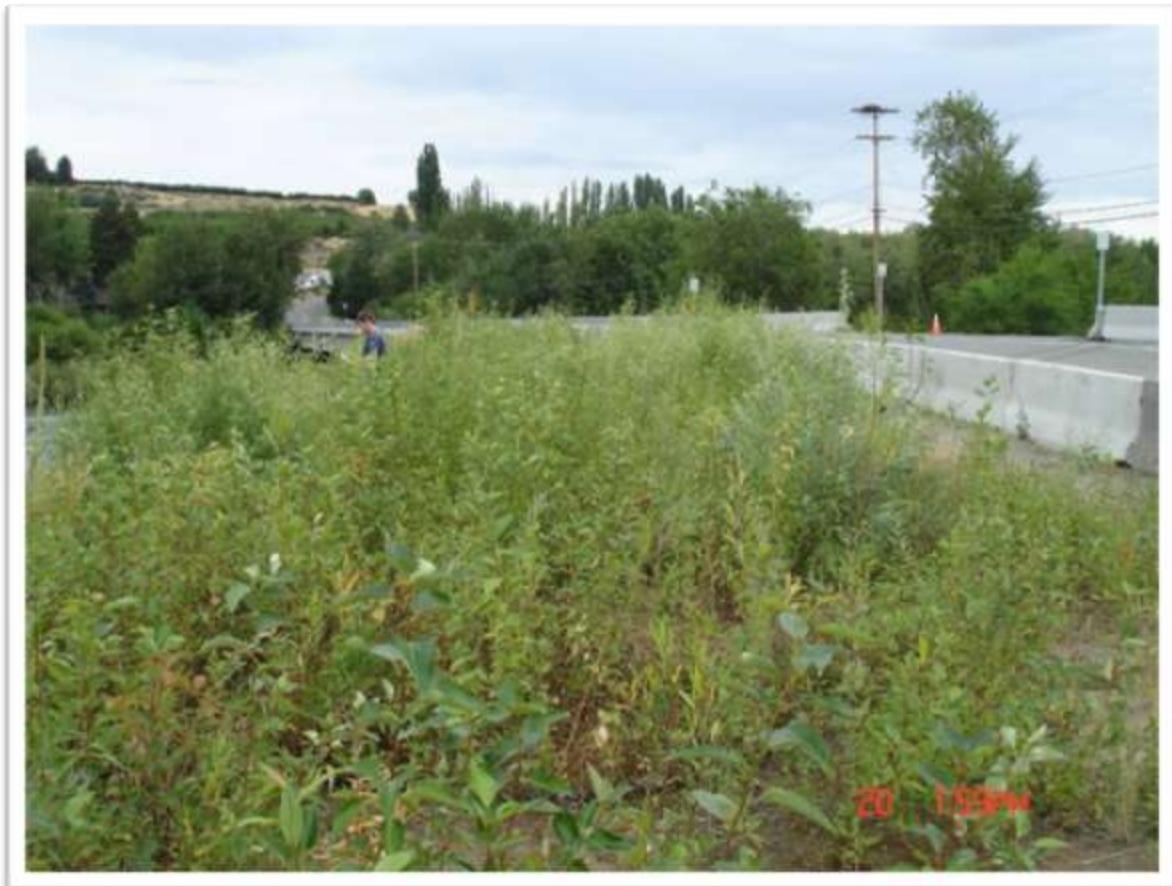
The Chelan Conservation District's Sleepy Hollow project is reinforcement and re-vegetation of an eroding bank of the Wenatchee River. Challenges this project faces include poor soil, dry site with full sun exposure, having to plant in rip rap with no available soil, competition with volunteer cottonwood seedlings, and unfavorable roadside site conditions.

The site was implemented in 2004 and consisted of planting an area approximately 200' long x 40' wide along the Wenatchee River. Major flood events in 1995-96 nearly washed out a large portion of Sleepy Hollow Road. Large rocks were placed along the river bank, and rock barbs were placed in the river to provide protection for the road. Federal and state permitting agencies required the addition of habitat features as a condition for construction of the project. Logs were cabled to large rocks in the river bed, and plantings were installed along the bank to help stabilize the banks and provide riparian habitat for local fauna species.

- preparing a suitable planting bed in thick rip-rap material
- invasive species
- dry soil conditions

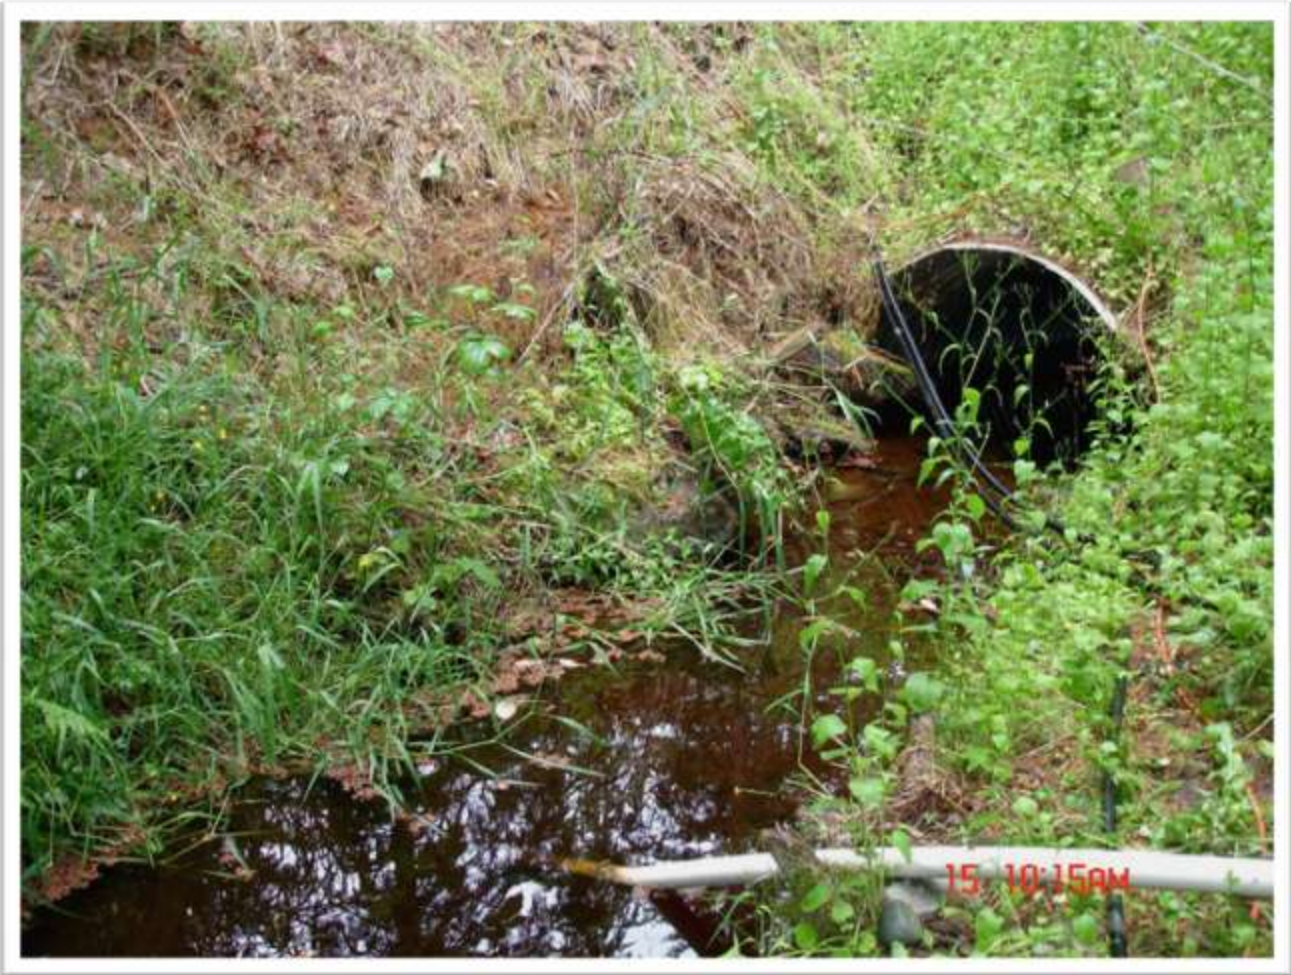
Kitsap CD-Little Bear Photos

The culvert was replaced with a 95” x 67” arch culvert, and LWD was placed in the culvert and nearby streambed to enhance habitat. The larger culvert now allows for easier fish passage.

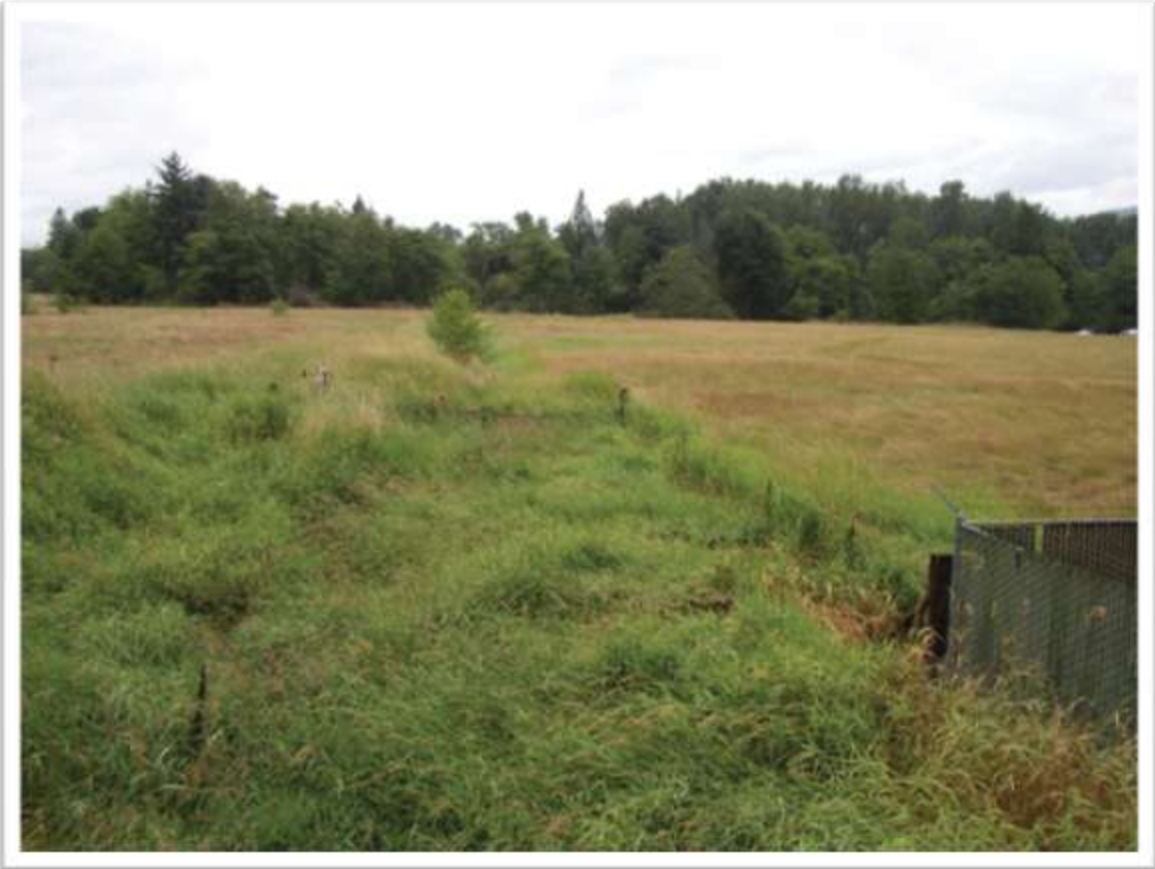
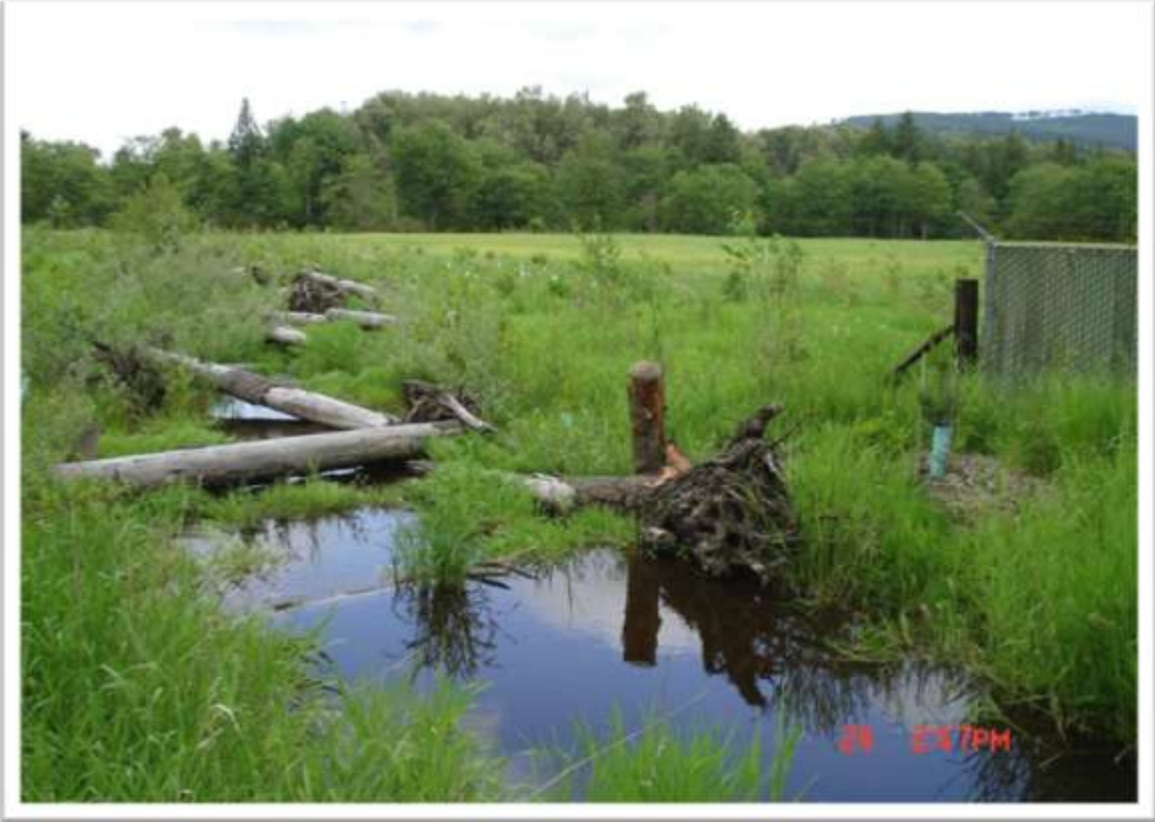
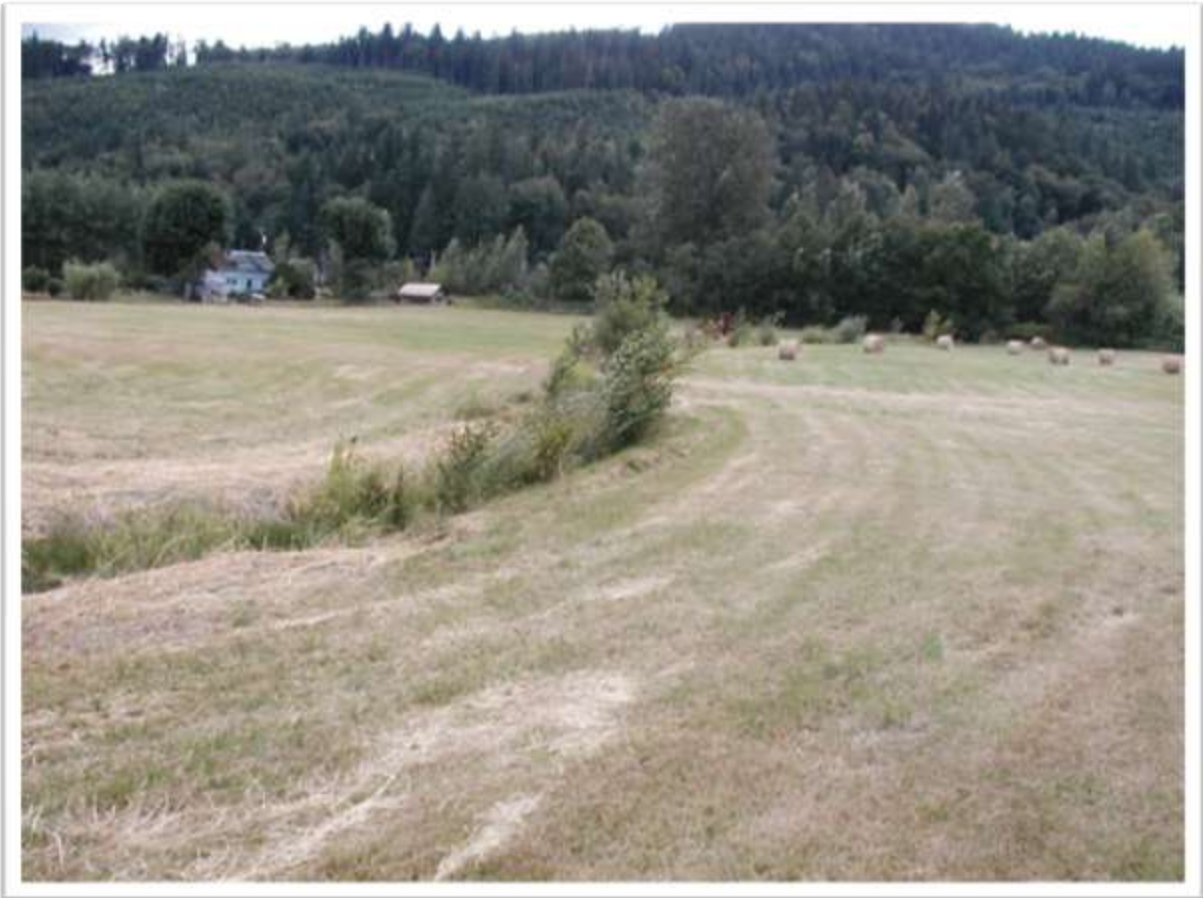
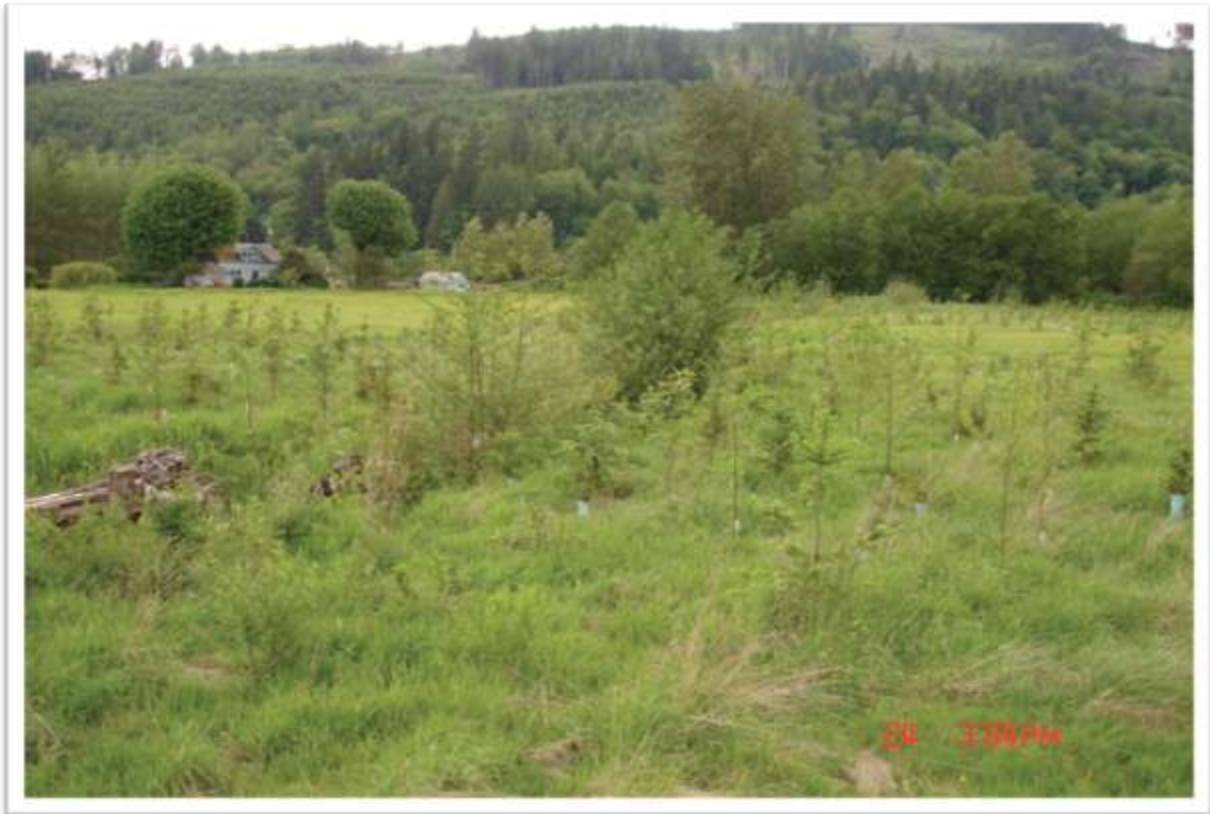
**Nooksack Salmon Enhancement Association-Landingstrip Creek Photos
2004**

The site is making progress toward full habitat restoration and is currently ranked successful by this evaluation. The availability of water, choice of appropriate plant species, and the use of tree protectors seem to be the key factors in the success of this site. The LWD are intact and functioning. Some of the woody debris has caused the accumulation of more debris. Weed matting and some light maintenance could help suppress an invasive grass problem.

- need for weed matting
- more maintenance

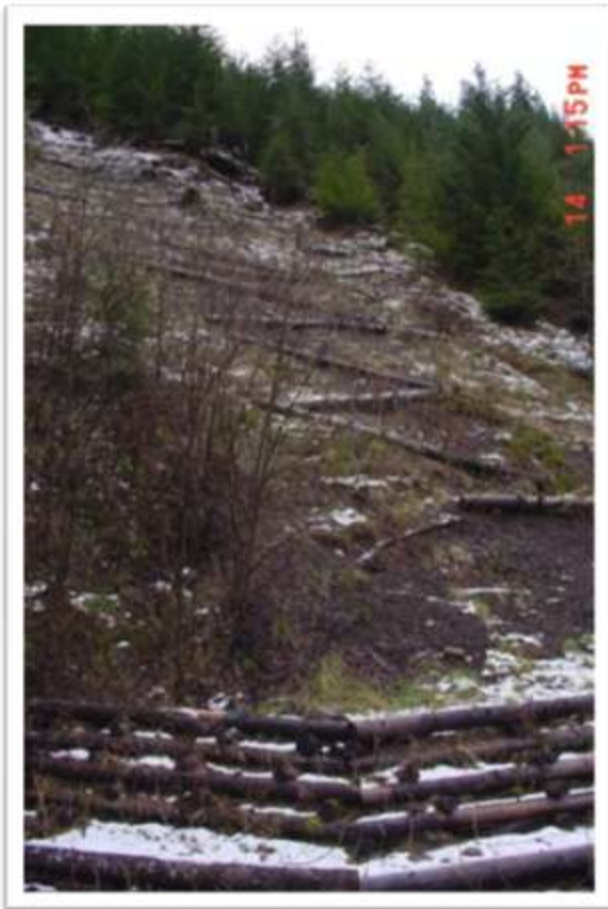
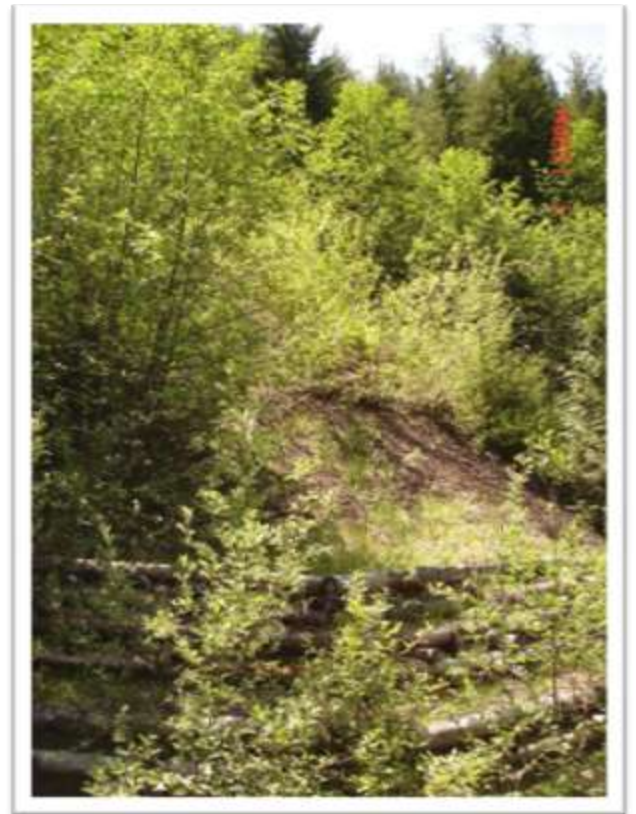
Olympic National Forest-Walters Creek Photos

This project was started in 1999. The project area consisted of a slope failure along a 1,000 ft. of stream bank. These bioengineering structures consisted of the construction of willow crib walls and fascines that extended an estimated 900 as well as log terraces intended to catch loose debris sloughing from the hillside. Bare root plantings were focused above log terraces and also stretched throughout the slope failure. A final application of seed and mulch was spread over the treatment area.

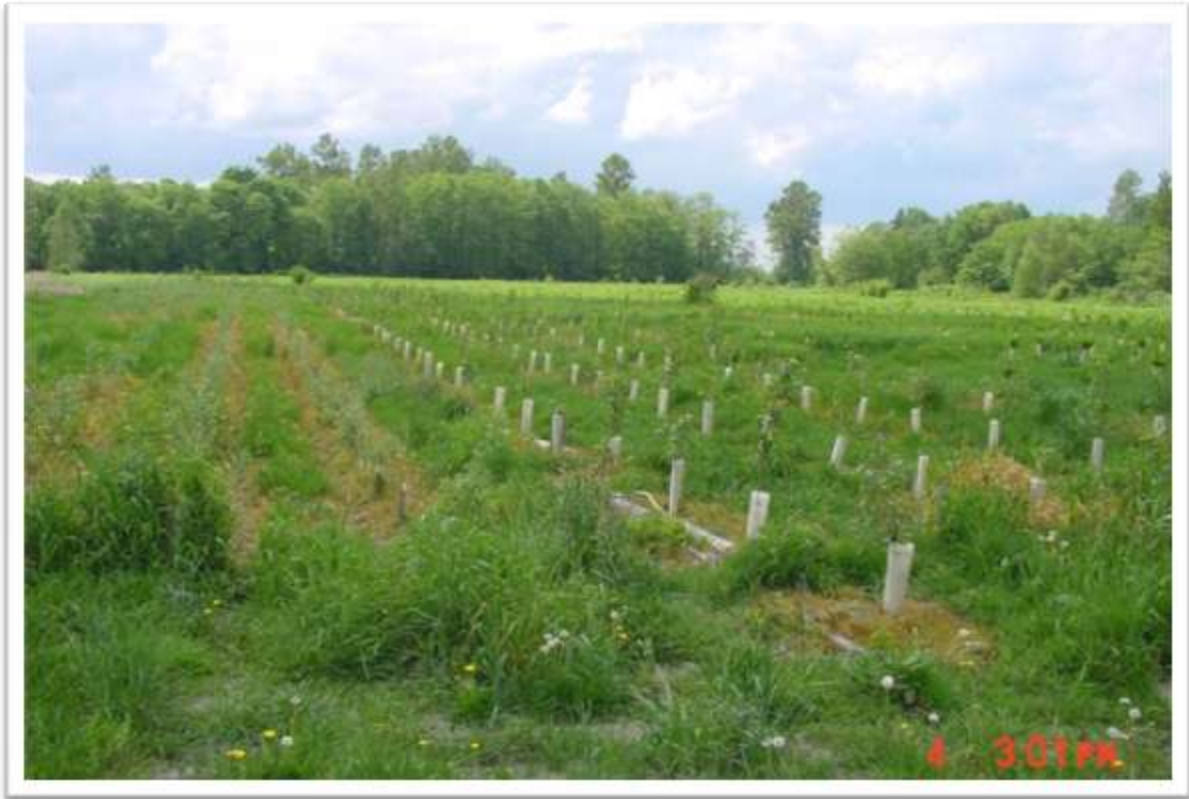
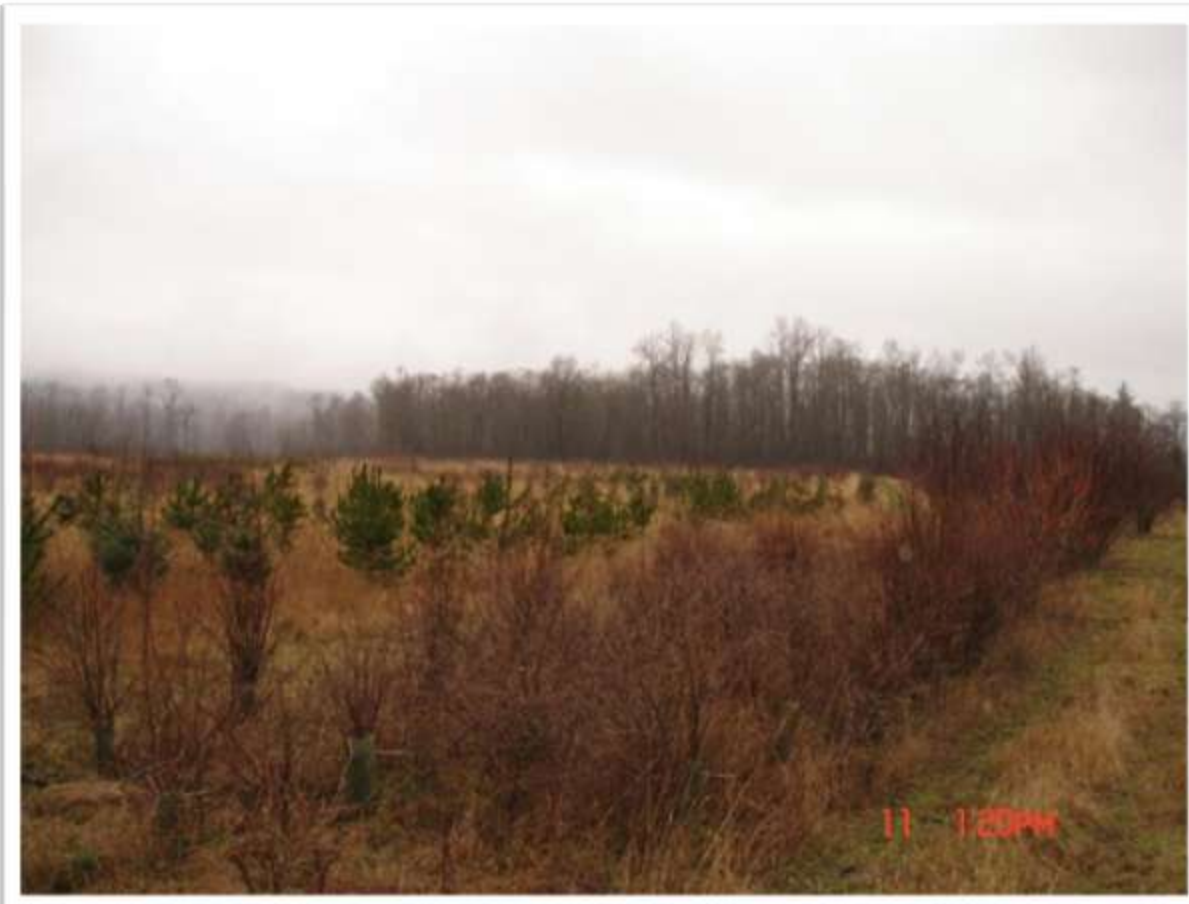
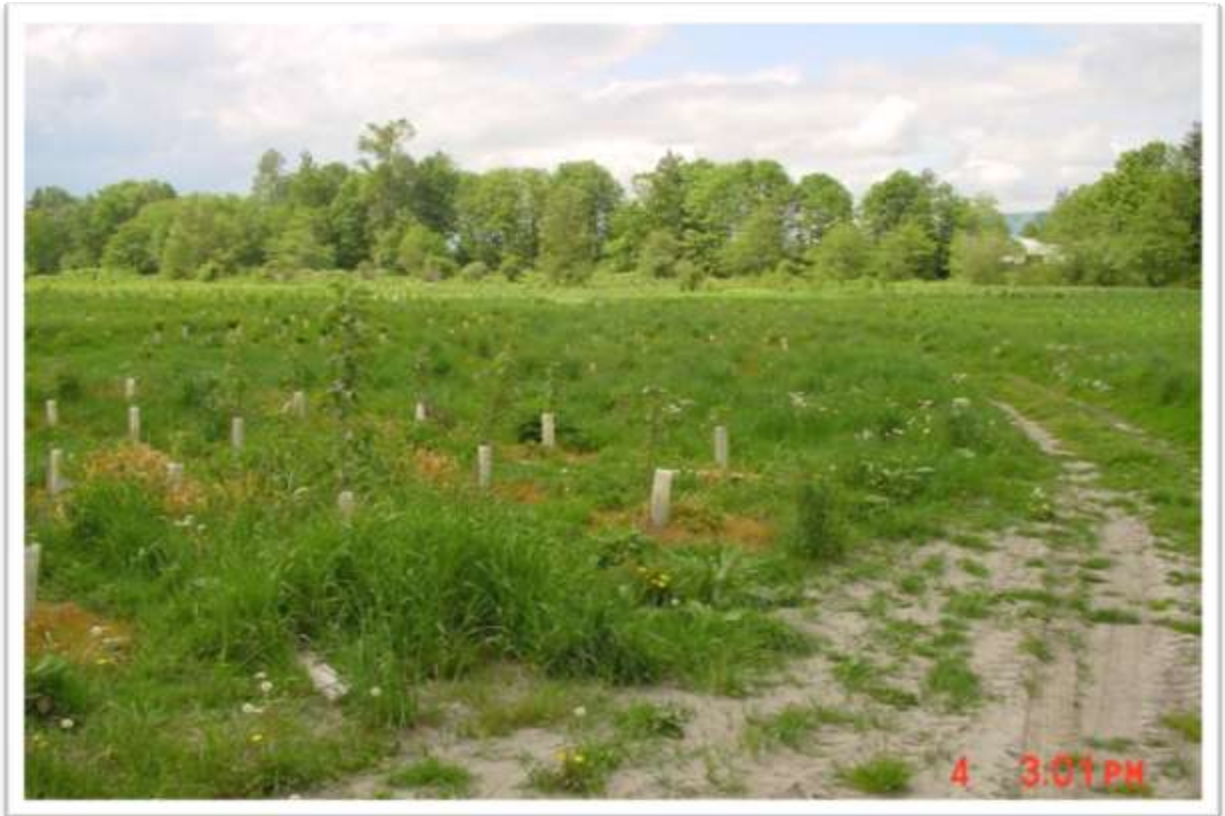
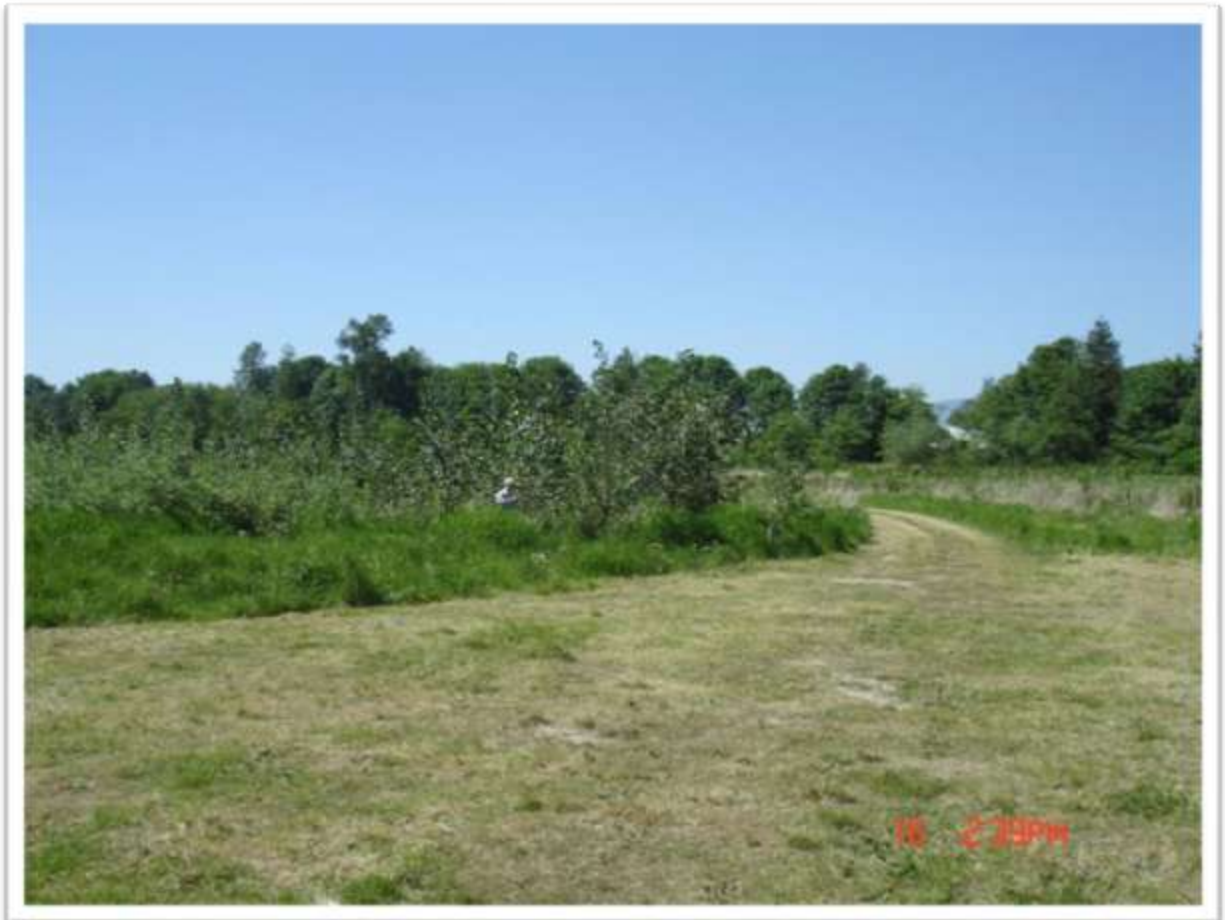
The site is making progress toward full habitat restoration and is currently ranked successful by this evaluation. The use of an array of species, as well as the density and spacing, seemed to be the biggest contributing factors to the success of this site. The planted vegetation seems to be healthy and is now competing with the non-native grasses and Himalayan blackberry. Cattle are allowed into the project site and there are signs of plant damage due to the cattle. Also, the river bank is eroding in some spots, which removes plantings. Large woody debris and/or rip rap may help to slow this erosion.

- continued erosion
- presence of livestock
- invasive plant species
