Lower Duwamish Waterway River Mile 3.9-4.3 East (Slip 6)

Source Control Action Plan

September 2008

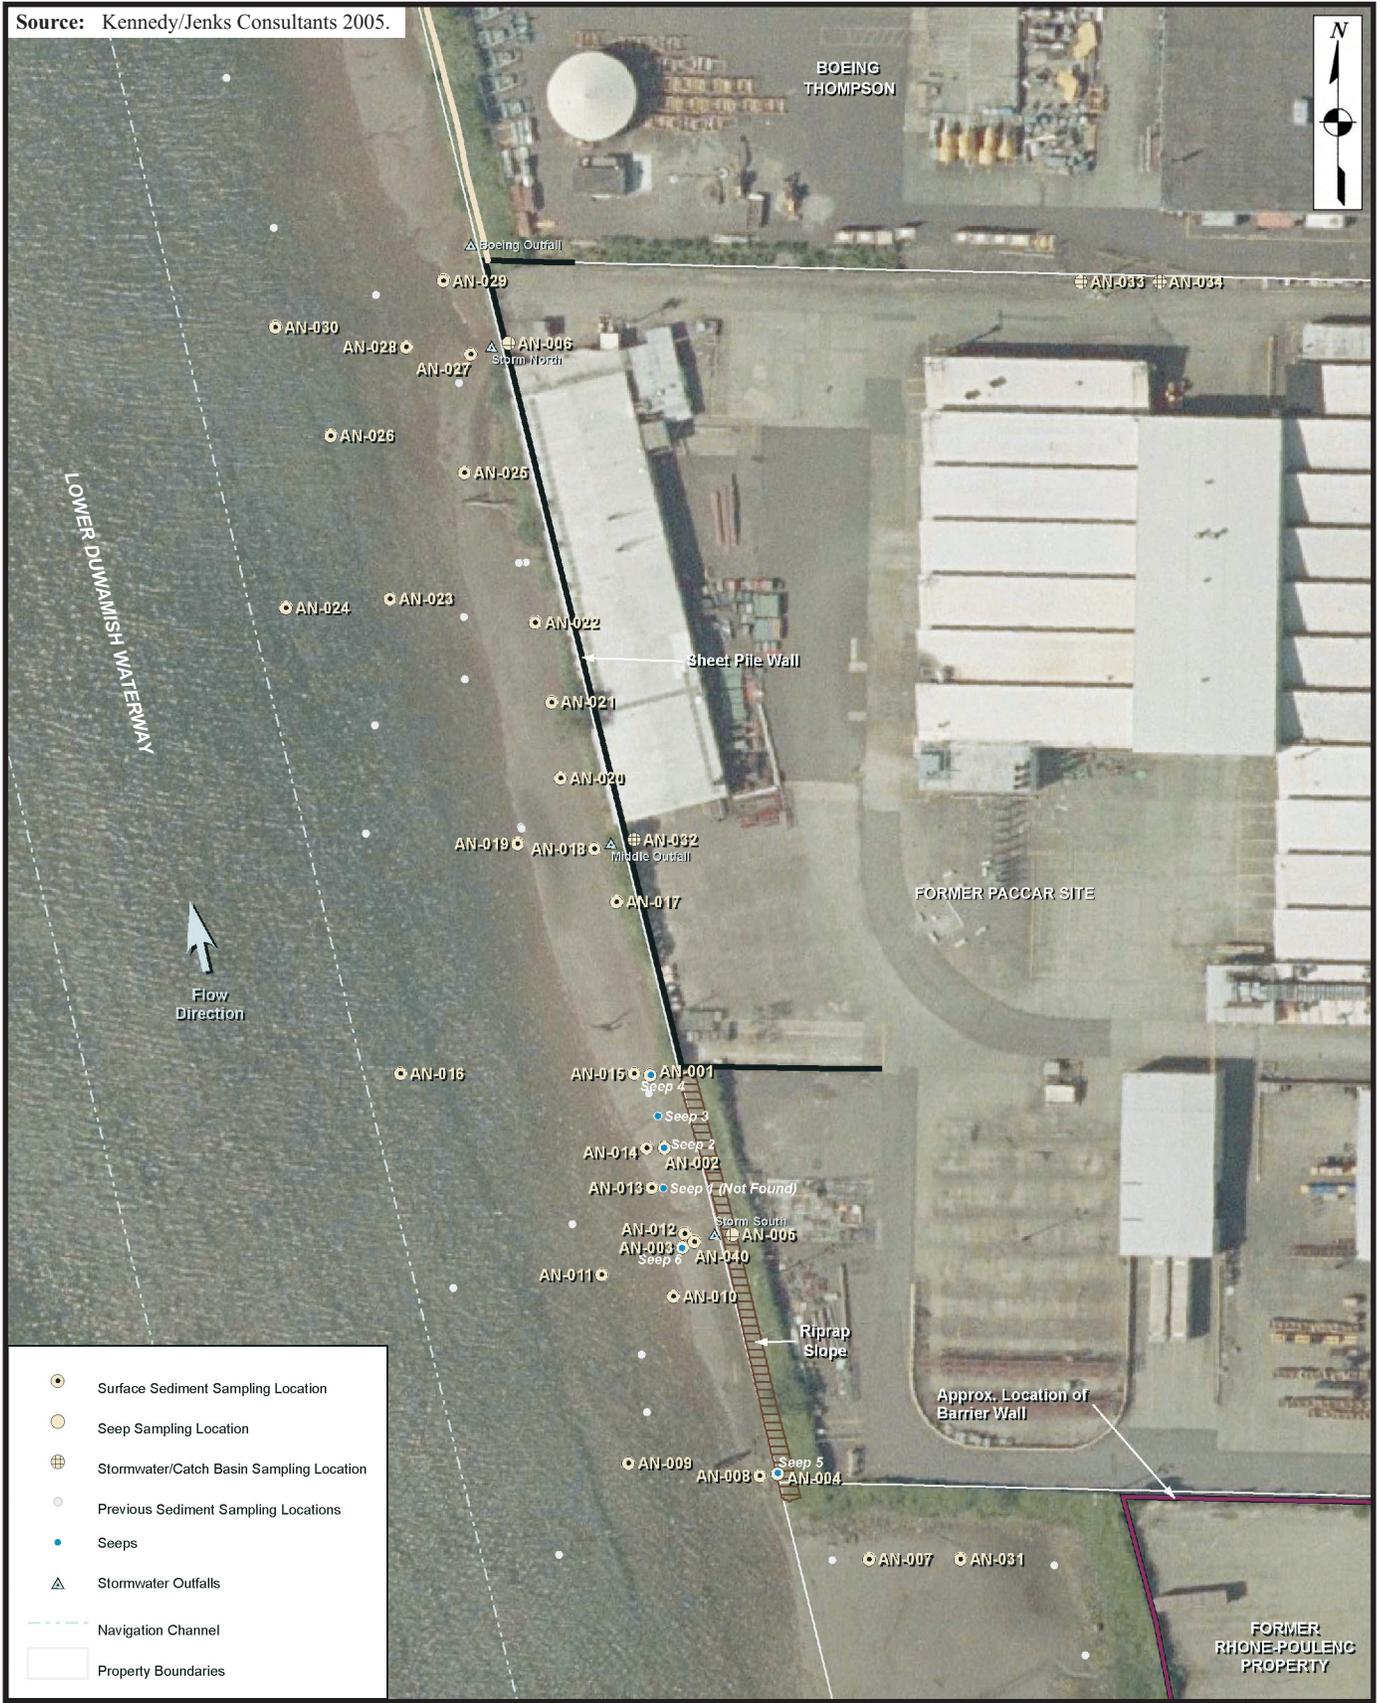
Figure 2
SLIP 6 SOURCE CONTROL AREA

- Surface Sediment Sampling Location
- Seep Sampling Location
- ⊕ Stormwater/Catch Basin Sampling Location
- Previous Sediment Sampling Locations
- Seeps
- ▲ Stormwater Outfalls
- - - Navigation Channel
- ▭ Property Boundaries

³ The area referred to herein as the ‘Slip 6 drainage basin’ is actually a sub-drainage basin of the LDW valley. The LDW valley drainage basin has been divided into the sub-drainage basins, defined tentatively by storm water collection systems and outfalls, as shown in Figure 2.

The former Rhône-Poulenc, Inc. site is located on the east side of the LDW from RM 4.0 to 4.2. The site is approximately 21.5 acres, 19.5 of which are uplands and 2.0 of which are intertidal mudflats in the LDW. The site is bordered by the former PACCAR site to the north, East Marginal Way South to the east, the BDC and the Slip 6 inlet to the south, and the LDW to the west (Figure 2). The site and surrounding area are zoned for heavy industrial use.

The MOF includes two properties, located to the east and west, respectively, of East Marginal Way (Figures 2 and 20). Both properties are owned by the MOF; however, the property to the west of East Marginal Way was formerly owned by Boeing. For the purpose of this report, the two properties will be referred to as the MOF property (Parcel 3324049019) and the former BDC property (Parcel 5624201034).

The BDC is located on the eastern shoreline of the LDW from approximately RM 4.2 to 5.0 and lies within three separate source control areas. The portion of the BDC within the Slip 6 drainage basin is located from RM 4.2 to 4.3 with the Slip 6 inlet to the north (Figures 2 and 24). Although information for the entire BDC was reviewed, only information for the portion of the BDC within the Slip 6 drainage basin is discussed in this report. Information on the BDC related to other source control areas may be found in the *Early Action Area 7 Source Control Action Plan* (Ecology 2007a), and in the *RM 4.3 to 4.8 East Source Control Action Plan* that has not yet been published.

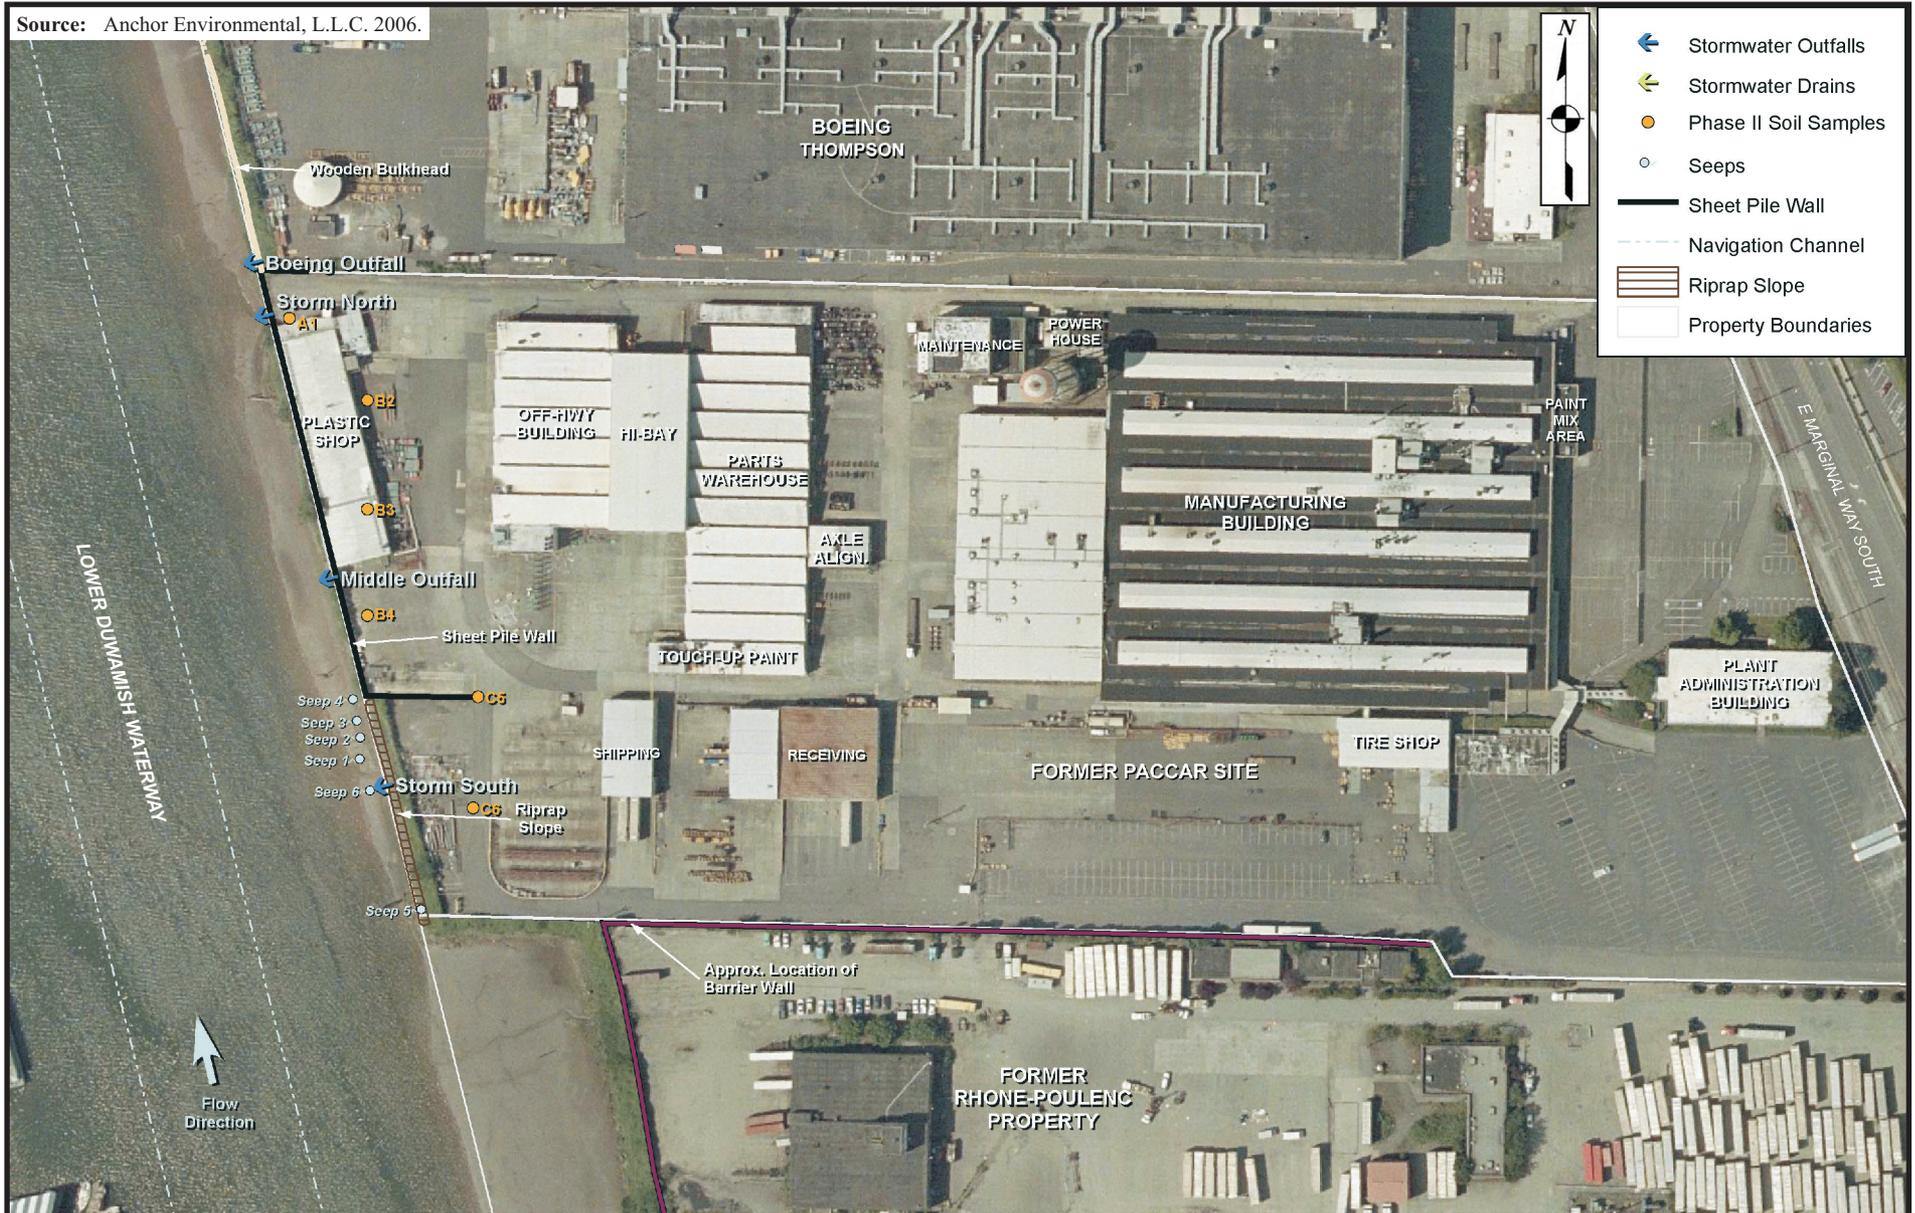
Figure 6
 FORMER PACCAR SITE MAP

- Stormwater Outfalls
- Stormwater Drains
- Phase II Soil Samples
- Seeps
- Sheet Pile Wall
- Navigation Channel
- Riprap Slope
- Property Boundaries
