DEPARTMENT OF
ECOLOGY
State of Washington

Lower Duwamish Waterway Source Control Status Report September 2008 through June 2009

August 2009

Publication No. 09-09-183

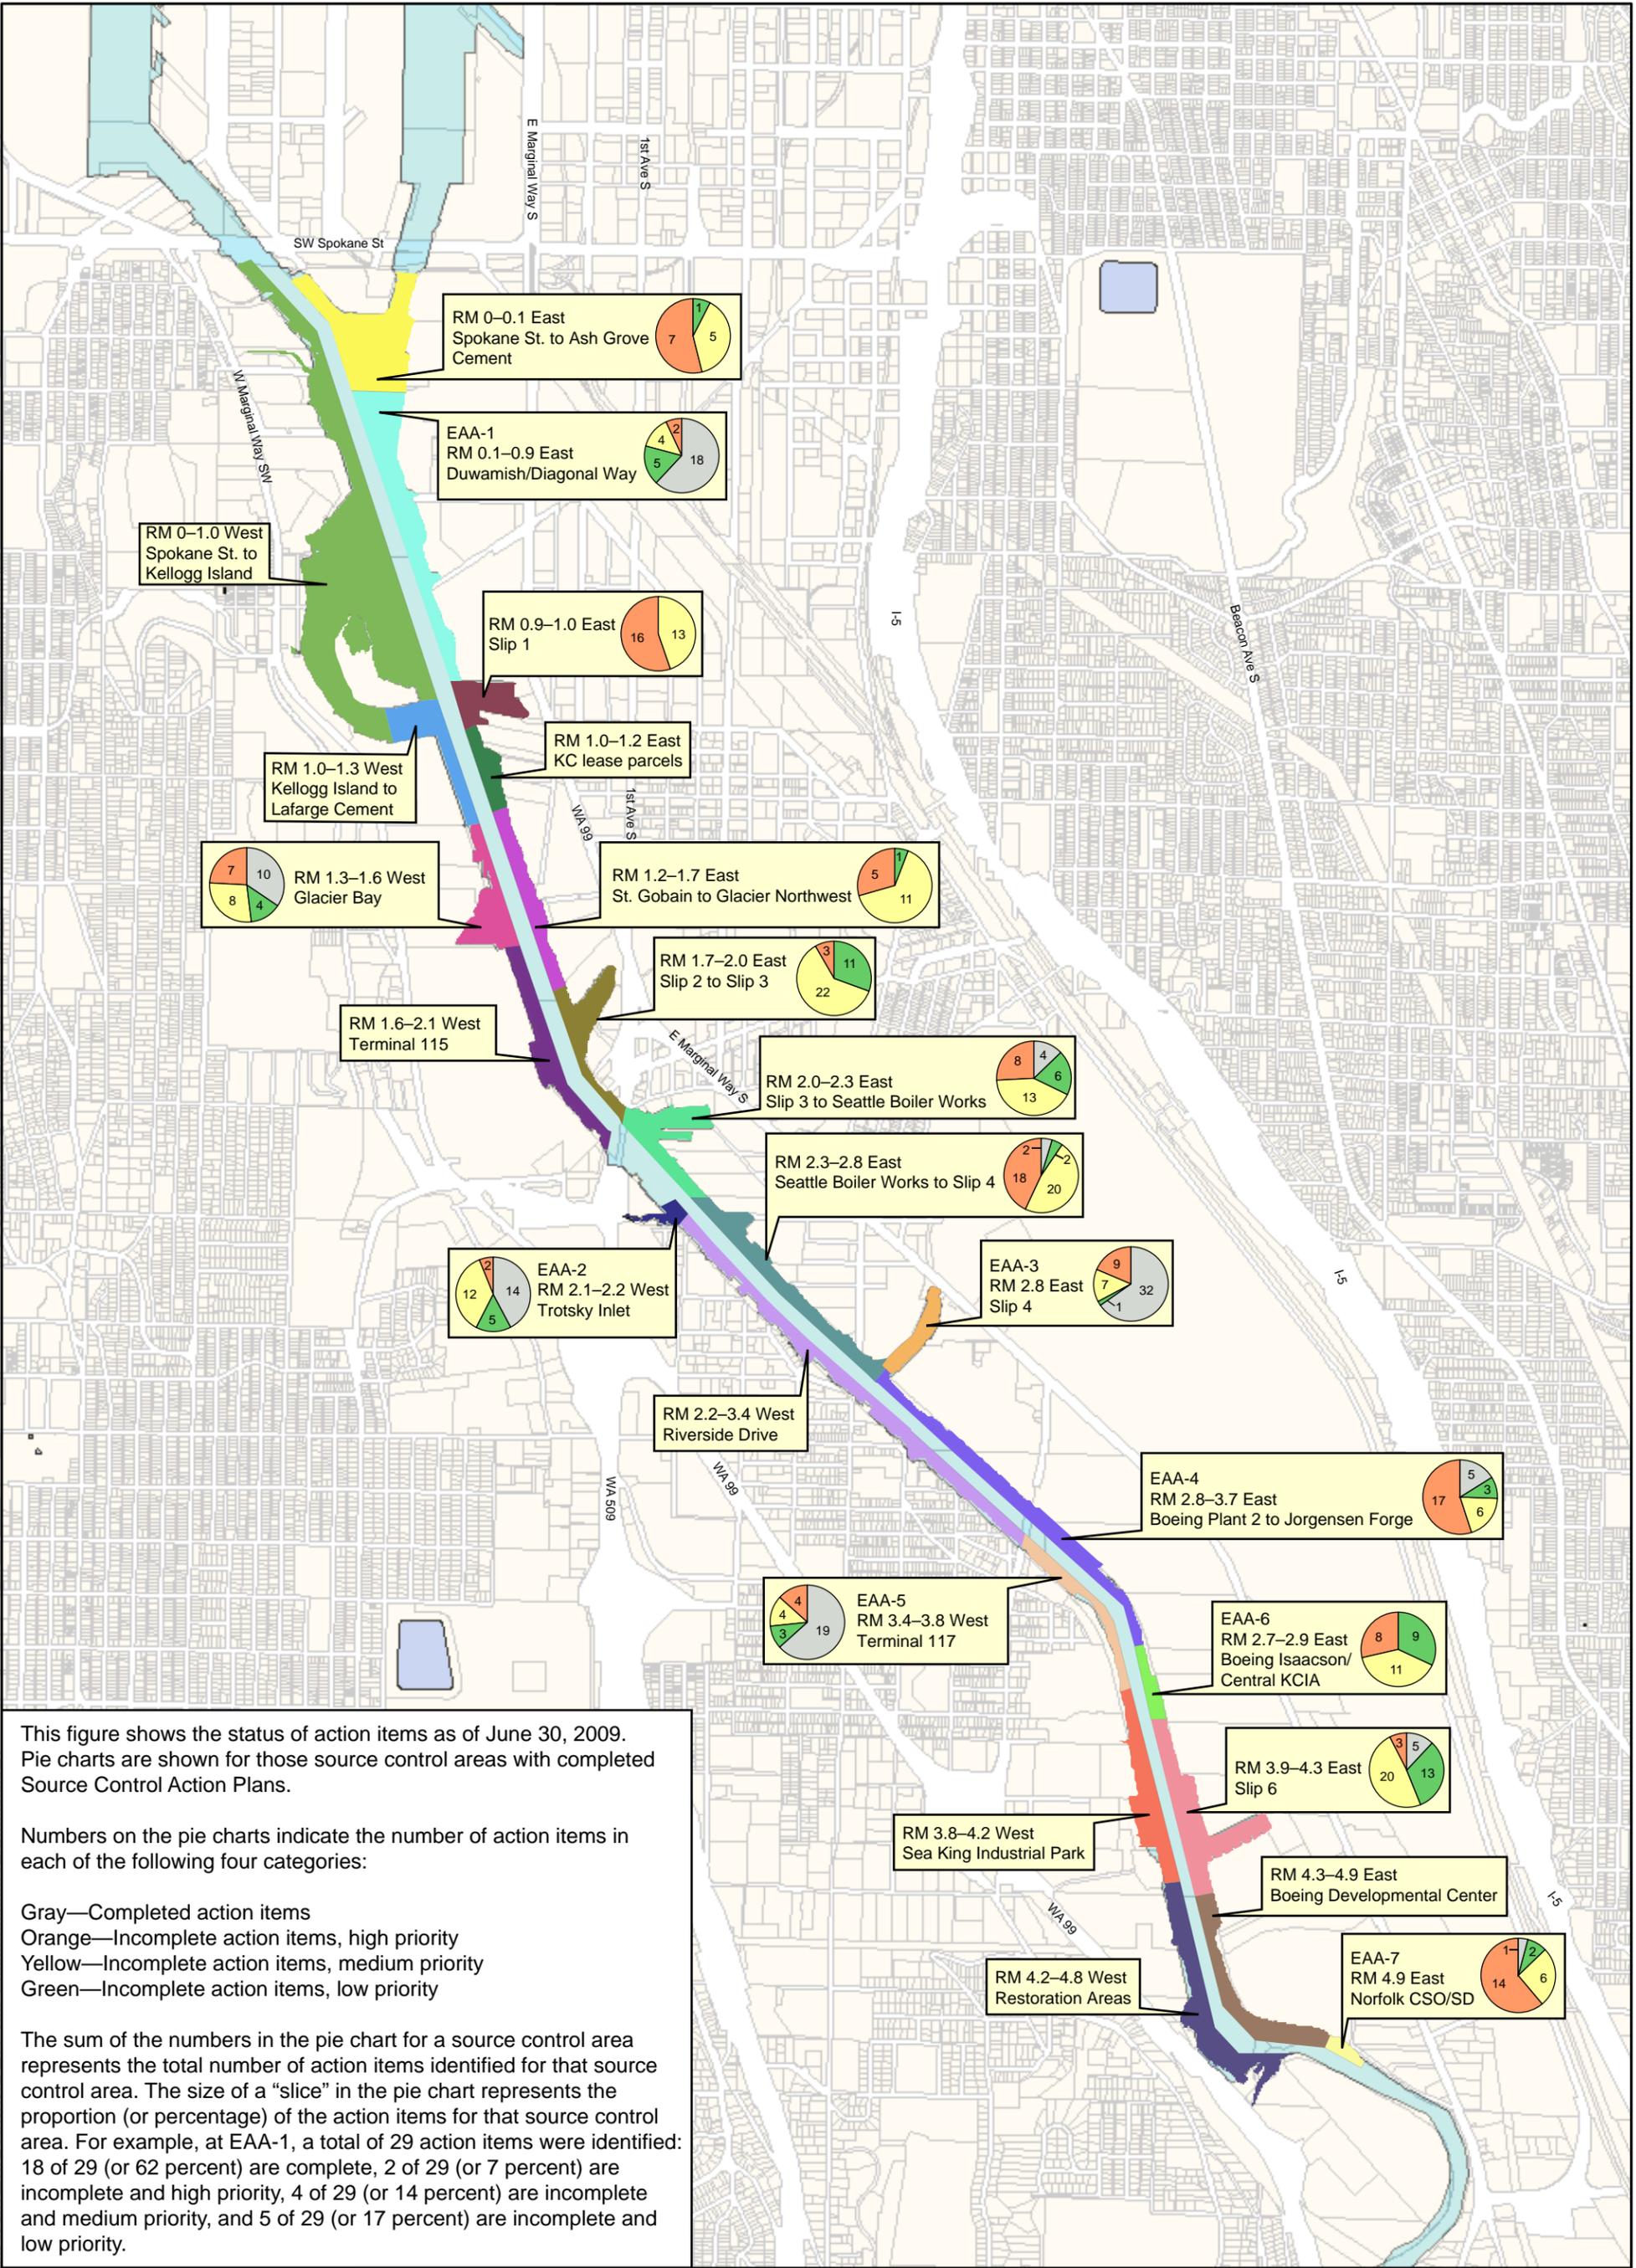
This figure shows the status of action items as of June 30, 2009. Pie charts are shown for those source control areas with completed Source Control Action Plans.

Numbers on the pie charts indicate the number of action items in each of the following four categories:

A total of 457 source control action items have been identified based on the 15 SCAPs published as of June 30, 2009; 111 of these action items have been completed, and 4 are not needed or have been combined with another action item (a total of 25 percent). Of the remaining 342 action items, 113 (33 percent of the remaining action items) are considered high priority (to be completed prior to sediment cleanup), 162 (47 percent) are medium priority (to be completed prior to or concurrent with sediment cleanup), and 67 (20 percent) are low priority (ongoing actions or actions to be completed as resources become available). The current status of action items is shown in Figure ES-1.

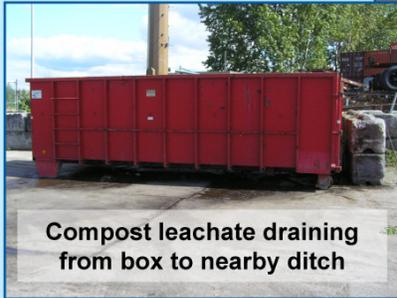
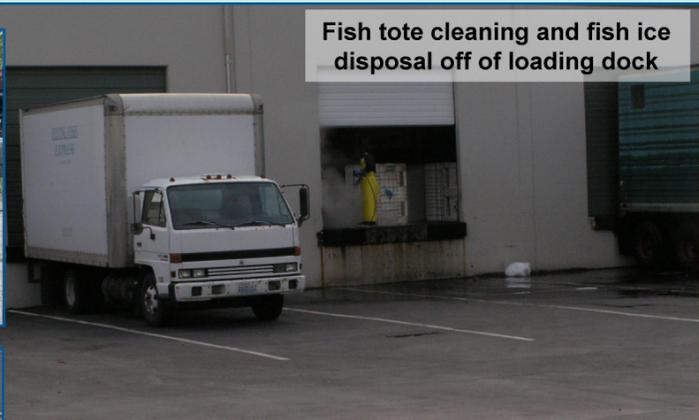
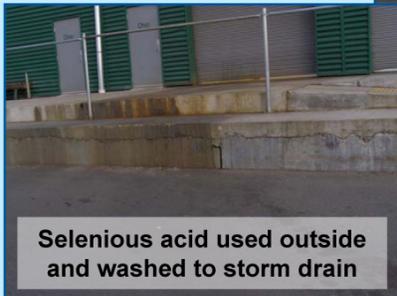
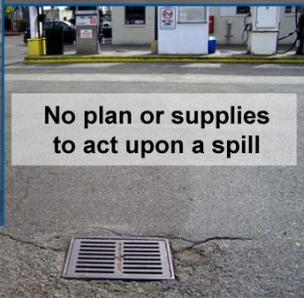
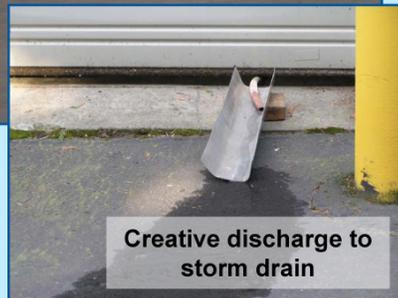
Potential Sources of Contamination: Releases from Spills, Waste Disposal, and Industrial Processes

Examples of the types of problems observed during the inspections are shown on the following pages.

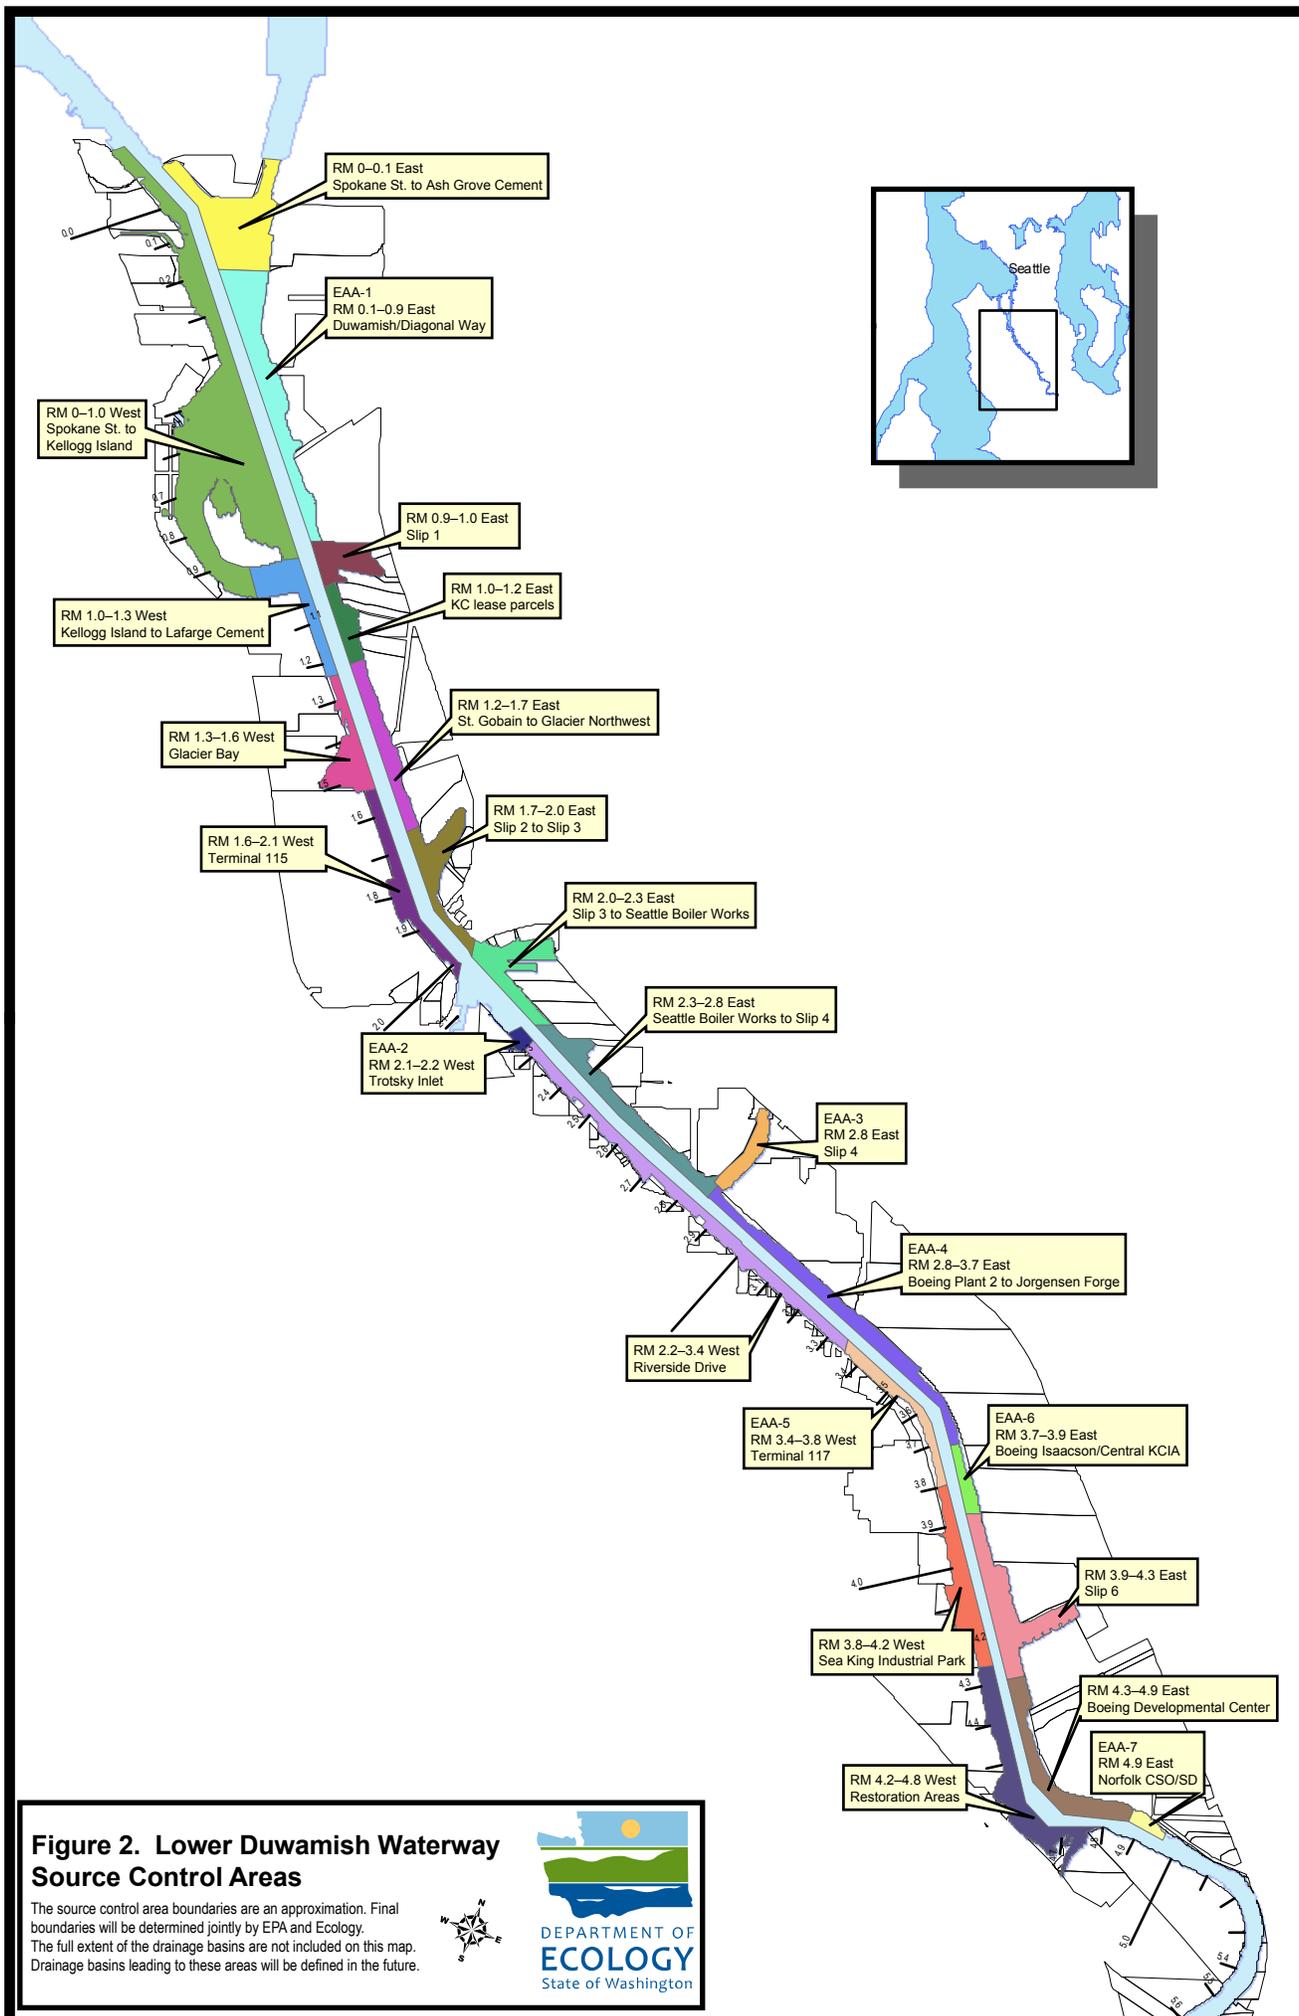
Figure 2. Lower Duwamish Waterway Source Control Areas

The source control area boundaries are an approximation. Final boundaries will be determined jointly by EPA and Ecology. The full extent of the drainage basins are not included on this map. Drainage basins leading to these areas will be defined in the future.
