# Snohomish River Basin

## An Ecosystem in Transition

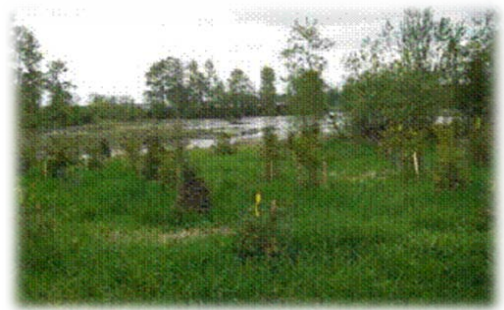
Figure 2. Native tree plantings along Snohomish River riparian areas.

Invasive species Japanese knotweed, Himalayan blackberry, and Reed canary grass were removed in order to reestablish native plants. Western Red Cedar and Sitka Spruce were primary tree species planted in the riparian areas. An over-abundance of trees were planted in anticipation of mortality. Snohomish County has estimated that approximately twenty-five percent of the plantings survived.

With a survival of rate of only twenty-five percent for native plantings, it is suspected that over-pruning of the root balls is the primary reason for the high mortality rate. A continuing effort to control Japanese knotweed, Himalayan blackberry, Reed canary grass, and any other non-native species is necessary in order for native plants to establish dominance in the area.

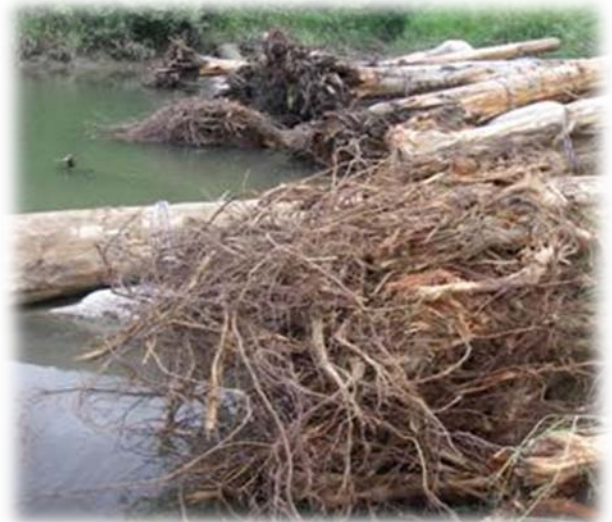
**Figure 3. Large woody debris structure.**

The third major undertaking of this project was to anchor large woody debris and root wads along the shorelines of both estuarine sites. This portion of the project was complete in the spring of 2009. The anchored logs all made it through the winter successfully and acquired several new large pieces of wood during storm events. Also, several species of fish were observed in the structures.

The anchored logs all remain intact and have recruited several additional large logs and woody debris from the season's storms and floods. All major tasks of this project are complete, and Snohomish County staff will continue to monitor the project area for the next five years. Based on the success of this project, the county may seek more funding to implement more projects along the Snohomish River.

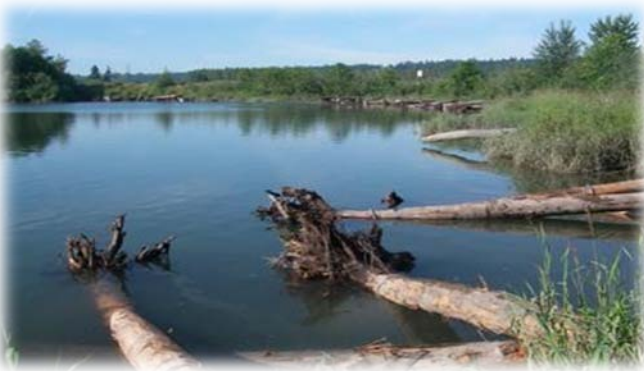
**Figure 4. Anchored logs in Snohomish River**
