White Salmon River Watershed Fecal Coliform Bacteria Attainment Monitoring Study

August 2011 Publication No. 11-03-046

Scott Collyard

Waterbody Number: WA-29-3010

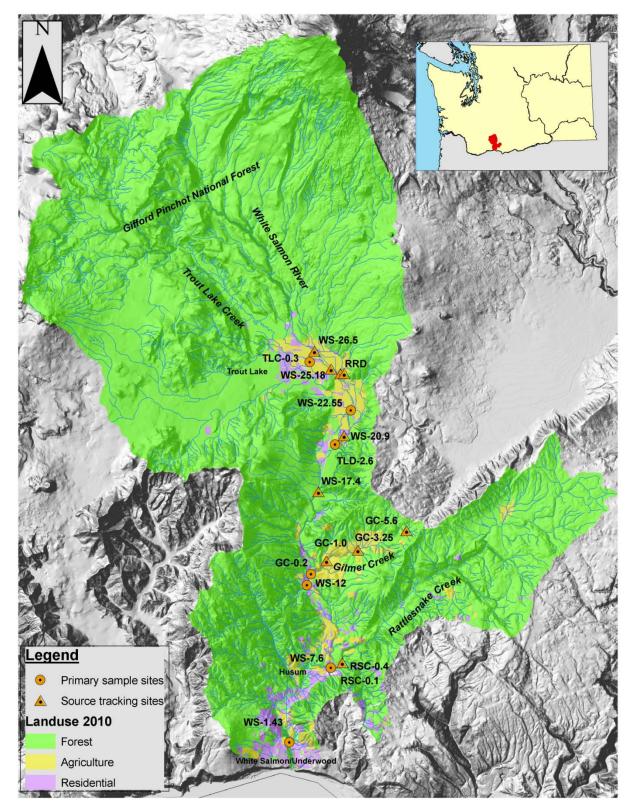
Figure 1. White Salmon River watershed, land uses, and sampling stations.

The major land uses within the watershed include forest (93%), agriculture (4%), and residential (3%) (Figure 1). The Gifford Pinchot National Forest makes up 78% of the forestlands within the watershed. Public and private timberlands make up the remainder (Ecology, 2010).

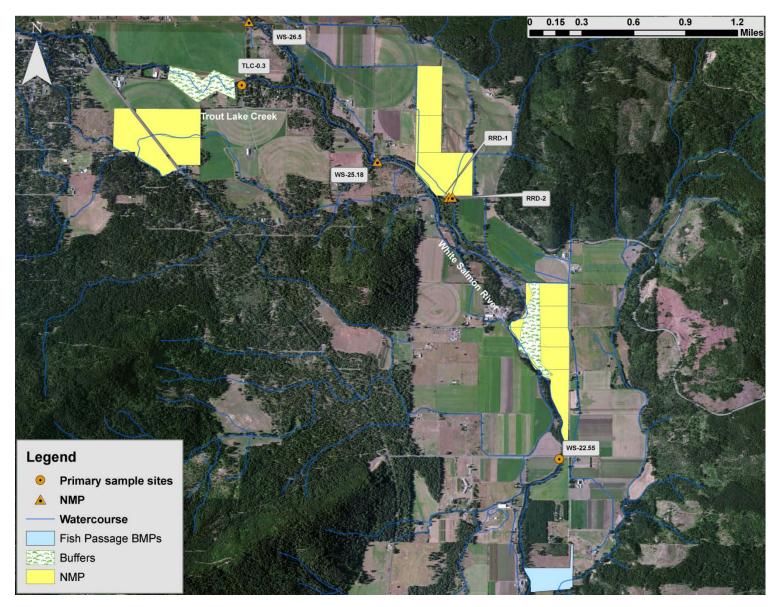
Figure 2. Approximate locations and type of best management practices implemented in the White Salmon River watershed. *NMP: Nutrient Management Plan.*

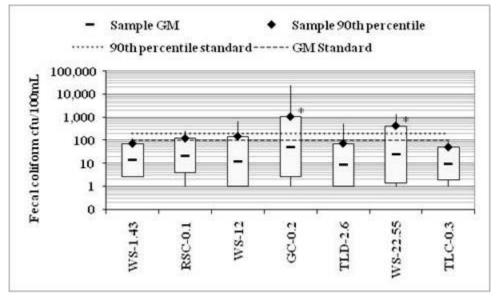
During the 2009-10 monitoring study, all primary sampling stations meet the yearly geometric mean water quality standard for FC (Figure 3). The yearly 90th percentile water quality standards were met at all stations with the exception of GC-0.2 and WS-22.55. Although Figure 3 suggests most stations are meeting yearly standards for FC, exceedances may be masked by averaging data over time. Because of this, water quality standards require, if sufficient data exist, the data to be averaged by season (Ecology, 2008).

Figure 3. Yearly FC geometric means and 90th percentiles, 2009-10. *Red indicates value is above water quality criteria.*

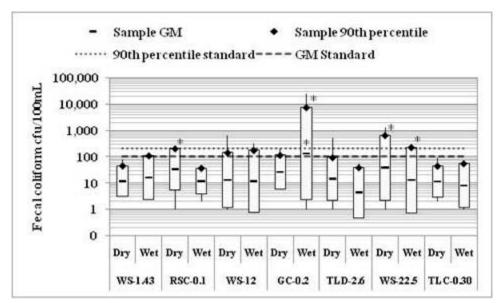
Wet-season and dry-season GM and 90th percentiles for sampling stations are presented in Figure 4. Partitioning FC data into wet and dry seasons resulted in the exceedance (not meeting) of the 90th percentile standard at RSC-0.1 during the dry season. Also, the GM and 90th percentile were not met during the wet season at GC-0.2 while no exceedances of either standard occurred during the dry season. Both wet and dry season FC 90th percentiles did not meet standards at WS-22.5 and suggest several sources or activities may be contributing to the yearly FC levels. No other exceedances of the water quality standard were observed (Figure 4). Differences between wet and dry season were mixed among stations and likely reflect differences in FC sources or source delivery to surface waters.

Figure 4. Critical season FC geometric means and 90th percentiles, 2009-10. *Red indicates value is not meeting water quality criteria.*

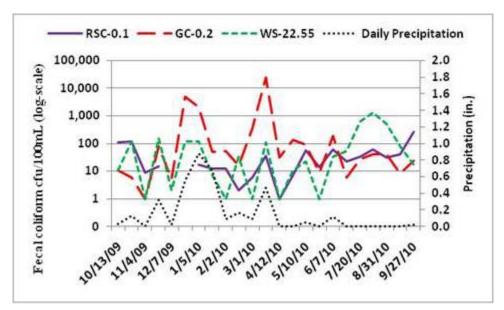
Overall, FC concentrations increased with increasing precipitation (Figure 5). There were, however, several high FC events occurring during the dry season that were not related to precipitation. Increases in FC levels in Rattlesnake Creek at station RSC-0.1, Gilmer Creek at GC-0.2, and the White Salmon at WS-22.5 from June to September 2010 were not related to precipitation events.

Figure 5. FC concentrations at selected sampling stations plotted against daily precipitation collected near the town of Trout Lake.

FC concentrations above water quality standards in Gilmer Creek GC-0.2 were first observed on 12/27/09. High FC levels continued periodically through the wet season and appeared to be correlated with precipitation events (see Figure 5).

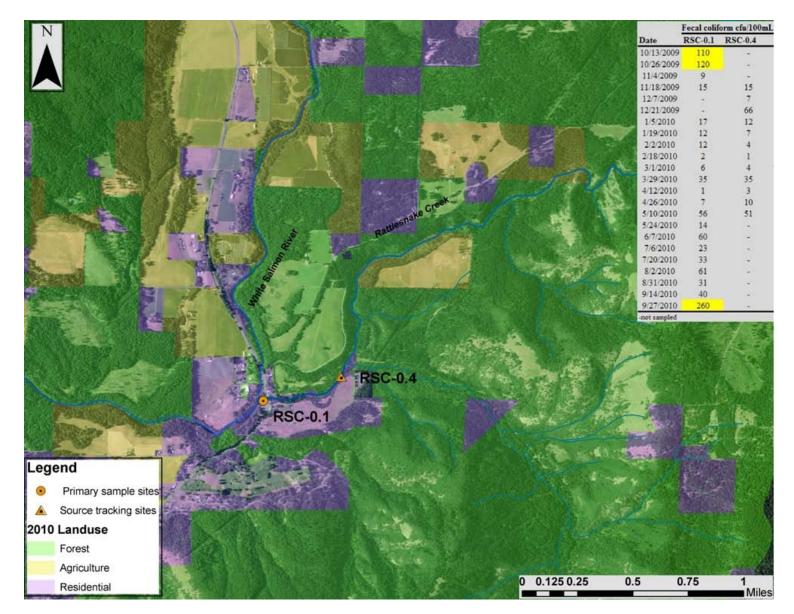
The first two FC samples collected on Rattlesnake Creek (RSC-0.1) were above (did not meet) the water quality standard of 100 cfu/100 mL (Figure 6). For purposes of identifying sources, an additional station was added on 11/18/09, 0.4 miles upstream of RSC-0.1. When no additional exceedances were observed after several weeks at either station, sampling was discontinued at RSC-0.4 (Figure 6). A third FC sample collected on 9/27/10 was above the FC water quality standard; however, this was the final sampling event for the study.

Land uses within the Rattlesnake Creek sub-watershed include forest (about 96% of area), residential (3%), and agriculture (1%) (Figure 2). The majority of residential activity is located in the lower river segment just above RSC-0.1 (Figure 6). Agricultural activities in this sub-watershed appear to be limited to hay and pasture lands that have little connectivity to surface water. Onsite sewage systems just above RSC-0.1 are one of the suspected sources of FC pollution, although other possible sources cannot be ruled out completely

Figure 6. Rattlesnake Creek sub-watershed sampling stations and land use.

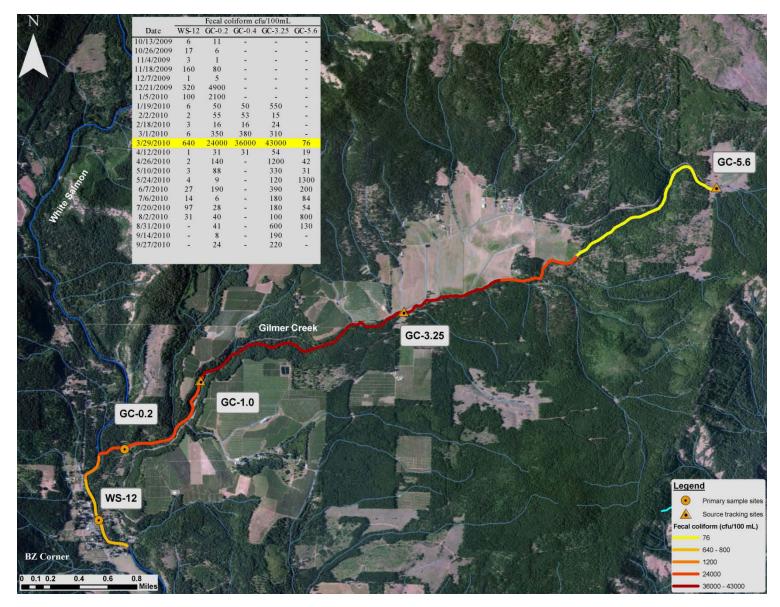
Figure 7 presents a sampling event that occurred on 3/29/10 on Gilmer Creek in which high FC levels were observed between RM 0.1 and 3.25. FC concentrations from Gilmer Creek appeared to be high enough to increase FC levels on the White Salmon River (WS-12), approximately 0.65 miles below the confluence with Gilmer Creek. The source of FC was determined to be originating from a livestock operation between RM 3.25 and 5.6.

Figure 7. 2009 orthophoto of Gilmer Creek, FC sampling stations, and results from the 3/19/10 sampling event. *FC results between sampling stations are an estimate based on results of upstream and downstream sampling stations.*

Following this event, Ecology nonpoint pollution staff worked with the Underwood Conservation District and the landowner of the livestock operation to identify sources. Recognizing the need to address surface water impacts from livestock operations, the landowner began implementing BMPs to remediate FC sources in the spring of 2010. This was done with the assistance from the Conservation District as well as Ecology grants. Details of this effort are presented in Appendix I.

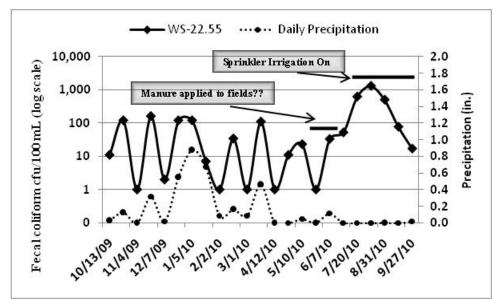
FC concentrations on the White Salmon River at RM 22.55 (station WS-22.55) were above the water quality standard of 100 cfu/100 mL eight times during this study. FC followed precipitation patterns closely between 10/13/09 and 4/12/10 (Figure 8). During this period, FC samples above the water quality standard ranged between 120 and 160 cfu/100 mL. Overall, FC levels ranged from 1 - 160 cfu/100 mL during this period.

Beginning on 7/20/10, FC levels at WS-22.55 began increasing steadily before peaking at 1300 cfu/100 mL on 8/2/10. After the peak, FC levels at this station gradually decreased to below water quality standards after four weeks (Figure 8).

Figure 8. Instantaneous FC results from the White Salmon River at river mile 22.55 (WS-22.55) and total daily precipitation.

The increase in FC between these sampling periods appears to correlate with two activities observed by Ecology field staff during this time period (Figure 8):

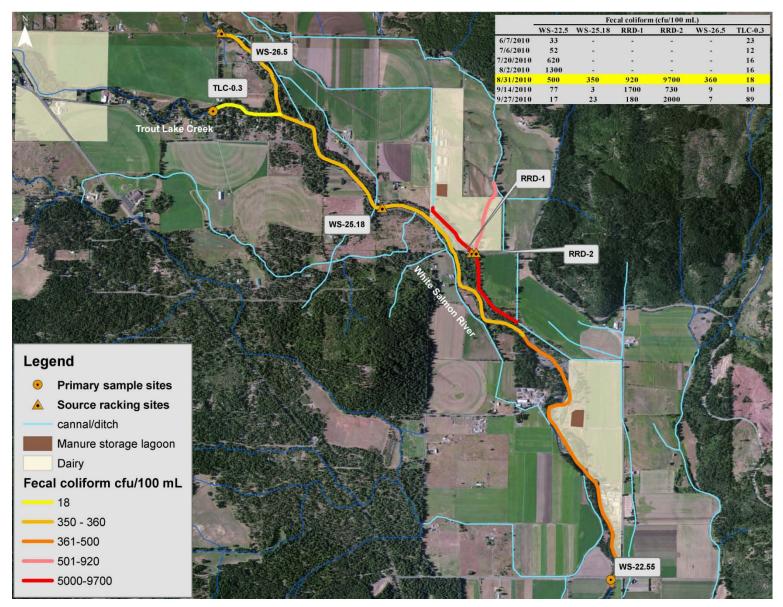
On 8/31/10, four additional sampling stations were added upstream of WS-22.55 (Figure 9). Two of these stations were located on the White Salmon mainstem at RMs 25.18 and 26.5. The other stations were located on two irrigation return ditches (RR-1, RR-2) which cross River Road, approximately three miles upstream from WS-22.55. FC samples were collected from these source tracking stations through the remainder of the study.

Figure 9. 2009 orthophoto of the White Salmon River, FC sampling stations, and monitoring results from the 8/31/10 sampling event. *FC results between sampling stations are estimates based on FC results from sampling stations.*

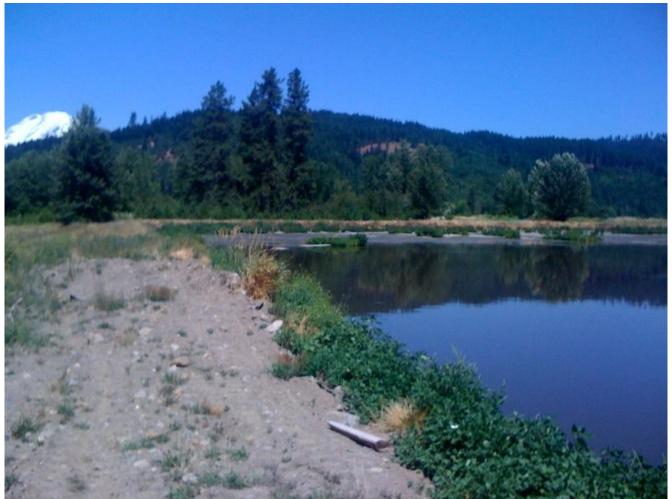
- The manure lagoon appeared to be in good condition. Sergio noted that there was no evidence of breaching or leakage. It was placed in an elevated site, 35-40' rise from stream edge to lagoon (Figure 1). The floodplain in this area is expansive and contains the entire farm and Trout Lake valley bottom.

Figure 1. Facing north overlooking the manure lagoon. The stream would be about 100' or more to the left. The CREP buffer is directly ahead as it juts out after narrowing between the stream and the lagoon. The lagoon is slightly elevated compared to the rest of the farm topography.

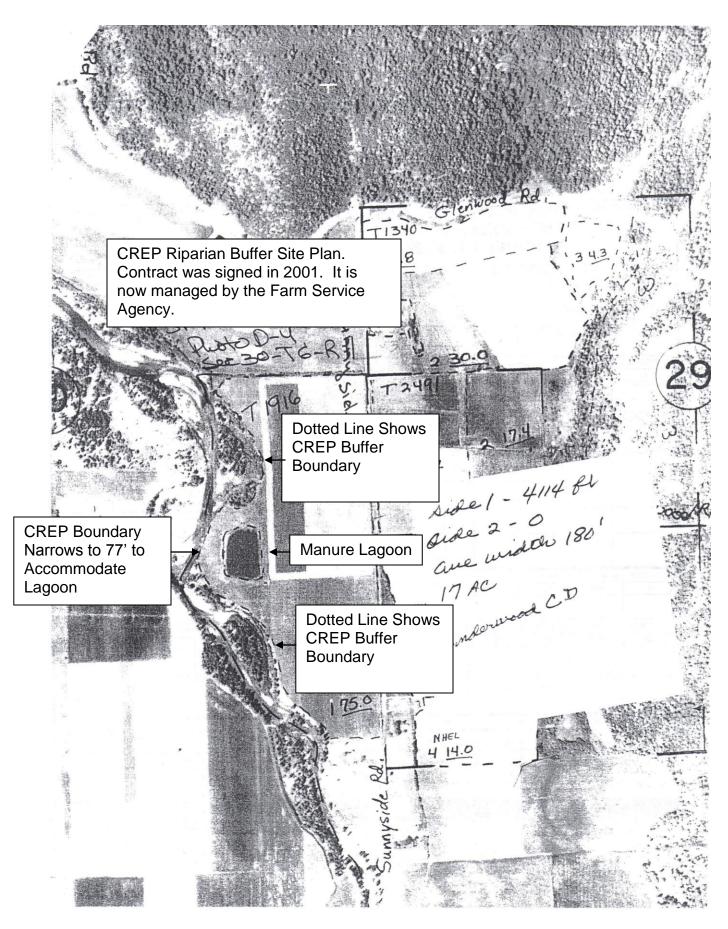
Figure 2. The CREP site plan which shows that the buffer did not include the lagoon.

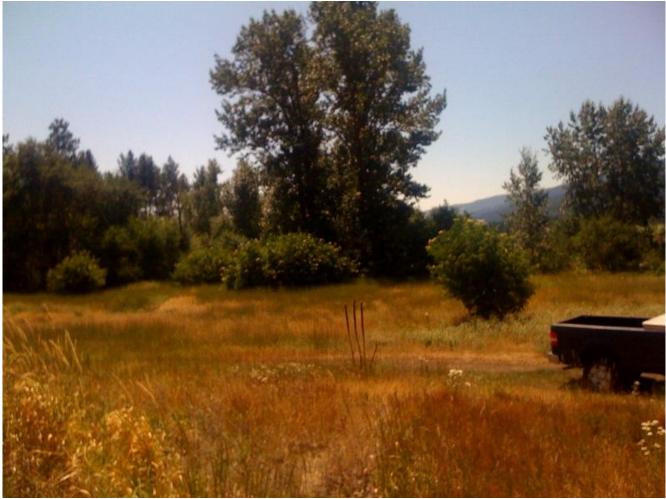
- In general, the CREP buffer is of variable quality. There is a band of mature existing trees, mostly cottonwood, along much of the stream length, but this pre-existing band of trees varies in width from 0-200'. The CREP buffer was planted outside of the existing riparian vegetation with the intention to increase buffer width and increase the conifer component. Downstream of the lagoon, the pre-existing buffer is wide (up to 400') and the buffer condition appeared be to be good. Although we did not walk this section, we could look down and see it, and I can measure the buffer through aerial photos. The CREP plantings just southwest of the manure lagoon had poor survival (Figure 3). This area was also the site of construction for the Ecology-funded stream restoration. Some of the low survival might be due to that activity. Just west of the lagoon and further upstream, the buffer condition ranged from good to fair (Figure 4). In this area, there is a mix of ponderosa pine, elderberry, spirea, snowberry, and hawthorn in addition to the pre-existing mature trees that are mostly cottonwood. Survival of the CREP plants was adequate with good growth in one section and more limited growth in another, likely due to wildlife browse judging from the droppings. There is no evidence of livestock presence in the CREP buffer.

Figure 3. This shows part of the CREP buffer that has poorer plant survival with barren areas along the outer edge. The buffer extends from the stream to the access road and ranges from 77'-102' in this area. To increase functionality, conifers and denser plantings are needed. The lagoon lies behind the photographer and is not in the CREP buffer.

- The CREP buffer is not in good shape in one small area southwest of the lagoon. However, this stream does not provide salmon habitat, and this CREP buffer should not have been approved, as it is ineligible if no salmon are in the reach. Given the need to prioritize our limited CREP funds at this time, we cannot recommend spending funds to improve the buffer in this one section. However, the landowner has been voluntarily planting ponderosa pine within the buffer at his own expense, and district staff thought he might be willing to restore this section himself.

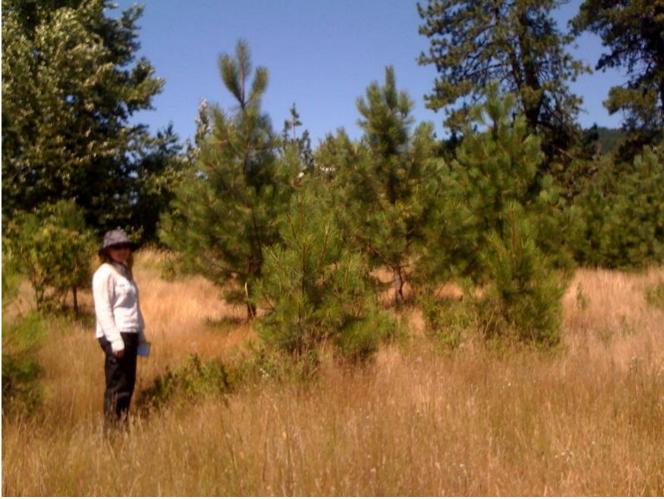
Figure 4. The CREP buffer just west of the lagoon and upstream of the lagoon is in better condition with improved plant density, conifer component, and adequate growth.

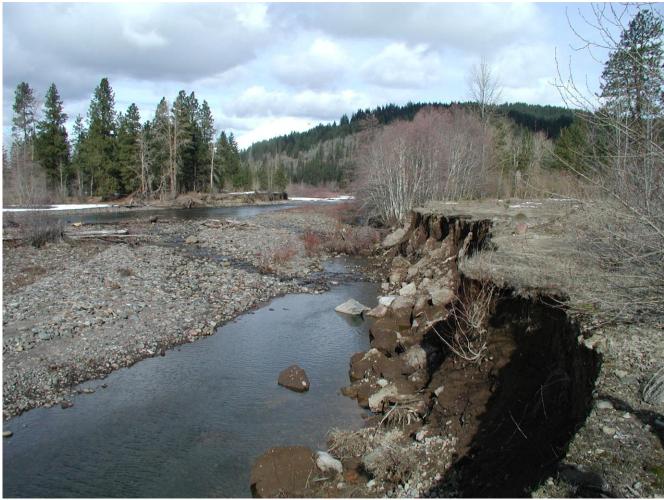
Figure 5. This is a "before" picture of the DOE project in 2006.

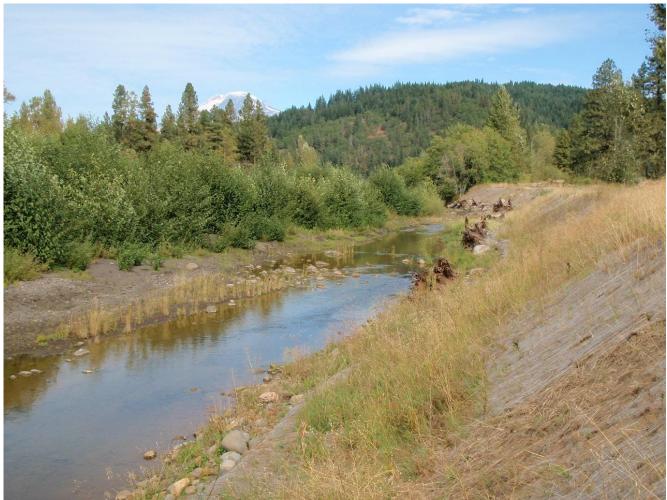
Figure 6. This is the same area shown in Figure 5, but two years after the restoration project (photo taken in 2009).

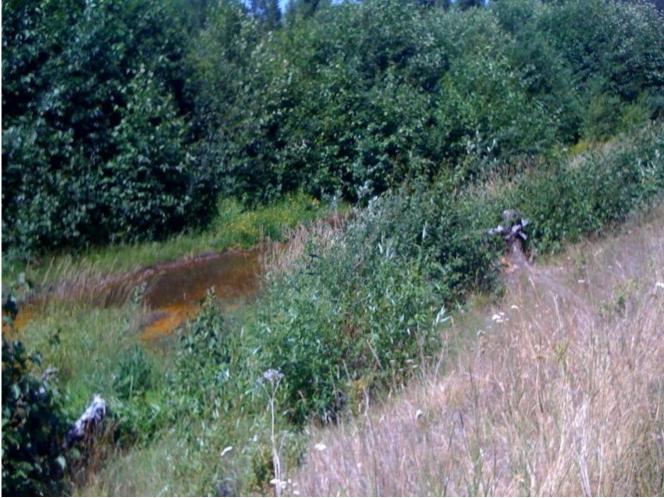
Figure 7. This is the same area shown in Figures 5 and 6, but reflects current, 2011, conditions. This side channel has successful willow establishment, pulled back vegetated banks, and instream wood components.

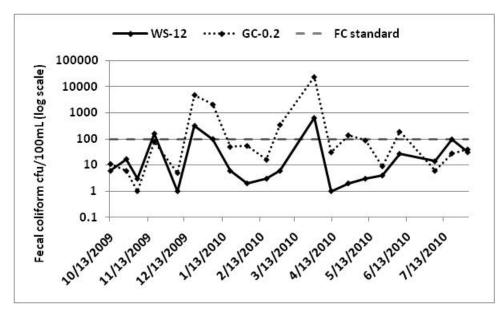
Figure H-1. Instantaneous FC results from the White Salmon River below the confluence with Gilmer Creek (WS-12) and Gilmer Creek at GC-0.2.

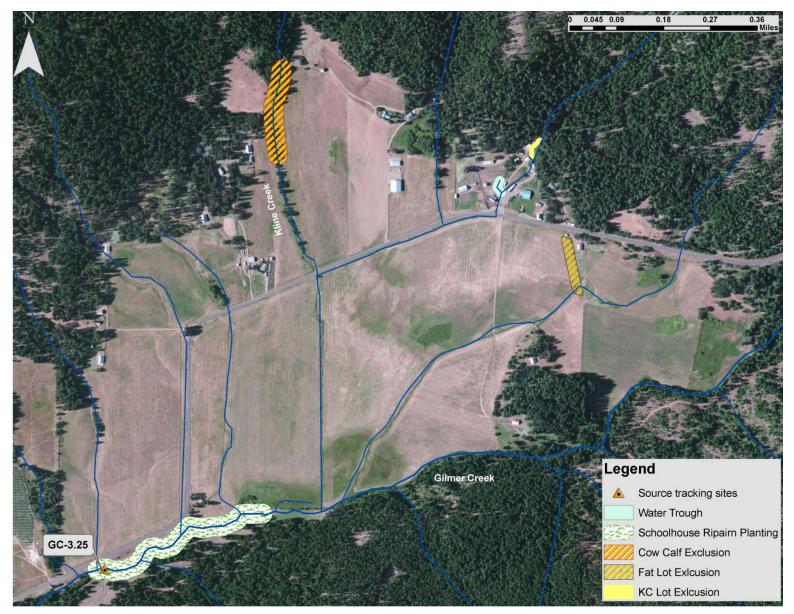
Figure I-1. BMPs installed on livestock operations within the Gilmer Creek sub-watershed in 2010-11.

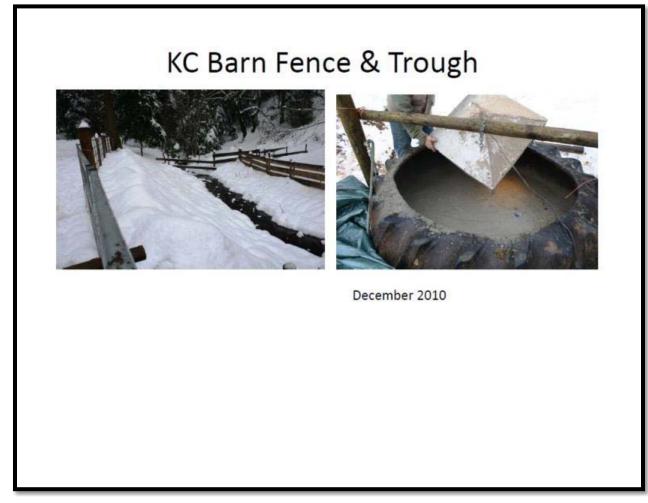
Figure I-2. KC Barn fence and off-channel water trough photos.

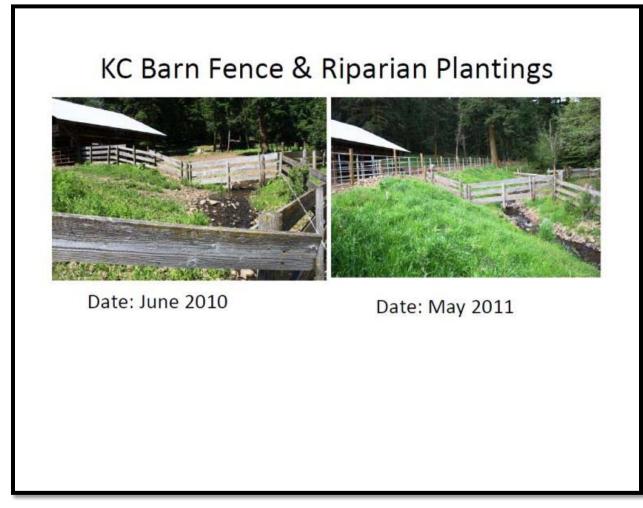
Figure I-4. Before and after photos: KC Barn fence and riparian planting.

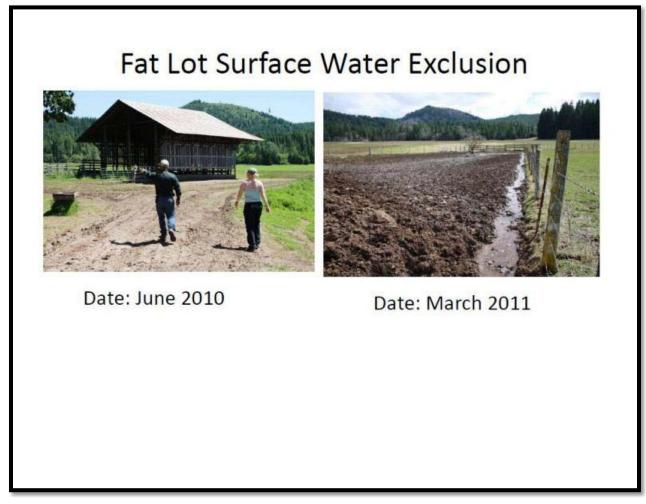
Figure I-5. Before photos: Fat Lot surface water exclusion fencing and seeding.

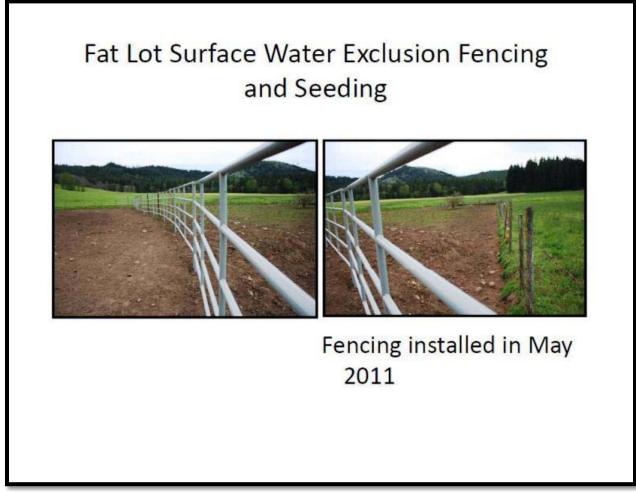
Figure I-6. After photos: Fat Lot surface water exclusion fencing and seeding.

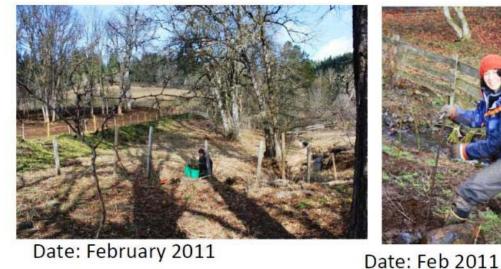
Description: Native willow cuttings and native bareroot riparian plants were installed in later winter 2011

Figure I-7. Before photos: Cow/Calf Barn fencing and riparian planting.

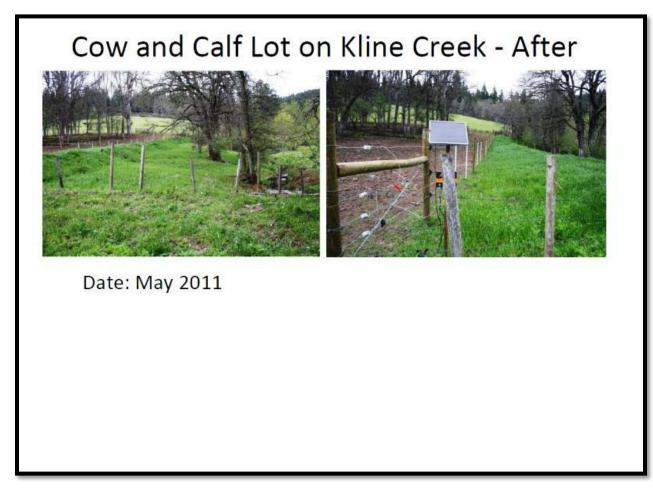
Figure I-8. After photos: Cow/Calf Barn fencing and riparian planting.

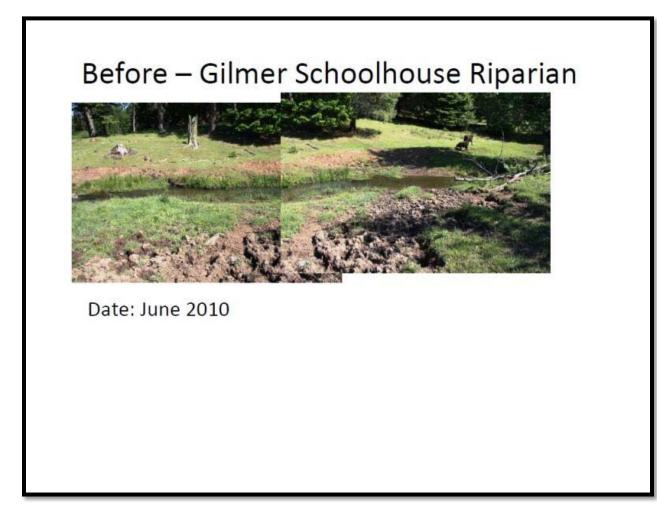
Figure I-9. Before photos: Schoolhouse lot riparian planting.

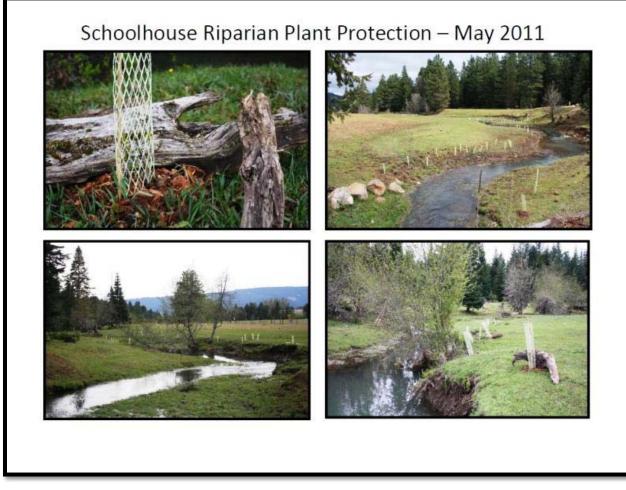
Figure I-11. After photos: Schoolhouse lot riparian planting.
