**American Plating
Post-Interim-Action
Groundwater Monitoring Results**

May and September, 2011

February 2012

Publication No. 12-03-015

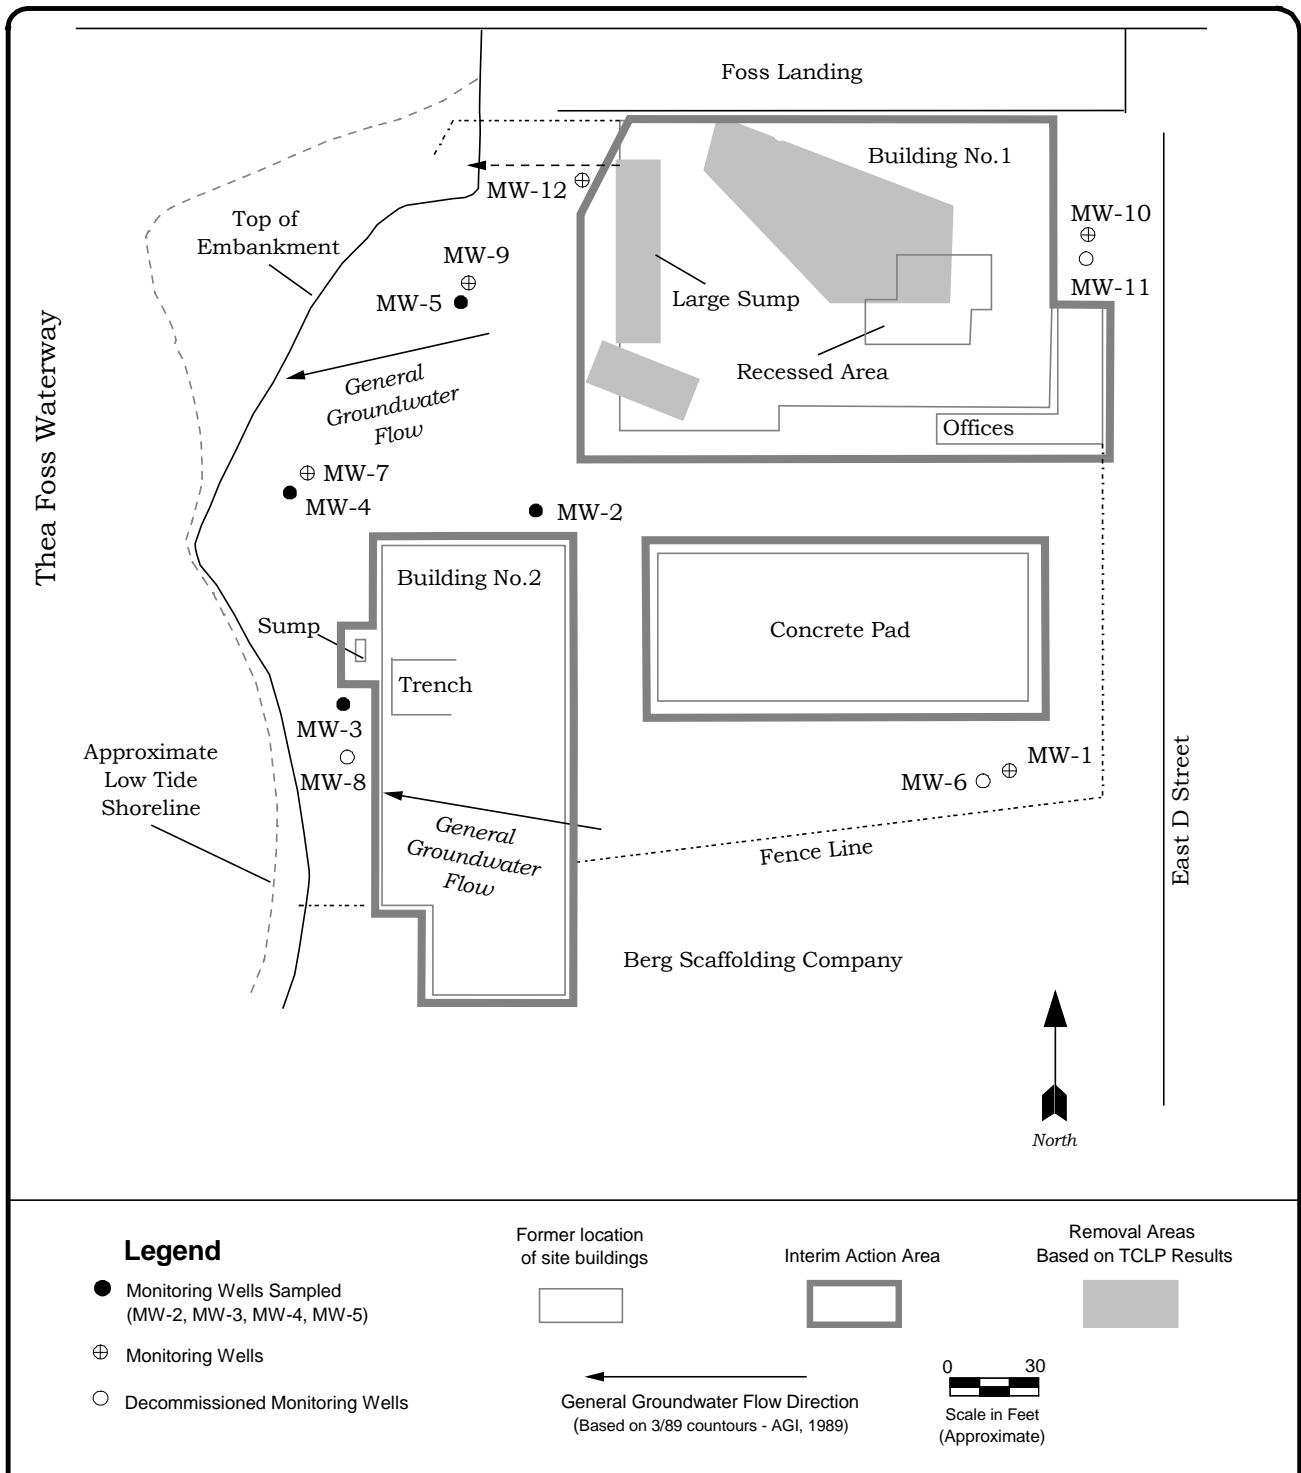
Figure 2. American Plating Sampling Site Locations.

Ecology collected groundwater samples from four monitoring wells in May and September 2011 (Figure 2). Ecology samples taken since 2004 have been limited to wells screened in the upper unconfined aquifer. Several of the sites deep monitoring wells were decommissioned in 2003 because concentrations of the contaminants of concern were low or non-detect and there was concern that the wells continued presence could provide potential connections between the two aquifers.

The four wells sampled (MW-2, MW-3, MW-4, and MW-5) were completed in the upper fill/marsh deposits aquifer at depths of about 14.5 to 17 feet. The wells have 5-foot screened intervals at their base.

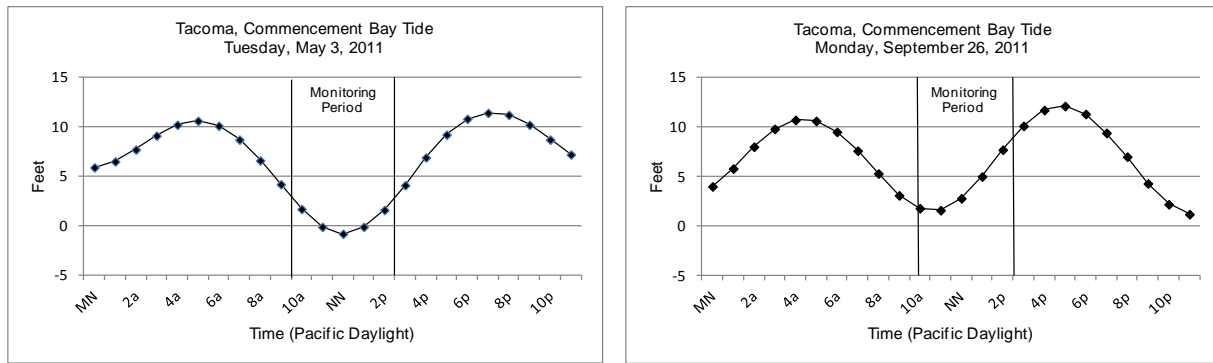
Figure 3. Tide Phase for May 3 and September 26, 2011.

Figure 3 shows the tidal phase when water levels were measured and samples were collected. The May monitoring occurred during a low tide and the September monitoring occurred during a rising tide. Samples collected at or near low tide are assumed to be more representative of groundwater conditions flowing toward the waterway. Depth-to-groundwater ranged from 3.51 to 6.46 feet below the measuring points in May, and 3.07 to 7.69 feet in September. Groundwater elevations ranged from about 9 to 12 feet above mean sea level during the two sample rounds.

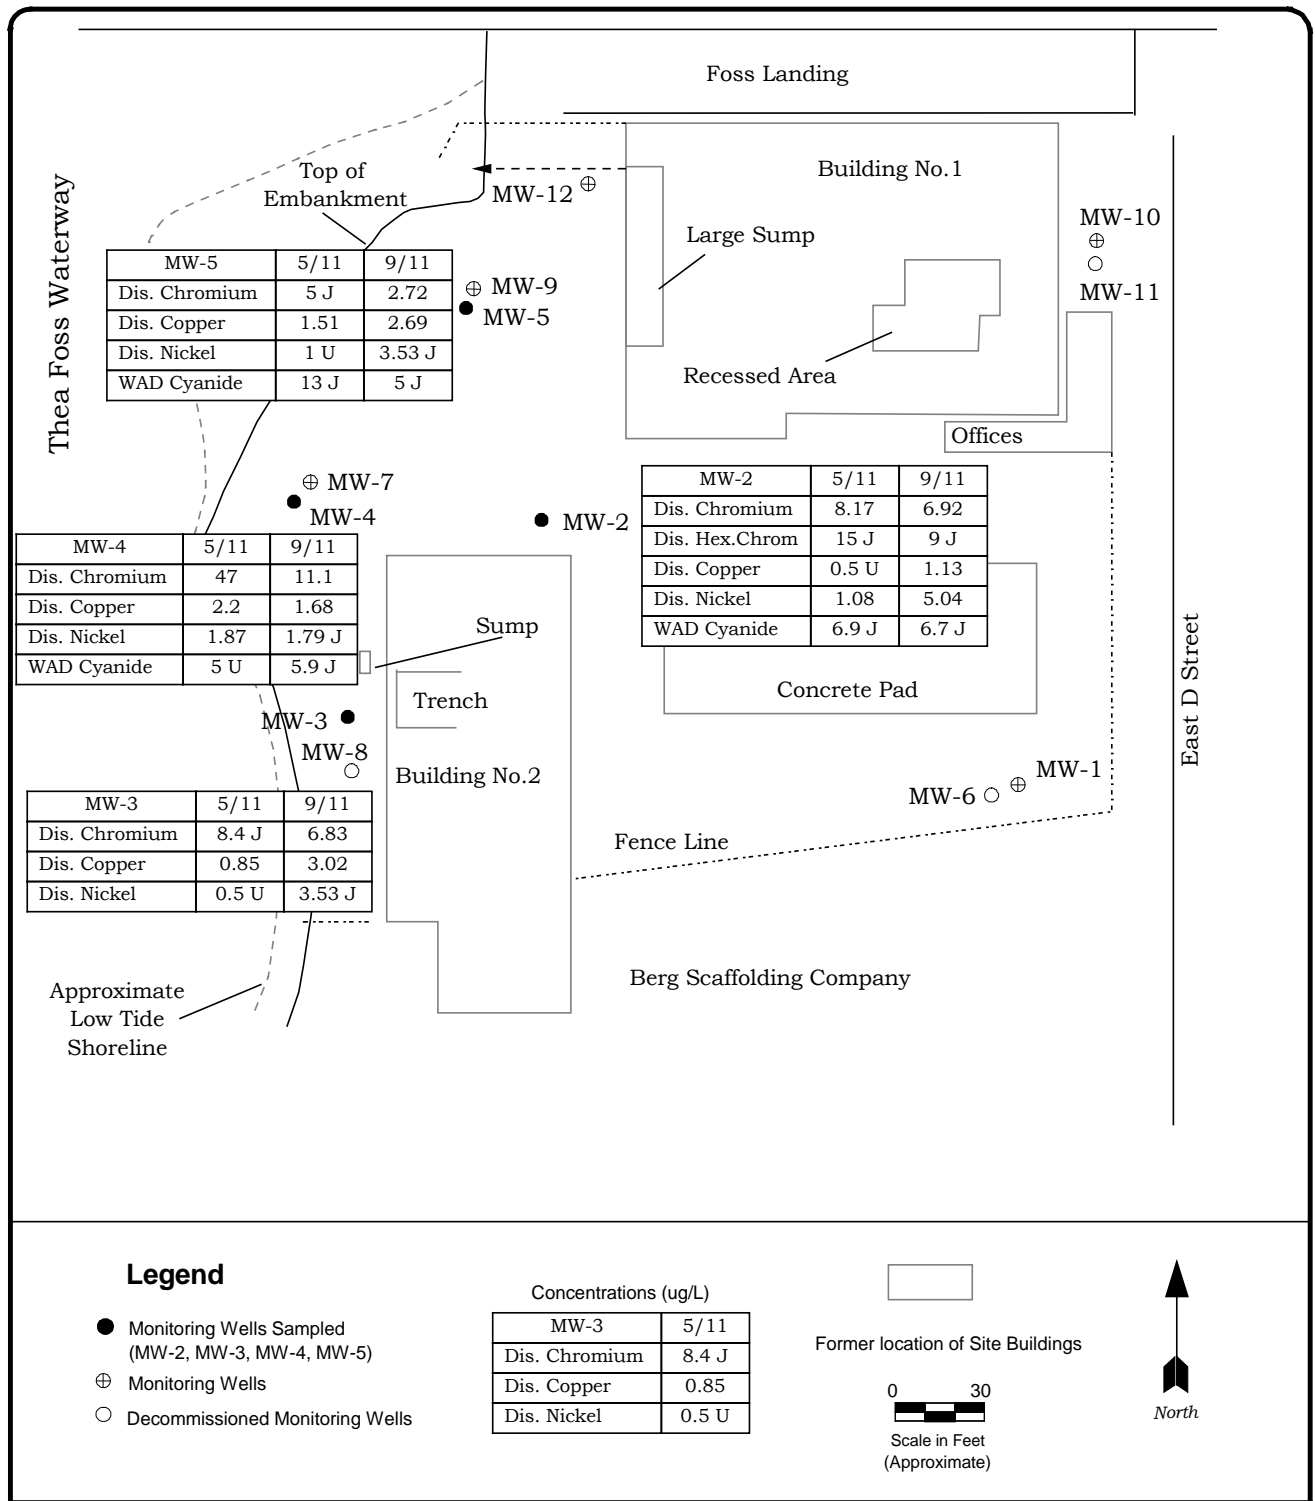
Figure 4. American Plating Summary of Analytical Results (ug/L).

Analytical results for dissolved metals and WAD cyanide are summarized in Table 4 and presented in Figure 4. A summary of historical data for this project is presented in tables and graphs in Appendix A.

Dissolved chromium, copper, and nickel were detected at low concentrations in the groundwater samples.

Dissolved hexavalent chromium was detected in samples from well MW-2 at an estimated concentration range of 9 to 15 ug/L. Hexavalent chromium was detected in this well in 2010 at similar concentrations.

WAD cyanide was detected in wells MW-2, MW-4, and MW-5 near the reporting limit of 5 ug/L. Samples from wells MW-3 and MW-4 tested positive for sulfide during both sample rounds. The presence of sulfide can interfere with cyanide analysis and bias the results low. As in the past the May and September cyanide samples were preserved with sodium hydroxide to a pH of 12. Cyanide converts to thiocyanate in the presence of sulfide and high pH. Therefore, the results for samples from wells MW-3 and MW-4 may be under reported due to sulfide interference and therefore have been qualified as estimates.

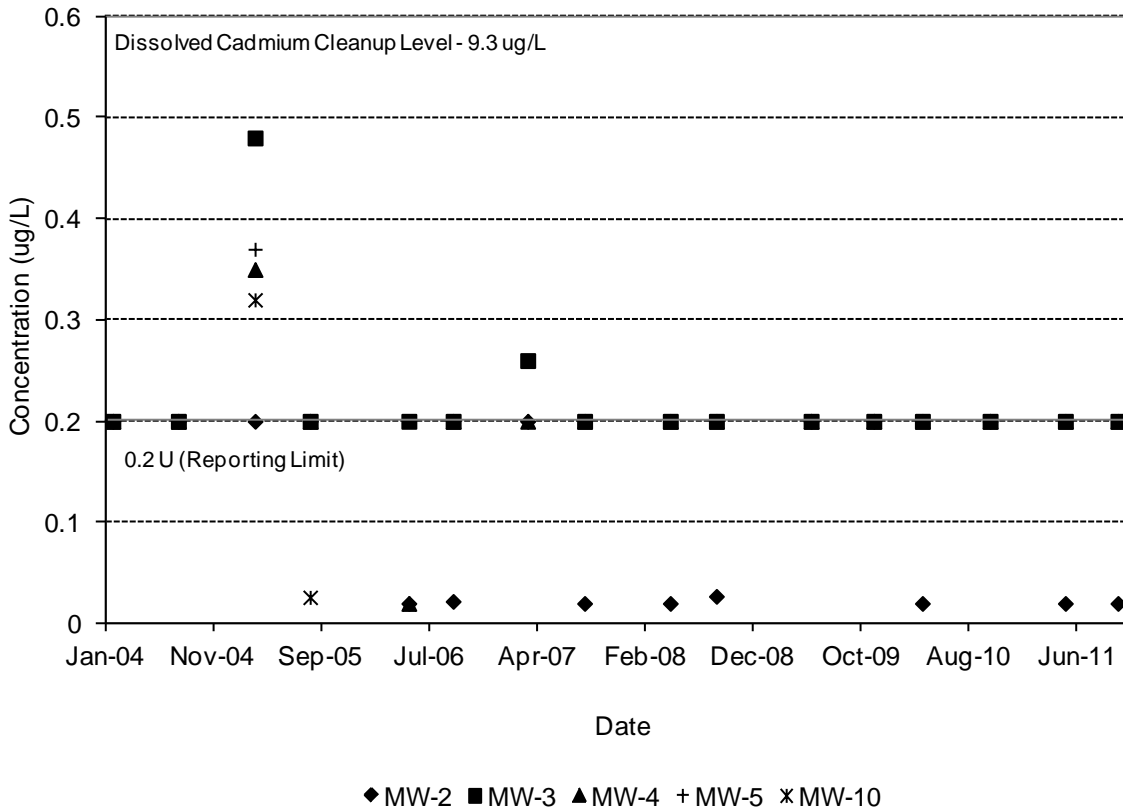
Figure A-1. Dissolved Cadmium Results (ug/L) from February 2004 to September 2011.

A summary of historical data for this project is presented in tables and graphs in Appendix A.

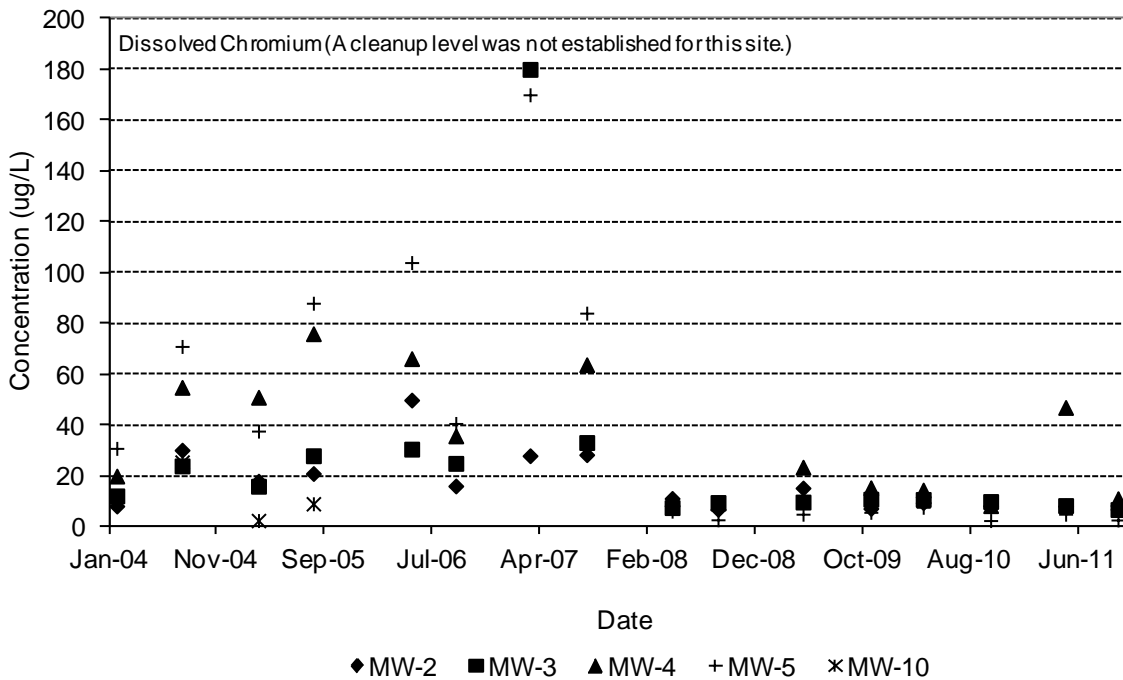
Figure A-2. Dissolved Chromium Results (ug/L) from February 2004 to September 2011.
NOTE: April 2007 MW-4 value of 750 ug/L is not plotted.

In 2004, dissolved chromium concentrations in wells MW-4 and MW-5 exceeded Washington State surface water quality standard for protection of aquatic organisms in marine waters for acute exposure to hexavalent chromium of 50 ug/L (WAC 173-201A). Since it was not possible to determine which form of chromium (trivalent or hexavalent) was present, samples have been collected and analyzed for hexavalent chromium since August 2005. Dissolved hexavalent

chromium was first detected in May 2008. It has been detected sporadically since then, primarily in well MW-2. Dissolved hexavalent chromium was detected in the 2011 samples from well MW-2 at an estimated concentration range of 9 to 15 ug/L, which is below the state surface water quality standard.

Before removal of the metals-contaminated concrete rubble pile, dissolved chromium concentrations in samples collected between February 2004 and April 2007 from wells MW-2, MW-3, MW-4, and MW-5 had an average range of 25 to 150 ug/L. Since removal of the rubble pile in June 2007, concentrations have decreased significantly, as seen in Figure A2 in the Appendix. Average concentrations from September 2007 to September 2011 ranged from 11 to 23 ug/L.

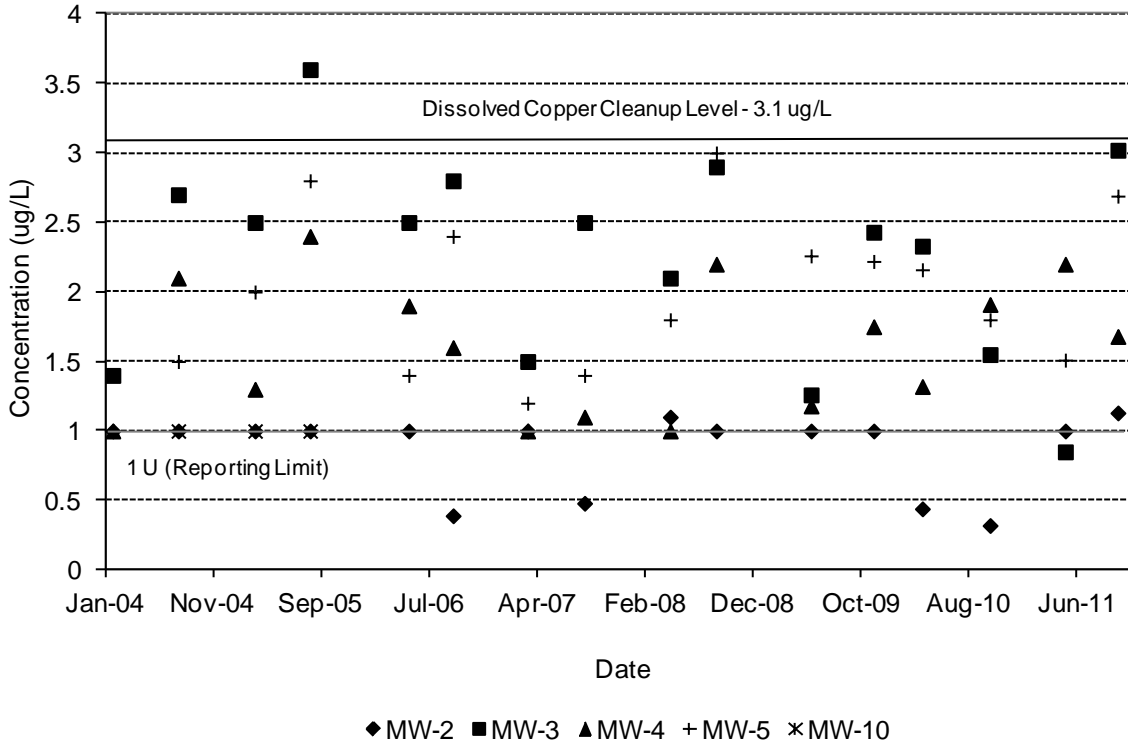
Figure A-3. Dissolved Copper Results (ug/L) from February 2004 to September 2011.

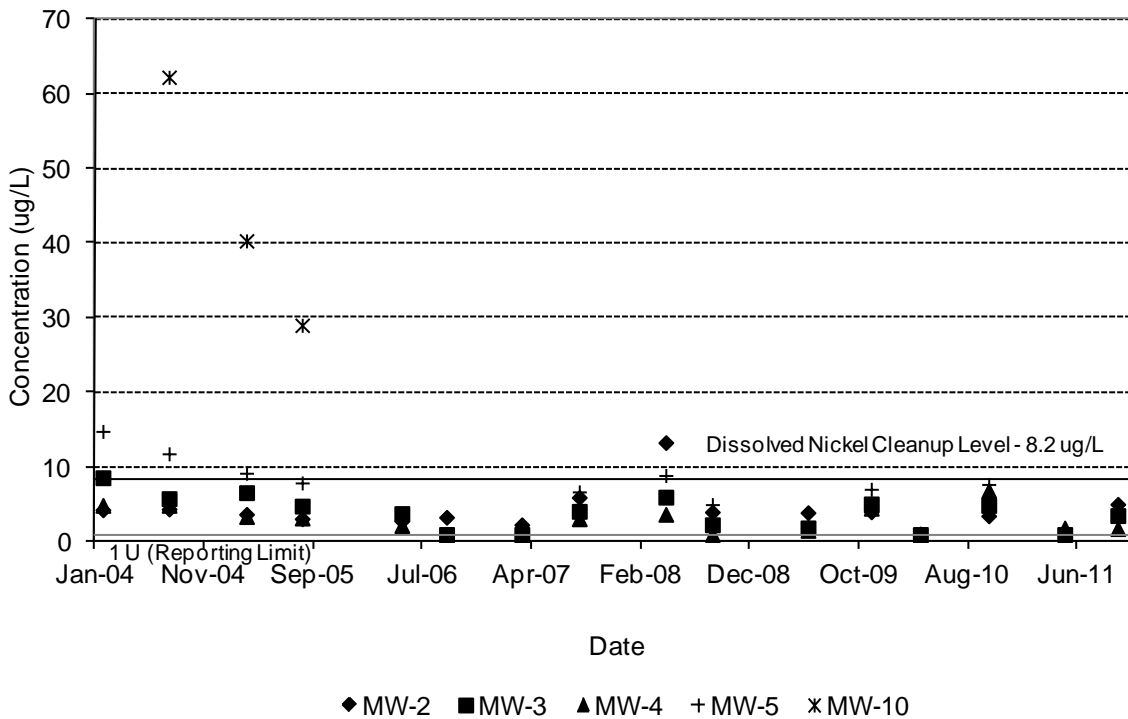
Figure A-4. Dissolved Nickel Results (ug/L) from February 2004 to September 2011.

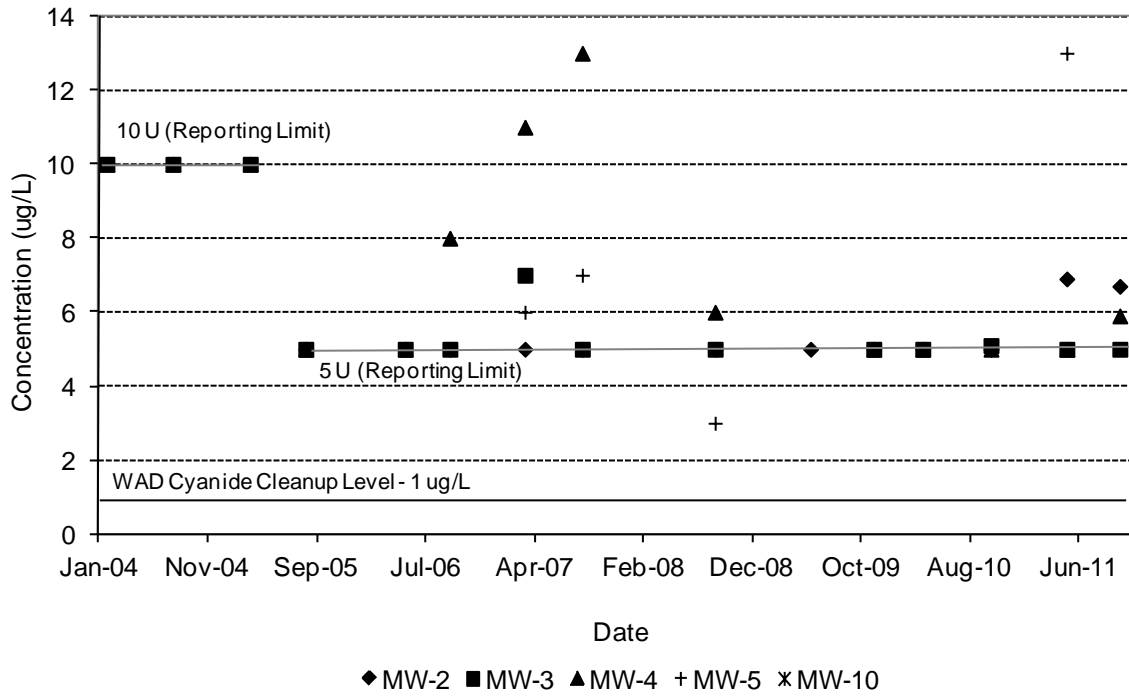
Figure A-5. WAD Cyanide Results (ug/L) from February 2004 to September 2011.

Sampling for WAD cyanide began in 2004; the parameter was detected in well MW-4 from 2006 to 2008 and well MW-5 in 2007 and 2008. It was not detected in these wells in 2009 or 2010. WAD cyanide was detected in wells MW-2, MW-4, and MW-5 in 2011 at concentrations above the reporting limit of 5 ug/L and the cleanup level of 1 ug/L established for this site (Figure A-5). Sulfide has been consistently detected in wells MW-3 and MW-4 and, to a lesser extent, well MW-5. The presence of sulfide in samples collected from wells MW-3 and MW-4 may interfere with the cyanide analysis and bias the results low. Total cyanide was detected in wells MW-2, MW-3, MW-4, and MW-10 in samples collected from 1988 to 1994 as shown in Appendix A.
