Eyes Over Puget Sound

Surface Conditions Report February 27, 2012

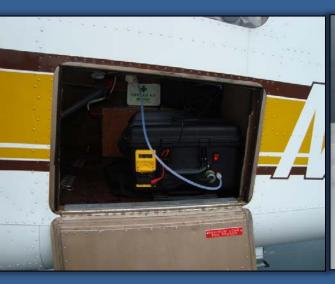
Donovan (Air Quality Program, Ecology) and Joe (pilot, Kenmore Air) getting the ozone analyzer set up

Instruments and intake tubing

Intake tubing for analyzer

GPS receiver

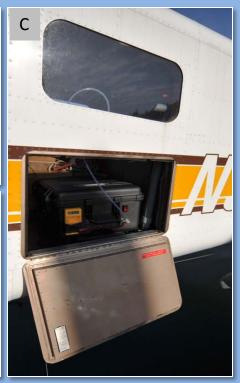
Donovan assembles the portable ozone analyzer (A) and installs GPS (B) and tubes for the air intake (C) on board the float plane.

The instrument is turned on and continuously records ozone concentrations, position, and altitude during the routine marine flight. This saves resources and time.

Donovan has rigged up a special box to hold the ozone sensor, a fan, a battery pack and a GPS unit. A GPS receiver is strung through to the front window of the plane and tubing which connects to the analyzer is threaded out of the cabin vent to "sniff" and gather data. We are in the testing phase right now. We want to be ready to collect quality data this summer when ozone plumes can be found in our more urban areas. Collaborations like this provide more data for the public and managers without additional costs. It also makes our time in the plane even more valuable and expands the contextual envelope for our own data.

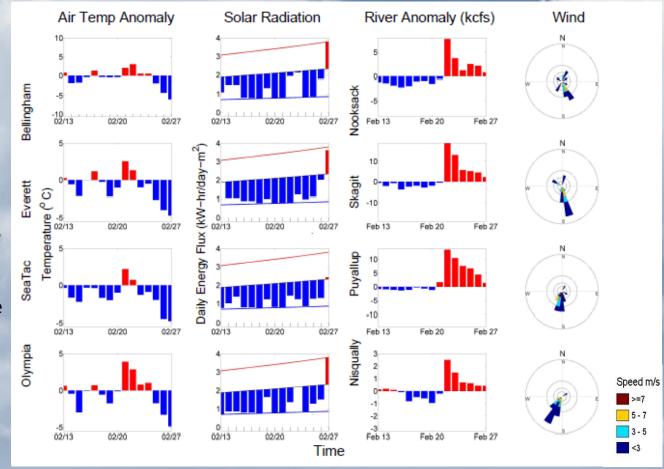
Weather of the last two weeks of Feb., 2012

Air temperatures during the past few days have been increasingly colder than expected. This follows a weak warm spell a week ago.

Sunshine has been very low except on the day of the marine flight.

Rivers have been running above normal for the past week.

Winds have been predominantly from the SE in the north, to the SW in the south.

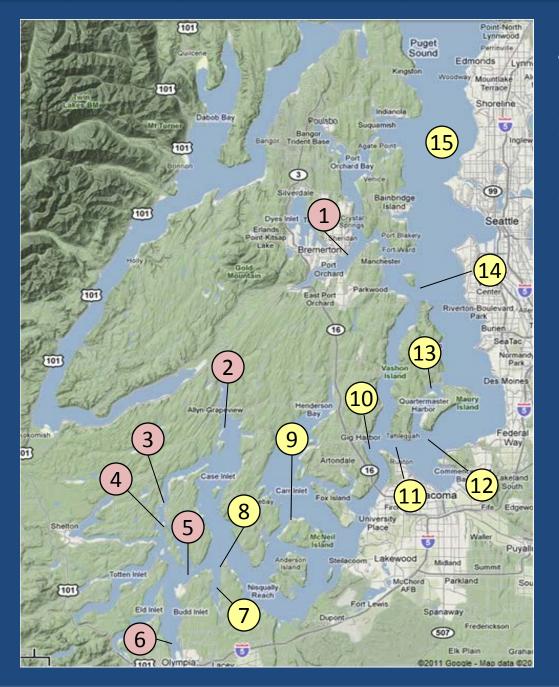
Aerial photography image guide 2-27-2012

Visible blooms: 6 7
South Budd Inlet and Henderson Inlet

Debris 1 2 3 4 7 8 11
South Sound: West of Harstine Island, Dana Passage
Central Basin: Off Shilshole Bay

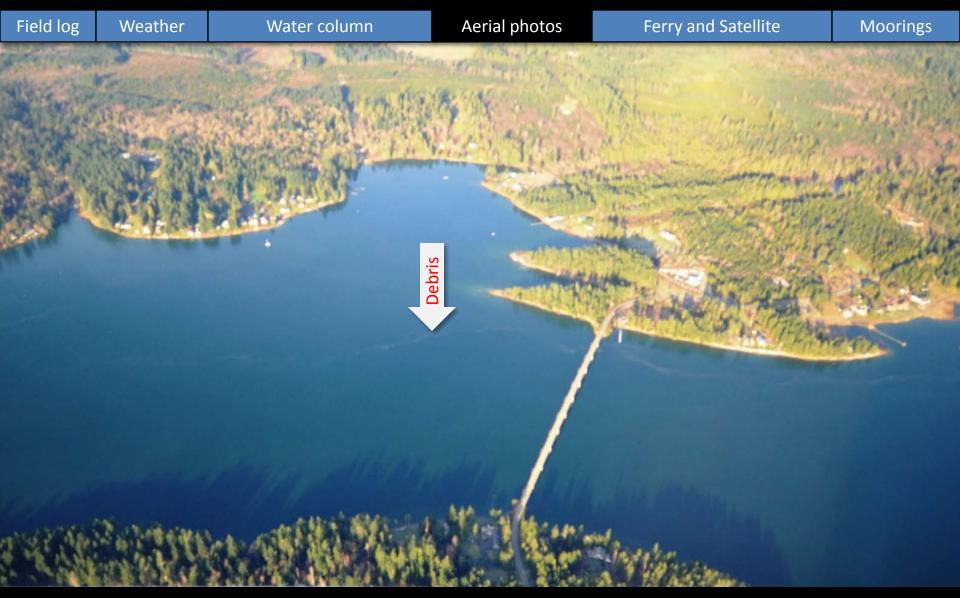
Front, debris line and plume. Location: Harstine Island, Case Inlet 8:31 AM

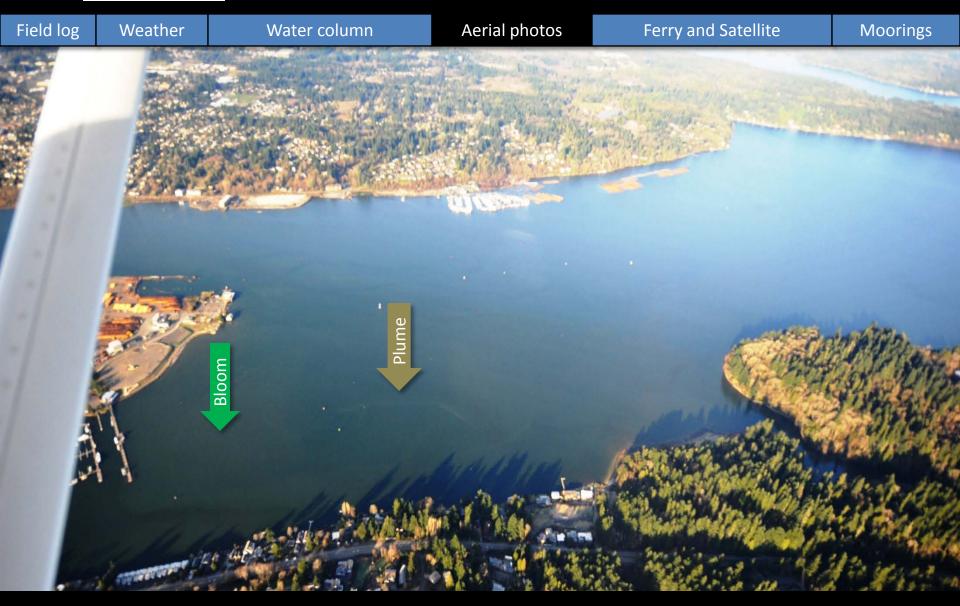
Beginning bloom. Location: Near Swantown Marina, Budd Inlet (South Sound), 8:46 AM

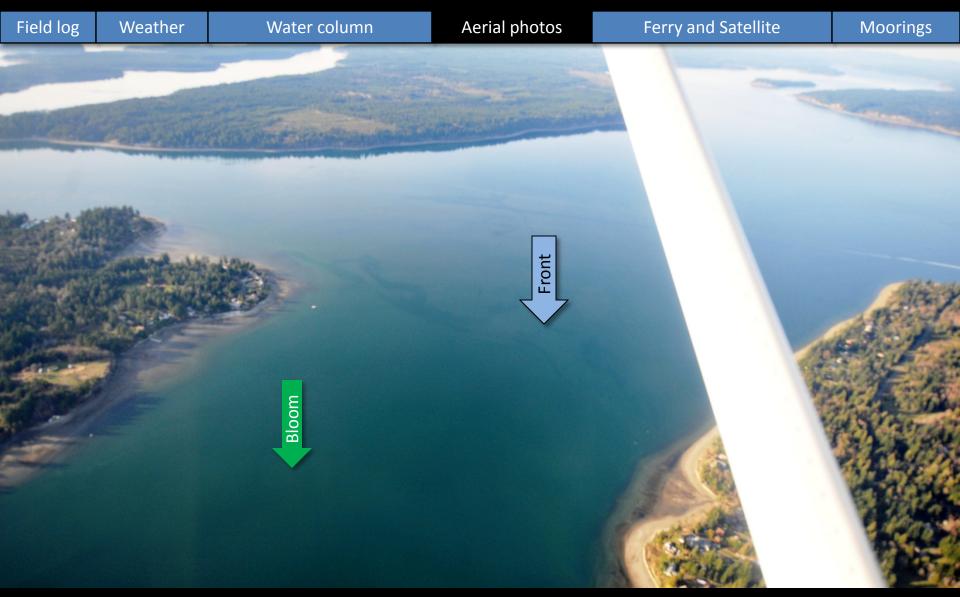
Algal bloom and weak front. Location: Henderson Inlet (South Sound), 4:15 PM

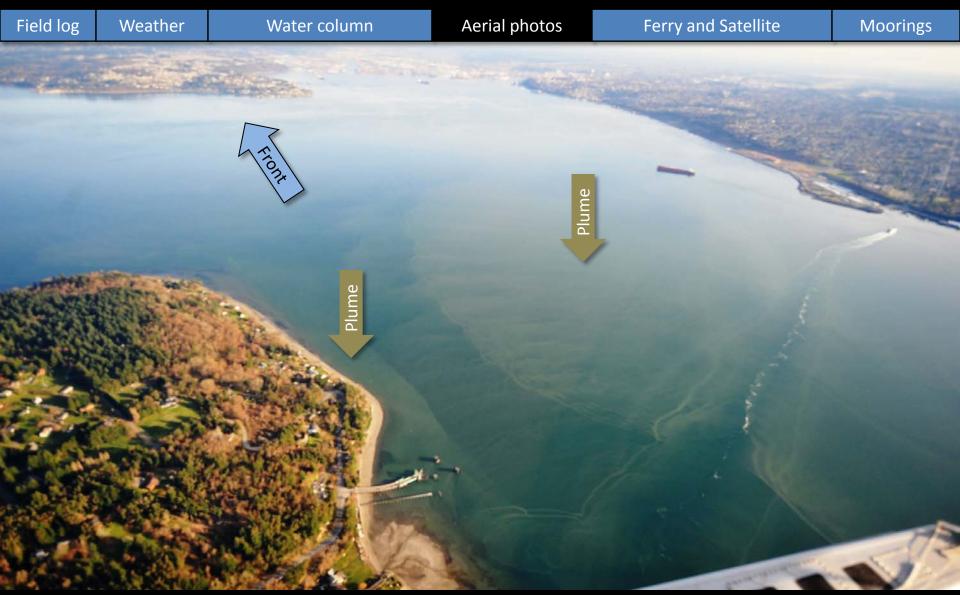
River plume west of Tacoma. Location: Vashon Island (Central Sound), 4:22 PM

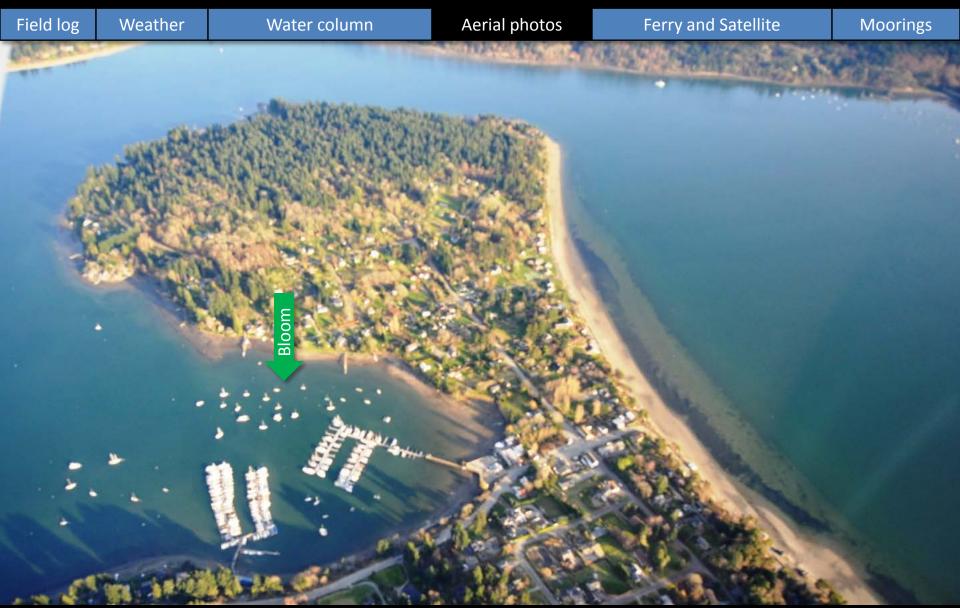
Front and river plume. Location: Entrance to Quartermaster Harbor, Vashon Island (Central Sound), 4:23 PM

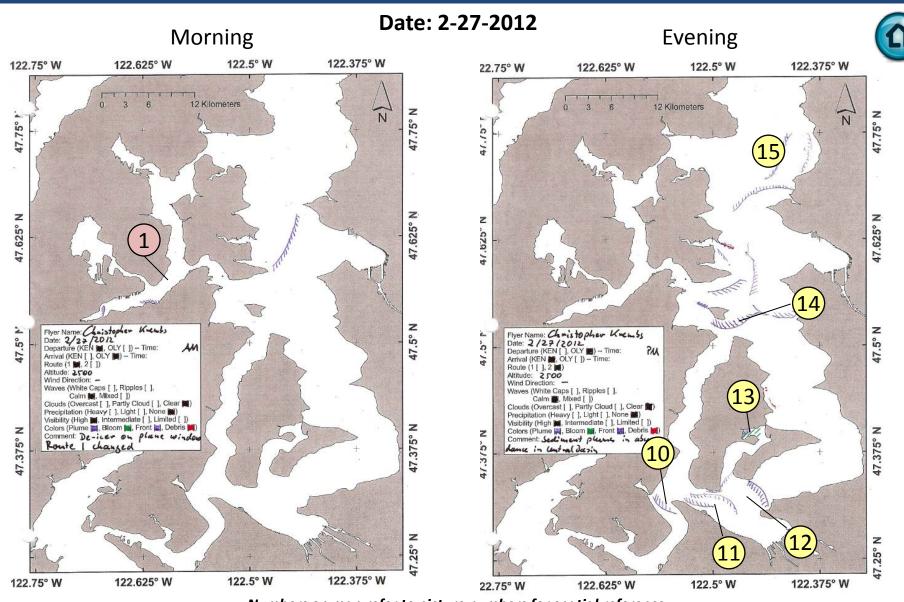
Aerial photography observations in Central Sound

Numbers on map refer to picture numbers for spatial reference

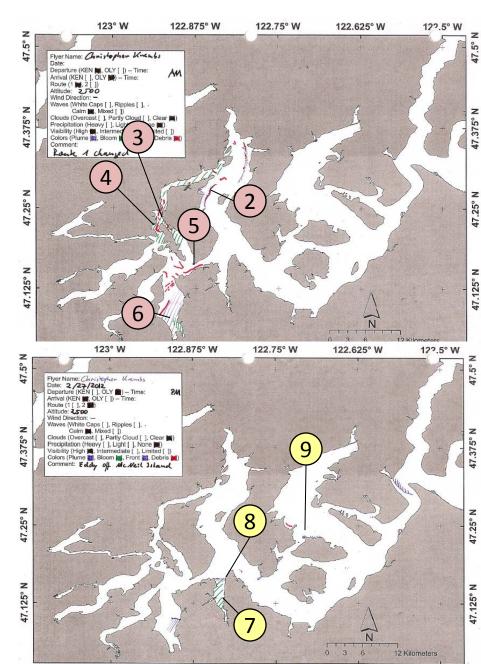
Observations in South Sound: 2-27-2012

Numbers on map refer to picture numbers for spatial reference

Maps are produced by observers during and after flights. They are intended to give an approximate reconstruction of the surface conditions on scales that connect to and overlap with satellite images in the section that follows.

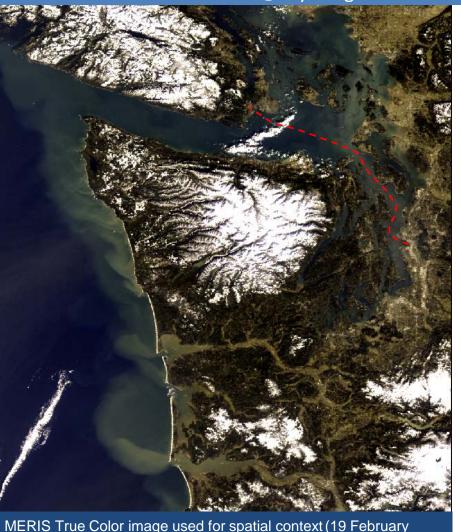
Daily ferry and satellite observations in Central Sound, 2-27-2012

Sea surface temperature (SST) is the water temperature close to the surface (2-3 m below). Warm colors show higher SST.

Measurements of Colored Dissolved Organic Matter (CDOM) fluorescence can be high in rivers and stormwater. Warm colors are often associated with river

Localized areas of high colored dissolved organic material (associated with higher river flows); surface temperatures are 7-8 °C throughout Central Sound and the Strait of Juan de Fuca.

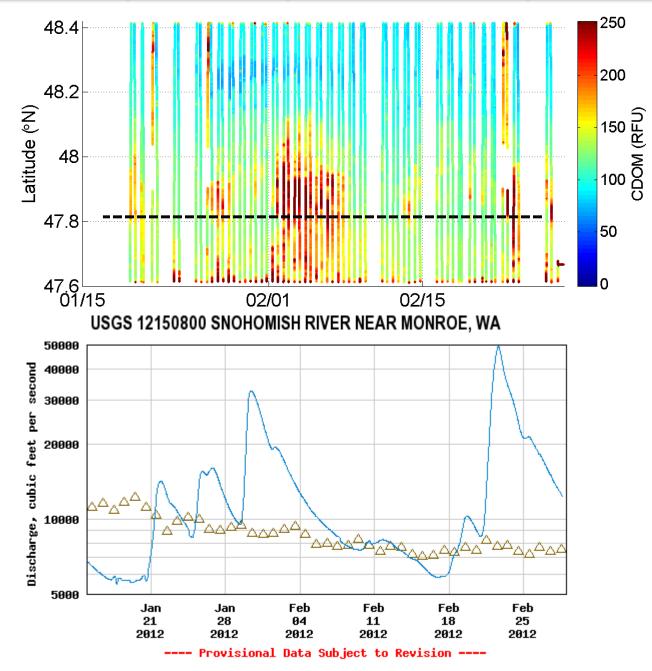
A primary source of <u>Colored</u>
<u>Dissolved Organic Matter</u>
(CDOM) to Puget Sound is
from rivers.

Pulses of colored water have been seen making their way from Whidbey Basin into Central Puget Sound, associated with recent rainfall and high river flows.

🛆 Median daily statistic (48 years) —— Discharge

Summary: On February 19 the freshwater layer thickness was low reflecting the Snohomish discharge minimum (see previous page).

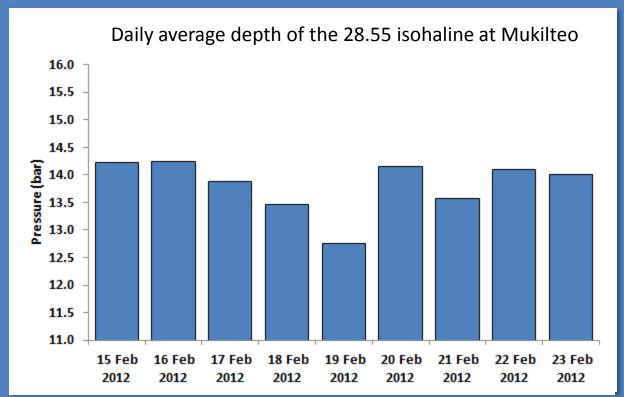
The mooring report is currently limited to describing the thickness of the freshwater layer between Whidbey Basin and Central Basin.

We track the depth of the isohaline 28.55 (±0.05) and measure the thickness of the freshwater layer at our Mukilteo station. The sensor experiences tidal pressure variations of 11.8 to 15.6 dbar.
