**CLOVER-CHAMBERS CREEK BASIN  
GROUND WATER MANAGEMENT PROGRAM  
IMPLEMENTATION PROJECT**

**FINAL REPORT**

Tacoma-Pierce County Health Department  
Federico Cruz-Urbe, M.D., M.P.H., Director of Health

October 1995

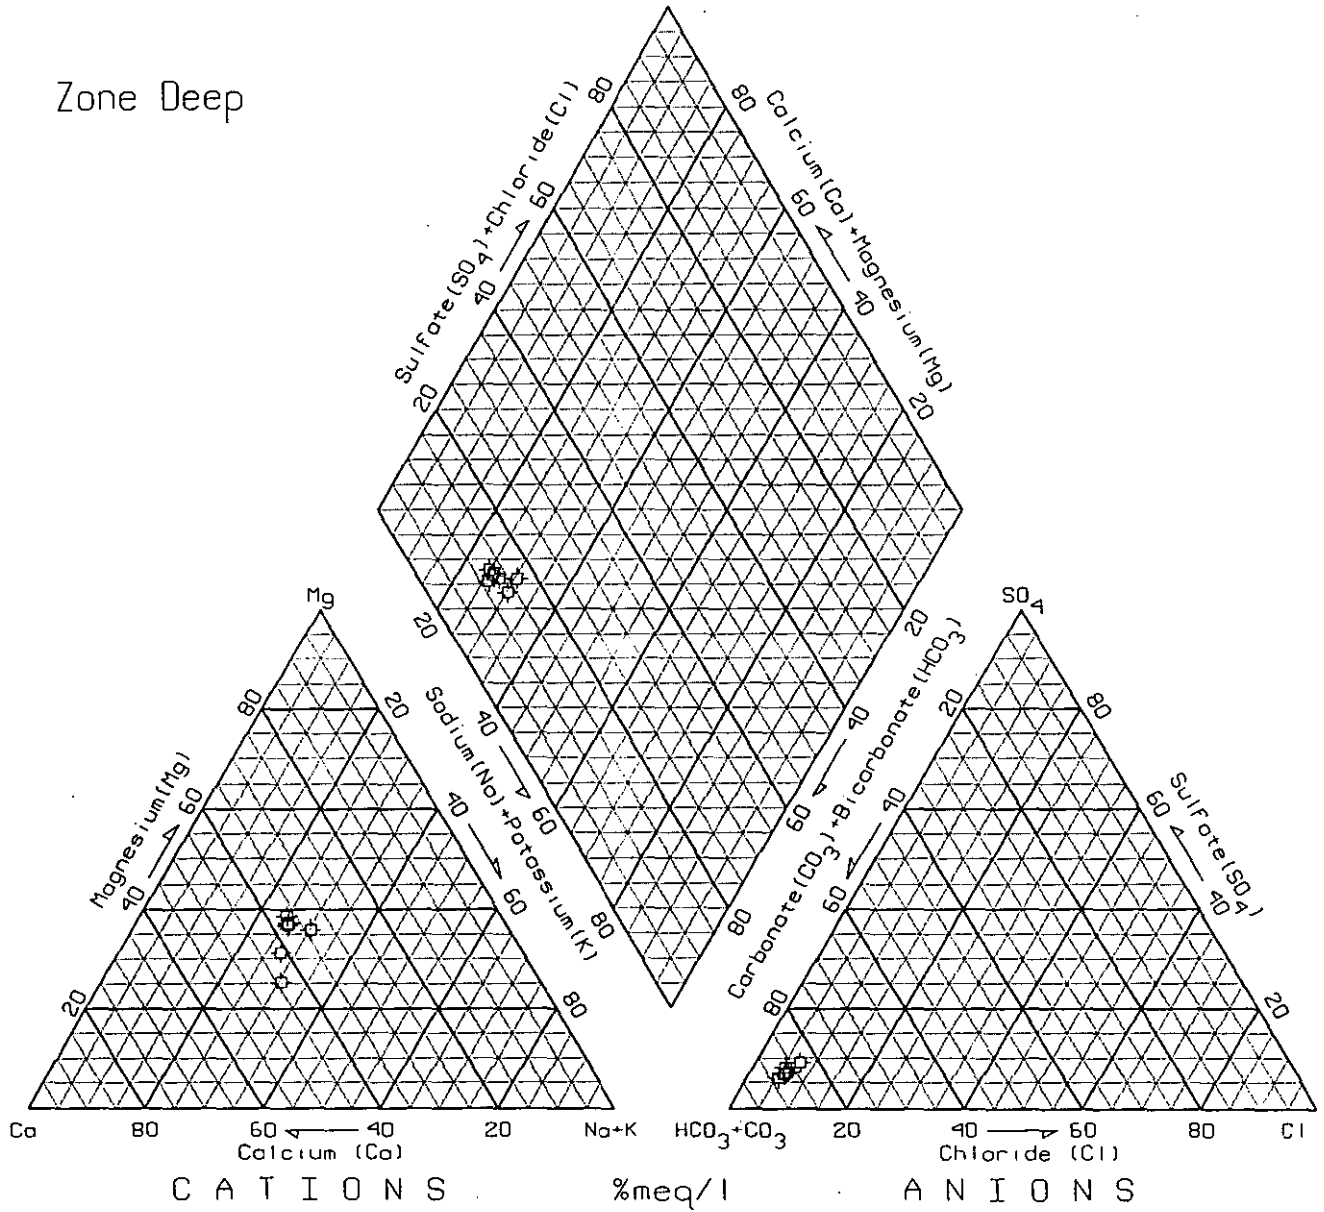
Figure 4-8  
 CLOVER-CHAMBERS CREEK  
 MONITORING PROGRAM  
 AQUIFER ZONE DEEPER  
**TRILINEAR PLOT**

Major ion data were queried from the combined database. A total of 118 complete major ion analyses were grouped into four hydrostratigraphic zones. This was all of the major ion data available. Data were plotted for zones A, C, E, and Deeper (Figures 4-5 through 4-8). A subtle trend was noticed in the data. Zone A was found to be relatively higher in sulfates and chlorides, whereas the deeper zones were higher in alkalinity. Because the data ranges overlap for many of the data points, the data from each zone cannot be distinguished by anion chemistry. Cation data for the four zones plot in similar areas on the trilinear diagram.
