# **Stressor Identification for Peabody Creek (Port Angeles)**

November 2013

Publication No. 13-03-040

Karen Adams

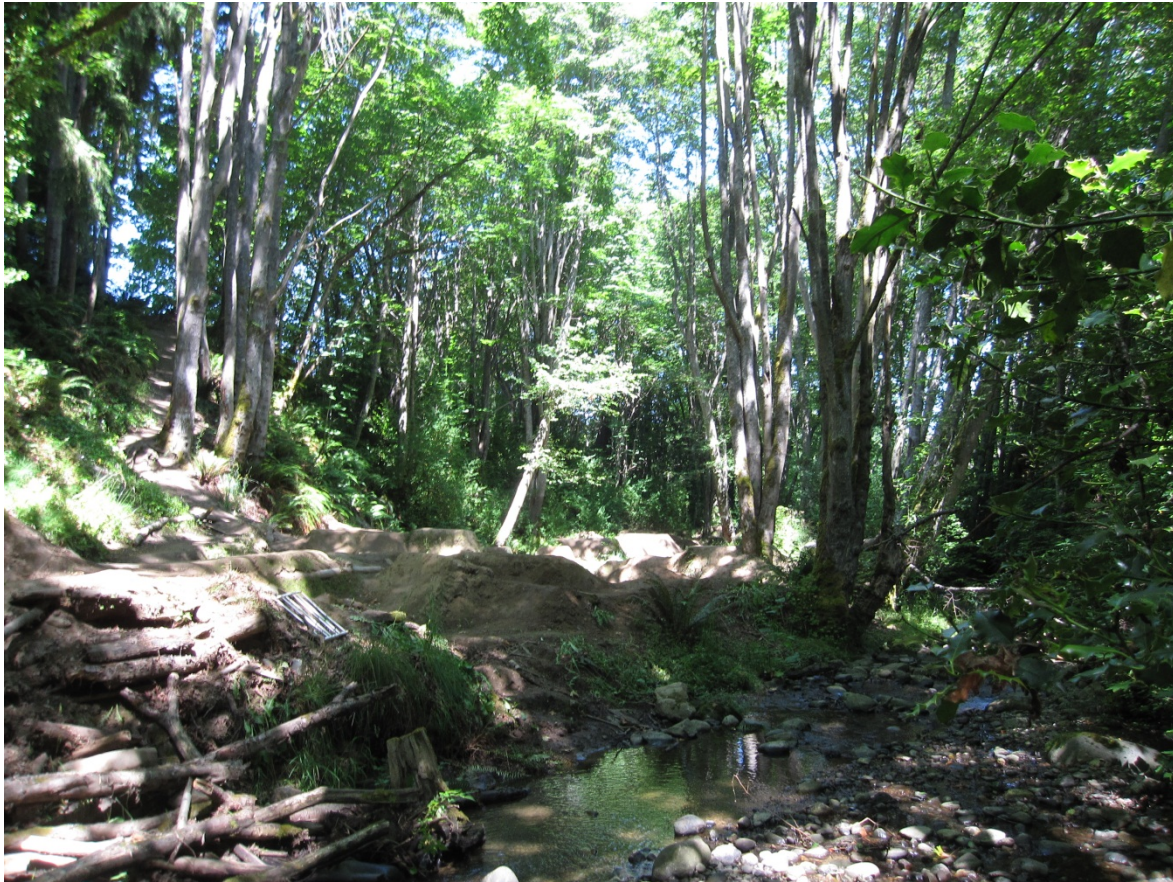
Figure 5. The motocross course located between transects D and I of the impacted field site.

In the unimpaired reach, the only human influence documented in the riparian area was the Peabody Creek foot trail on the hillside. The documented human influence was higher in the riparian area of the impaired reach. In the impaired reach, the primary forms of disturbance, in addition to foot paths, were trash, homes, out buildings, and a large area with a motocross bike course on the left bank from transect D to transect I (Figure 5). Most of the disturbance in the impaired reach occurred within 10 meters of the bank, while the footpath in the unimpaired reach was from 10 to 30 meters from the bank.

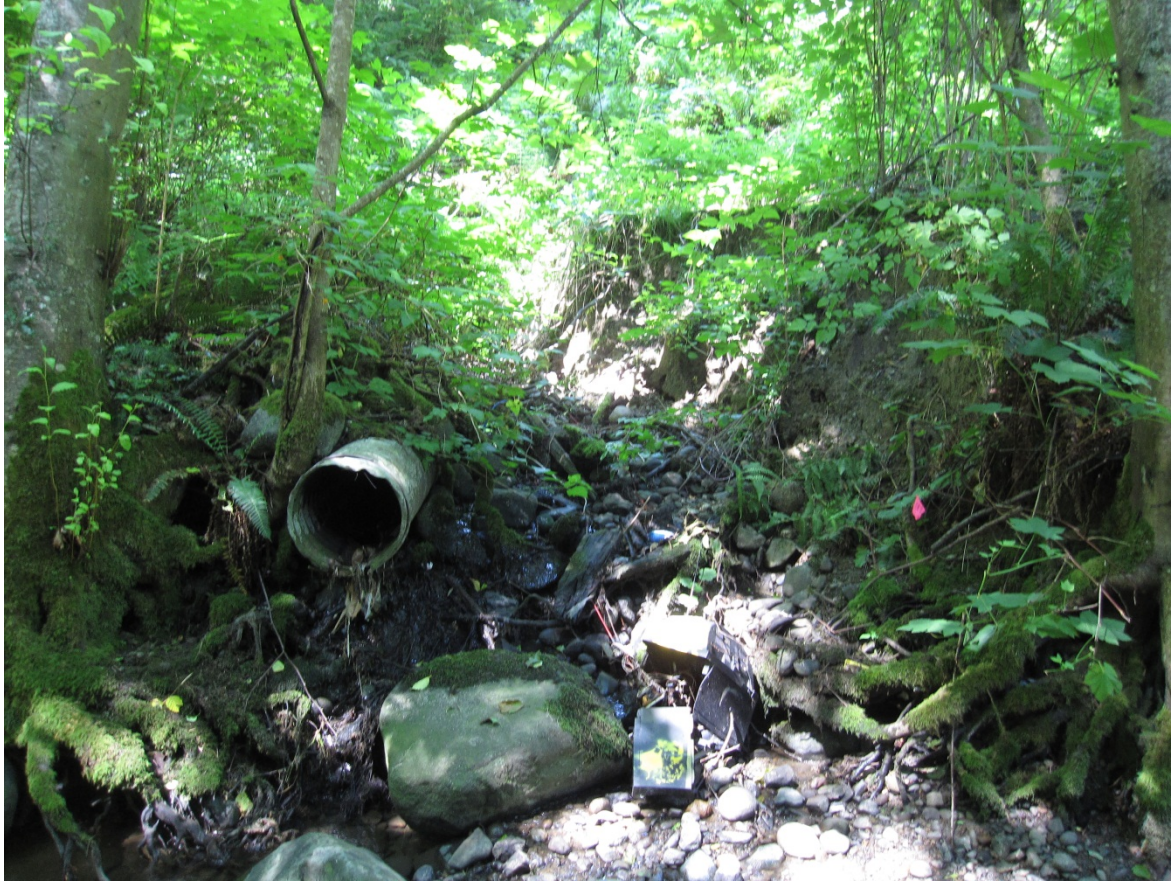
Culverts are also destroying habitat, as culverts entering the stream are often inadequate for the volume of water they carry. The runoff is creating gullies around the culvert and carrying sediment and trash to the creek (Figure 6). The large culverts that carry stream water under some of the road crossings are perched on the downstream side (Figure 7). These culverts carry large volumes of water that shoot out, at a high speed, at the streambed and banks on the downstream end. This causes significant erosion, scouring and suspending substrate and organic material such as pieces of wood that might have fallen during the dry season. Replacing these culverts with bridges would be ideal, but this may not be feasible due to costs.

Figure 6. Culverts are not effectively conveying runoff to the stream.

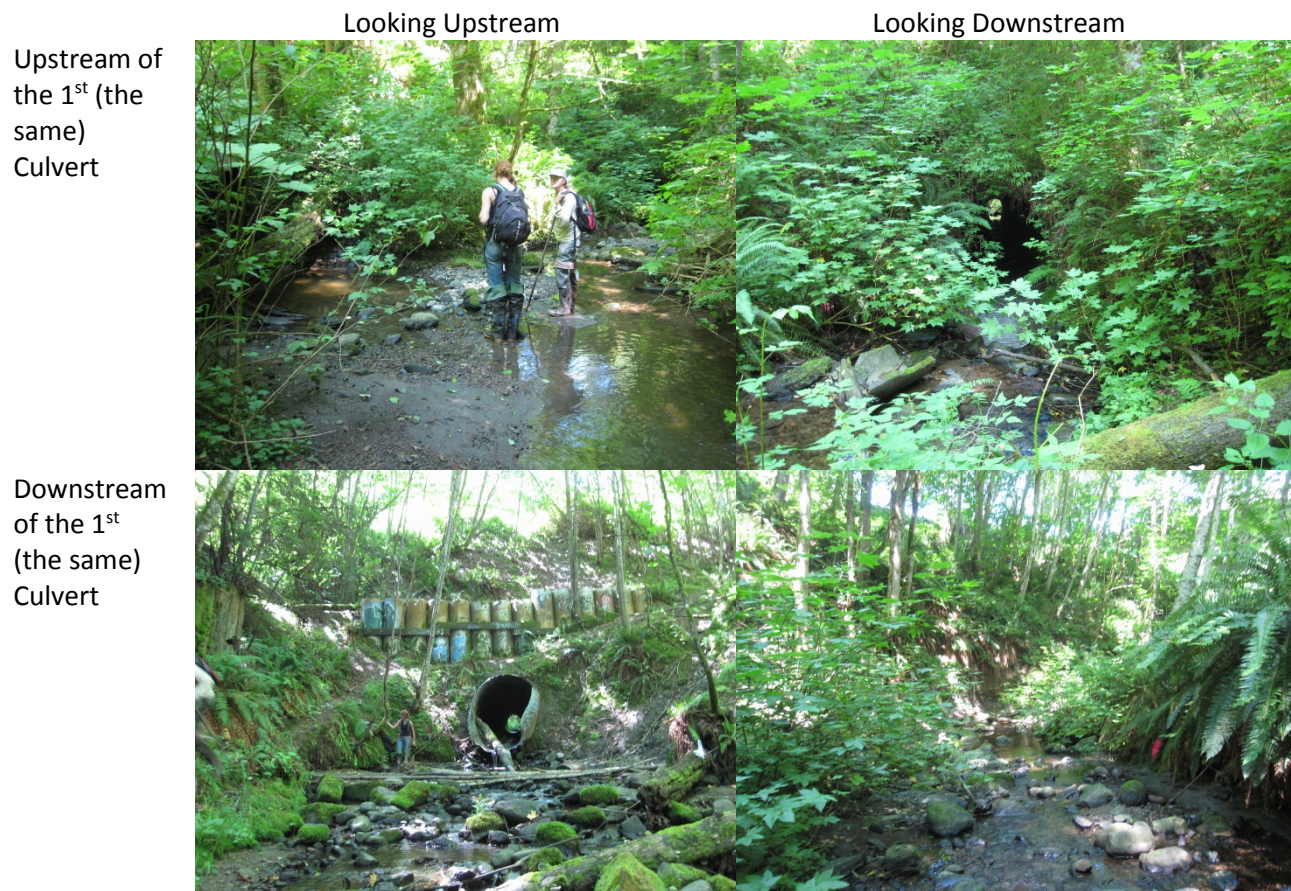
Figure 7. A comparison of immediately upstream and immediately downstream of the first culvert that conveys Peabody Creek under a road on the upstream end of the impaired reach.

Finding a way to reduce flows and protect the receiving portion of the stream are therefore crucial stop-gaps to improve conditions in Peabody Creek. An example of such a structure is already being implemented with some success in Peabody Creek (Figure 8). The water is conveyed downhill in a pipe which discharges into a rock basket and then down an armored path to the creek. There are no significant signs of erosion around these structures. However, based on the lack of vegetation surrounding them, they appear to have only been in use for a relatively short period of time.

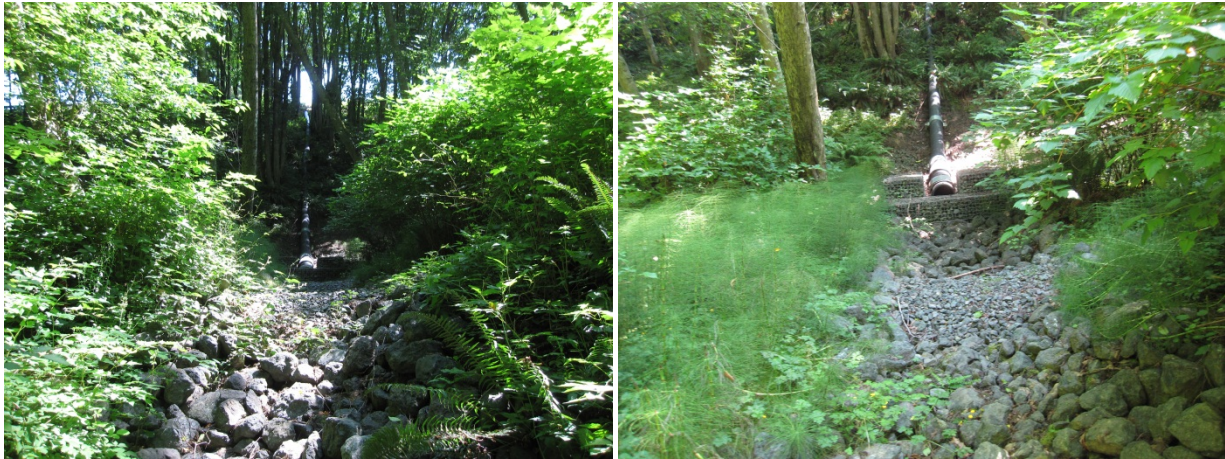
Figure 8. Structures built to convey stormwater from streets adjacent to Peabody Creek.

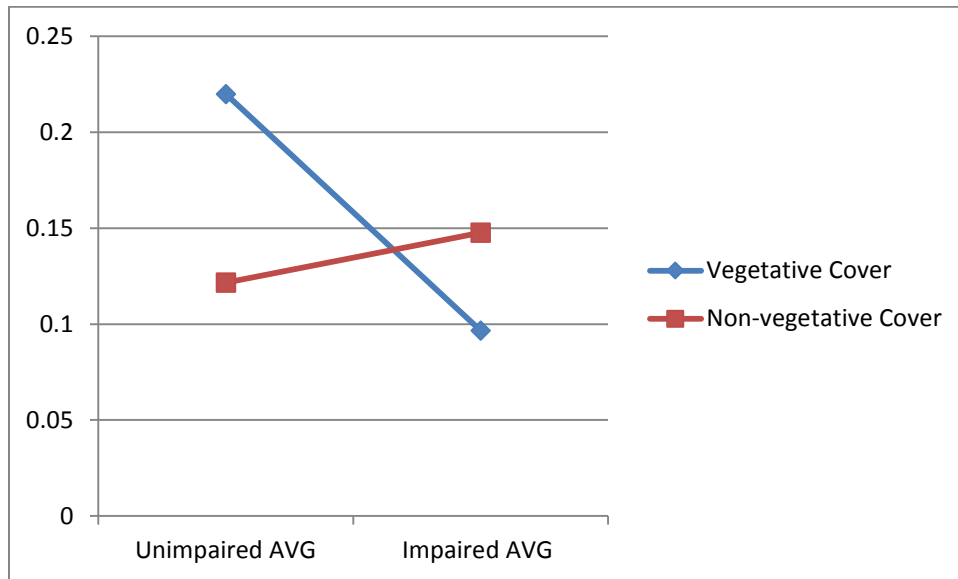
Figure 9. Comparison of non-vegetative and vegetative cover in impaired and unimpaired sites.

Fish cover varied between sites in both the amount (Table 15) and predominant type (Figures 9 and 10). In the unimpaired reach, there was more cover overall, composed mostly of non-aquatic vegetation. In addition, there was more persistent cover found in the unimpaired site than in the downstream site. Fish cover available in the creek responded differently to disturbance. The predominant cover type shifted from predominantly vegetative cover in the upstream to non-vegetative cover at the downstream site. This was due to a decrease in the amount of vegetative cover in the impaired reach as compared to the unimpaired reach but no change in the amount of non-vegetative cover types. Likewise, there was a decrease in the amount of persistent cover types in the impaired reach as compared to the unimpaired reach.
