# Eyes Over Puget Sound

Flight log Weather Water column Aerial photos Ferry and Satellite Moorings

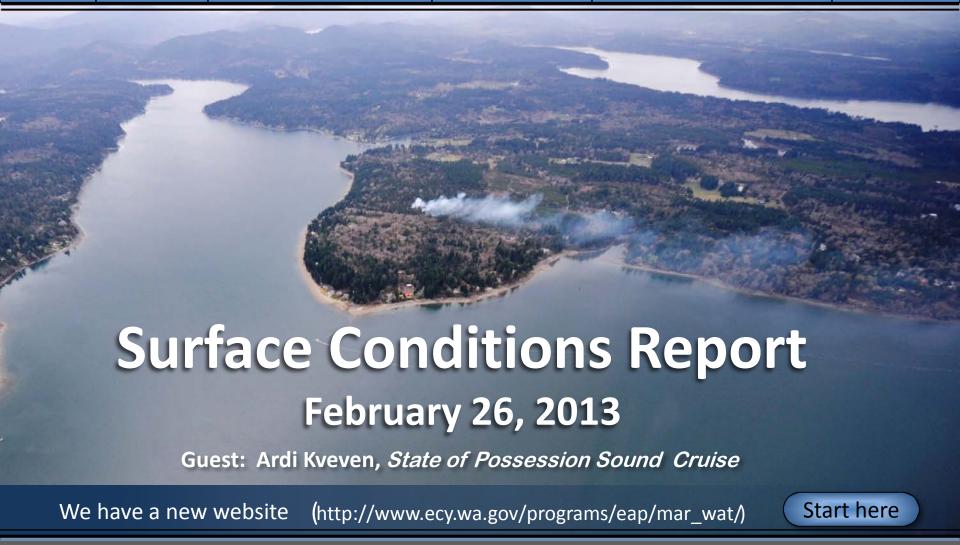
Up-to-date observations of visible water quality conditions in Puget Sound and the Strait of Juan de Fuca
