Eyes Over Puget Sound

Surface Conditions Report May 20, 2013

Up-to-date observations of visible water quality conditions in Puget Sound and the Strait of Juan de Fuca

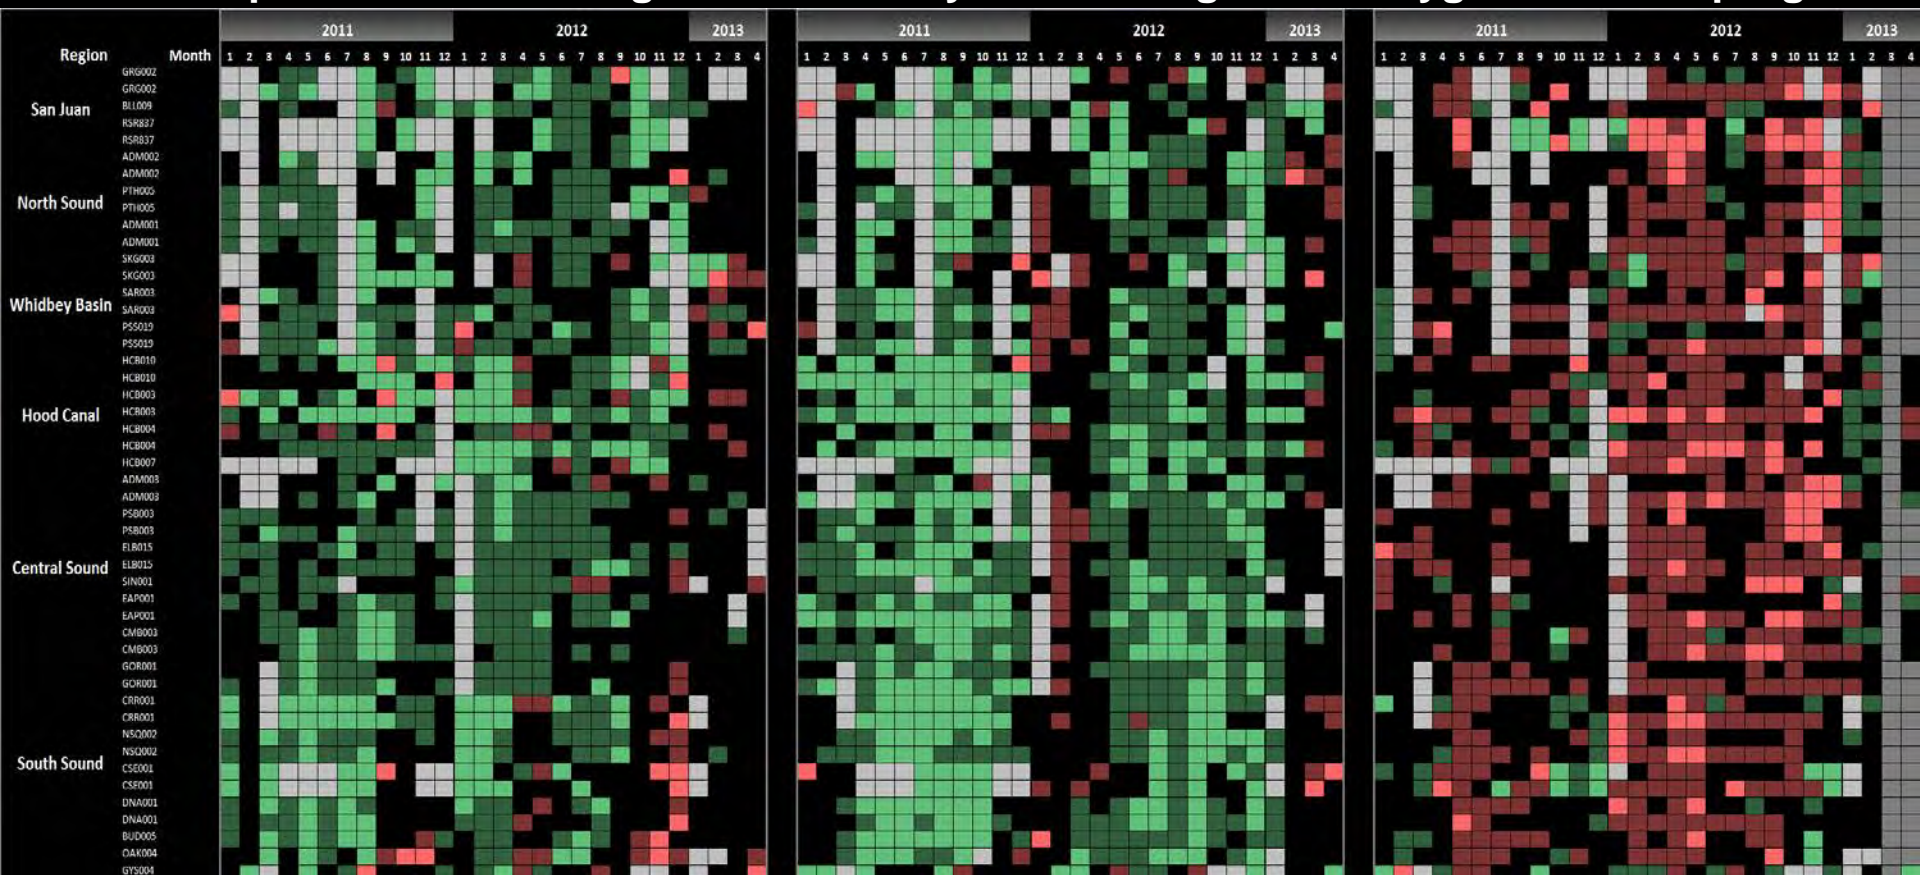
Conditions of the last two years change at our stations

Puget Sound water conditions are changing again! Compared to 2011-2012, when waters were colder and fresher with higher oxygen, Puget Sound is more expected so far this year. A sensor check prevented Mar. and Apr. oxygen data from being available for this report. Each pixel is a monthly survey at each station.

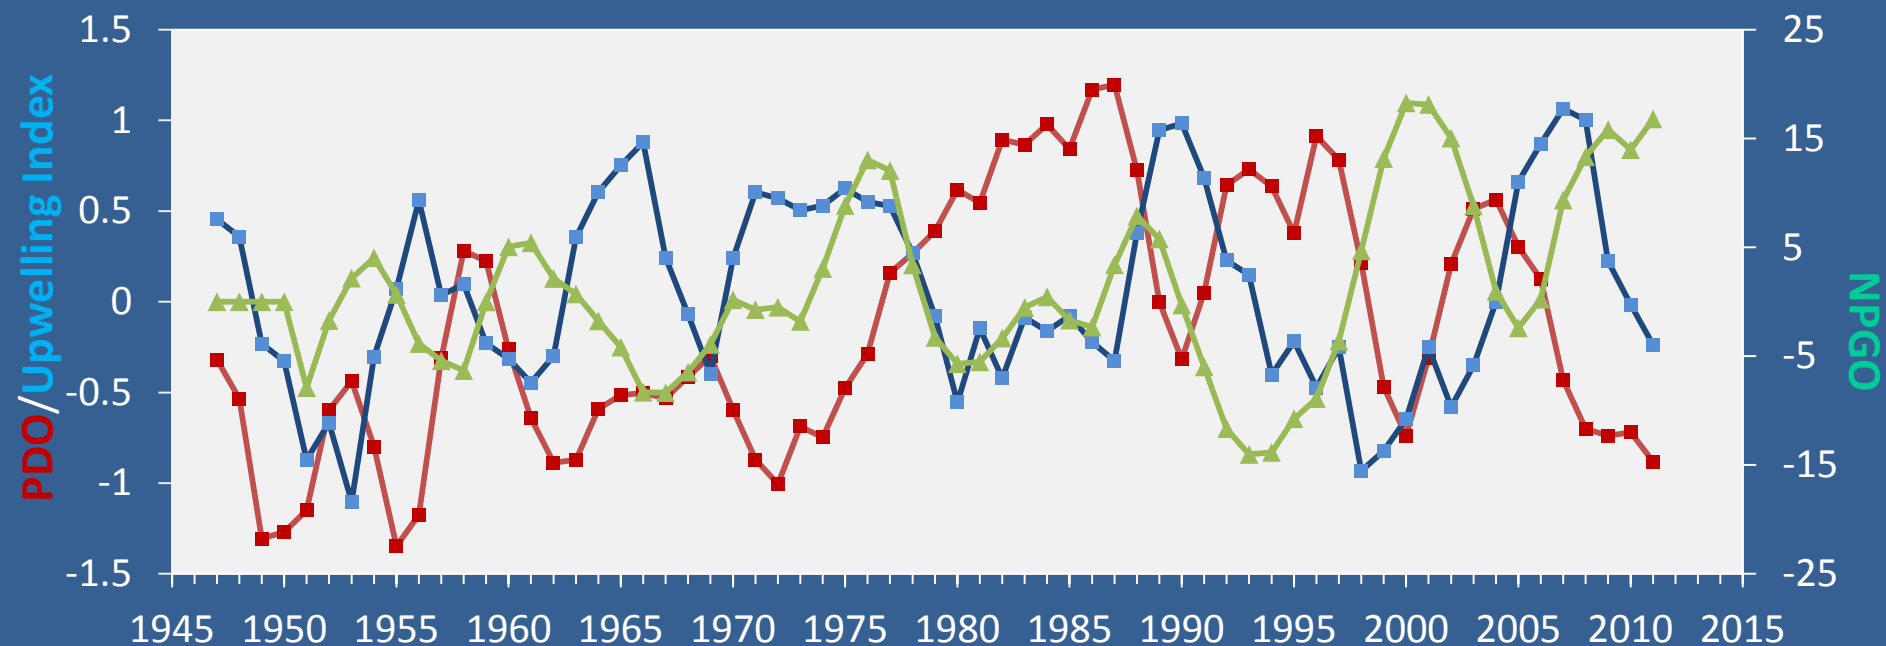
Three-year running average of PDO, Upwelling, and NPGO indices scores

Ocean boundary conditions have been favorable for water quality in Puget Sound; colder water (PDO), less upwelled, low oxygen, high nutrient ocean water reaching Puget Sound (Upwelling Index), and higher surface productivity along the coast (NPGO).

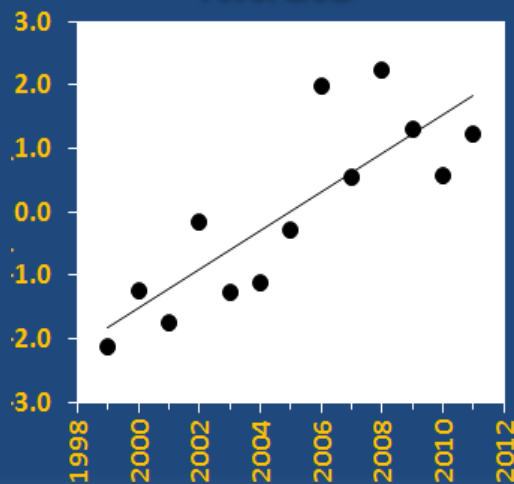
Nitrate

Nutrients in Puget Sound are increasing, read http://www.ecy.wa.gov/programs/eap/mar_wat/trends.html

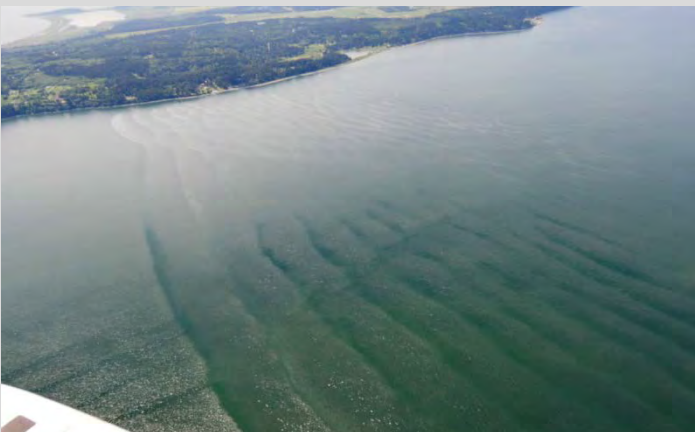
Internal waves in Saratoga Passage

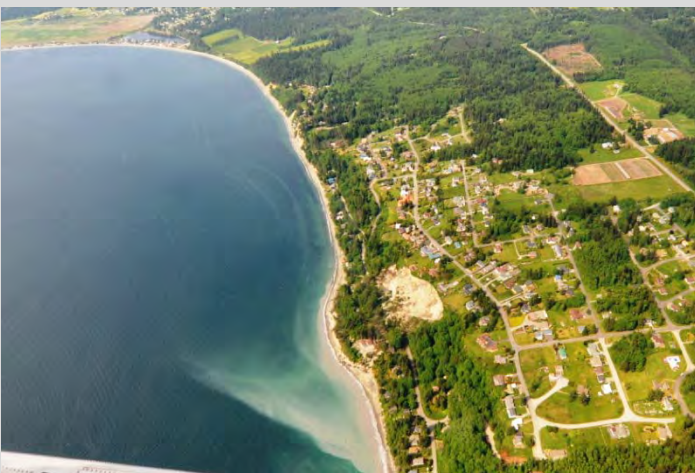
Large mudslide on Whidbey Island

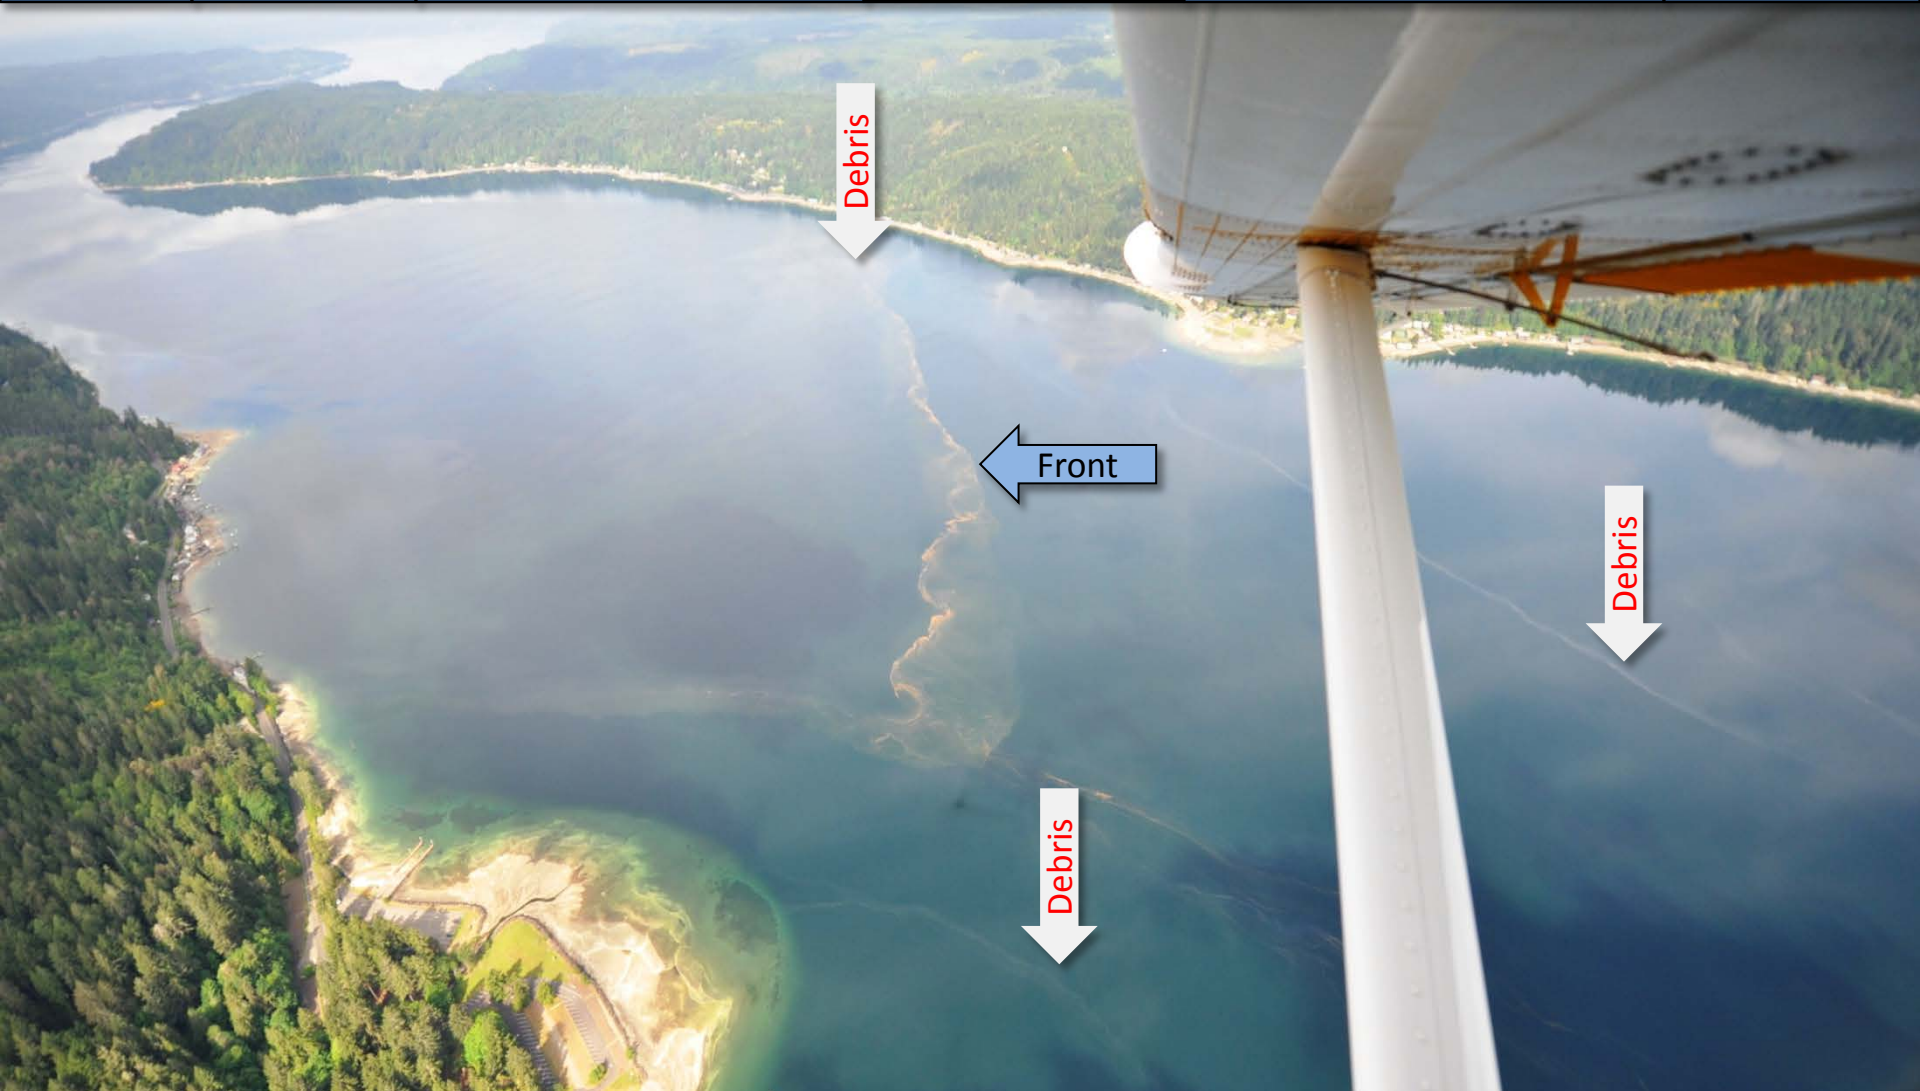
Noctiluca bloom accumulating in long band along a convergence.
Location: Near Twanoh State Park (Southern Hood Canal), 10:00 AM

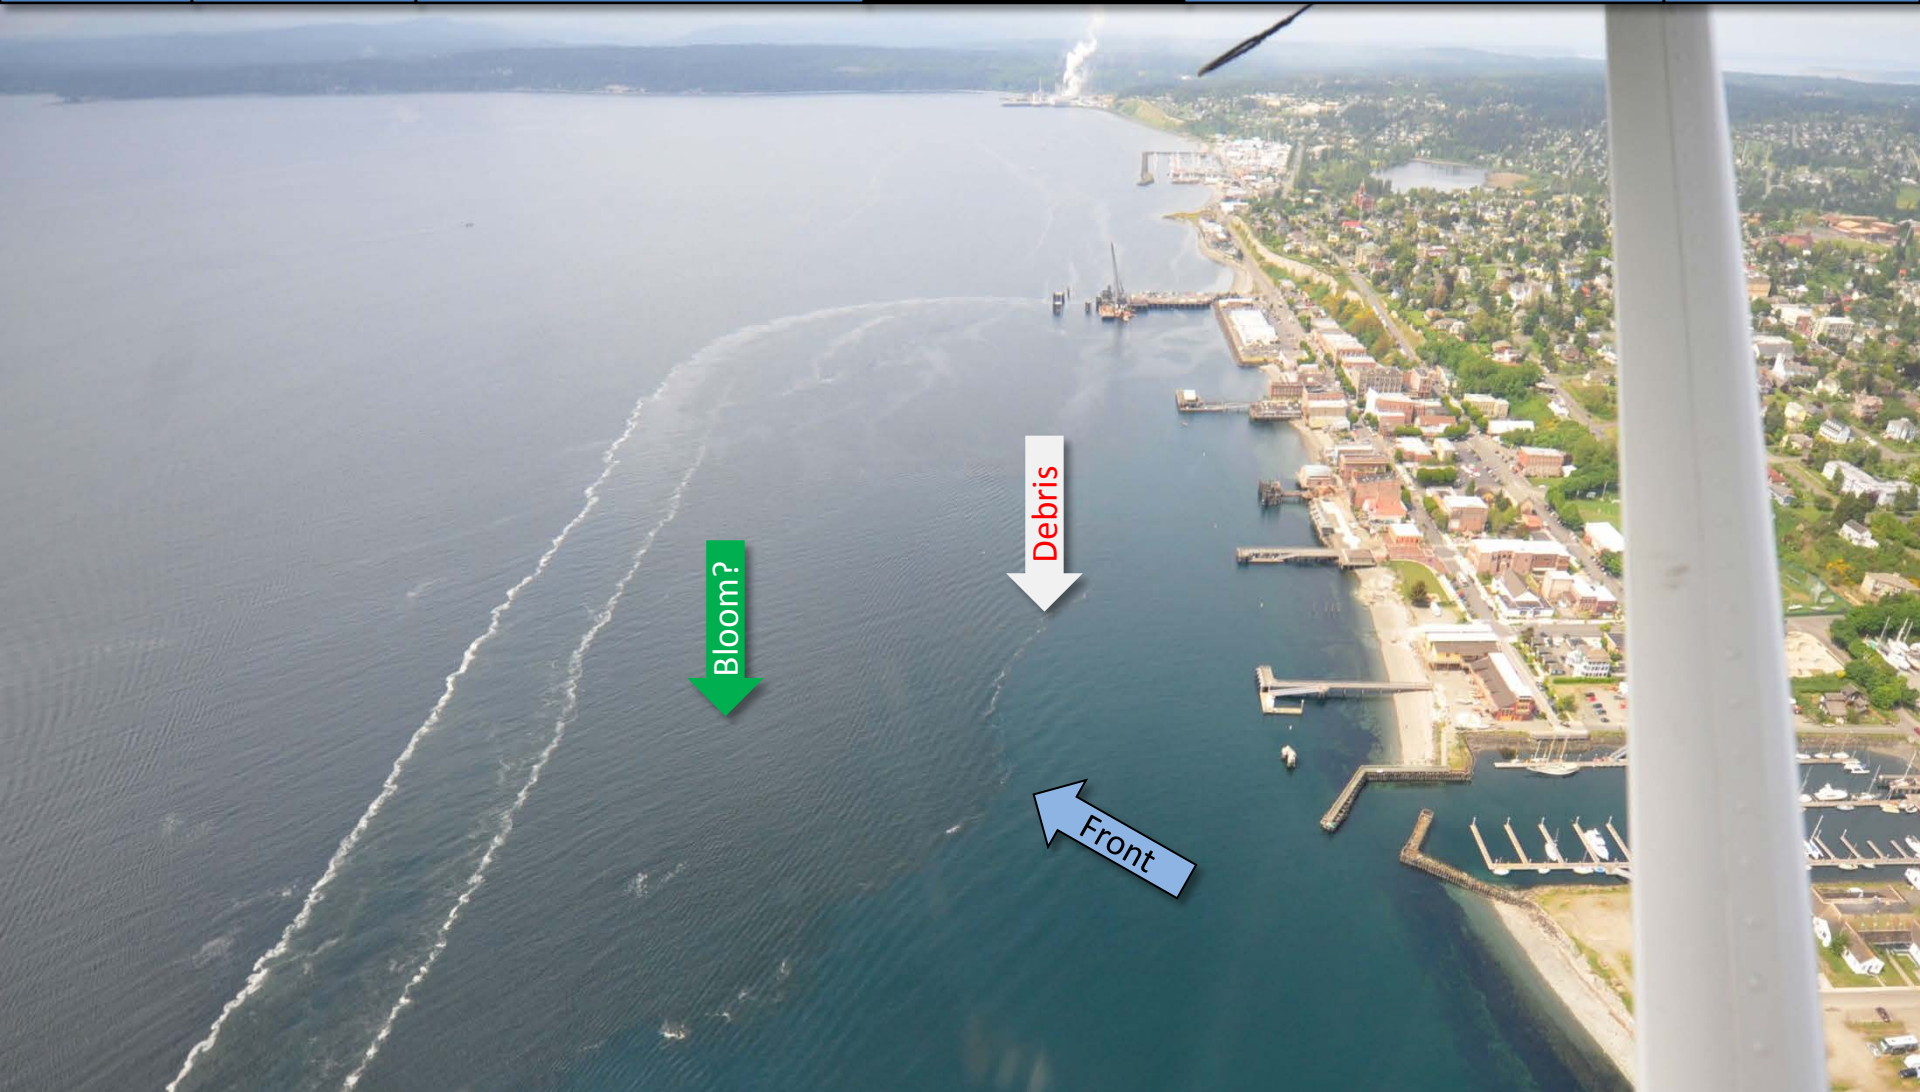
Location: Port Townsend (Admiralty Reach), 11:15 AM

Strong phytoplankton bloom and front.

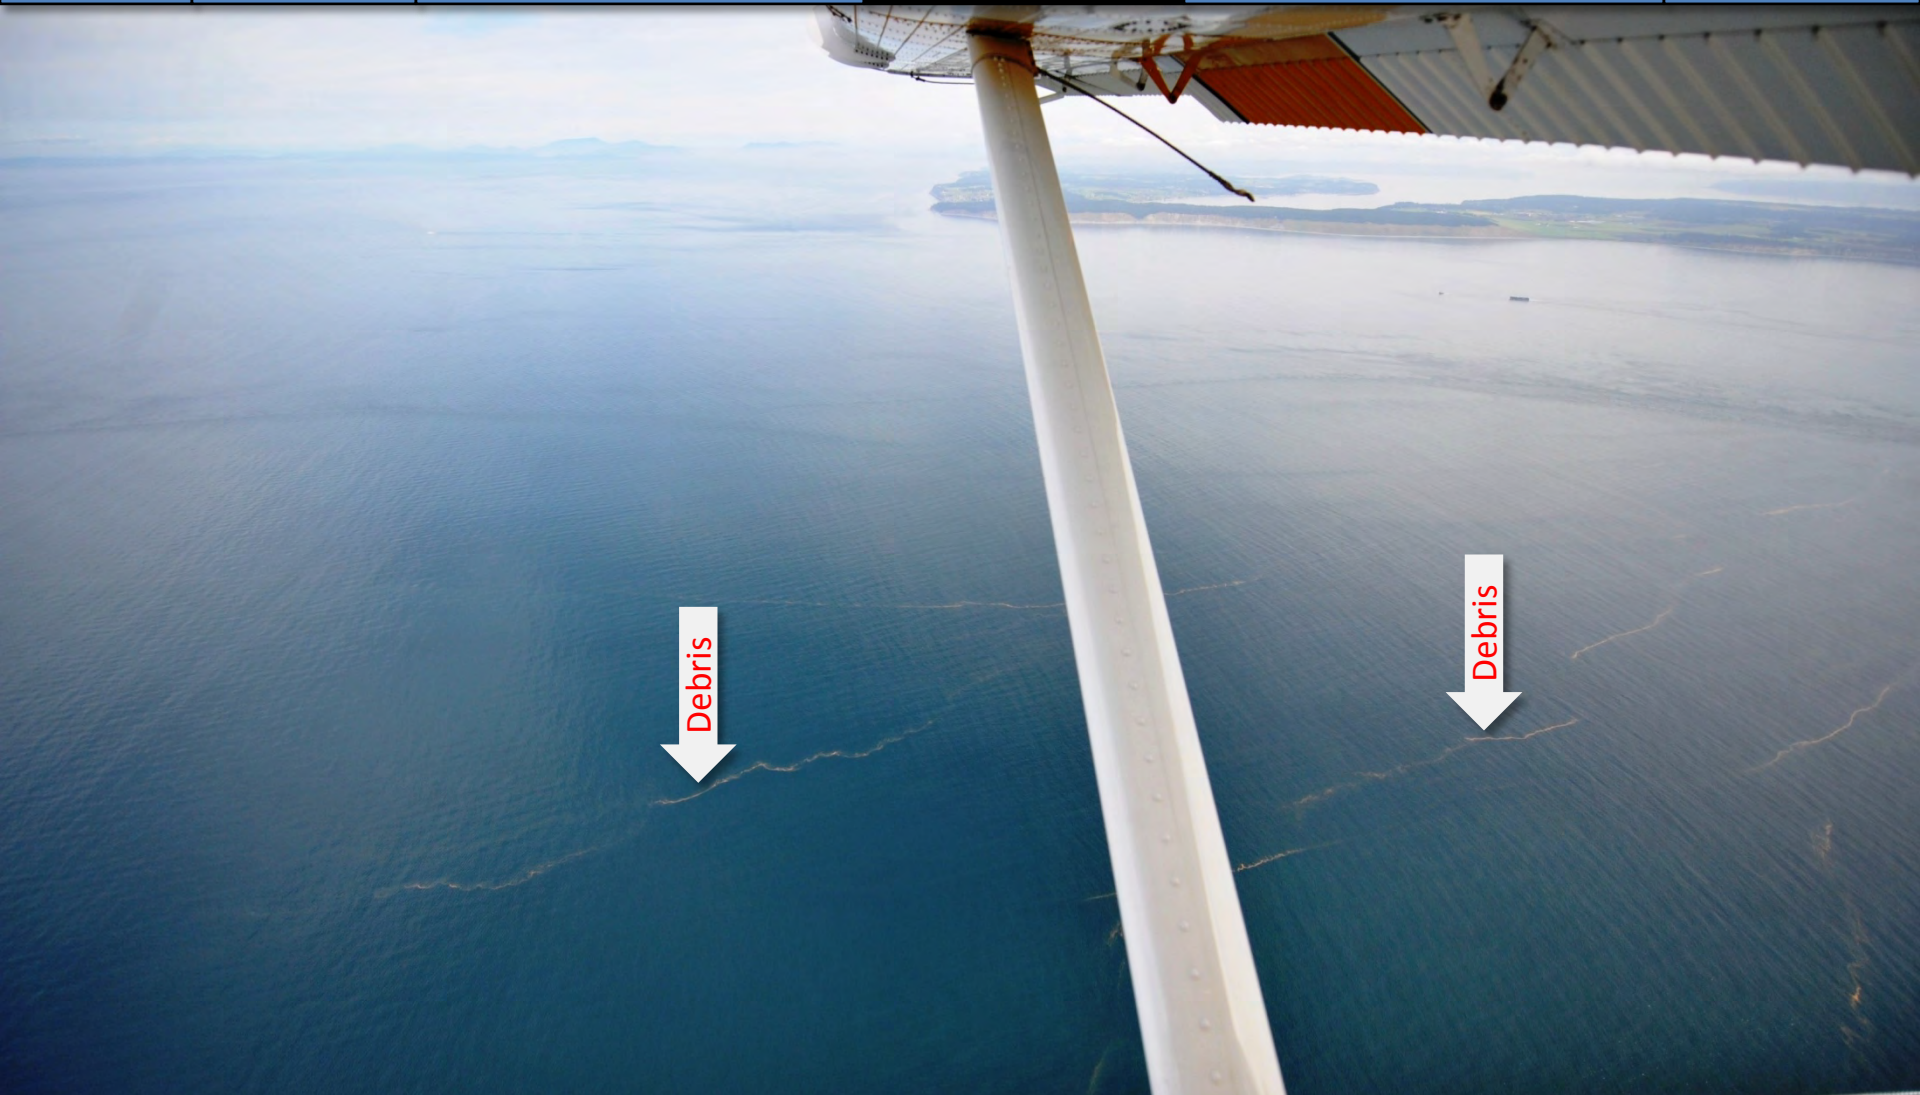
Streaks of Noctiluca accumulating at surface in the Strait of Juan de Fuca.
Location: Northwest of Fort Warden State Park (Admiralty Reach), 11:18 AM

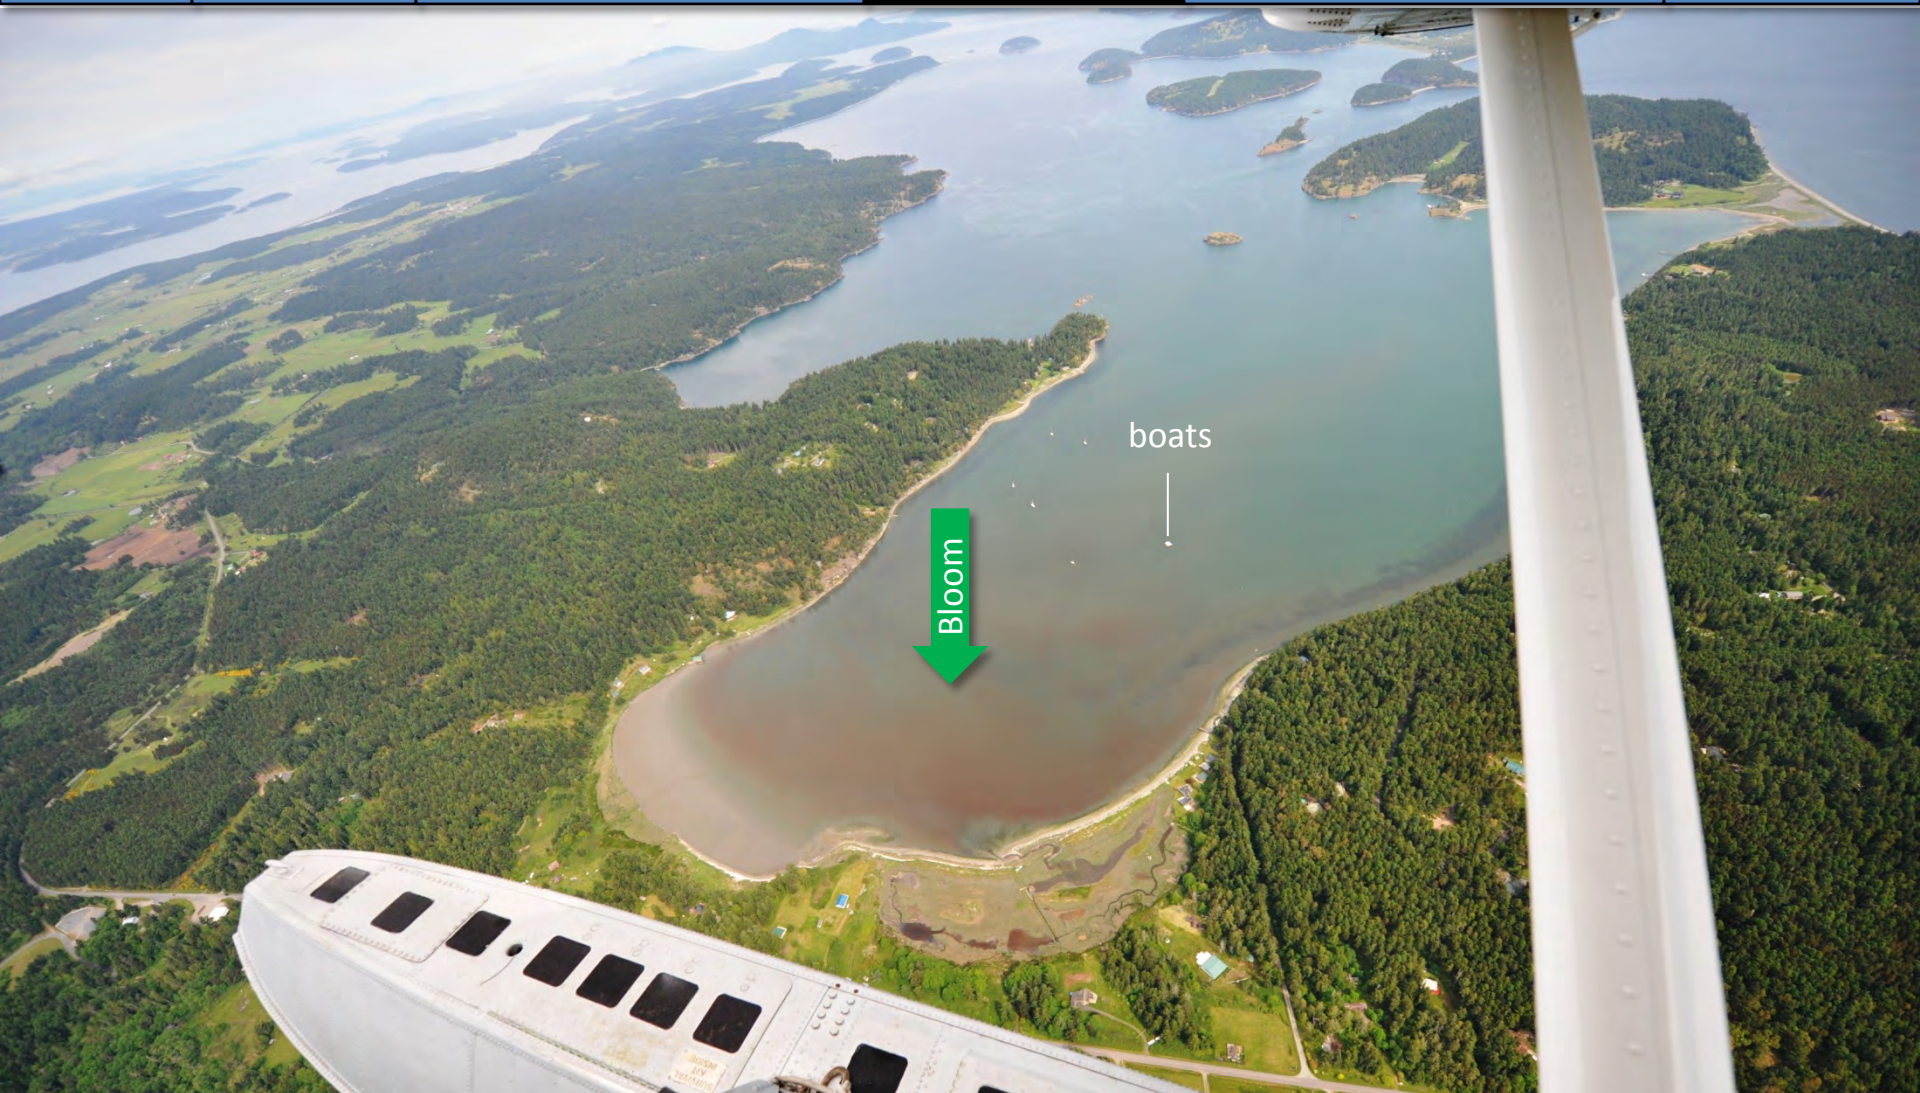
Location: Lopez Sound (San Juan Islands), 11:31 AM

Red phytoplankton bloom.

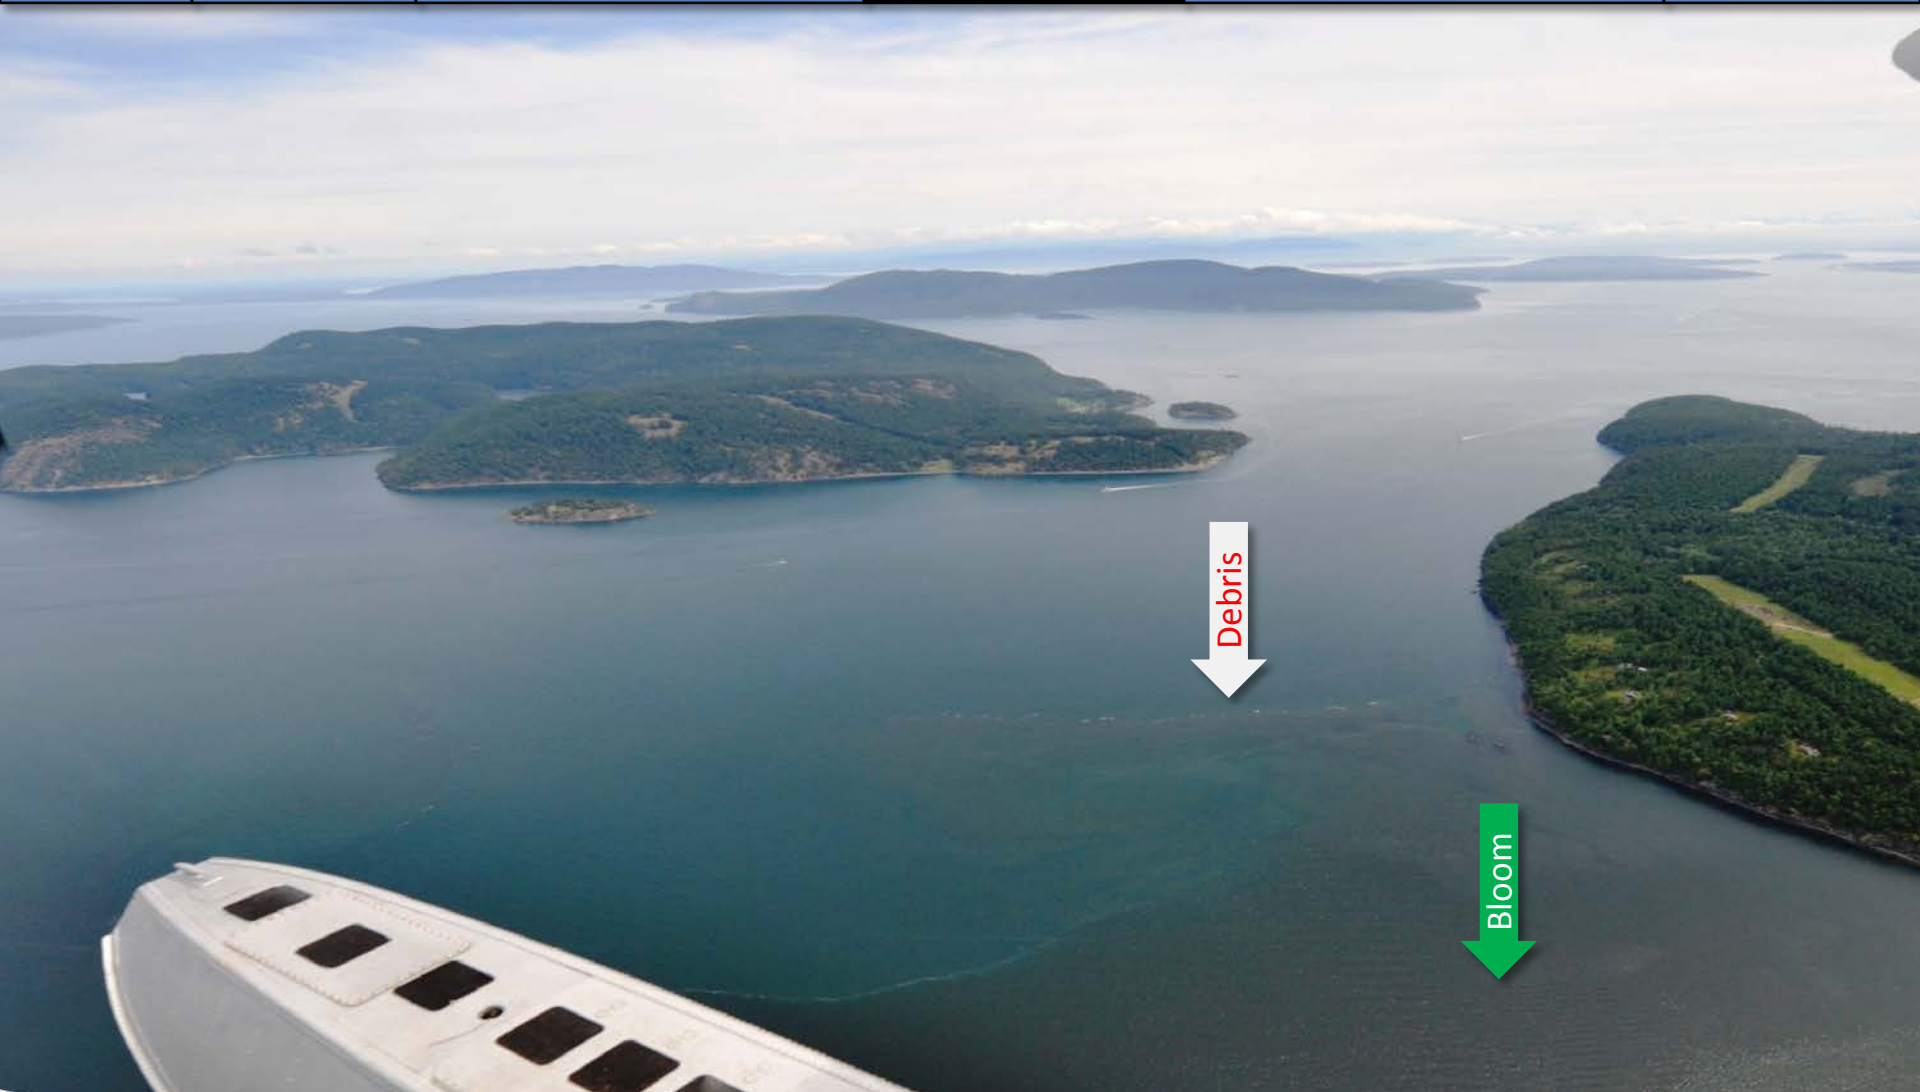
Location: Lopez Sound (San Juan Islands), 11:37 AM

Red phytoplankton bloom.

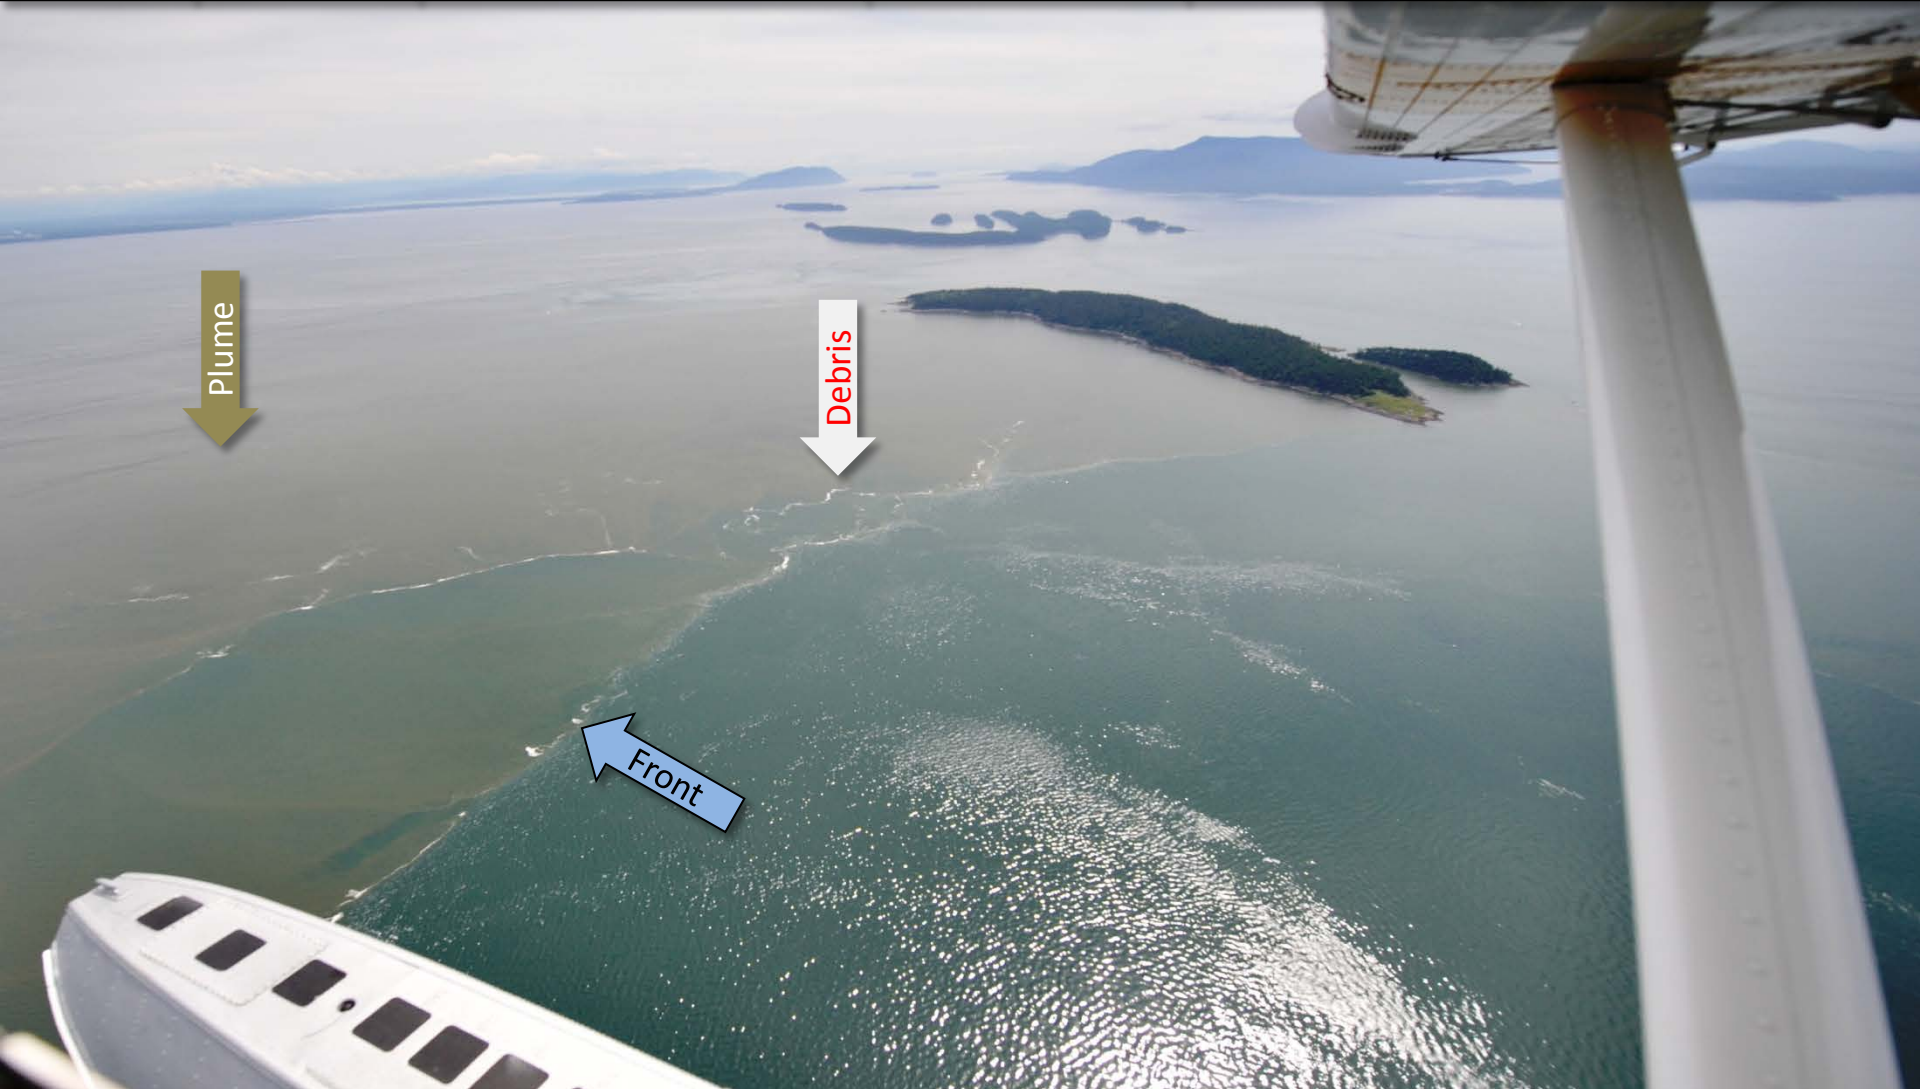
The far reaches of the sediment-laden river plume of the Fraser River
Location: Patos Island State Park (northern San Juan Islands), 12:21 PM

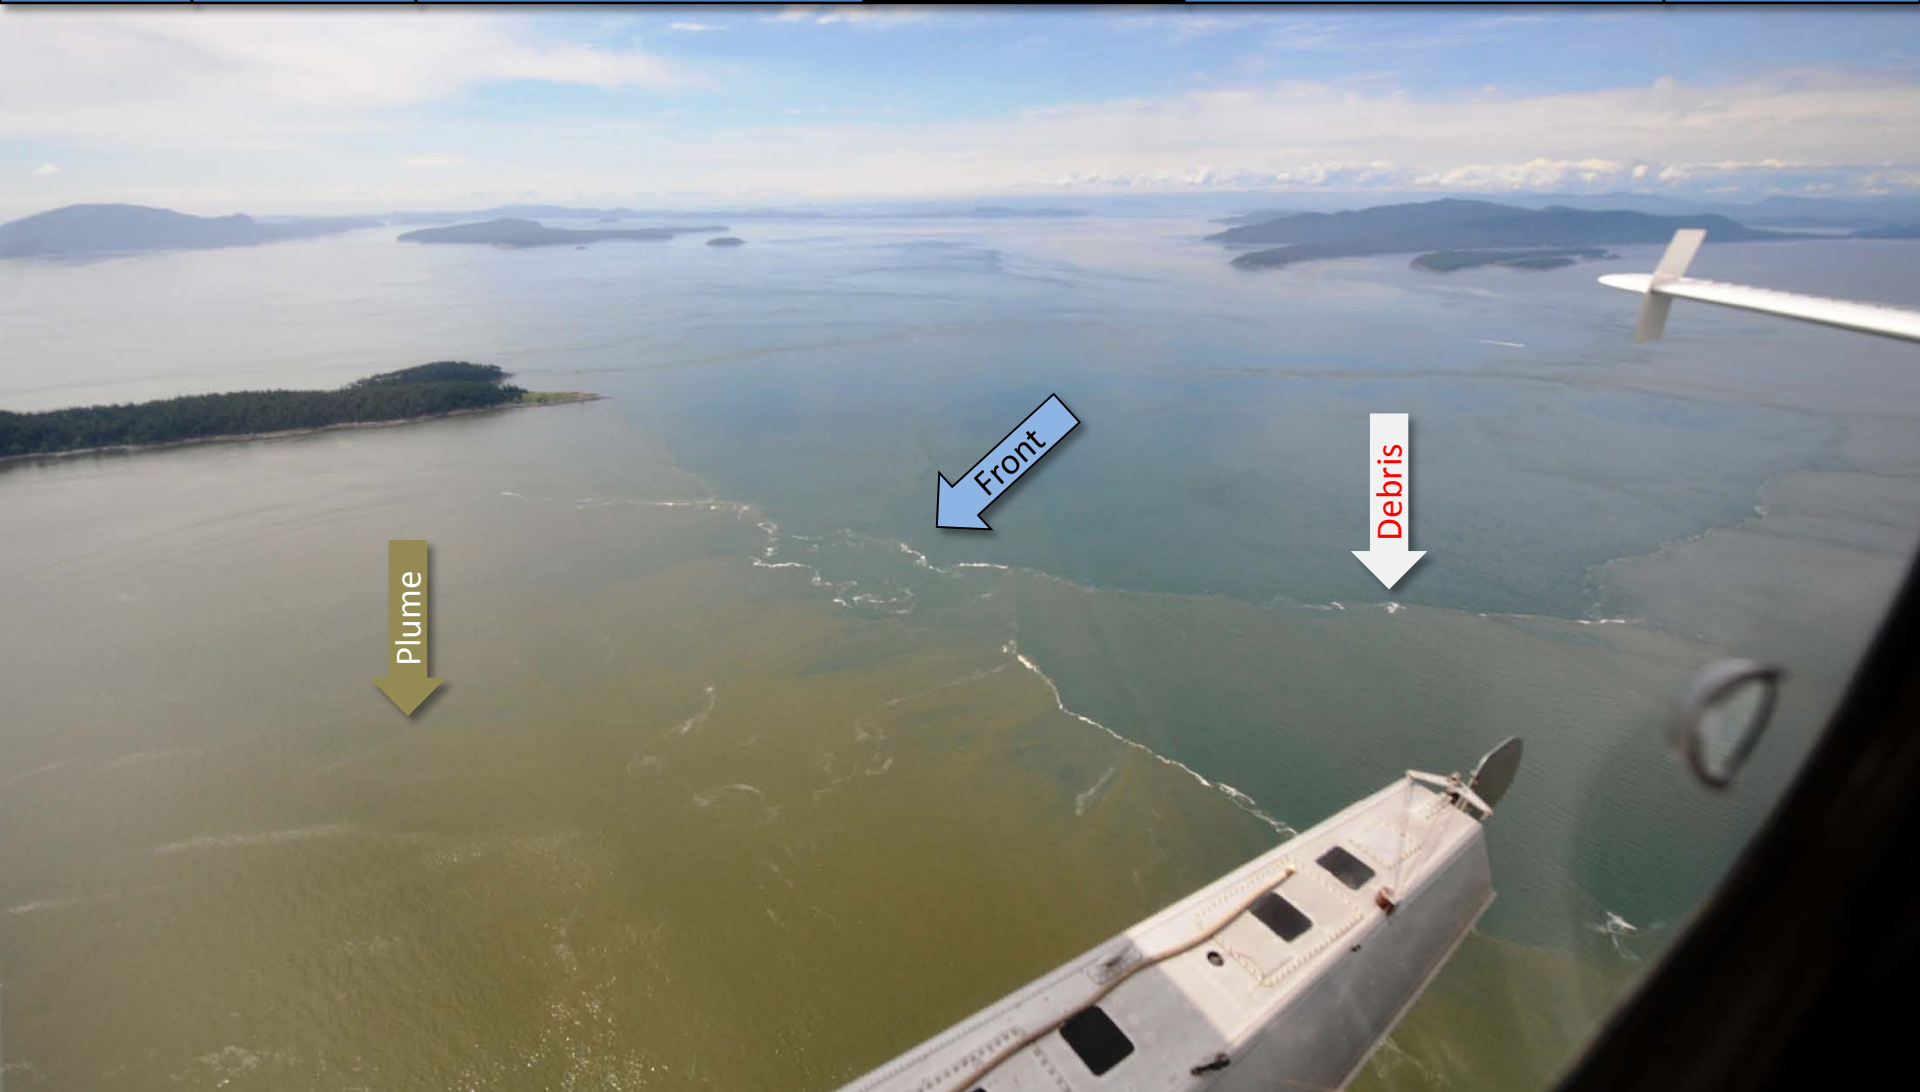
The far reaches of the sediment-laden river plume of the Fraser River
Location: Patos Island State Park (northern San Juan Islands), 12:22 PM

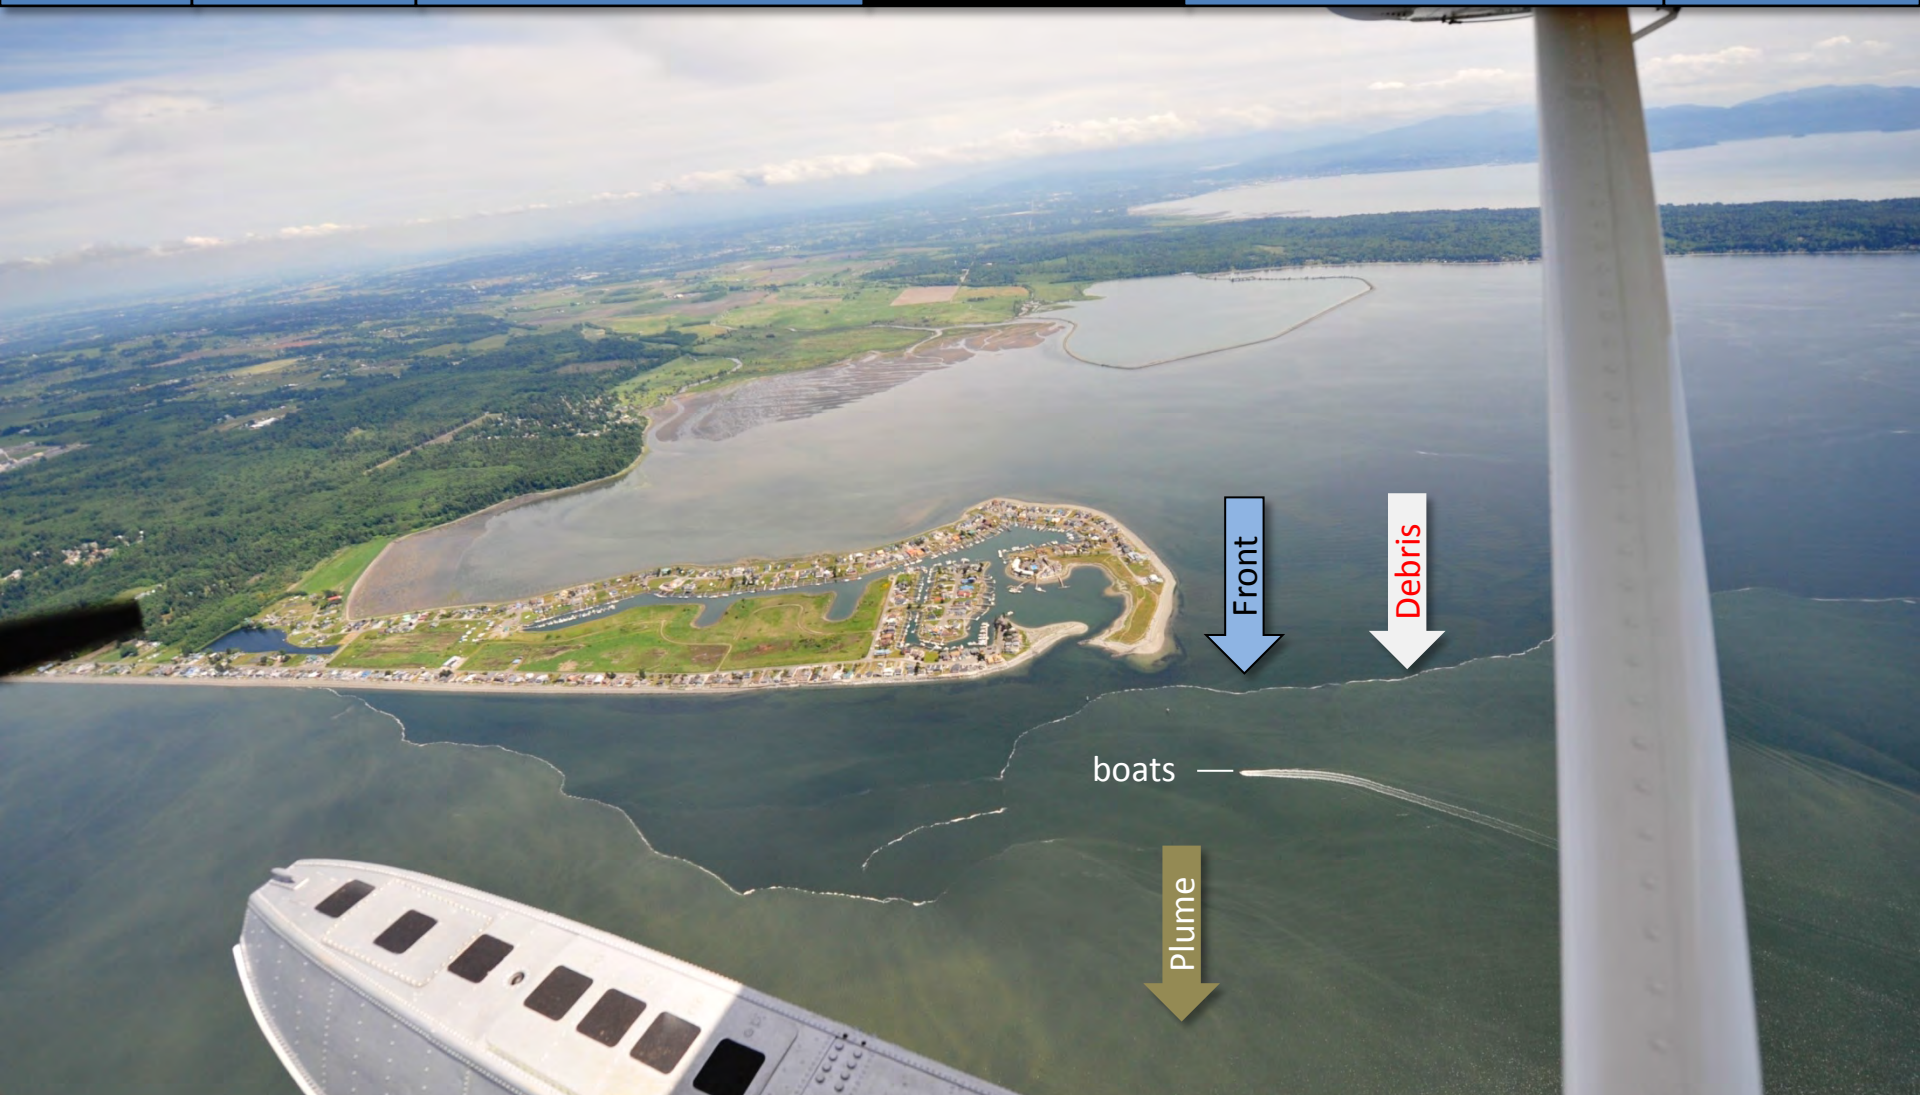
Location: Lummi Bay (Near Bellingham), 1:15 PM

The edges of the Fraser River plume with suspended sediment.

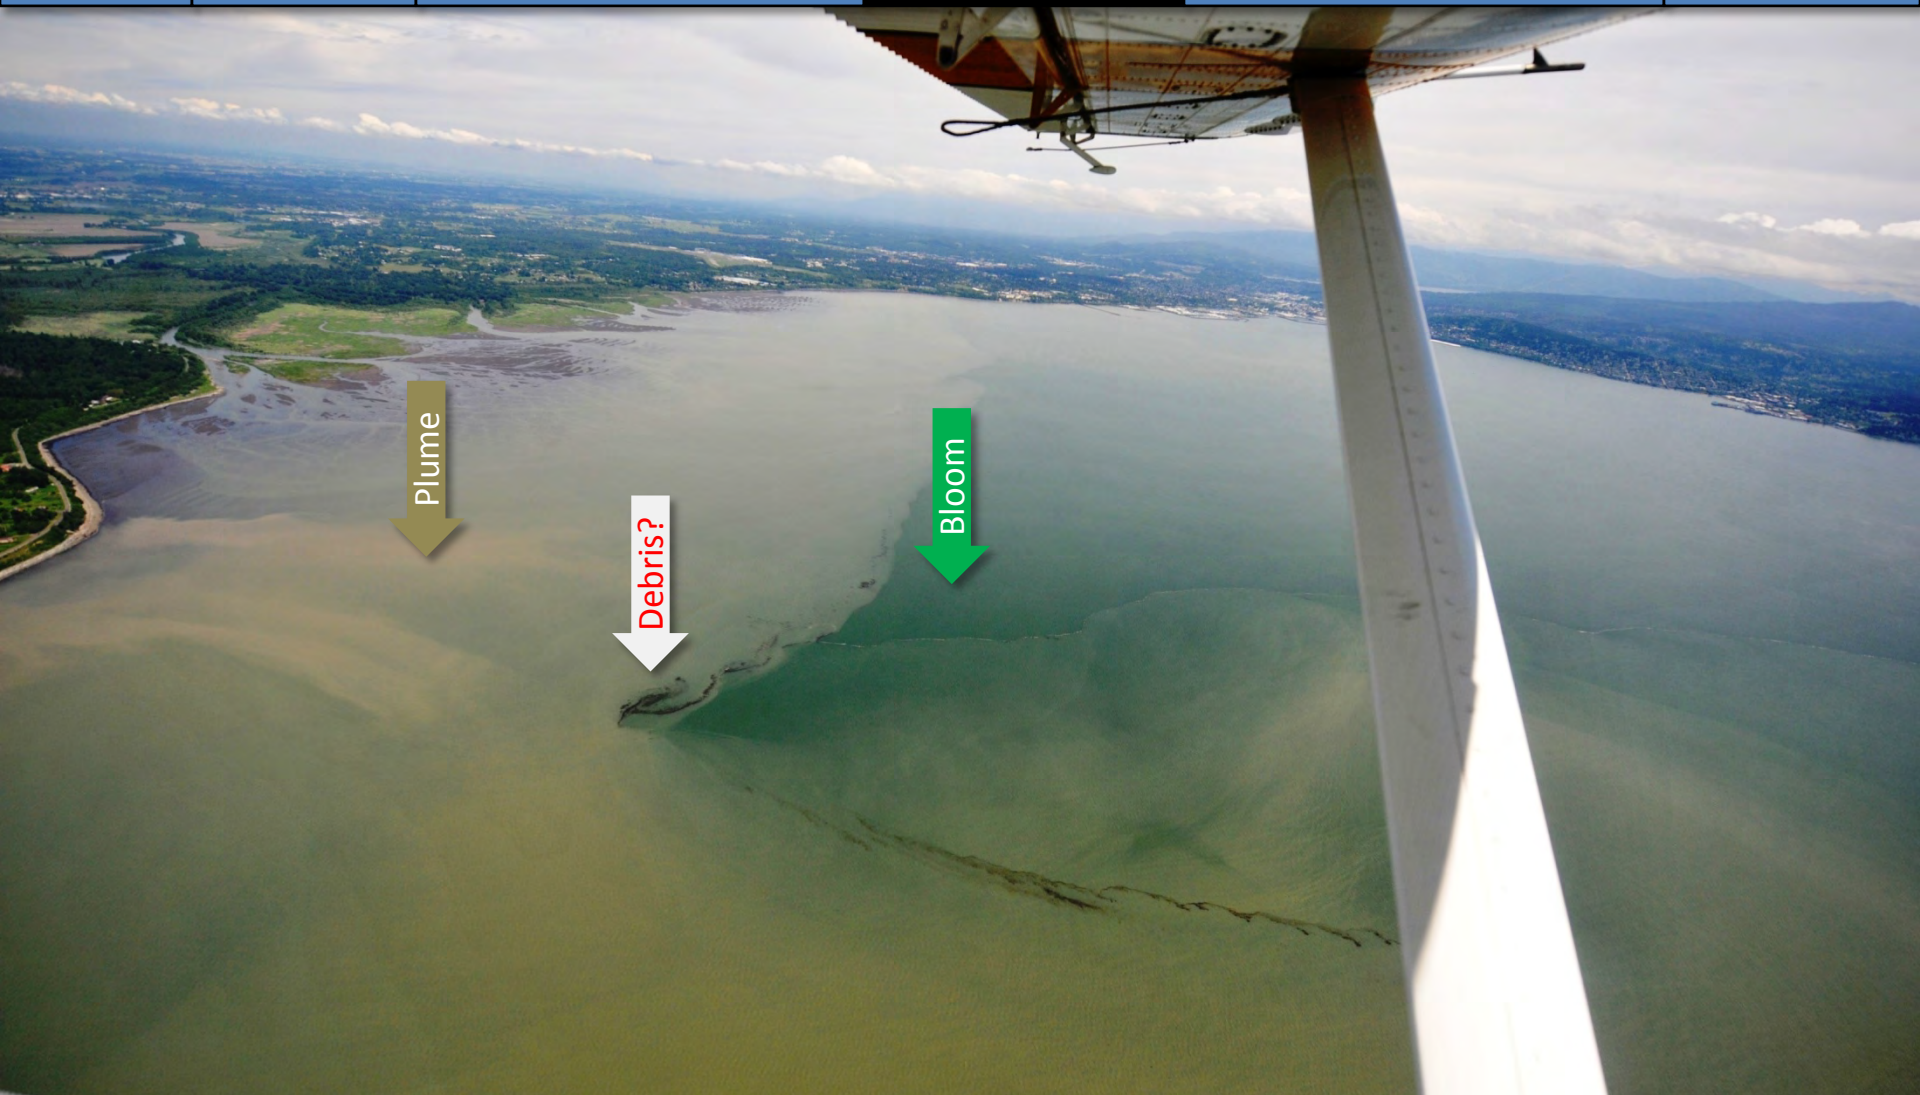
Location: Bellingham Bay, 1:19 PM

Sediment-laden river plume with black debris (kelp, plastic, oil?).
