Eyes Over Puget Sound

Surface Conditions Report May 20, 2013

Up-to-date observations of visible water quality conditions in Puget Sound and the Strait of Juan de Fuca

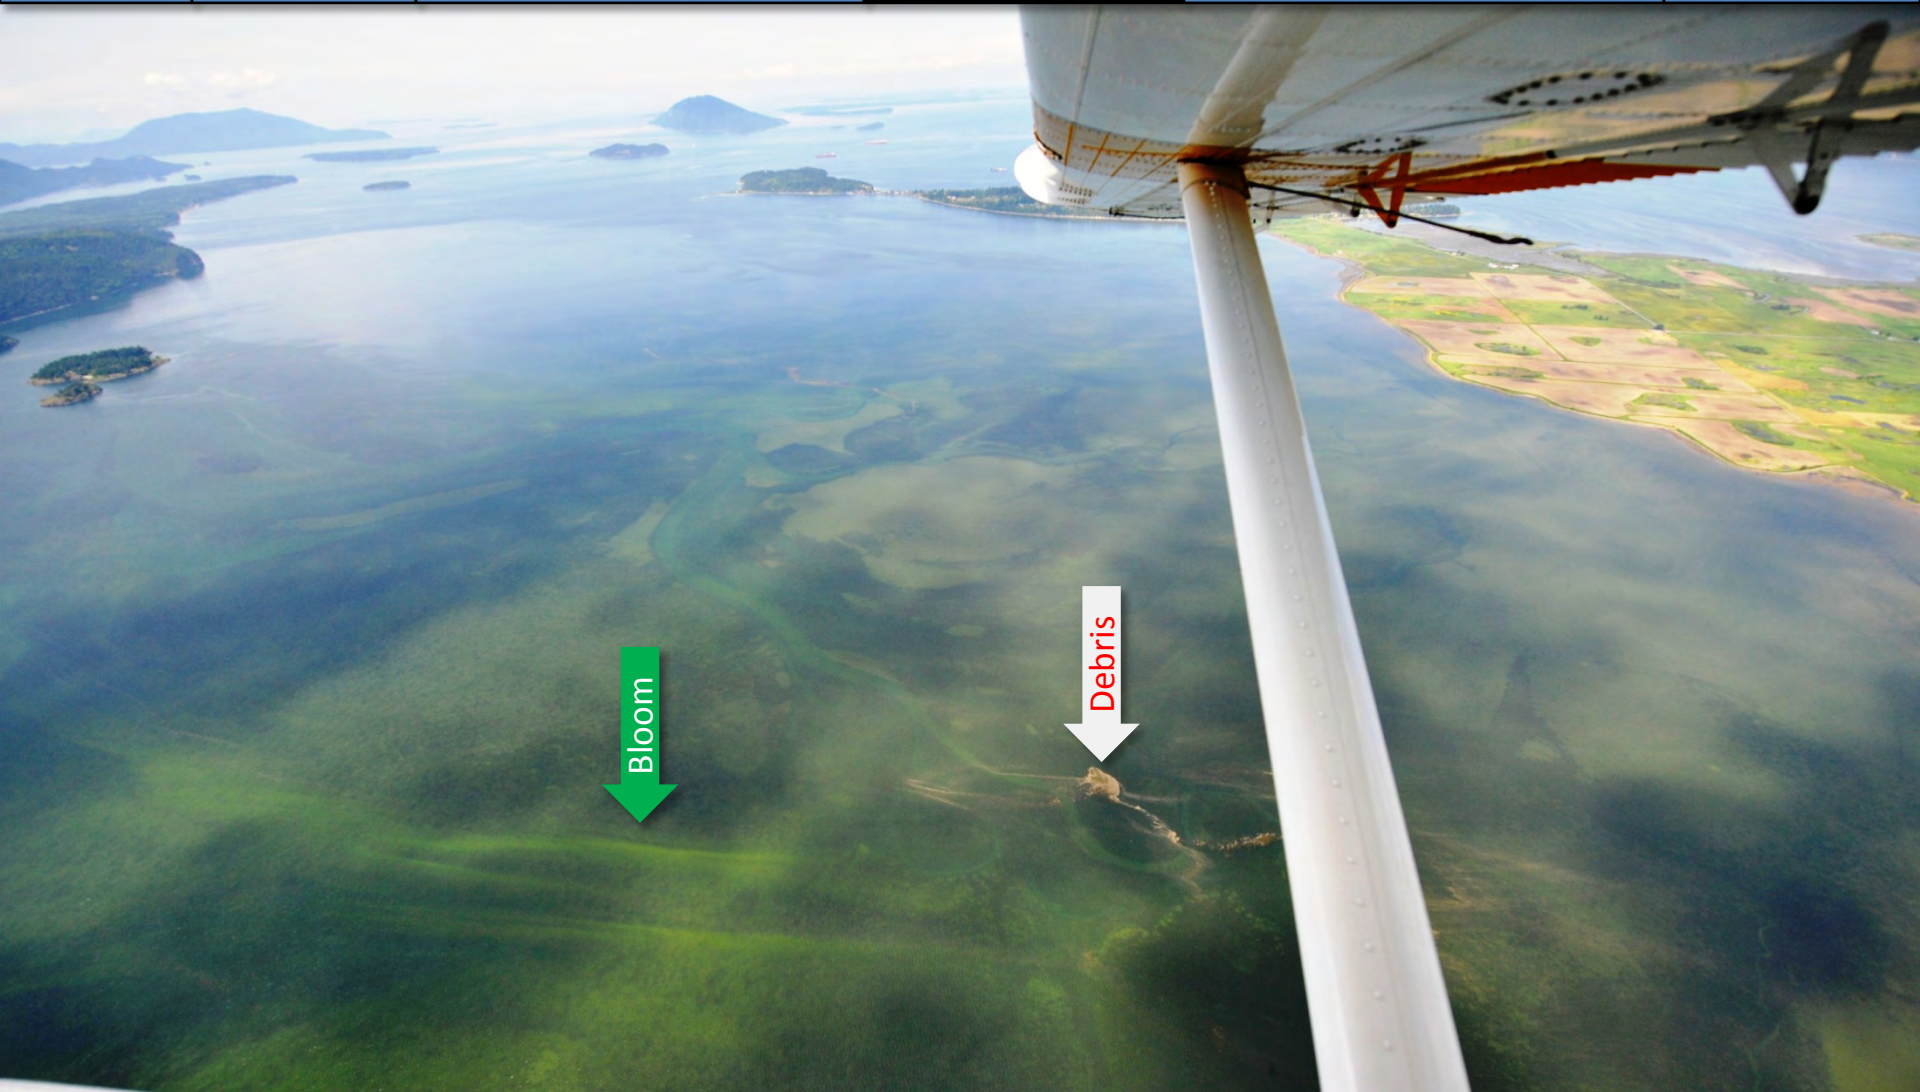
Bright green phytoplankton bloom and debris islands during high tide in shallow Padilla Bay.
Location: Padilla Bay, 2:00 PM

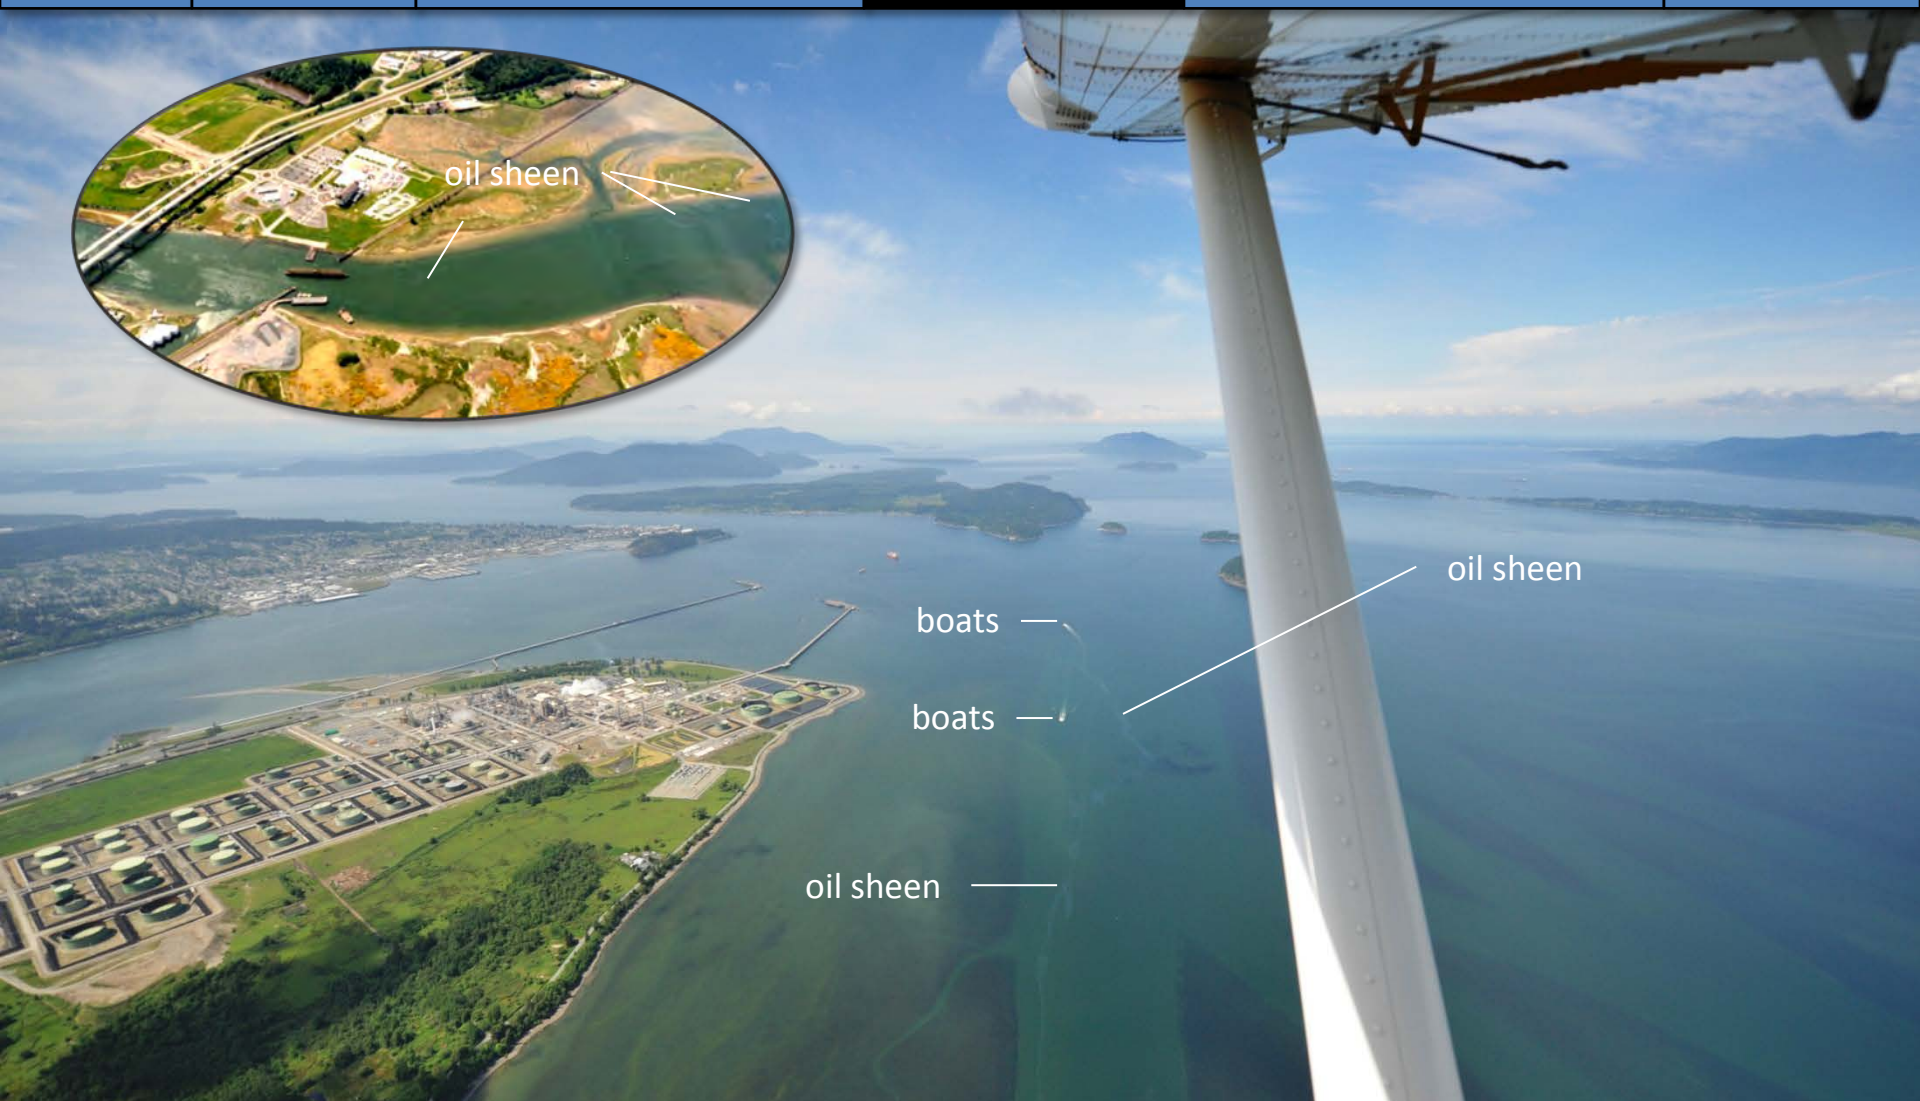
Location: Padilla Bay, 2:02 PM

Oil sheen stretching for miles originating near Twin Bridge Marina.

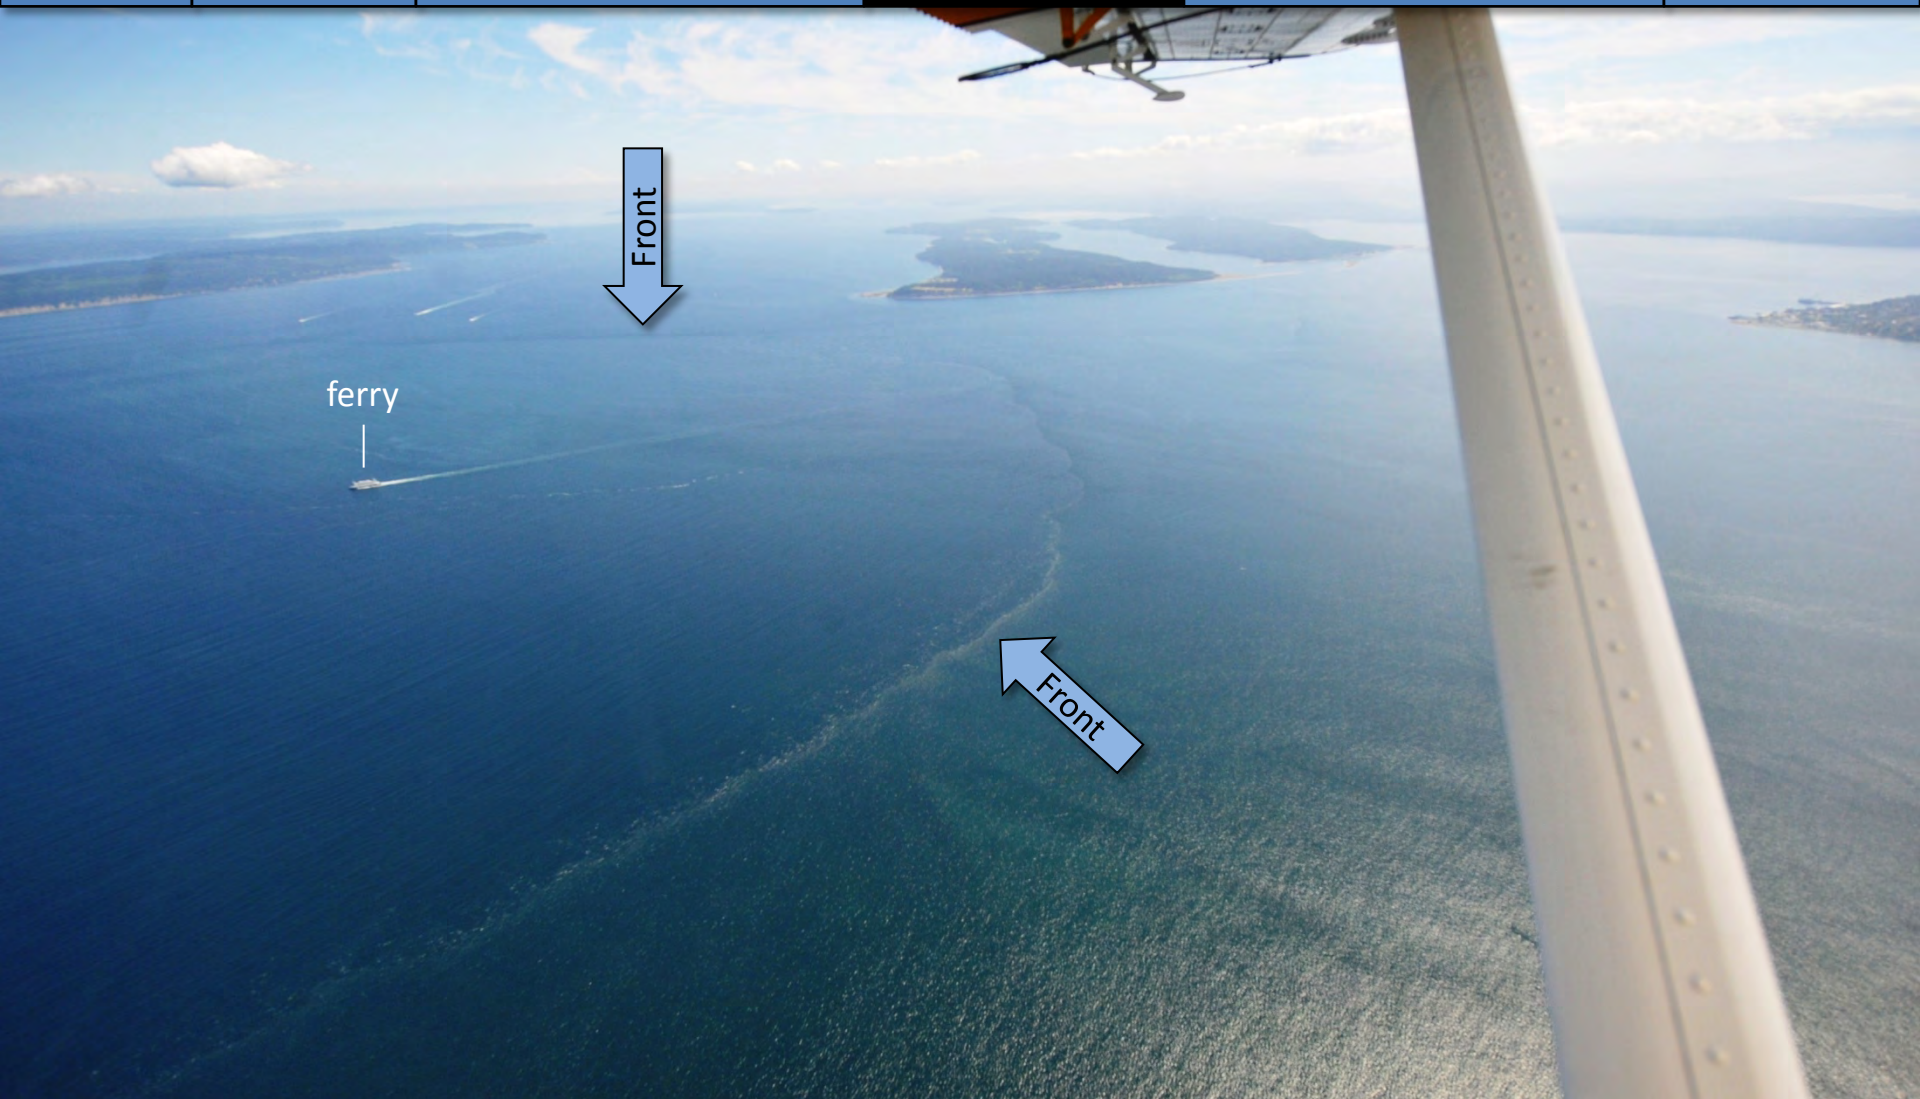
Long tidal front in Admiralty Reach.
Location: Admiralty Reach, 2:44 PM

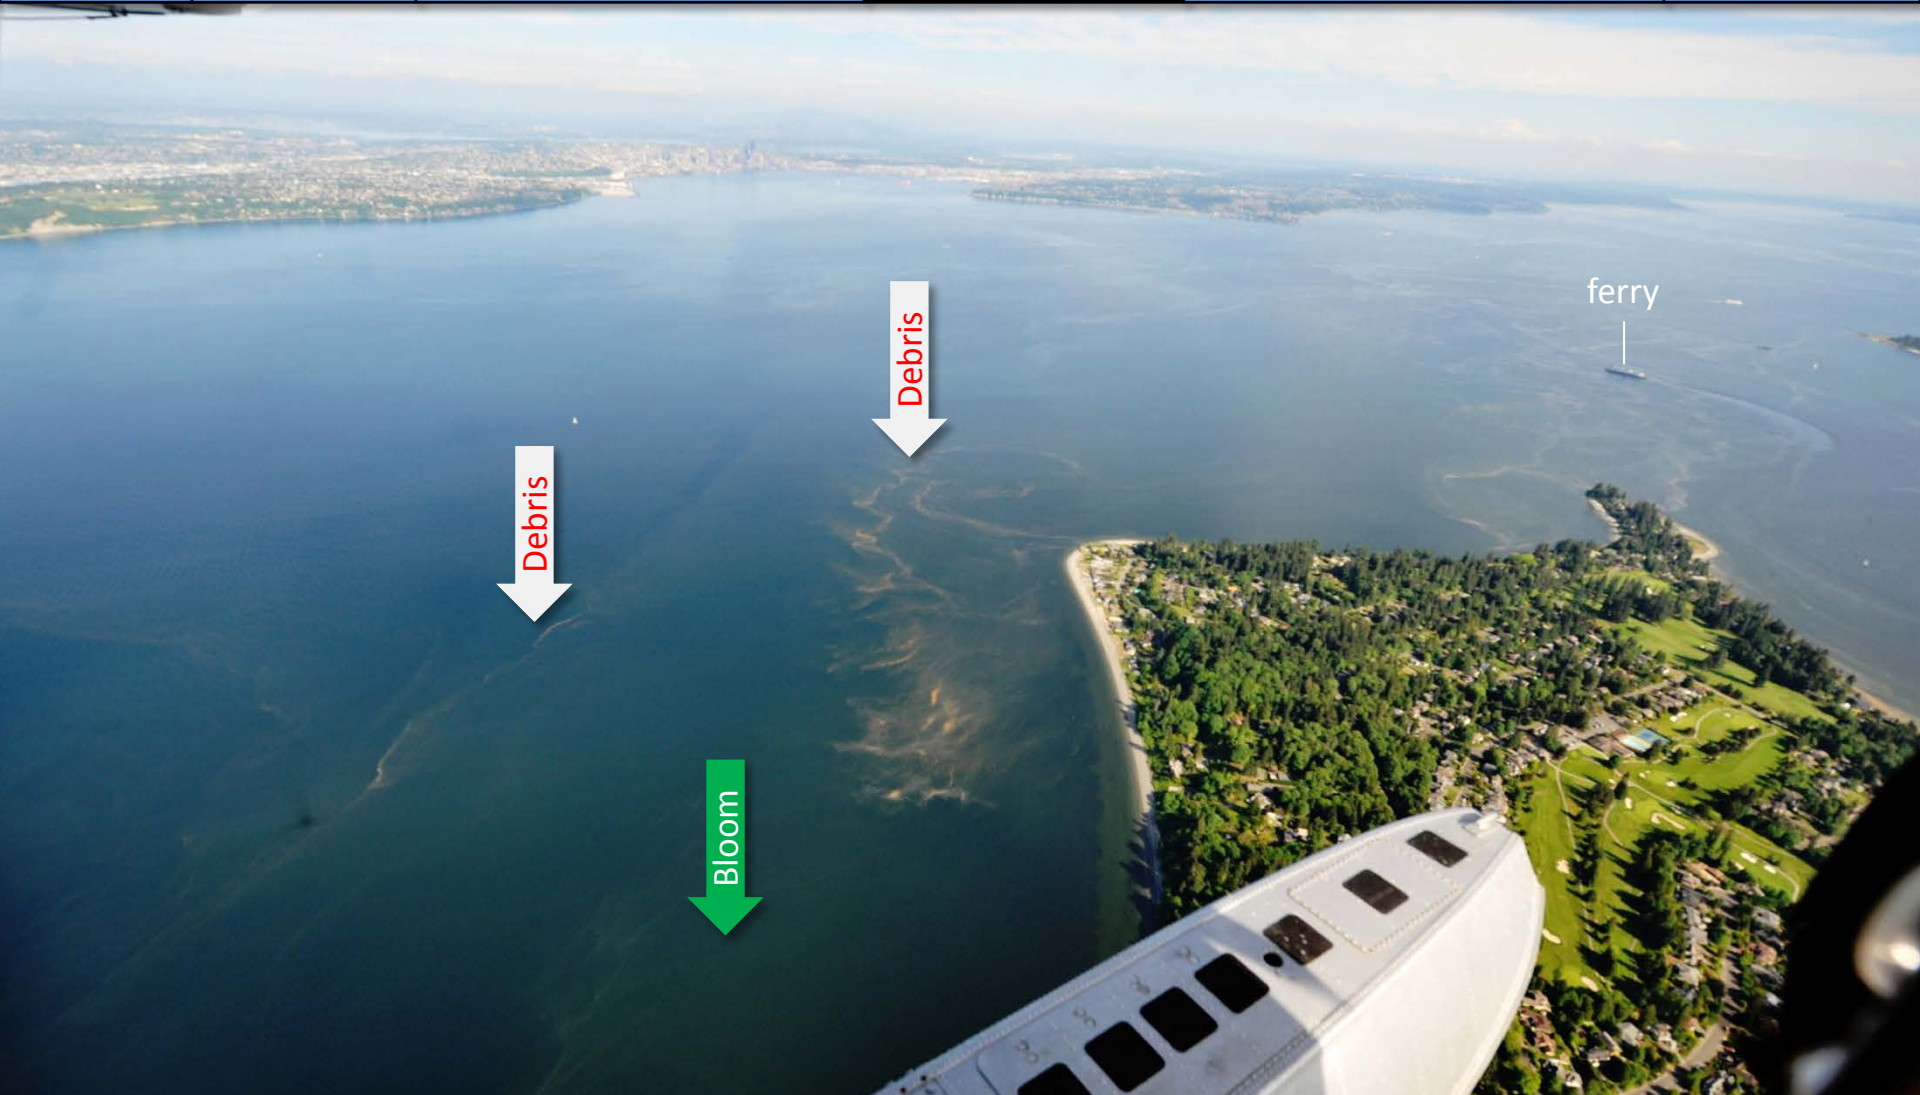
Location: Near Winslow, Bainbridge Island, 4:51 PM

Noctiluca bloom with Seattle to Bainbridge ferry in background.

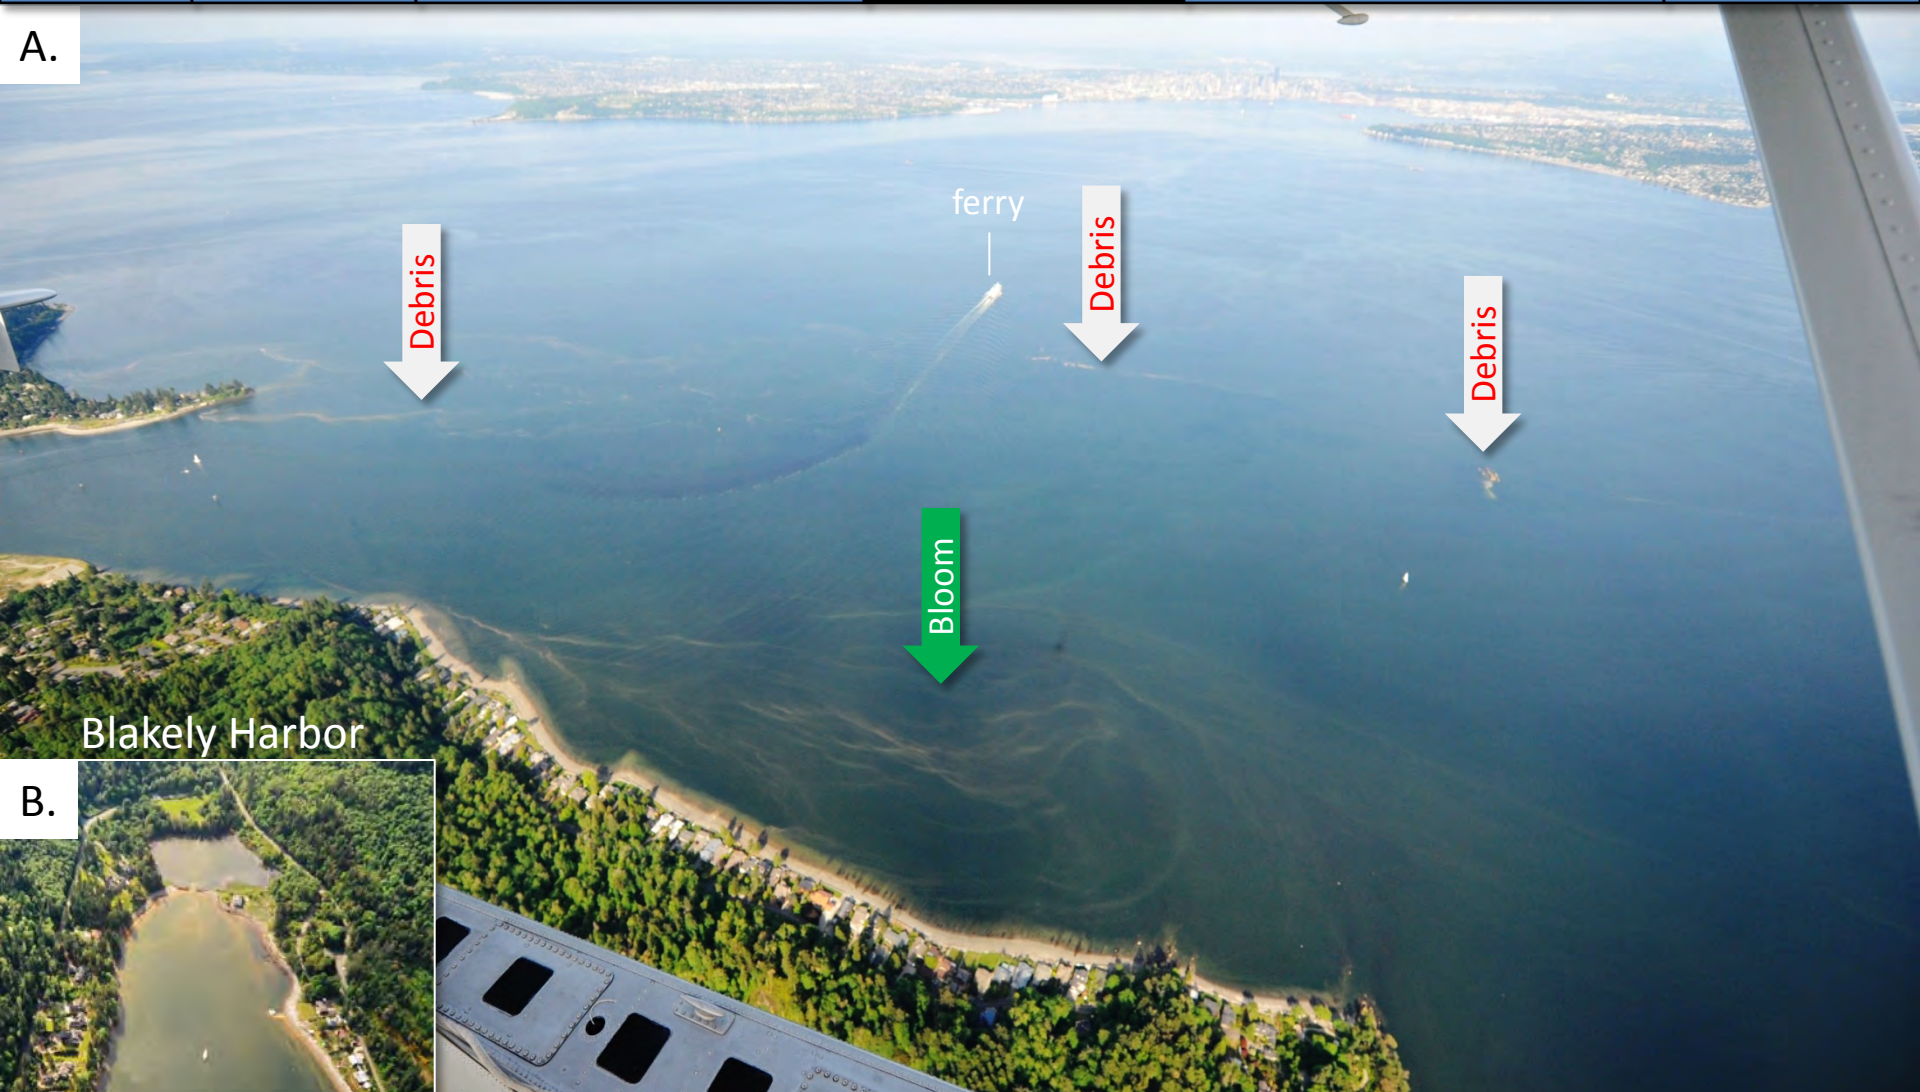
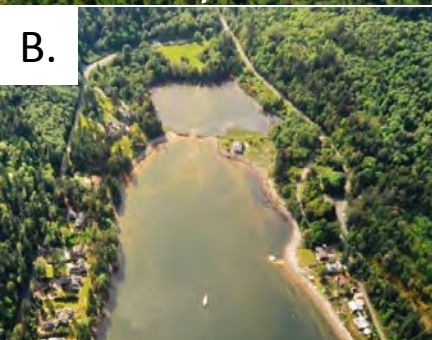
Location: Near Winslow, Bainbridge Island, 4:52 PM

A. *Noctiluca* bloom with Bainbridge ferry in background. B. Blakely Harbor.

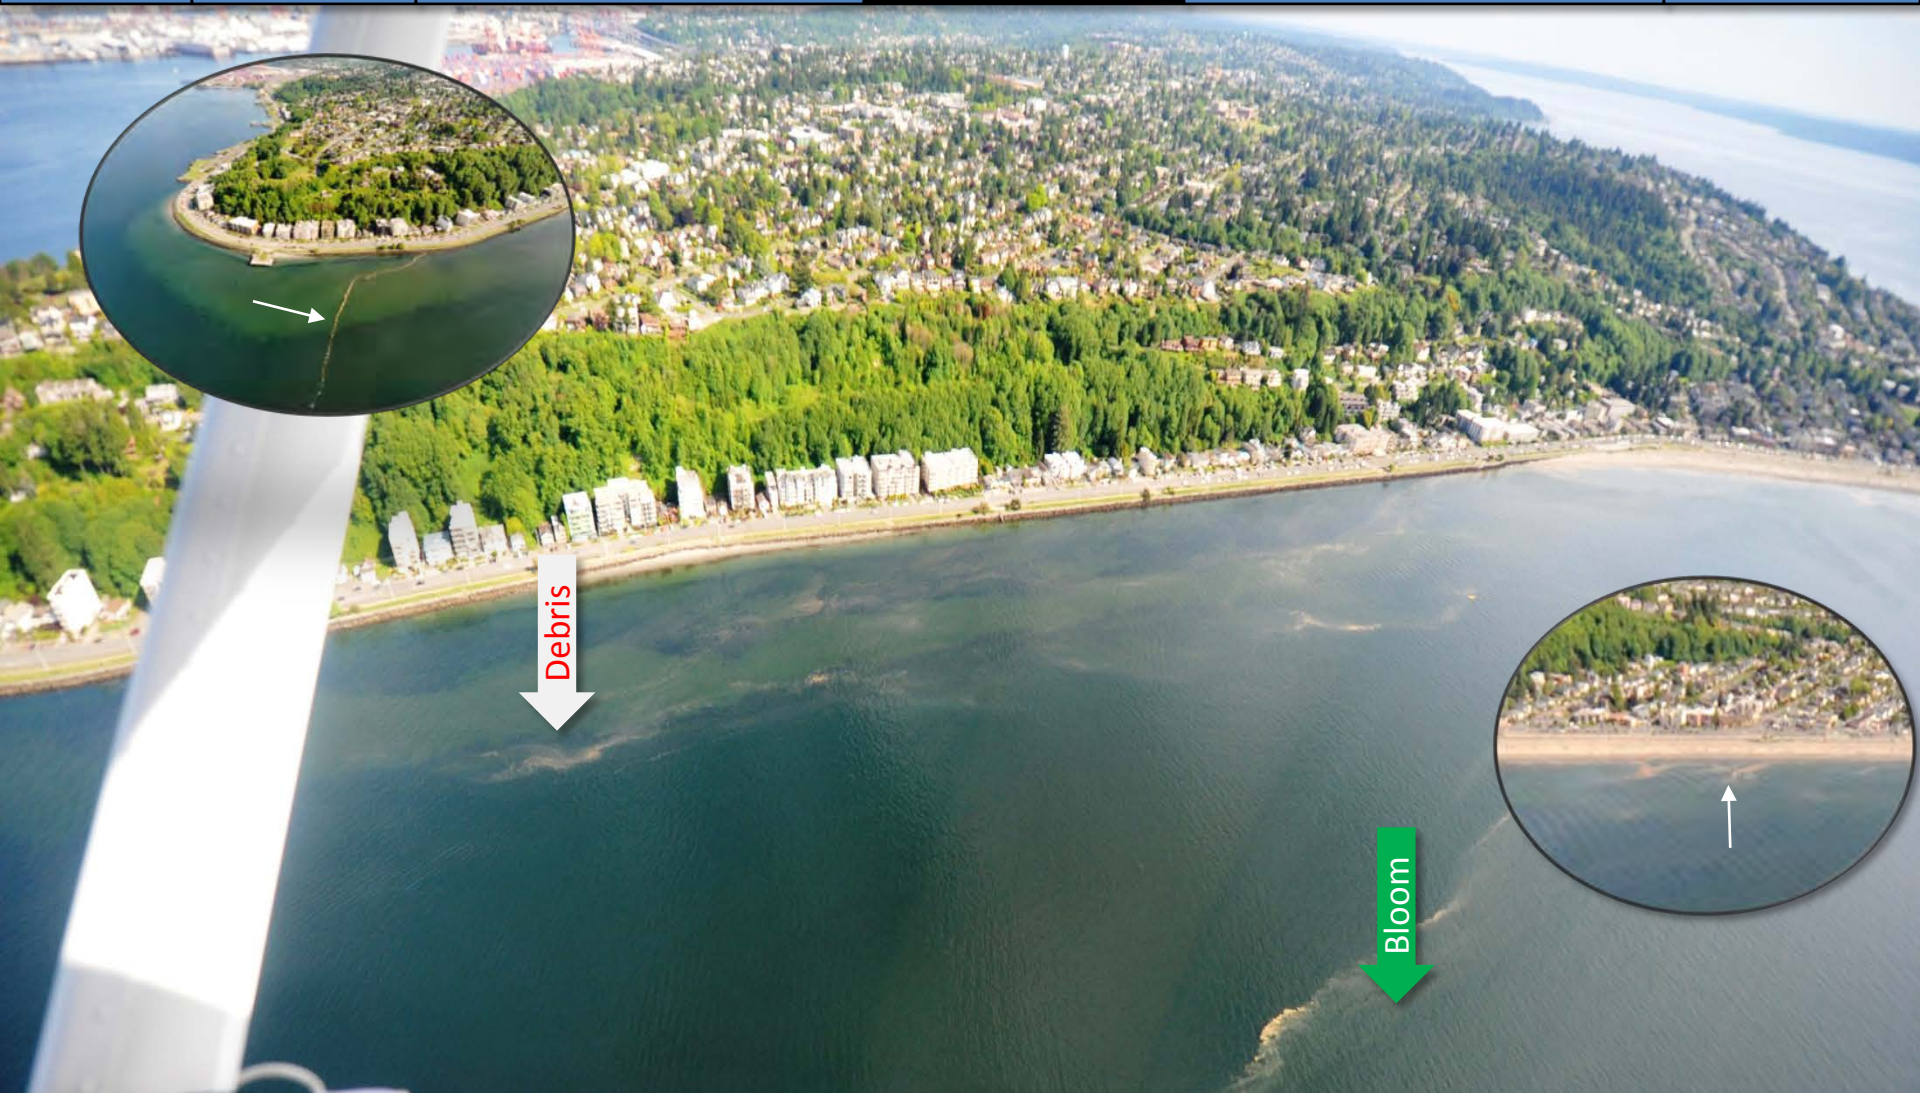
Location: Alki Beach, Seattle, 4:58 PM

Noctiluca bloom with West Seattle in background.

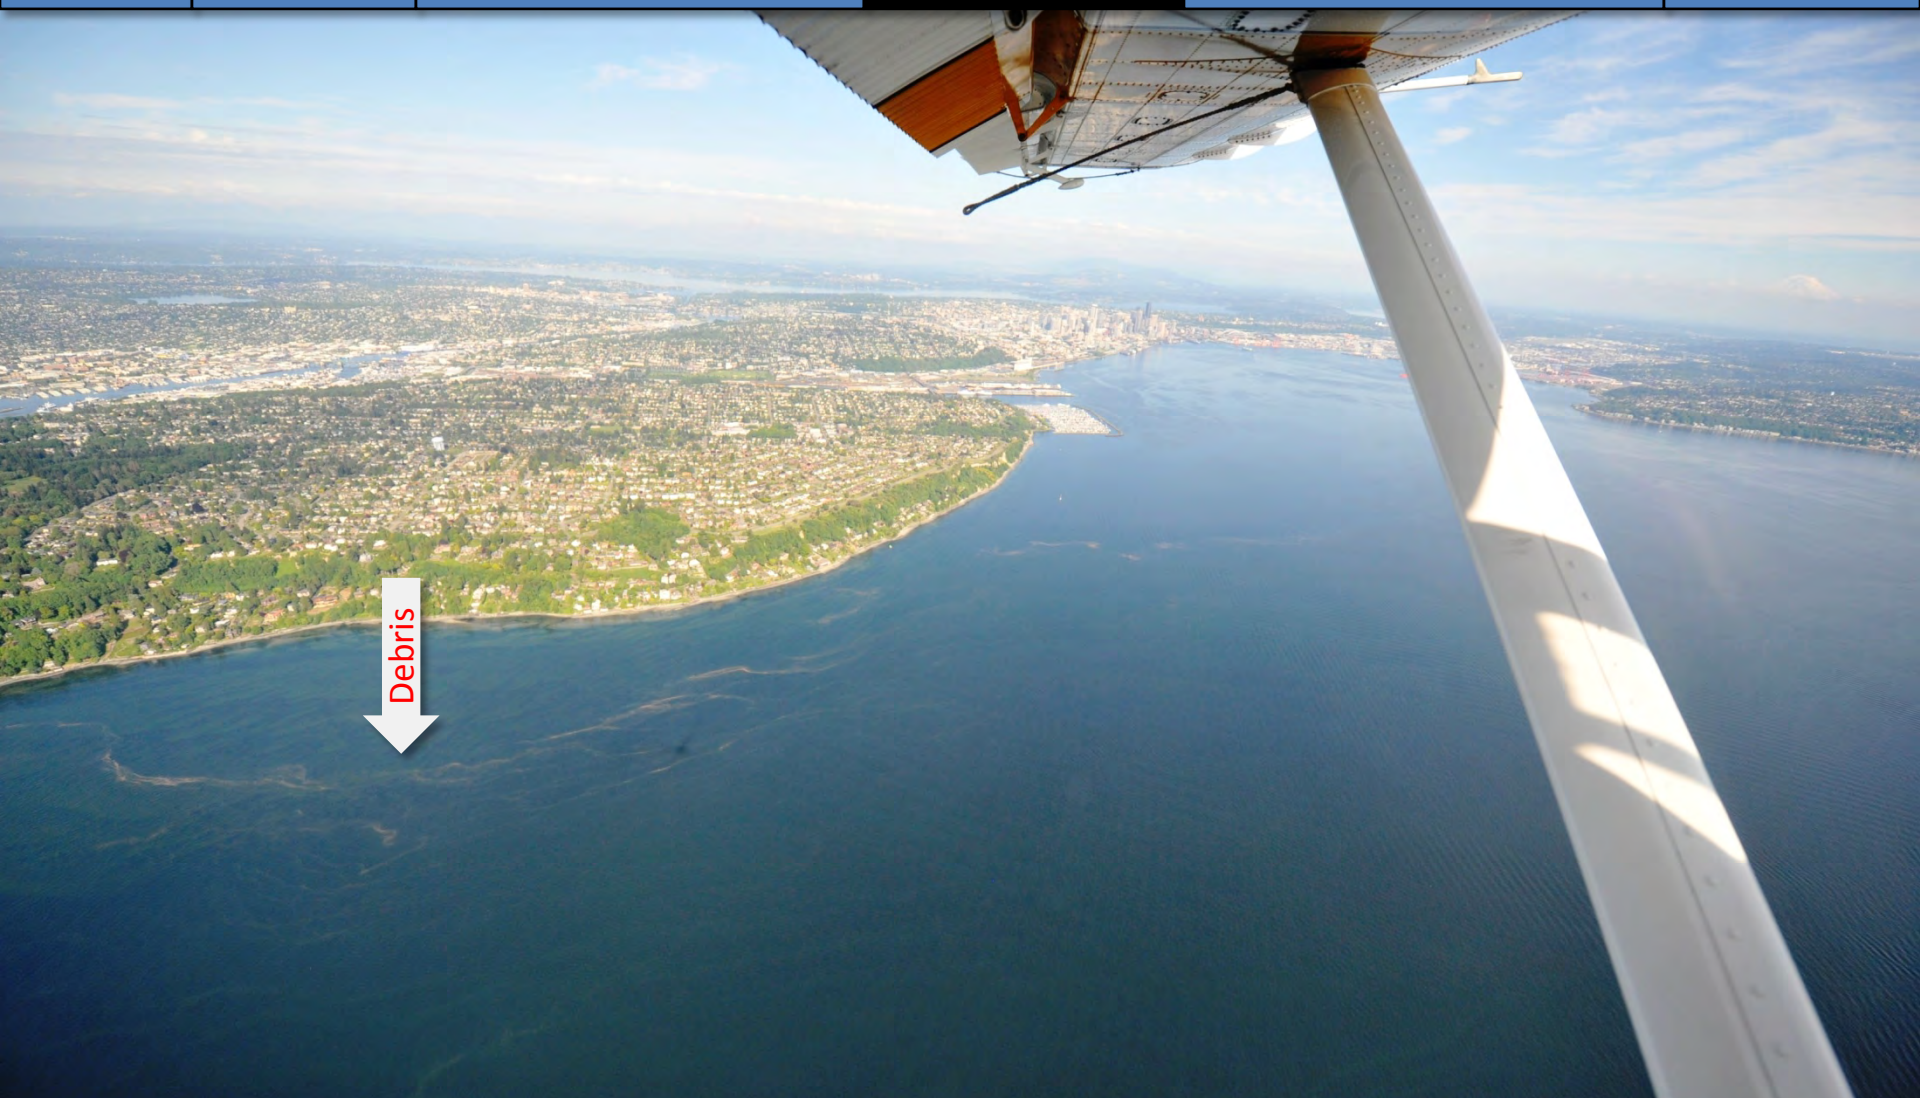
Noctiluca bloom with Elliott Bay in background.
Location: Off Magnolia Bluff, Seattle, 5:19 PM

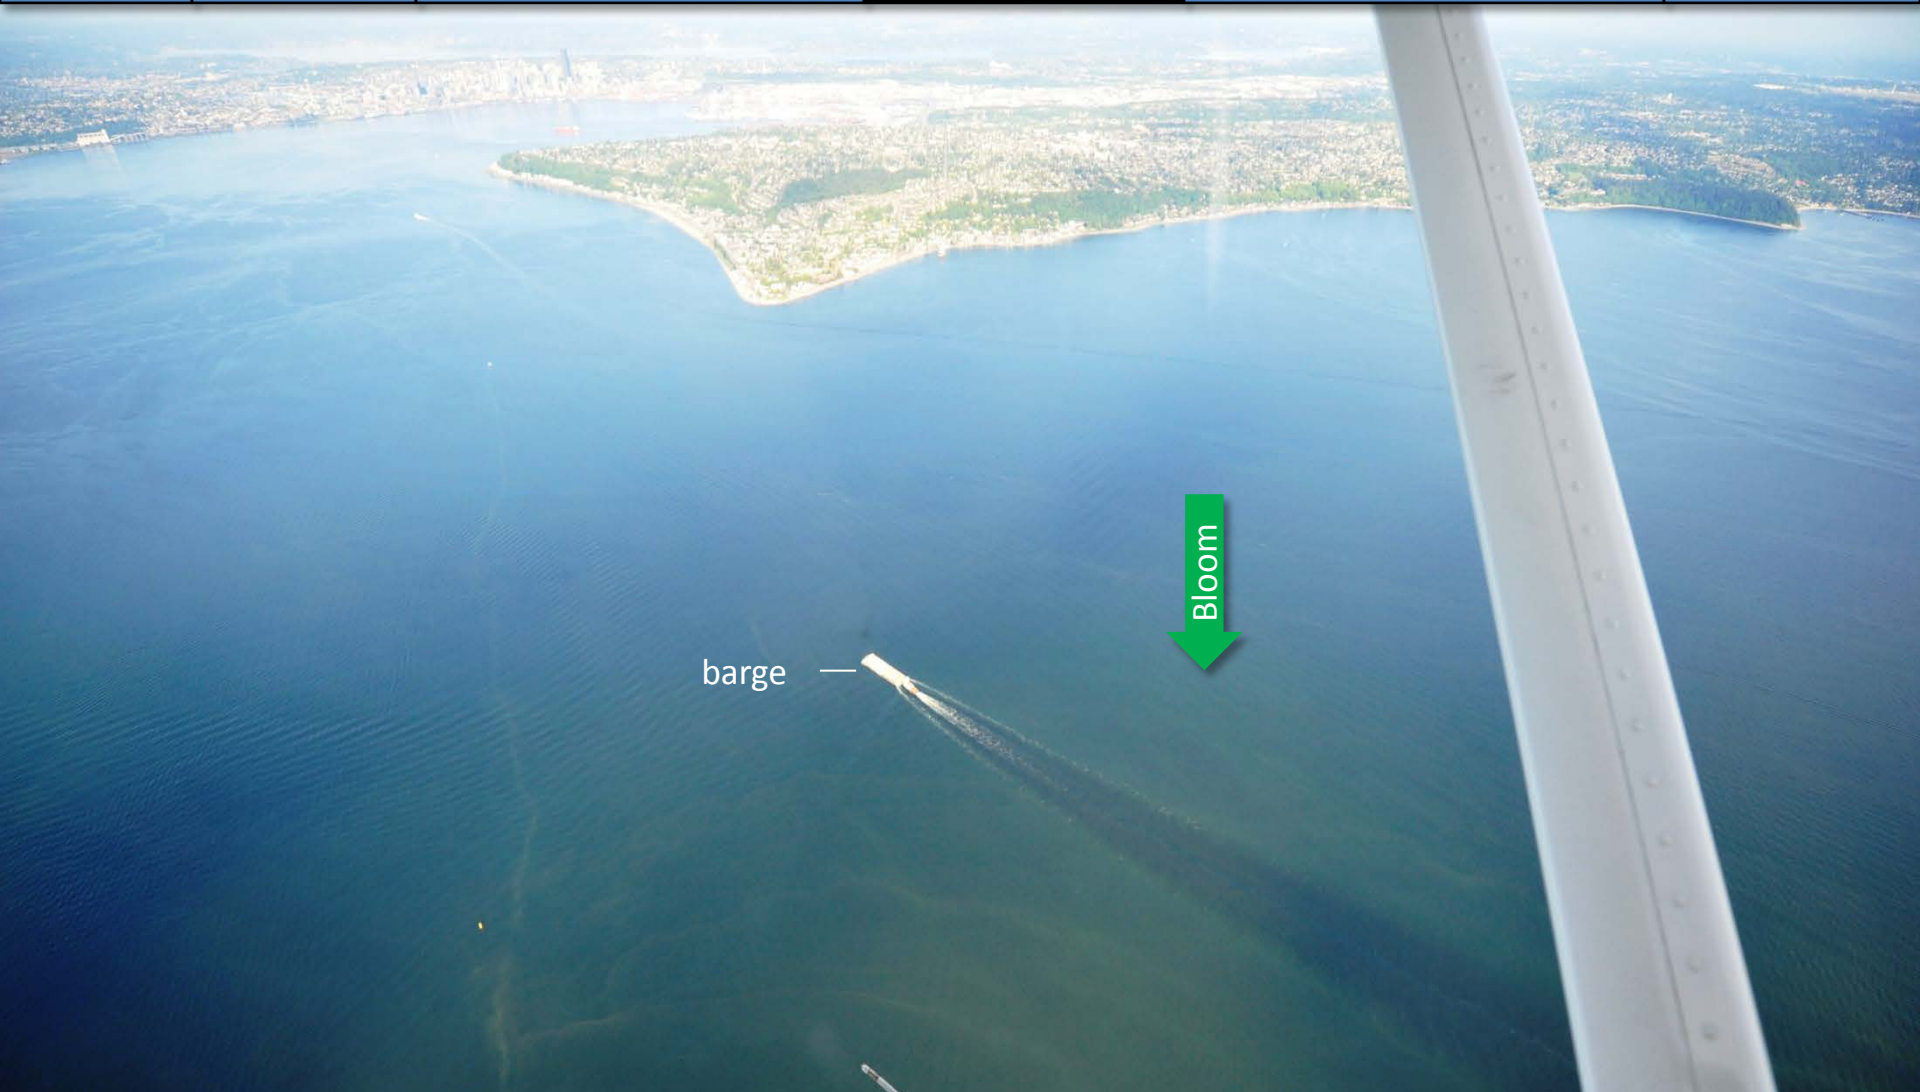
Wake of barge crossing bloom between West Seattle and Blake Island shows bloom is near the surface. Location: Main Basin, 5:22 PM

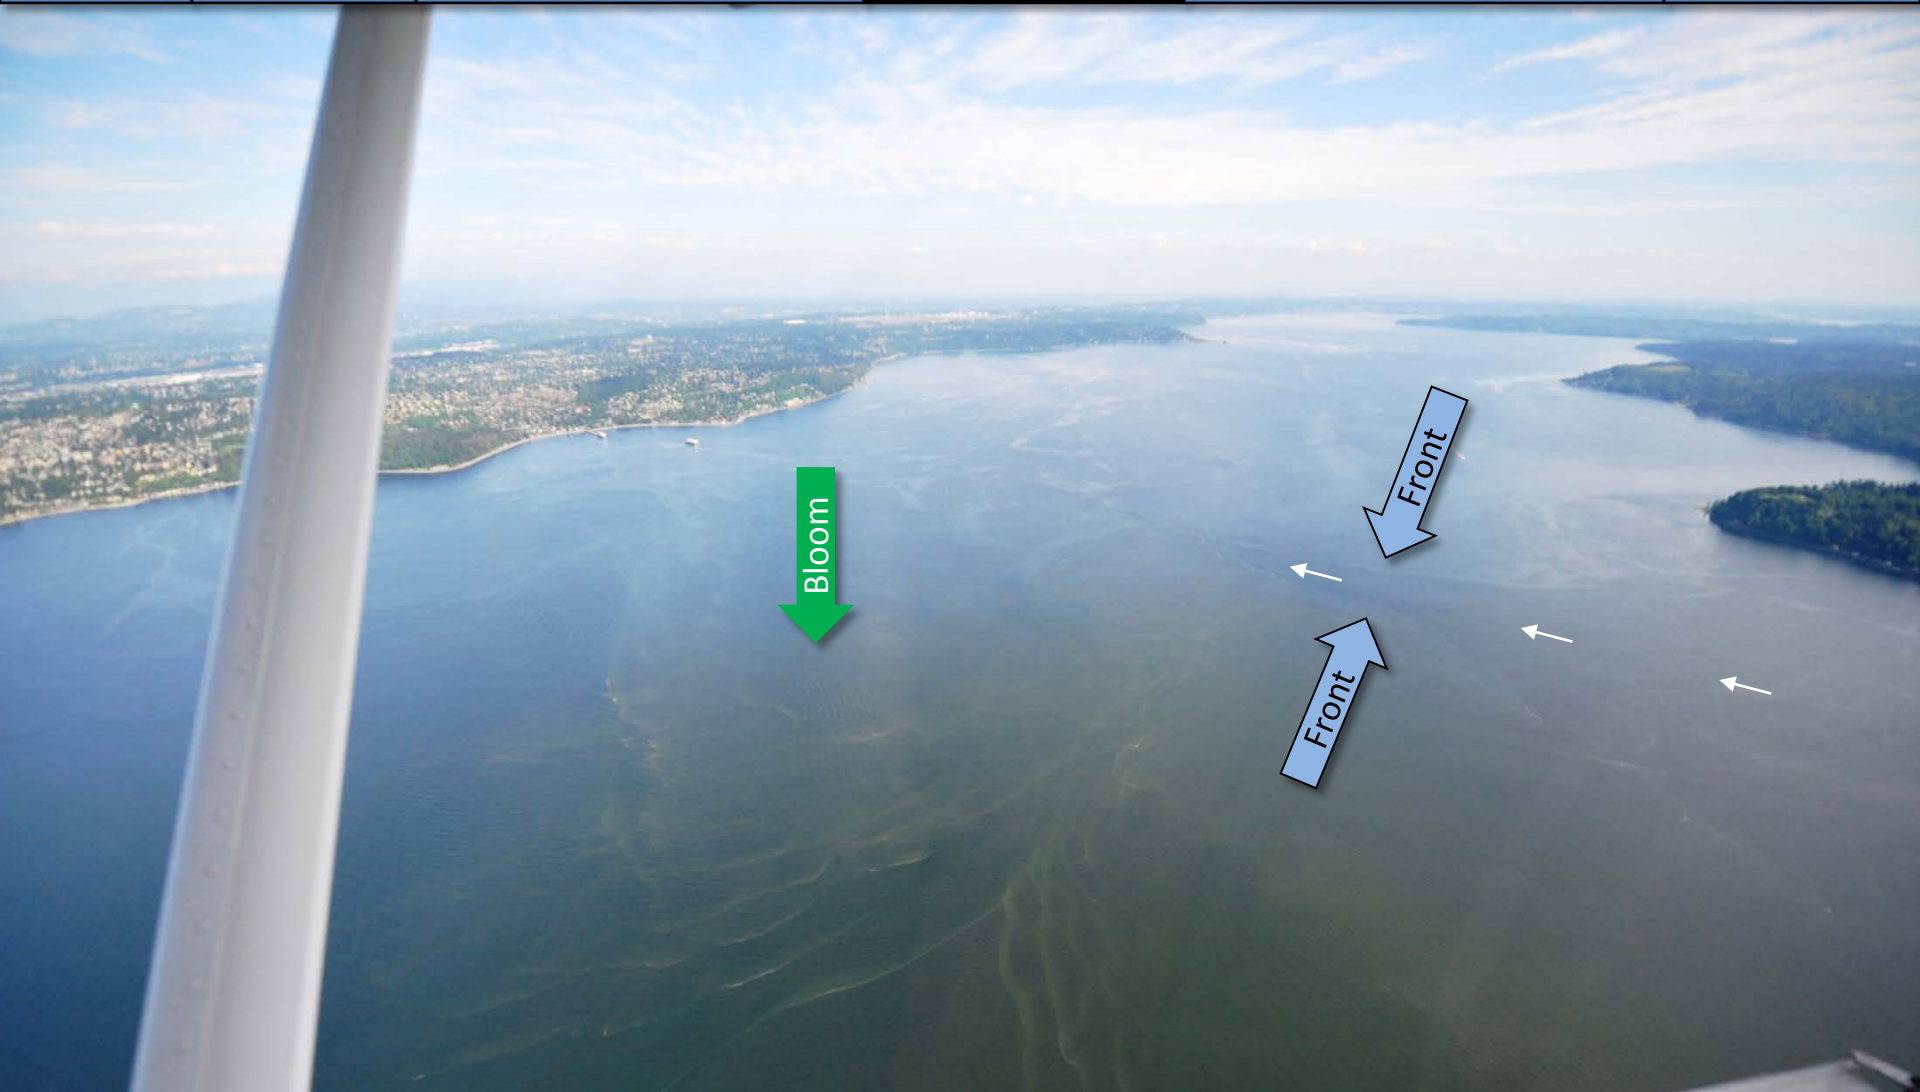
Red plankton bloom (likely Noctiluca) covering large parts of Main Basin, with clearer water moving in from west. Location: Between West Seattle and Vashon Island, 4:55 PM

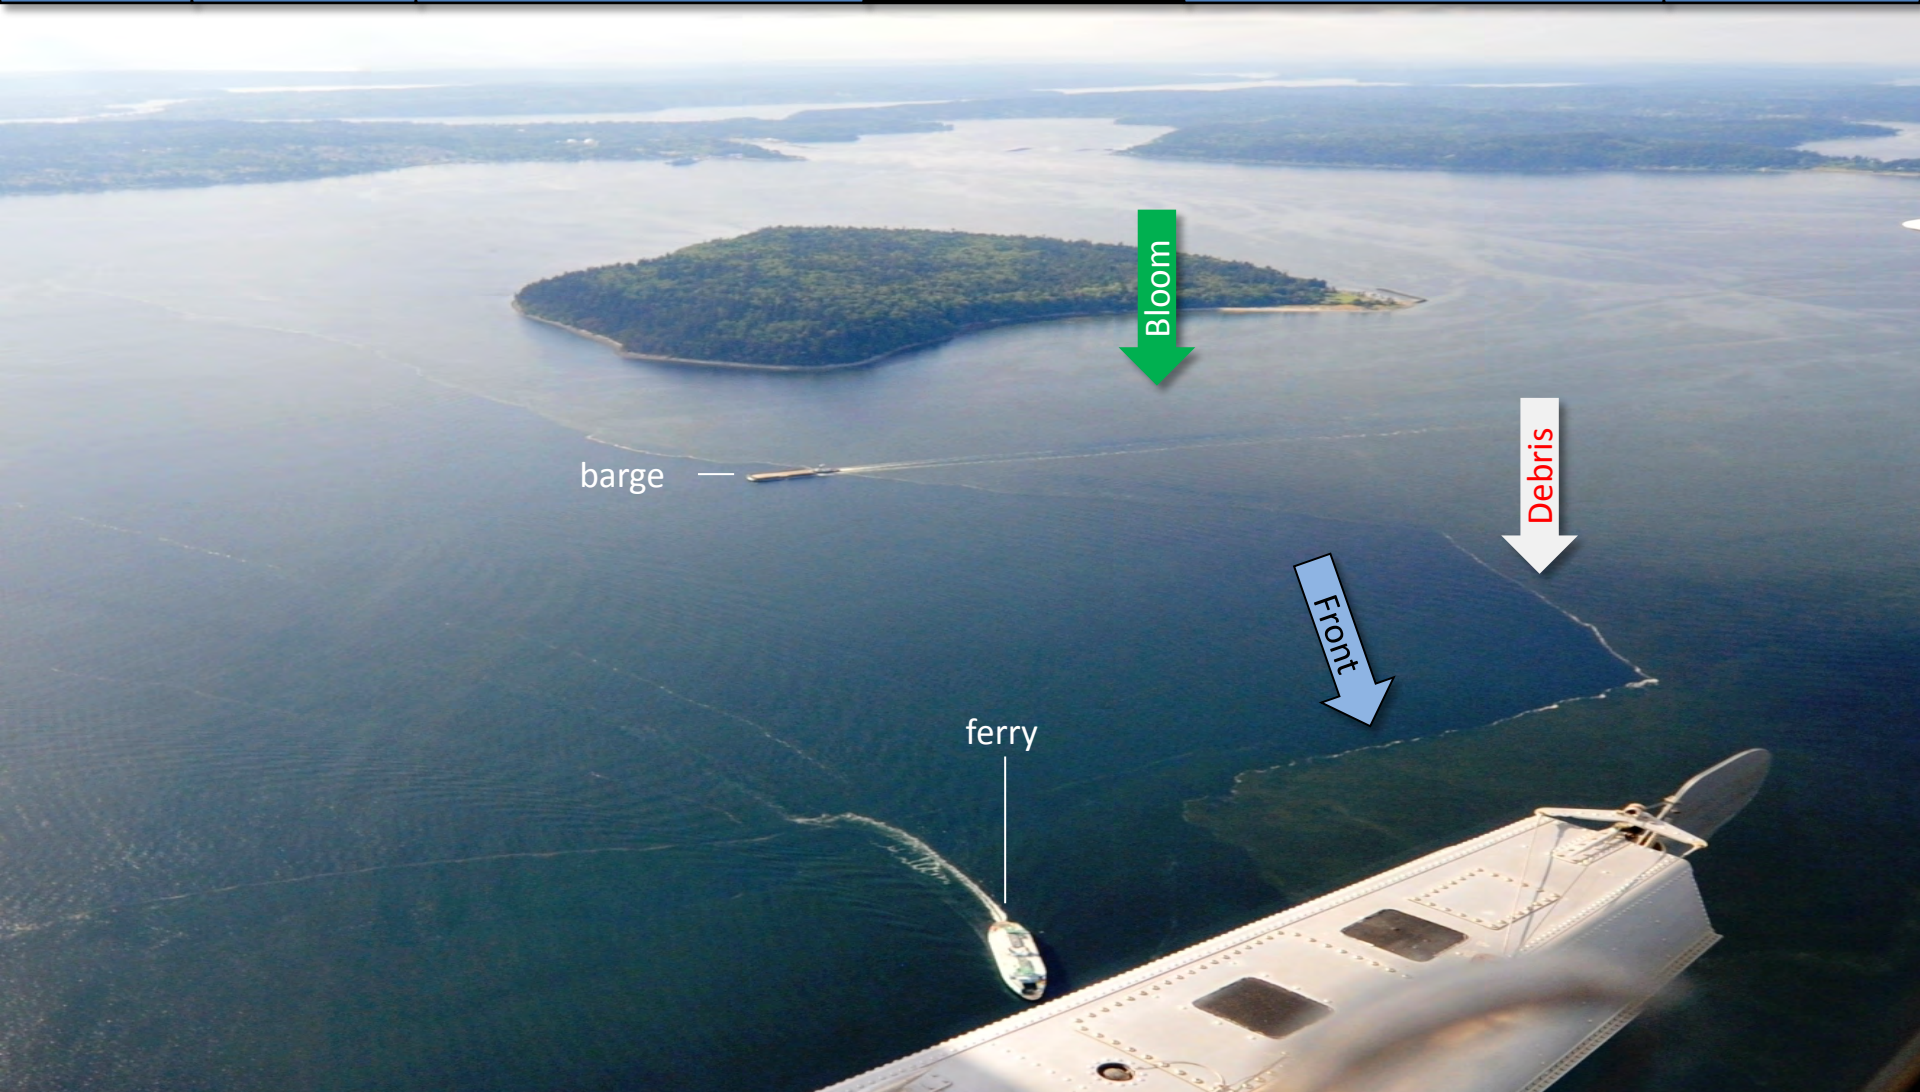
Location: Blake Island, Main Basin, 5:25 PM

Plankton bloom (likely Noctiluca) separated by sharp front and clear water.
