Eyes Over Puget Sound

Surface Conditions Report May 20, 2013

Up-to-date observations of visible water quality conditions in Puget Sound and the Strait of Juan de Fuca

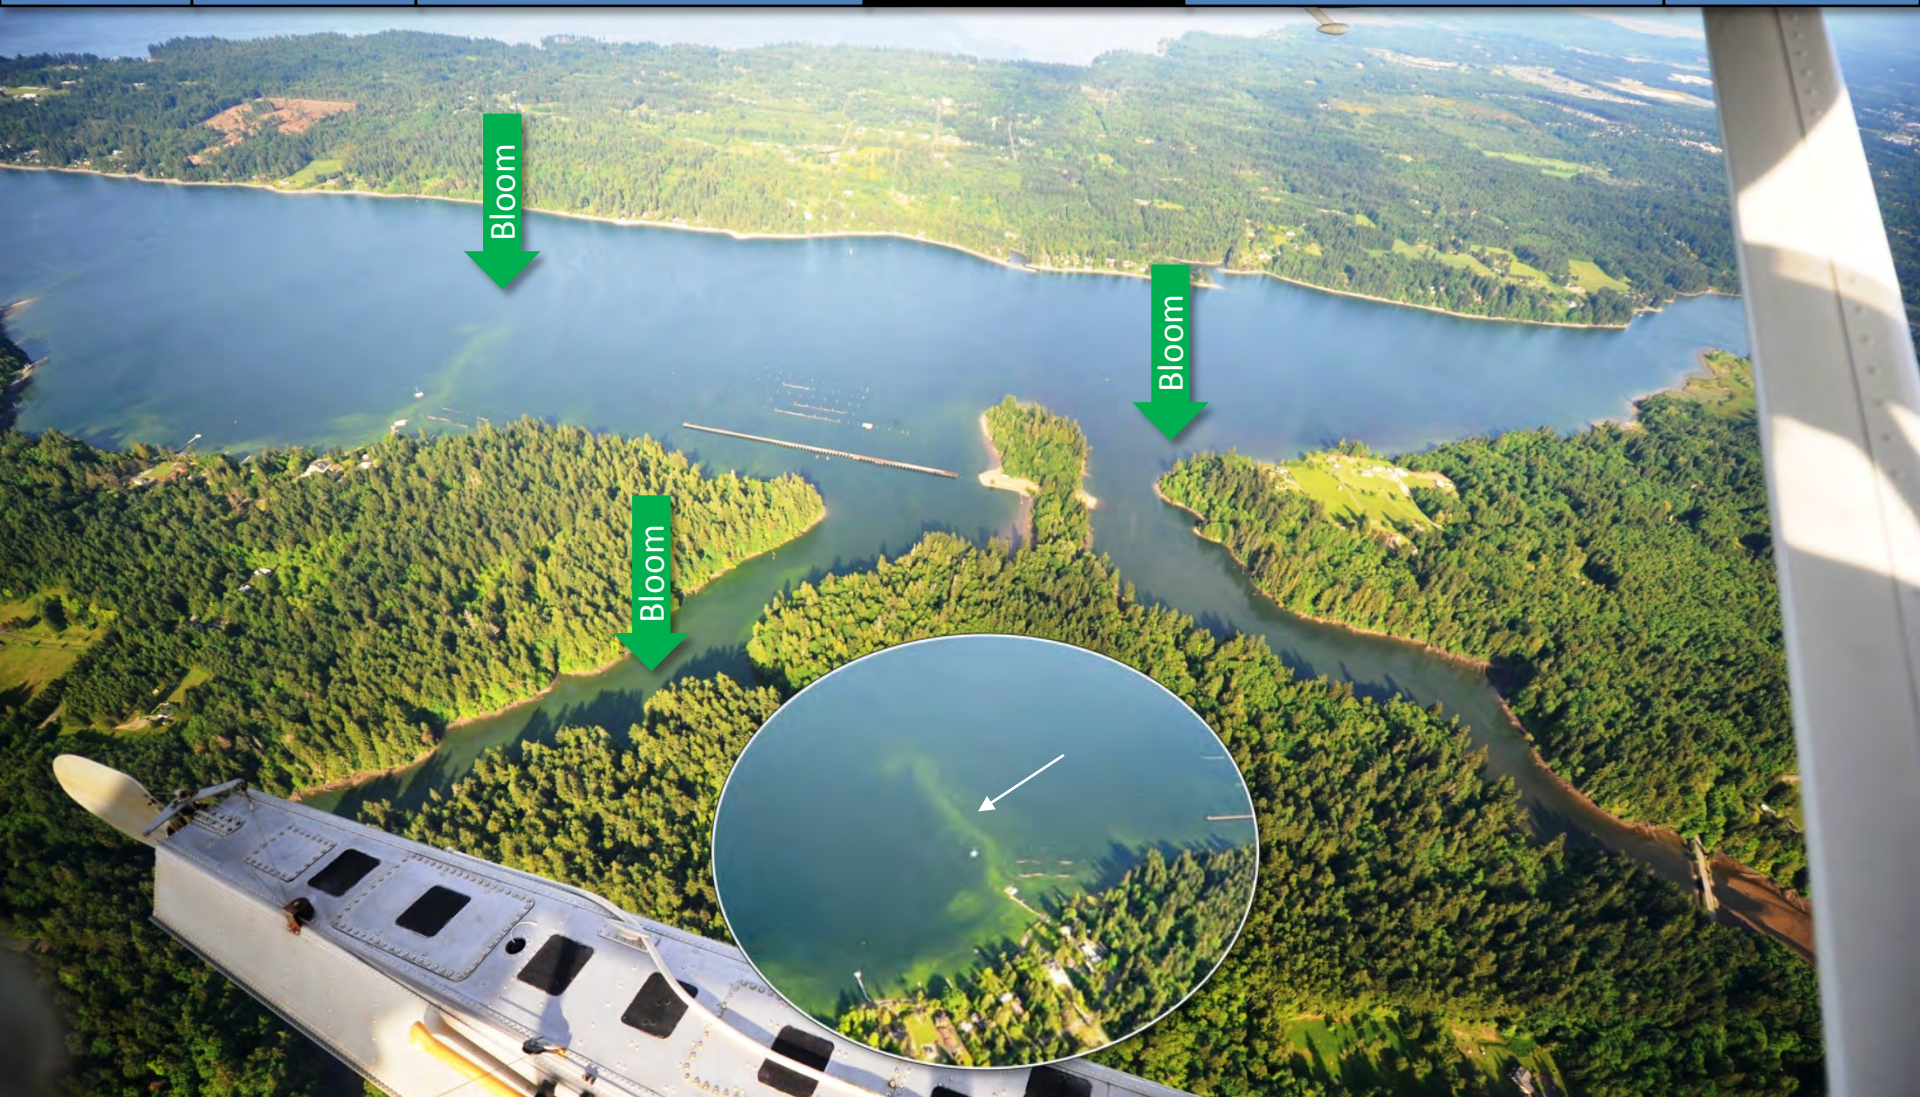
Green and red plankton bloom. Location: Henderson Inlet, 5:45 PM

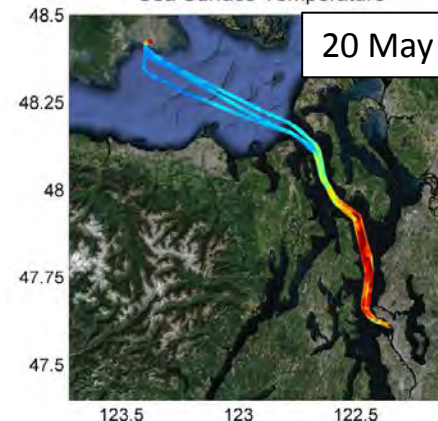
Sea Surface Temperature

Sea surface temperature (SST) is the water temperature close to the surface (2-3 m below). Warm colors show higher SST.

Warm, fresh water entering central Puget Sound from Whidbey Basin. Sea surface temperatures > 15 °C. Moderate fluorescence in Elliott Bay, south of fresh water plume.

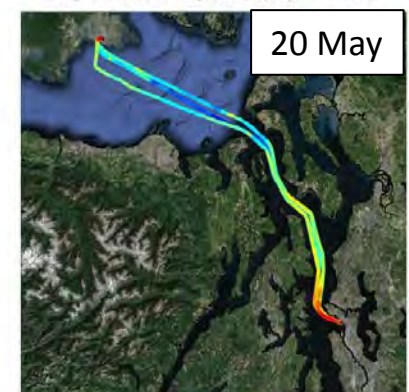
Algal Biomass (Chlorophyll Fluor.)

Chlorophyll a fluorescence gives an estimate of algal concentration/biomass. Warm colors show larger concentrations.

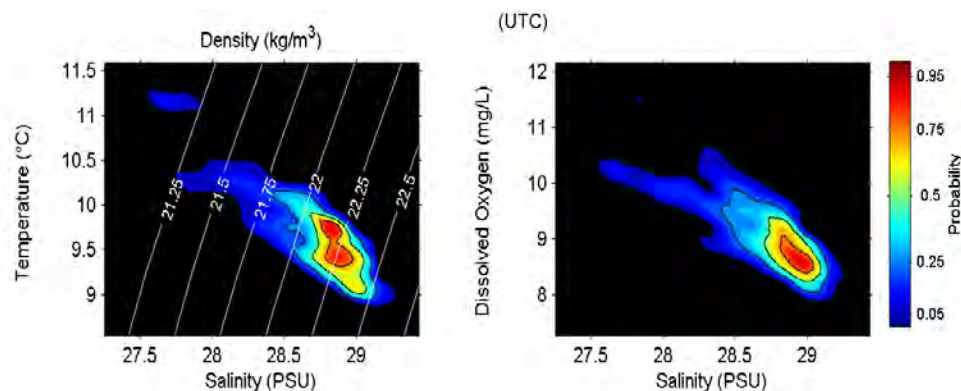
Left Panel: Probability of finding a specific density over the past two-week period. High probability shown in warm colors.

Right Panel: Dissolved oxygen concentration in relation to salinity. High probability shown in warm colors.

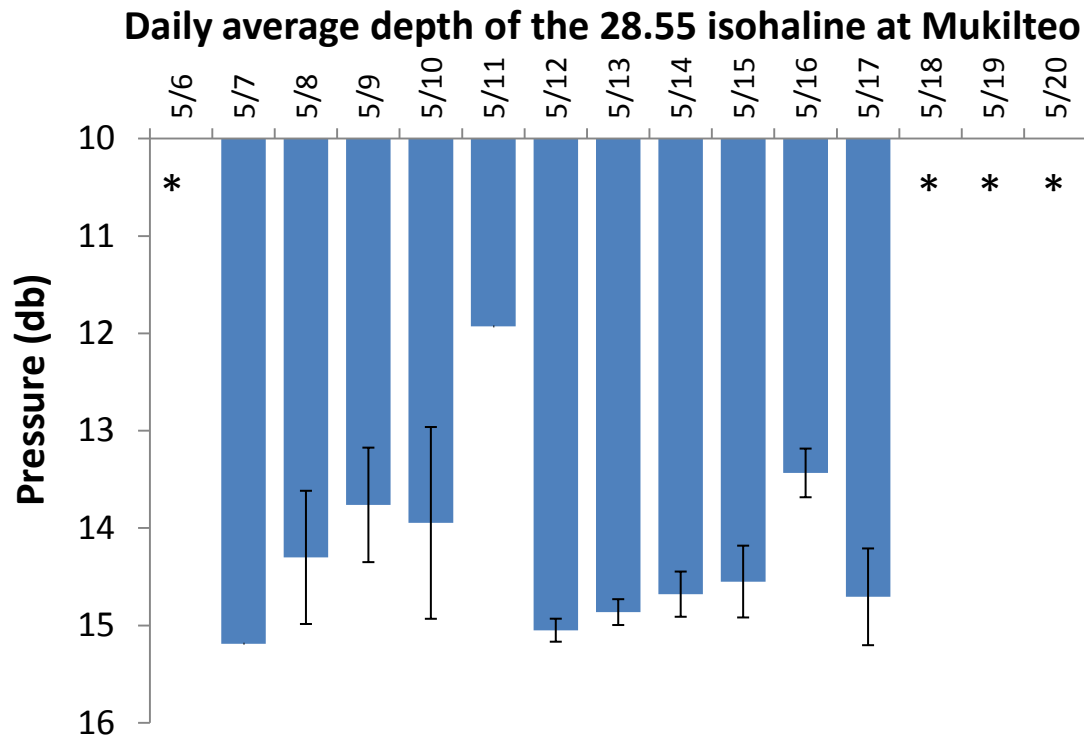
Summary: The depth of freshwater layer varies around 14 – 15 m and is about 1 – 1.5 m deeper than the previous month in response to higher than normal river flows.

We report on thickness of the freshwater layer by monitoring our near-surface sensor. This is another way to interpret the amount of freshwater entering Puget Sound.

We track the depth of the isohaline where salinity is 28.55 (± 0.05) to measure the thickness of the freshwater layer at our Mukilteo station. The near-surface sensor experienced tidal pressure variations of 11.0 to 16.0 meters (or decibars).

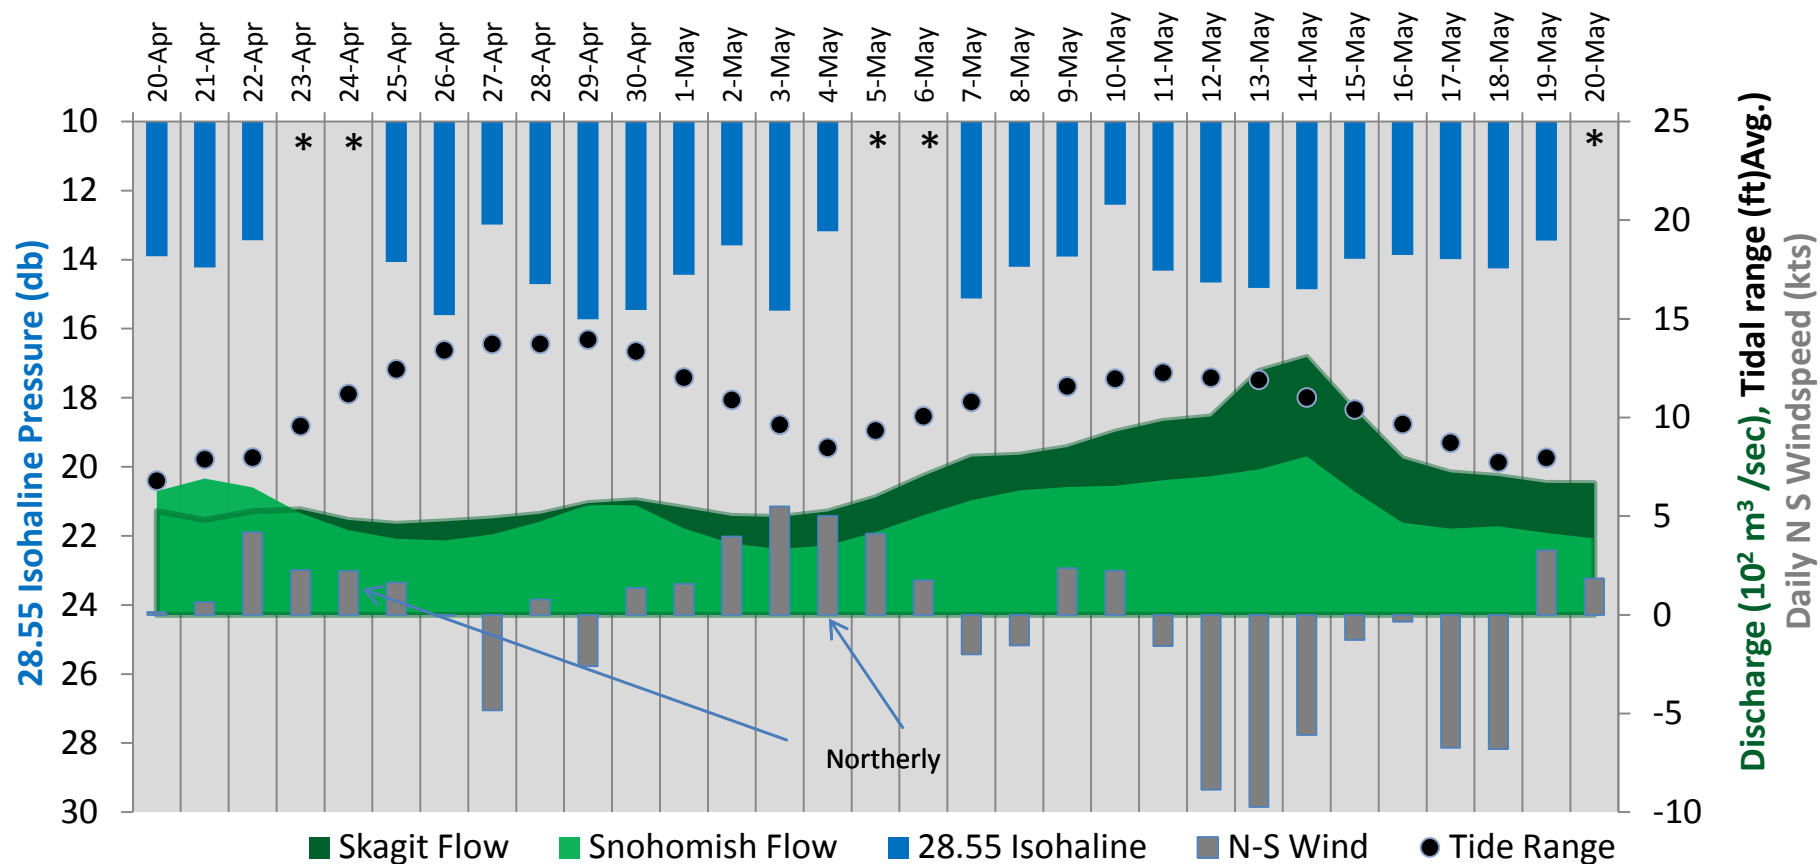
Thickness of freshwater layer at Mukilteo and influencing factors

In May at Mukilteo, the thickness of the freshwater layer showed no clear response to river flows or winds. Factors influencing the thickness of the freshwater layer include: mixing with tide changes, wind (speed, duration, and direction), freshwater discharge and the fortnightly tidal cycle (tidal range).

(*) The pycnocline is shallower and outside our monitored depth range.

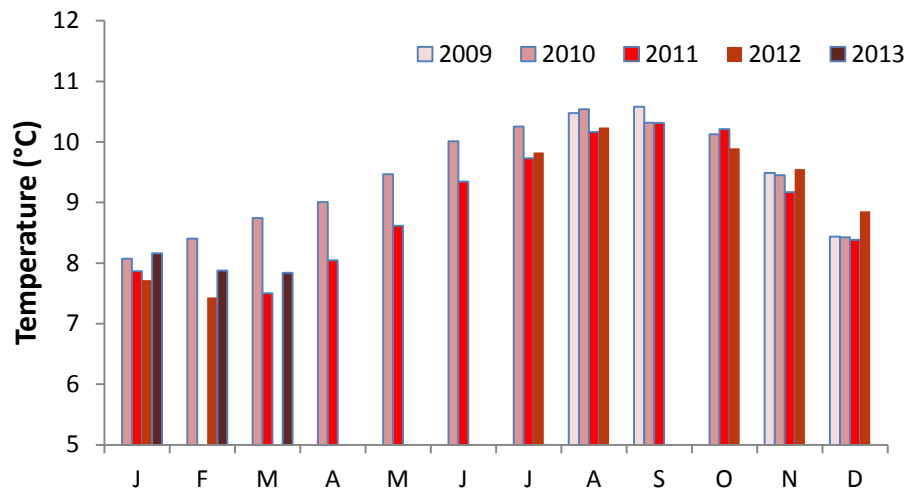
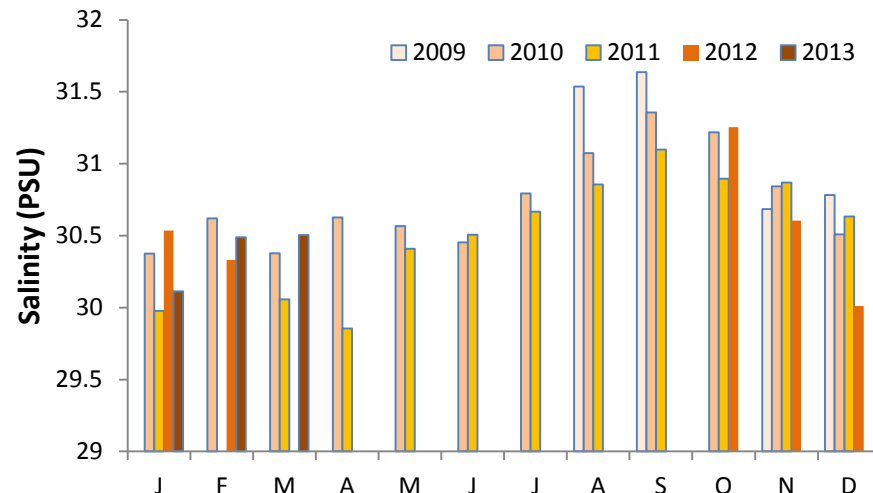
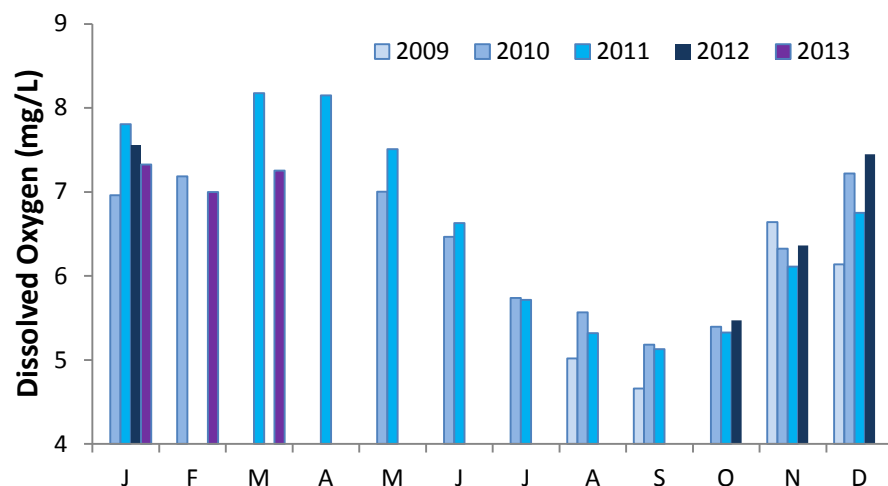
In Admiralty Inlet (52-56 m), we measure significant inter-annual variability in temperature, salinity and dissolved oxygen.

All three variables show strong seasonality, yet are shifted in phase.

Monthly dissolved oxygen is closely tied to monthly salinity. When salinity levels are higher, dissolved oxygen tends to be lower ($r^2=0.82$, Spearman Rank).
