Eyes Over Puget Sound

Surface Conditions Report, August 21, 2013

Up-to-date observations of visible water quality conditions in Puget Sound and the Strait of Juan de Fuca

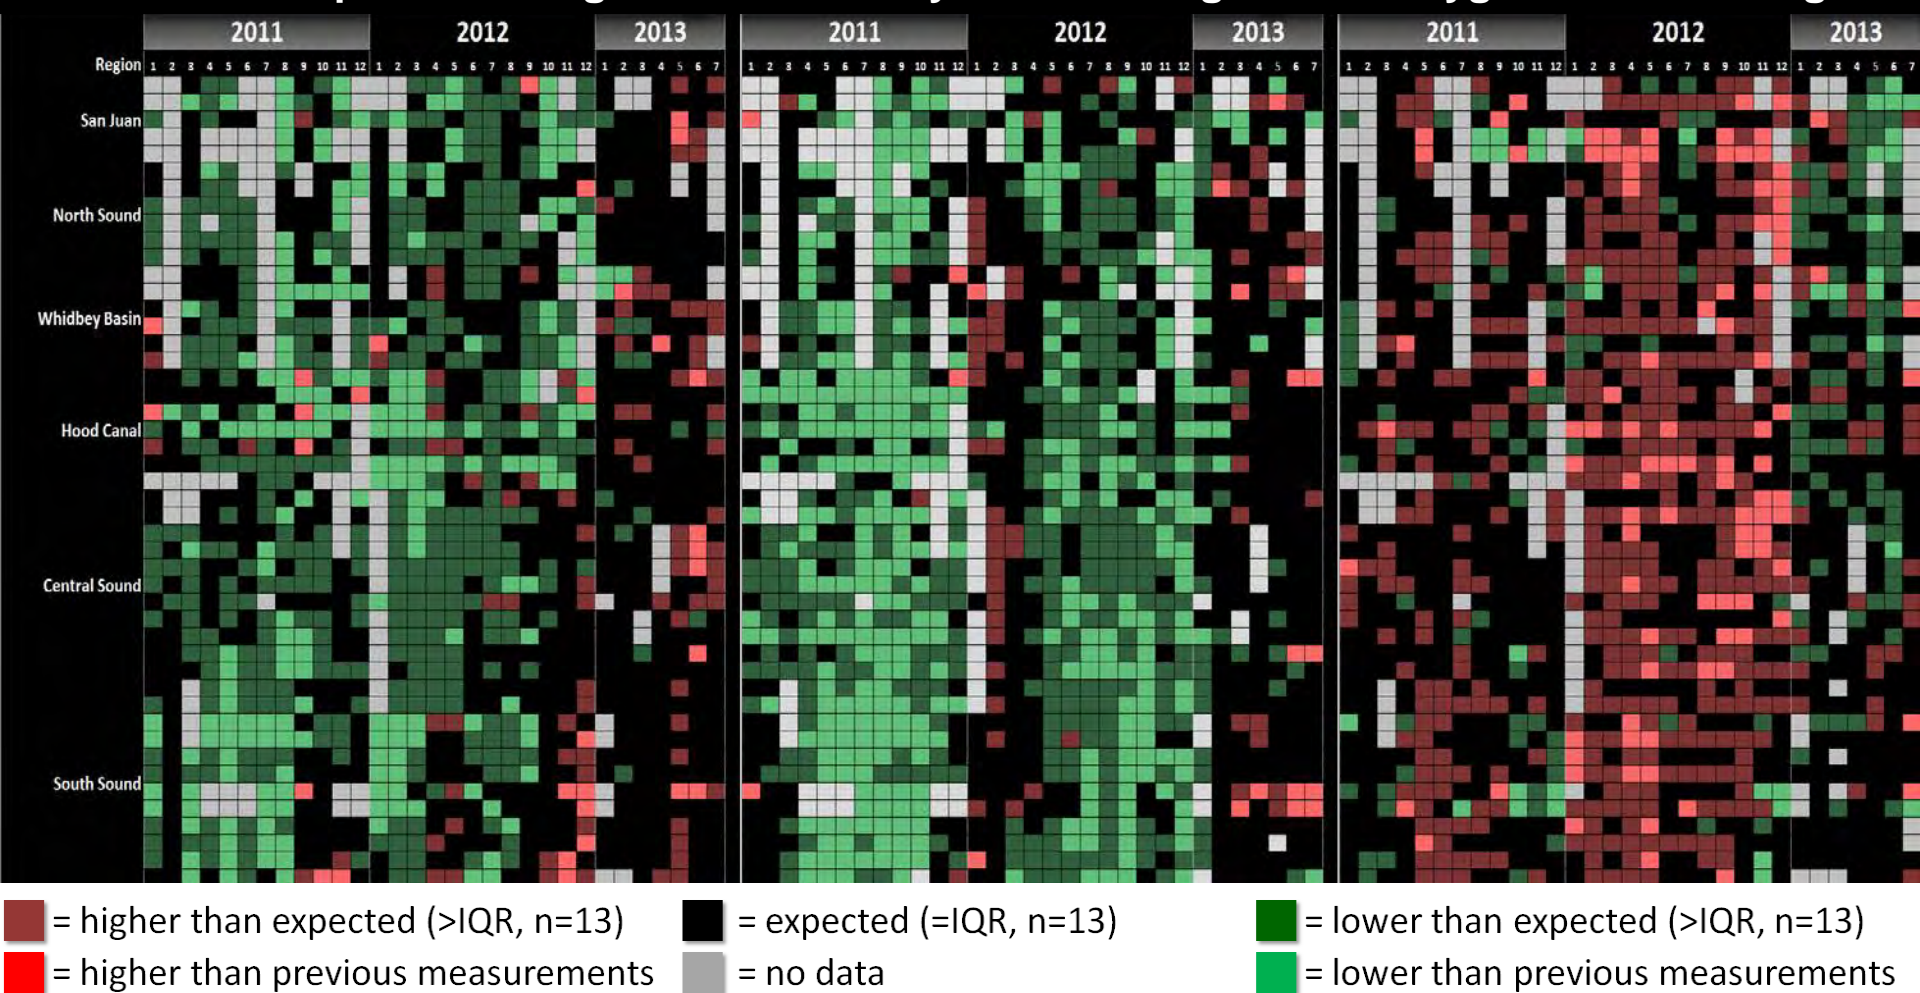
Puget Sound water conditions are changing again! Compared to 2011-2012, when waters were colder and fresher with higher oxygen, values are beginning to show signs of warmer temperatures and decreasing oxygen. Each pixel is a monthly survey at a single station.

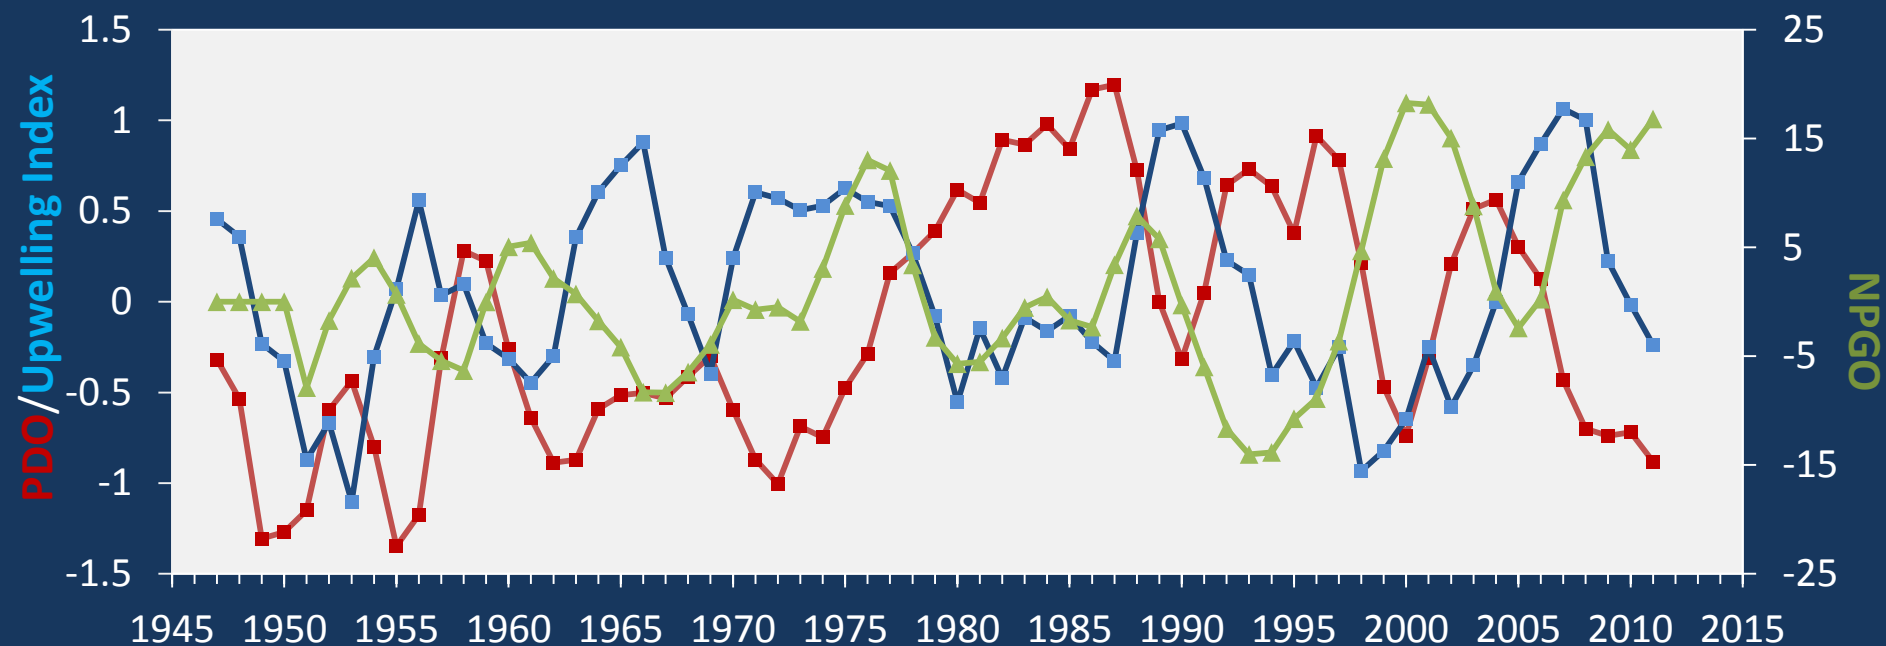
Three-year running average of PDO, Upwelling, and NPGO indices scores

Ocean boundary conditions have been favorable for water quality in Puget Sound: (a) colder water (PDO), (b) less upwelled low oxygen and high nutrient ocean water reaching Puget Sound (Upwelling Index), and (c) higher surface productivity along the coast (NPGO). Where are we heading next?

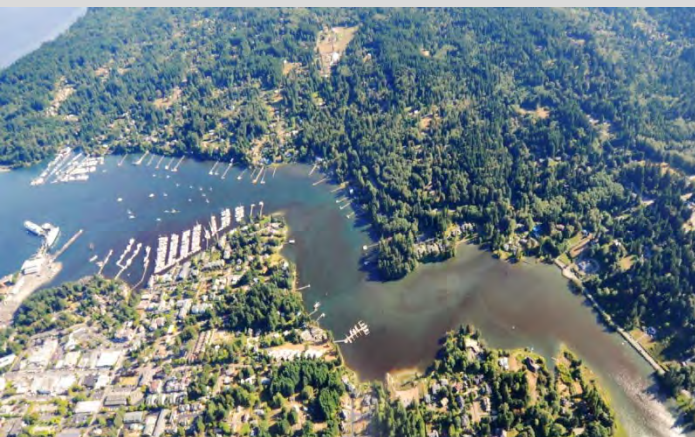
Small red-brown bloom, Bainbridge

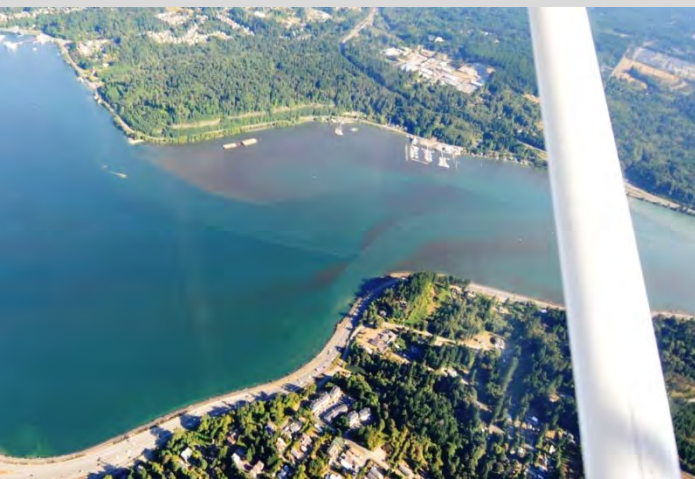
Small red-brown bloom, Sinclair Inlet

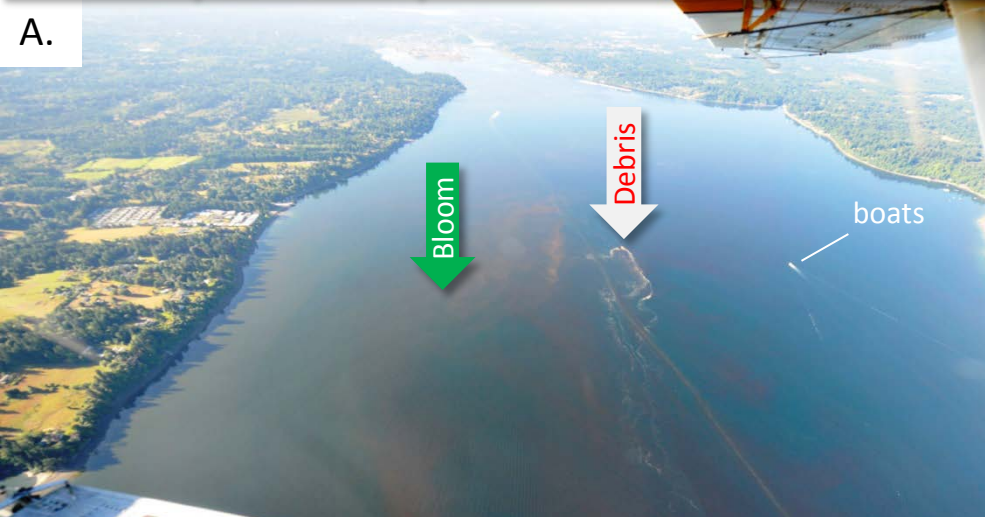
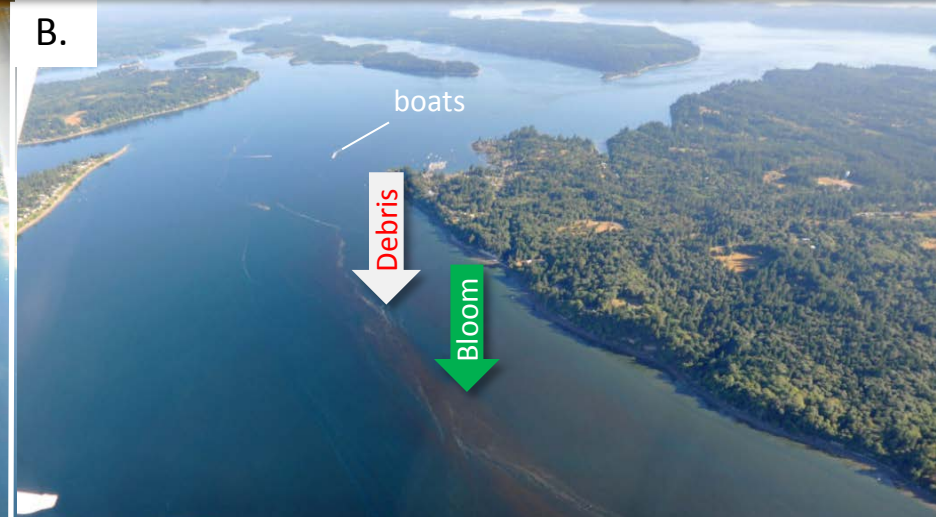
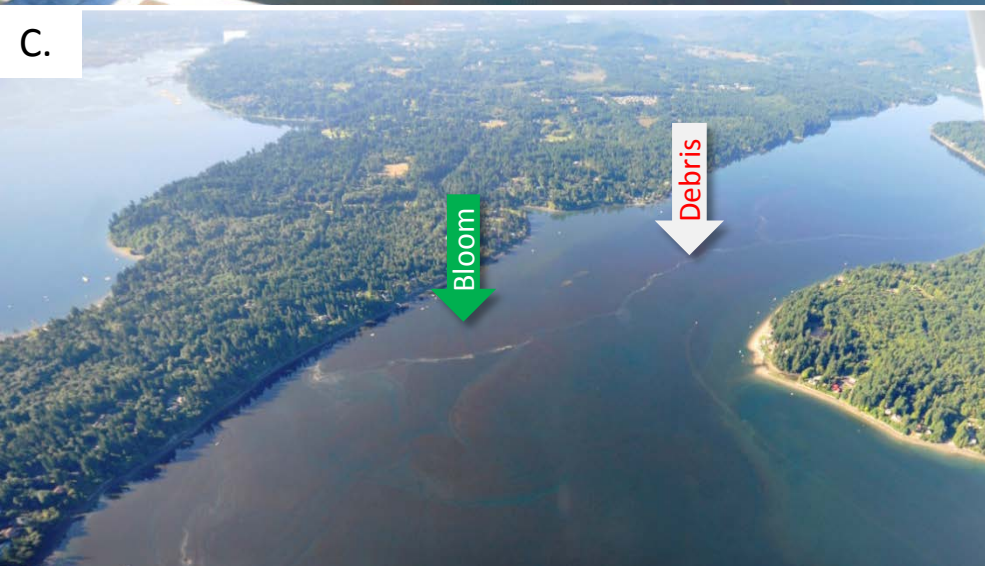
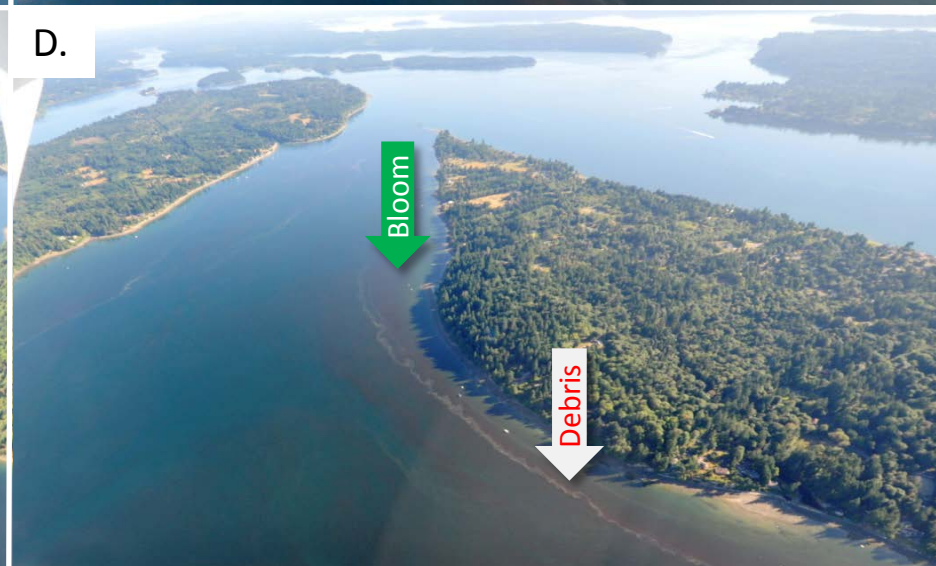
Location: A-B. Budd Inlet, C-D. Totten Inlet (South Sound) 9:12 AM.

Red-brown bloom and organic debris in southern inlets.

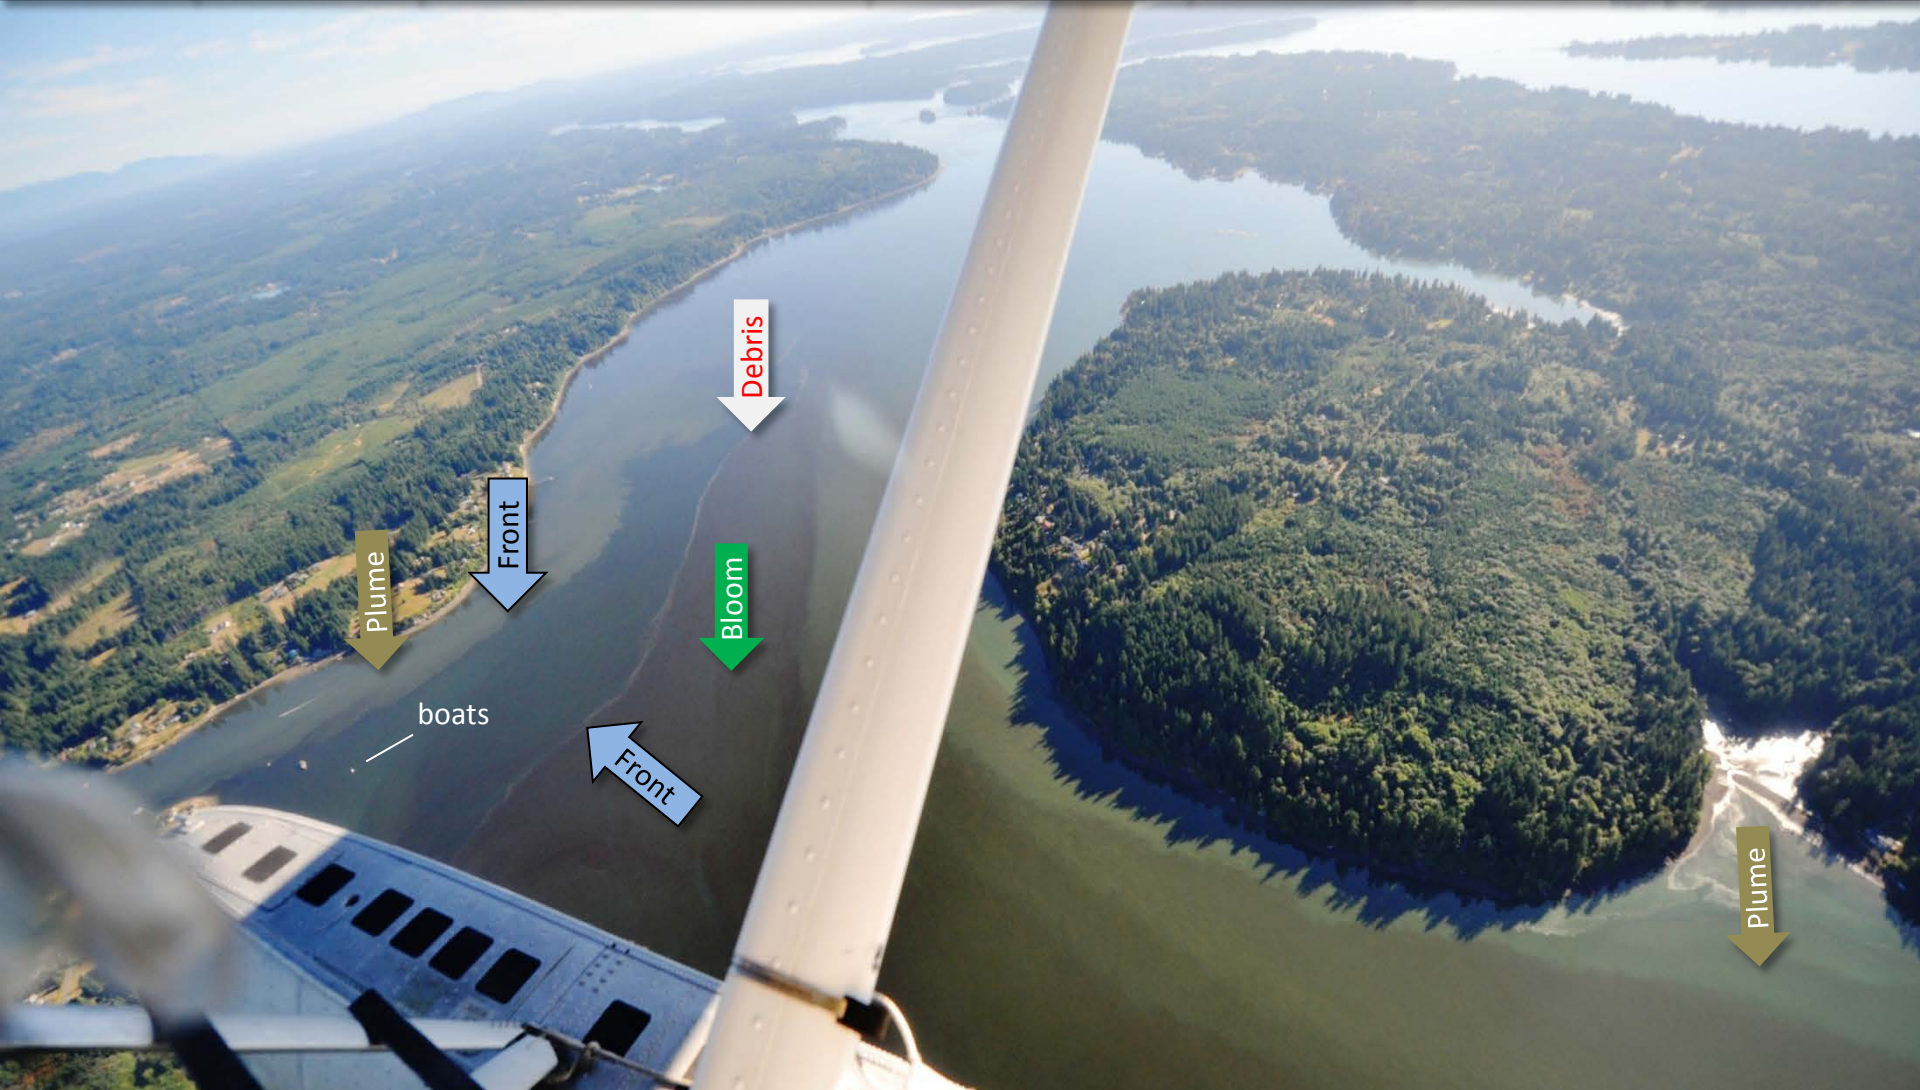
Different surface water with red-brown bloom, high sediment load, and clearly delineated by a long line of organic debris. Location: Eld Inlet (South Sound), 9:14 AM.

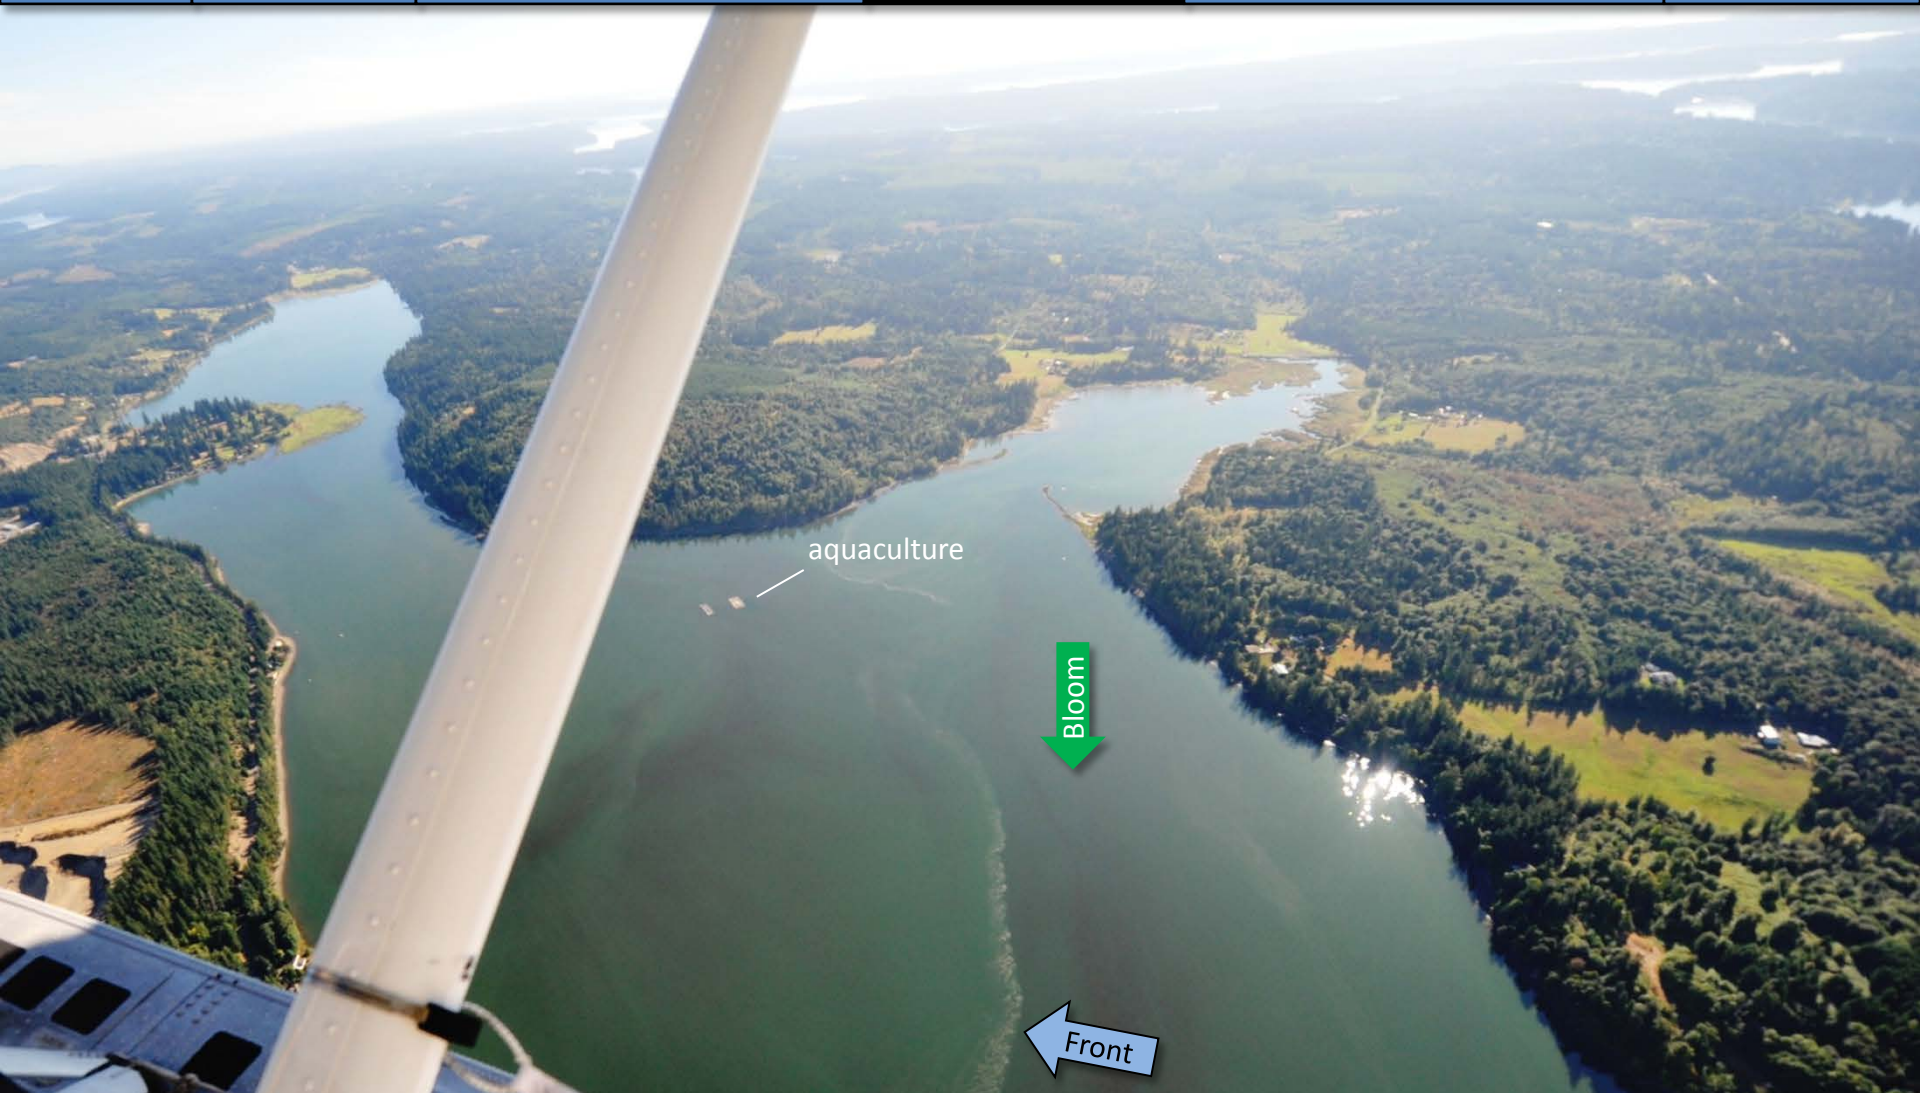
Sediment rich water, red-brown bloom, and lines of organic surface debris.
Location: Oakland Bay (South Sound), 9:18 AM.

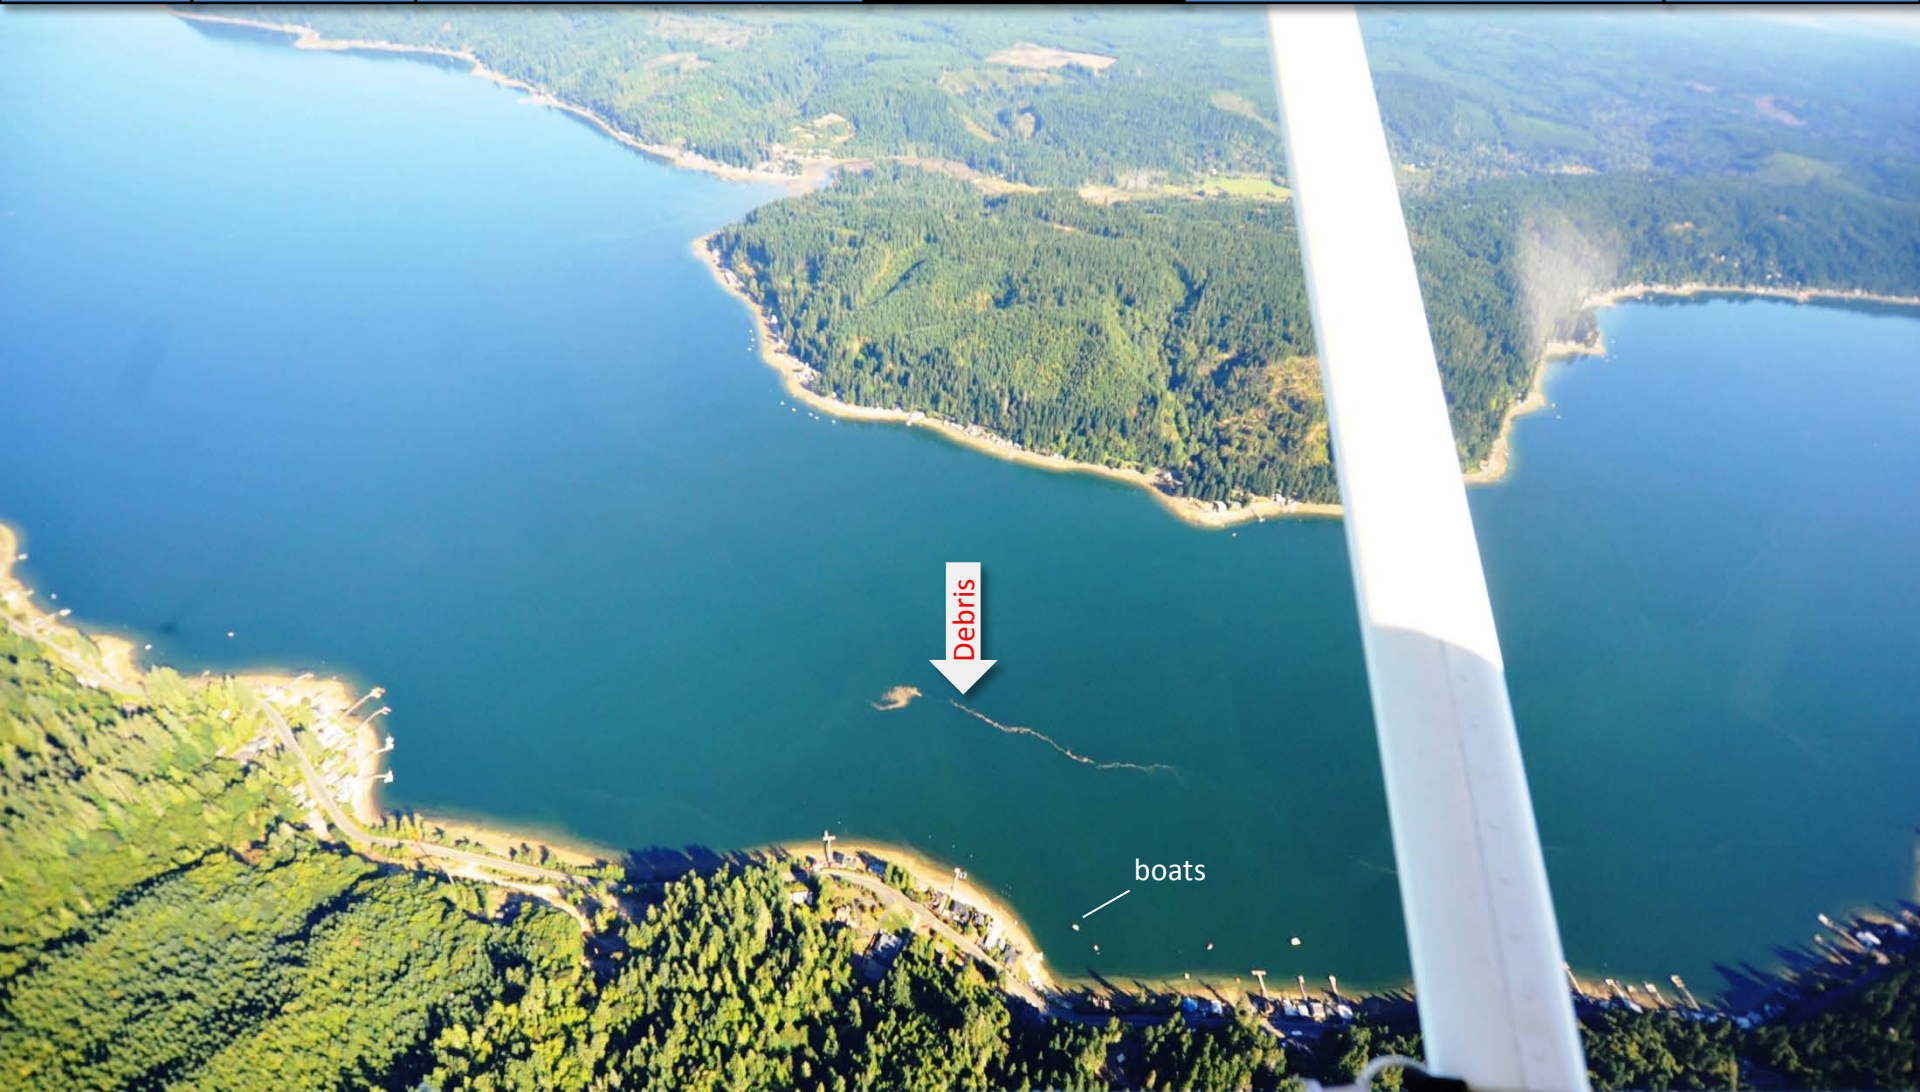
Large drifting mats of organic material at surface.
Location: Near Tahuya River (Hood Canal), 9:26 AM.

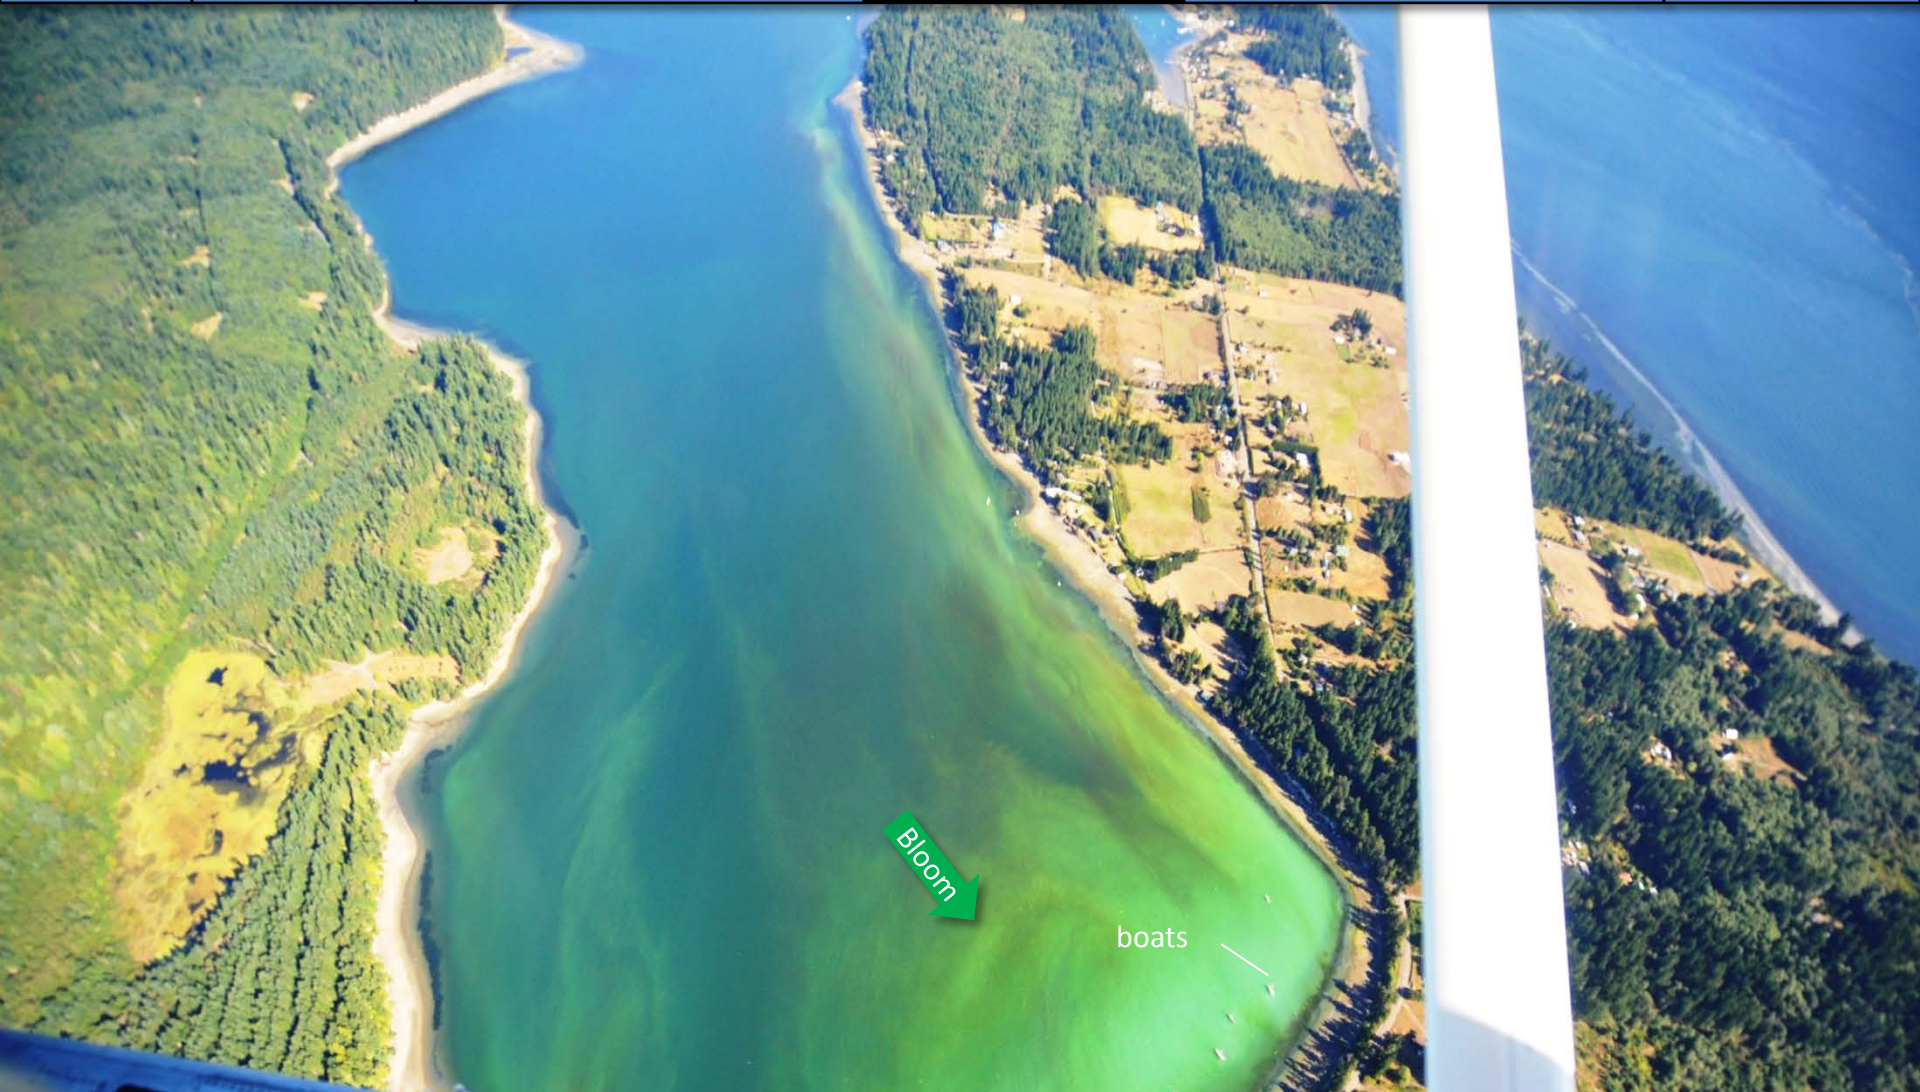
Location: Scow Bay in Kilisut Harbor (Indian Island near Port Townsend), 10:00 AM.

Intense green yellow and red-brown phytoplankton bloom.

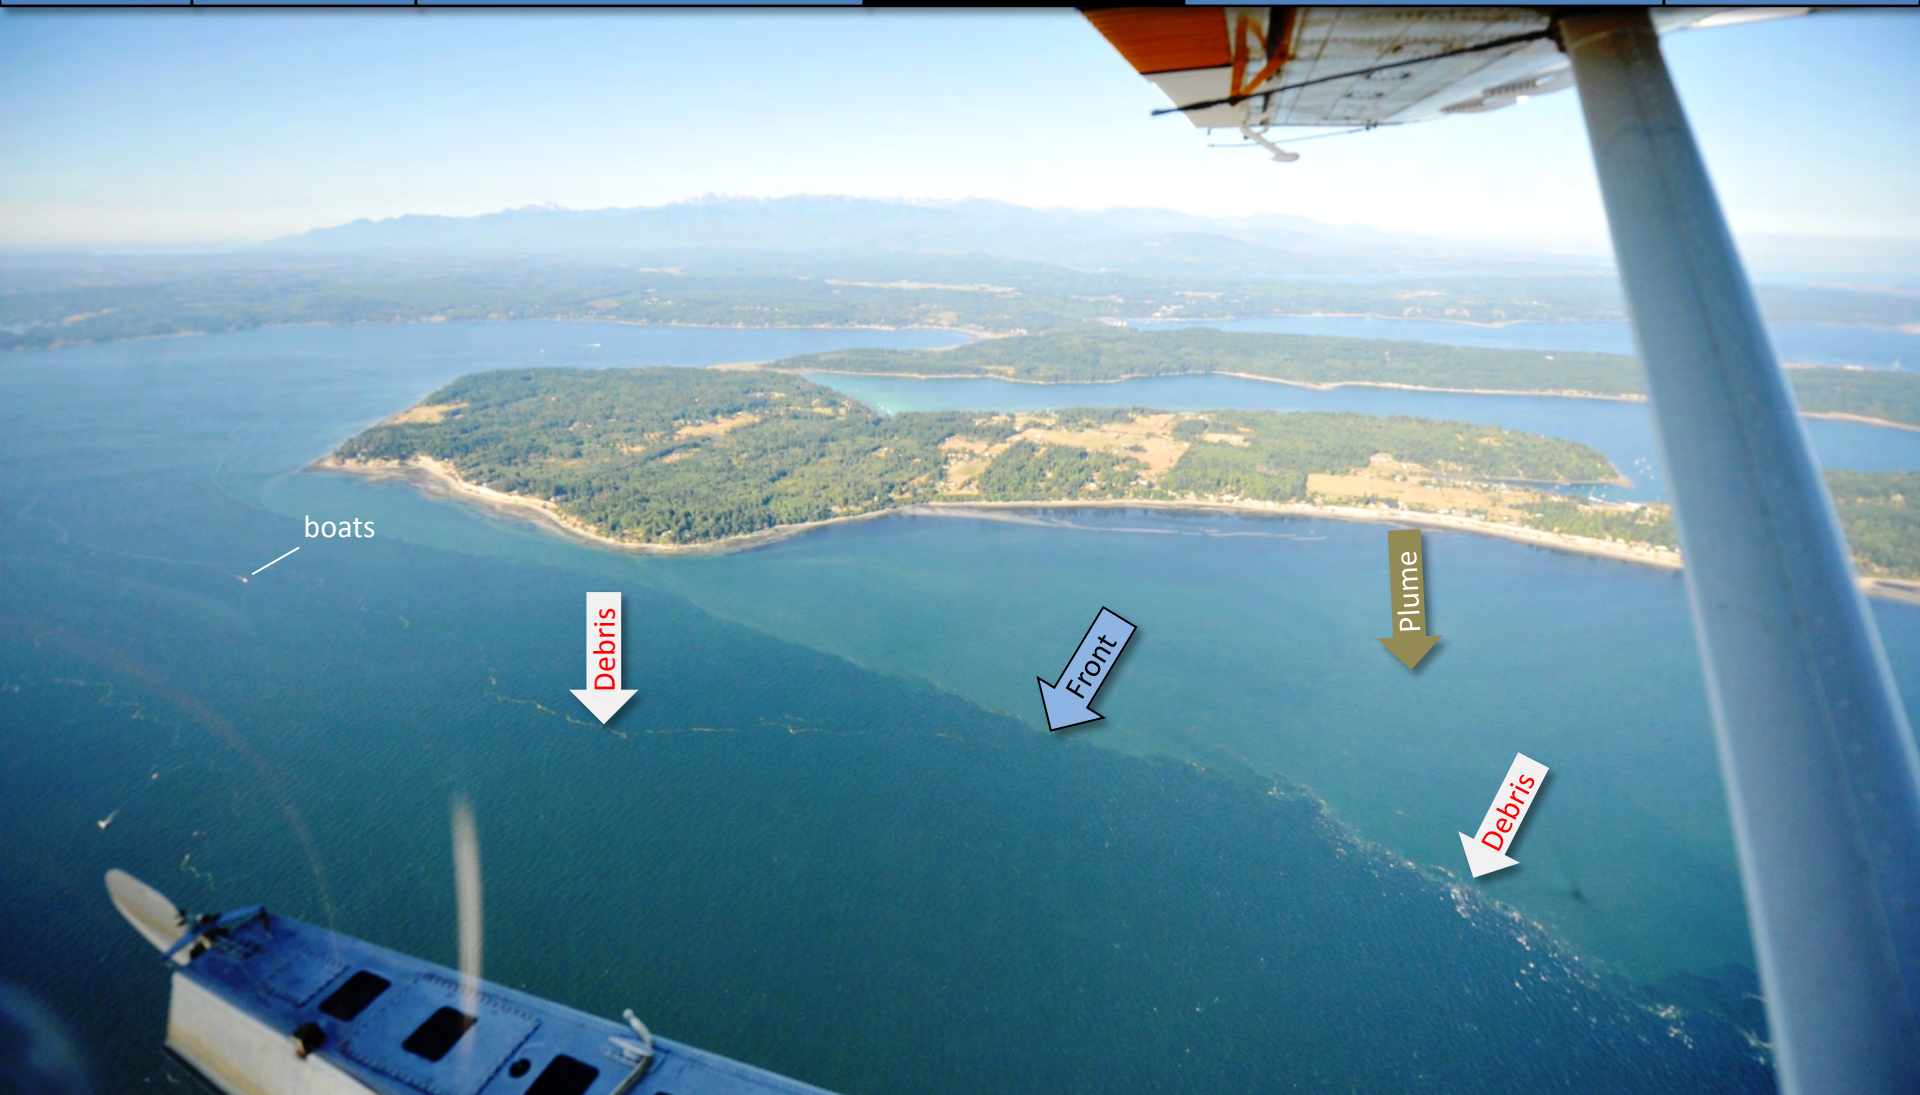
Surface debris (algal mats) and strong front with distinctly different water.
Location: Off Marrowstone Island (Central Sound), 10:02 AM.

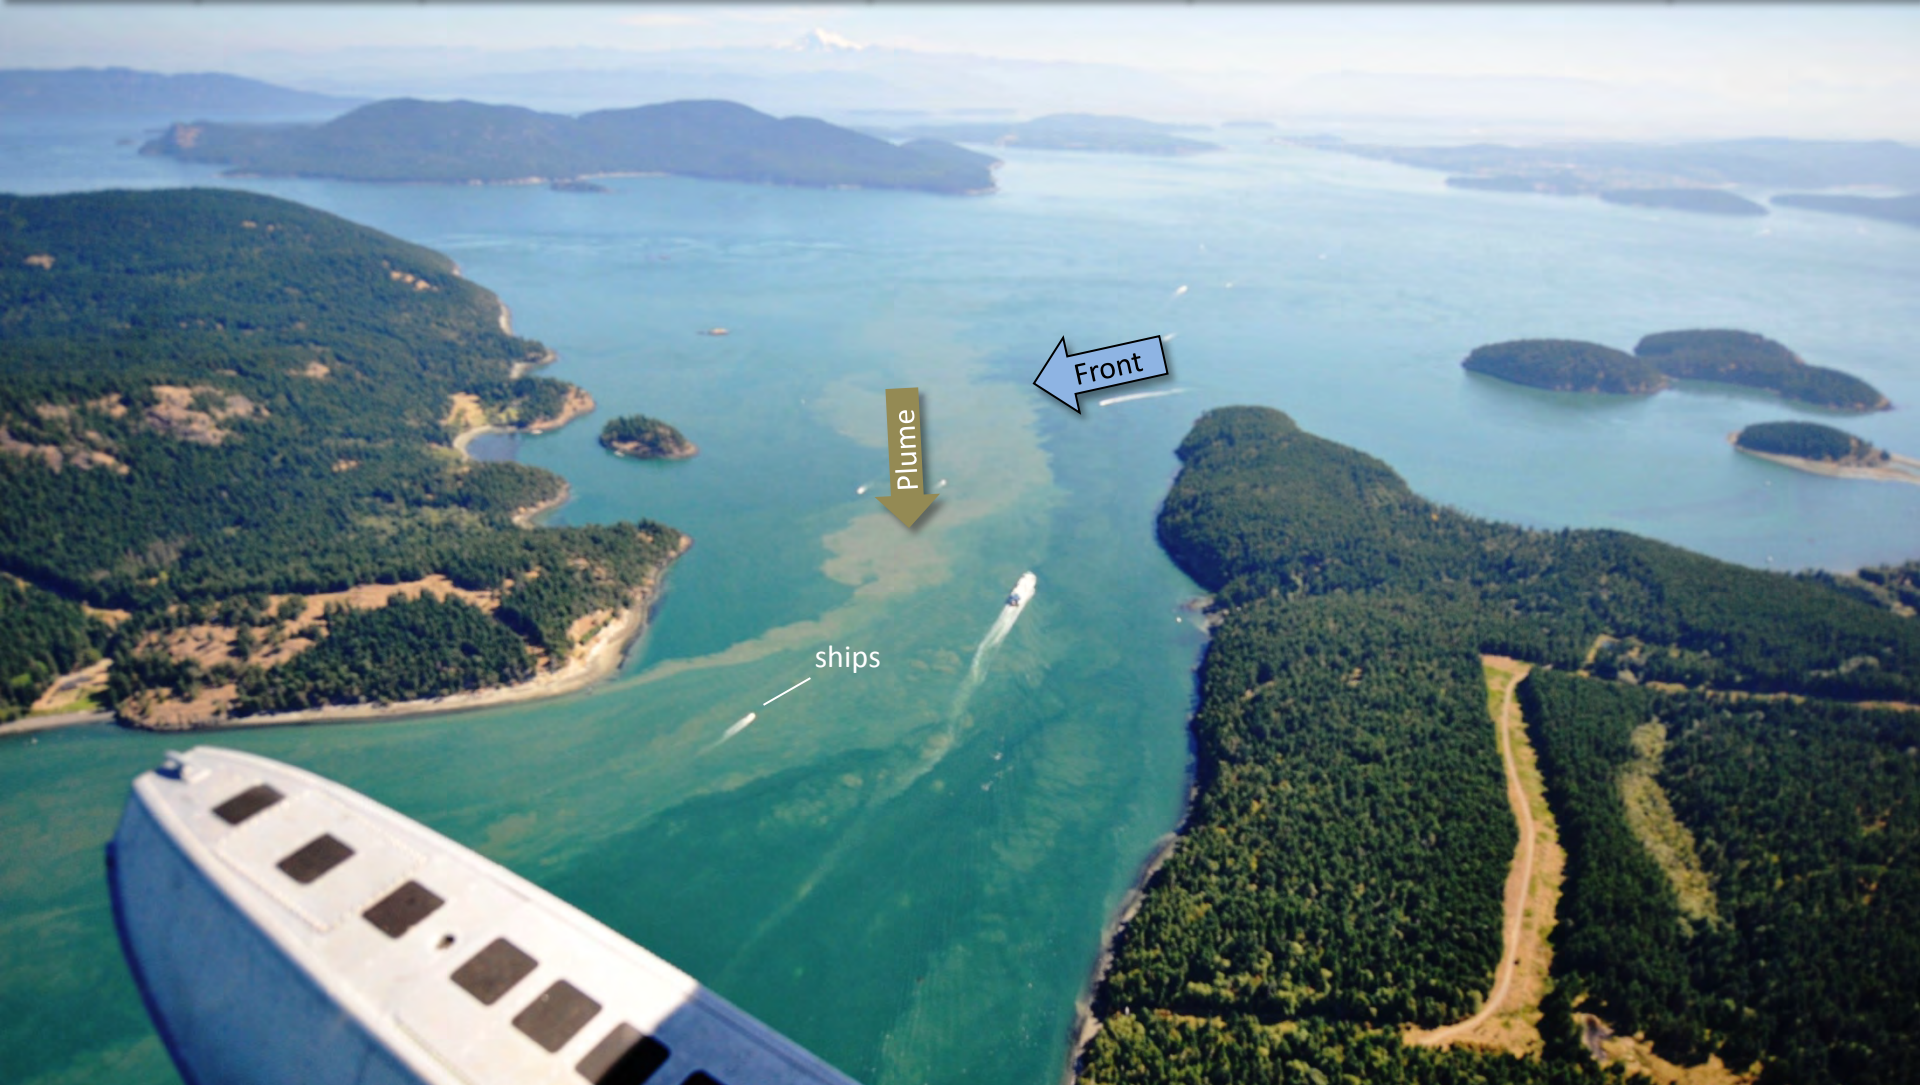
Fraser River sediment traversing and mixing dramatically with water in the San Juan Islands.
Location: Blakely Island (San Juan Islands), 11:45 AM.

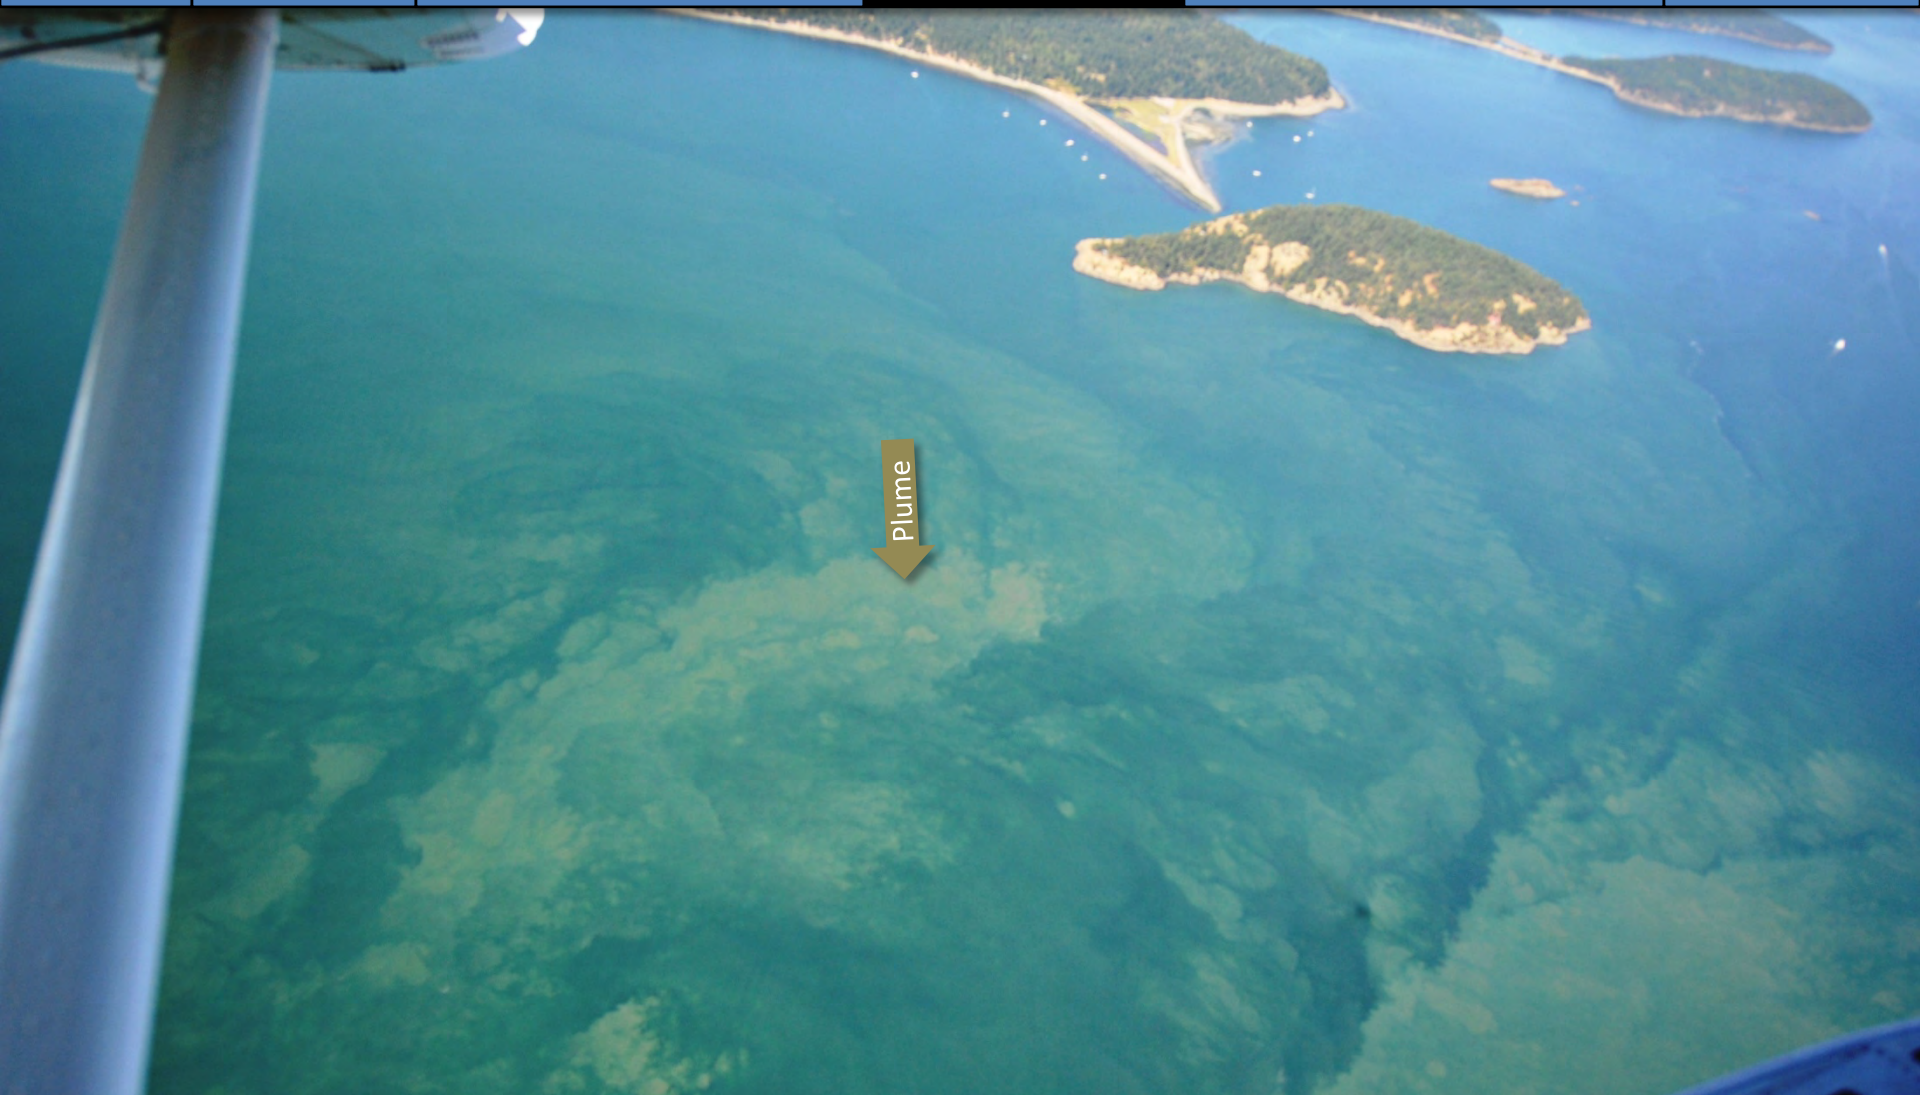
Fraser River sediment traversing and mixing dramatically with water in the San Juan Islands.
Location: Near Lopez Sound (San Juan Islands), 11:48 AM.

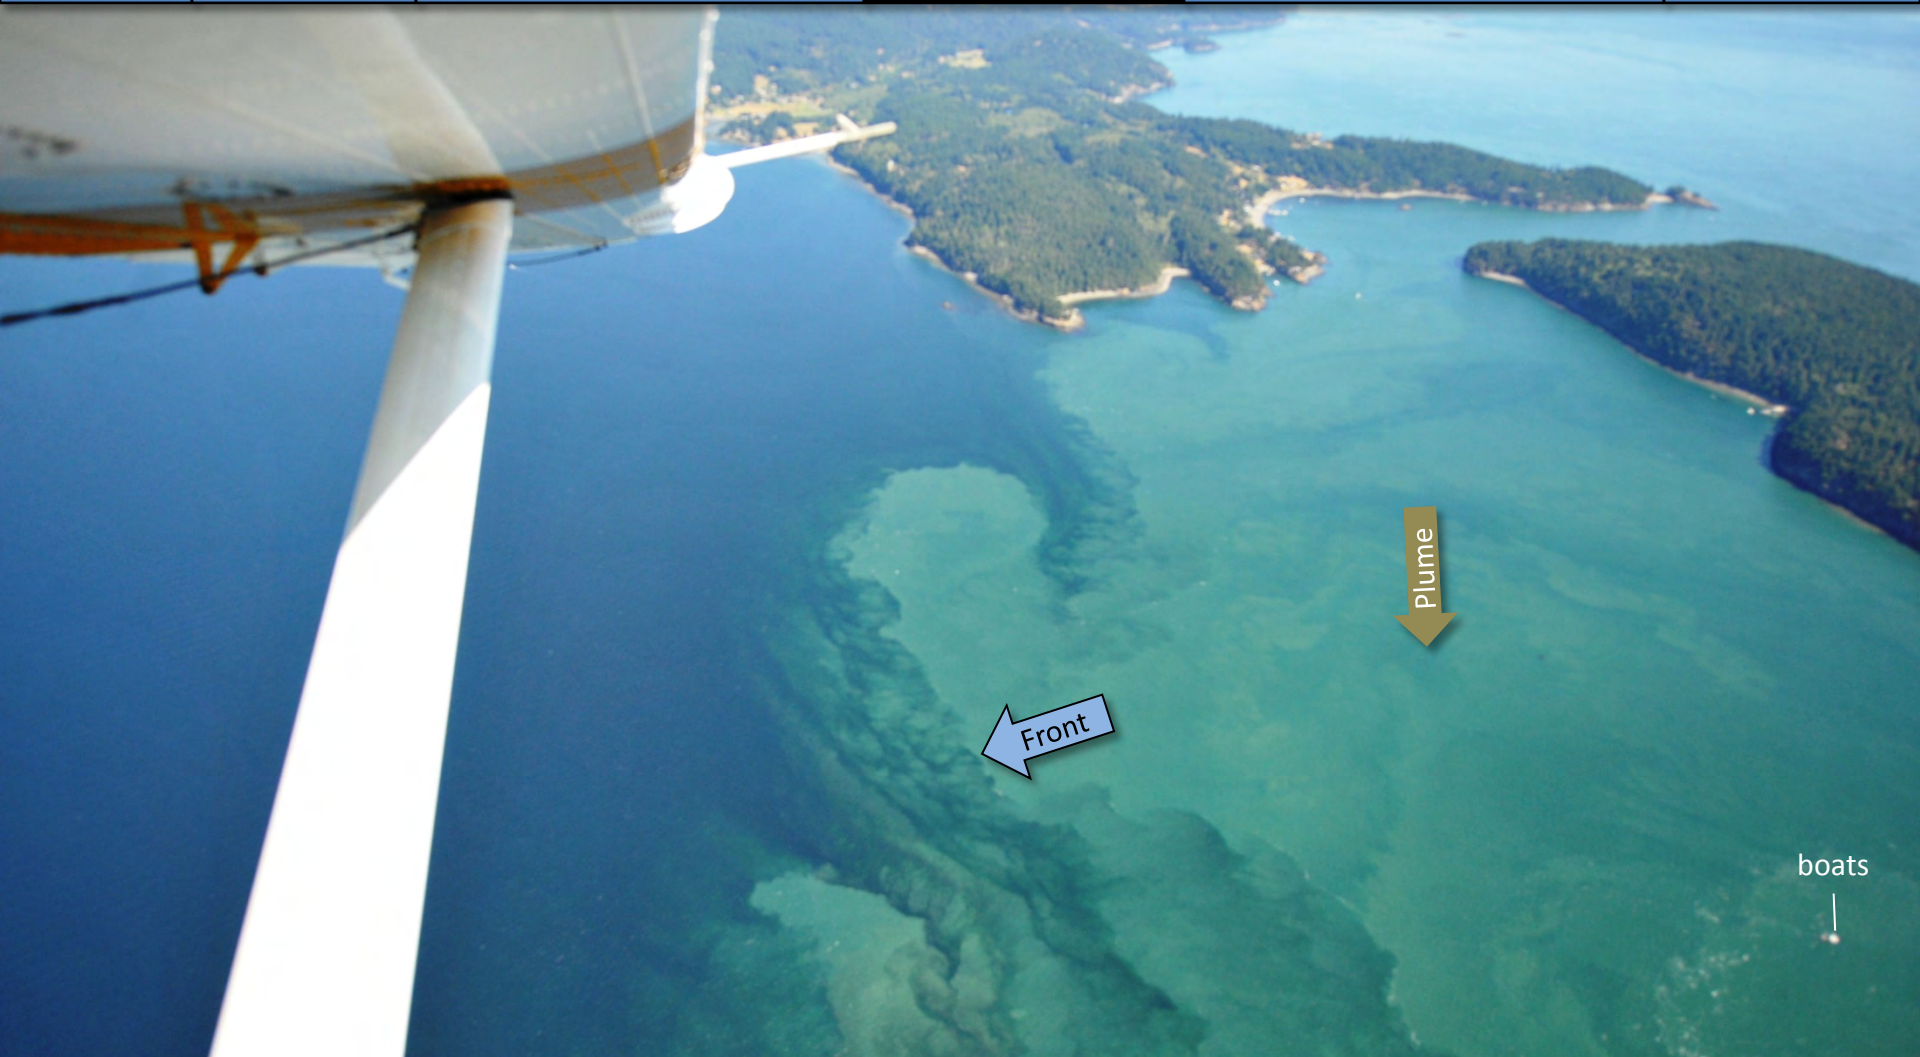
Fraser River sediment traversing and mixing dramatically with water in the San Juan Islands.
Location: Near Obstruction Island (San Juan Islands), 11:49 AM.
