Eyes Over Puget Sound

Surface Conditions Report, August 21, 2013

Up-to-date observations of visible water quality conditions in Puget Sound and the Strait of Juan de Fuca

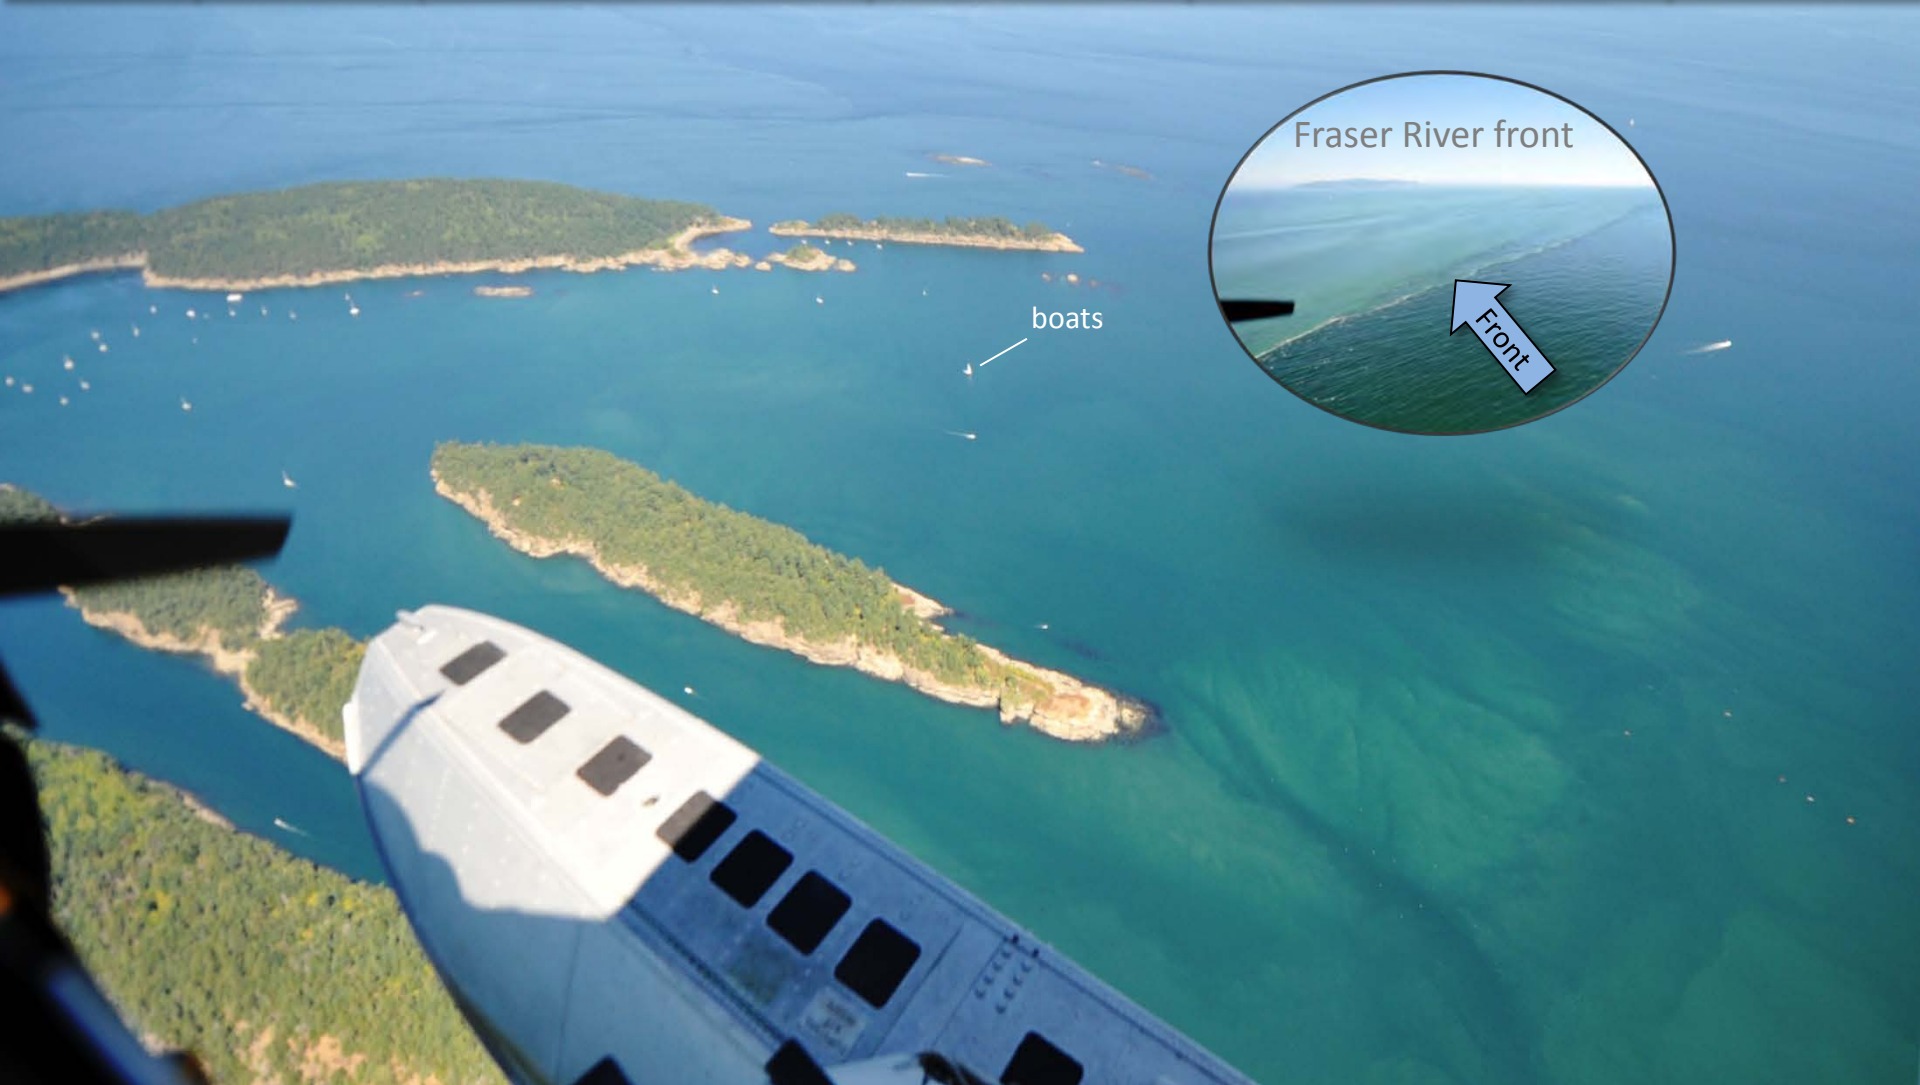
Location: Echo Bay, Sucia Island (San Juan Islands), 12:24 PM.

Subsurface Fraser River plume re-surfacing in response to tidal currents.

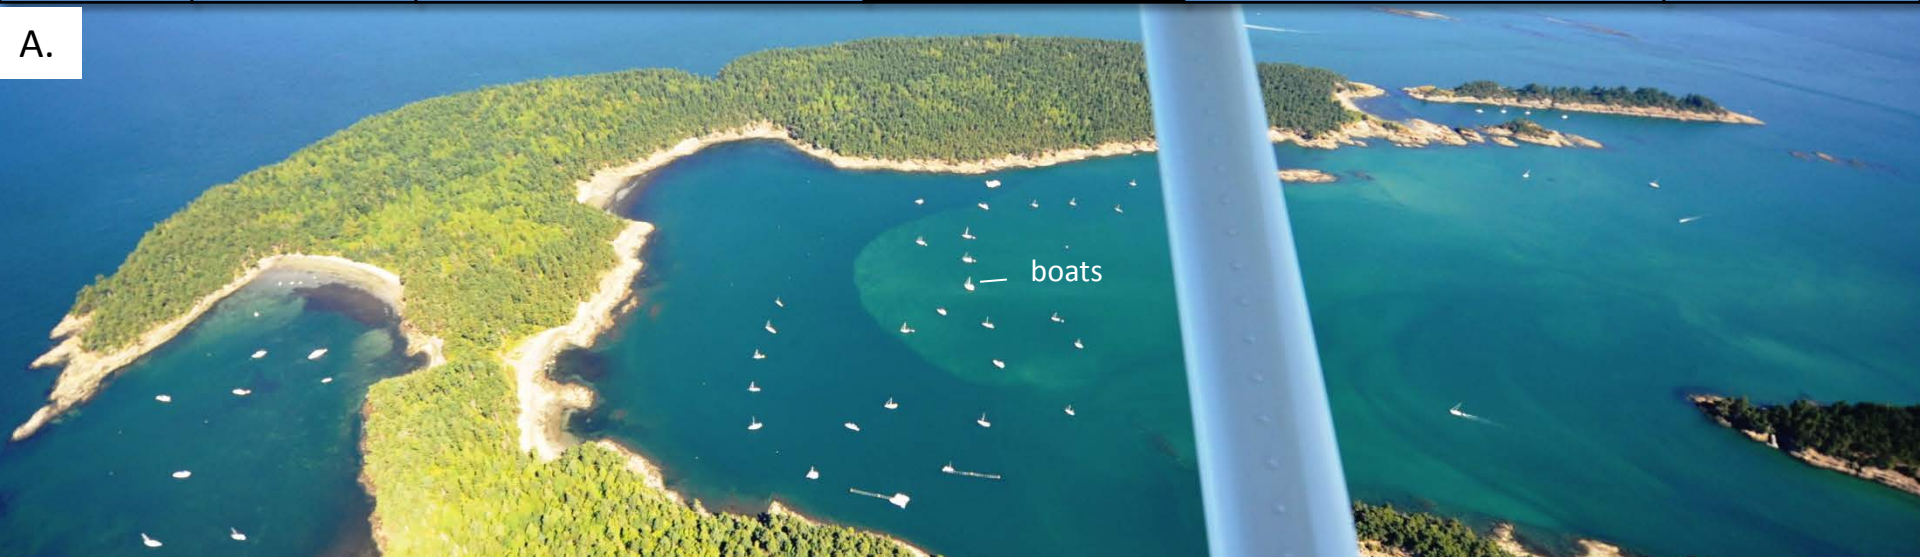
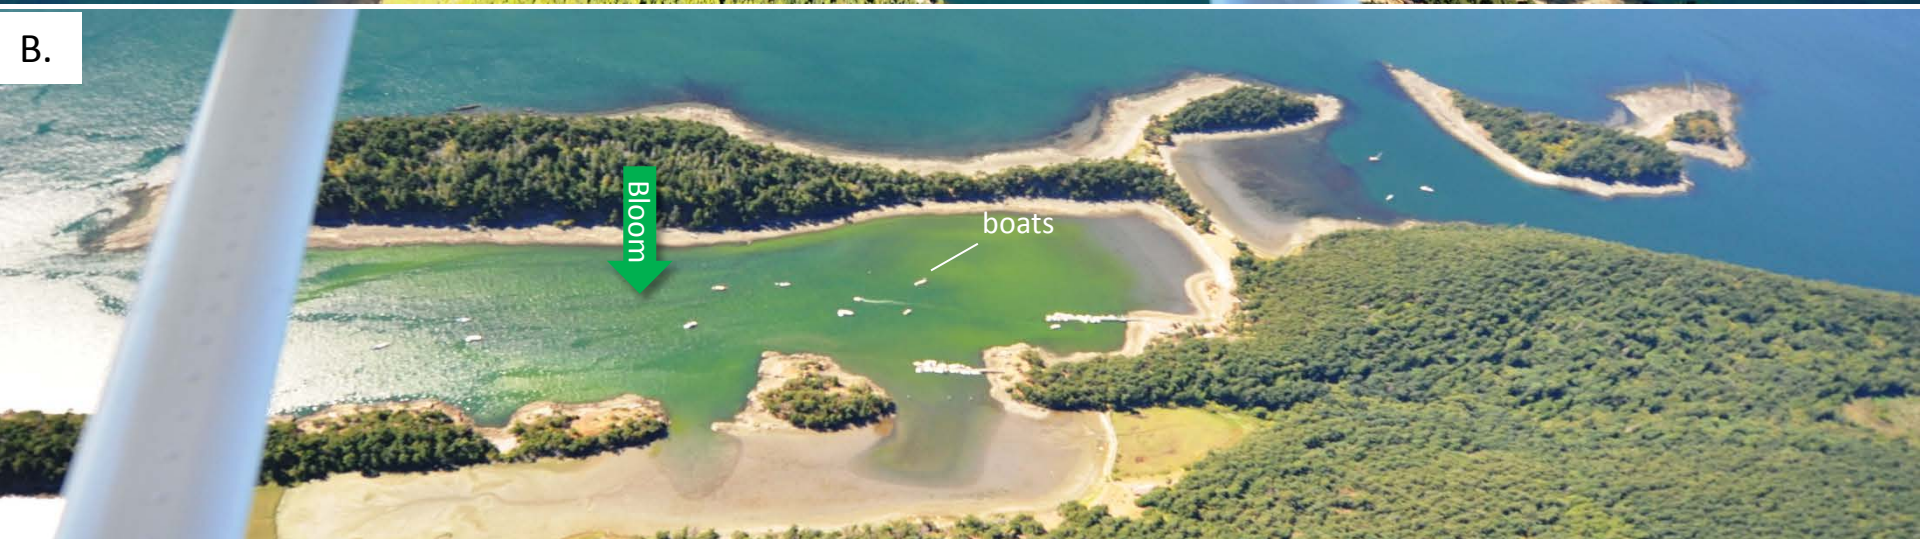
A. Sub-surface Fraser River plume entering Echo Bay. B. Yellow-green bloom in Fossil Bay.
Location: Echo Bay, Sucia Island (San Juan Islands), 12:24 PM.

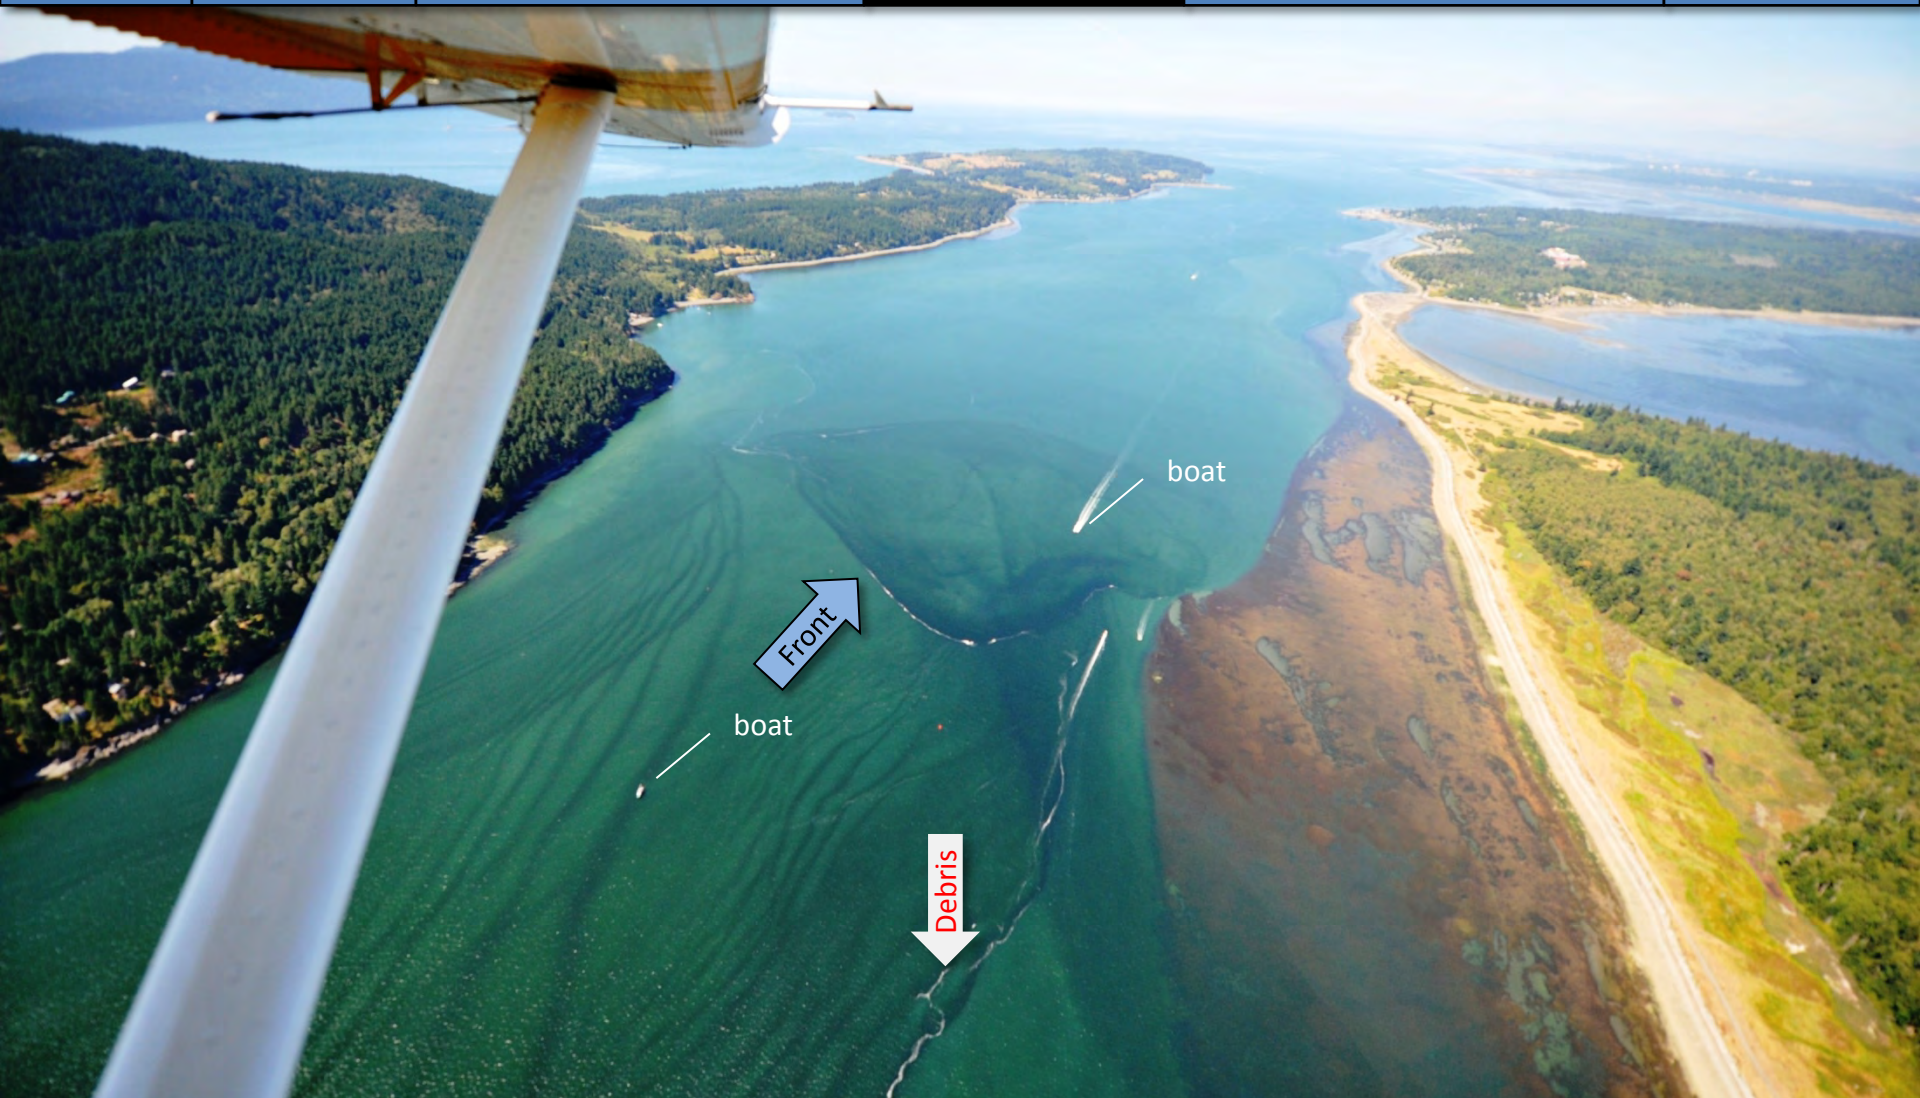
Location: East of Lummi Island (Bellingham Bay), 1:29 PM.

Interplay of water, sediment, and waves form striking surface patterns.

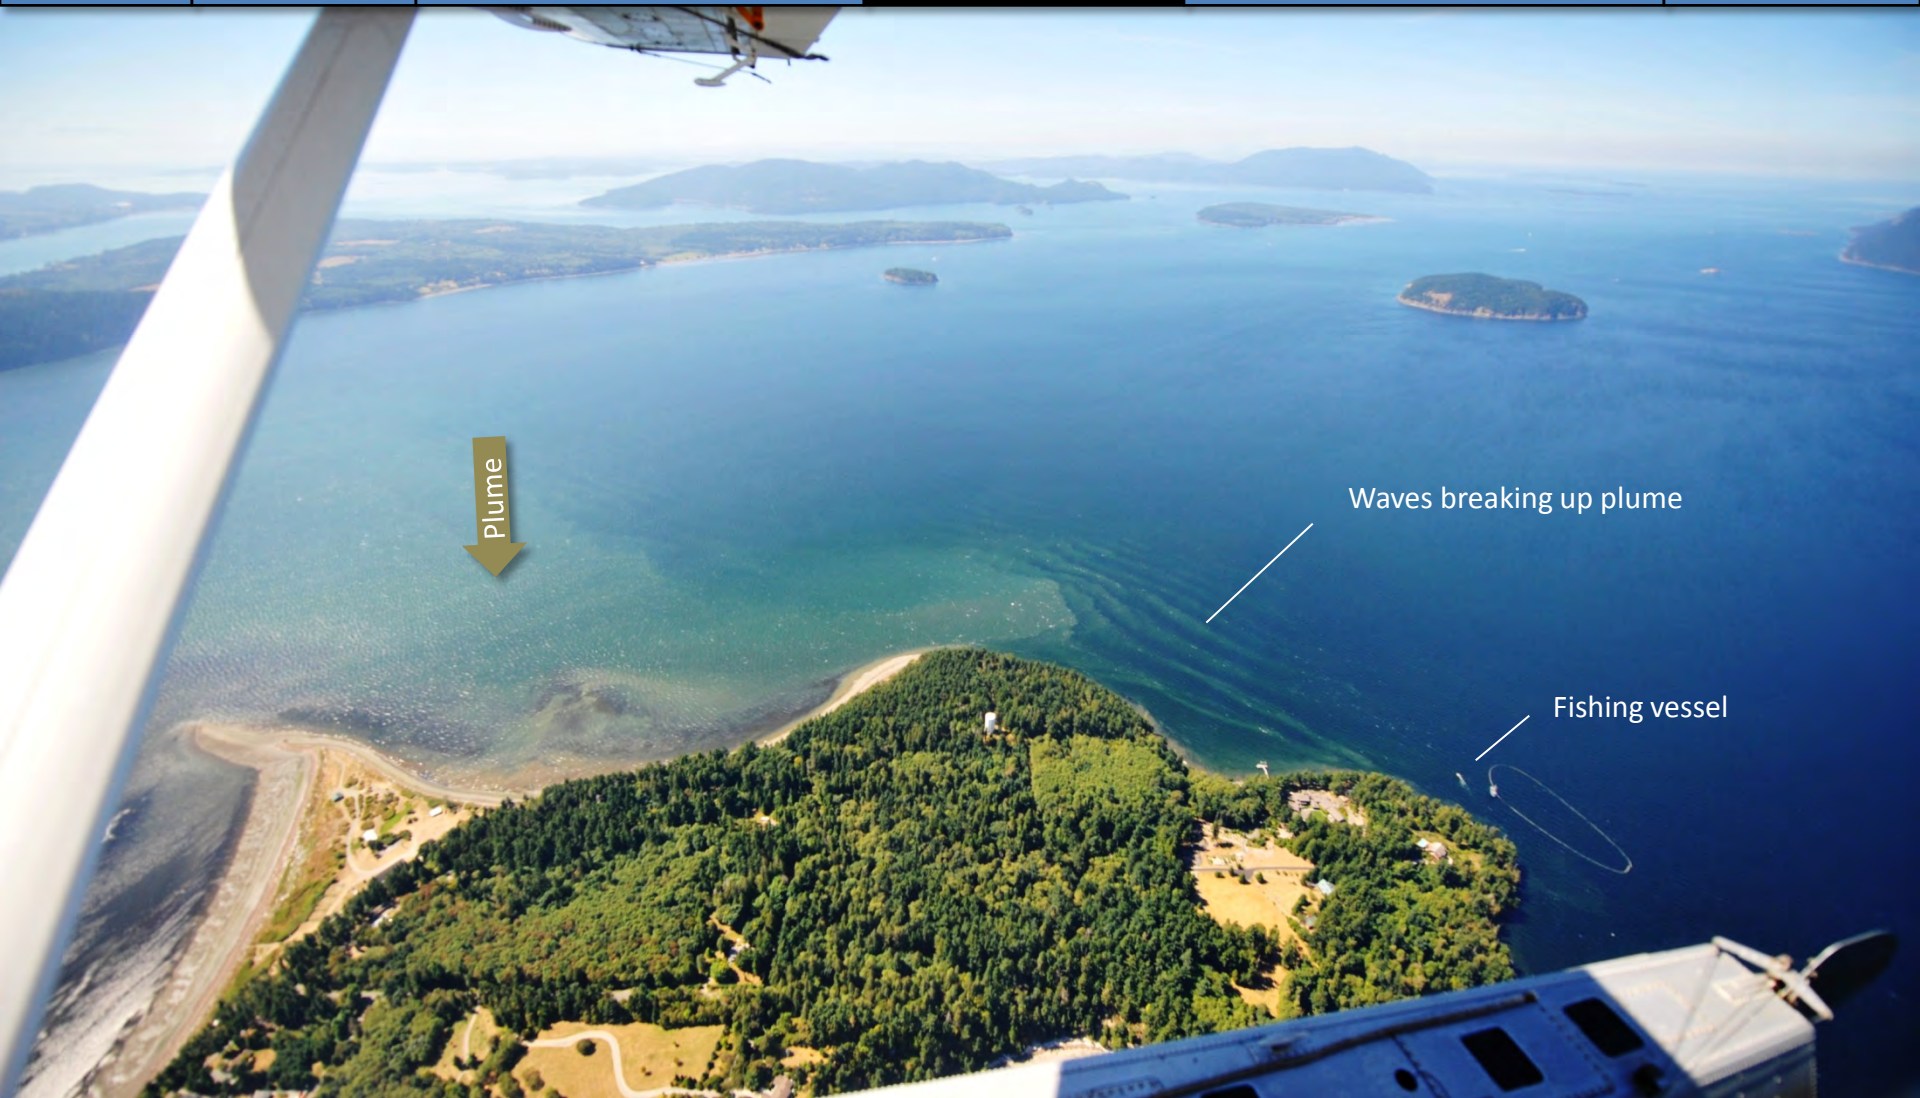
Location: Samish Island (Samish Bay), 1:58 PM.

Interplay of water, sediment, and waves form striking surface patterns.

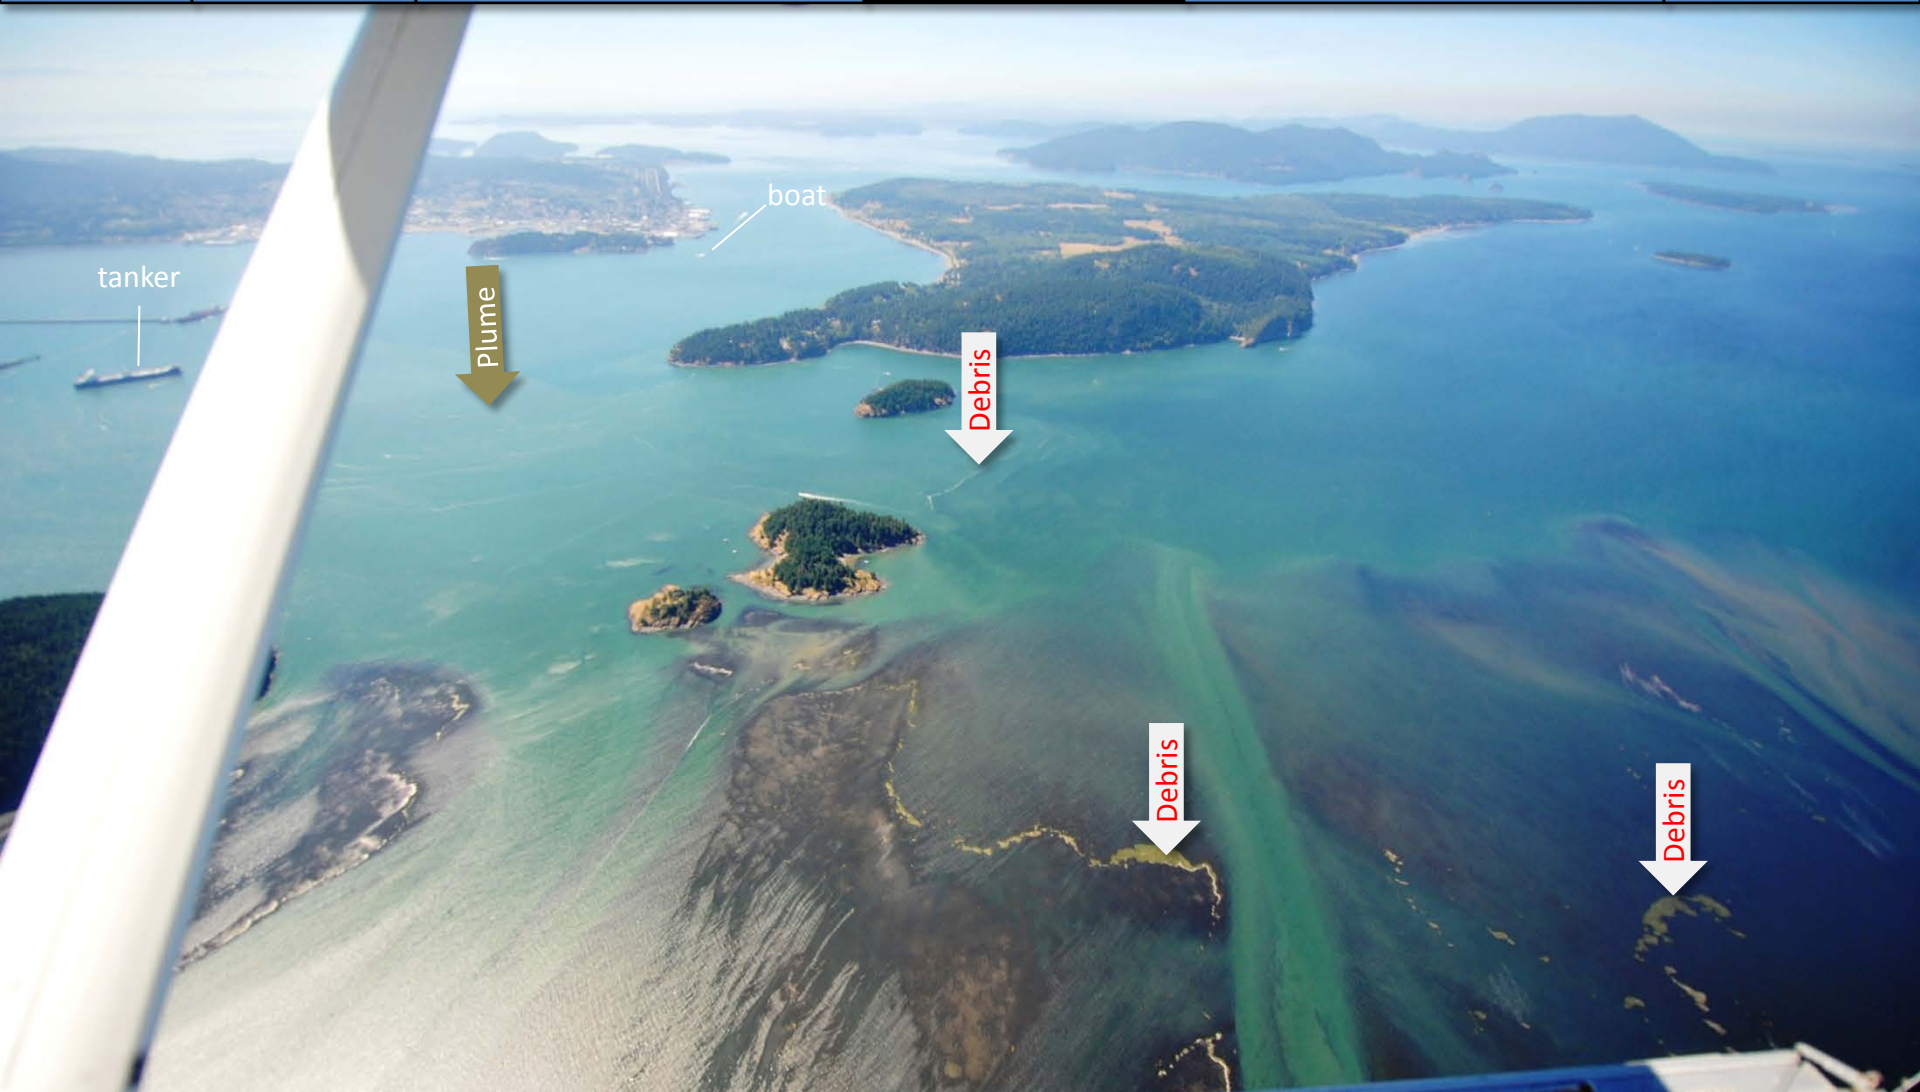
Location: Near Saddlebag Island (Padilla Bay), 2:00 PM.

Large algal mats and organic debris.

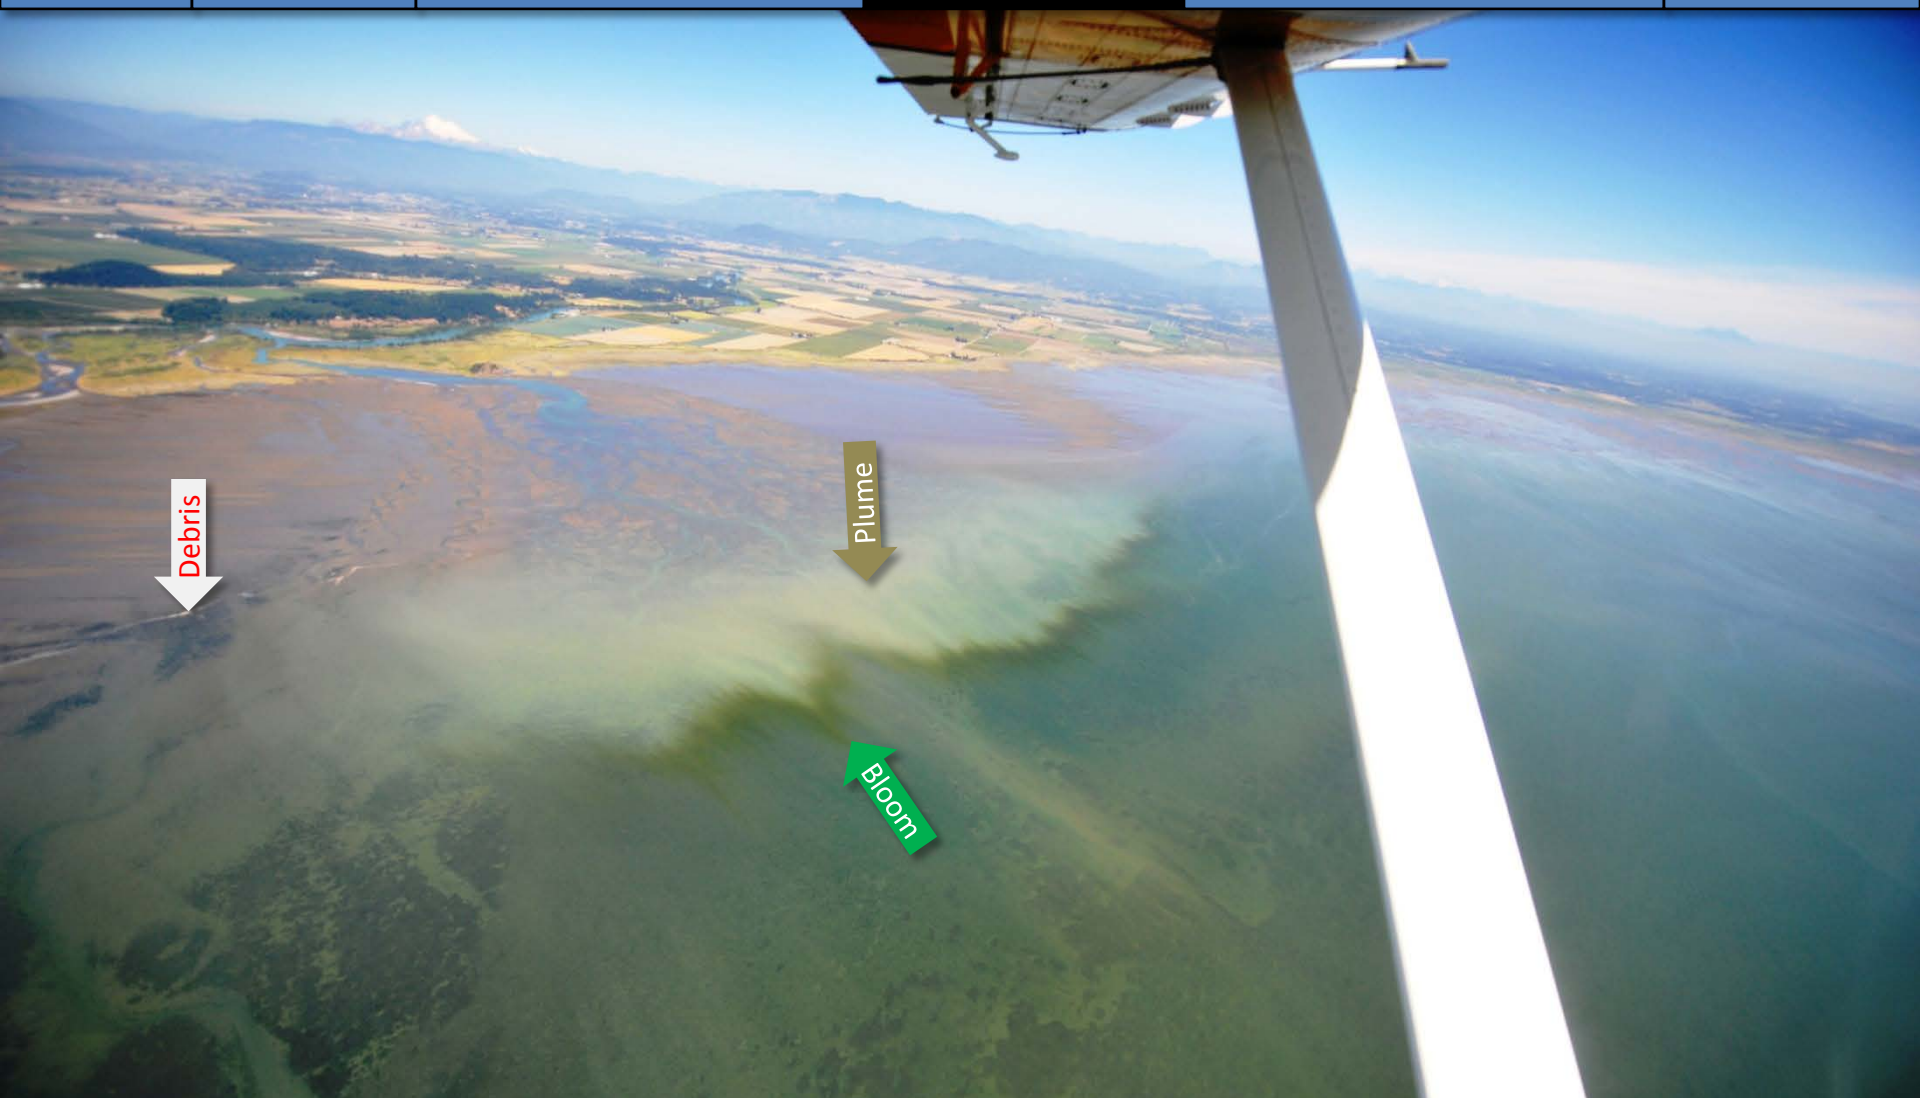
Green phytoplankton bloom forms a fringe along a sediment plume in shallow water.
Location: Skagit River estuary (Skagit Bay), 2:07 PM.

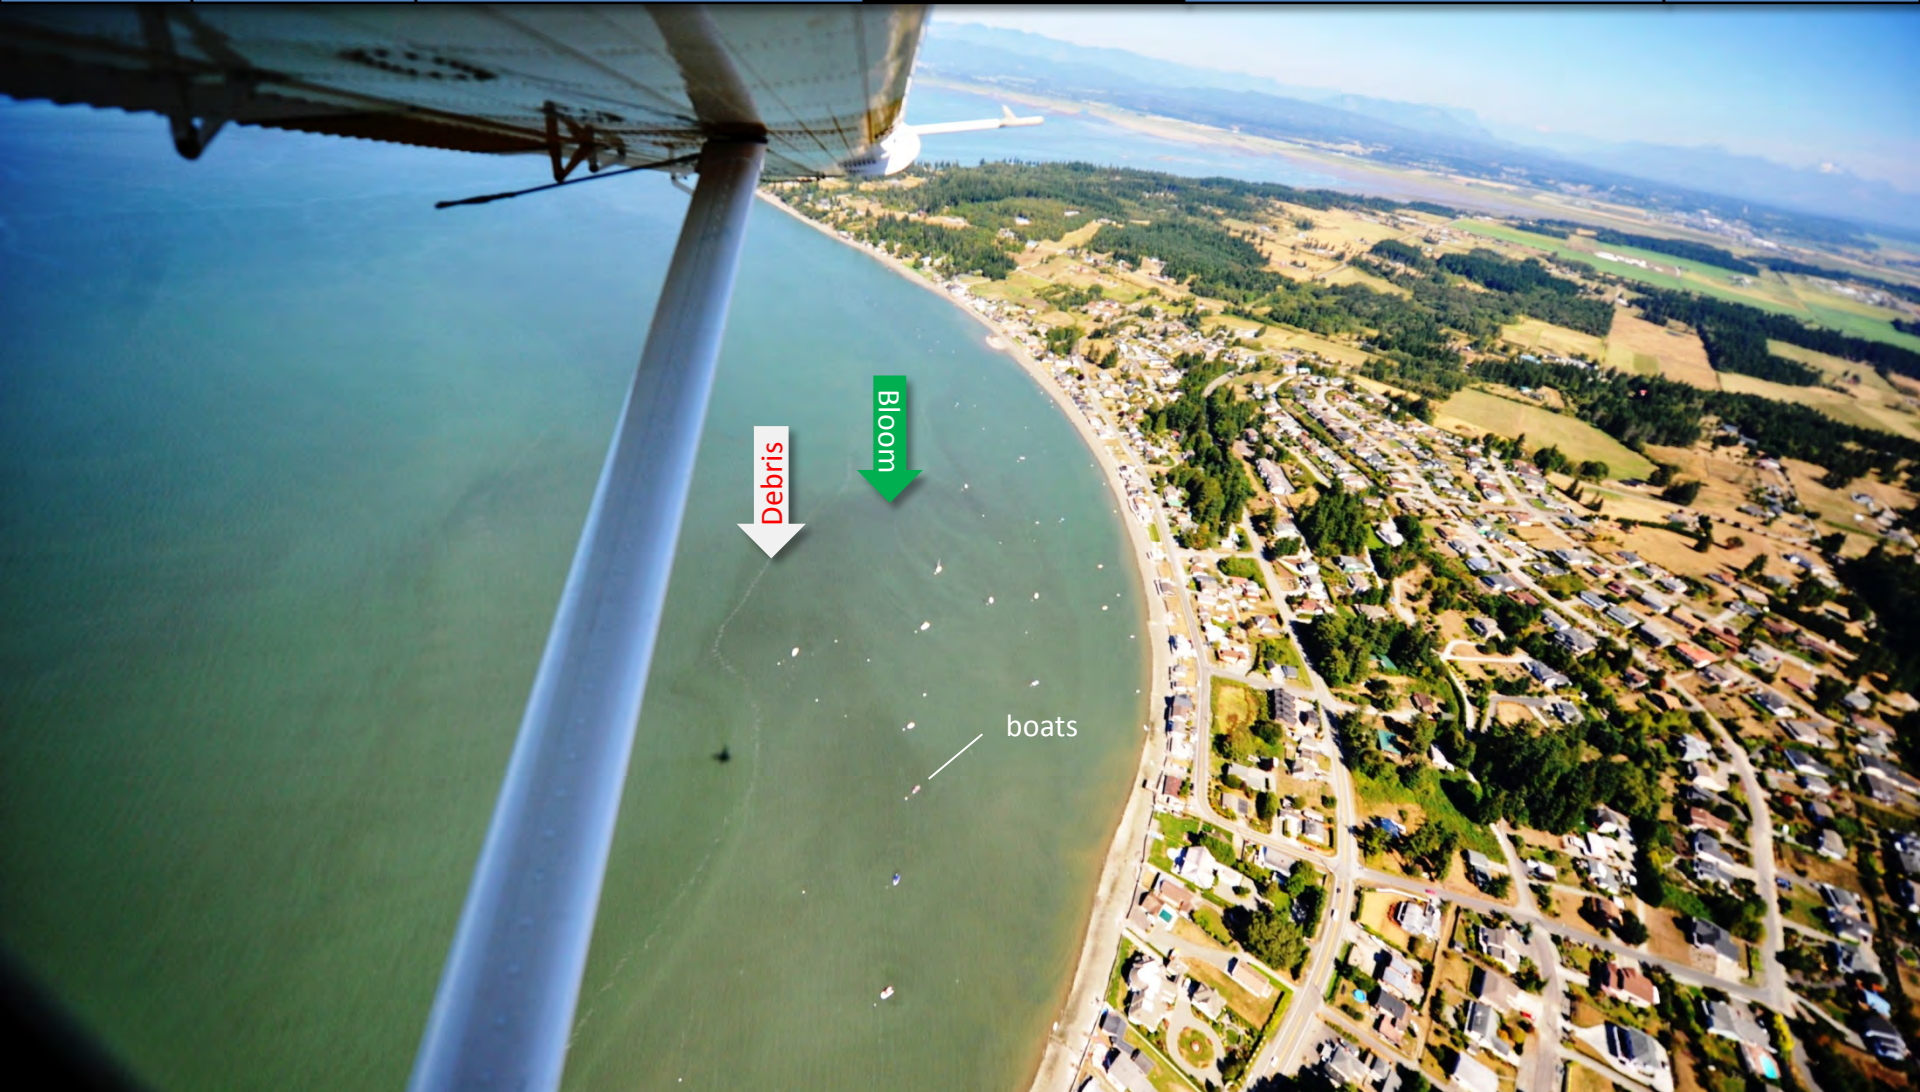
Location: North of Camano Island (Skagit Bay), 2:54 PM.

Red brown phytoplankton bloom mixed in with Skagit River sediment.

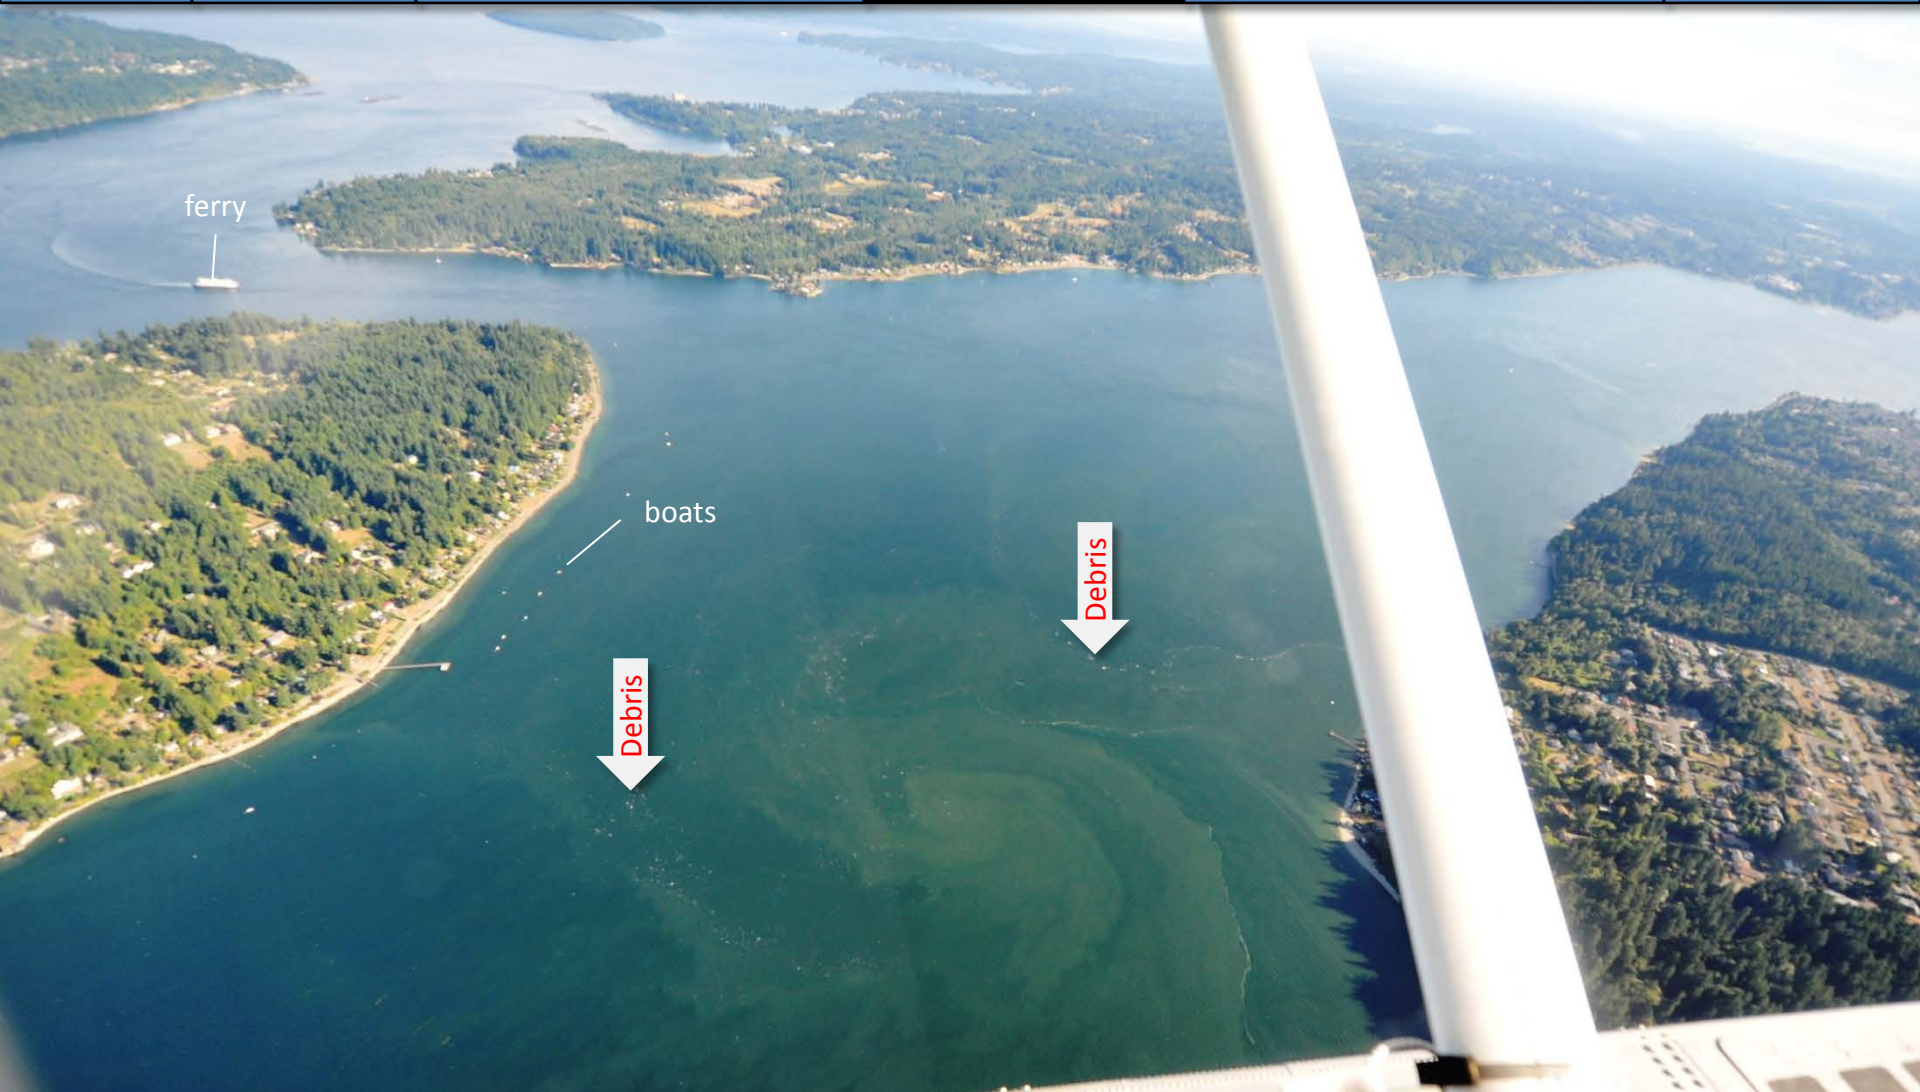
Large tidal eddy with sediment rich water and surface debris.
Location: Southern Bainbridge Island (Sinclair Inlet), 5:10 PM.

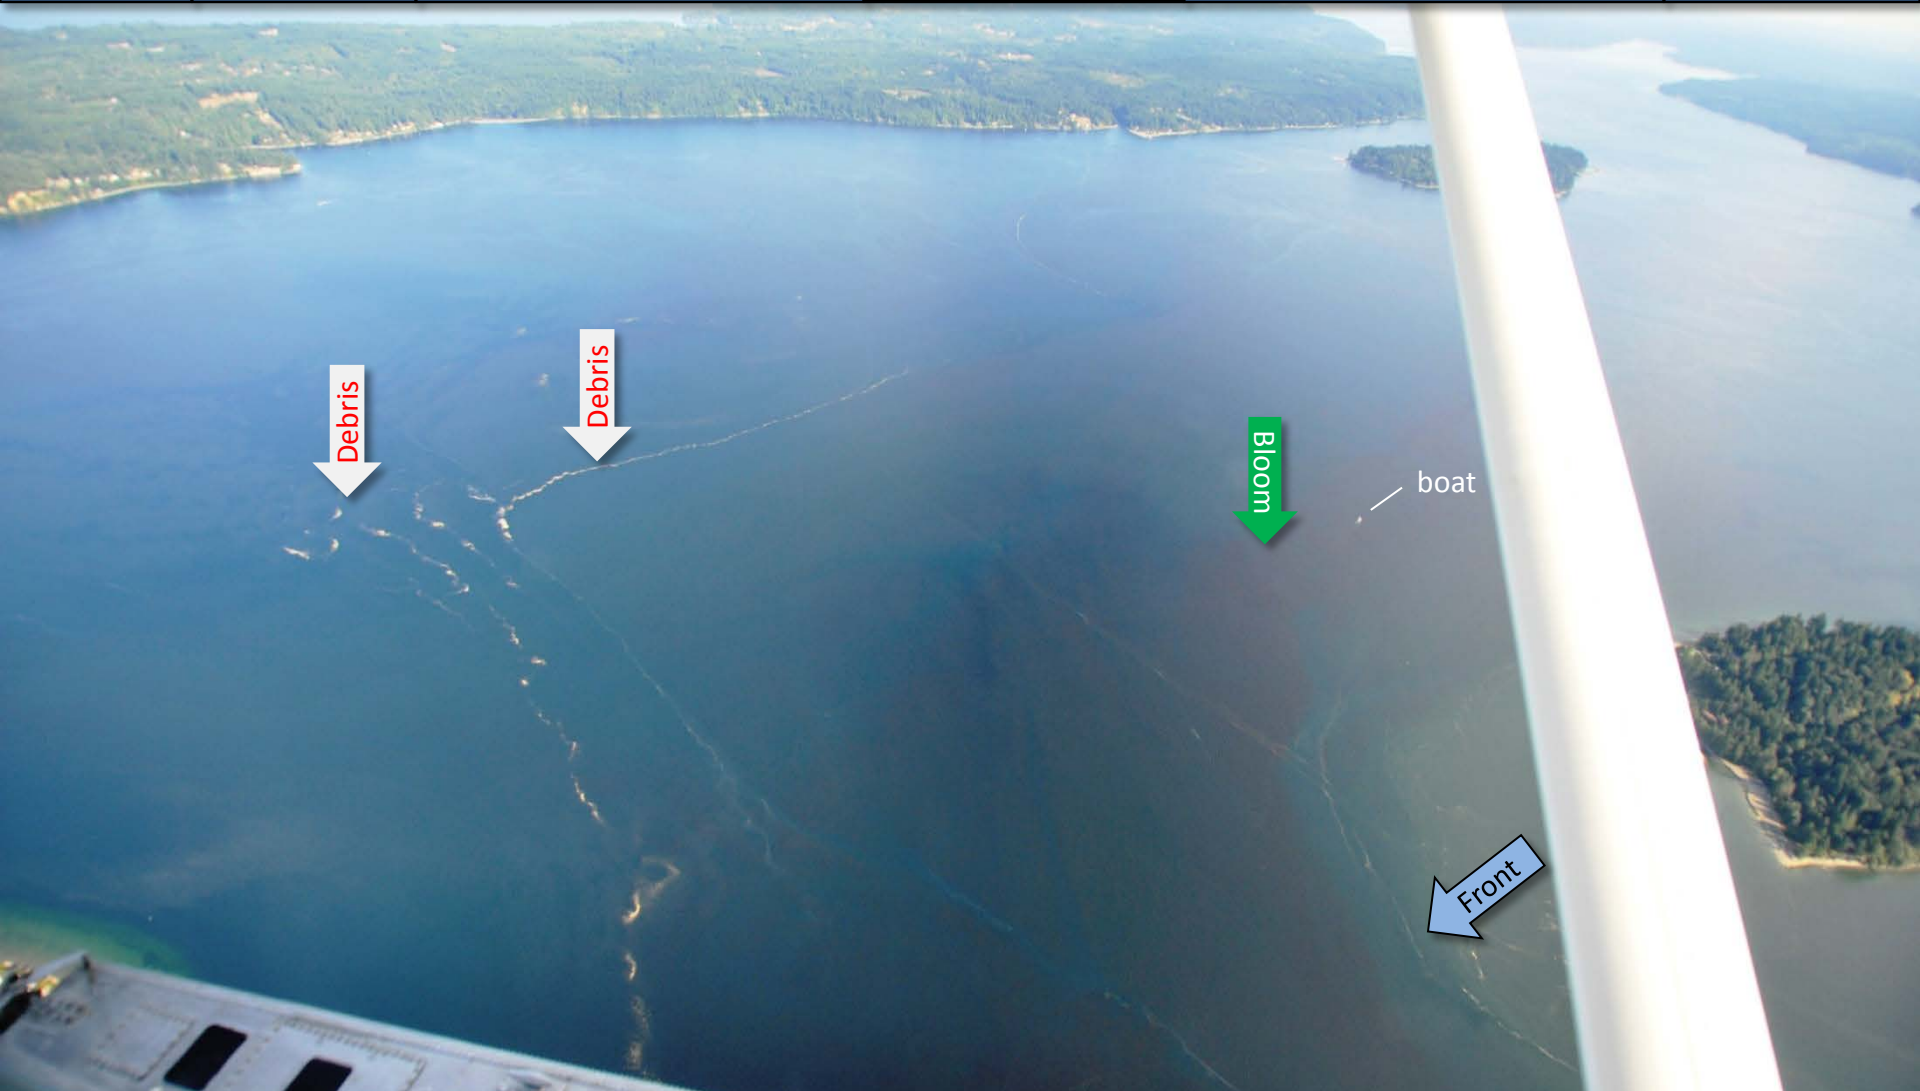
Location: Case Inlet (South Sound), 5:24 PM.

Red-brown algae bloom, sediment stained water, and surface debris.

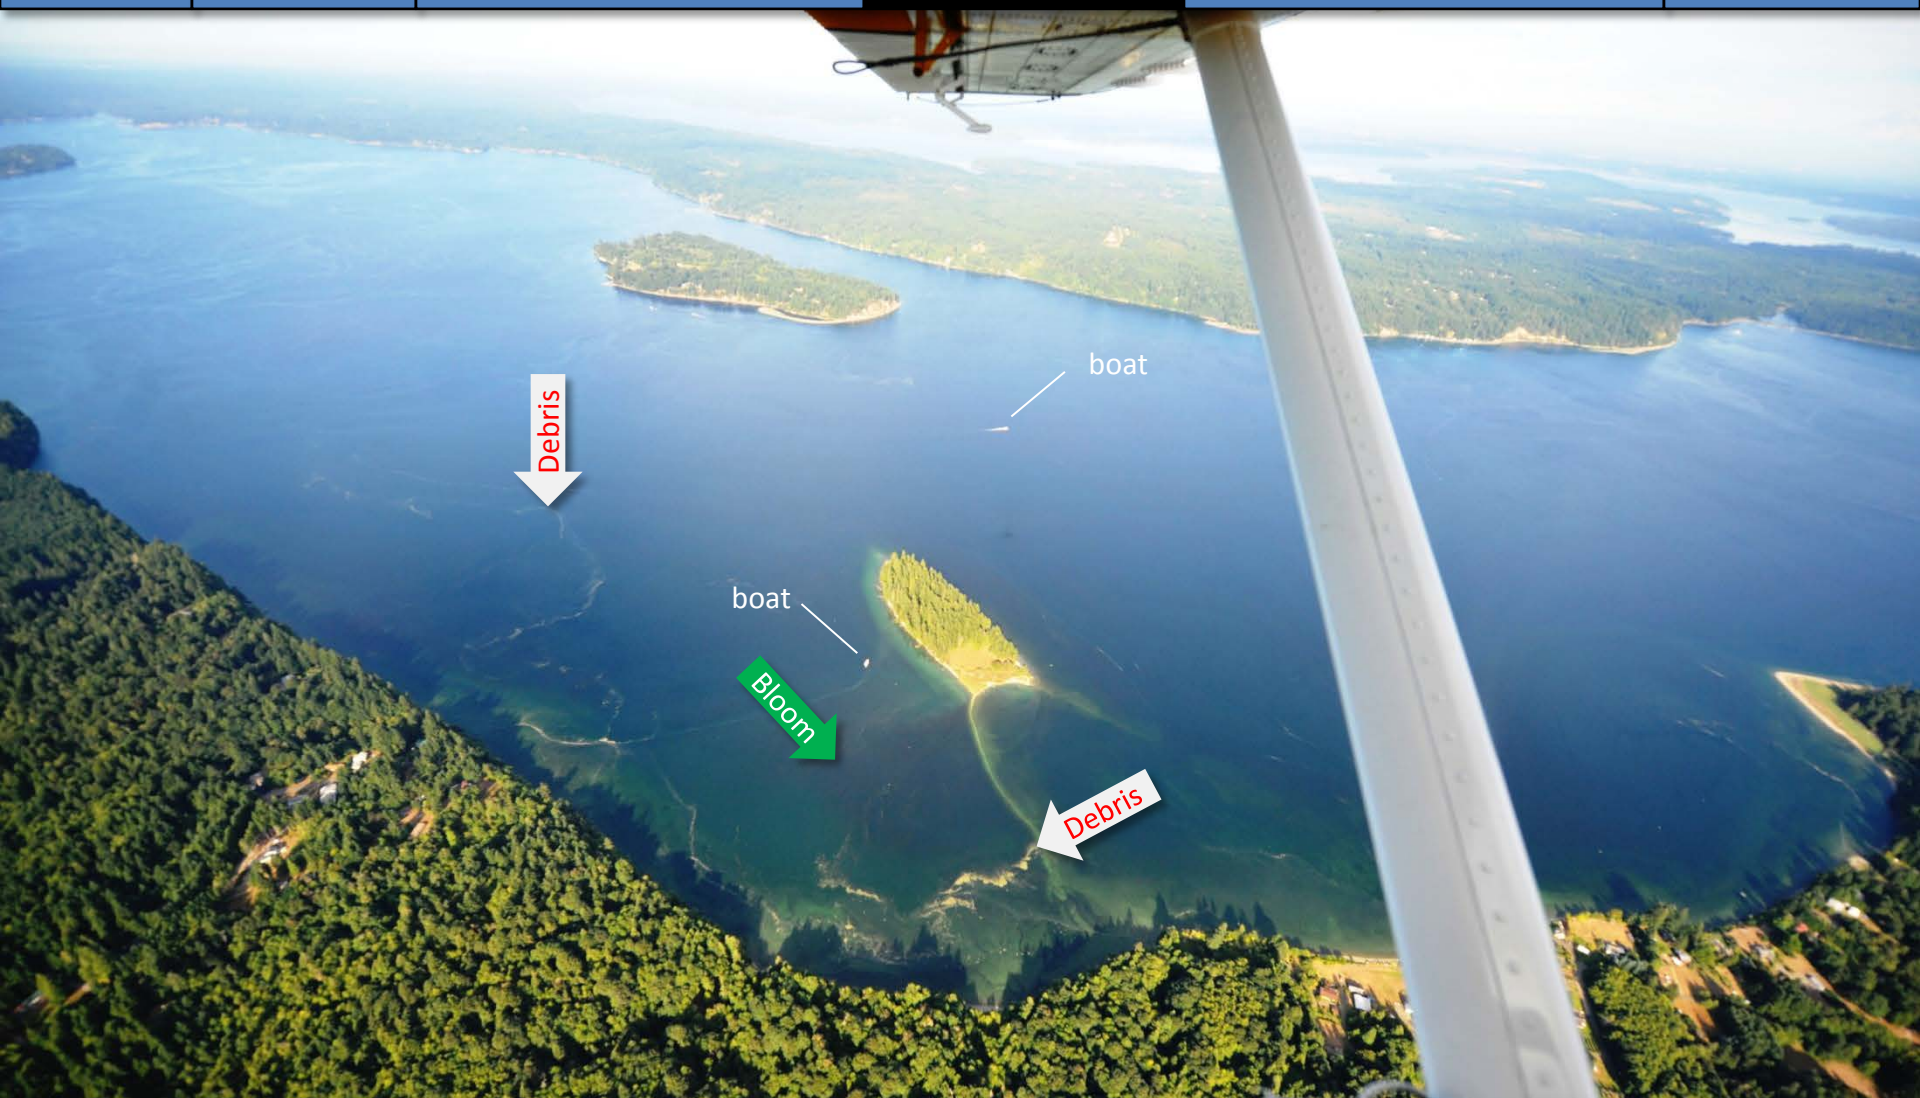
Location: McMicken Island (Case Inlet), 5:24 PM.

Red-brown algae bloom and abundant surface debris.
