Eyes Over Puget Sound

Surface Conditions Report, August 21, 2013

Up-to-date observations of visible water quality conditions in Puget Sound and the Strait of Juan de Fuca

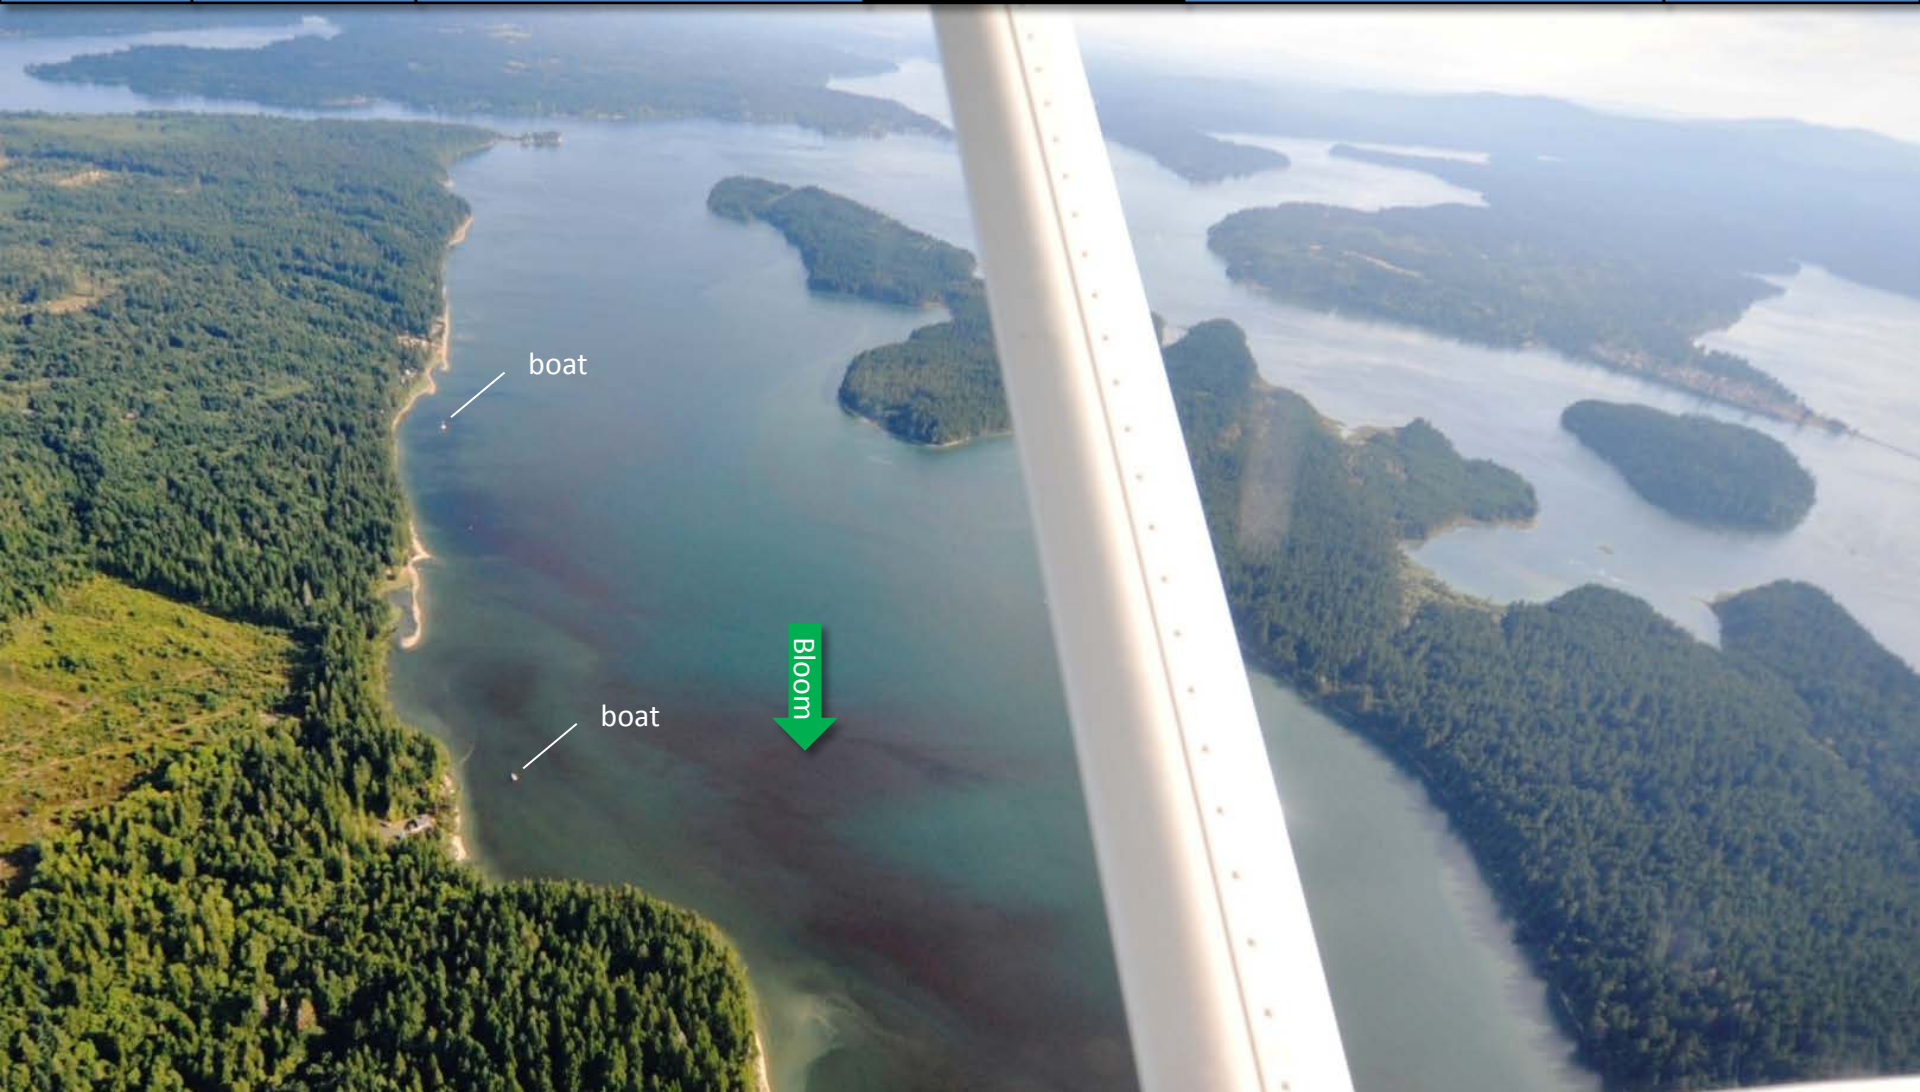
Location: Squaxin Island (South Sound), 5:28 PM.

Red-brown bloom between Harstine Island and Squaxin Island

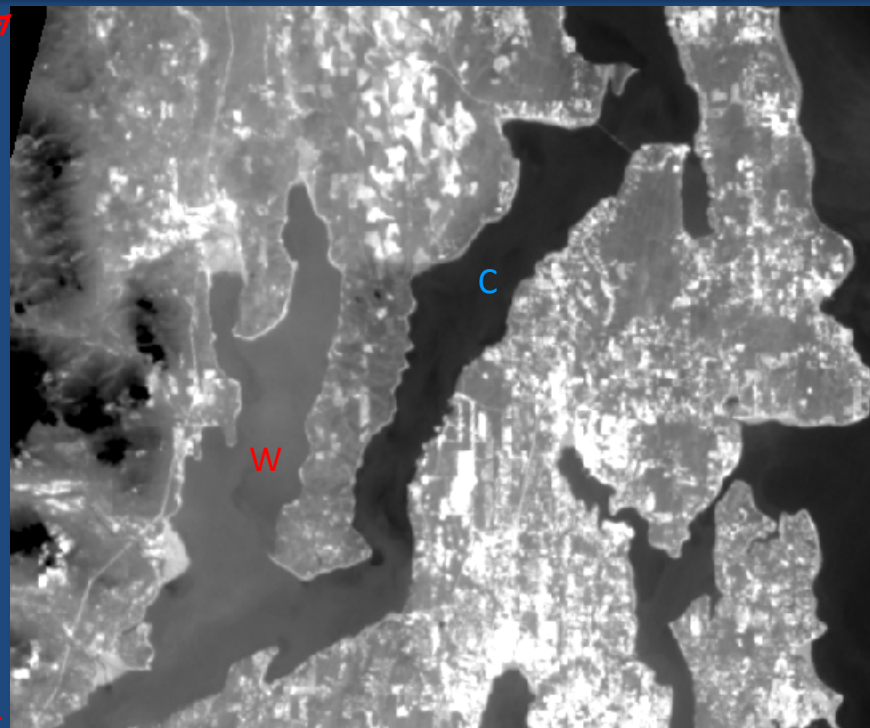
Northern arms of Case and Carr Inlet and central/southern Hood Canal are noticeably warmer than other areas in Puget Sound. Local rivers continue to add relatively warm water at the surface.

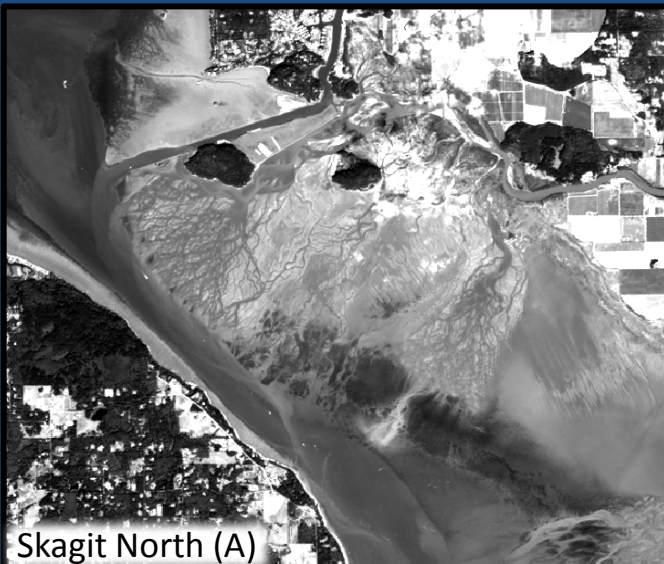
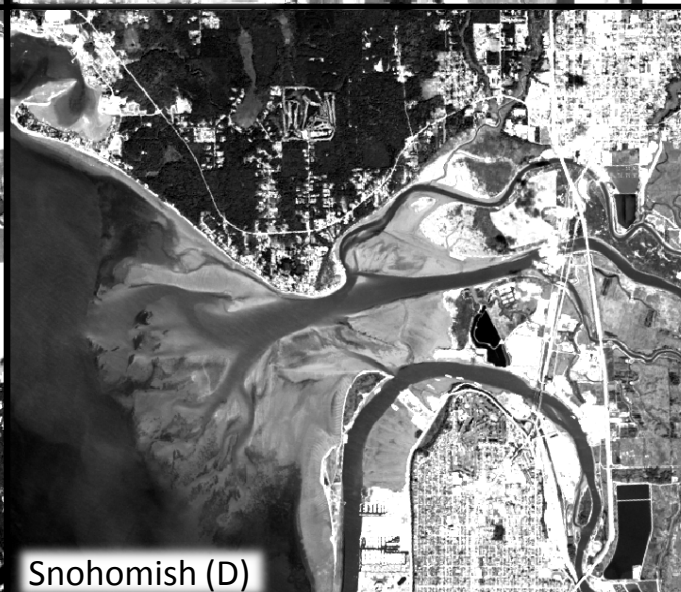
21 August 2013 - LANDSAT 8 - 15-m Panchromatic

LANDSAT 8 continues to provide valuable near-surface temperature estimates for Puget Sound. Low-tide imagery provides rare glimpse of beautiful braided channels criss-crossing Whidbey Basin river deltas!

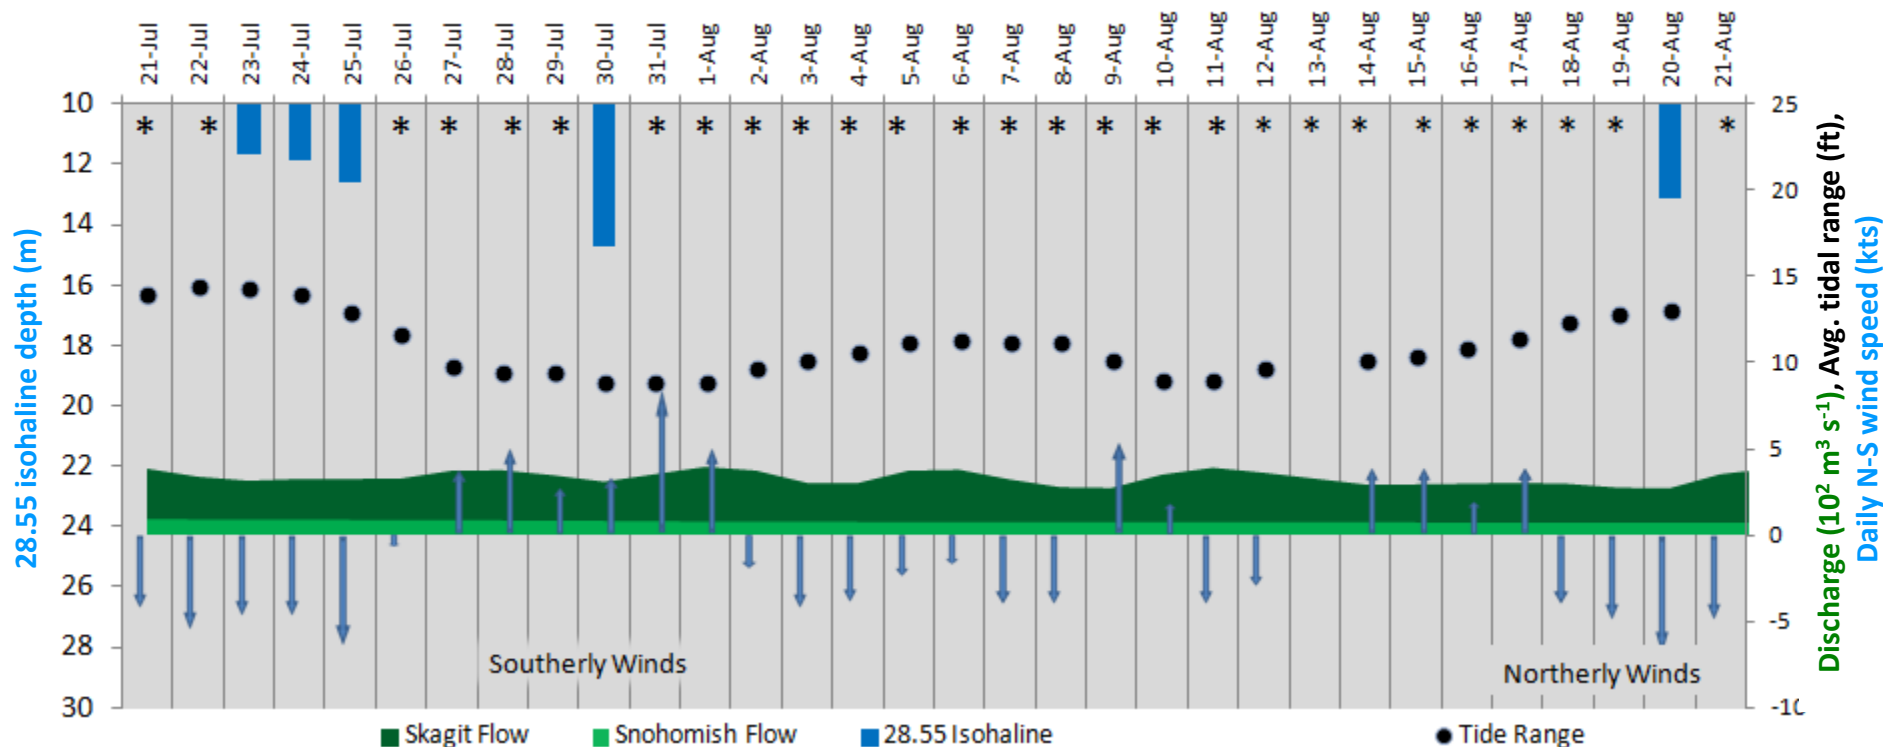
Thickness of freshwater layer at Mukilteo and influencing factors

We report on thickness of the fresher surface water layer by monitoring our sensor at 16m. We define its thickness using 28.55 (± 0.05) PSU. At Mukilteo (Whidbey Basin), winds, tidal cycle, and declining river flows influenced the surface water layer thickness, which was rarely detected over the past two weeks. Freshwater input from rivers continues to decline with the Skagit River contributing the largest portion.

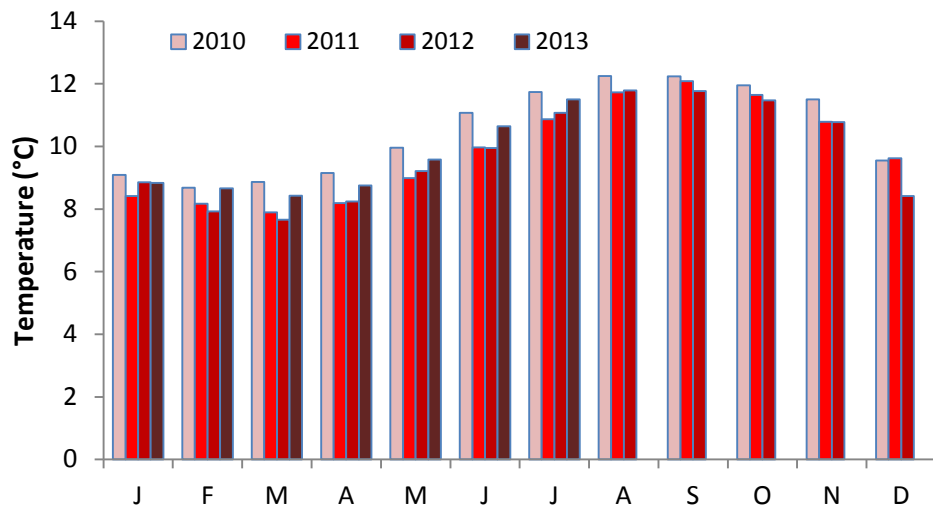
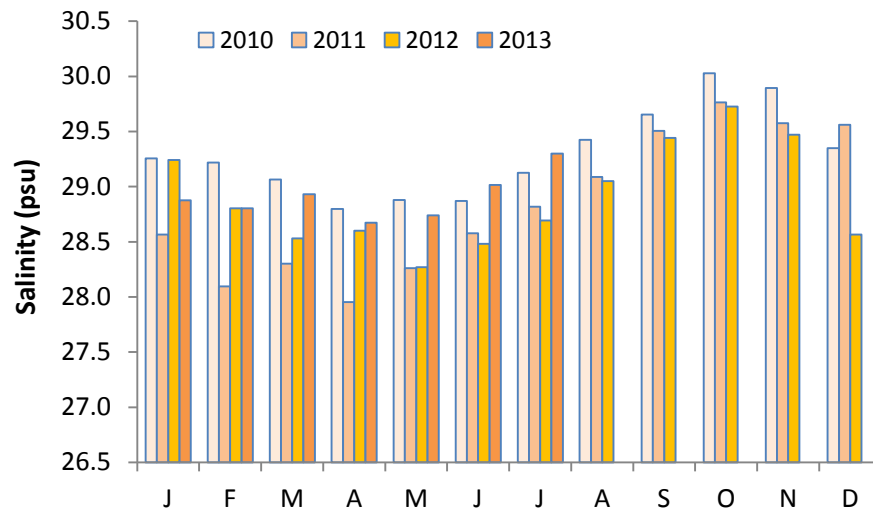
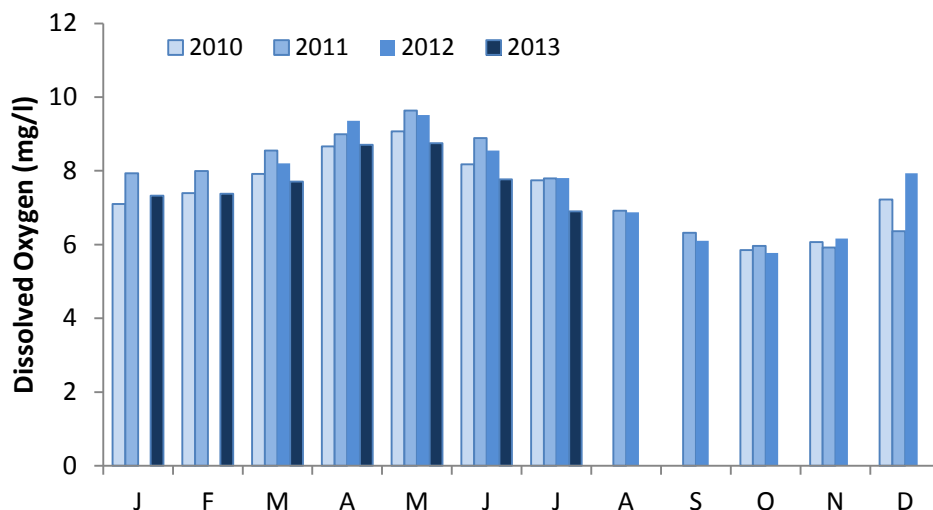
This slide shows data from our Mukilteo mooring capturing water exchange between the Main Basin and Possession Sound at 12-16 m.

Inter-annual variability in temperature, salinity, and dissolved oxygen is shown over a 3.5-year period. All three variables show strong seasonality.

Thus far in 2013, trends are appearing to be similar to 2010 with relatively warmer water temperature, higher salinity, but lower dissolved oxygen.
