Eyes Over Puget Sound

[Flight log](#)[Weather](#)[Water column](#)[Aerial photos](#)[Ferry and Satellite](#)[Moorings](#)

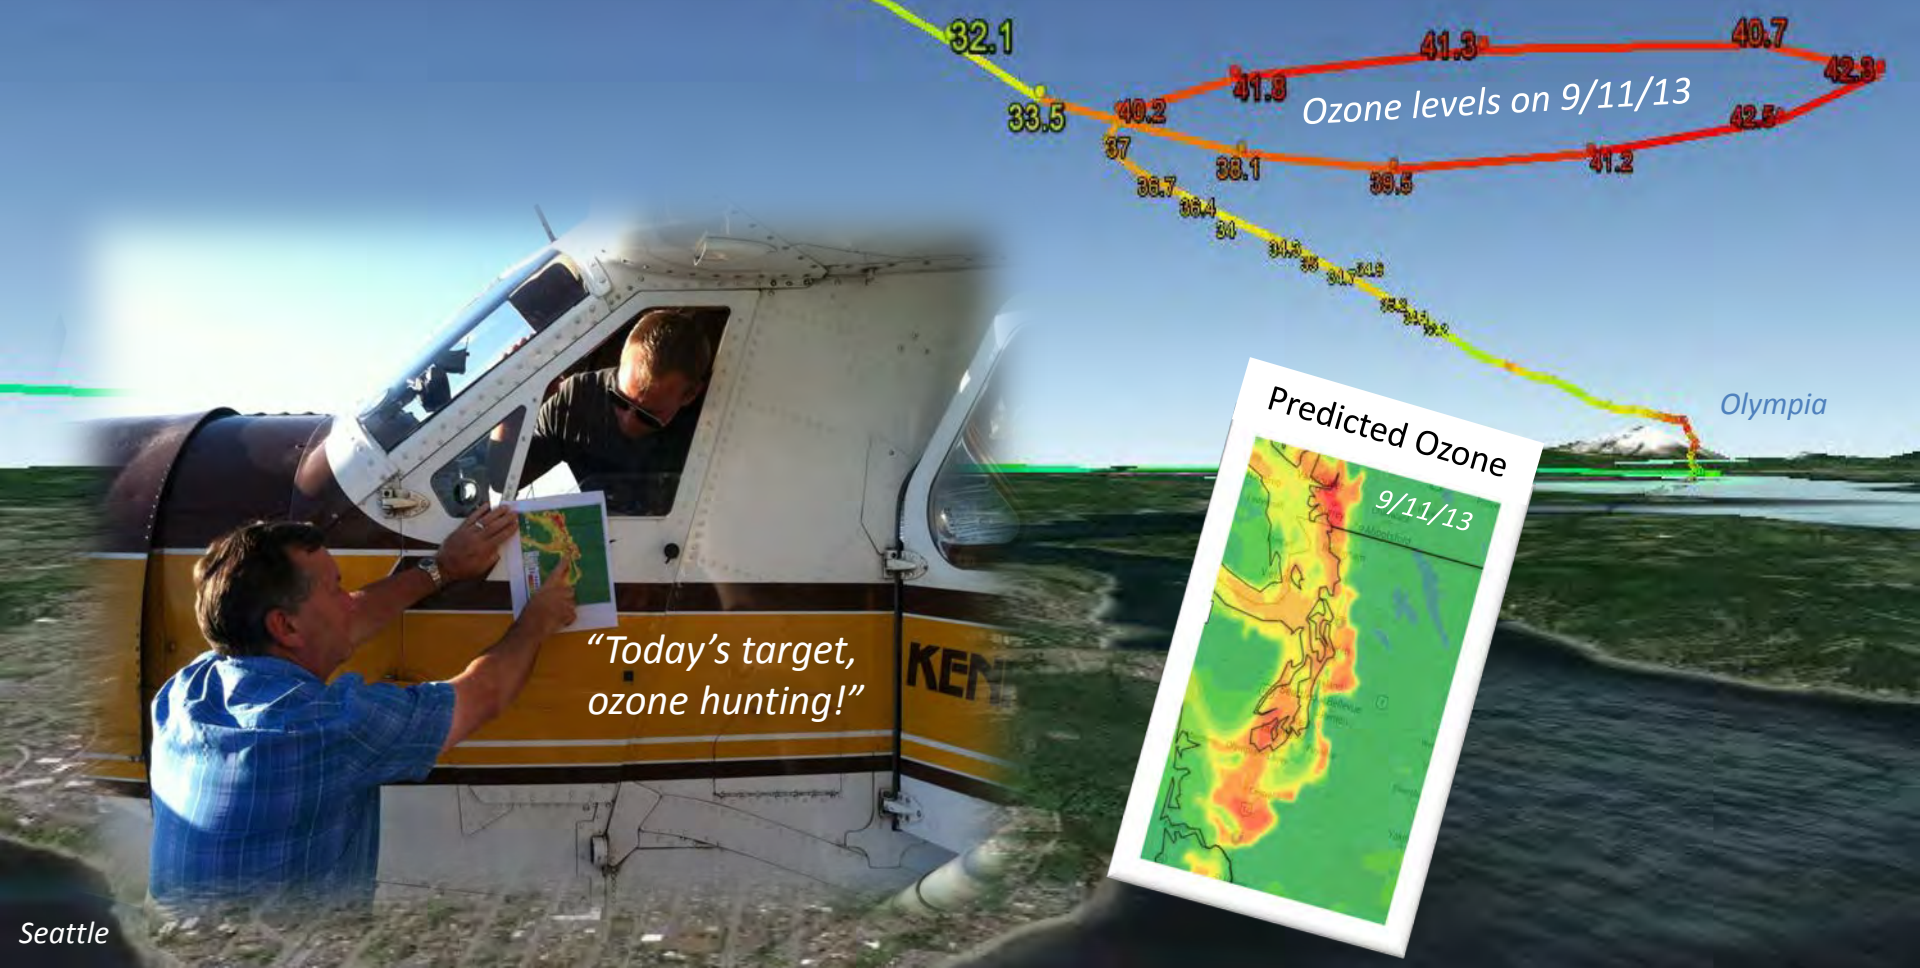
The [Air Indicator Report for Public Awareness and Community Tracking](#) (AIRPACT) is a computerized system for predicting air quality that might impact public and environmental health. With high ozone concentrations predicted on Sept. 11, GPS-referenced ozone monitoring equipment joined the flight to compare predicted (AIRPACT) and measured concentrations.

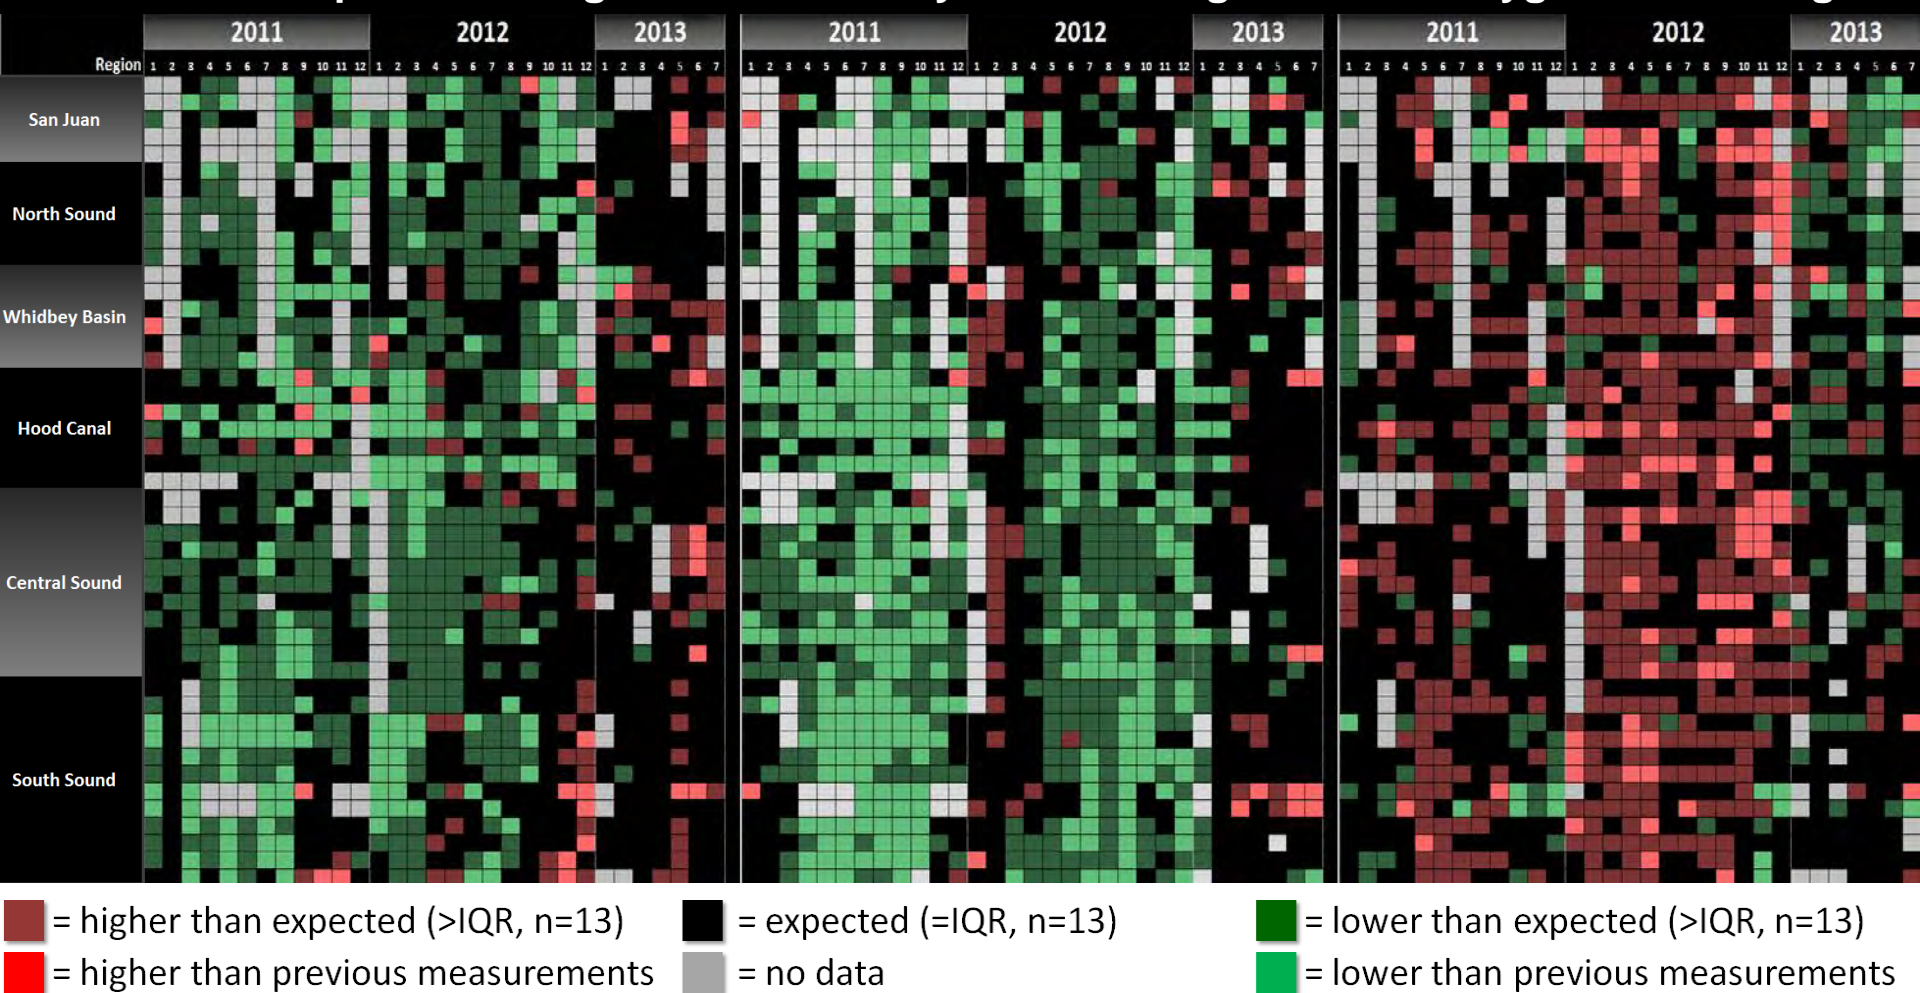
Puget Sound water conditions are changing again! Compared to 2011-2012, when waters were colder and fresher with higher oxygen, stations are showing signs of warmer temperatures and decreasing oxygen. Each pixel is a monthly survey at a single station.

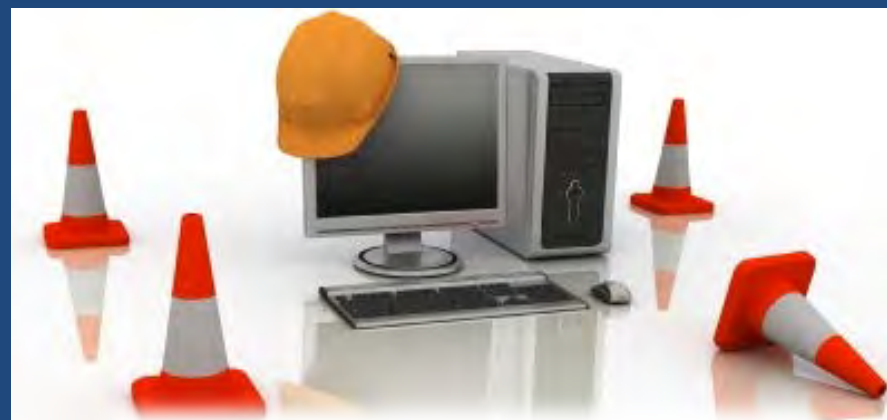
No Victoria Clipper data available –
Hardware upgrades in progress!!!
