Eyes Over Puget Sound

Surface Conditions Report

October 28, 2013

Up-to-date observations of visible water quality conditions in Puget Sound and the Strait of Juan de Fuca

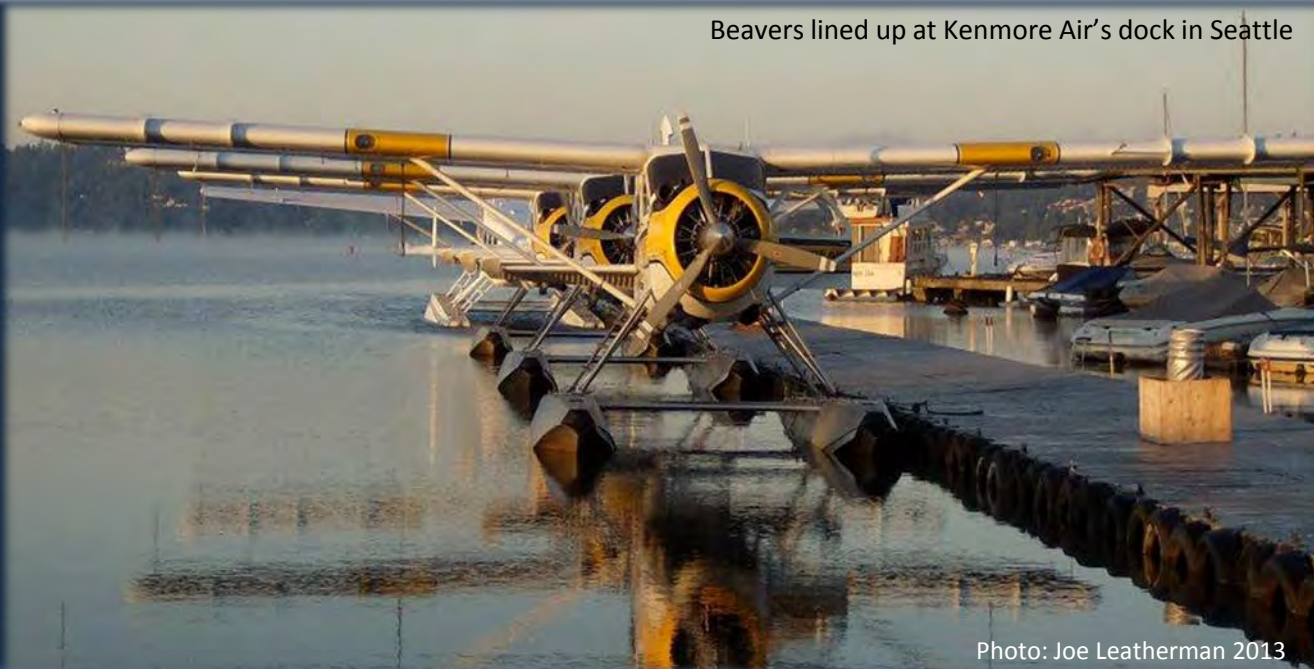
Beavers lined up at Kenmore Air's dock in Seattle

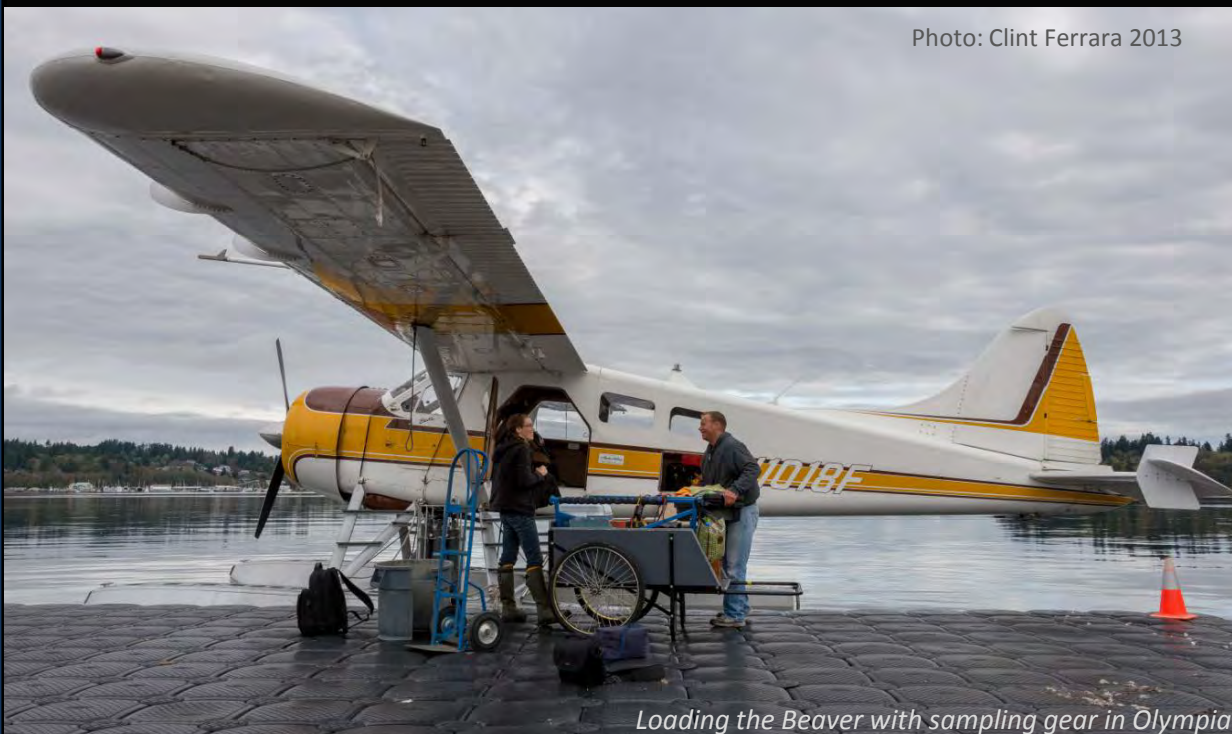
The belly hatch was used for crop dusting and other aerial applications. The designers would probably be thrilled to learn that the hatch allows us to deploy our CTD. We can add one more application to the Beaver's resume: **oceanographic sampling platform**.

Loading the Beaver with sampling gear in Olympia

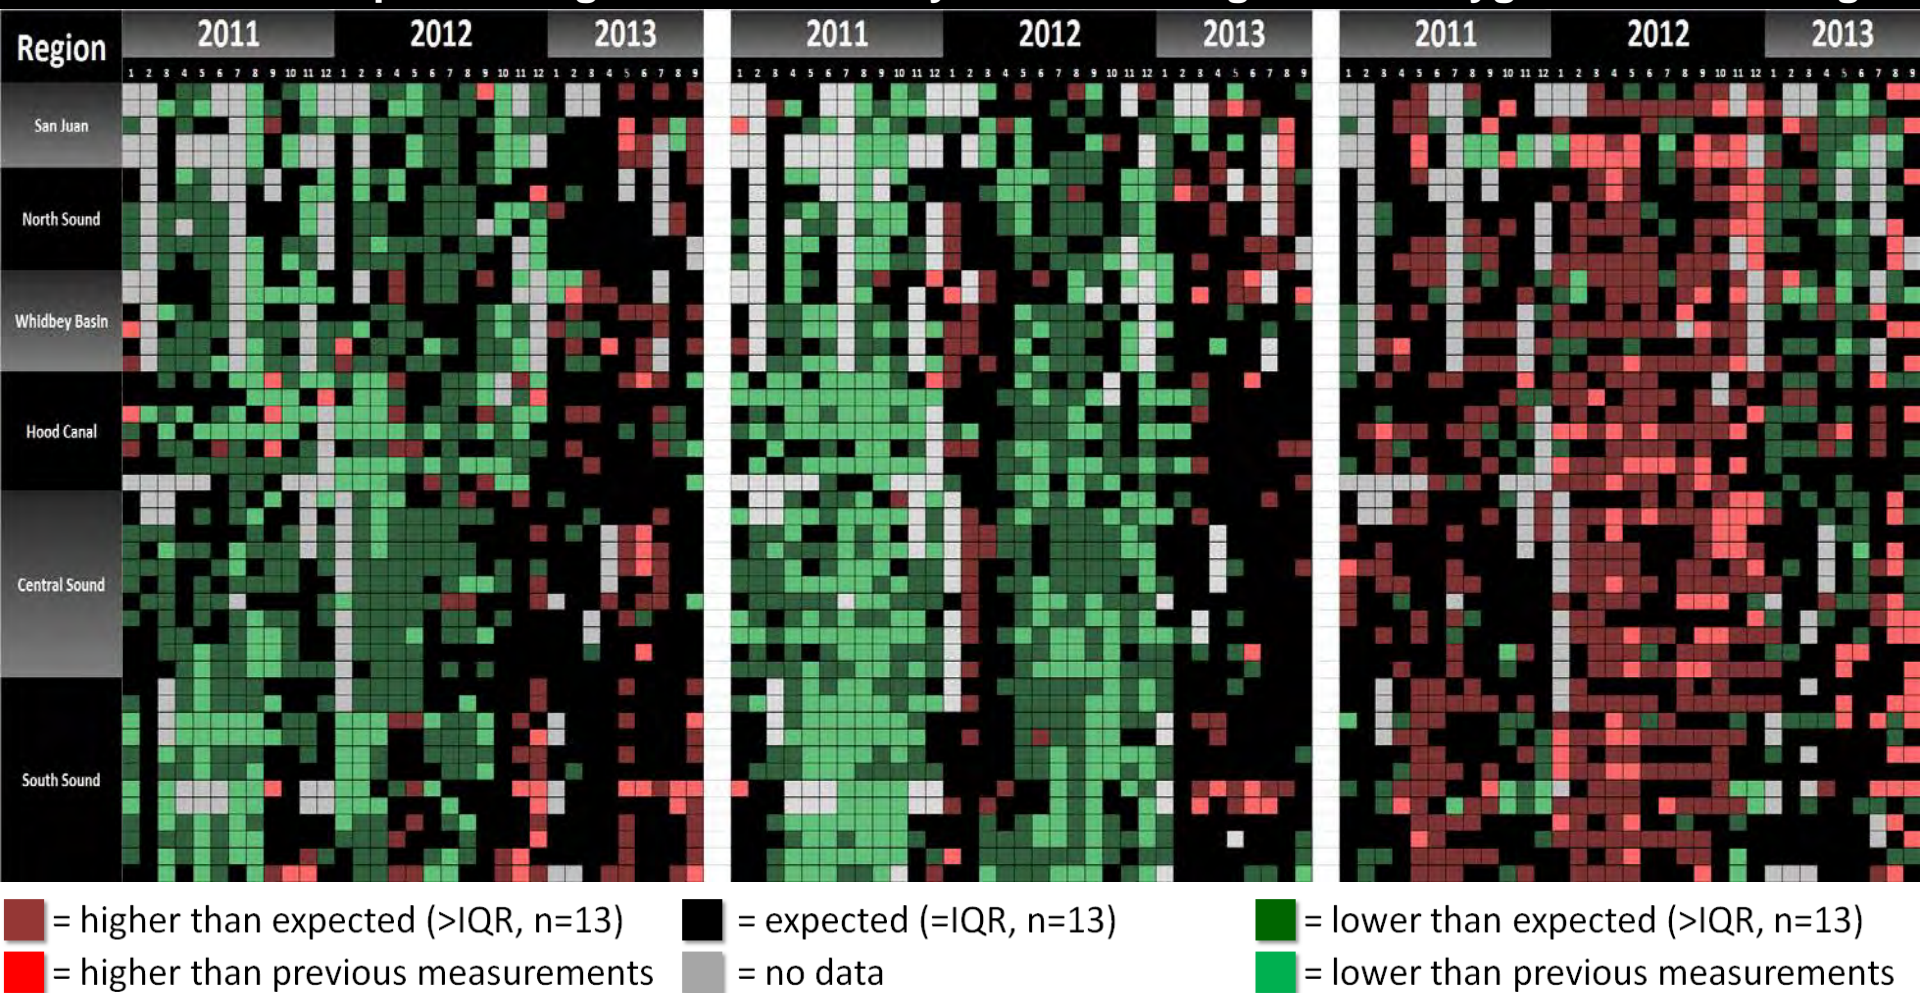
Puget Sound water conditions are normalizing after a 7-month reduced oxygen phase from Jan. to July, 2013. This follows two years (2011, 2012) of higher oxygen. Anomalies are calculated in reference to a time-averaged seasonal cycle using the years 1999 to 2008. Each pixel is a monthly survey at a single station.

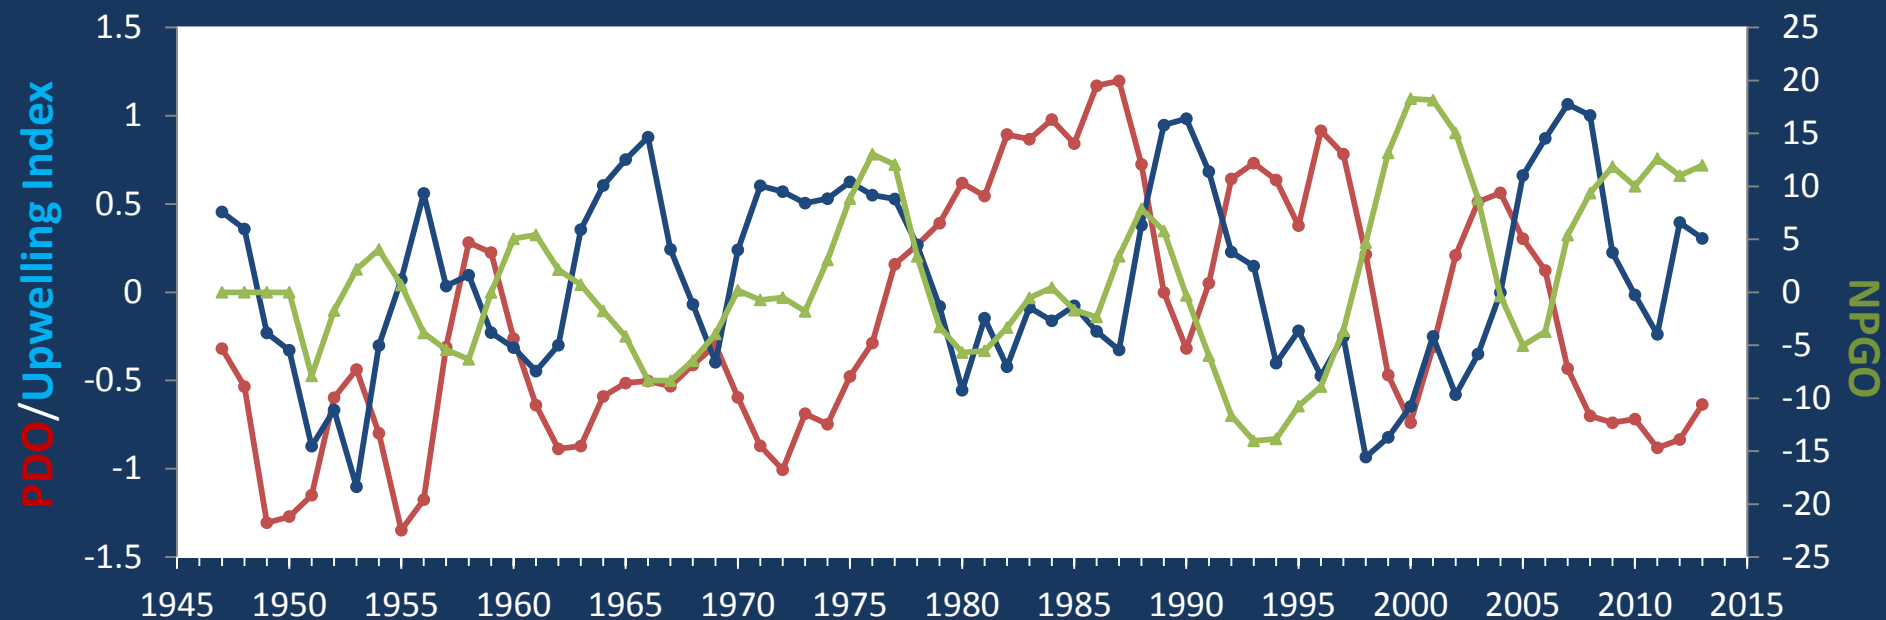
Three-year running average of PDO, Upwelling, and NPGO indices scores

Ocean boundary conditions have been favorable for water quality in Puget Sound: (a) colder water (PDO), (b) less upwelled low oxygen and high nutrient ocean water reaching Puget Sound (Upwelling Index), and (c) higher surface productivity along the coast (NPGO). Where are we heading next?

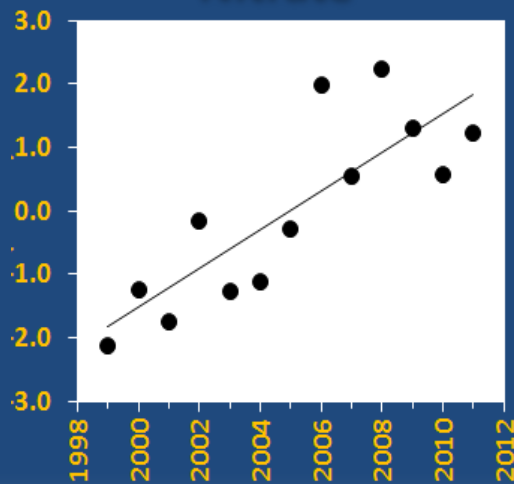
Nitrate

Nutrients in Puget Sound are increasing, read http://www.ecy.wa.gov/programs/eap/mar_wat/trends.html

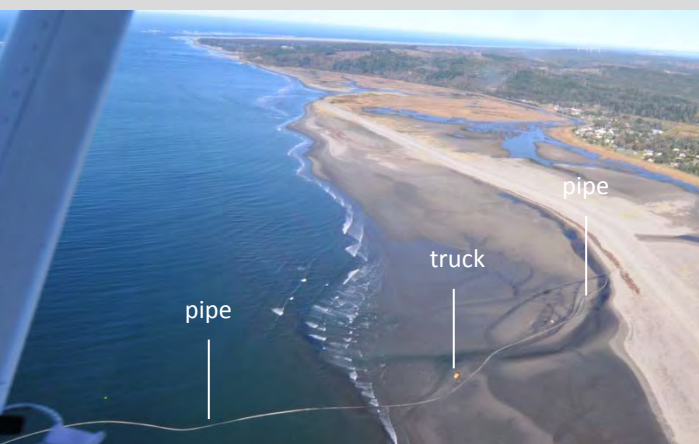
Long pipes running across beach, Tokeland

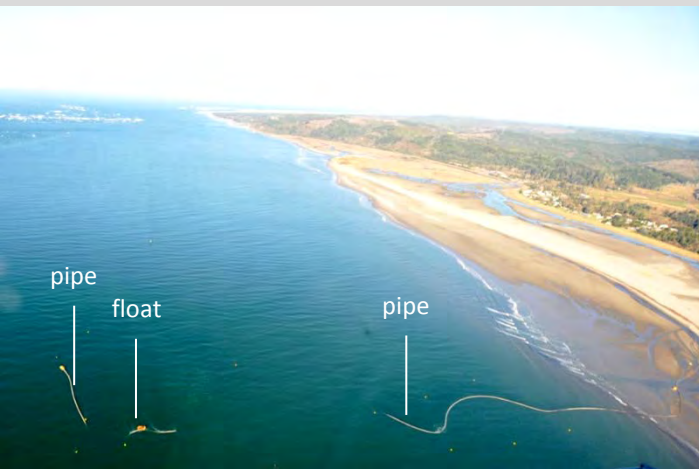
Pipes end mid-channel, Willapa Bay

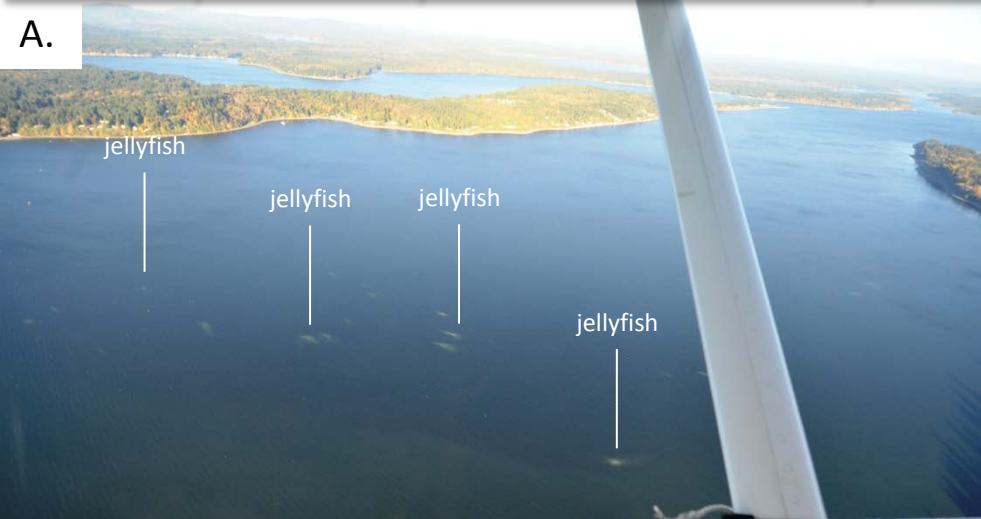
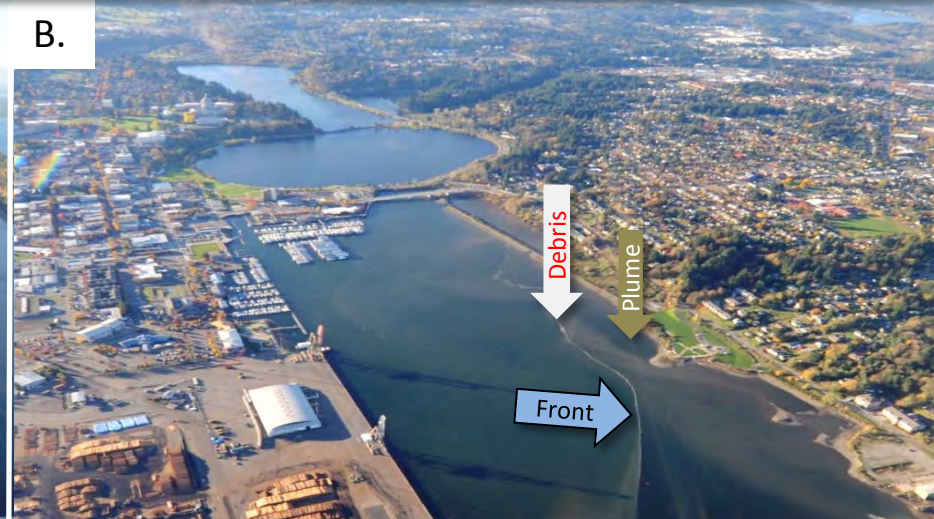
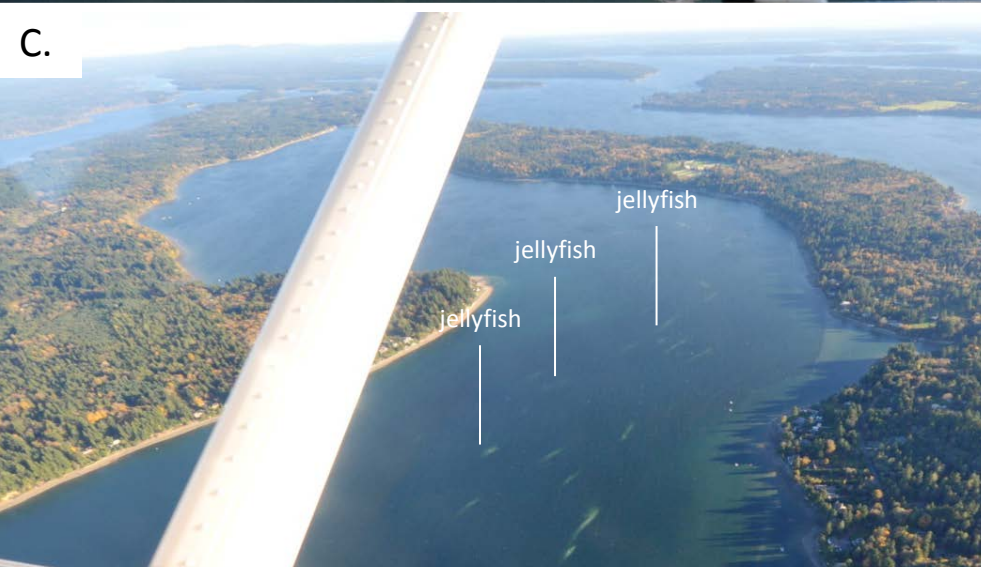
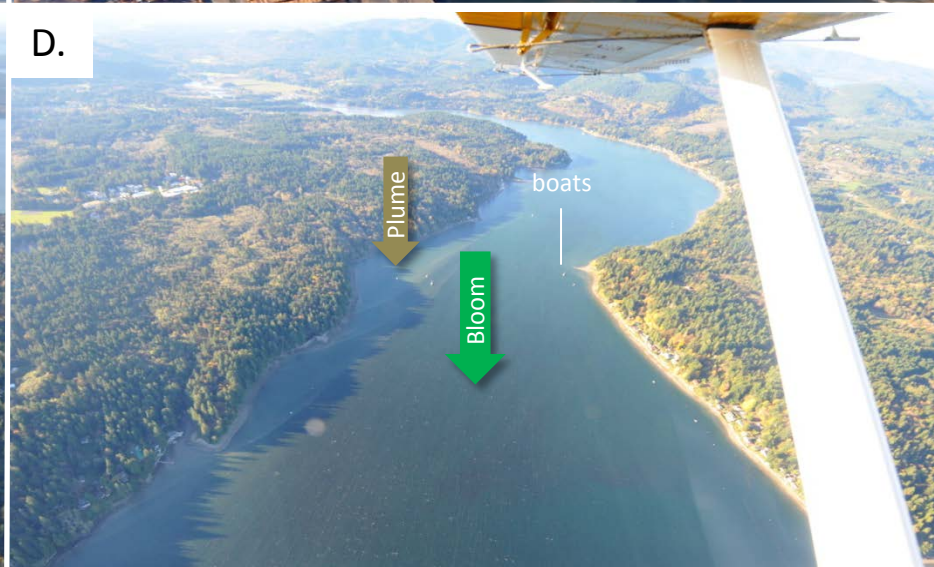
Jellyfish patches, front, suspended sediments, and red-brown algal bloom.
Location: A-B. Budd Inlet. C-D. Eld Inlet. (South Sound) 9:30 AM.

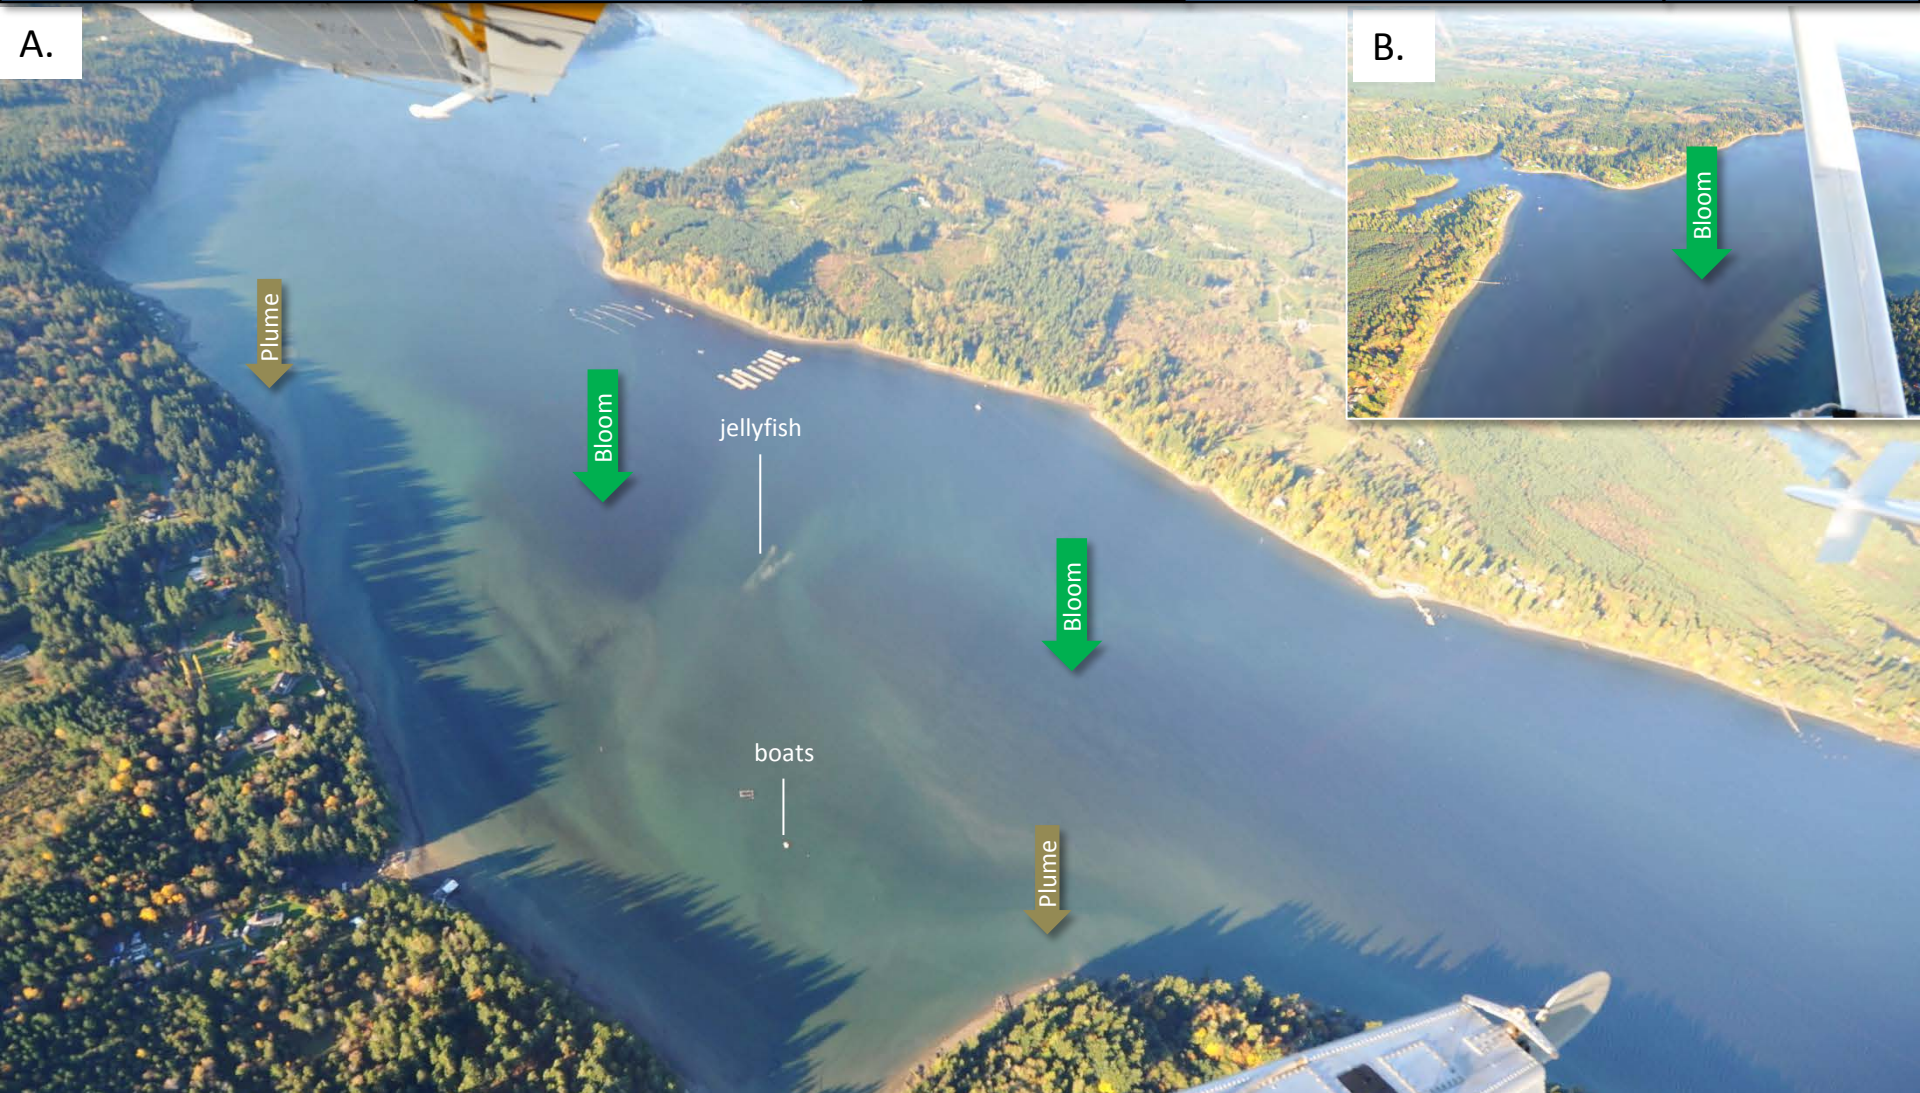
Red-brown bloom, jellyfish, and suspended sediment.

Location: Totten Inlet, A. Looking south, B. Looking north (South Sound), 9:40 AM.

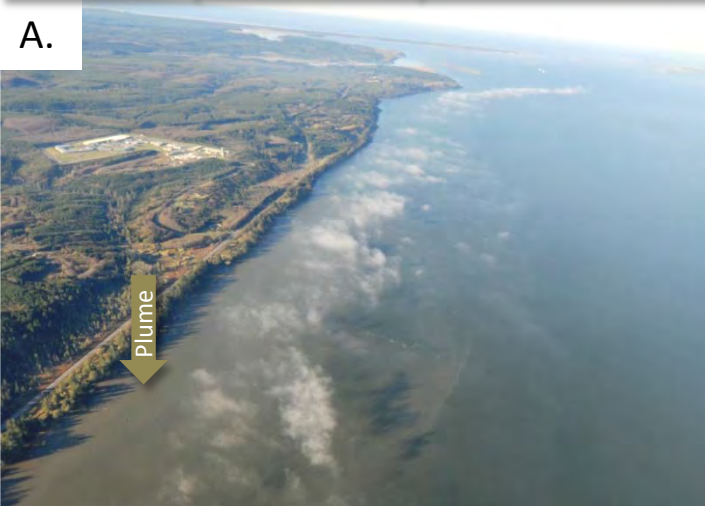
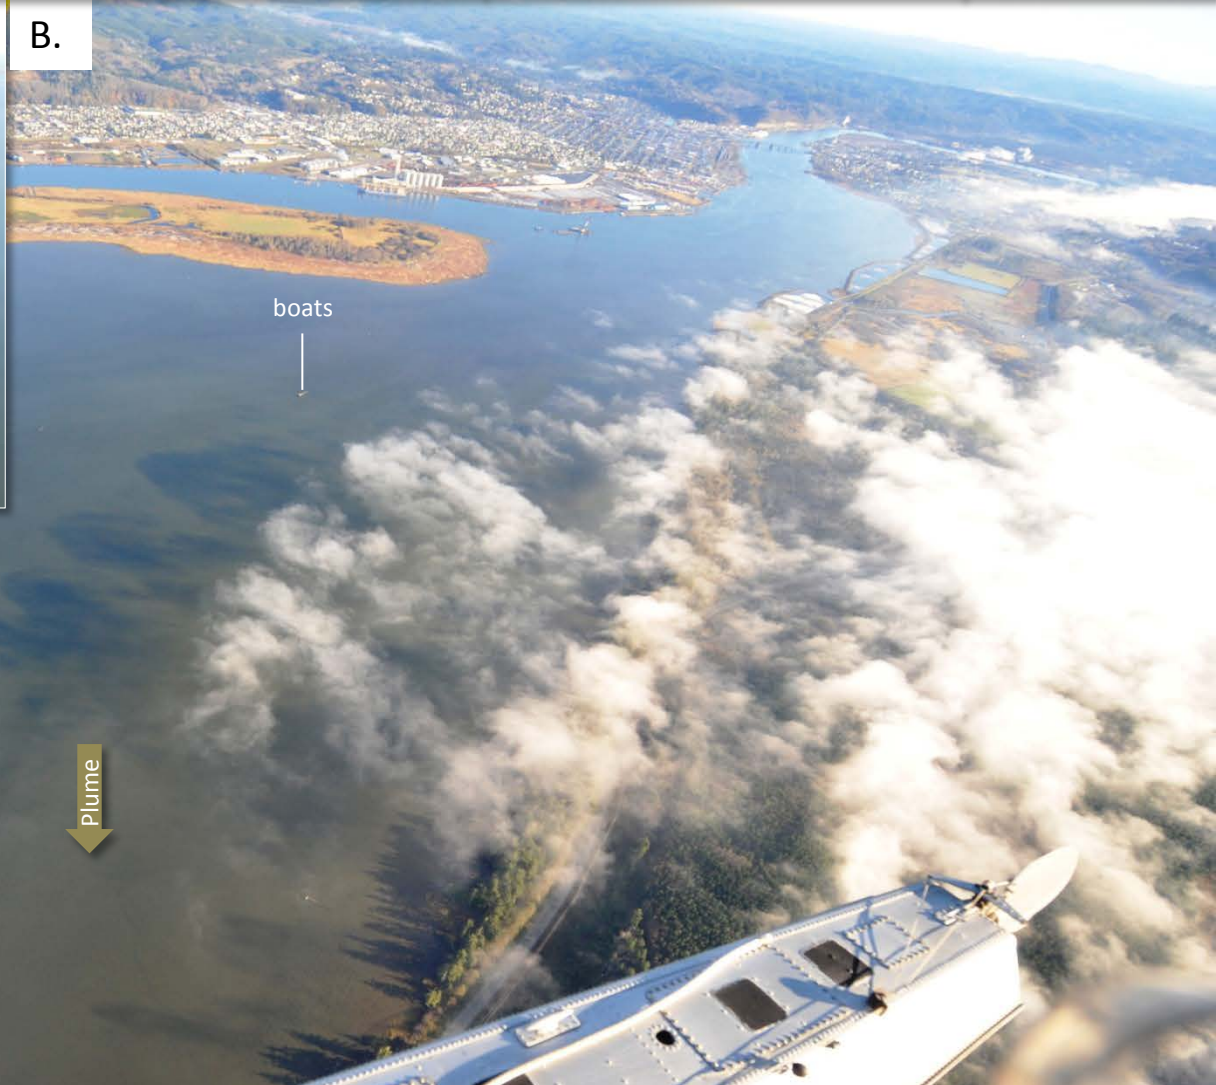
A. Cloud banks follow river plume with much suspended sediment. B. Low lying clouds follow Chehalis River into estuary. Location: Aberdeen (Grays Harbor), 10:06 AM.

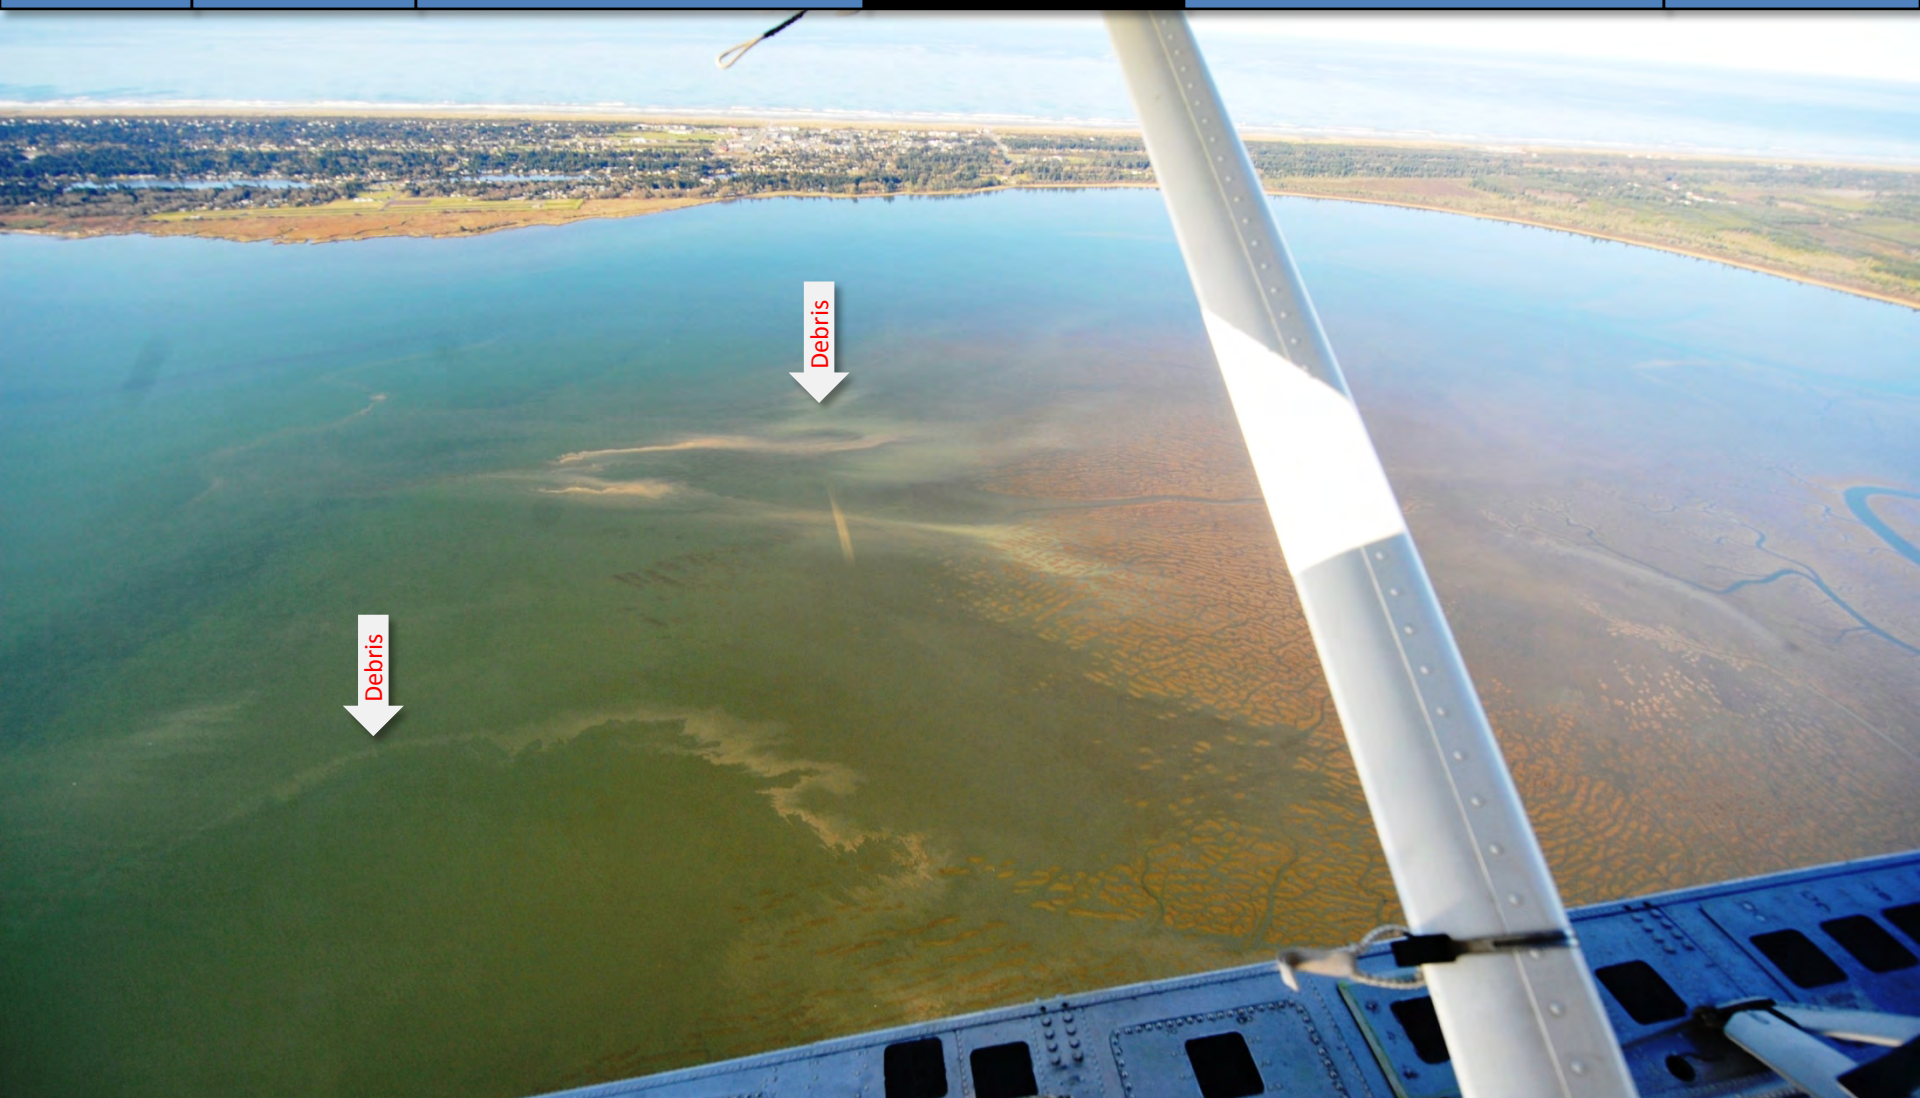
*Organic surface debris and suspended sediment near exposed mudflat.
Location: North Bay (Grays Harbor), 11:13 AM.*

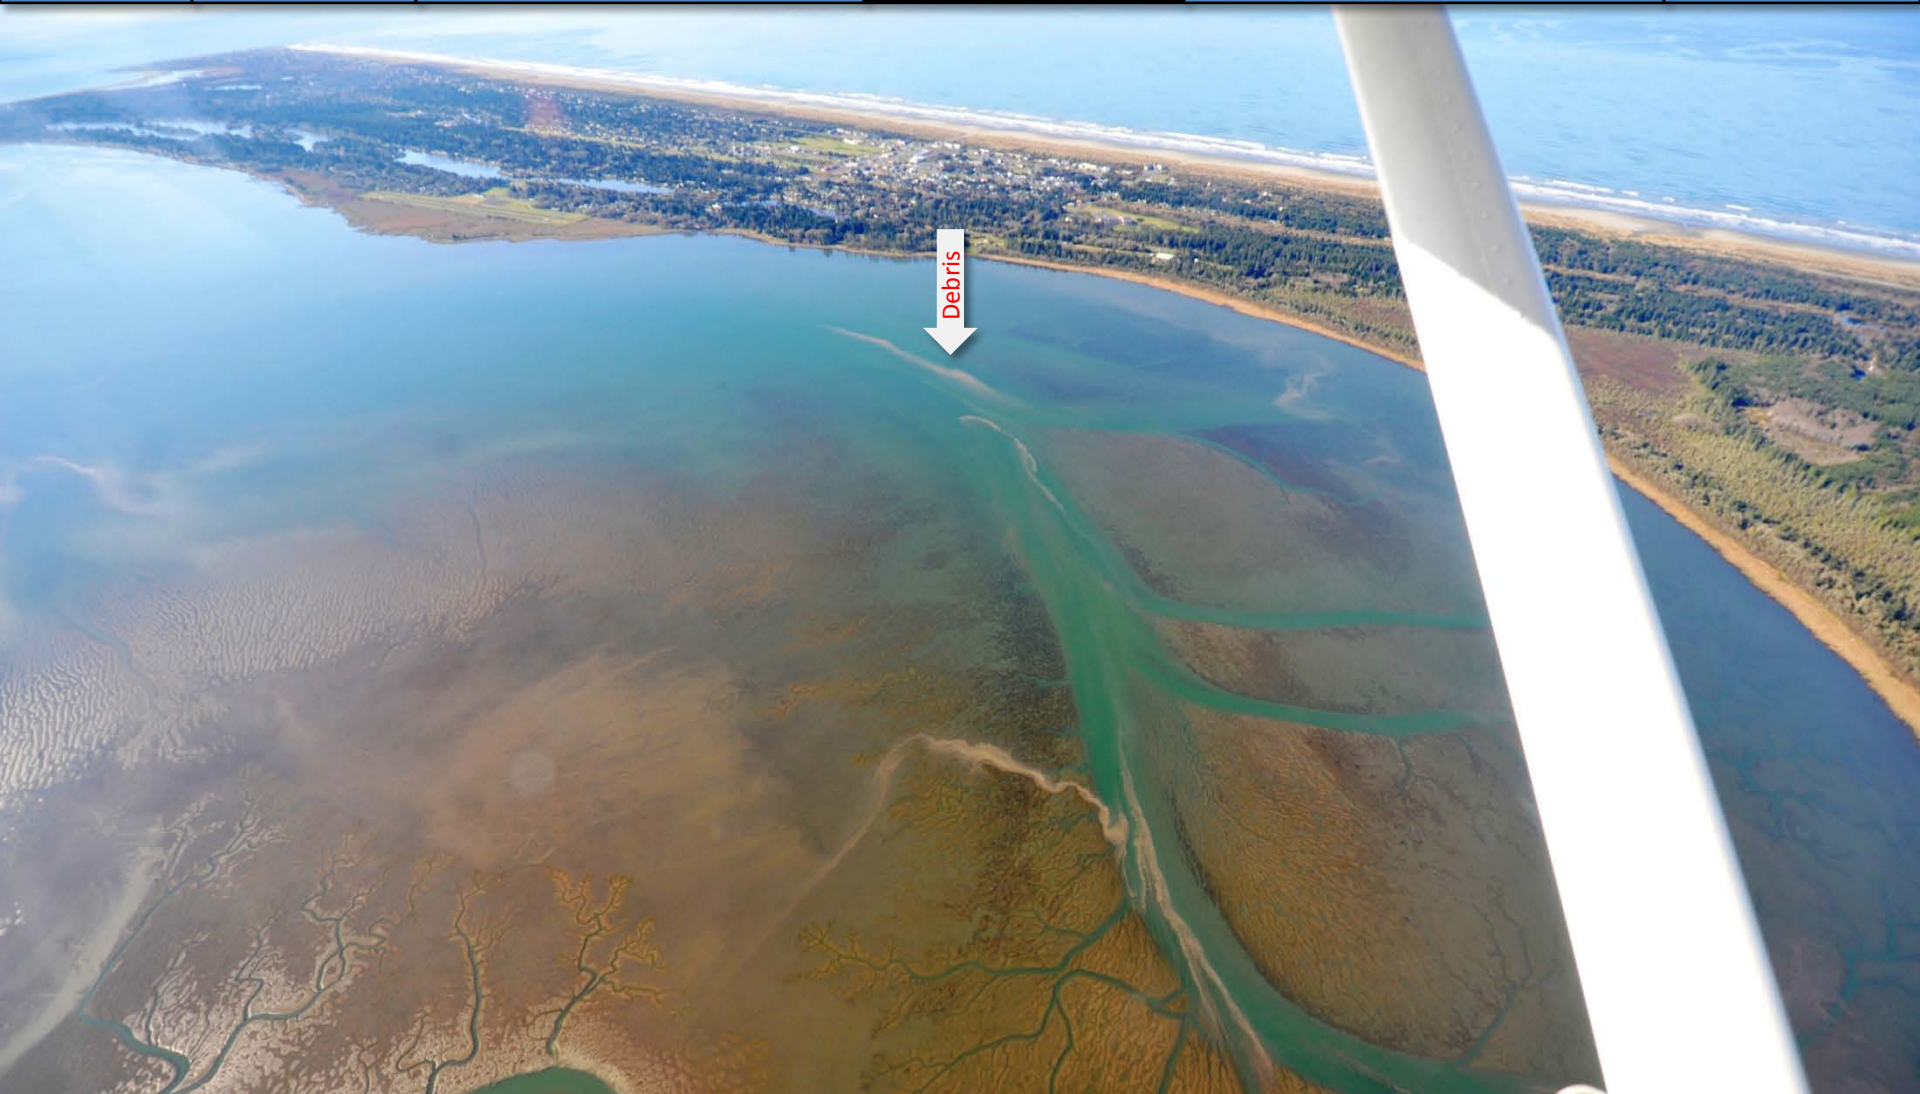
Organic surface debris in tidal channels near exposed mudflat.

Location: North Bay (Grays Harbor), 11:14 AM.

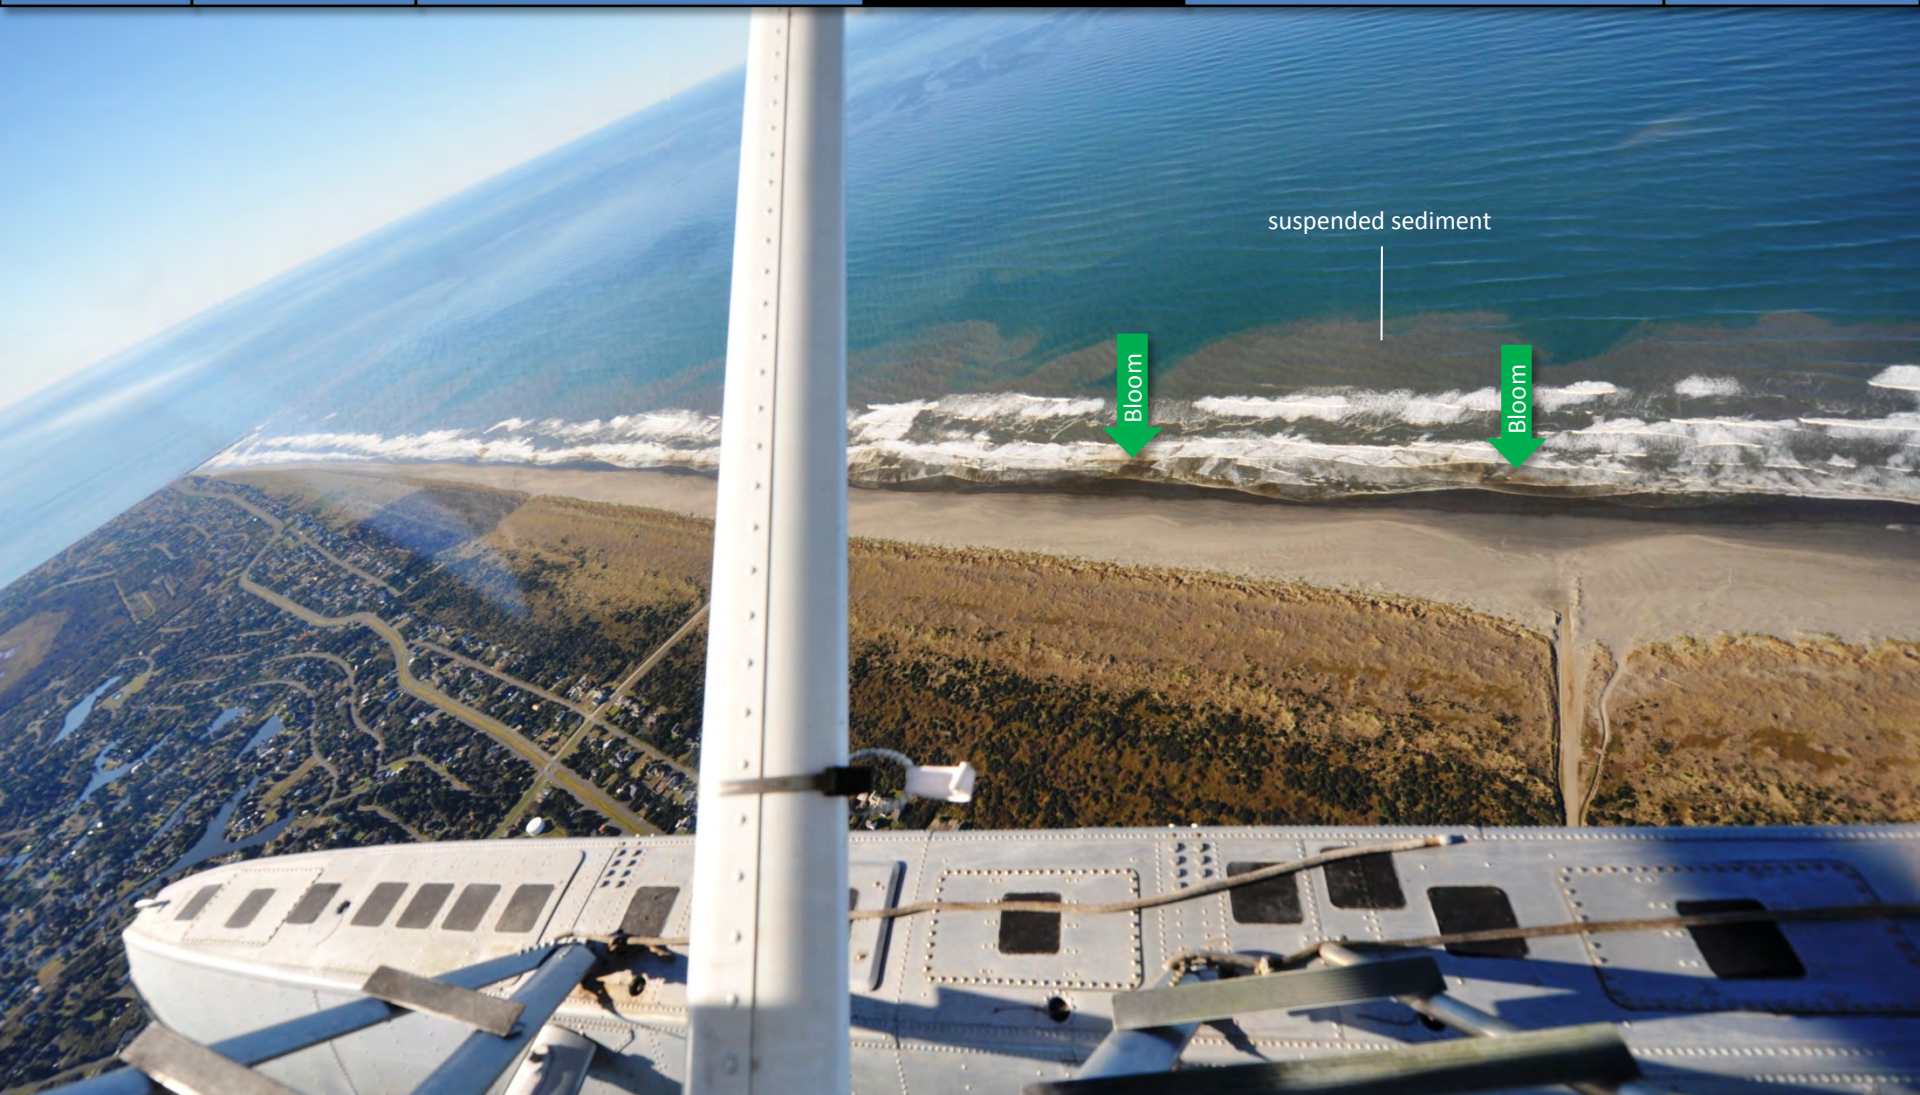
Suspended sediment from waves and diatom bloom at beach.

Location: Ocean Shores (Grays Harbor), 11:17 AM.

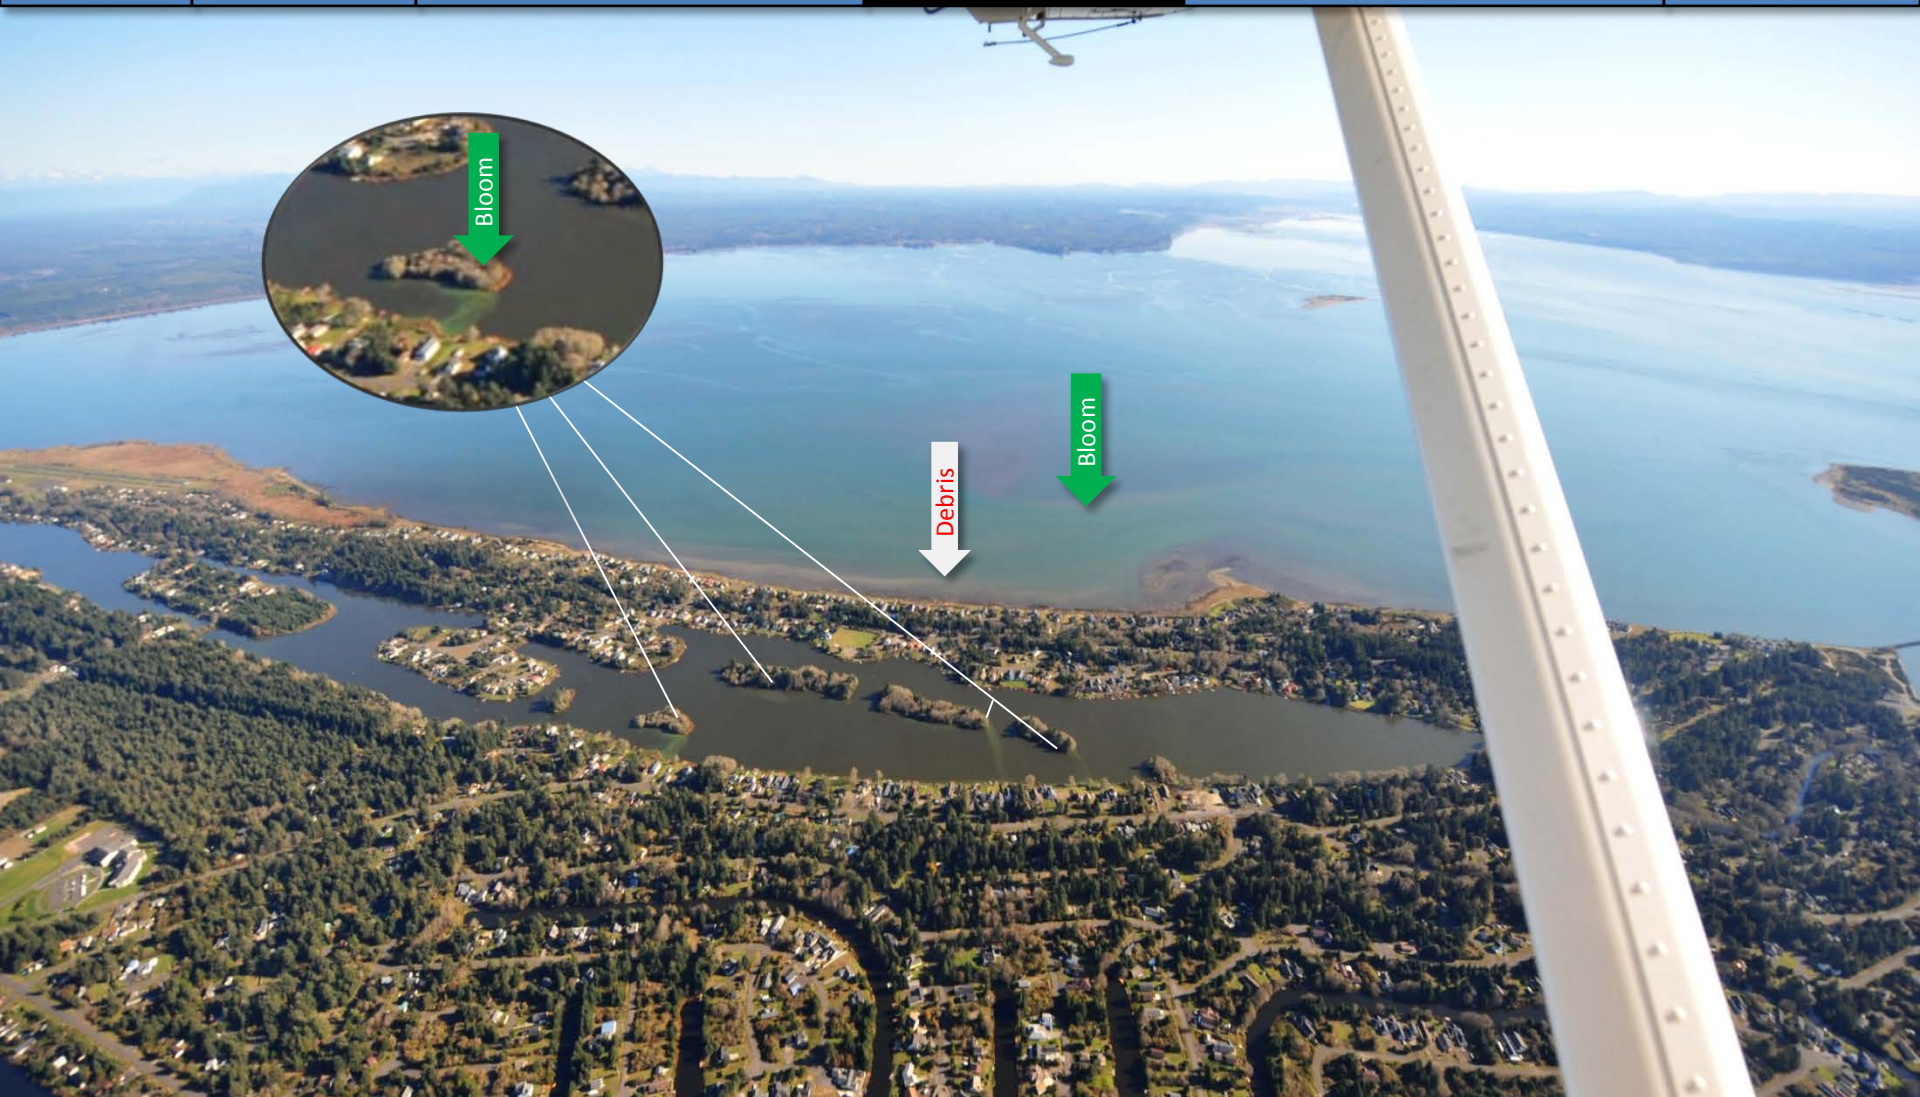
Brown, fresh water with bright green algal blooms. Green bay water from bloom.
Location: Duck Lake and North Bay (Grays Harbor), 11:18 AM.

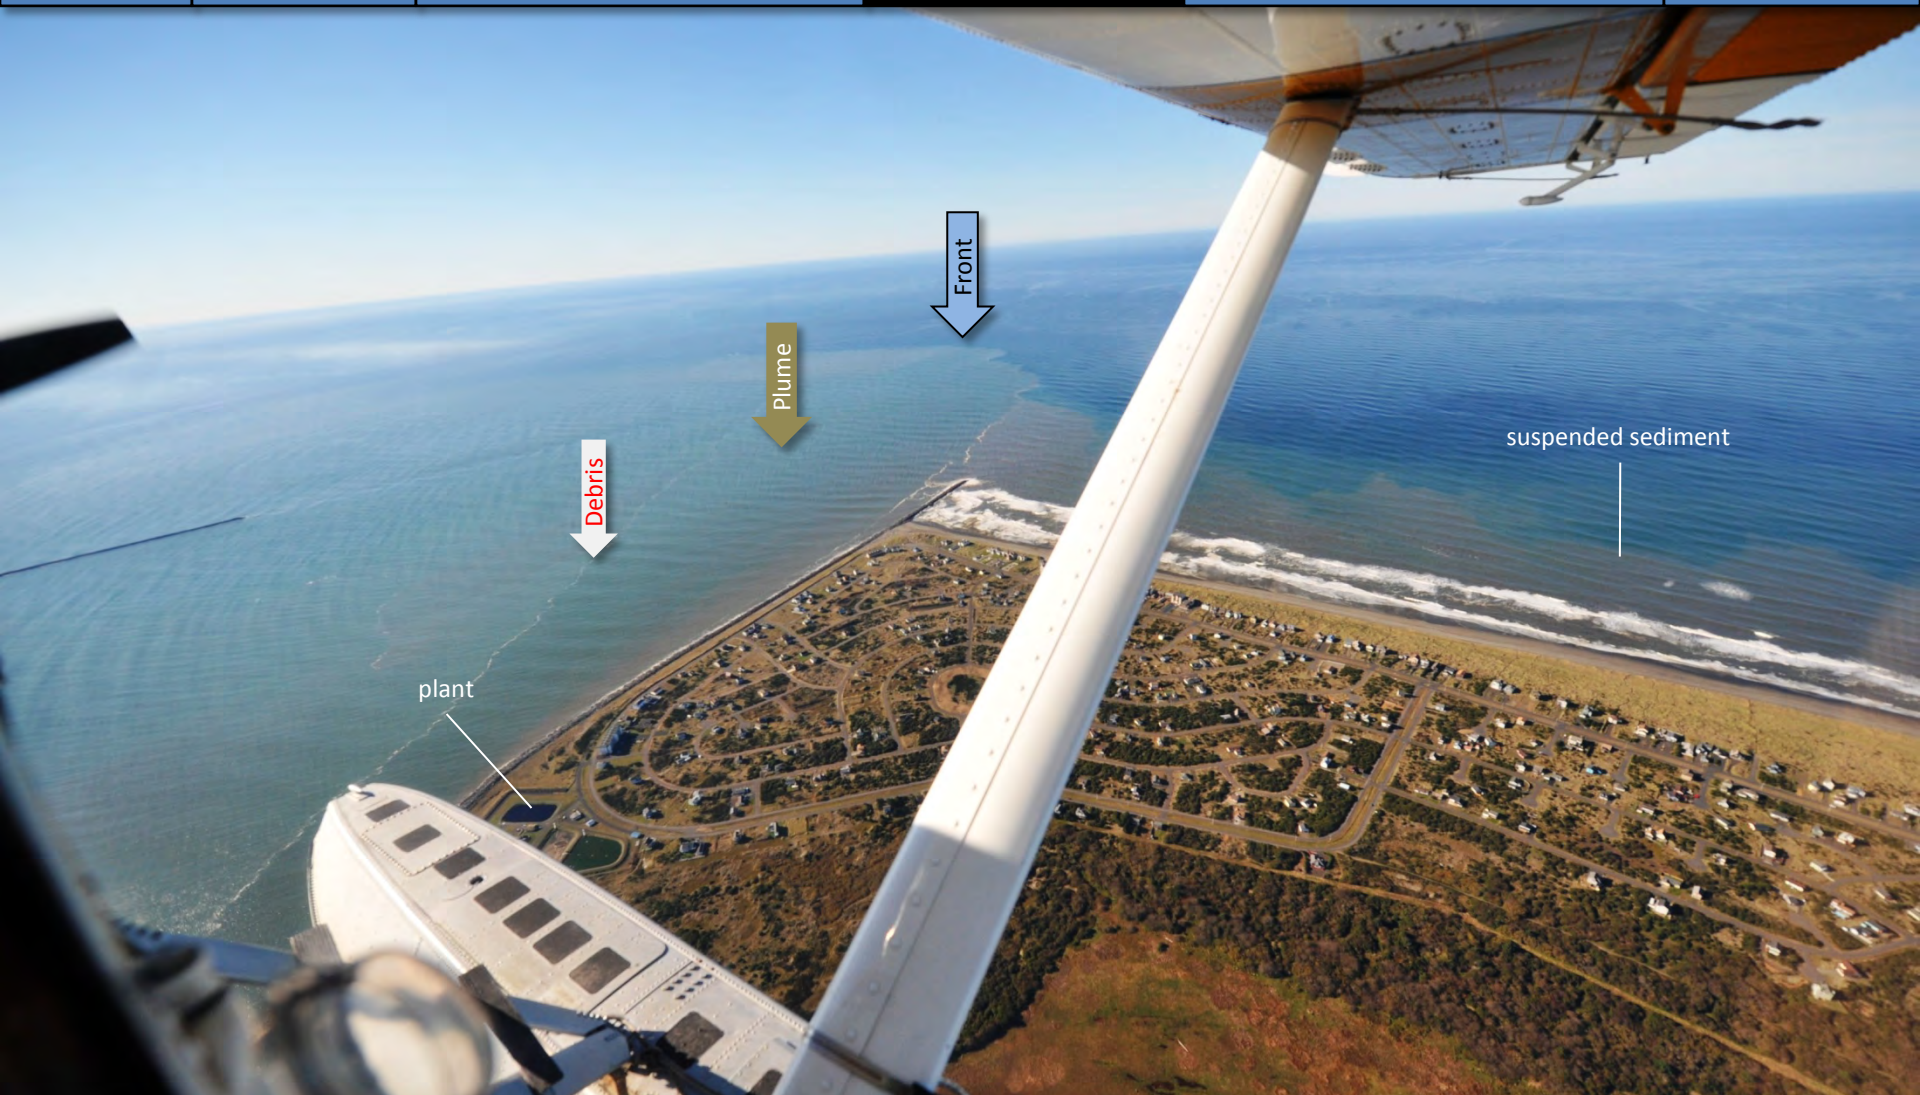
Grays Harbor water flowing into ocean past Ocean Shores sewage treatment plant. Location: North Jetty (Grays Harbor), 11:19 AM.
