Eyes Over Puget Sound

Surface Conditions Report

October 28, 2013

Up-to-date observations of visible water quality conditions in Puget Sound and the Strait of Juan de Fuca

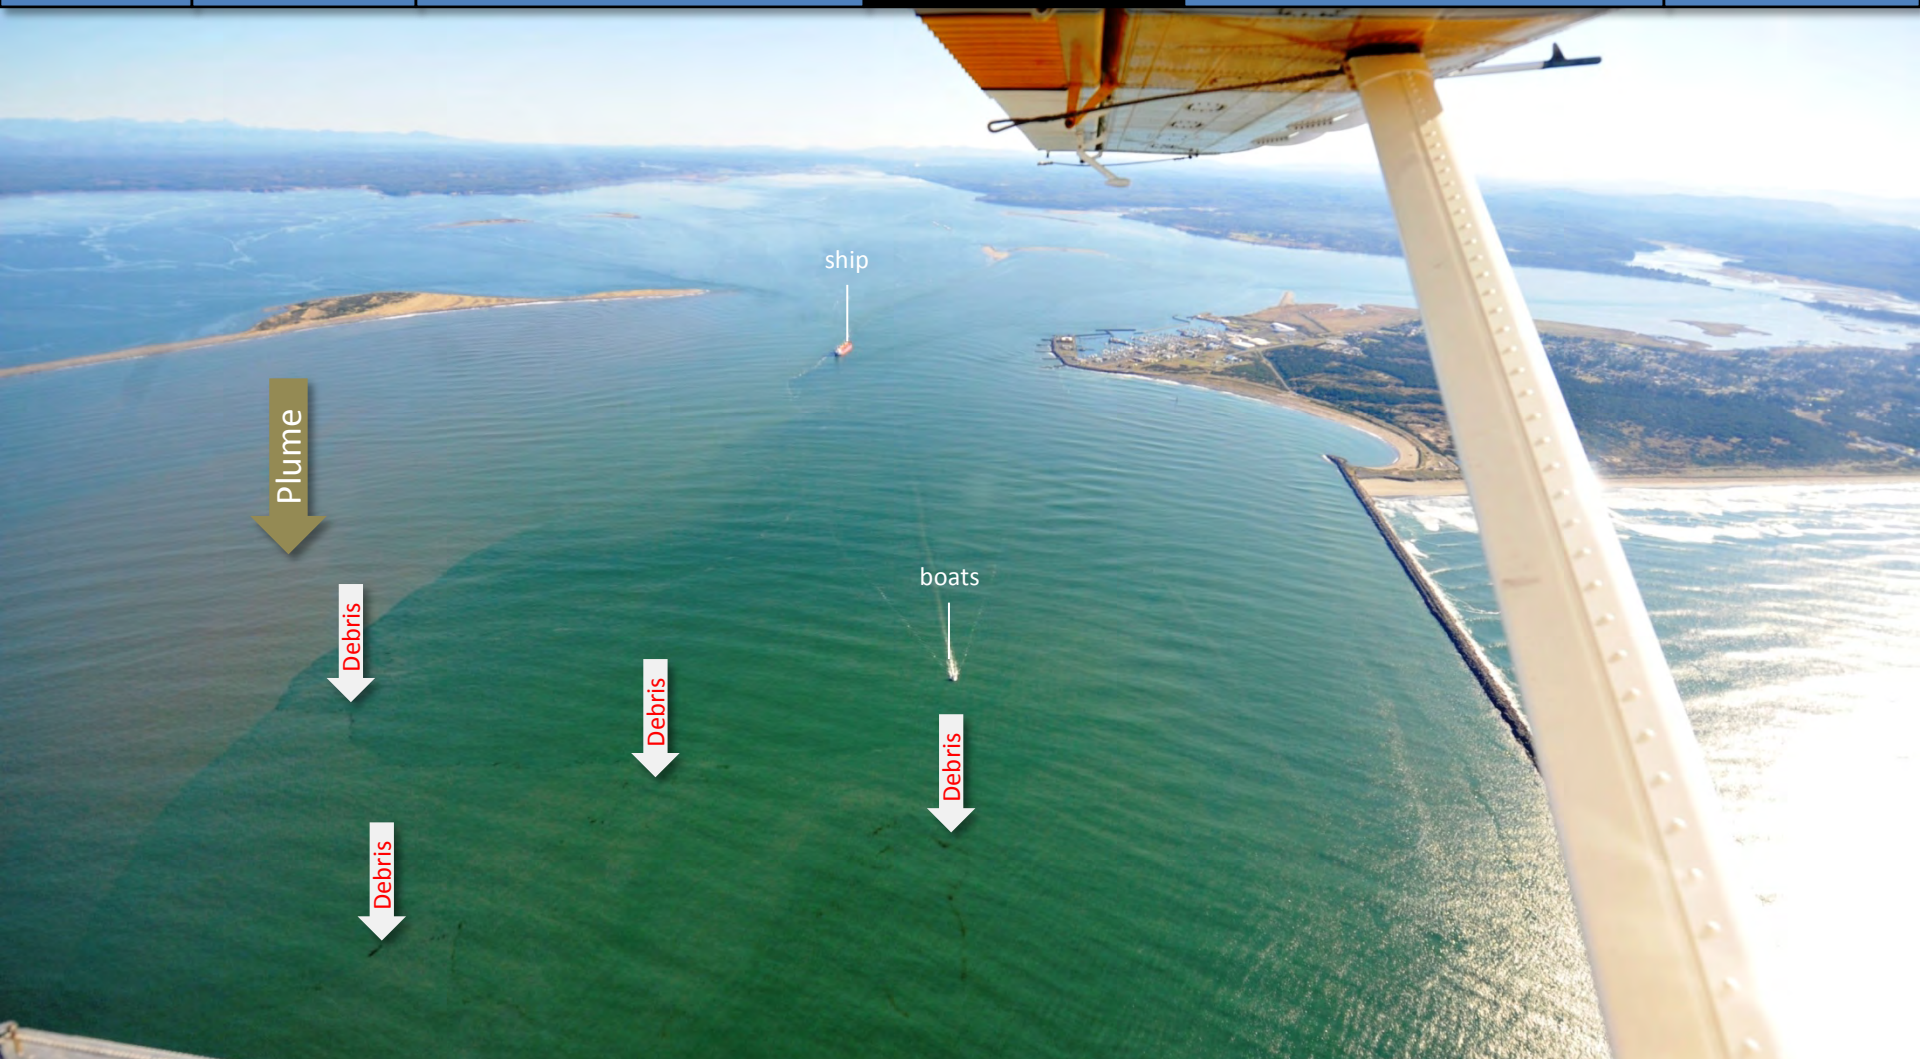
Waters with different sediment content and debris flowing out of bay on outgoing tide.
Location: Westhaven State Park (Grays Harbor), 11:19 AM.

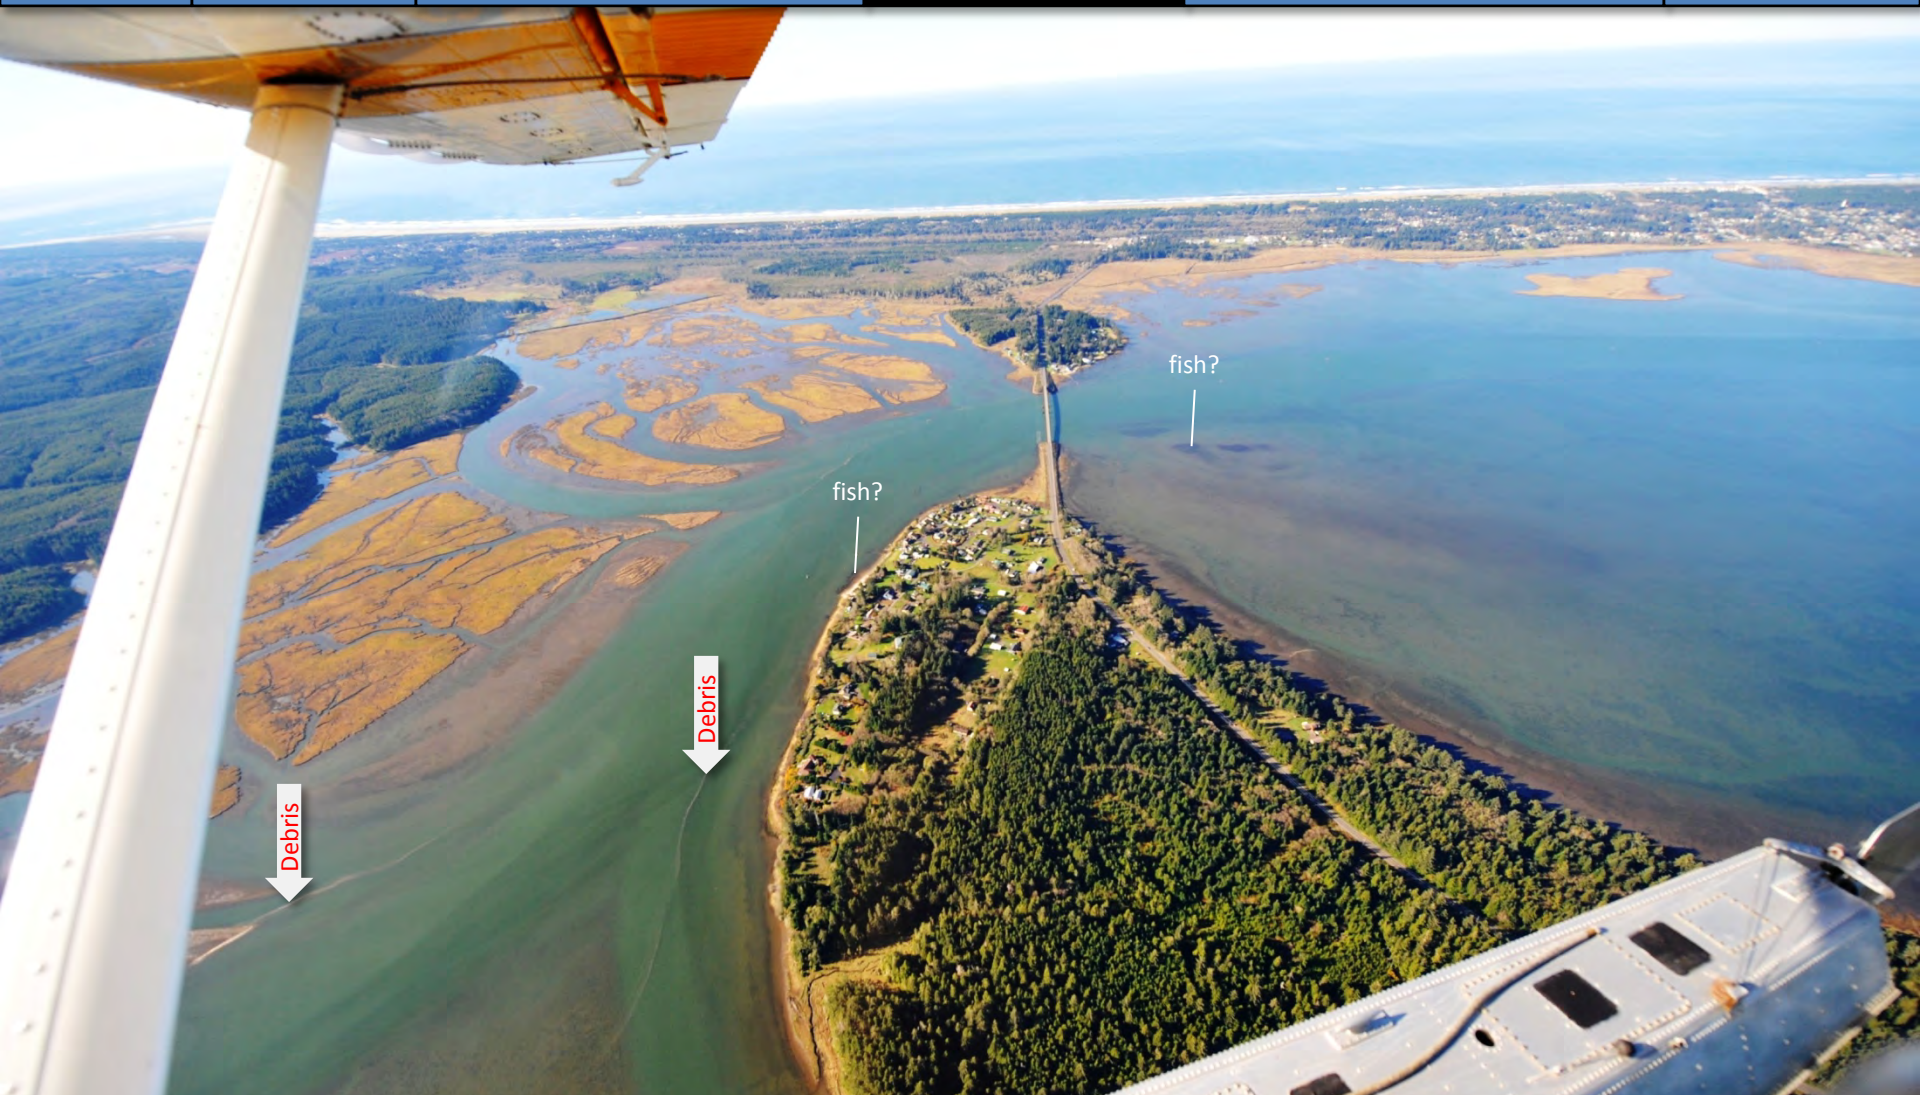
Lines of organic debris from Sopun, Mallard, and Beardslee Sloughs entering South Bay. Unidentified patches of seagrass or fish? Location: Hwy 105 bridge (Grays Harbor), 11:24 AM.

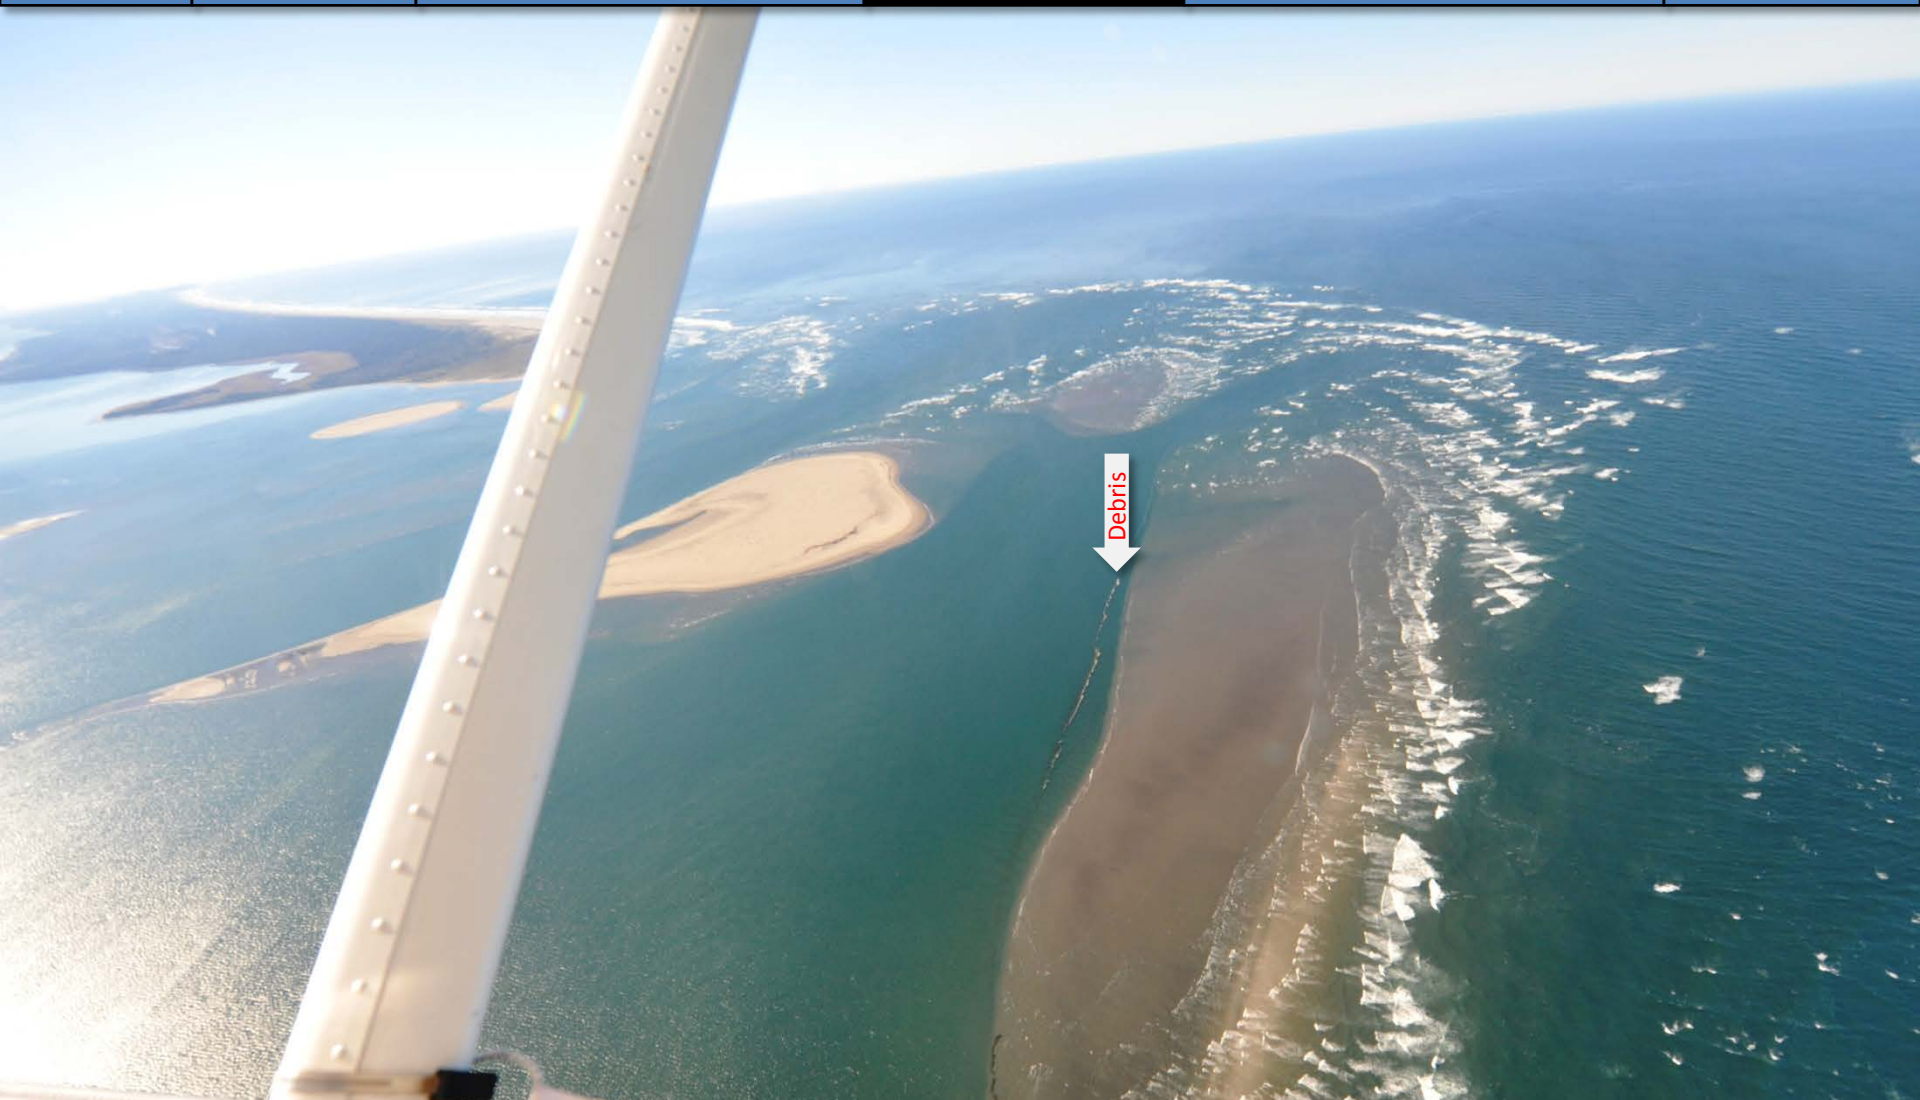
Long debris line along sandbar in mouth of Willapa Bay.

Location: North of Leadbetter Point State Park (Willapa Bay), 11:30 AM.

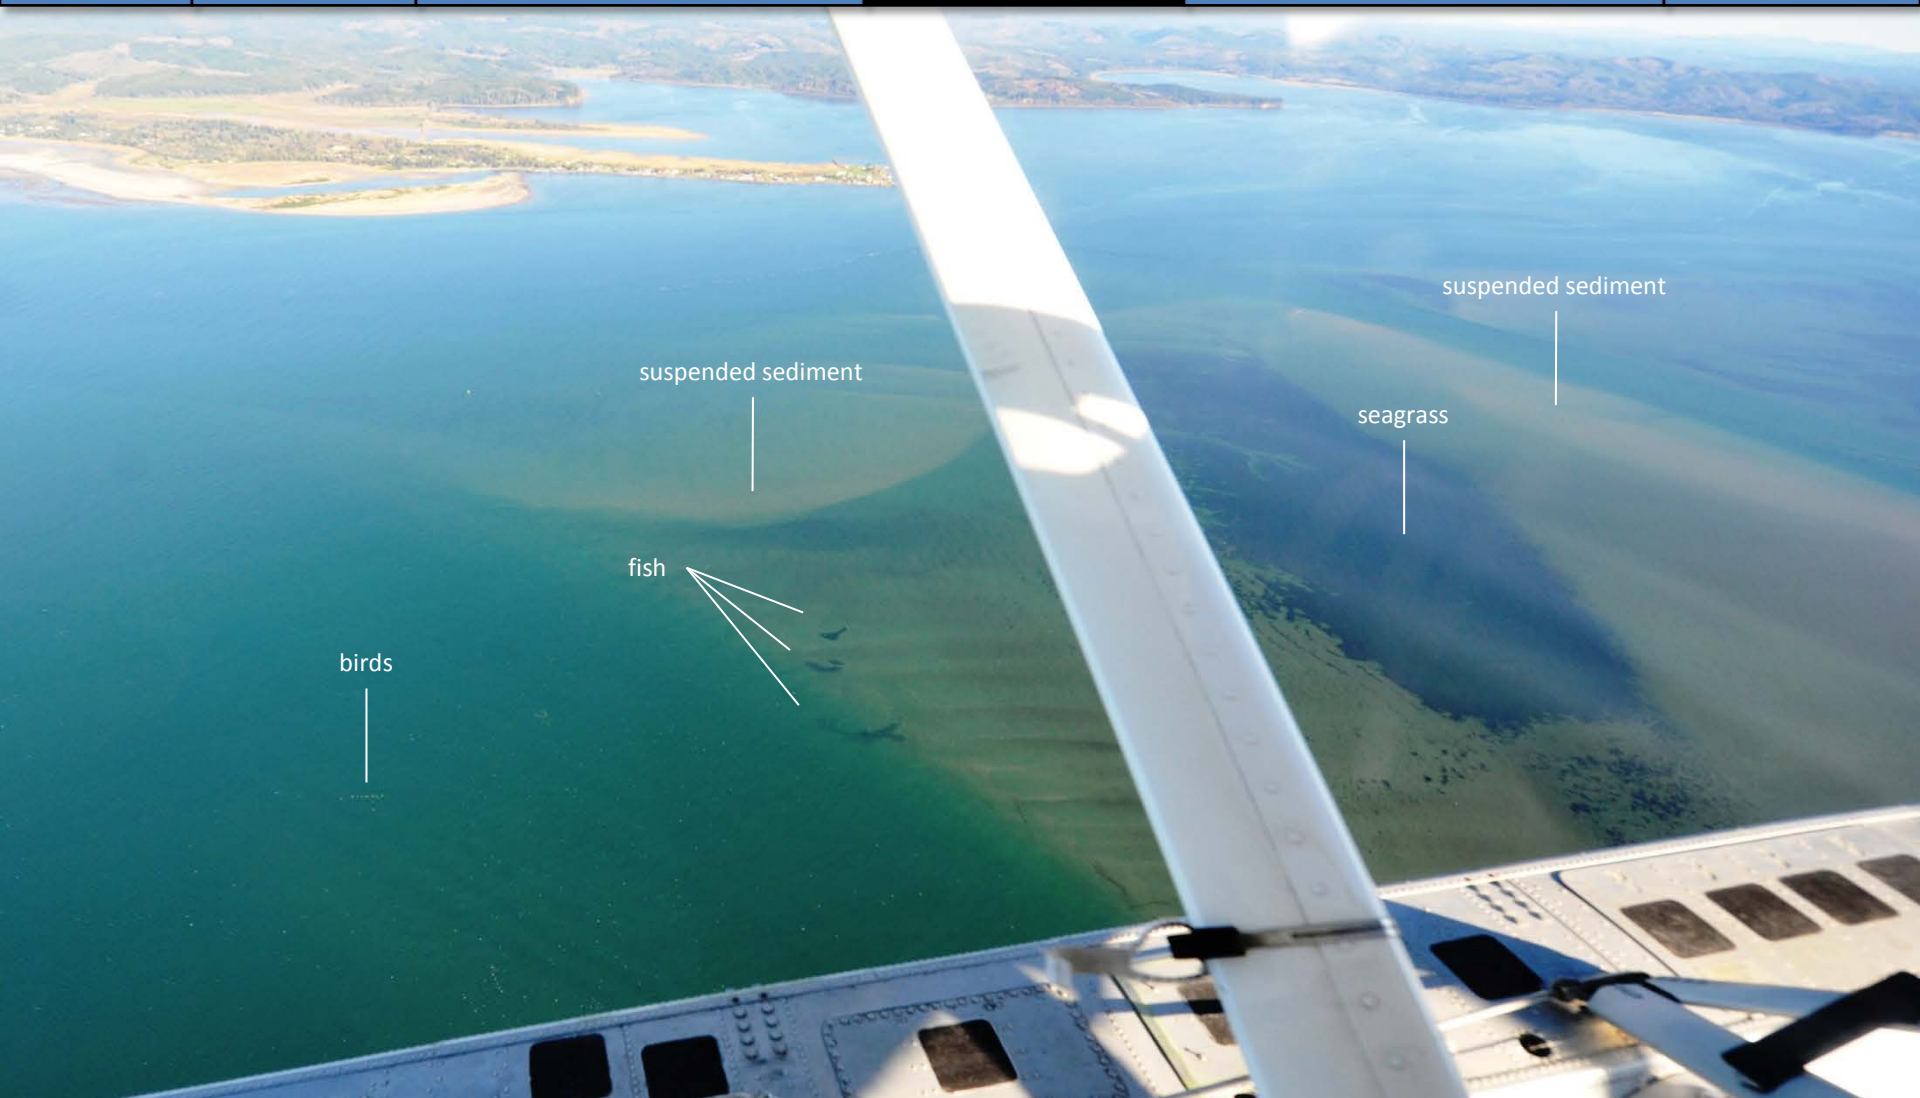
Schooling fish along shallow sandbar.

Location: South of Tokeland (Willapa Bay), 11:32 AM.

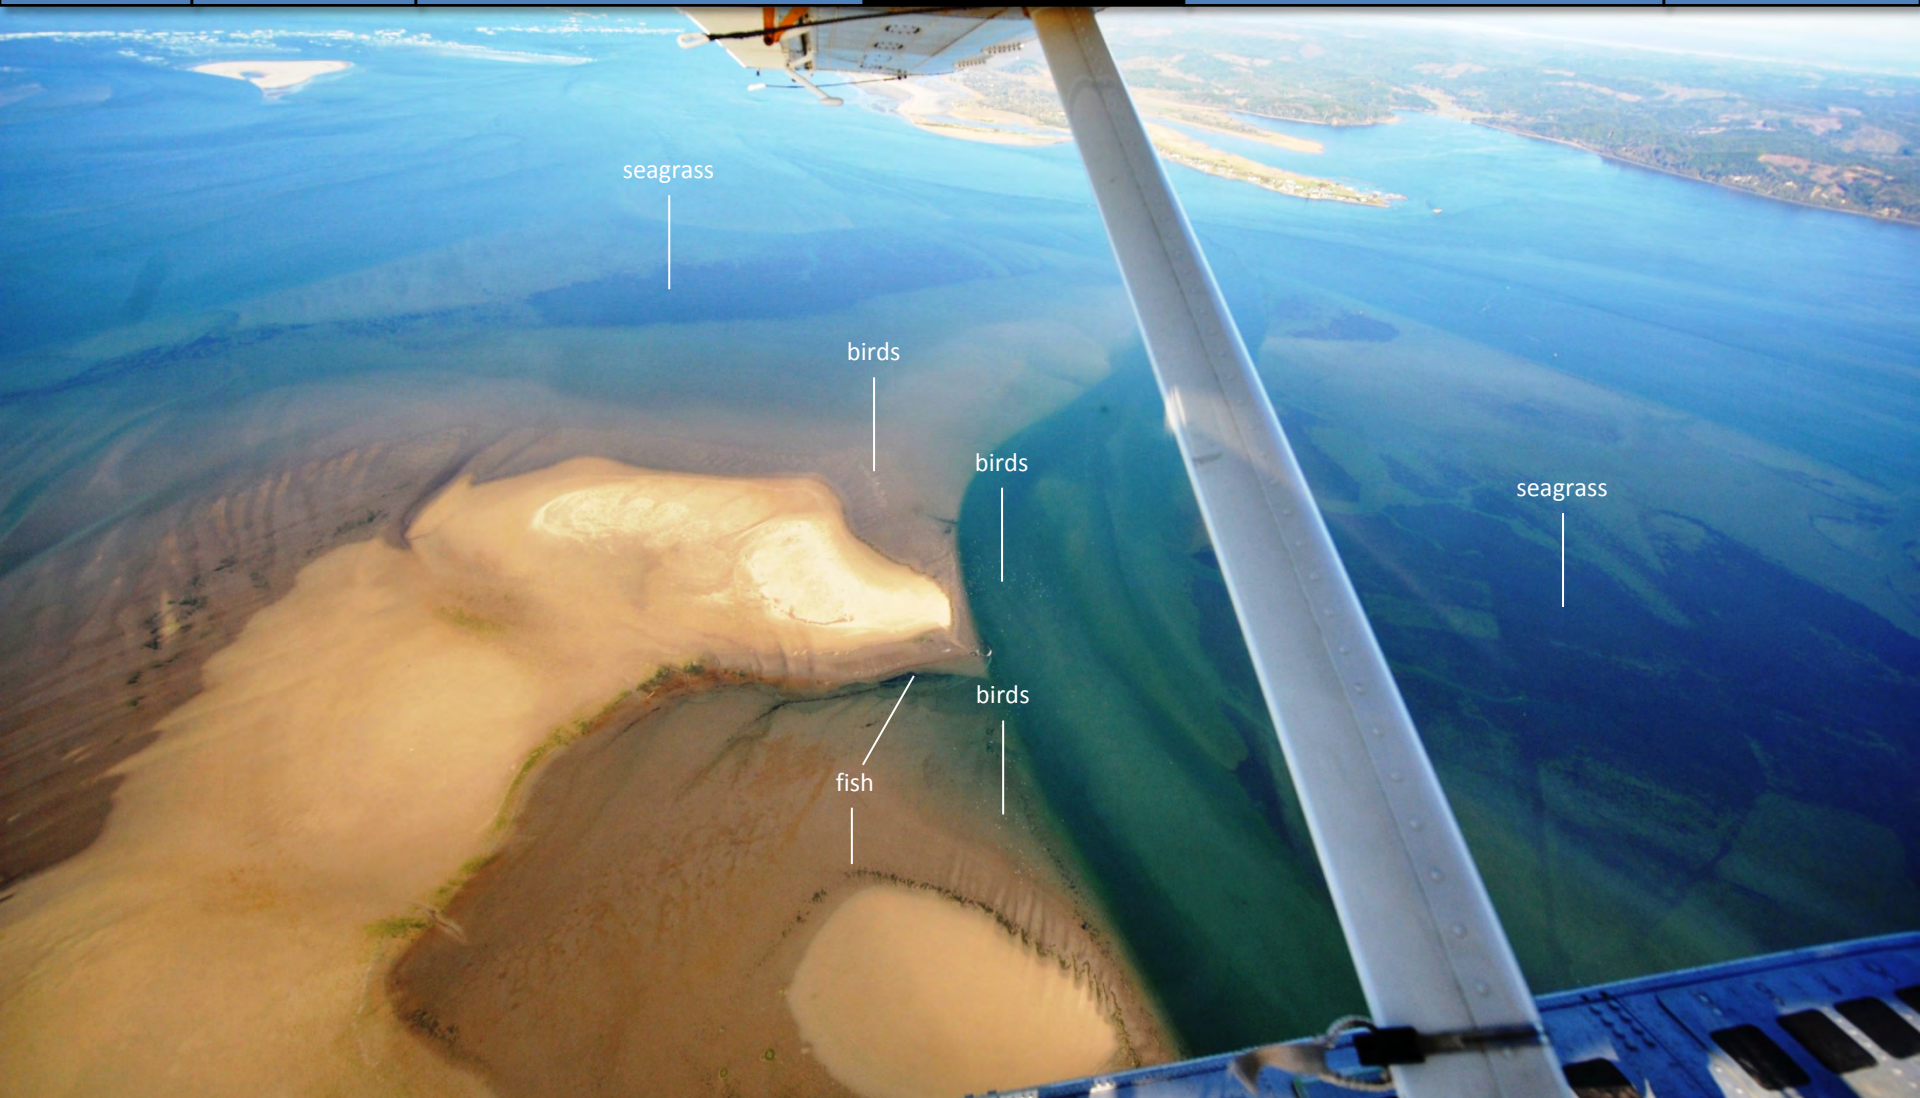
Schooling fish along shallow sandbars surrounded by seabirds (white little dots, hard to see).
Location: South of Tokeland (Willapa Bay), 11:33 AM.

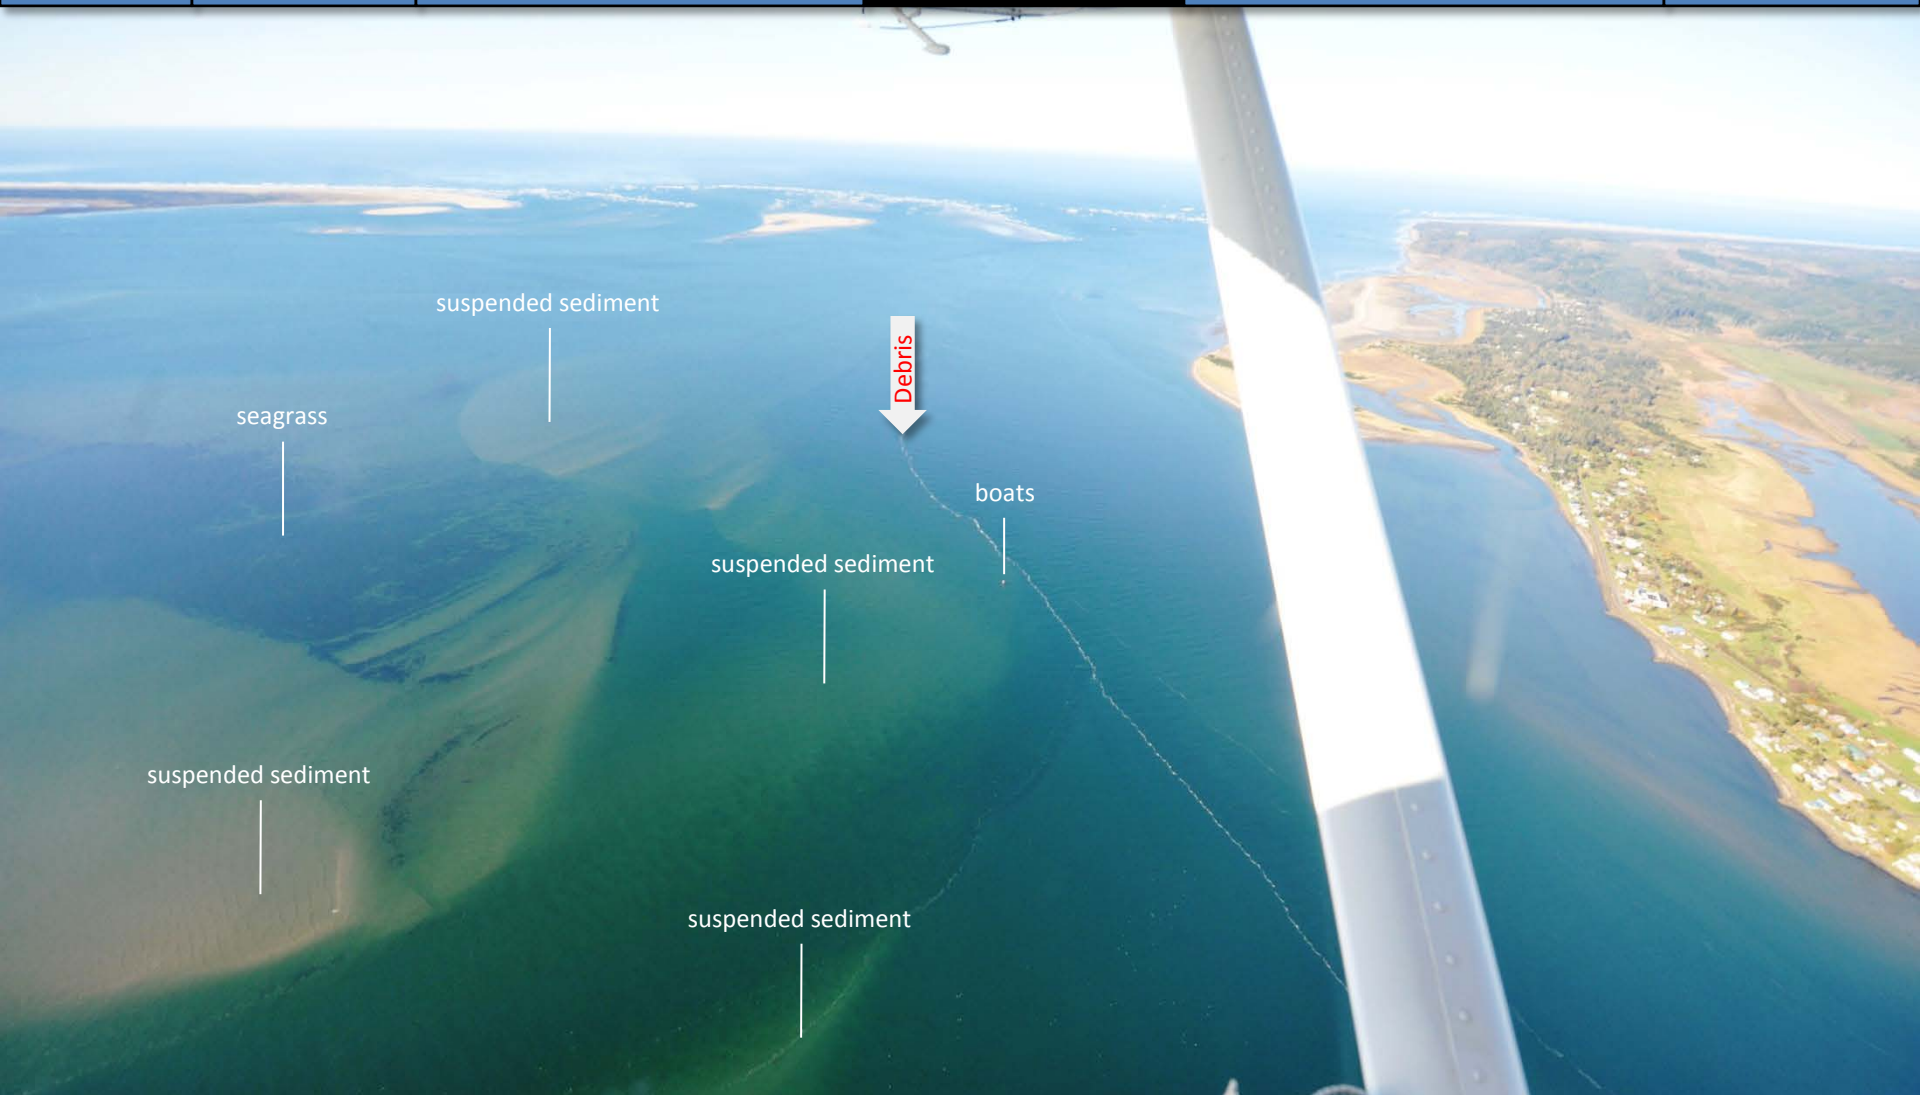
Long debris line. Green water originating from south and lined by re-suspended sediment flowing past Tokeland. Location: South of Tokeland (Willapa Bay), 11:35 AM.

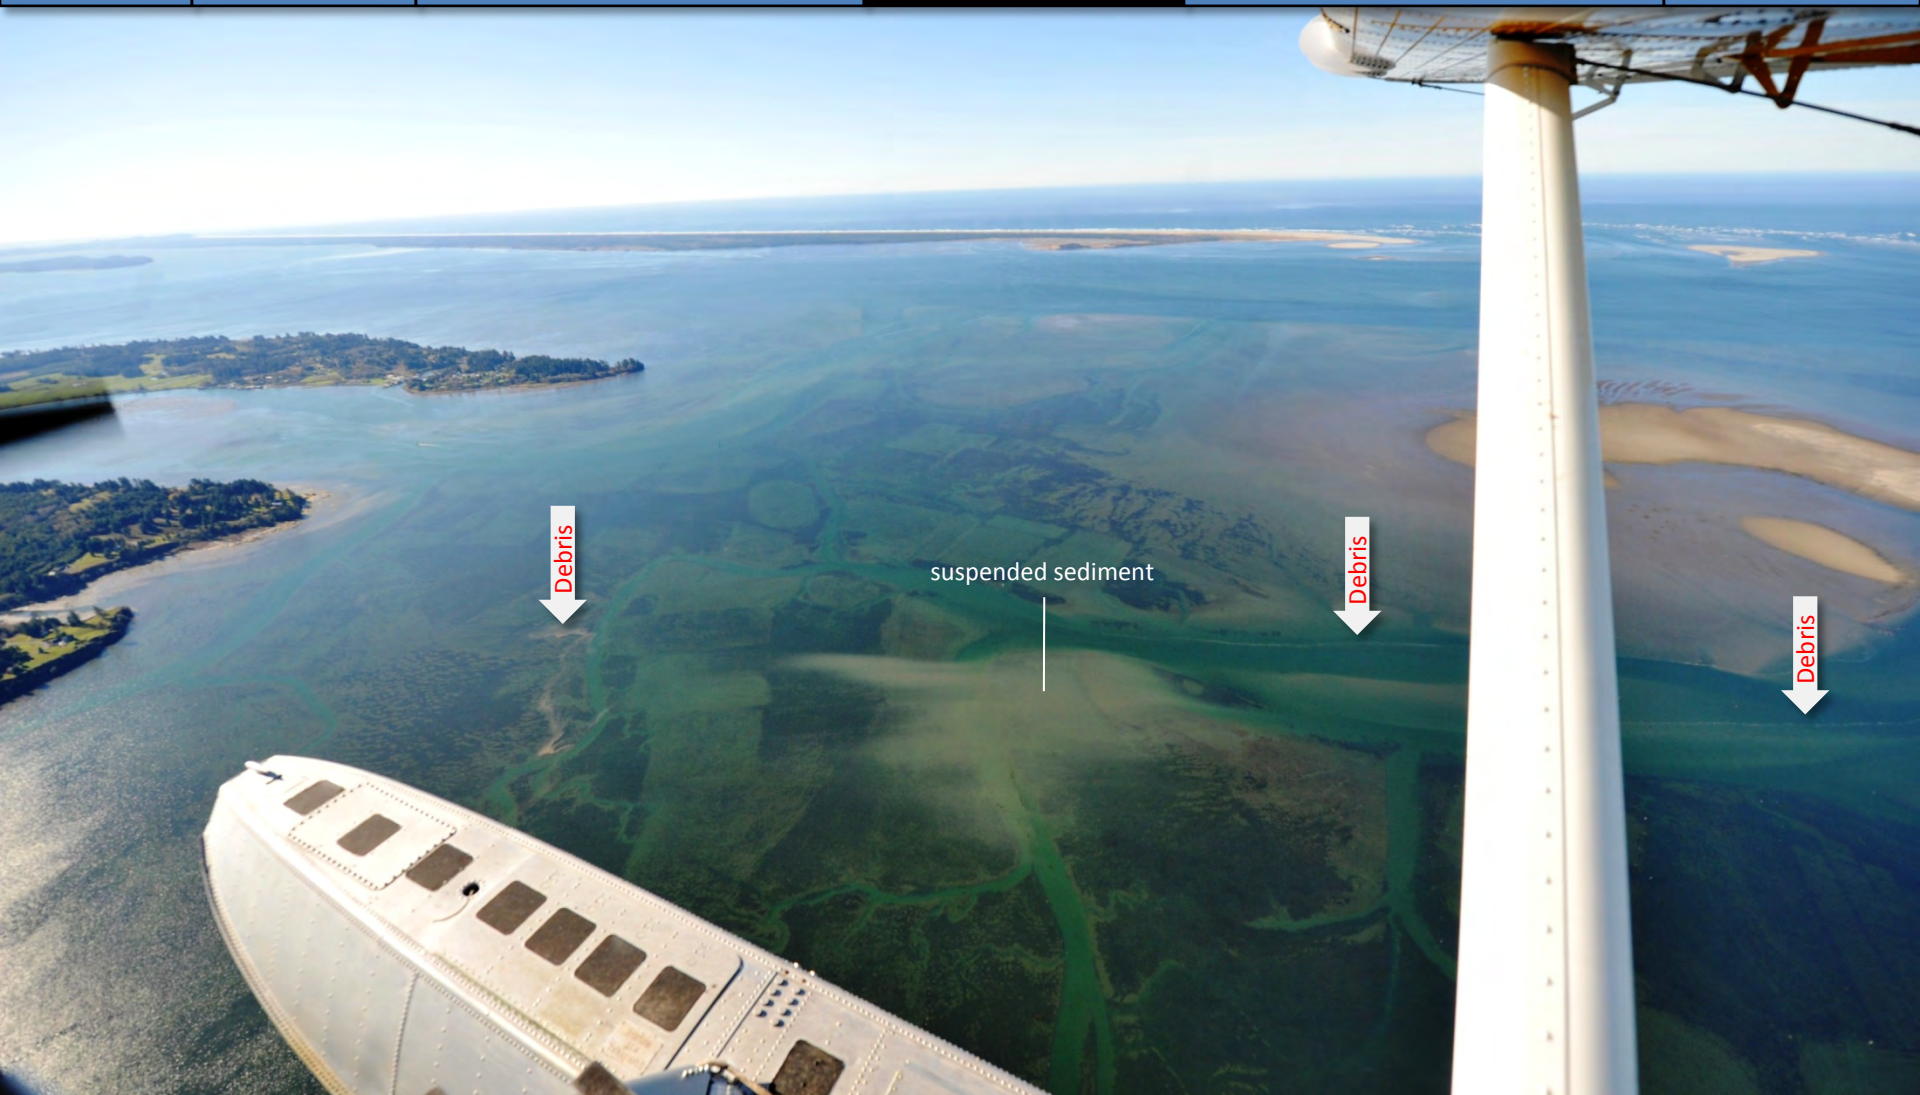
Pattern of shellfish farming on flooded mud flats. Large suspended sediment cloud and debris lines. Location: Off Bone River (Willapa Bay), 12:04 PM.

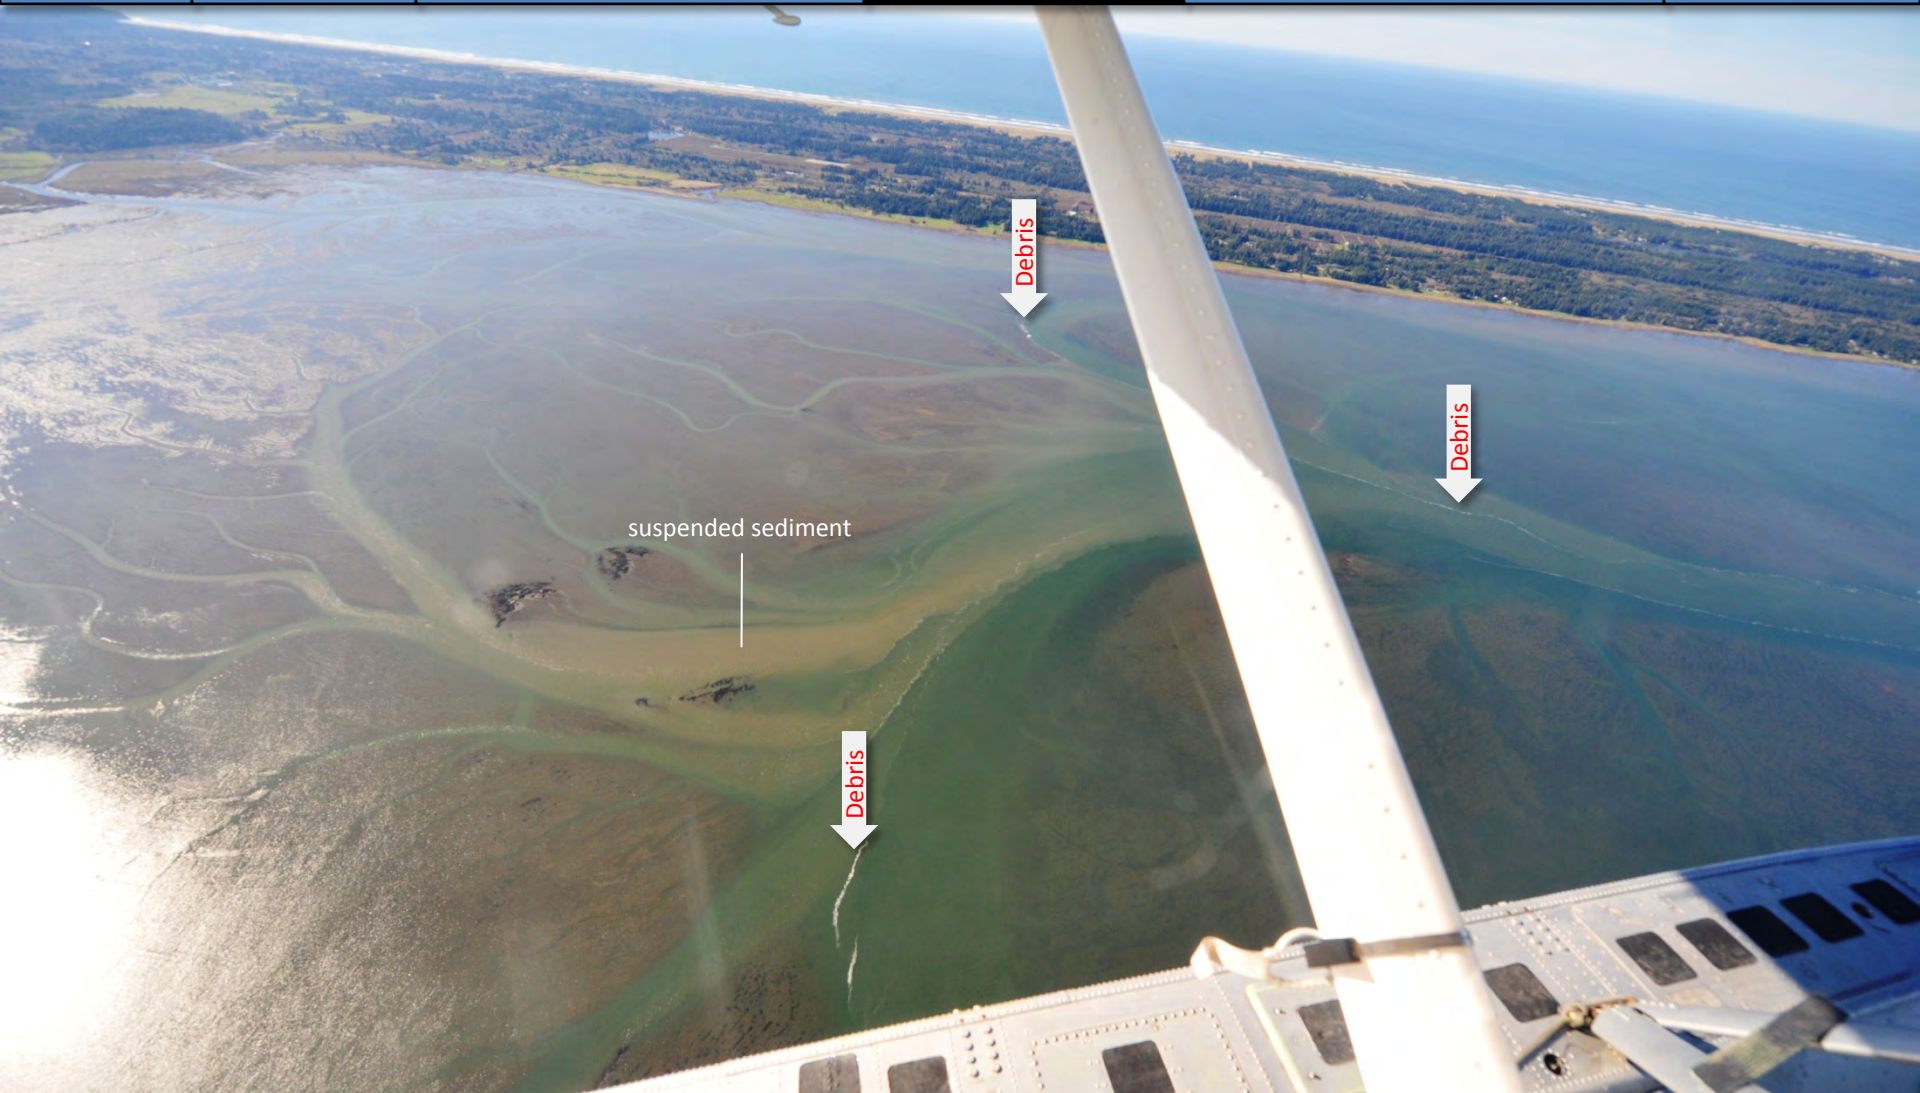
Tidally suspended sediment spilling out of Shoalwater Bay during ebb tide. Location: Willapa National Wildlife Refuge (Willapa Bay), 1:35 PM.

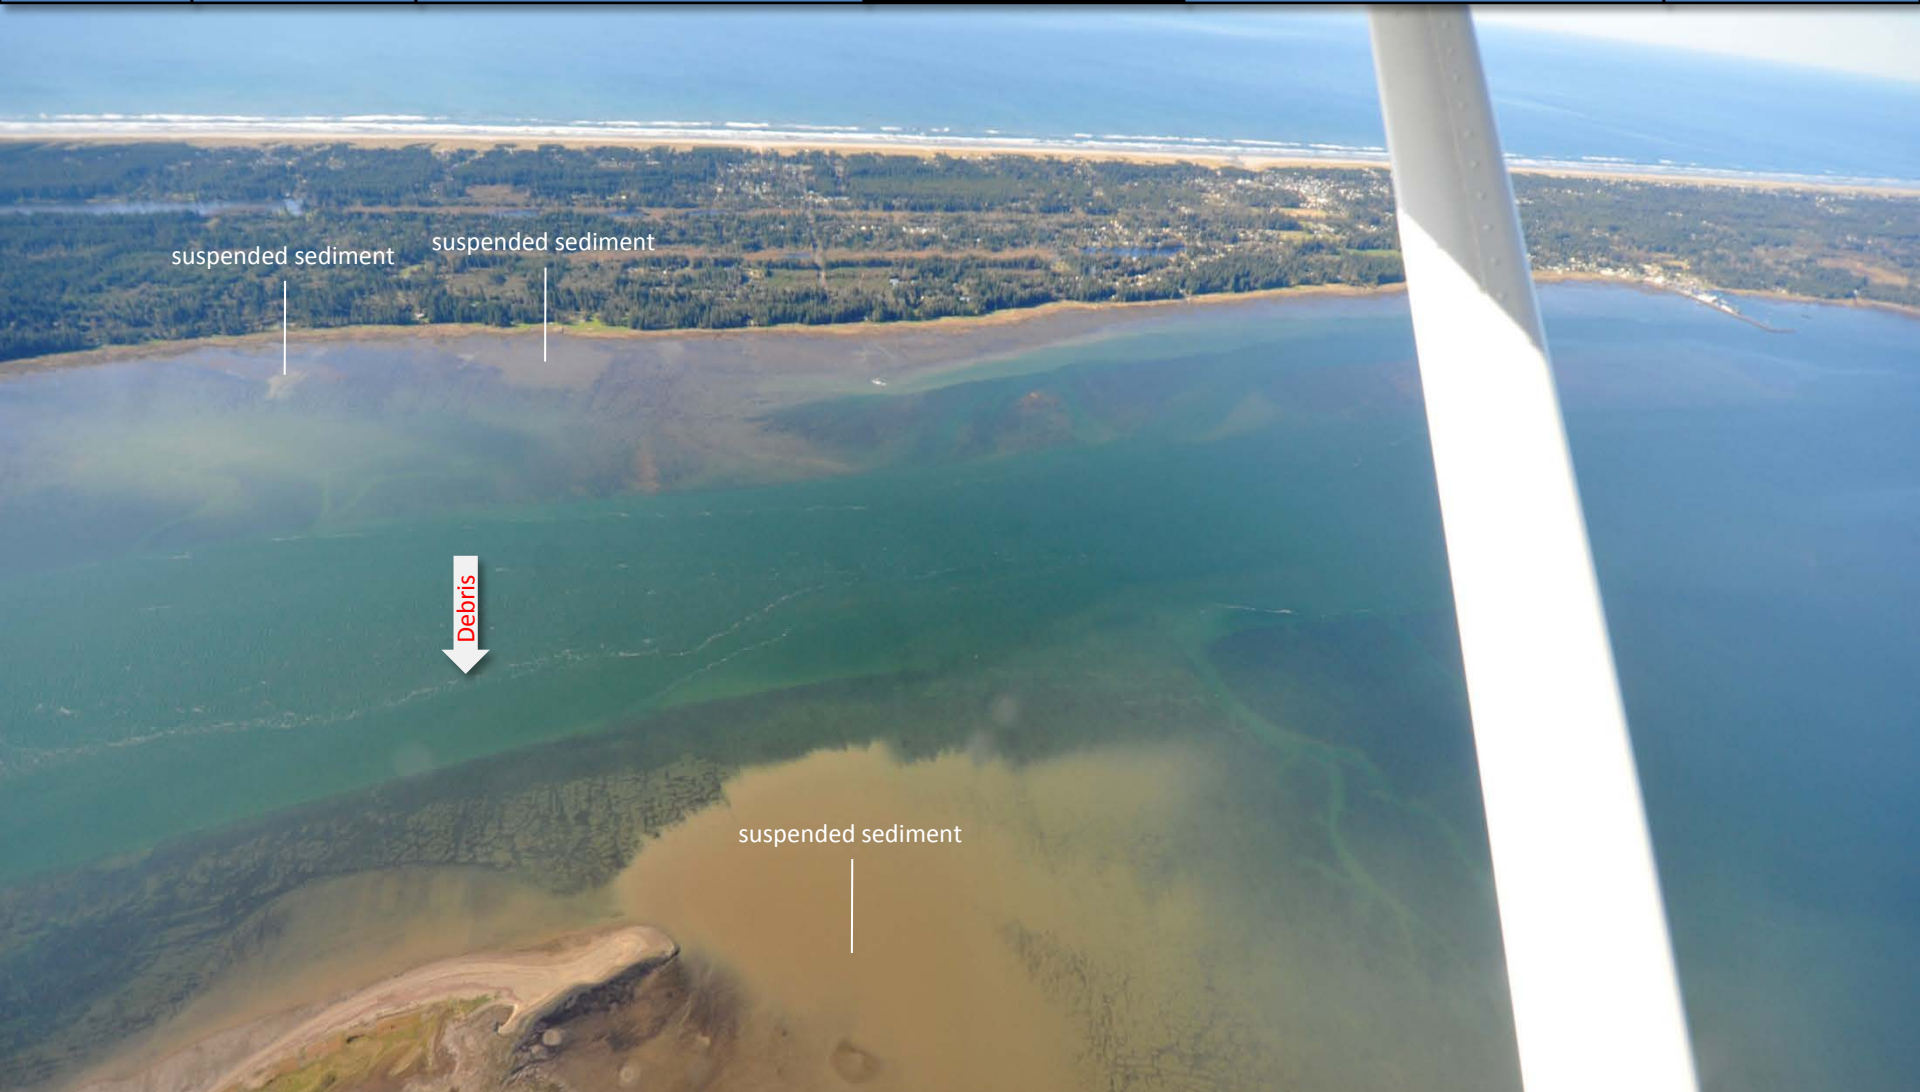
One of many unexplained large clouds of suspended sediment in shallow water.
Location: Jensen Point, a sand spit on west side of Long Island (Willapa Bay), 1:37 PM.

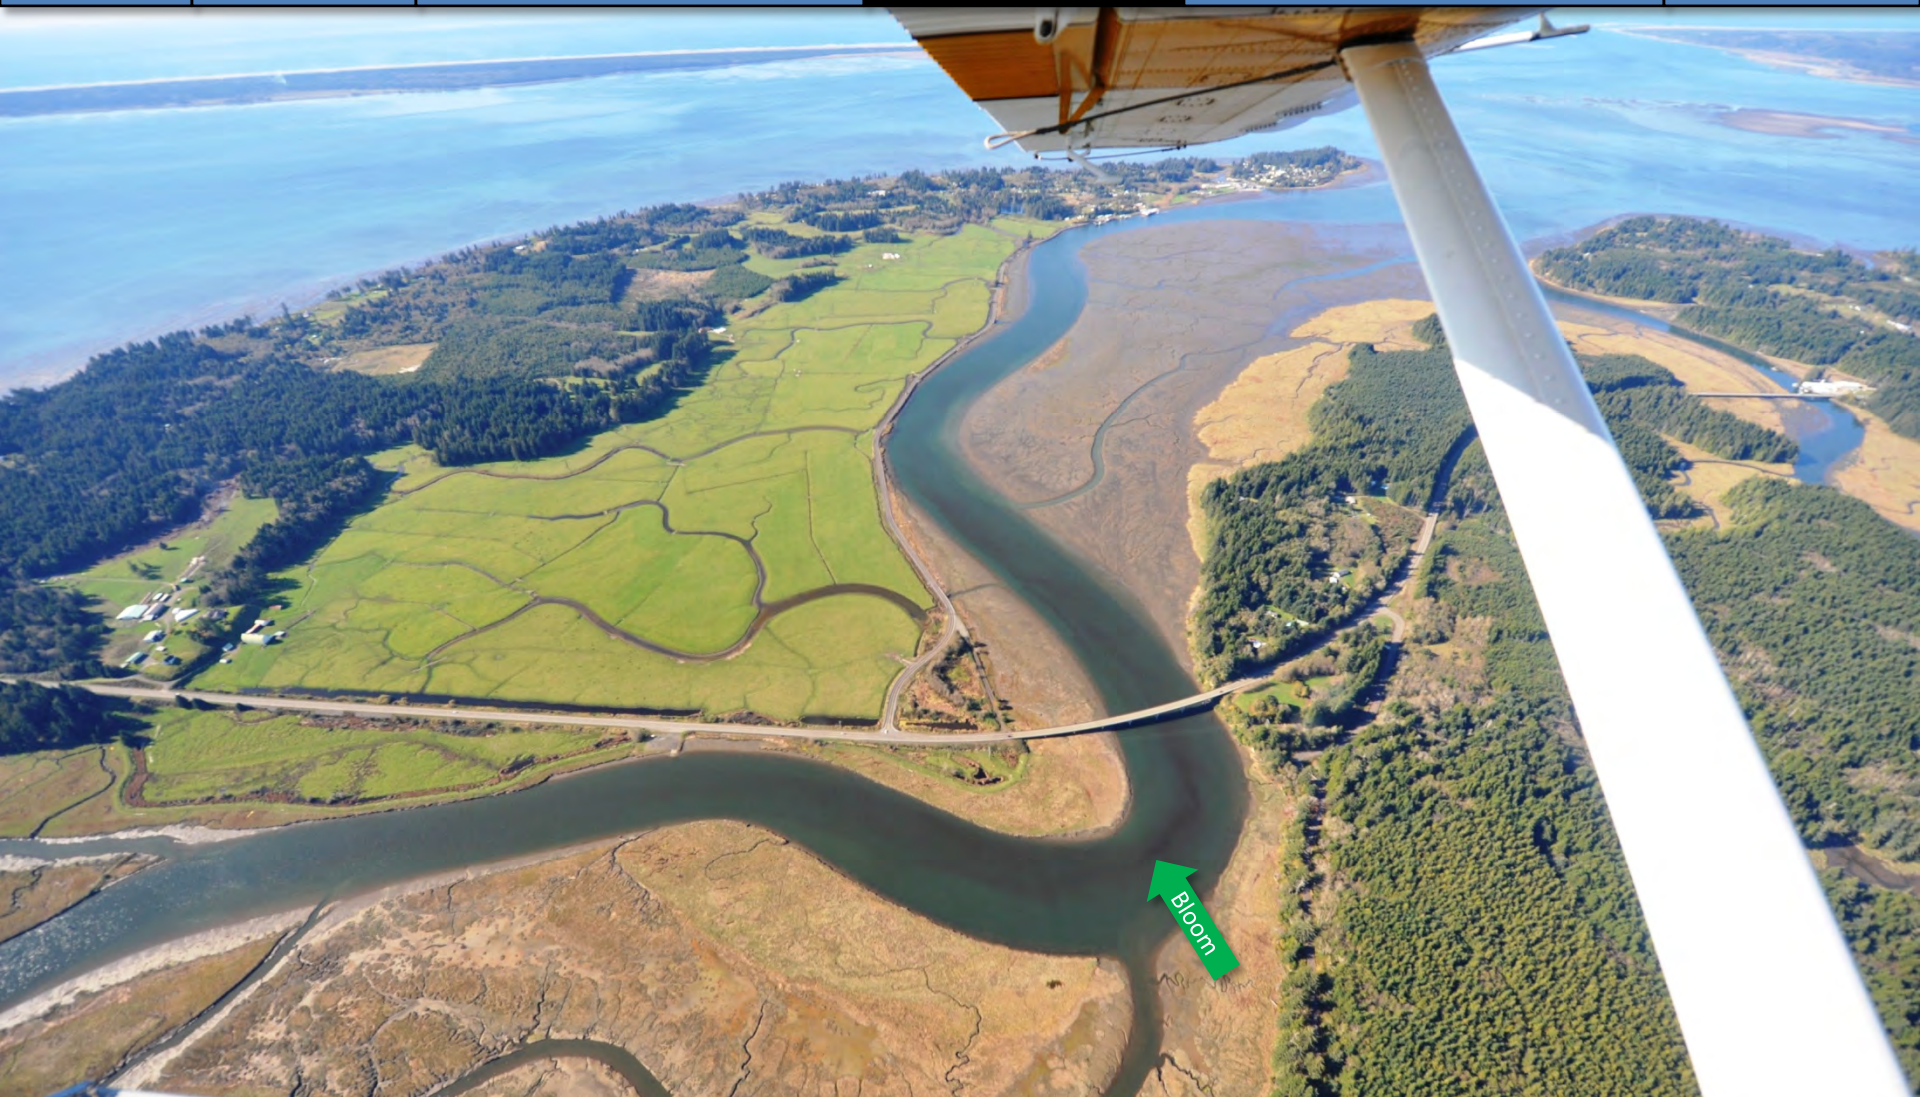
Red-brown algae bloom in Palix River near Bay Center.
Location: Palix River, US 101 bridge (Willapa Bay), 1:44 PM..
