Eyes Over Puget Sound

Surface Conditions Report

October 28, 2013

Up-to-date observations of visible water quality conditions in Puget Sound and the Strait of Juan de Fuca

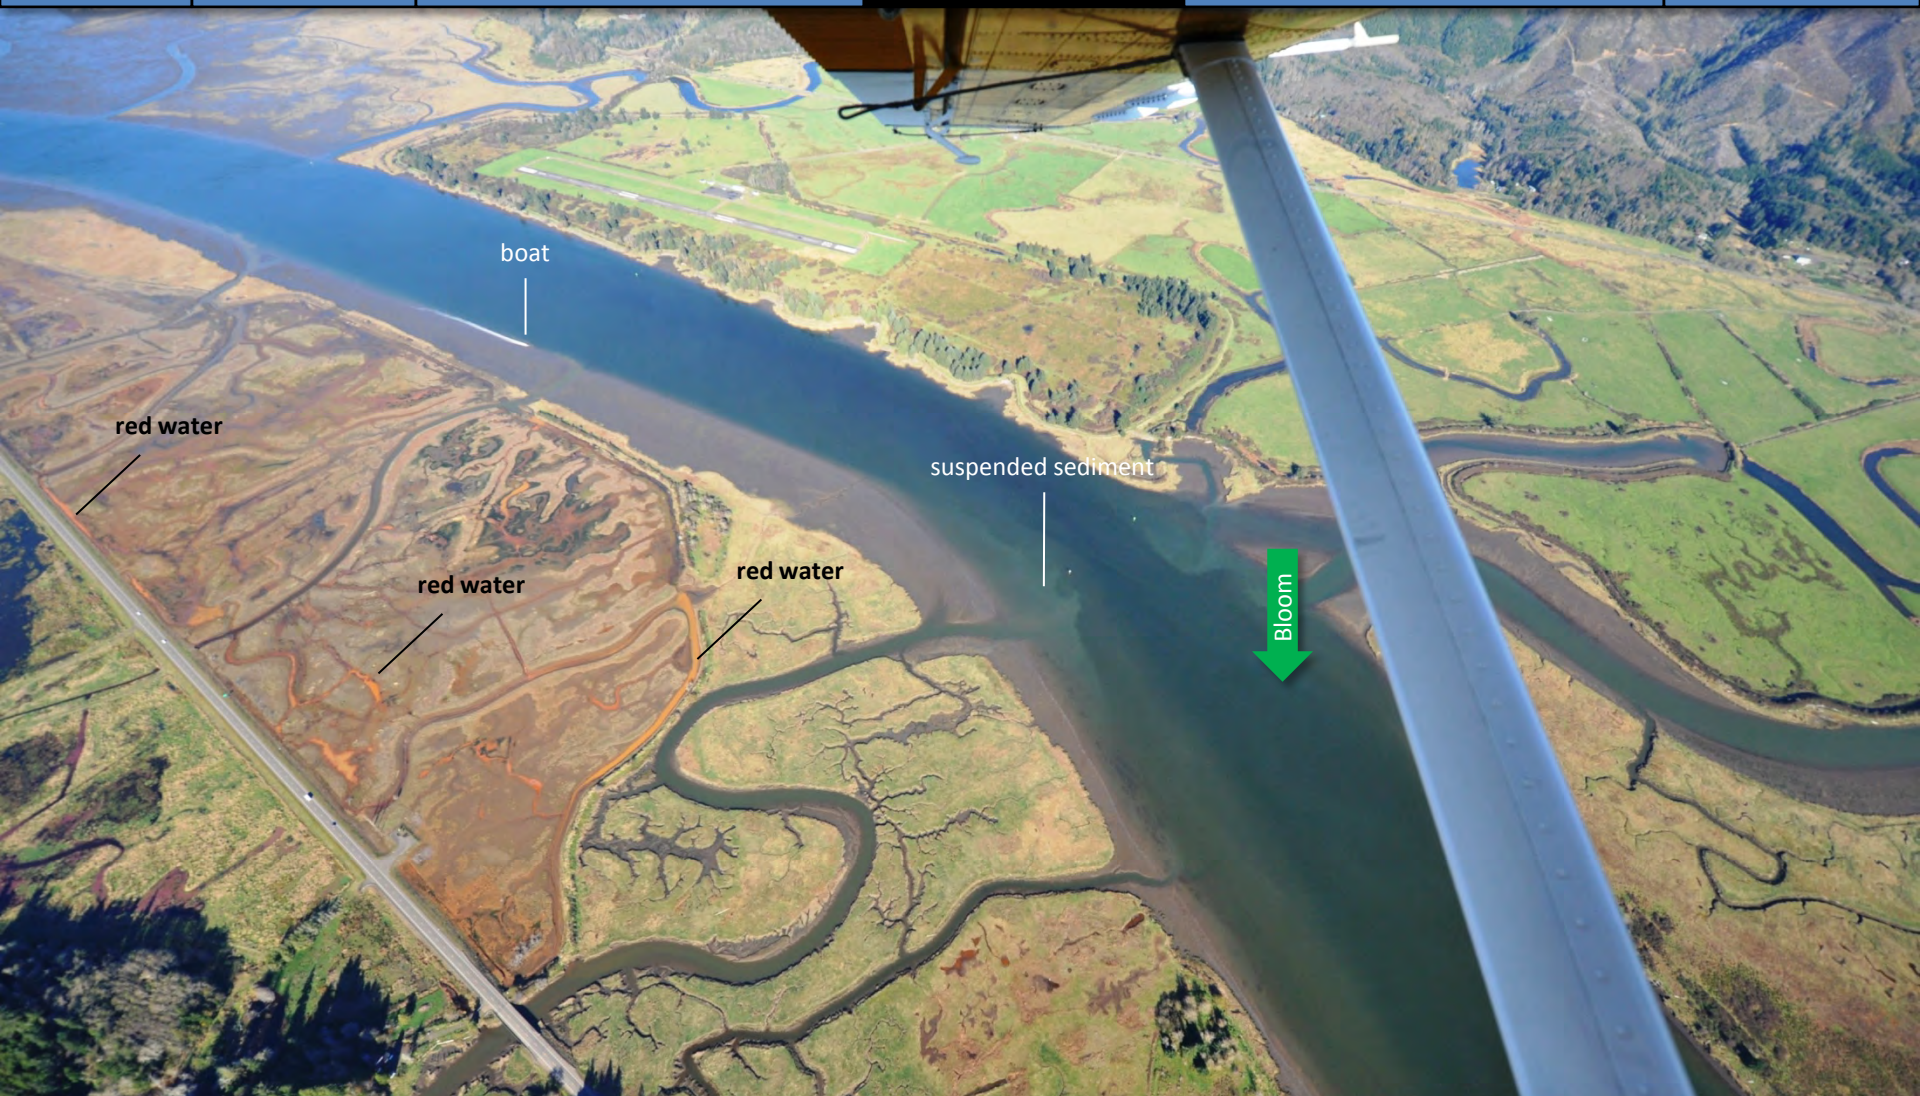
Red-brown algae bloom, suspended sediment, vegetation alteration, and red water color on flats across from Willapa Harbor Airport. Location: Willapa River (Willapa Bay), 1:49 PM.

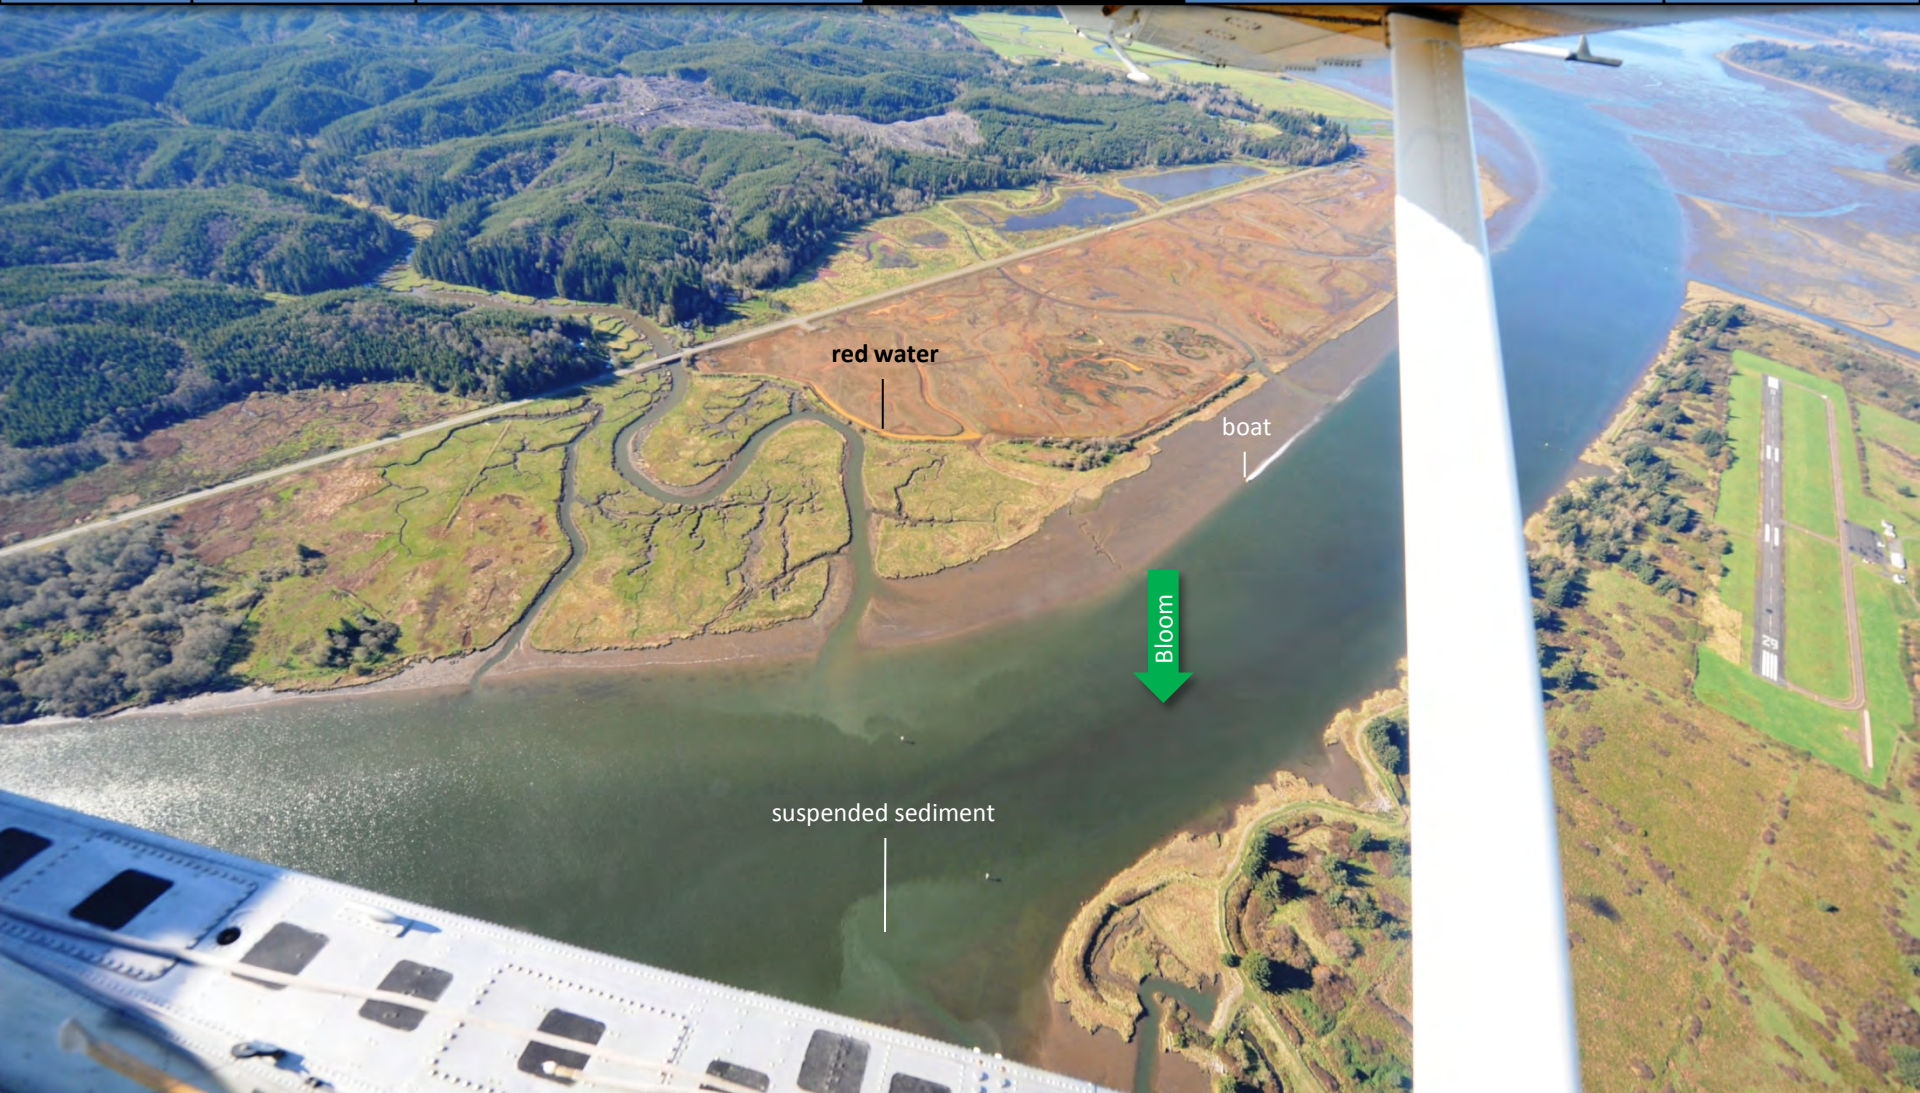
Red-brown algae bloom, suspended sediment, vegetation alteration, and red water color on flats across from Willapa Harbor Airport. Location: Willapa River (Willapa Bay), 1:49 PM.

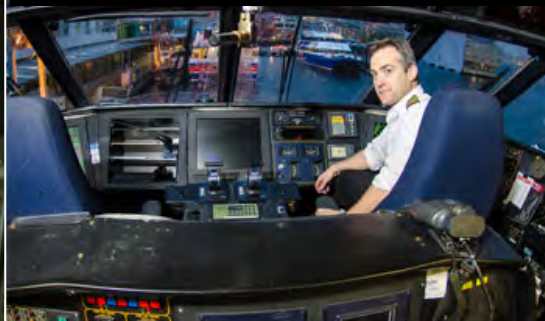
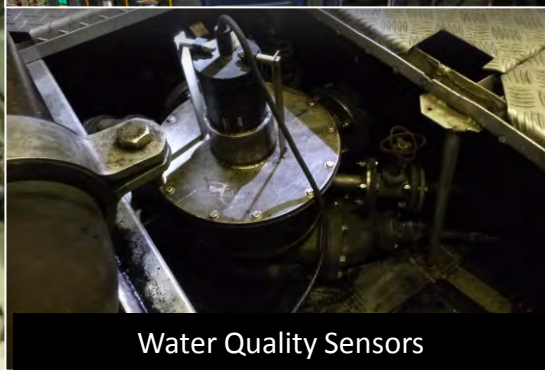
Water Quality Sensors

1. 132 feet long, 33.3 feet wide
2. 30 knots top speed (among the fastest passenger vessels in Western Hemisphere!)
3. Water jet propulsion system
4. Seattle-to-Victoria in 2 hrs 45 min; 1-2 trips daily
5. Holds 330 passengers
6. Vessel operates year-round, except for 2 weeks in January (for dry dock operations)
7. Water quality sensor suite installed in May 2010
