Eyes Over Puget Sound

2013 Review

LONG-TERM MARINE MONITORING UNIT, ECOLOGY

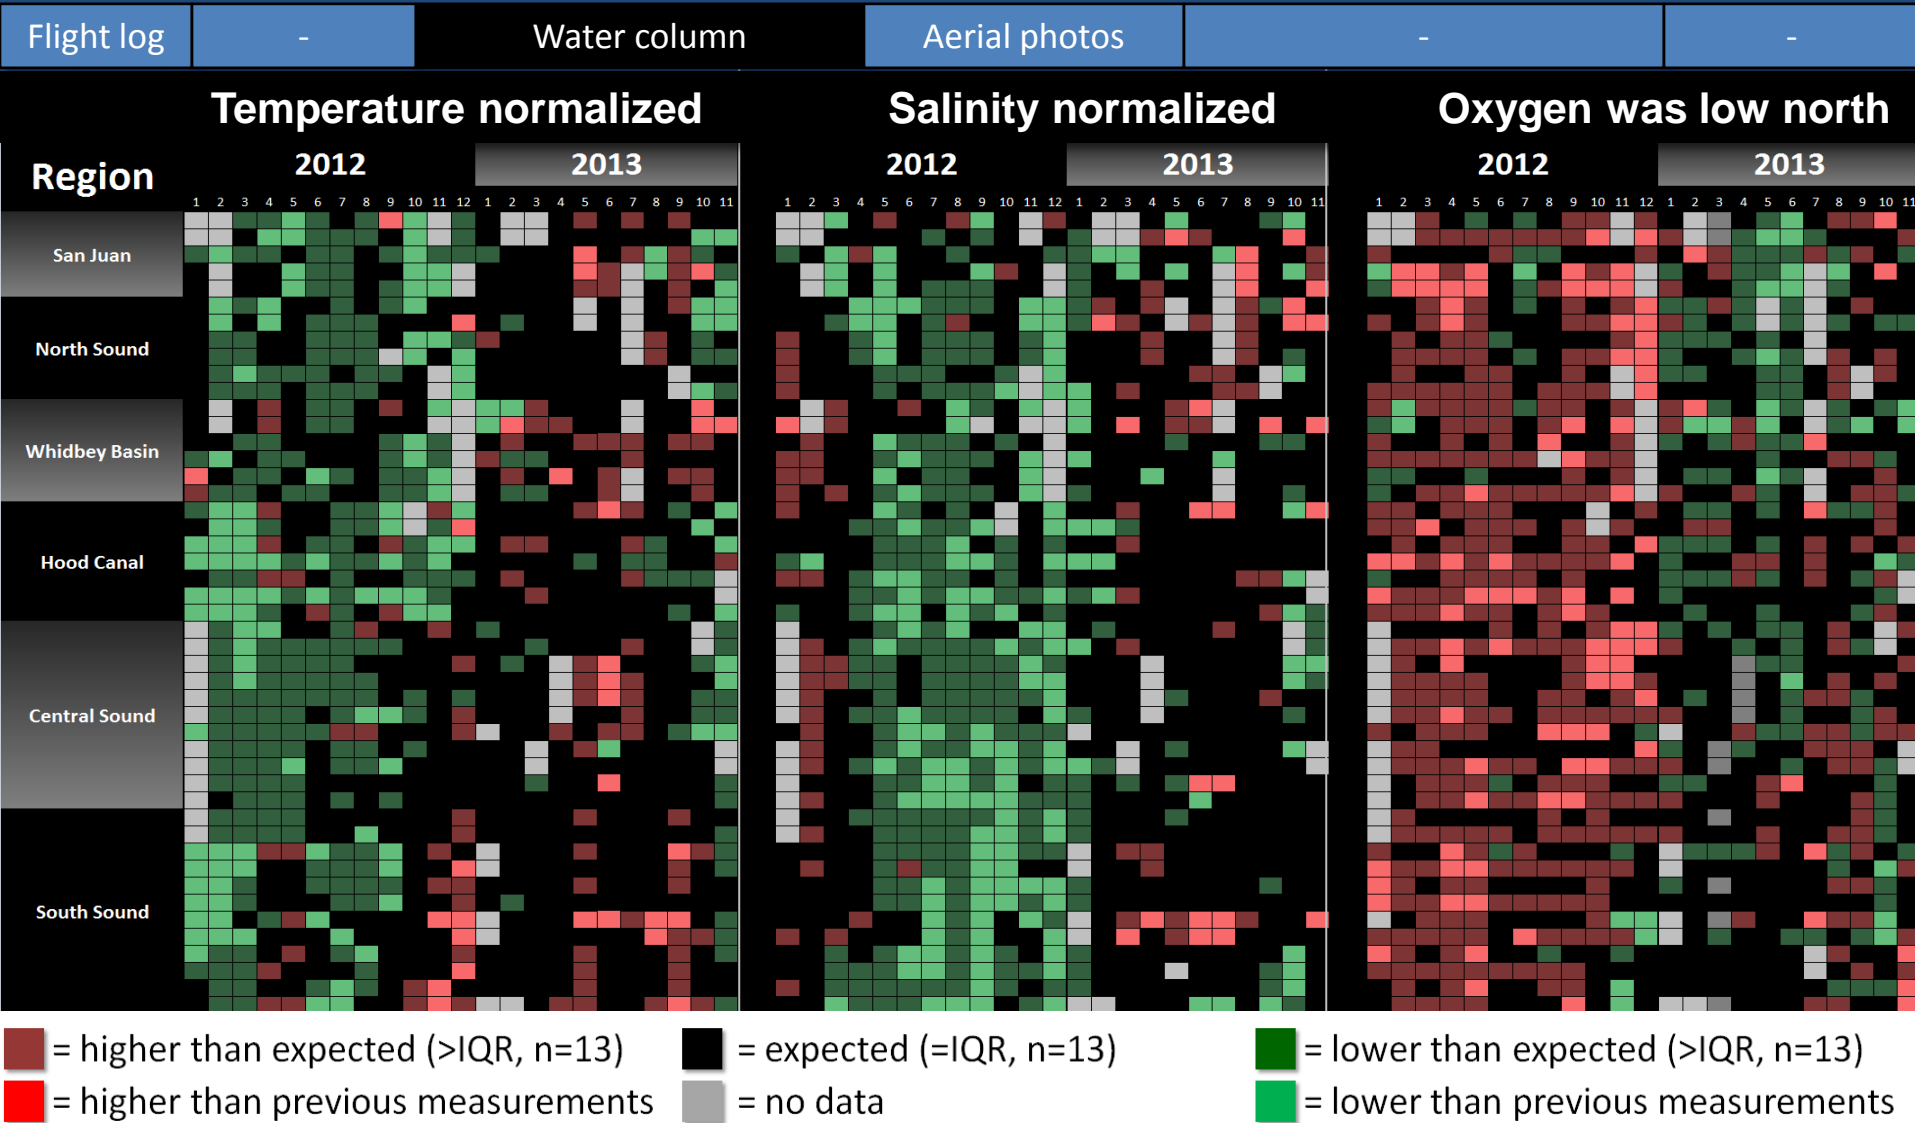
In 2013, water temperatures were expected or warmer until October, then became colder. Salinity in 2013 was mostly expected with greater variability in the north. Oxygen was lower than expected in the north until August, then varied regionally in the fall. 2013 looked very different from the previous two years (cold, fresher, and high in oxygen).

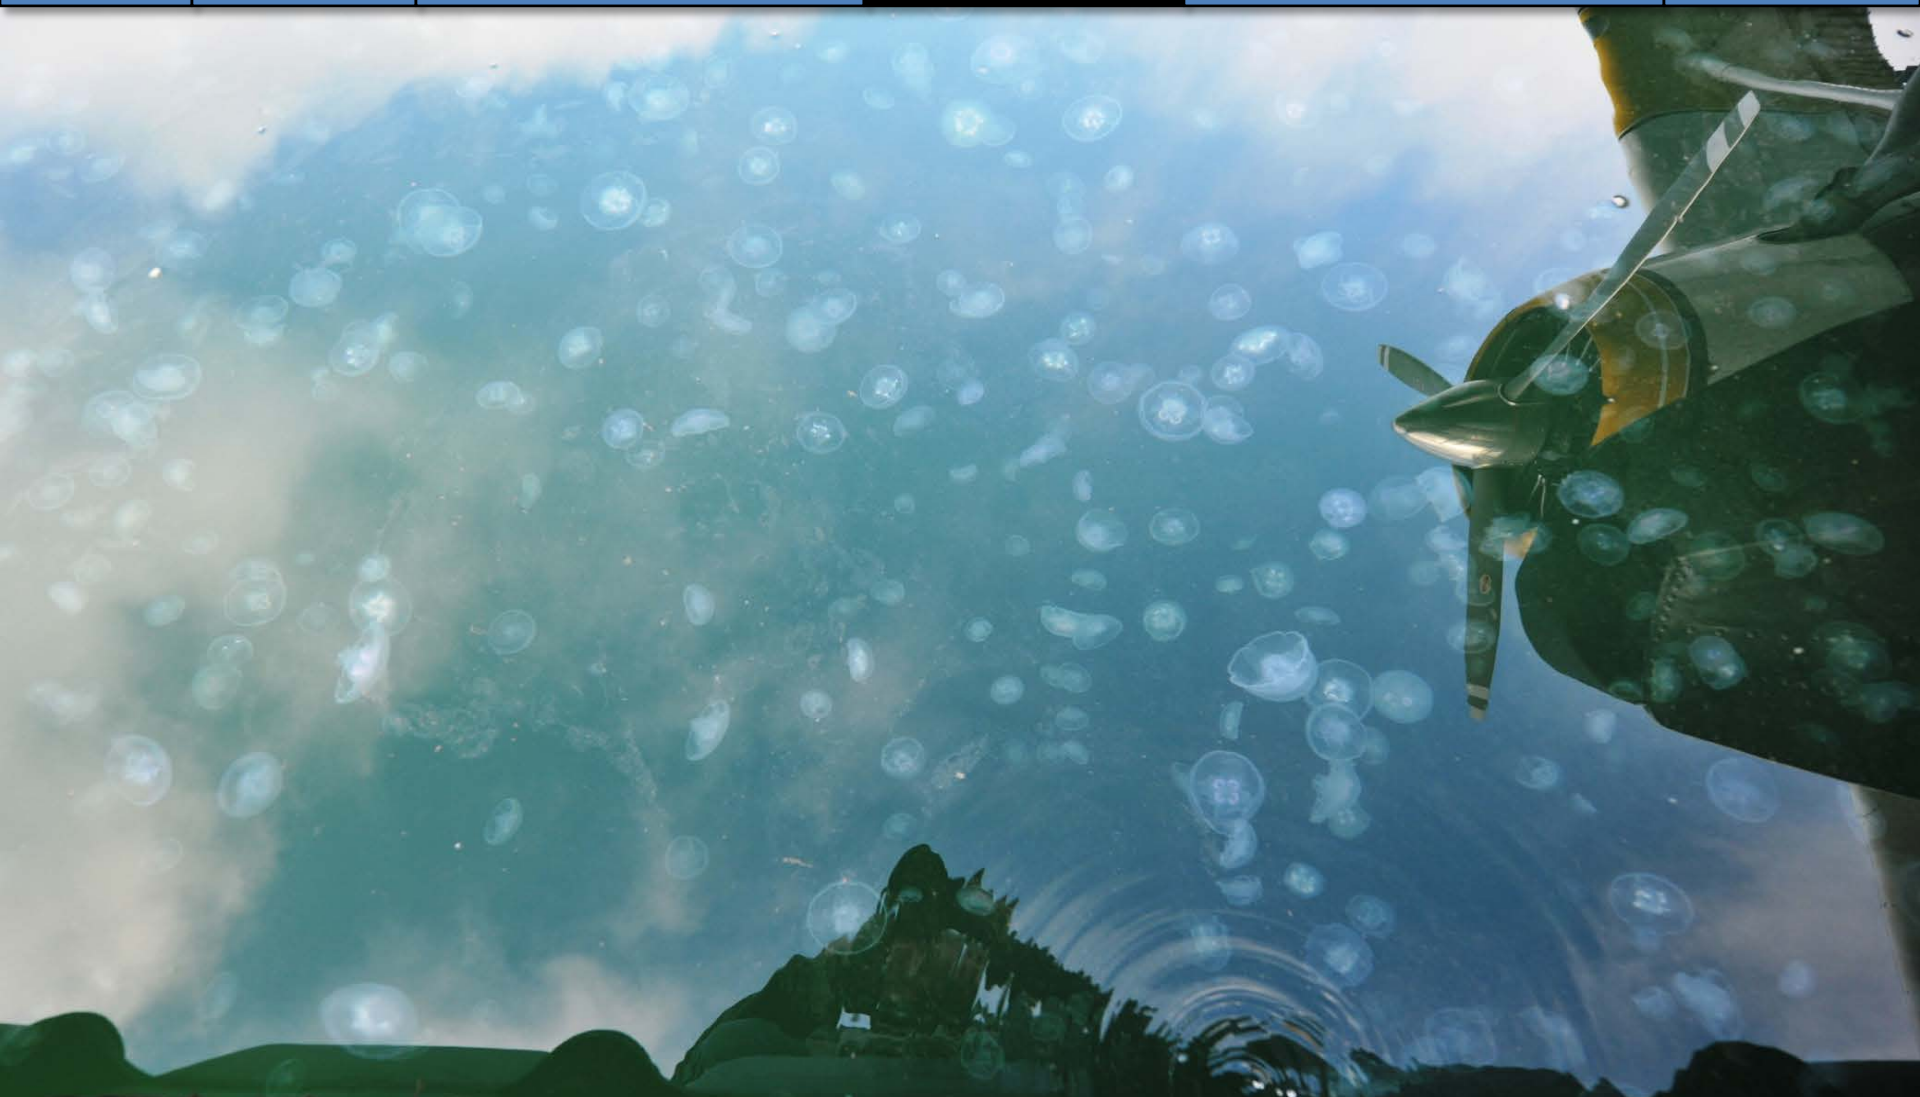
Sizable and numerous jellyfish (approx. 10 cm diameter). Location: Swantown Marina (Budd Inlet), 10:55 AM

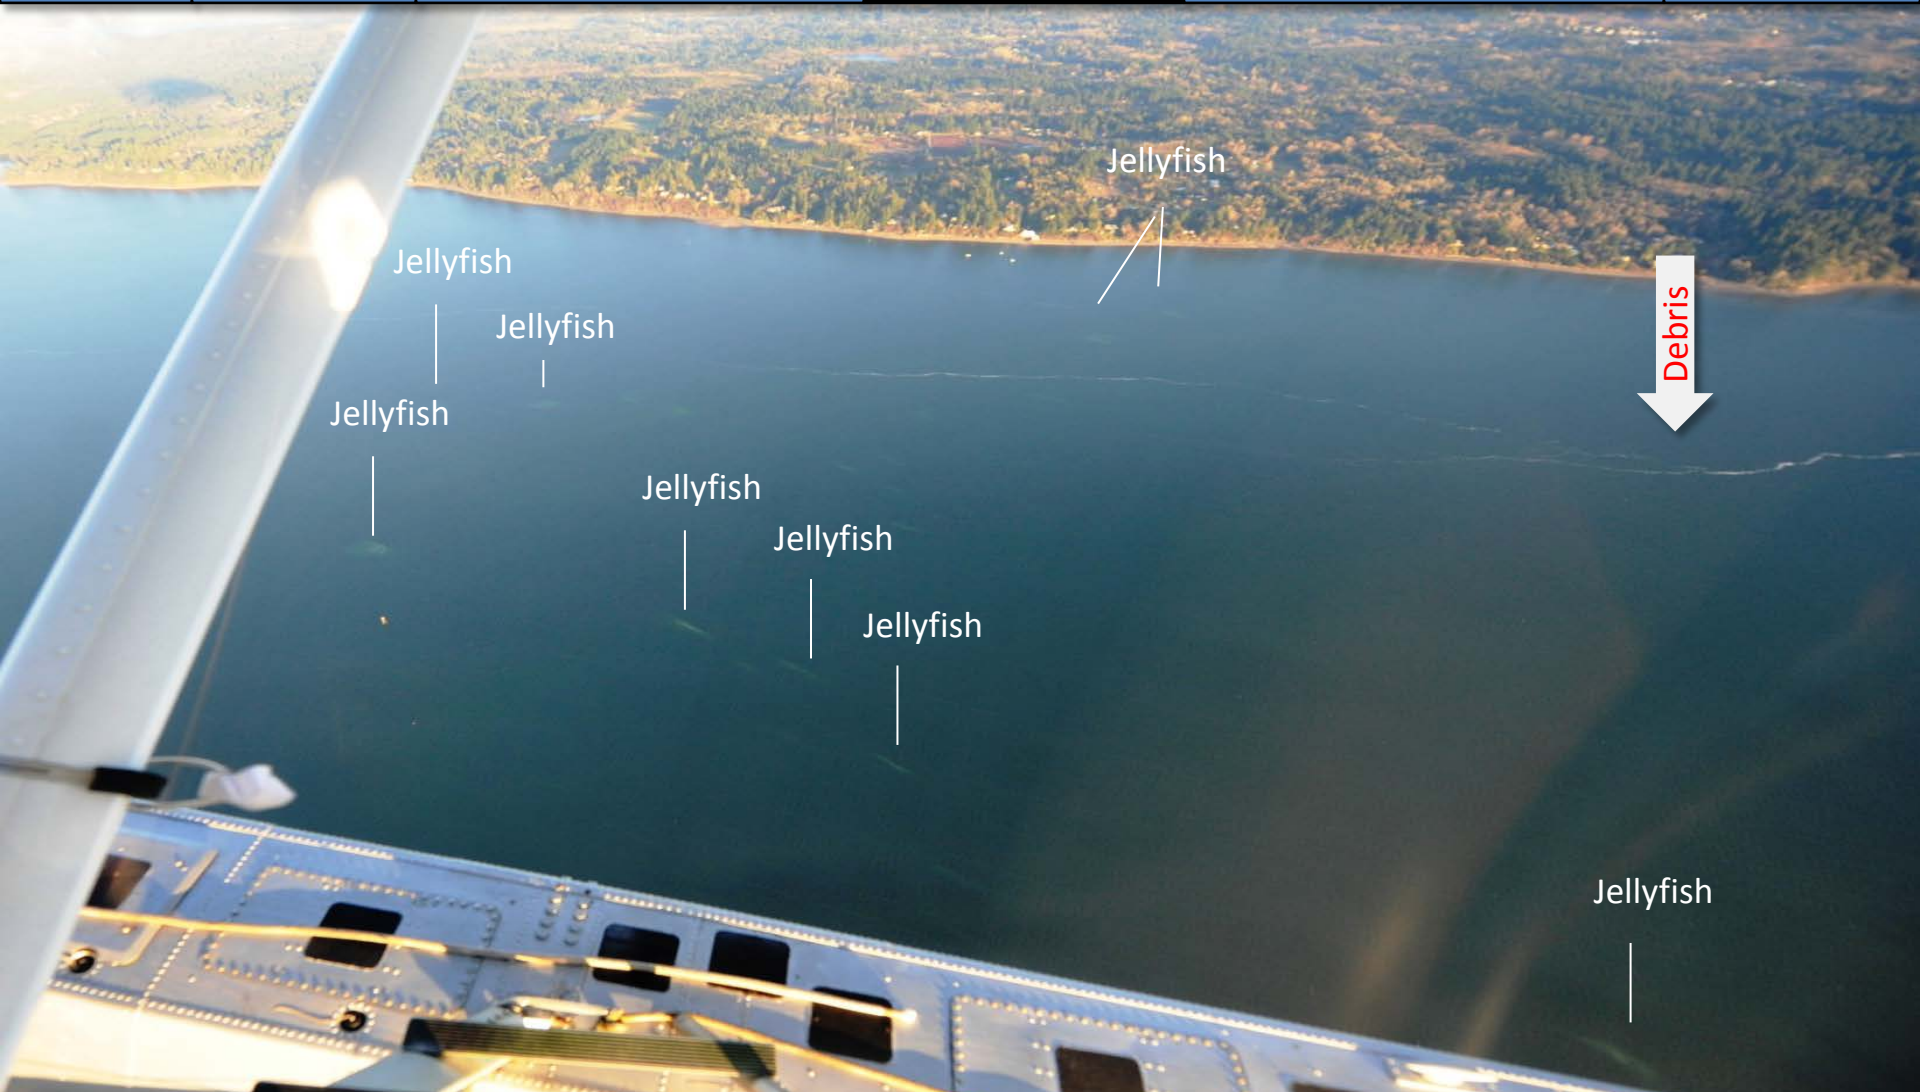
Jelly fish patches and debris line. Location: Budd Inlet (South Sound), 4:01 PM

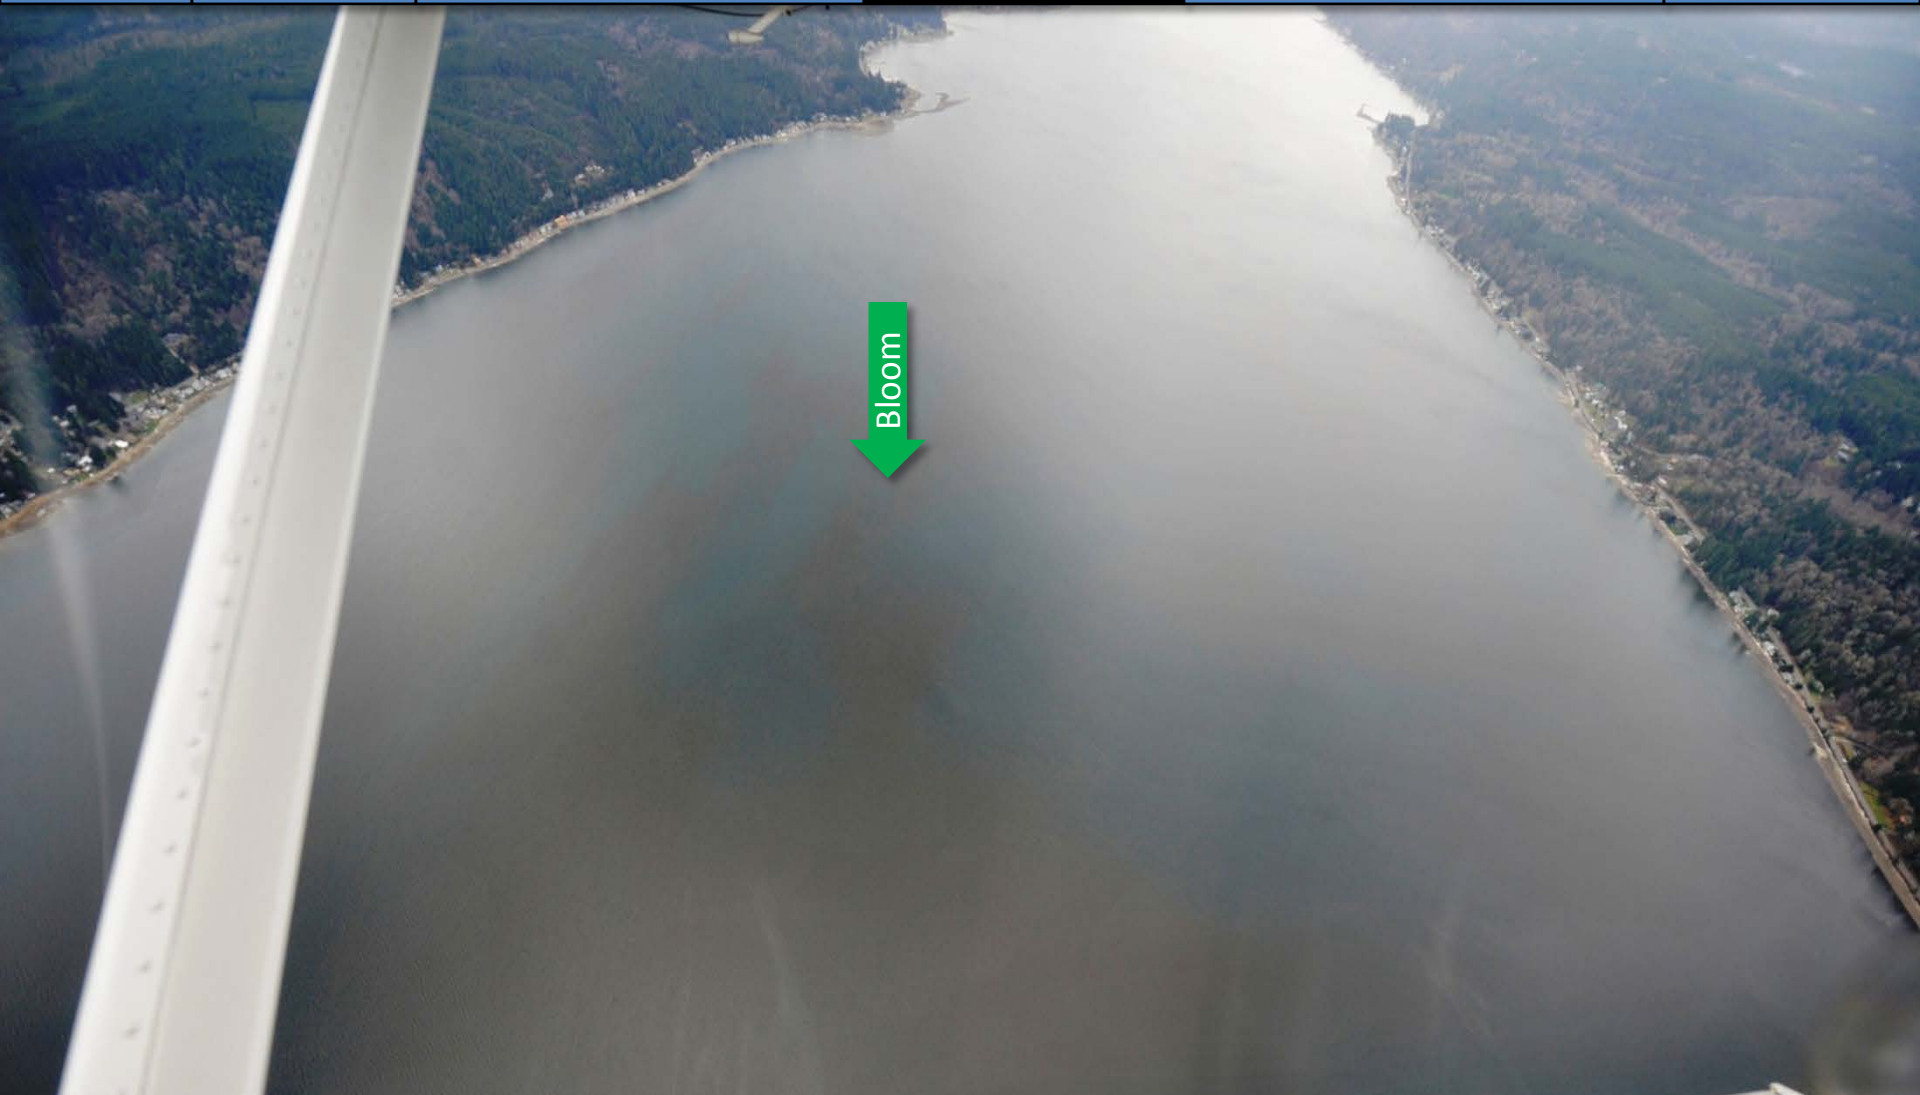
Early near-surface spring plankton bloom. Location: Hood Canal, 2:44 PM

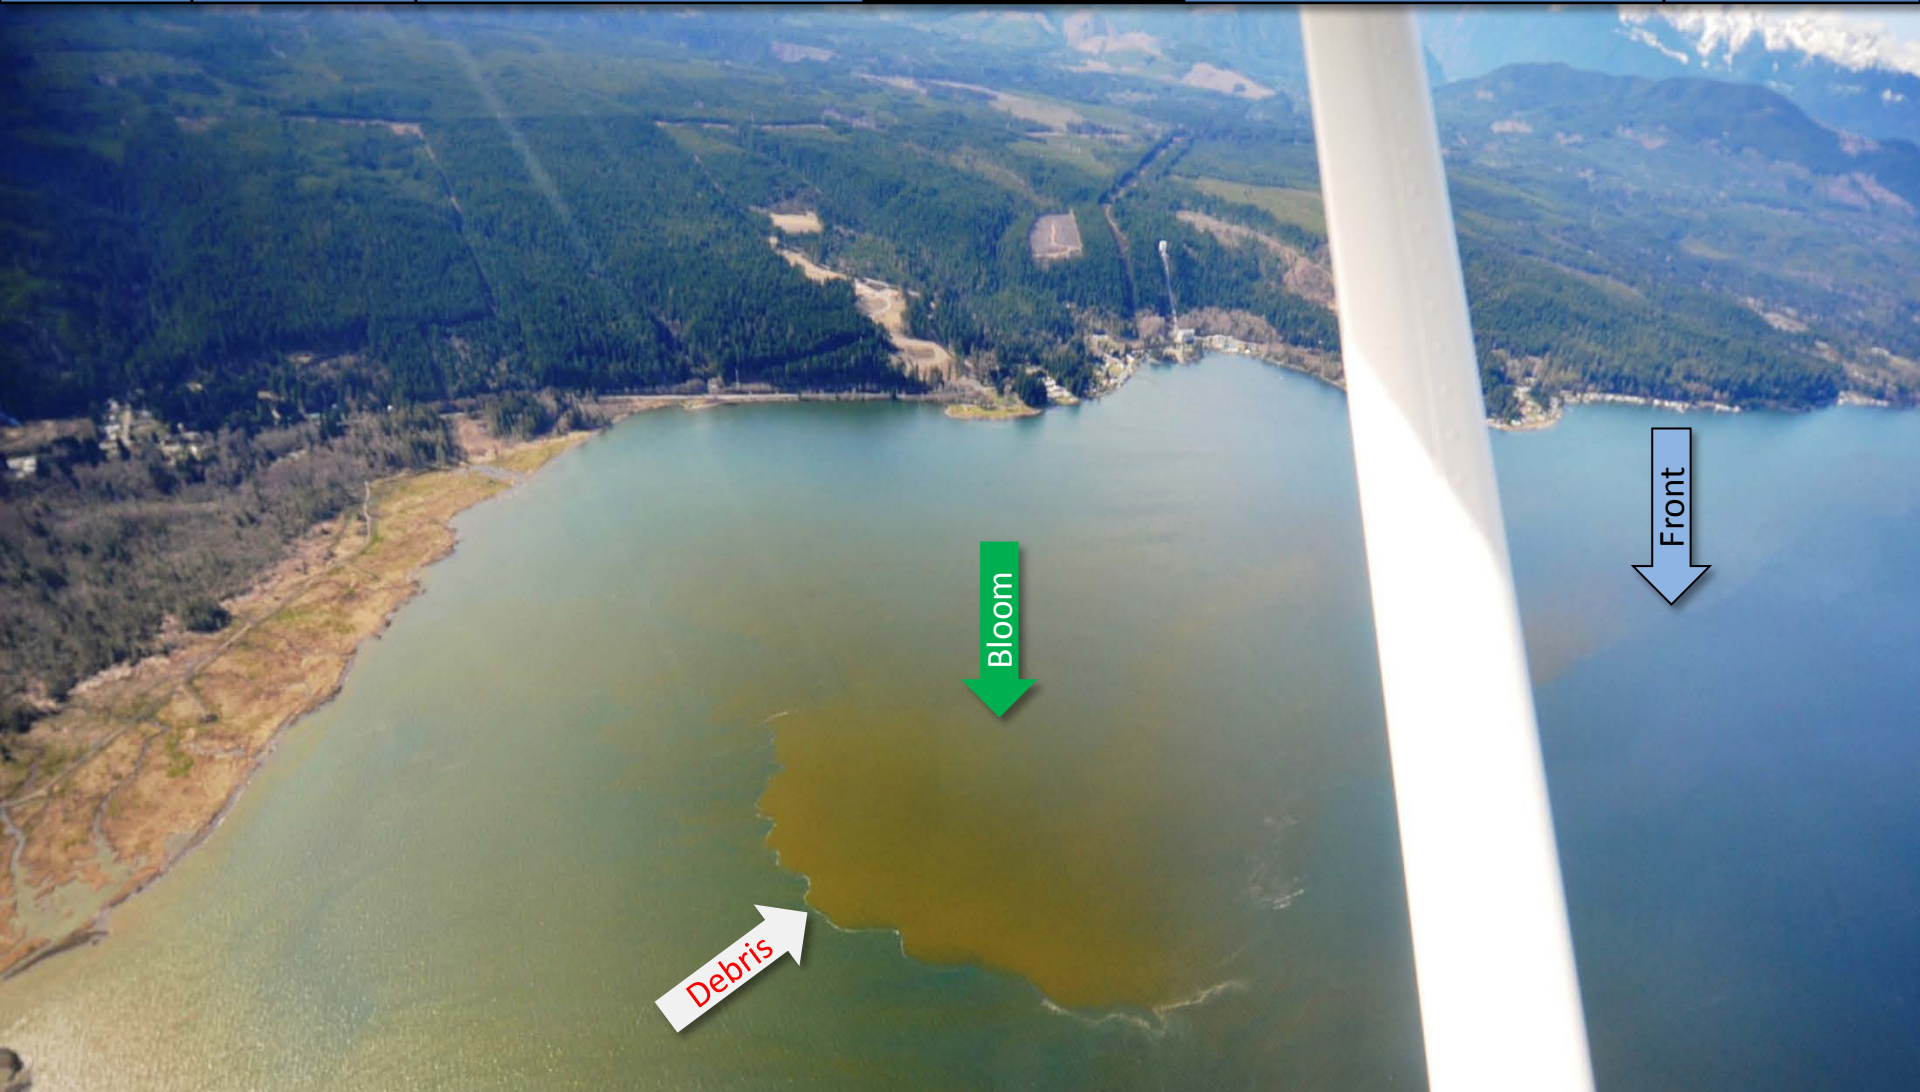
Large and intense red-orange-brown plankton bloom and surface debris.

Location: Hood Canal, 3:27 PM

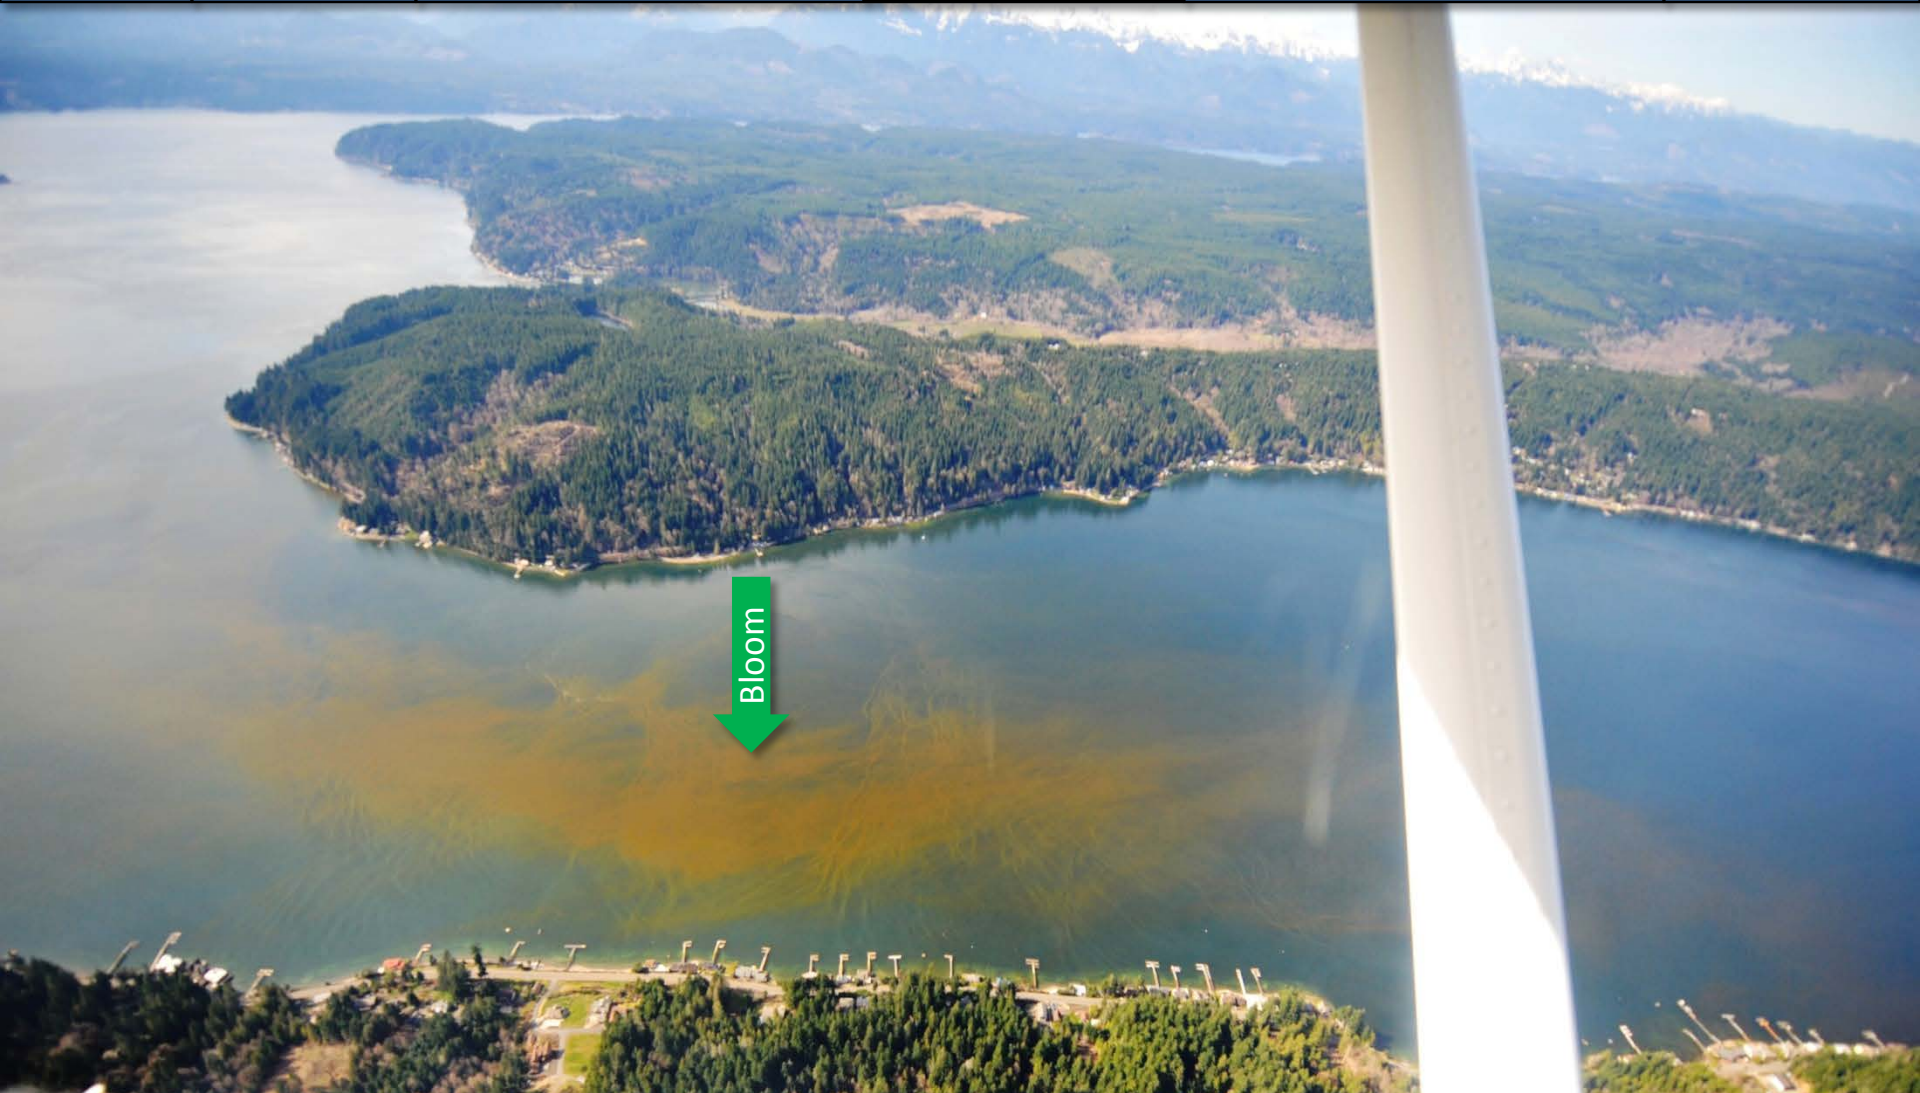
Large and intense red-orange-brown plankton bloom and river plume.

Location: Hood Canal, 3:33 PM

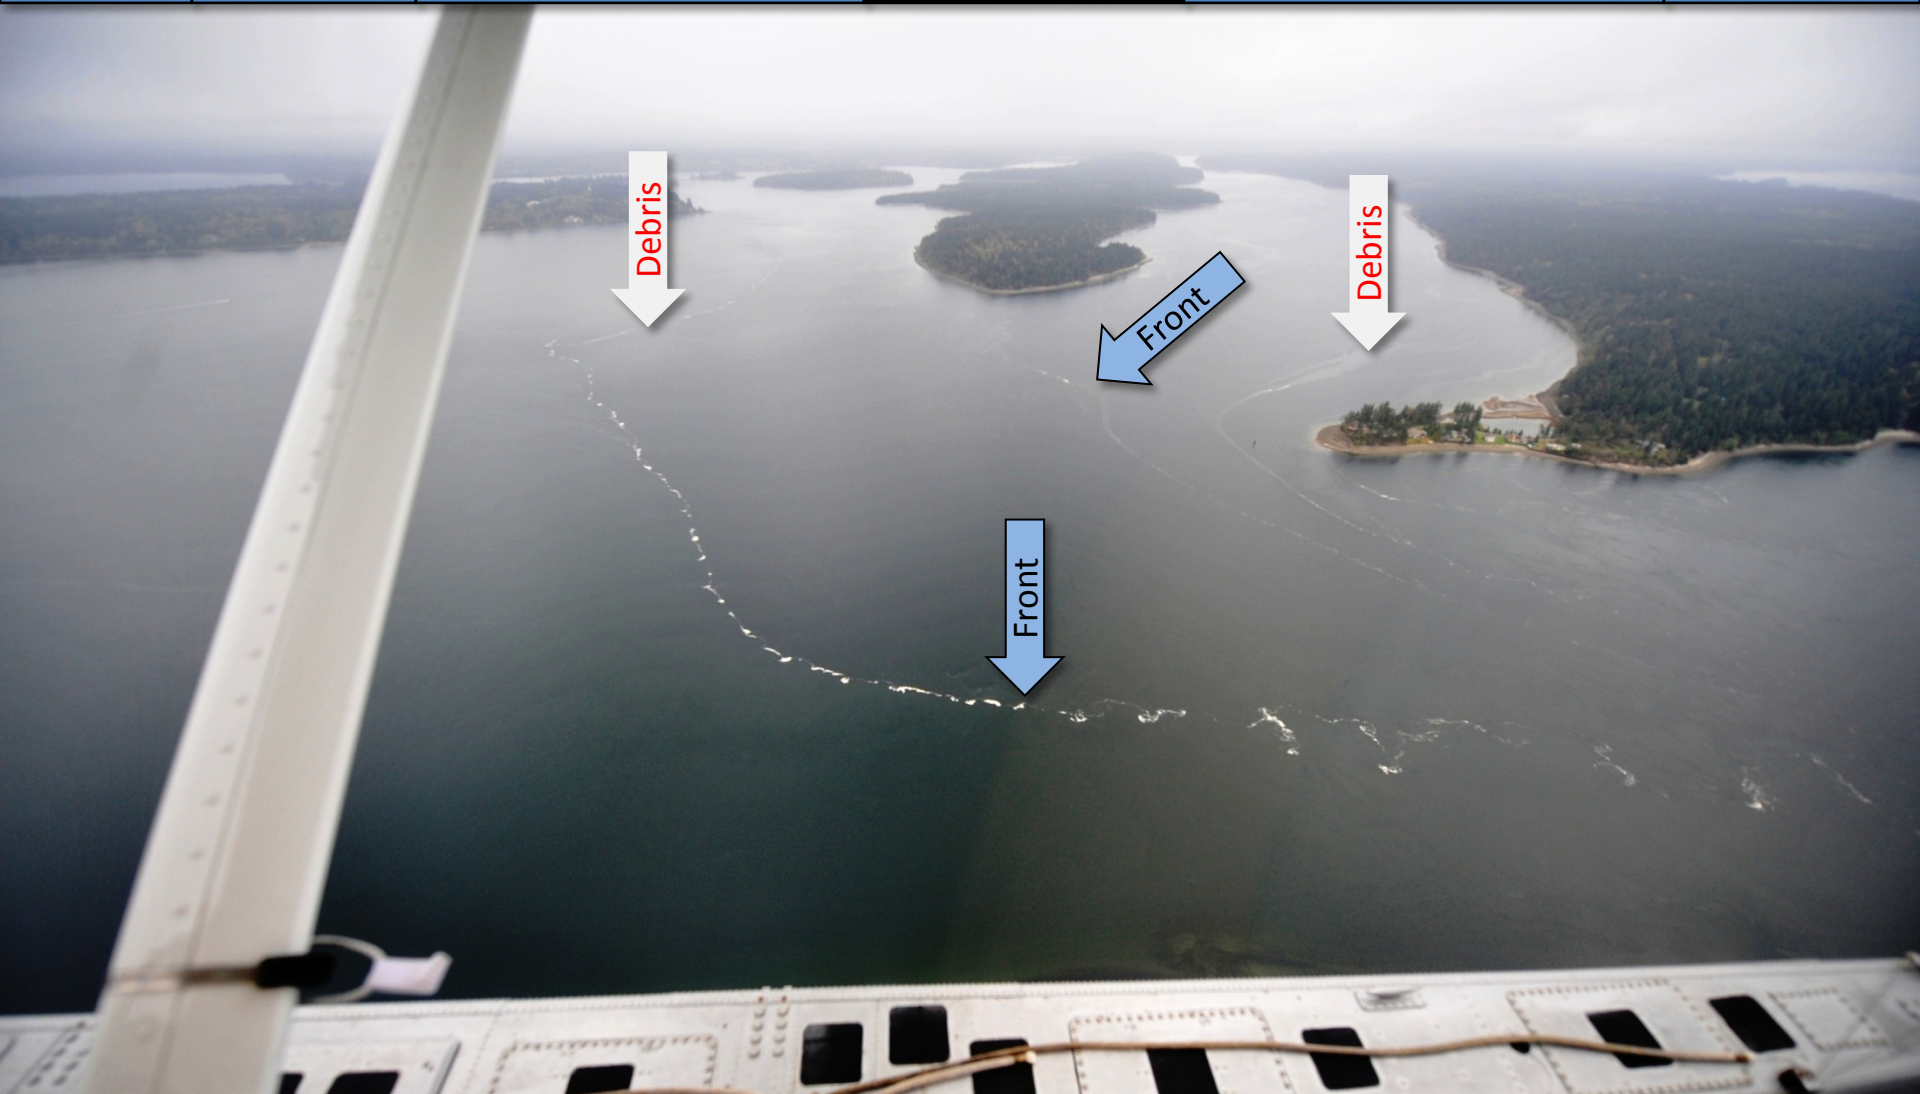
Intense surface debris (foam bands) delineating adjacent water masses.

Location: Dana Passage (South Sound), 9:08 AM

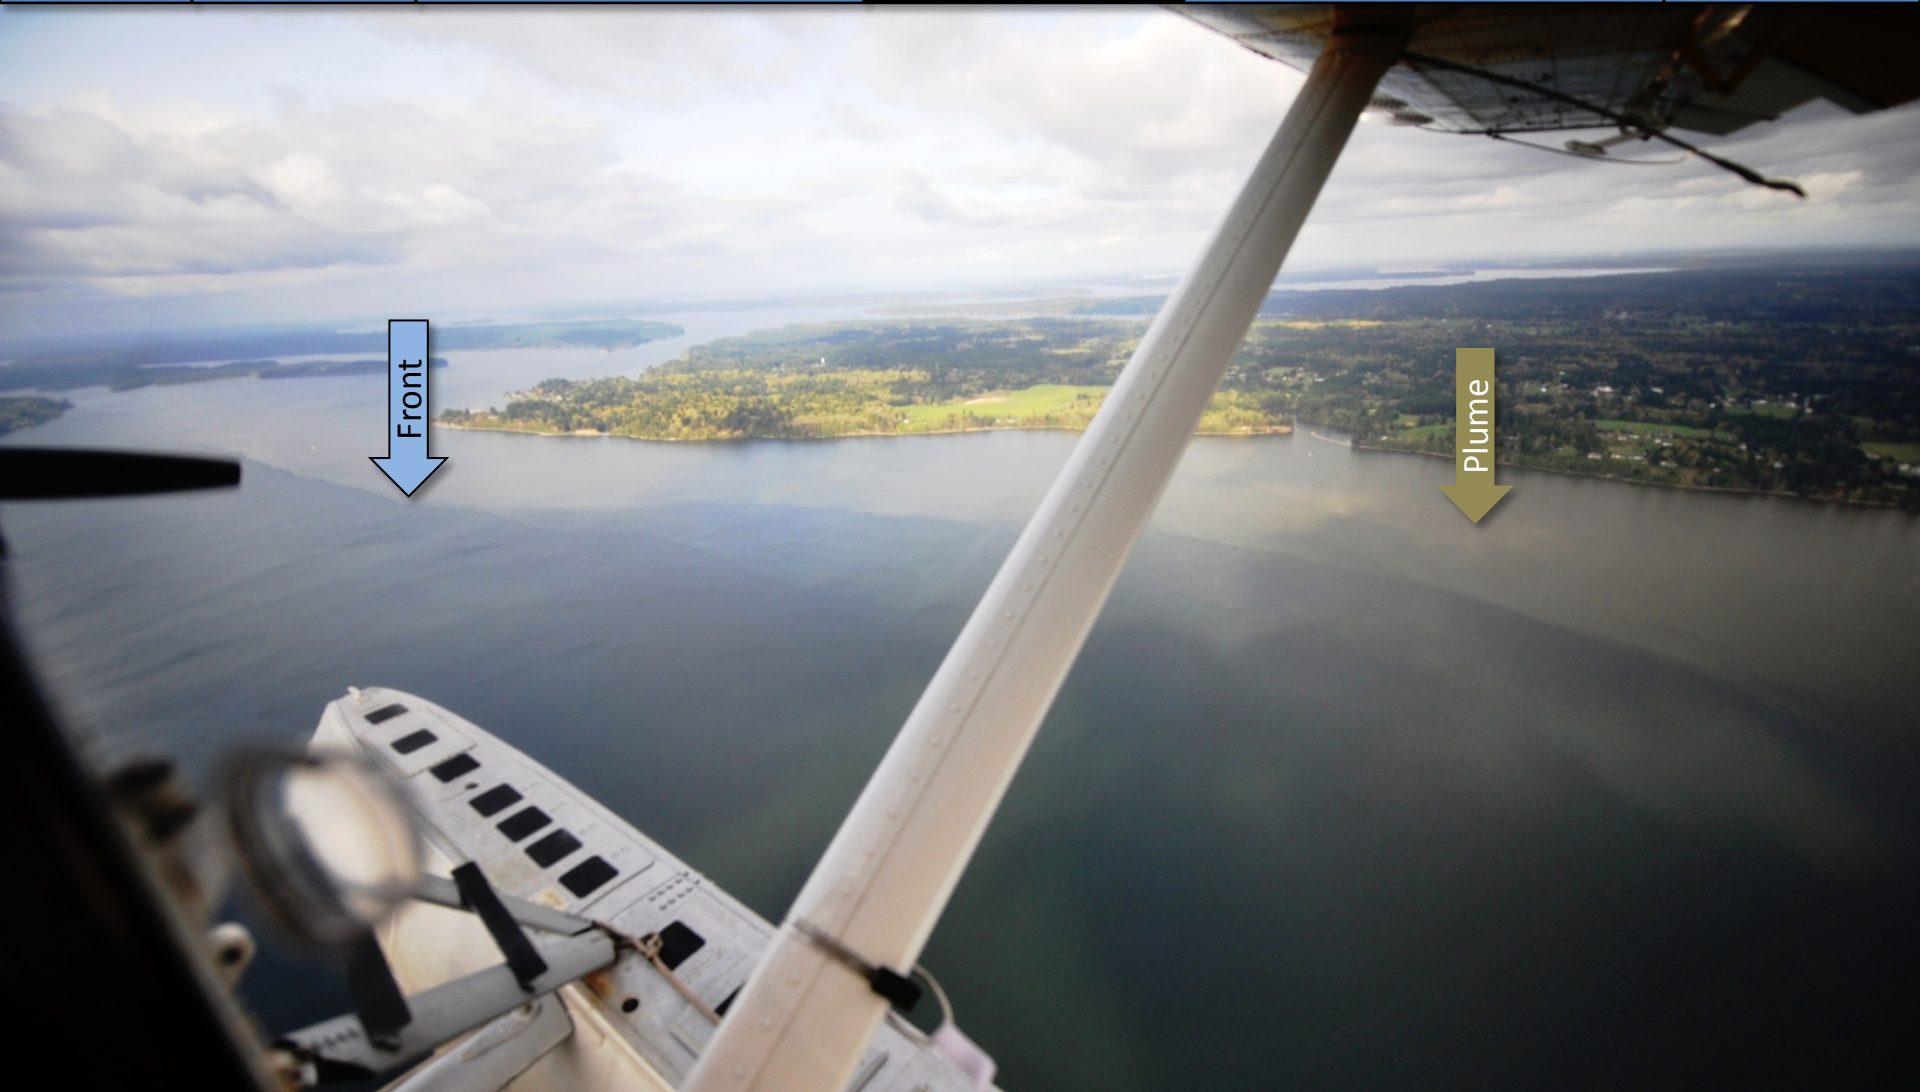
Deschutes River plume with suspended sediment filling the eastern side of the estuary.

Location: Budd Inlet (South Sound), 5:12 PM

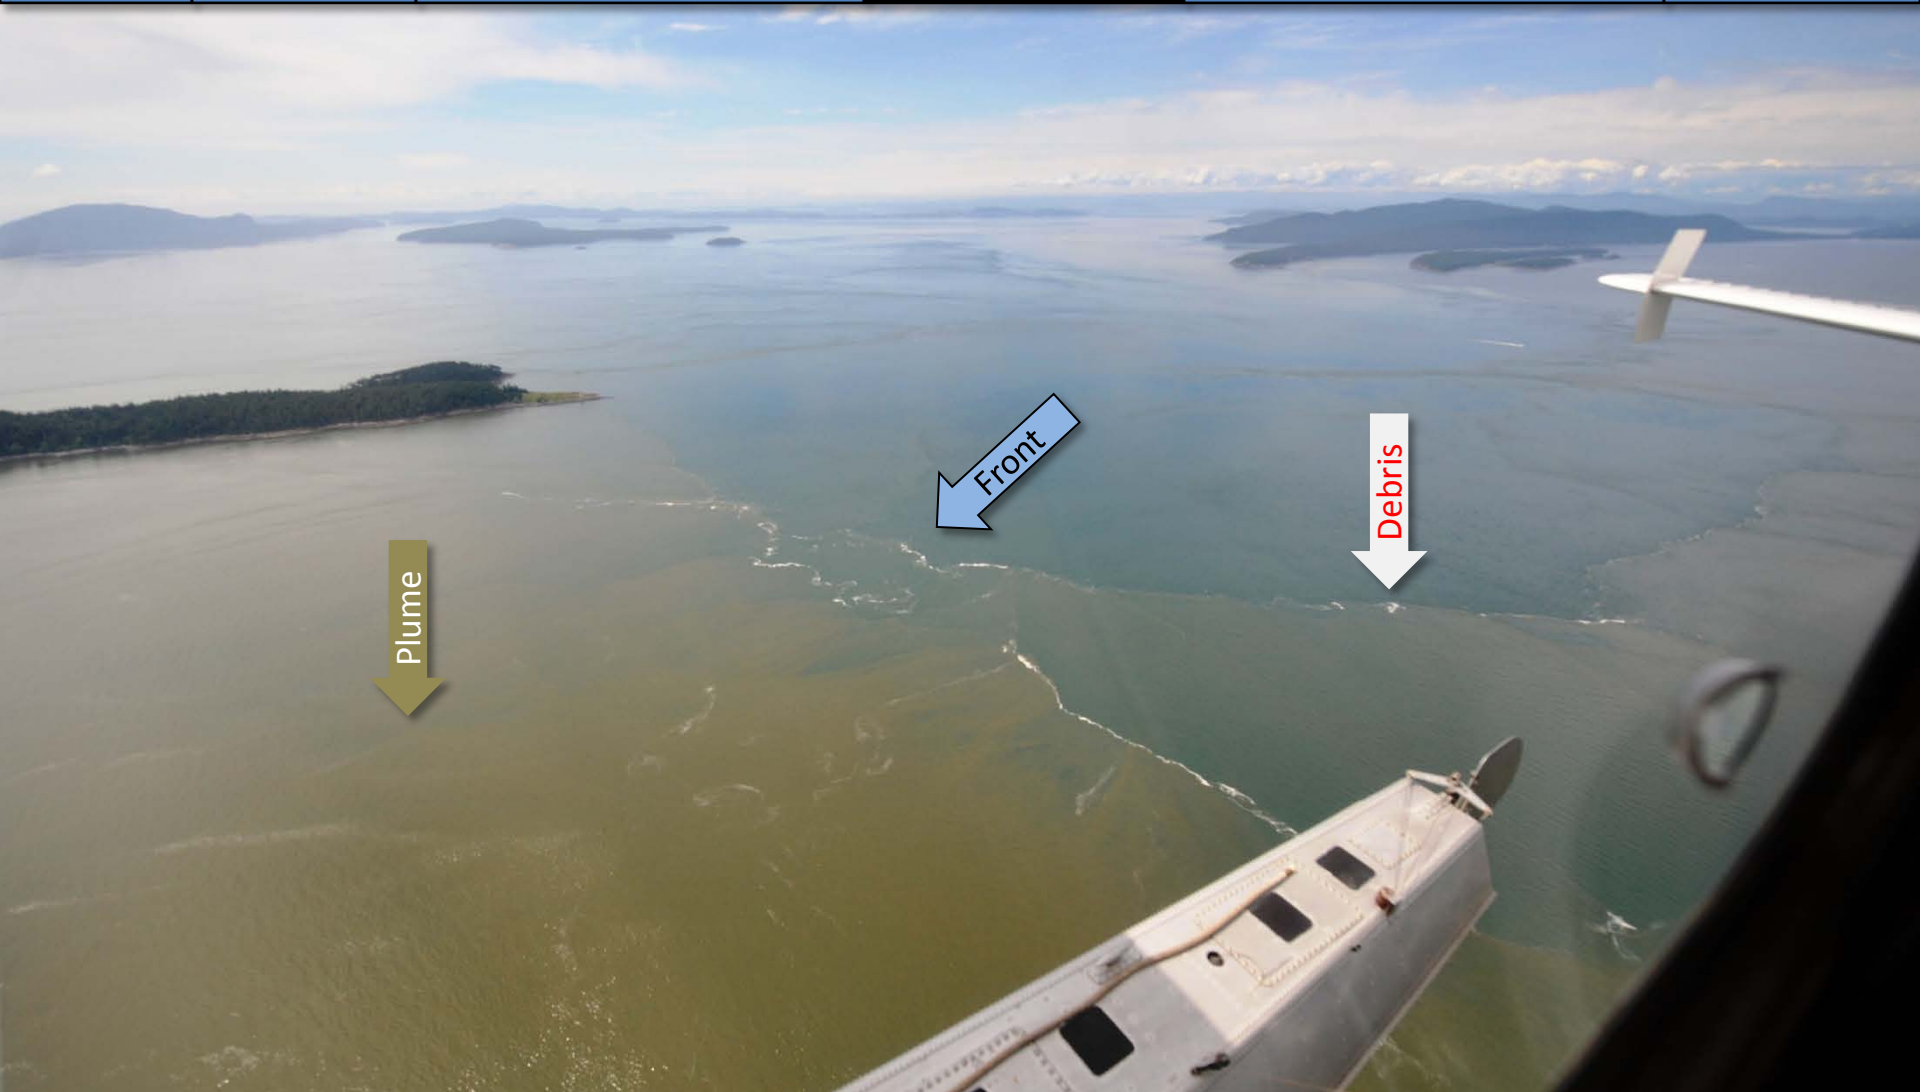
The far reaches of the sediment-laden river plume of the Fraser River
Location: Patos Island State Park (northern San Juan Islands), 12:22 PM

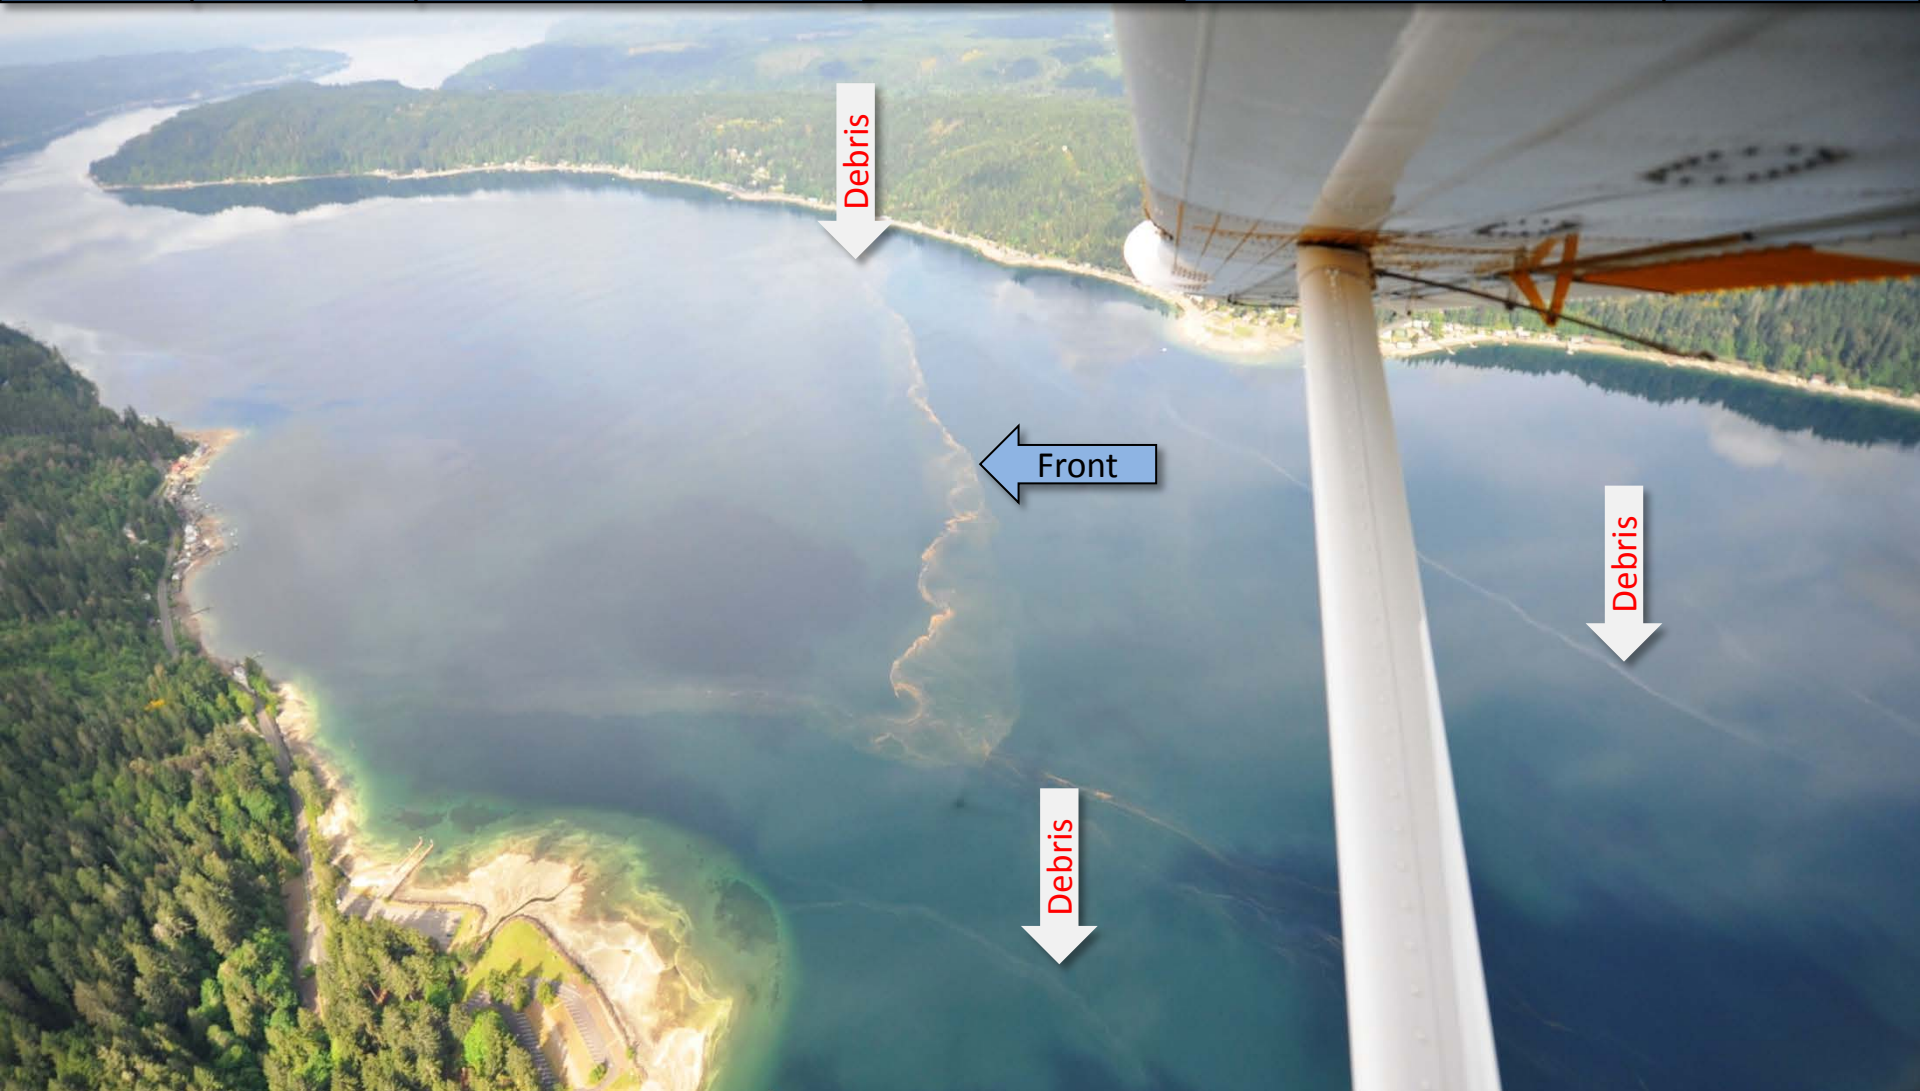
Noctiluca bloom accumulating in long band along a convergence.
Location: Near Twanoh State Park (Southern Hood Canal), 10:00 AM
