Eyes Over Puget Sound

2013 Review

LONG-TERM MARINE MONITORING UNIT, ECOLOGY

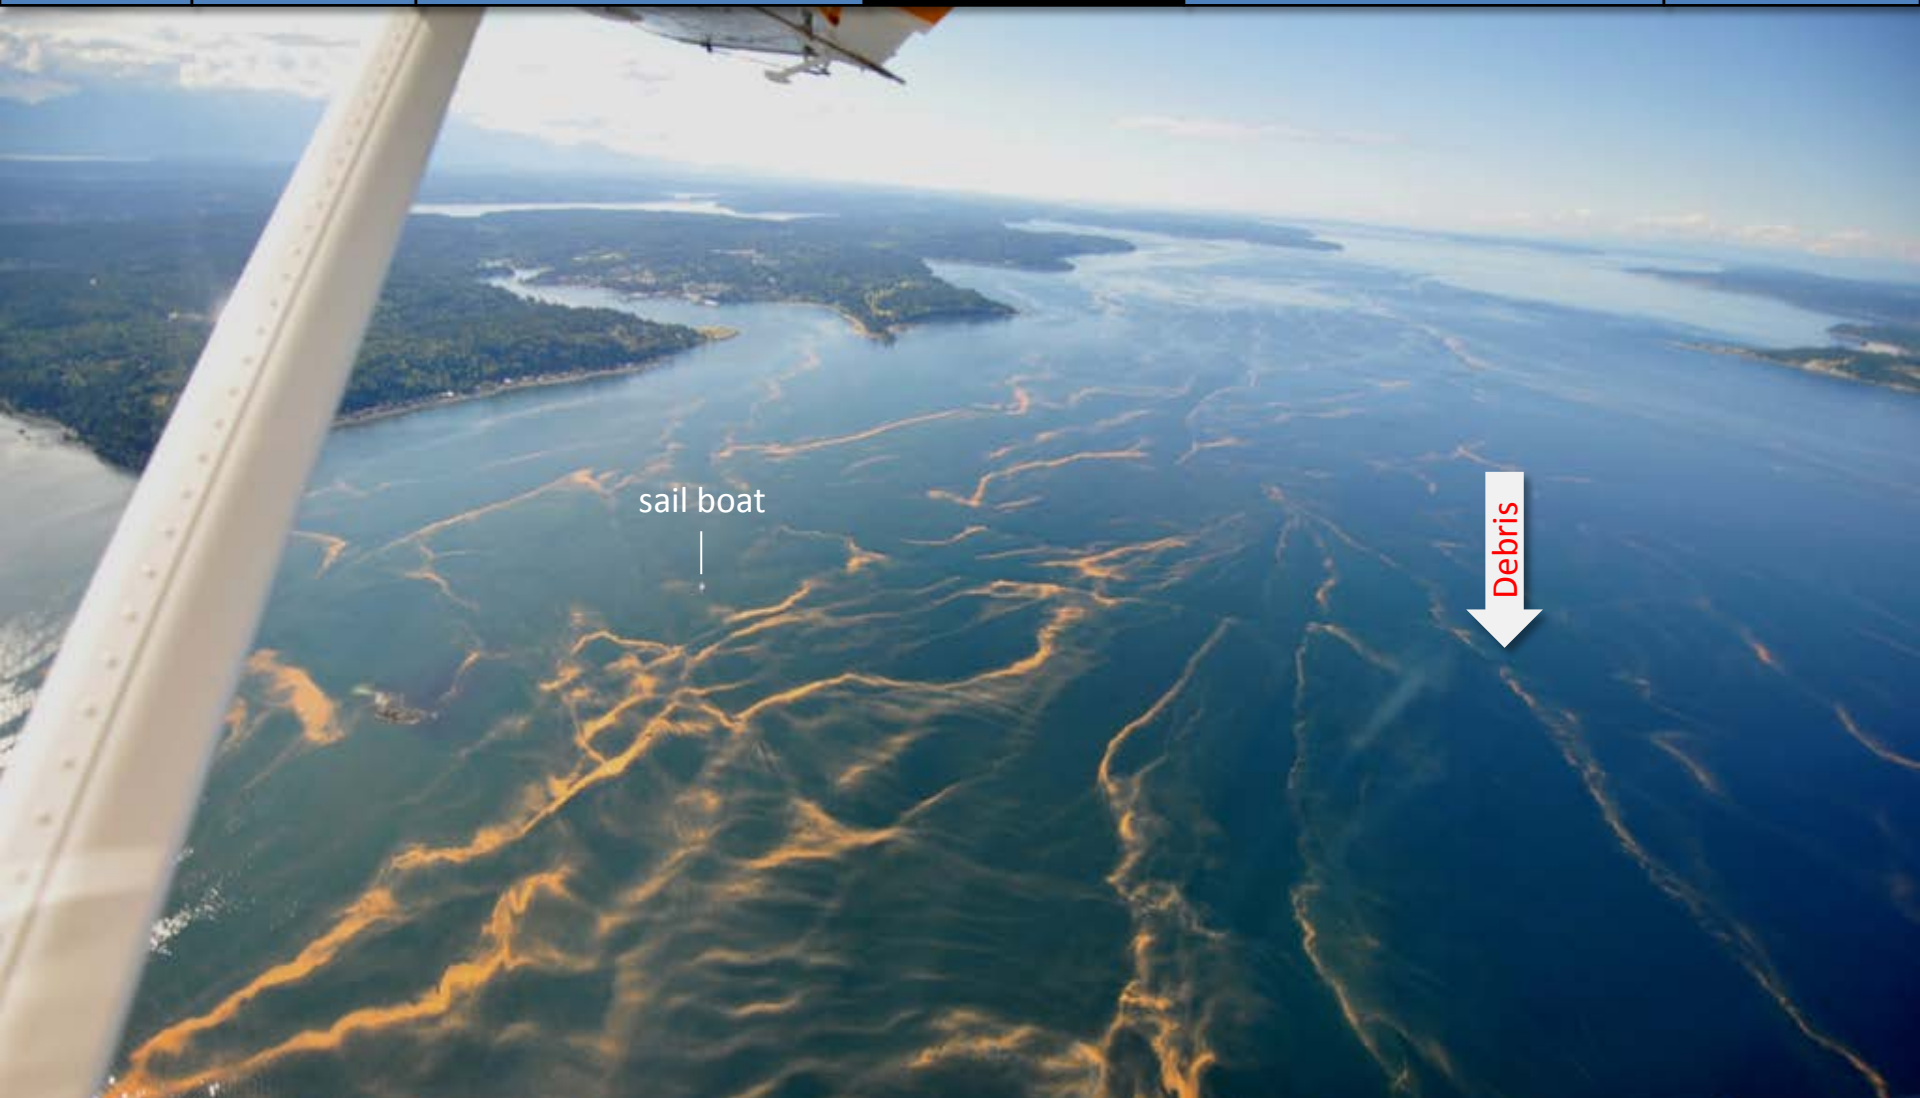
Noctiluca bloom at surface in very long bands.

Location: Between Bainbridge Island and Elliott Bay (Central Basin), 5:27 PM.

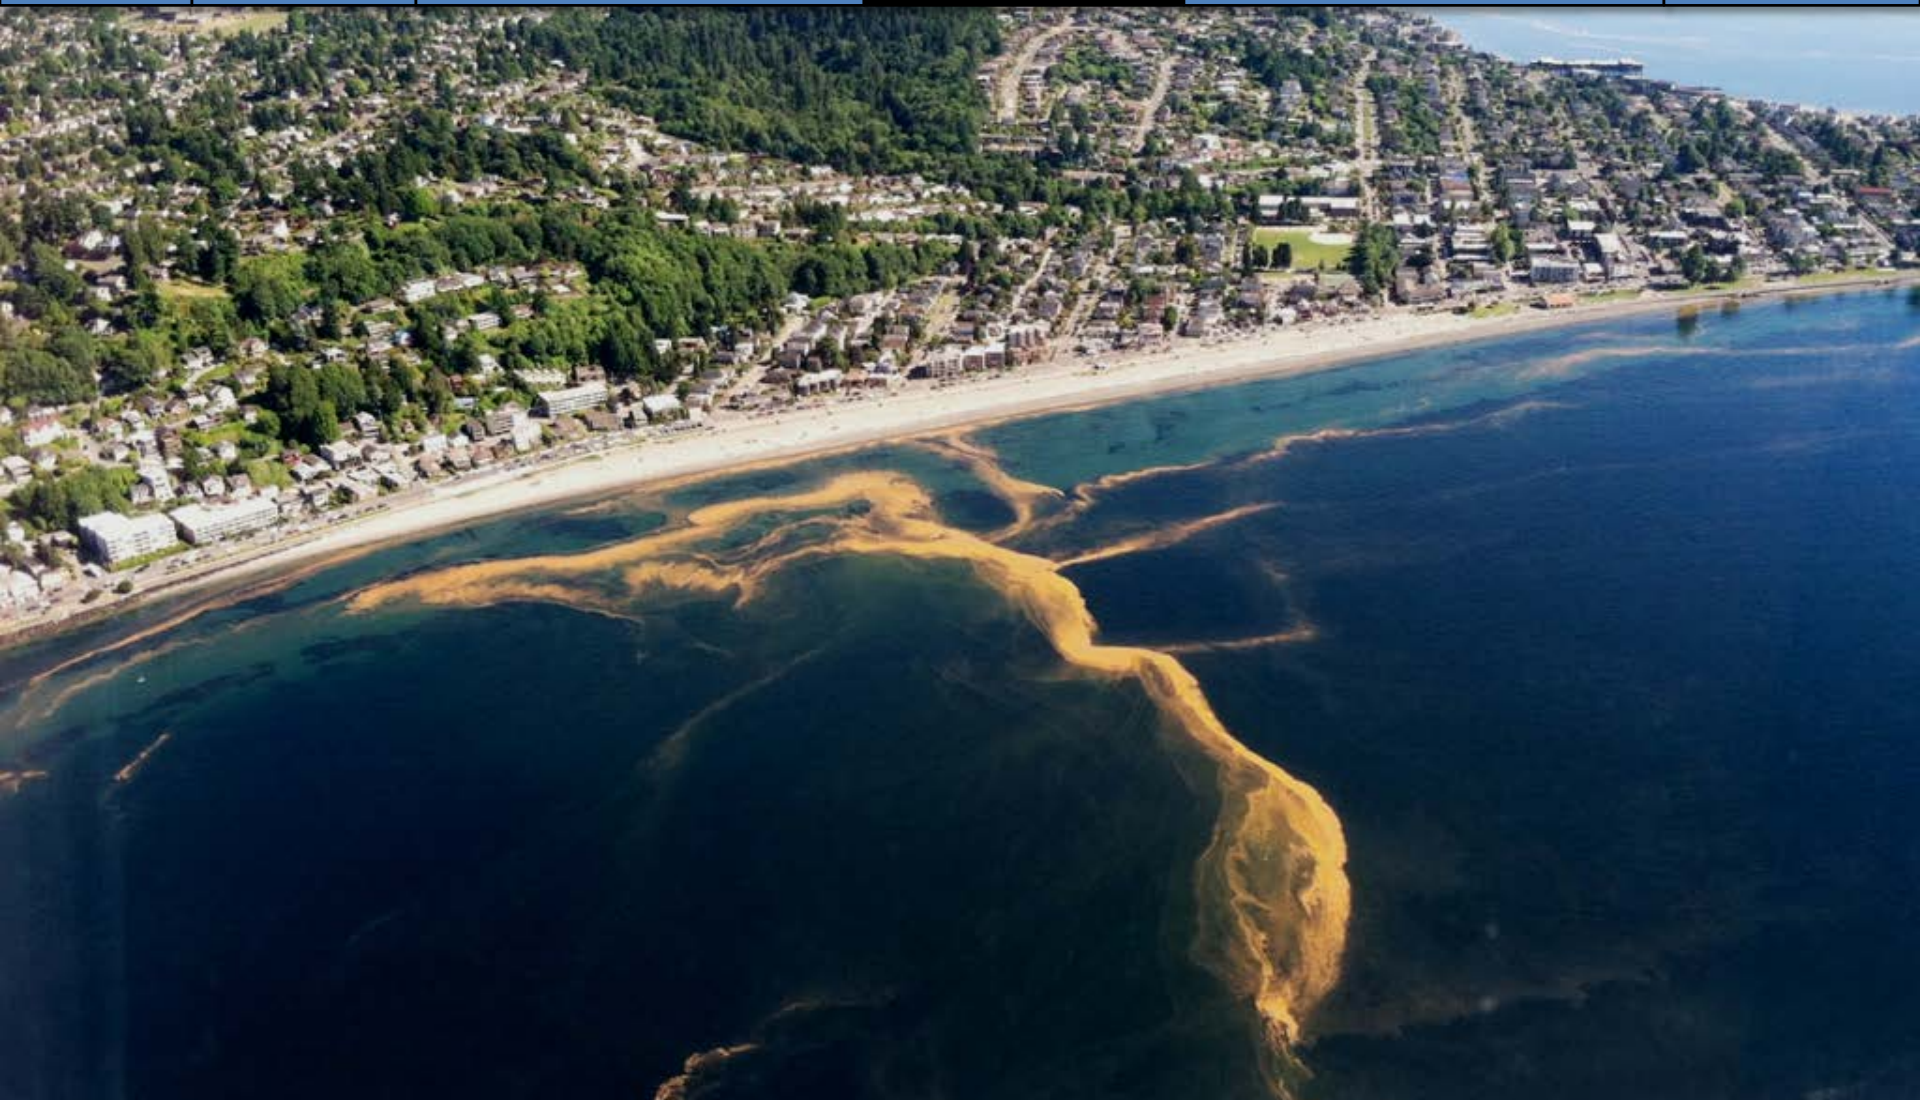
Noctiluca bloom at surface in large patch washing onto public beach.

Location: Alki Beach, West Seattle (Central Basin), 4:51 PM.

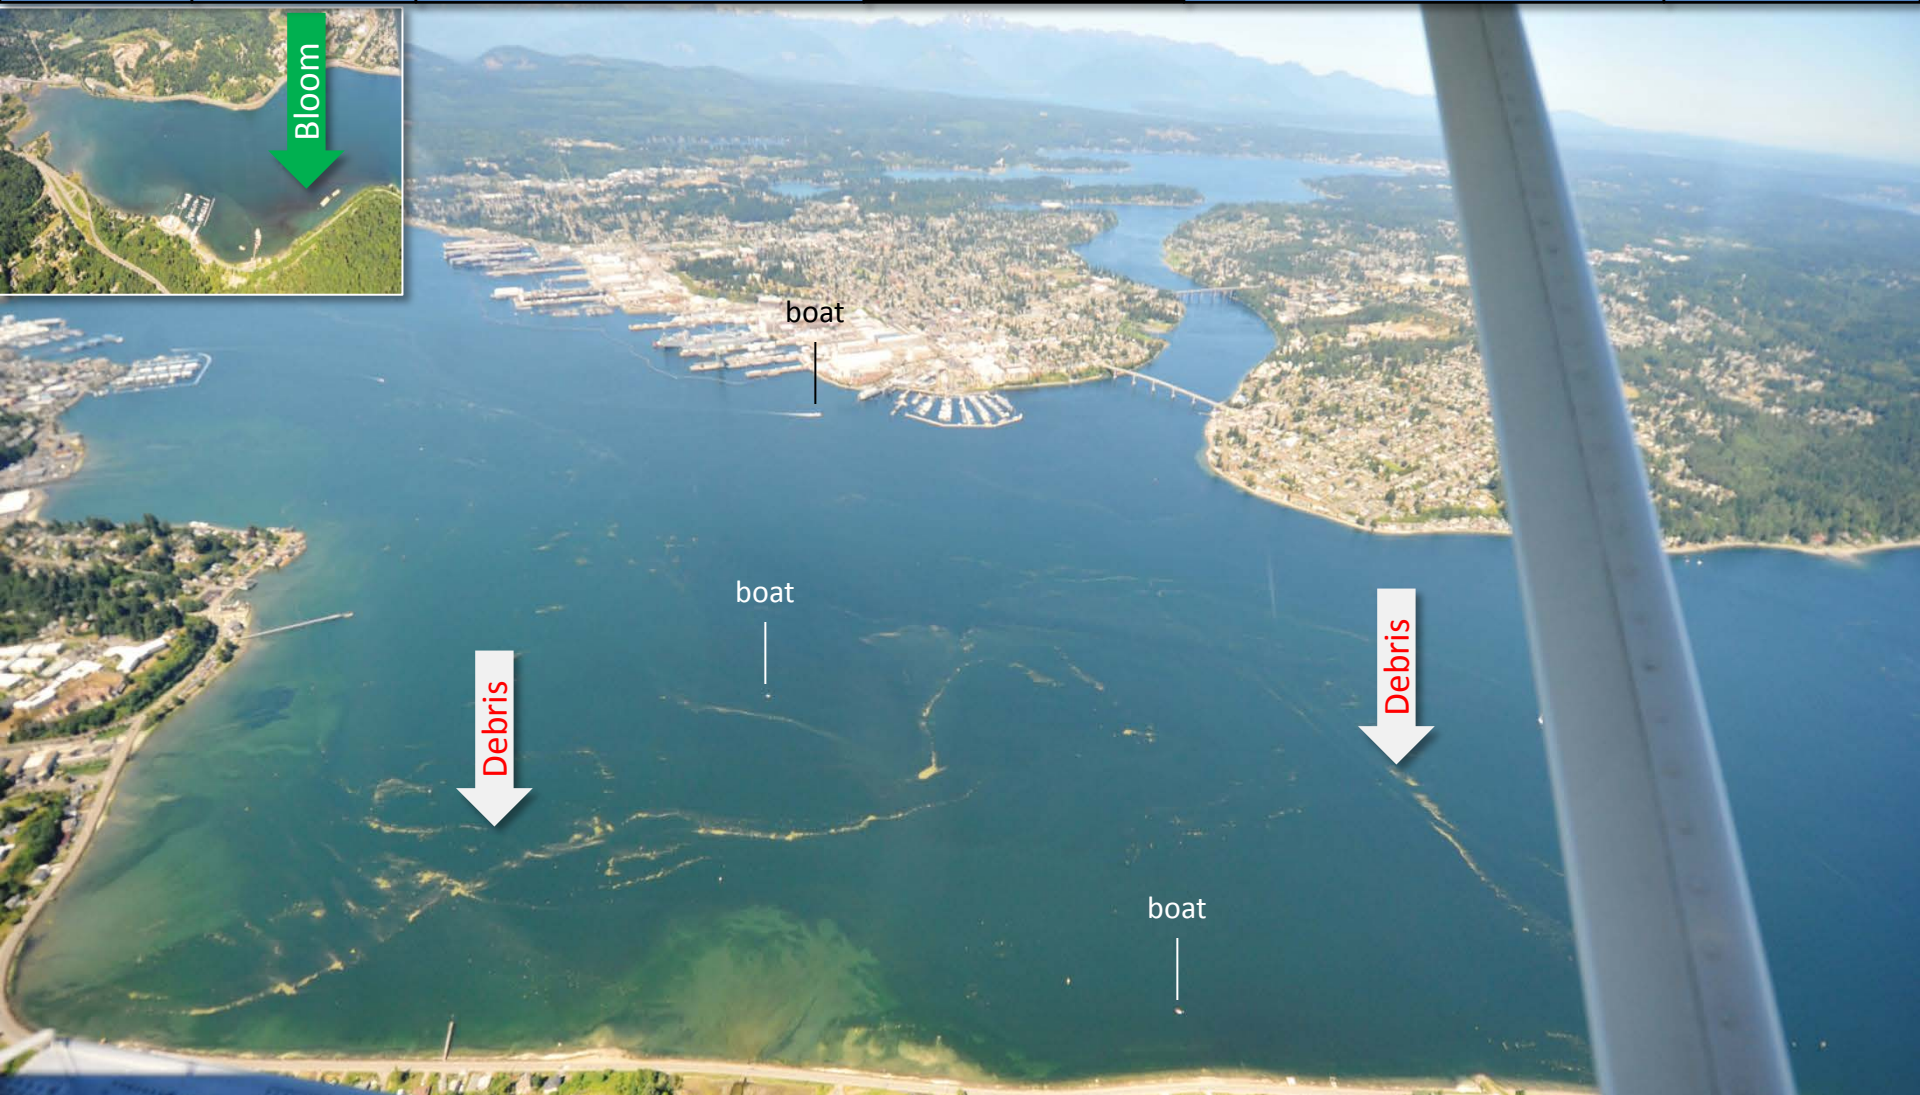
Large debris rafts (algal mats) following water movement.
Location: Sinclair Inlet (Kitsap Peninsula), 12:15 PM.

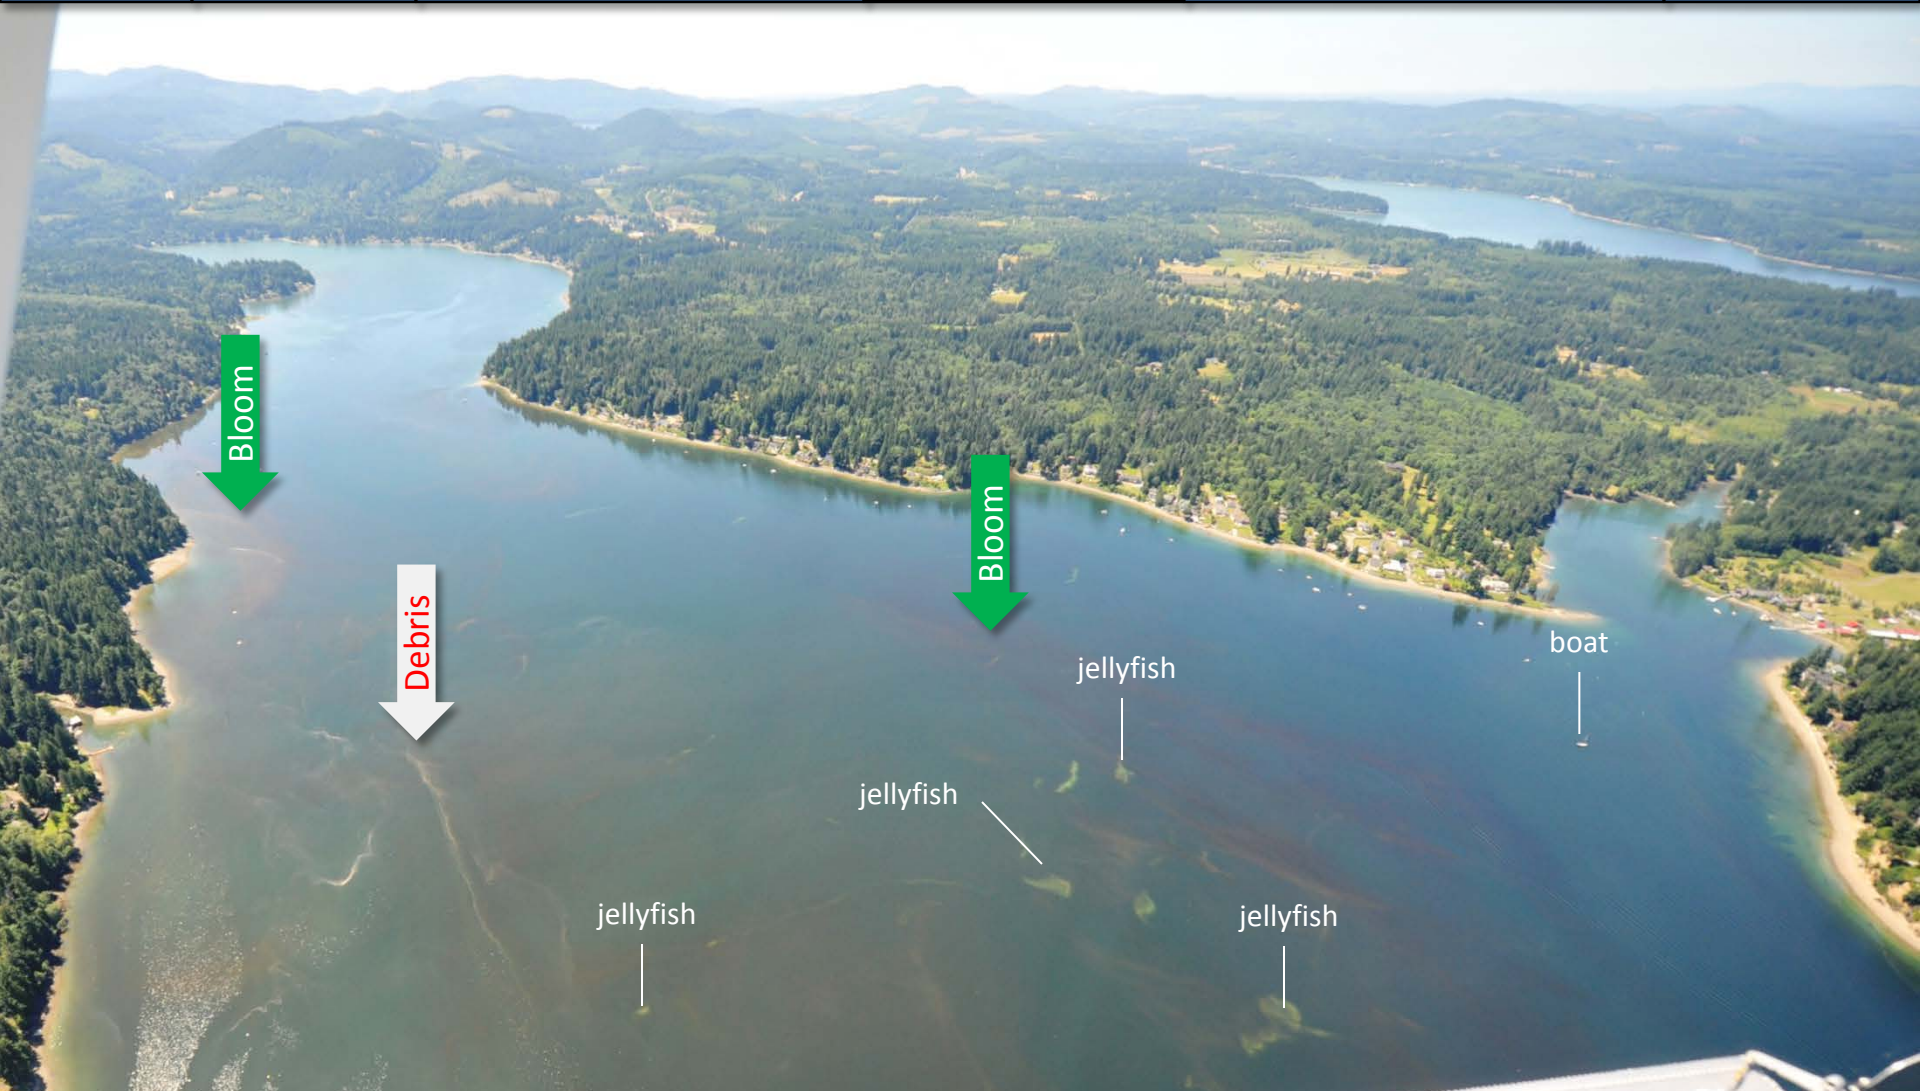
Orange and red-brown bloom and patches of jellyfish near the surface.

Location: Eld Inlet (South Sound), 1:47 PM.

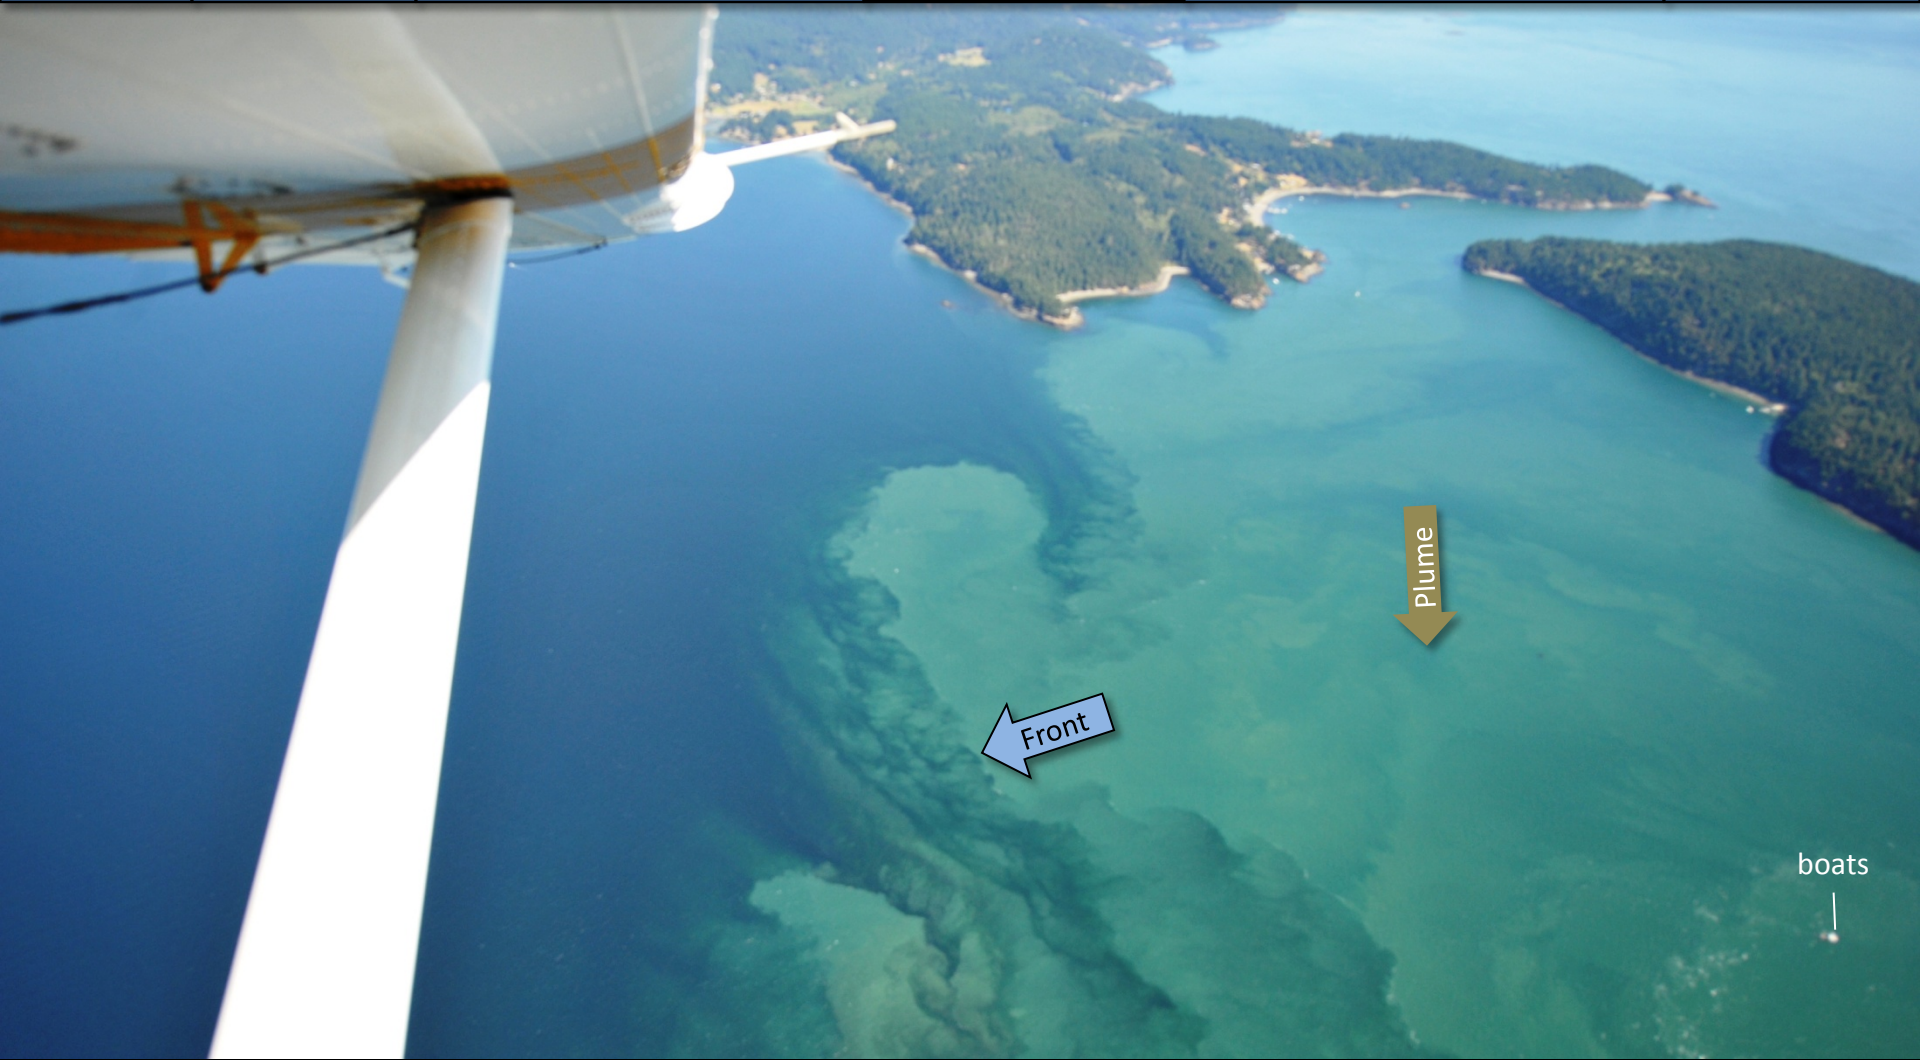
Fraser River sediment traversing and mixing dramatically with water in the San Juan Islands.
Location: Near Obstruction Island (San Juan Islands), 11:49 AM.

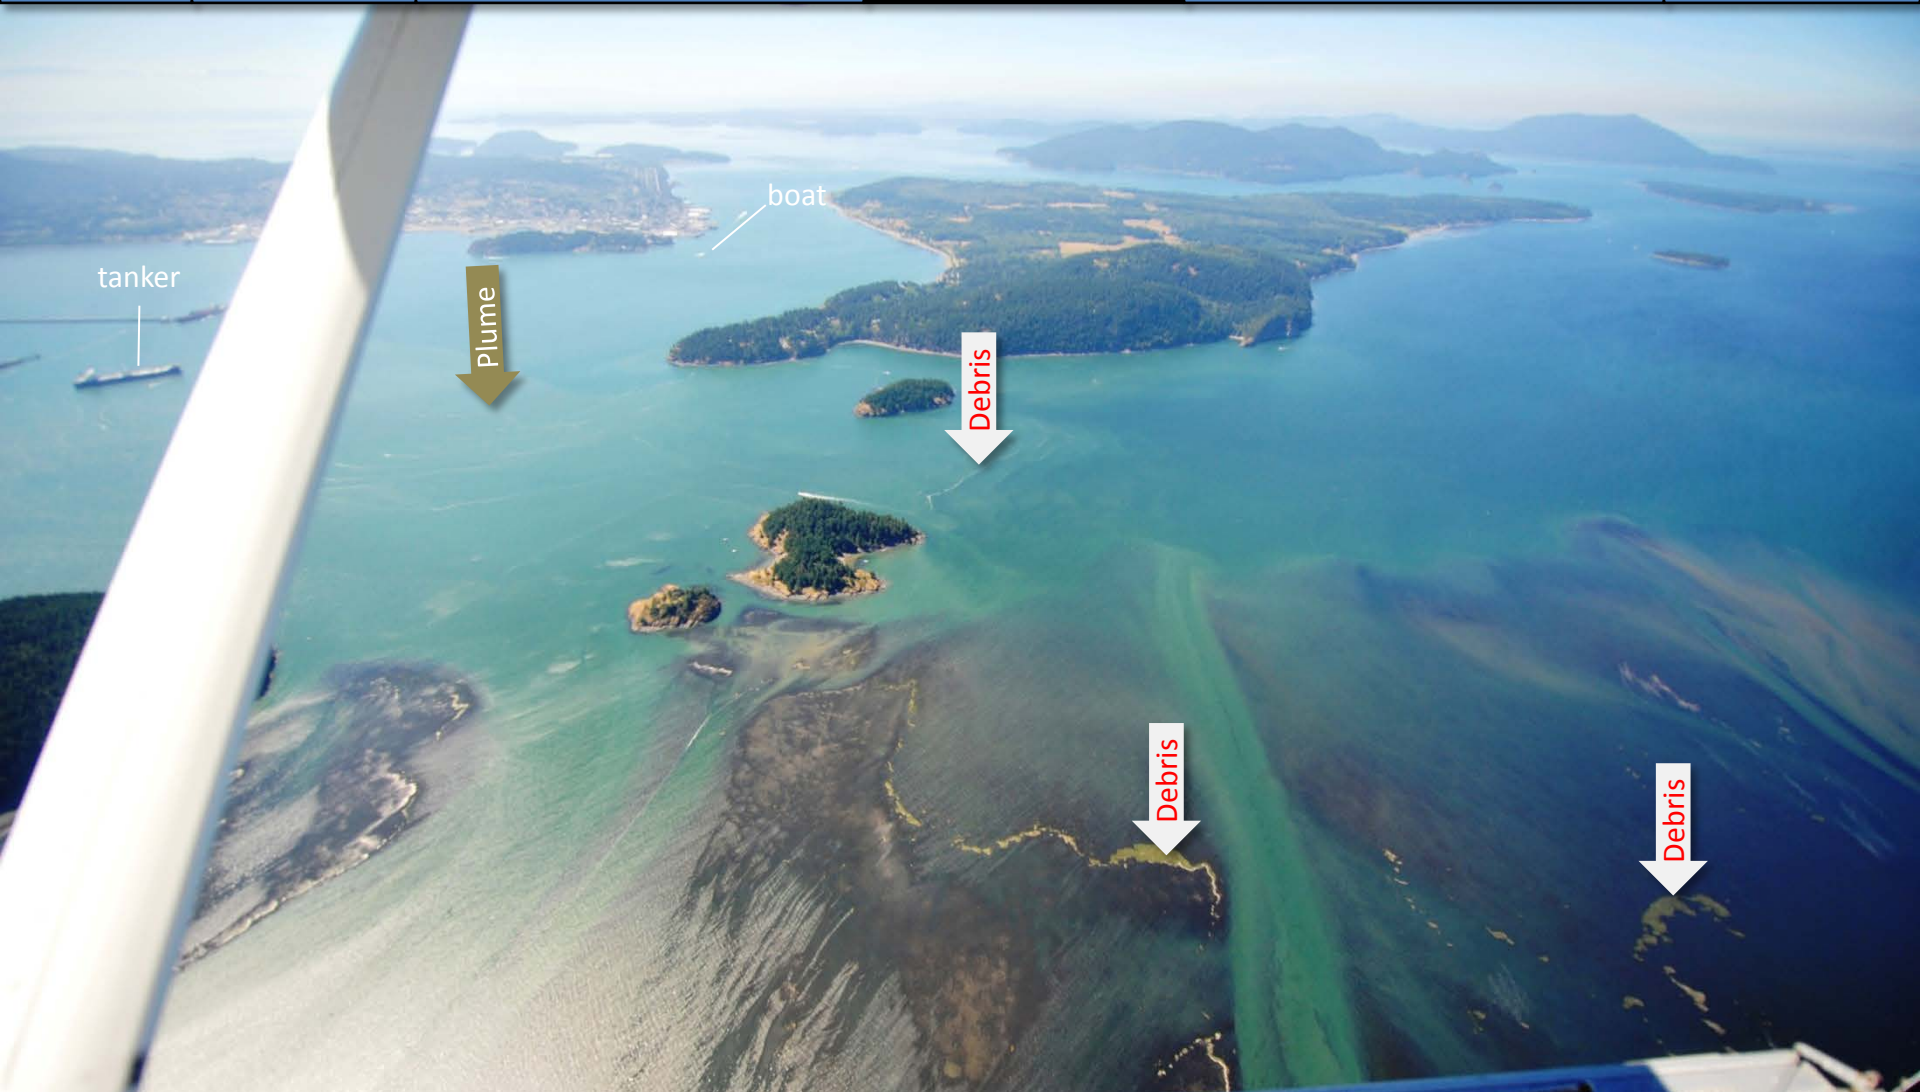
Large algal mats and organic debris.

Location: Near Saddlebag Island (Padilla Bay), 2:00 PM.

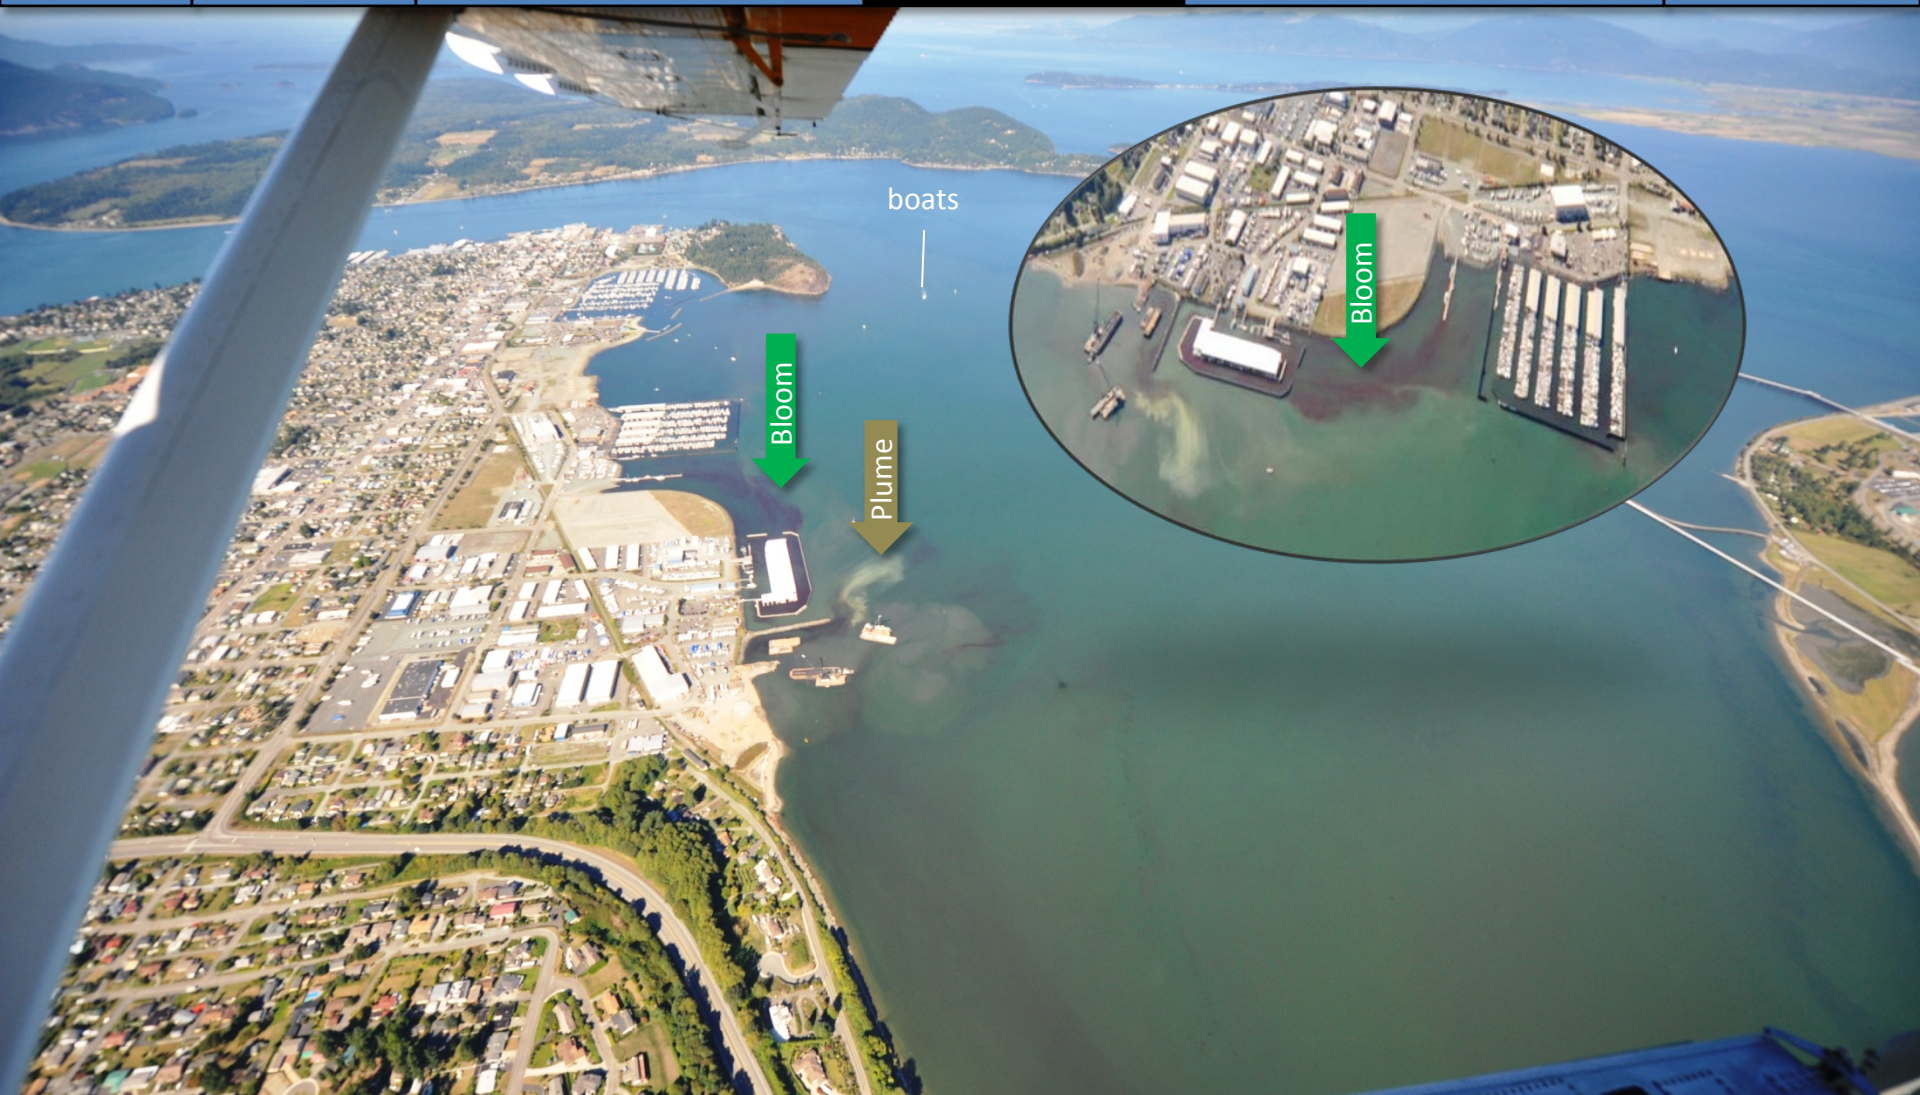
*Intense red-brown bloom in Cap Sante Marina and sediment in water near barge.
Location: Anacortes Harbor (Anacortes), 2:19 PM.*

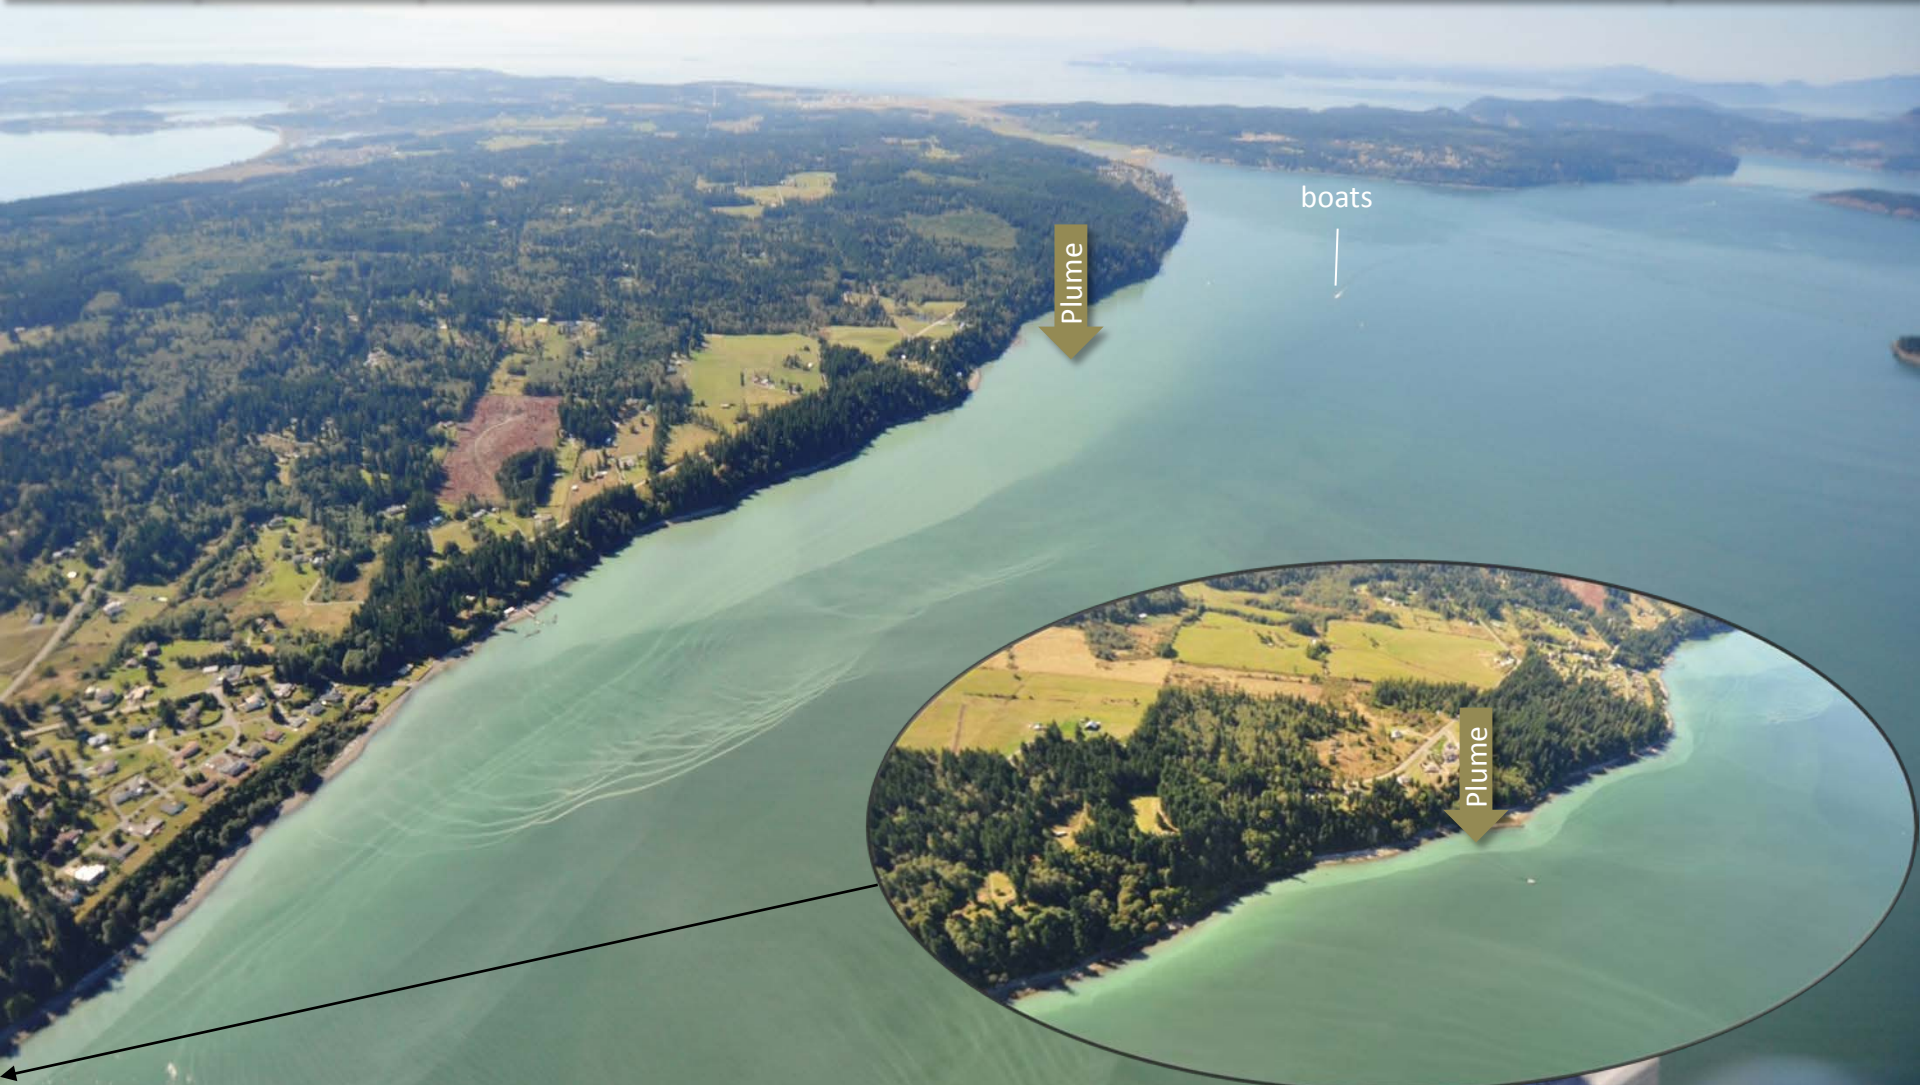
Narrow band of Skagit river plume rich in glacial silt hugging the western shore of Skagit Bay.
Location: Skagit River estuary near Dugualla Bay (Skagit Bay), 2:27 PM.

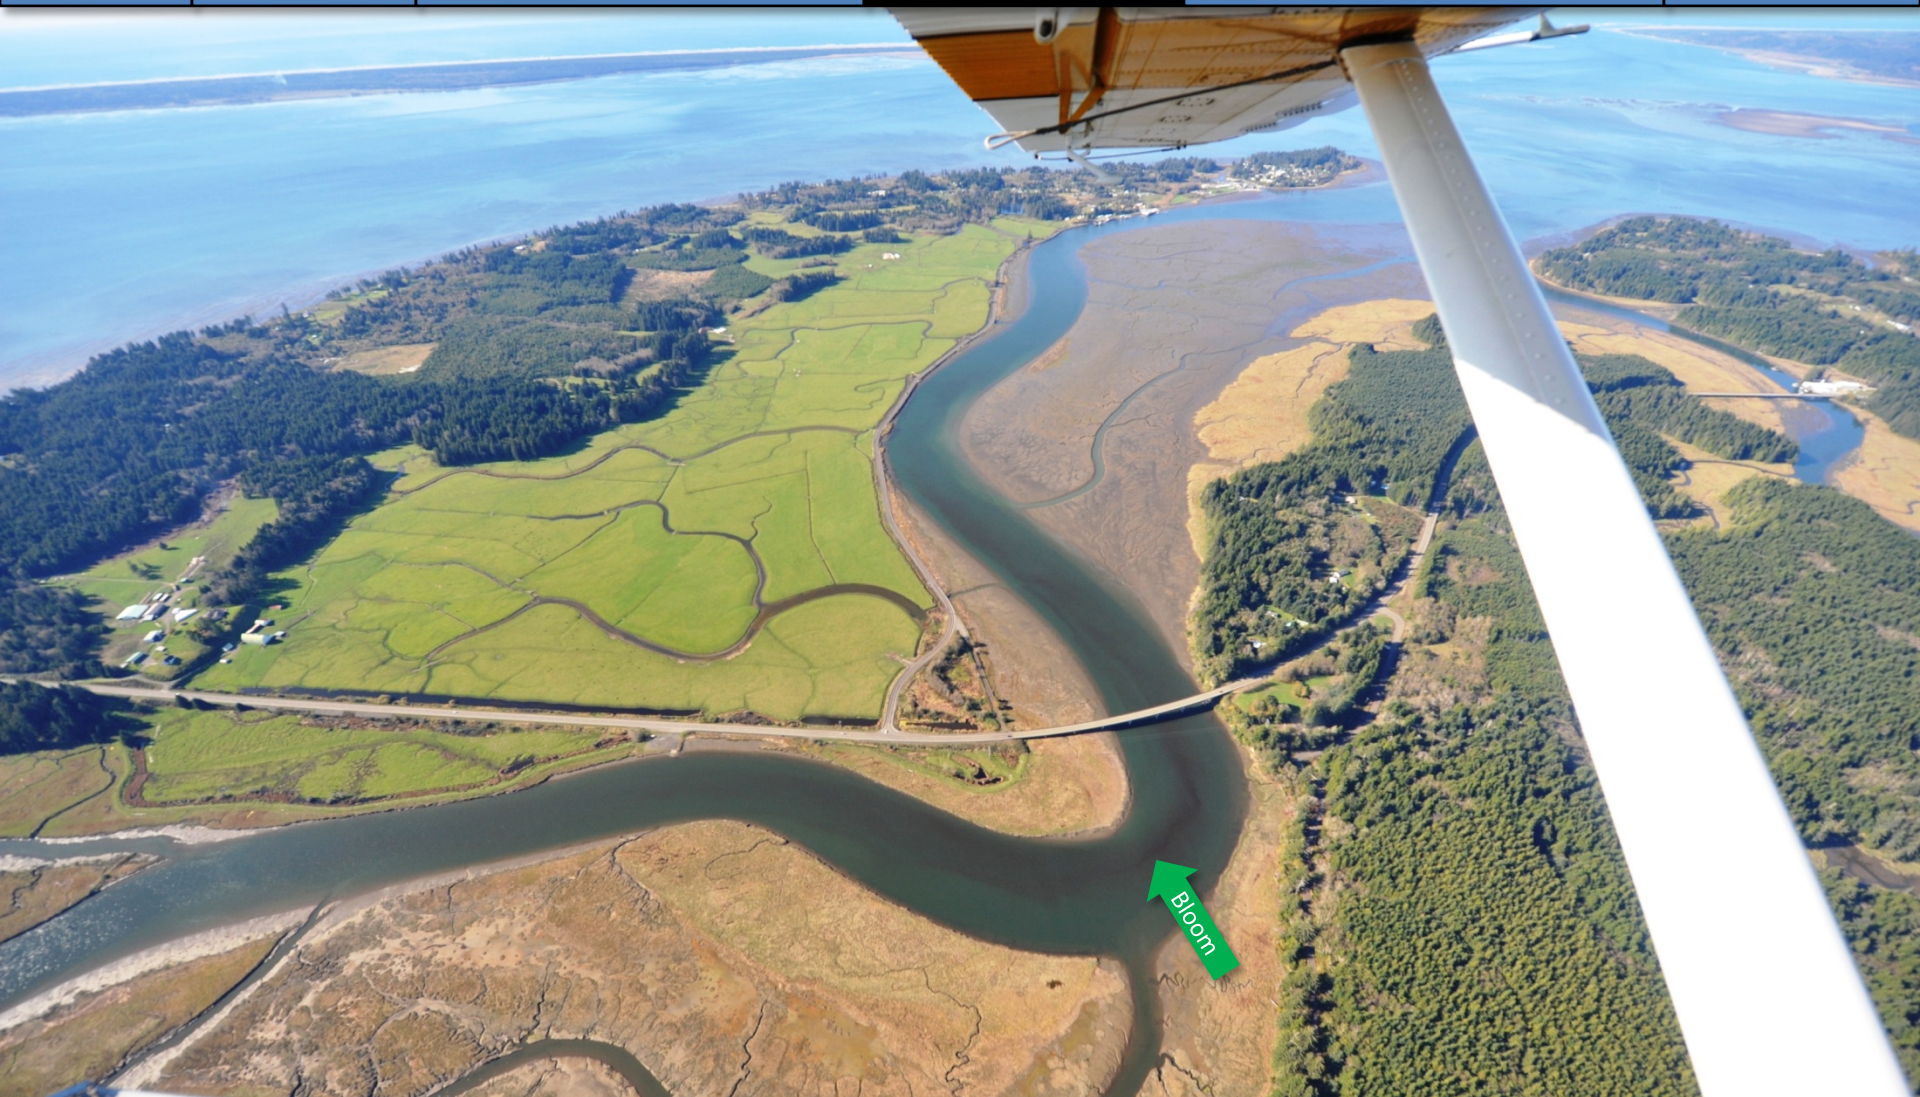
Red-brown algae bloom in Palix River near Bay Center.
Location: Palix River, US 101 bridge (Willapa Bay), 1:44 PM..

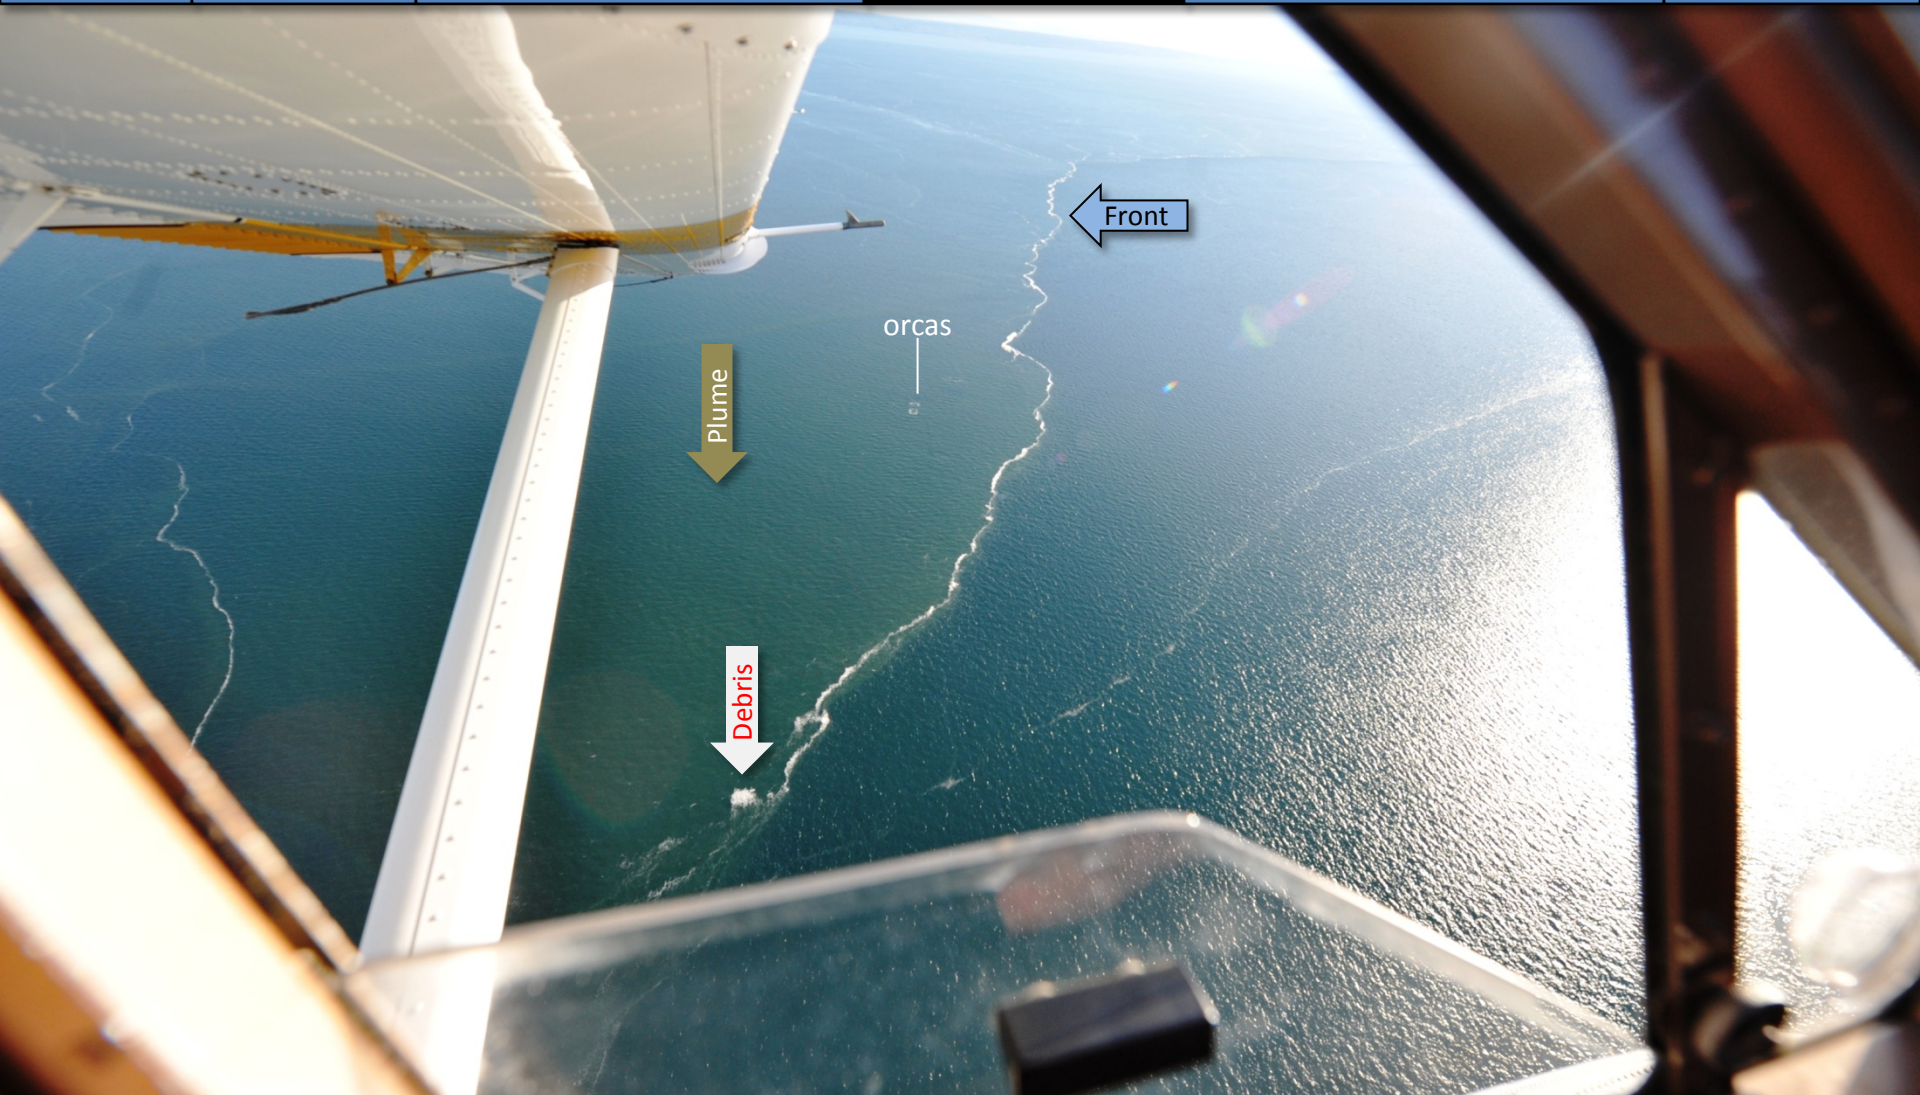
Many organic debris lines and sediment laden water originating from Whidbey Basin. Orcas swimming along front. Location: Point No Point (Central Sound), 1:50 PM.
